CAPITOL COMPLEX MASTER PLAN

FINDINGS & RECOMMENDATIONS (F & R) NEEDS ASSESSMENT

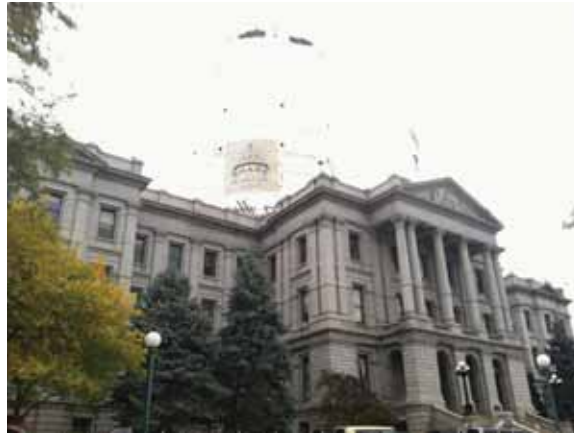
Front/West Elevation of the State Capitol

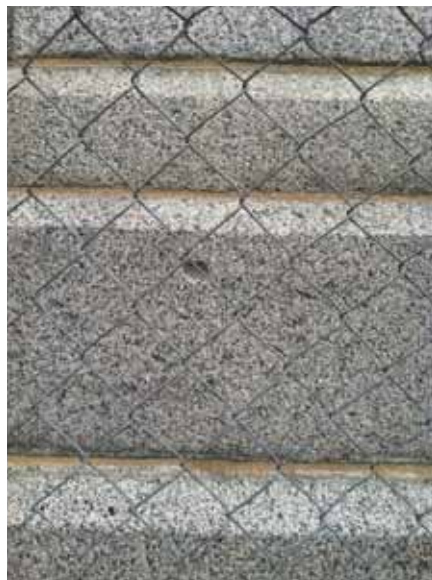
Fig. 2.1.A.1 Minor spalling of the granite observed in a few locations around the exterior of the building.

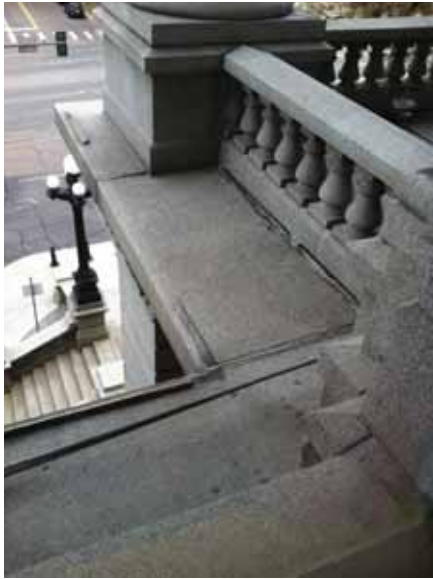
Fig. 2.1.A.2 General soiling and deterioration noted along the top edges of the readily observable sections of the granite ledges.

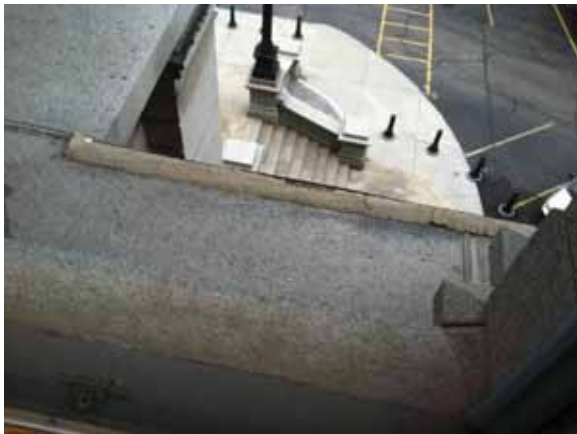
Fig. 2.1.A.3 General soiling and deterioration noted along the top edges of the readily observable sections of the granite ledges.

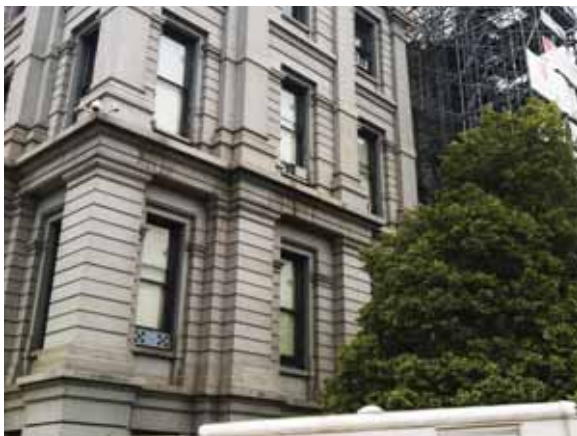
Fig. 2.1.A.4 Generally soiled granite panels noted around the exterior of the building.

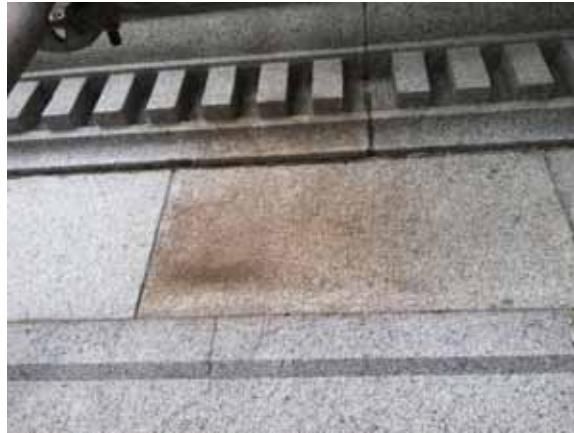
Fig. 2.1.A.5 Generally soiled granite panels noted around the exterior of the building.

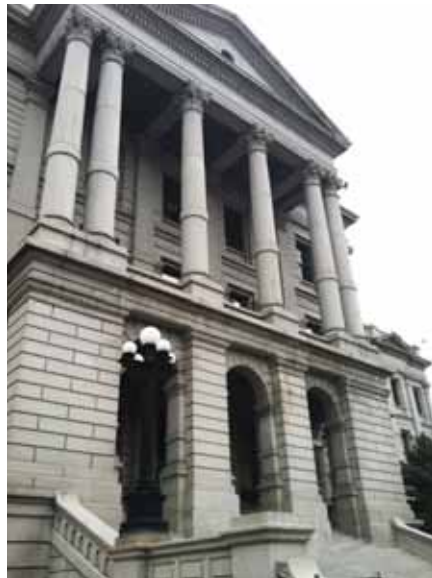
Fig. 2.1.A.6 Soiling noted around the second-story porticos above the monumental entrance porticos.

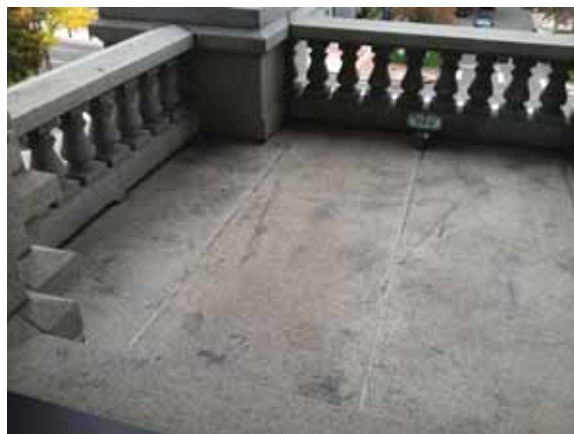
Fig. 2.1.A.7 Evidence of water damage noted at a second-story porch above a monumental entrance portico.

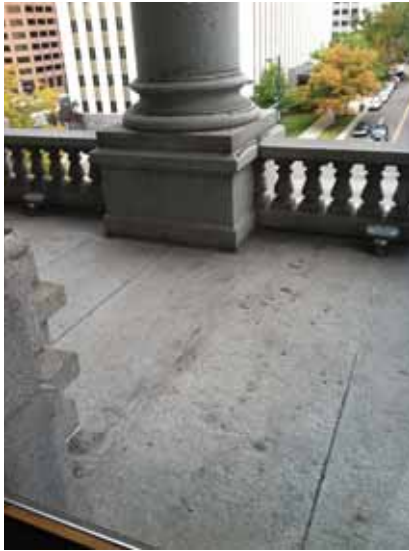
Fig. 2.1.A.8 Evidence of water damage, with spalling of the granite, noted at a readily observable second-story porch above a monumental entrance portico.

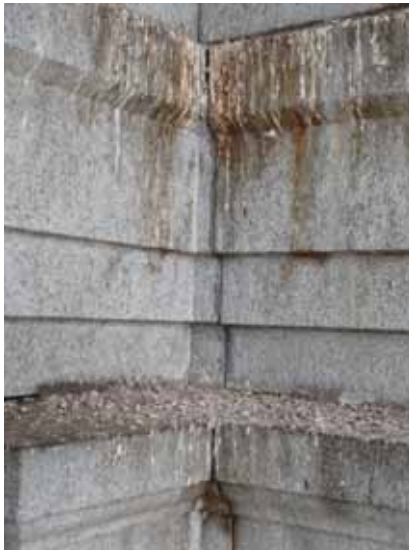
Fig. 2.1.A.9 Soiling caused by the build-up of bird droppings and dirt along the exposed top edges of the granite.

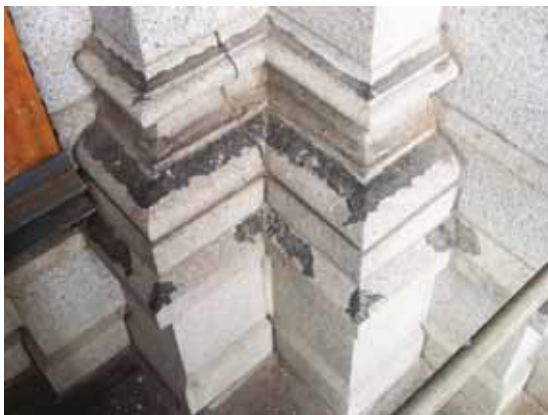
Fig. 2.1.A.10 A black rubber-like material that was applied to areas along the exposed top edges of the granite is deteriorating.

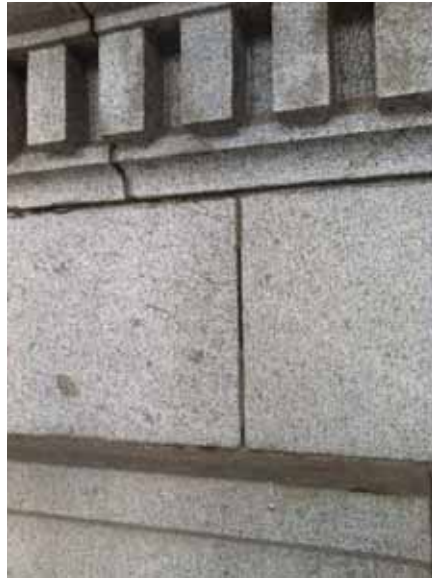
Fig. 2.1.A.11 Widespread deterioration of the material between the joints of the granite panels.

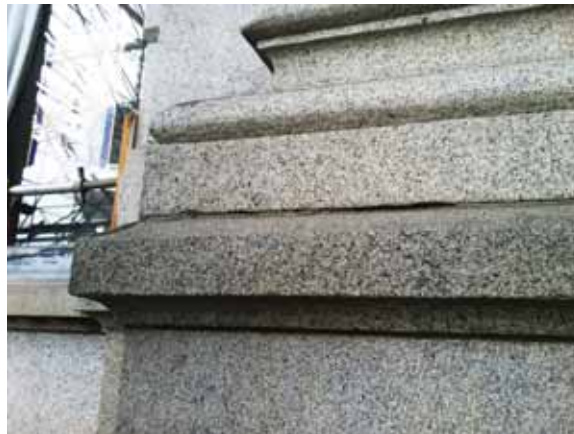
Fig. 2.1.A.12 Widespread deterioration of the material between the joints of the granite panels.

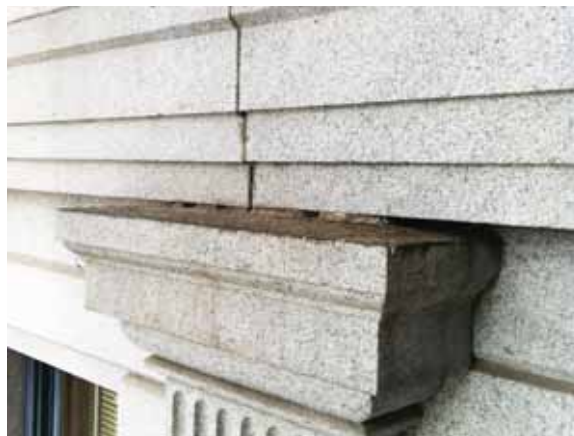
Fig. 2.1.A.13 Widespread deterioration of the material between the joints of the granite panels.

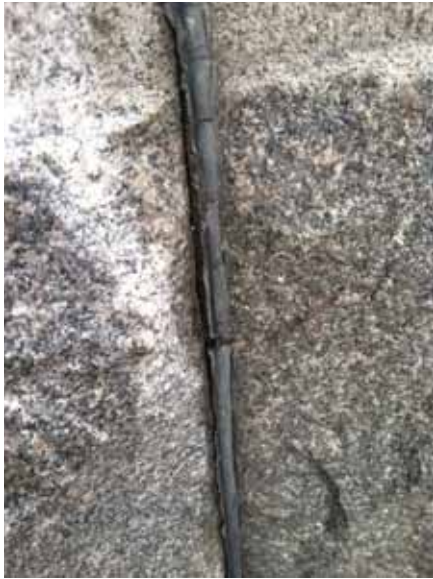
Fig. 2.1.A.14 Widespread deterioration of the material between the joints of the granite panels.

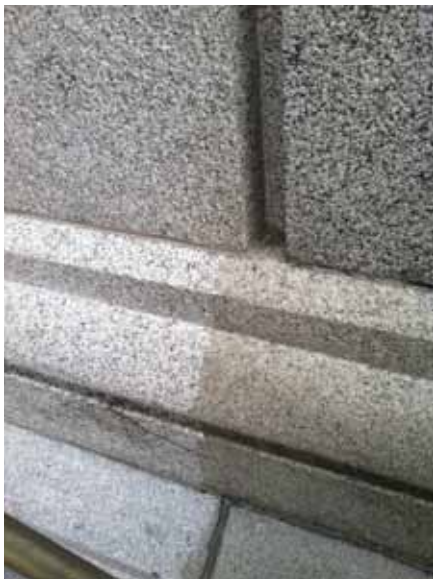
Fig. 2.1.A.15 Test-cleaning of the granite panels was observed to have started on the south end of the east side of the building.

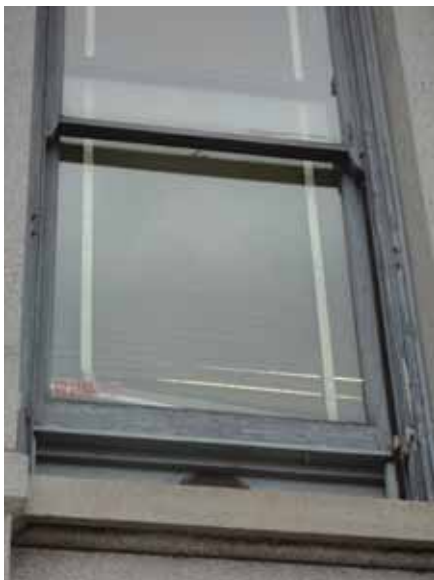
Fig. 2.1.A.16 Generally faded and peeling paint observed at the wood window frames.

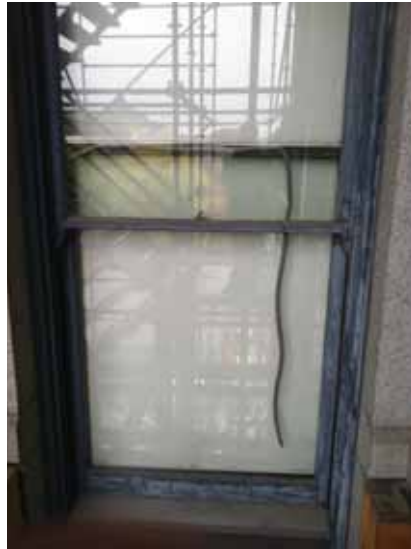
Fig. 2.1.A.17 General deterioration noted at the readily observable windows around the exterior of the building.

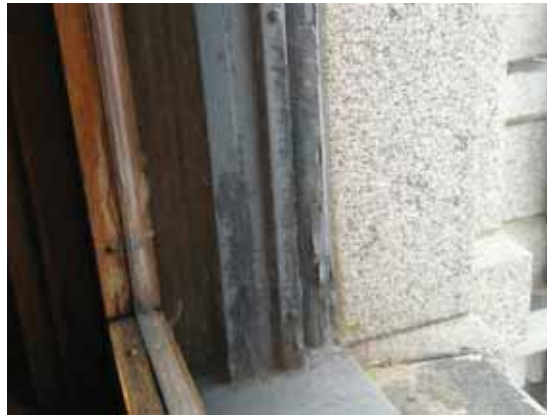
Fig. 2.1.A.18 Generally faded and peeling paint observed at the wood window frames.

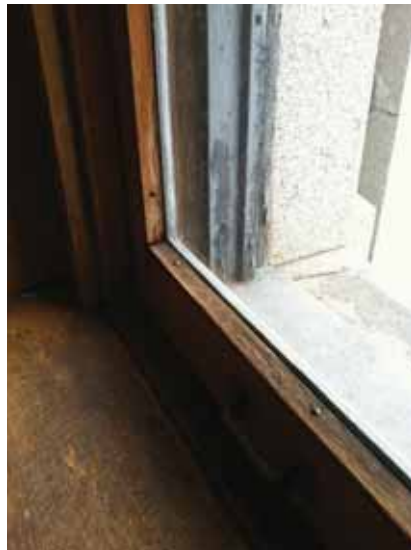
Fig. 2.1.A.19 Evidence of water damage viewed from the interior side of a window.

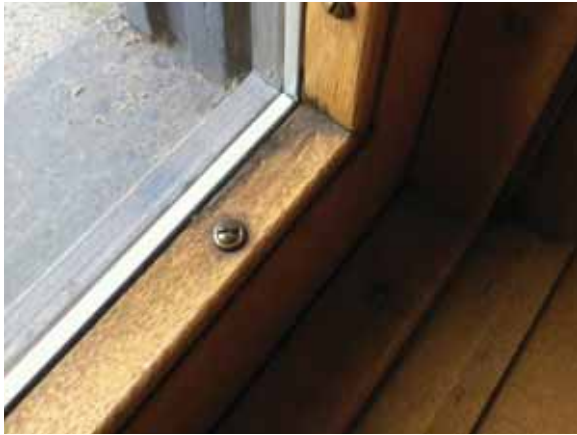
Fig. 2.1.A.20 Evidence of water damage viewed from the interior side of a window.

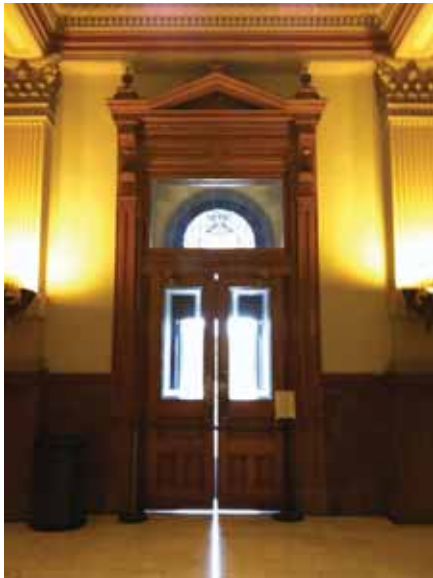
Fig. 2.1.A.21 Interior doors at the entrance vestibules were generally noted to have air gaps between the door slabs.

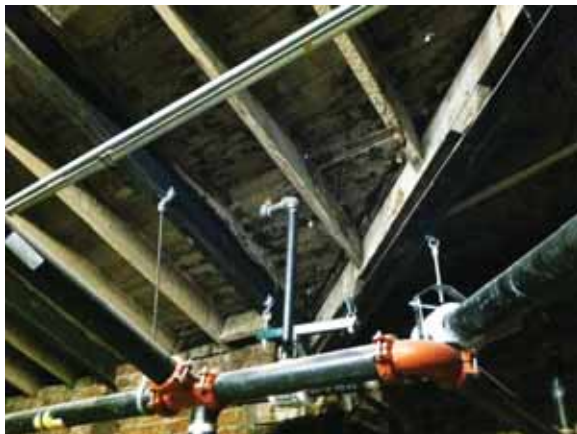
Fig. 2.1.A.22 Signs of water damage observed at the roof throughout the Attic.

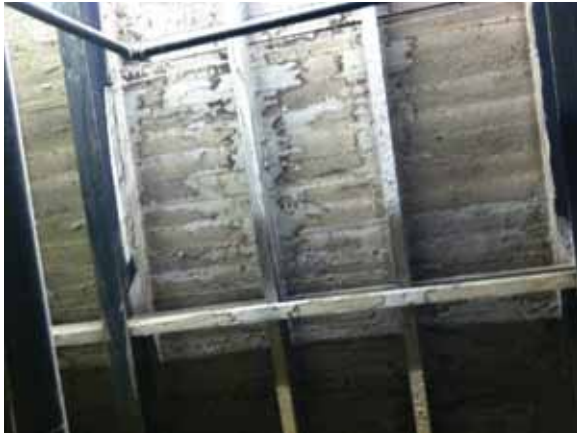
Fig. 2.1.A.23 Signs of water damage observed at the roof throughout the Attic.

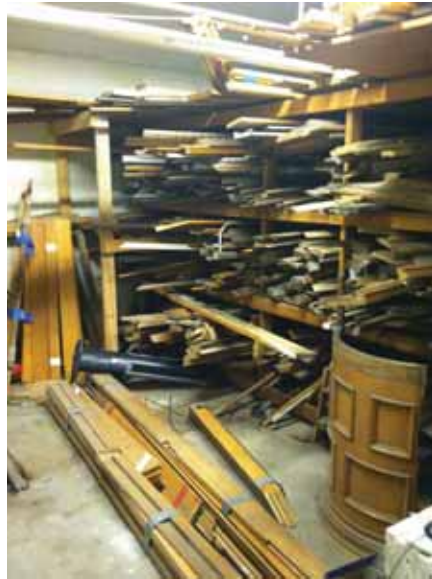
Fig. 2.1.B.1 Storage of worn and damaged oak doors and trim observed in the sub-basement.

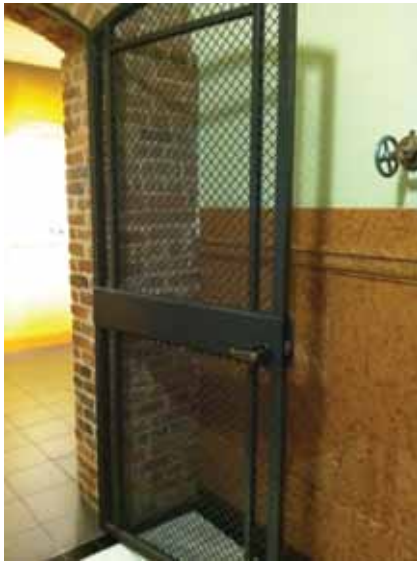
Fig. 2.1.B.2 Non fire-rated doors leading from the northwest and southwest exit stairways to the Attic Floor.

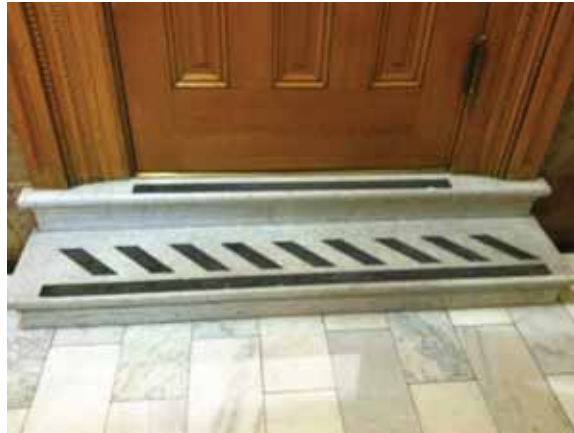
Fig. 2.1.B.4 Location noted where stairs lead directly from a door to a change in floor elevation. Landings are required for code compliance.

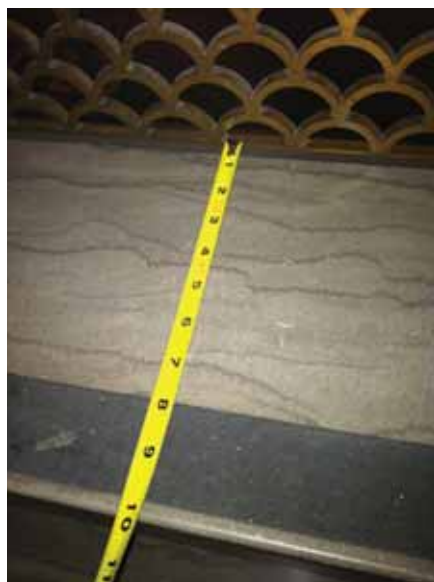
Fig. 2.1.B.5 Depth of the stair treads noted in the northwest stairway between the Third Floor and the Attic Floor.

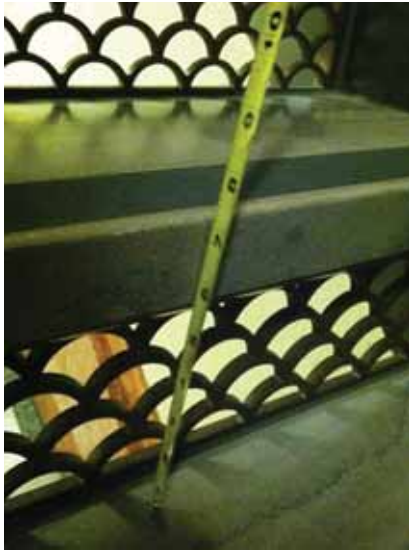
Fig. 2.1.B.6 Height of the stair risers noted in the northwest stairway between the Third Floor and the Attic Floor.

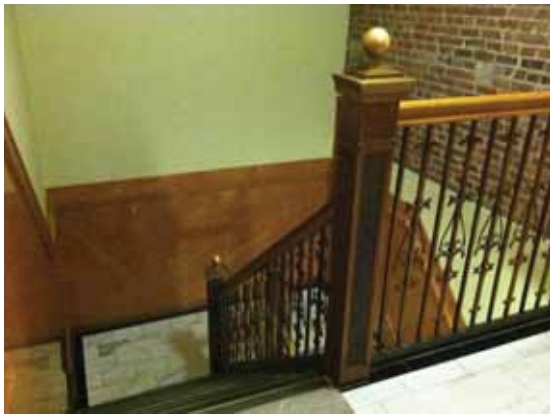
Fig. 2.1.B.7 Handrails currently exist on only one side of the stairs.

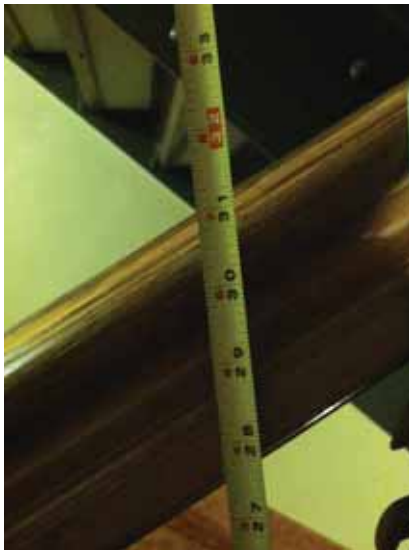
Fig. 2.1.B.8 The height to the top of the handrails, measured above the stair tread nosing, throughout the stairways from the Basement Floor to the Third Floor.

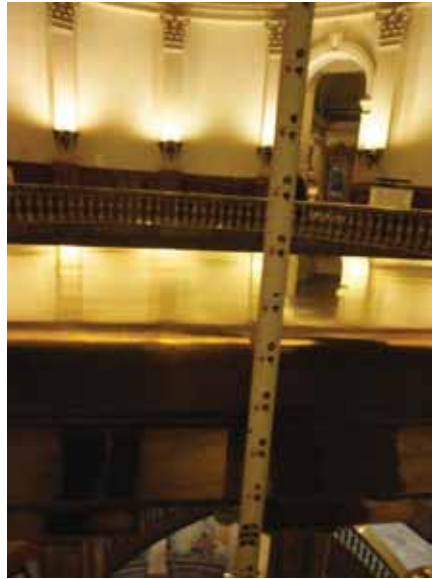
Fig. 2.1.B.9 The height to the top of the balcony railings located throughout the central arcade spaces on the First through Third Floors.

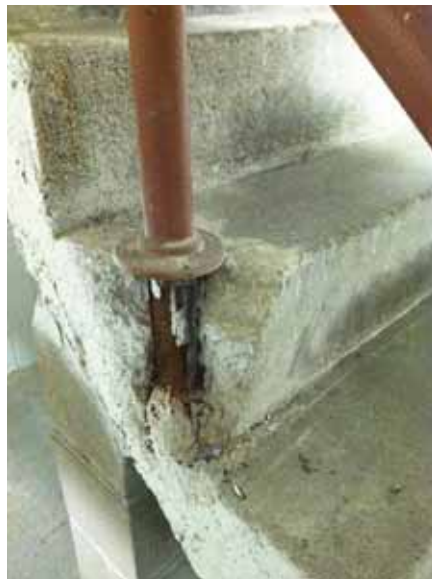
Fig. 2.1.B.10 Loose railing at the stairway leading from the south tunnel to the main floor of the sub-basement.

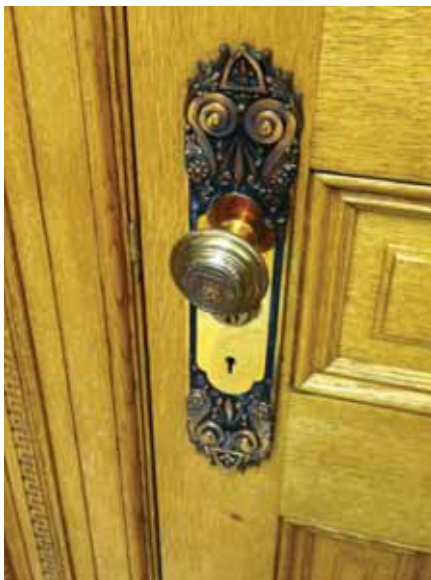
Fig. 2.1.B.11 Typical historic knob-style door handle found throughout the building.

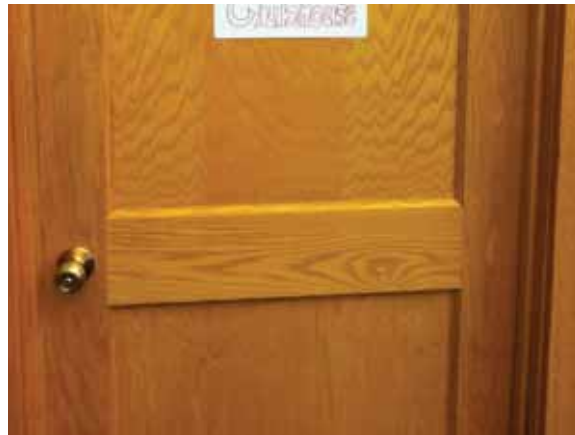
Fig. 2.1.B.12 Typical non-historic knob-style door handle found on some doors throughout the building.

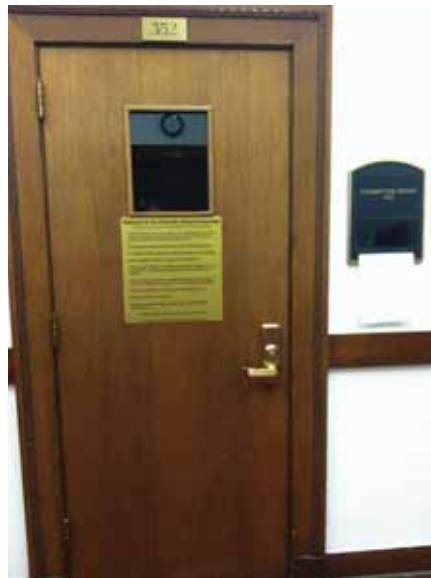
Fig. 2.1.B.13 Typical lever-style door handle found on some doors throughout the building.

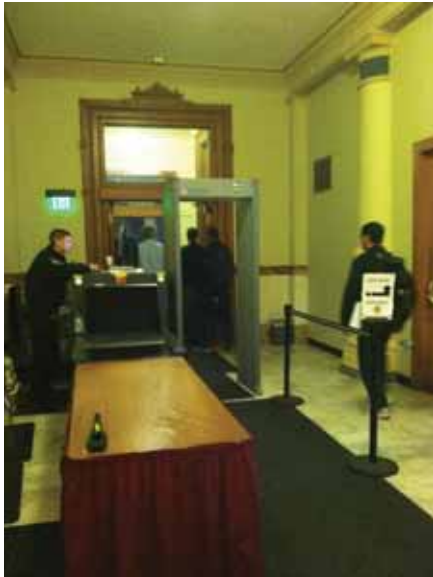
Fig. 2.1.B.14 The East 14th Avenue Entrance on the south side of the building at the Basement Floor is the accessible means of public access to and from the building.

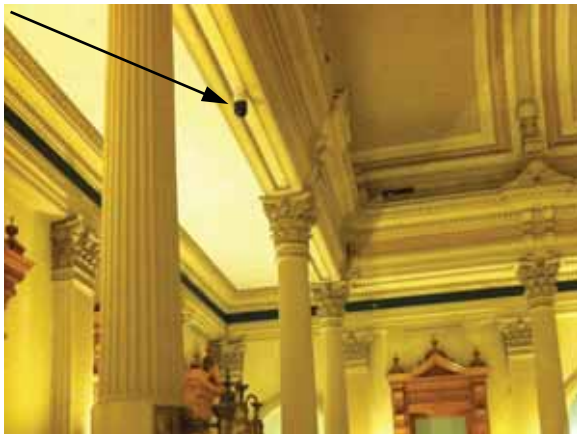
Fig. 2.1.B.15 Typical security camera observed during the site survey visit.

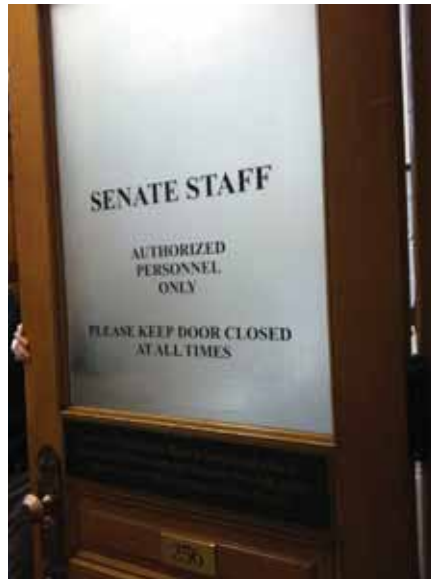
Fig. 2.1.B.16 Signage observed on a door regarding security specific to an area of the building.

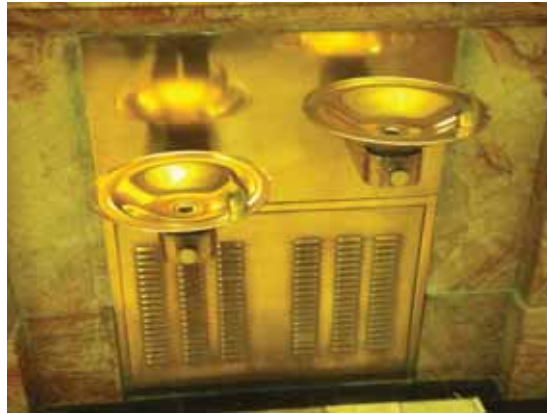
Fig. 2.1.C.3 Typical accessible drinking fountain observed during the site survey visit.

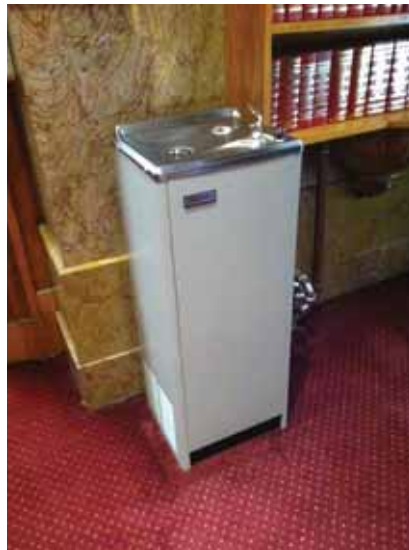
Fig. 2.1.C.4 Non-accessible drinking fountain noted in the Senate Gallery.

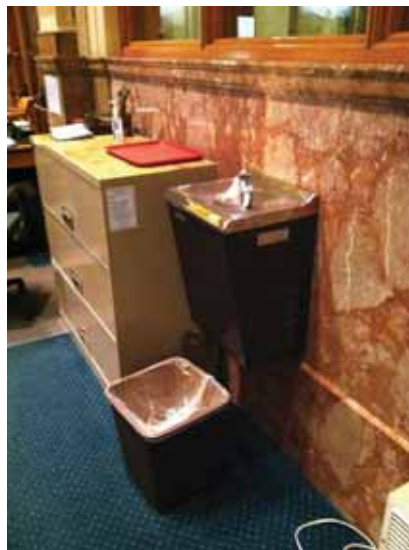
Fig. 2.1.C.5 Non-accessible drinking fountain noted in the House of Representatives Gallery.

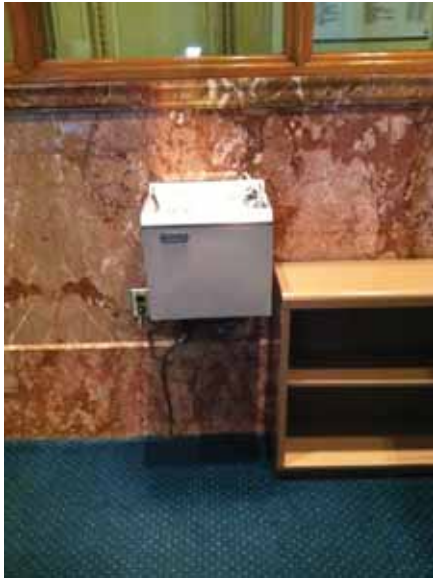
Fig. 2.1.C.6 Non-accessible drinking fountain noted in the House of Representatives Gallery.

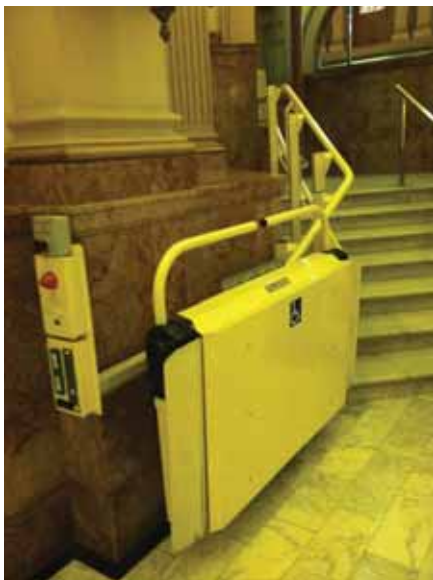
Fig. 2.1.C.7 Wheelchair lift observed on the Second Floor outside of the House of Representatives Gallery.

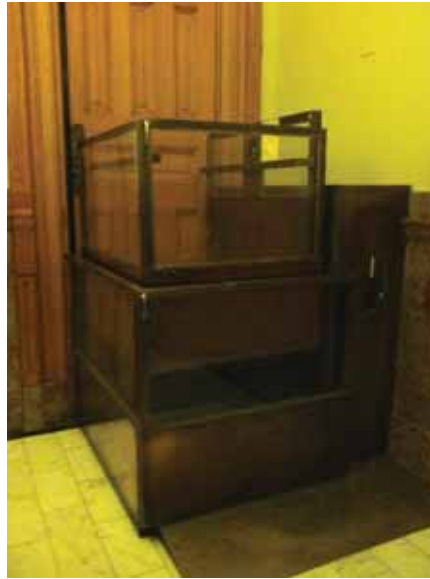
Fig. 2.1.C.8 Wheelchair lift observed on the Second Floor outside of the Senate Gallery.

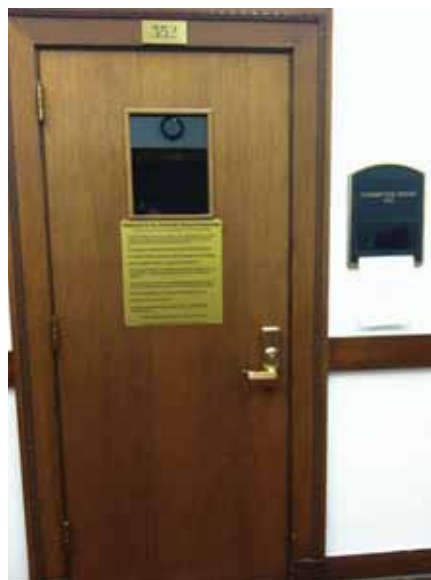
Fig. 2.1.C.9 Inconsistent signage styles observed throughout.

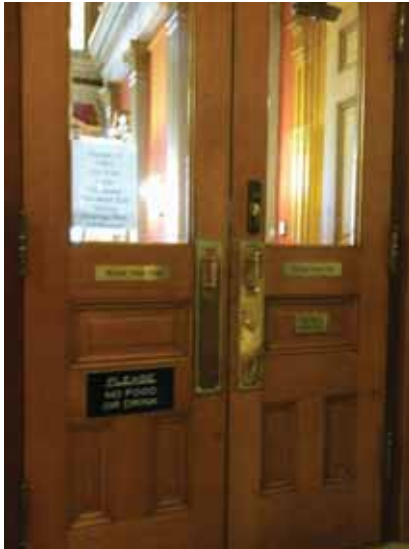
Fig. 2.1.C.10 Inconsistent signage styles observed throughout.

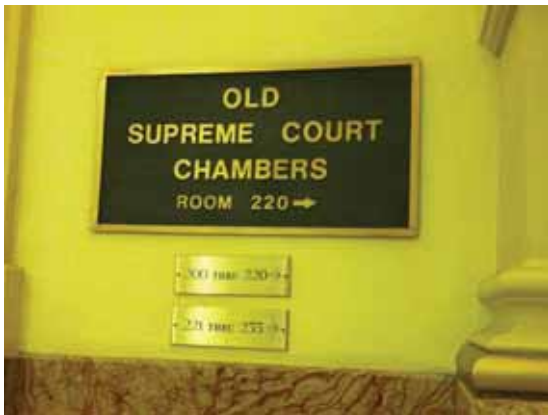
Fig. 2.1.C.11 Inconsistent signage styles observed throughout.

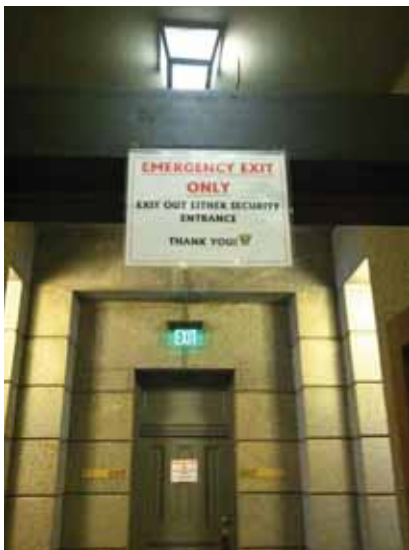
Fig. 2.1.C.12 Inconsistent signage styles observed throughout.

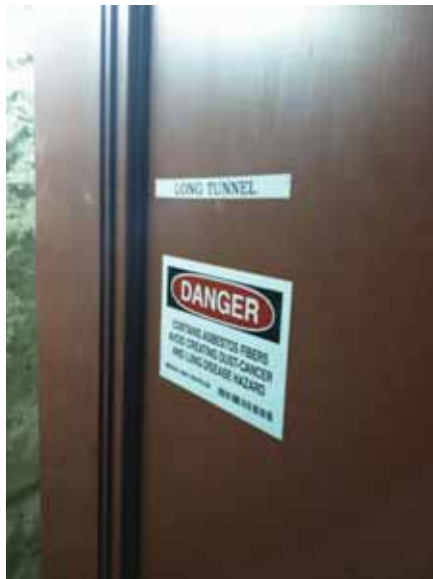
There is also asbestos known to be present throughout the Long Tunnel (see Fig. 2.1.E.1).

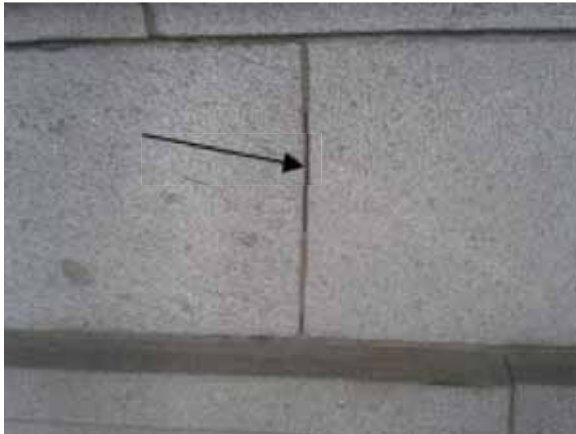
The exterior of the structure was in good condition. Minor spalls and cracks were observed in a few areas on the granite, but are not a concern at this time. Mortar joints between the granite masonry were deteriorated and allow water to enter the structure that leads to further deterioration (Fig. 2.2.A.1).

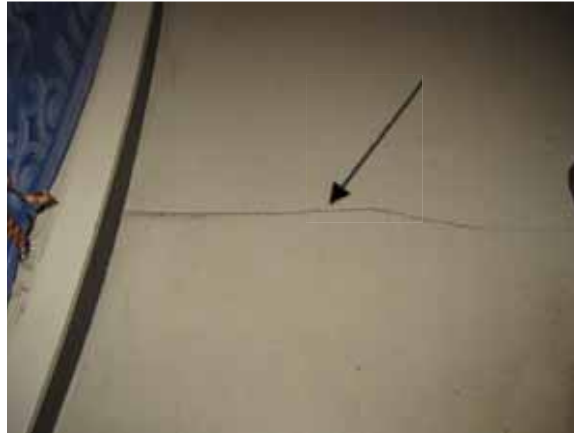
Cracks were observed throughout the interior with the majority of them concentrated on the third floor (Figs. 2.2.B.1-2.2.B.3). The cracks are minor, but should be monitored for additional movement.

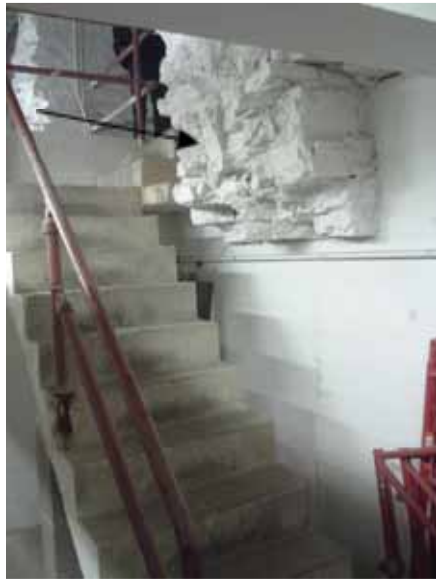
Portions of the stone columns were removed at the east tunnels (Fig. 2.2.B.4). Upon further review, a portion of the columns appear to have been removed due to a remodel and these conditions do not pose a structural concern.

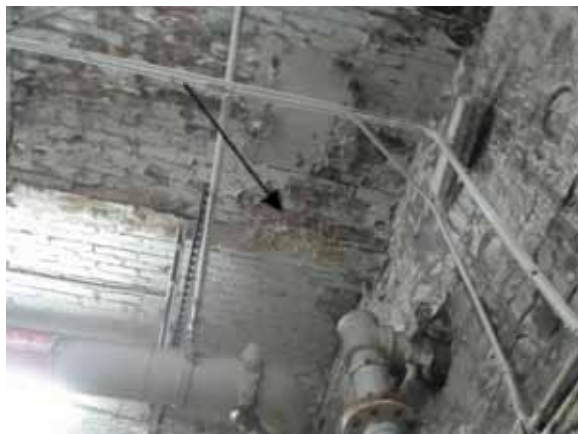
Water intrusion was observed at a portion of the south tunnel and vault ceiling (Fig. 2.2.B.5). The water has caused corrosion on some of the structural framing and paint to peel off the brick masonry. The extent of deterioration to the structural beams could not be observed. The tunnel should be waterproofed from above to prevent further water infiltration and the tunnel should be replaced with new concrete framing and a waterproofing membrane applied.

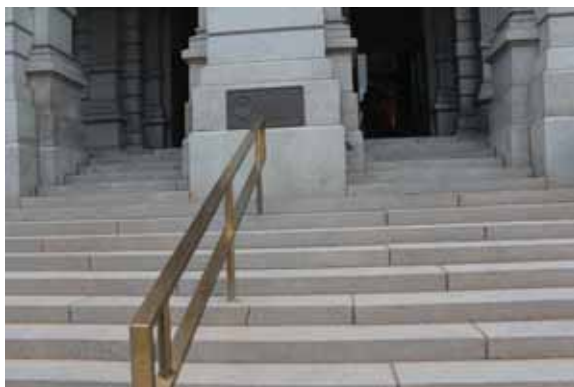
Figure 2.3.A.2 – East Entrance Stairs

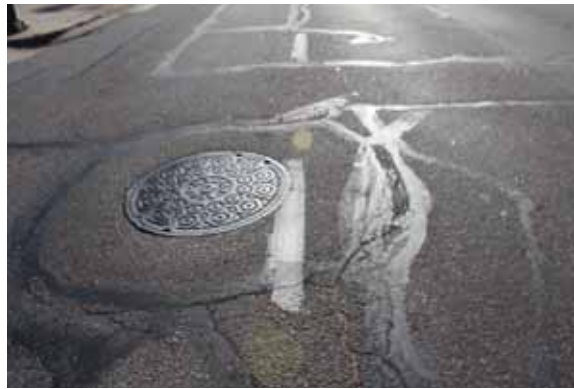
Figure 2.3.A.4 – Street Utilities

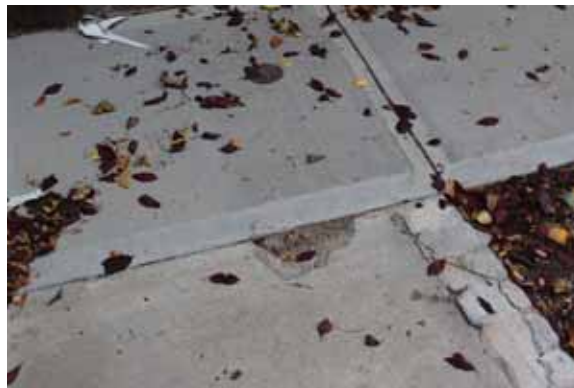
Figure 2.3.A.5 Broken Site Concrete

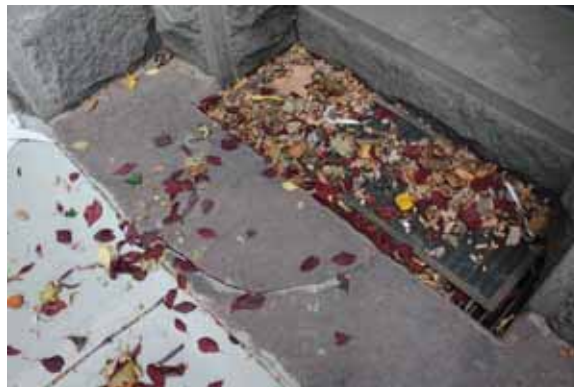
Figure 2.3.A.6 Site Pavement Crack

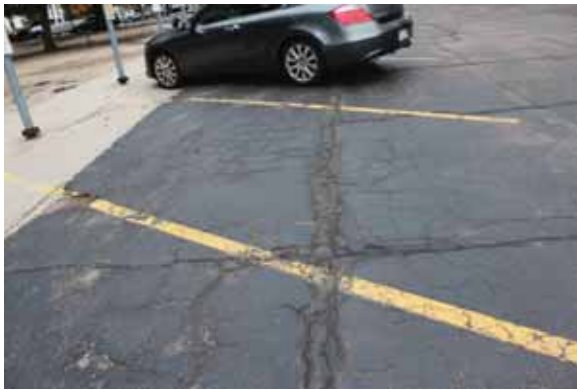
Figure 2.3.A.7 Poor Site Asphalt Condition

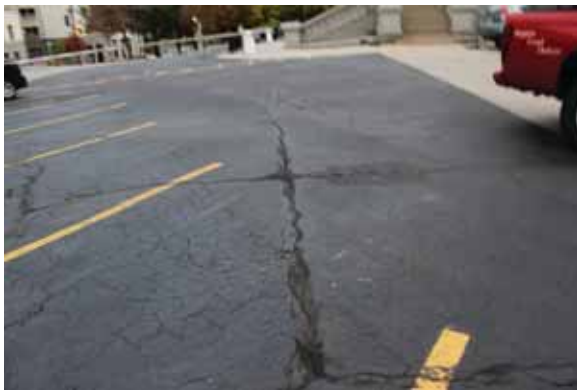
Figure 2.3.A.8 Poor Site Asphalt Condition

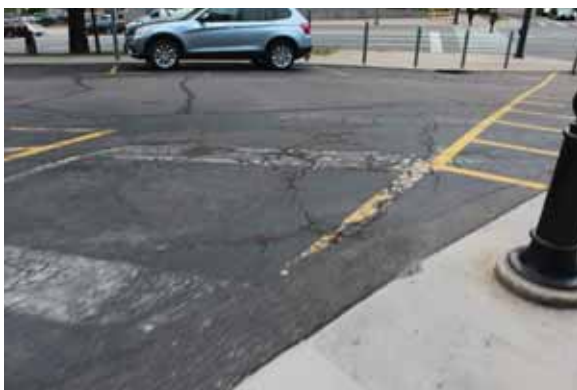
Figure 2.3.A.9 Poor Site Asphalt Condition

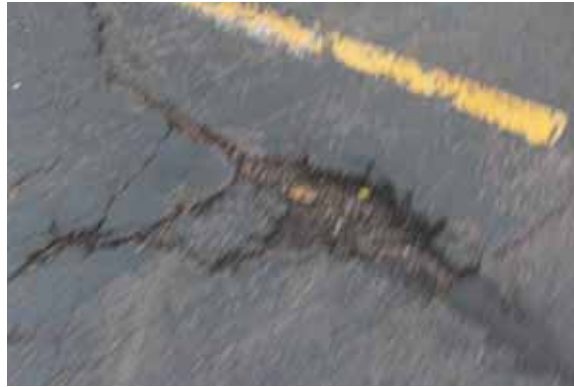
Figure 2.3.A.10 Poor Site Asphalt Condition

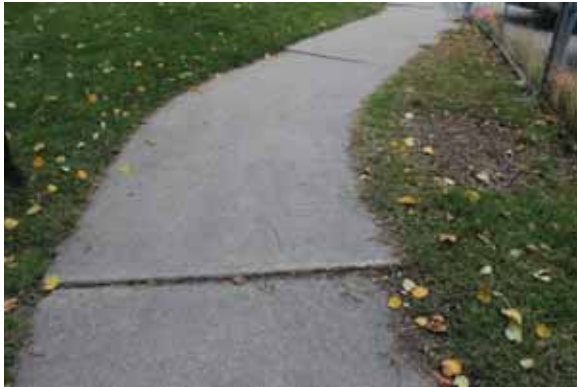
Figure 2.3.B.1 – Settlement in Concrete Along ADA Walkway

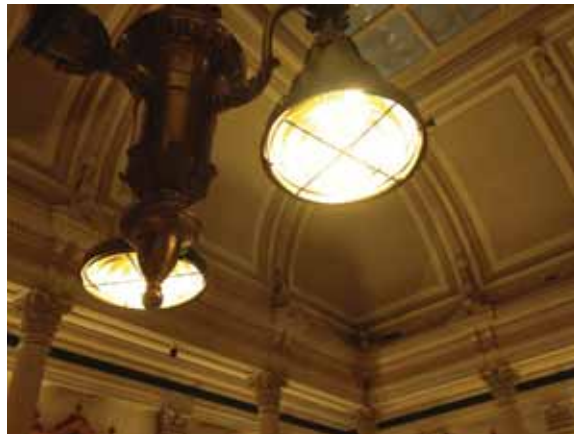
Fig. 2.4.A.5 – Compact fluorescent lamps

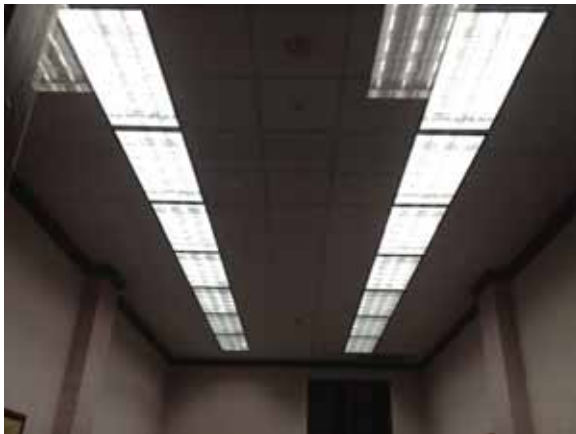
Fig. 2.4.A.7 – Linear recessed fluorescent

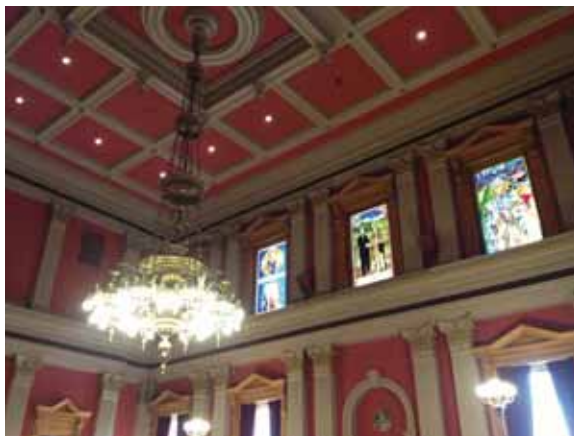
Fig. 2.4.A.9 – Chandelier and ceiling luminaires

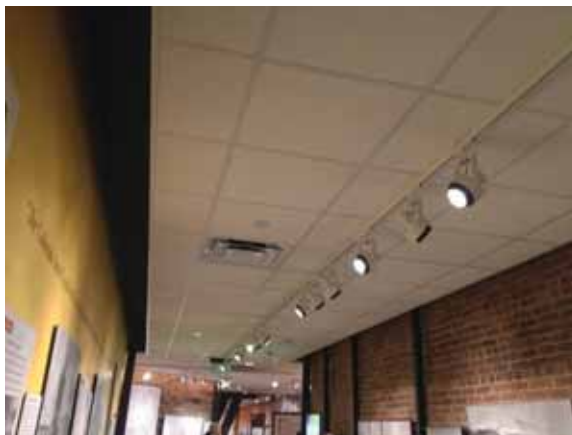
Fig. 2.4.A.13 – LED retrofit luminaires

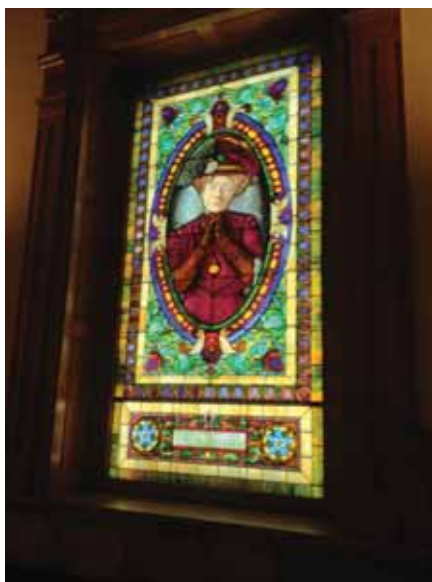
Fig. 2.4.A.14 – Backlit Display

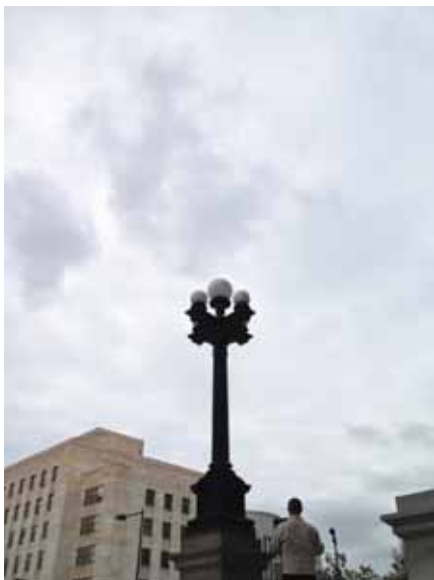
Fig. 2.4.A.16 – Exterior luminaires

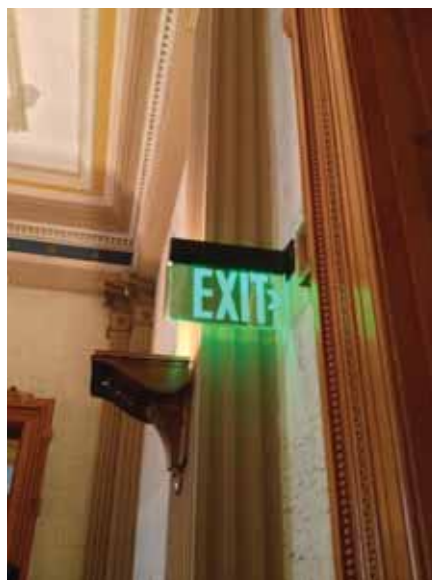
Fig. 2.4.A.18 – Exit Sign

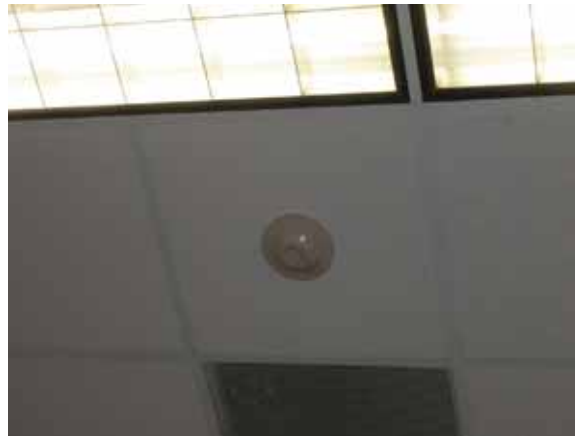
Fig. 2.4.A.20 – Smoke detector

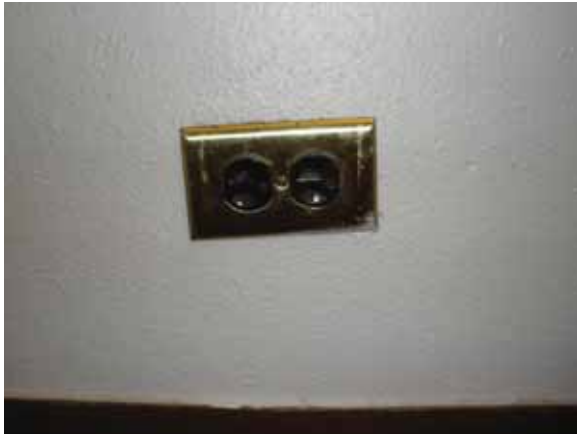
Fig. 2.4.A.22 – General receptacle

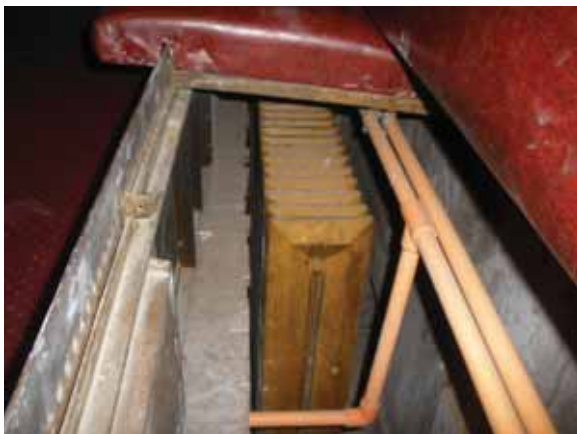
Fig. 2.4.A.26 – Supply air plenum

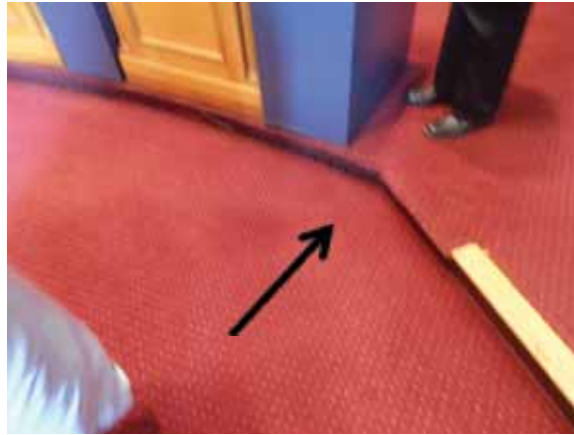
Fig. 2.4.A.27 – Supply air grille

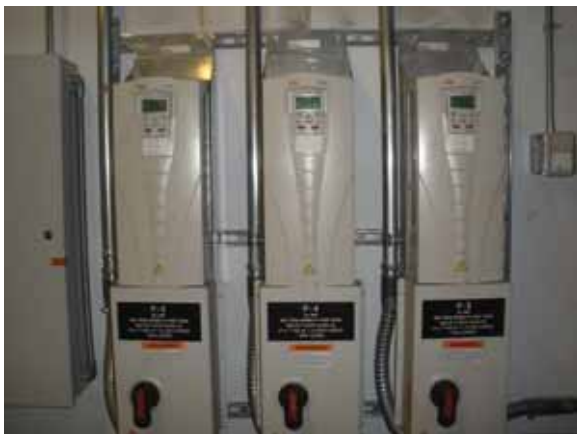
Fig. 2.4.A.31 – Supply air plenum

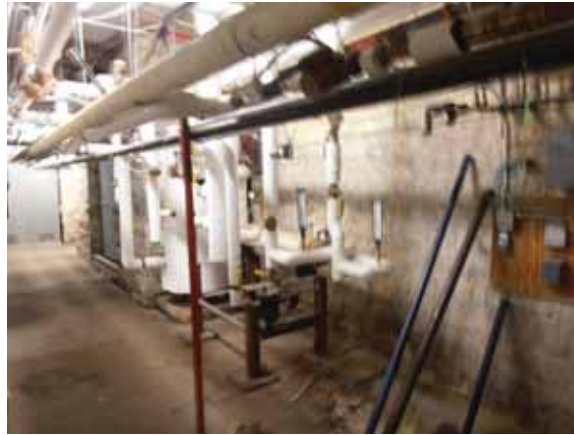
Fig. 2.4.A.33 – Domestic hot water heater

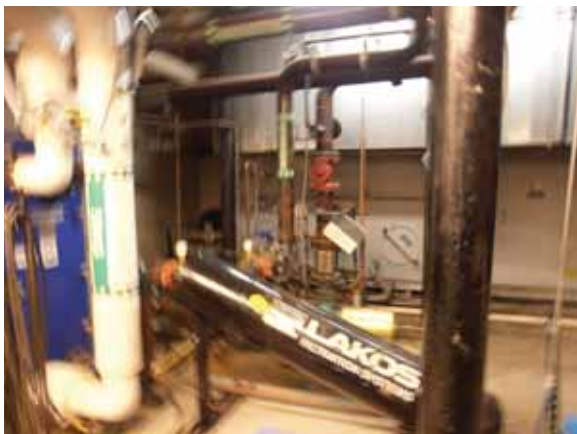
Fig. 2.4.A.38 – Cooling
tower and heat recharger

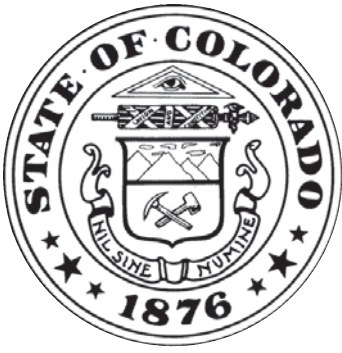
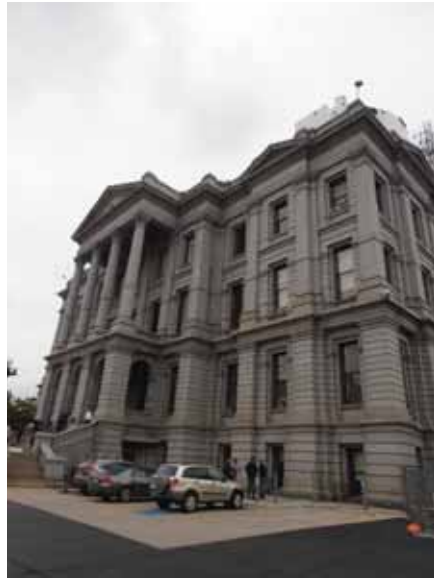
Fig. 2.4.A.39 – Window AC units

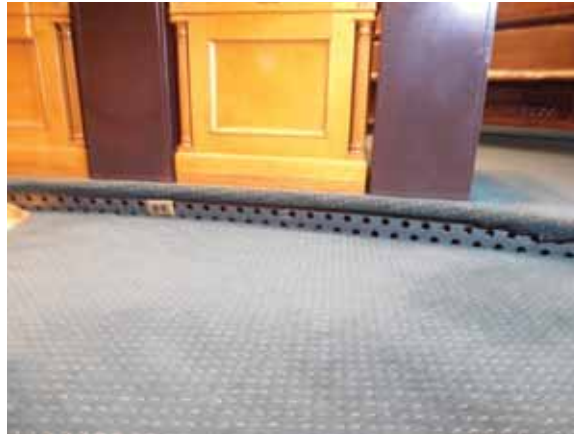
Fig. 2.4.A.45 – Supply air griller

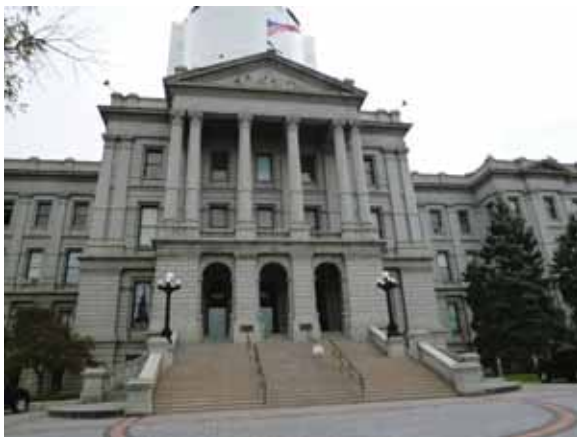
Zone 1 Exterior Facade:
West elevation

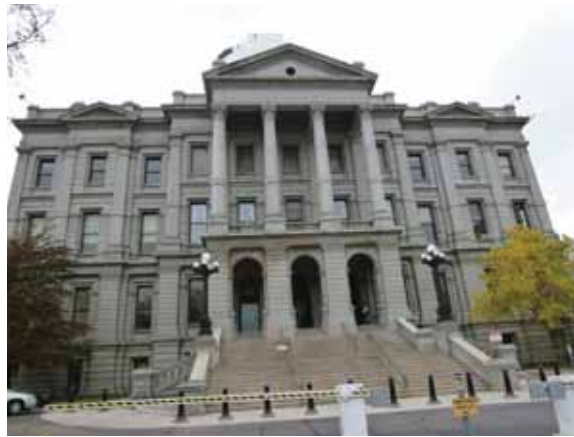
Zone 1 Exterior Facade:
North elevation

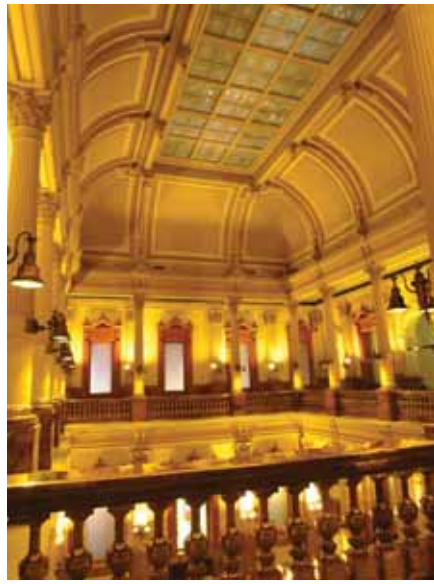
Zone 2 Original Interior Circulation:
Interior skylight at the top of the east
atrium

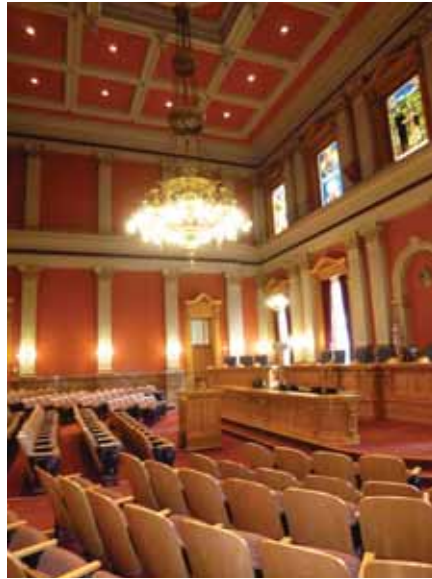
Zone 3 House & Senate Chambers & Supreme Court: Supreme Court

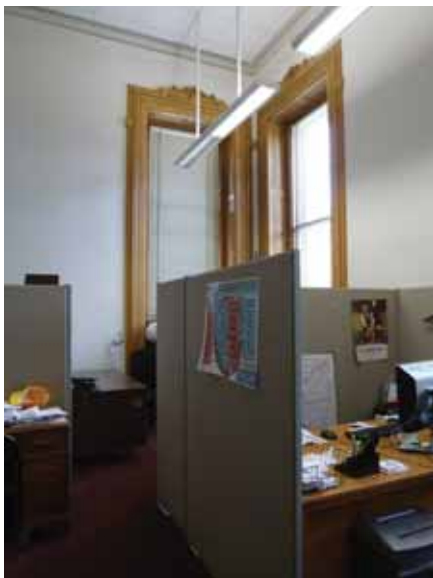
Zone 4 Office Space: Office space with historic wood window trim intact

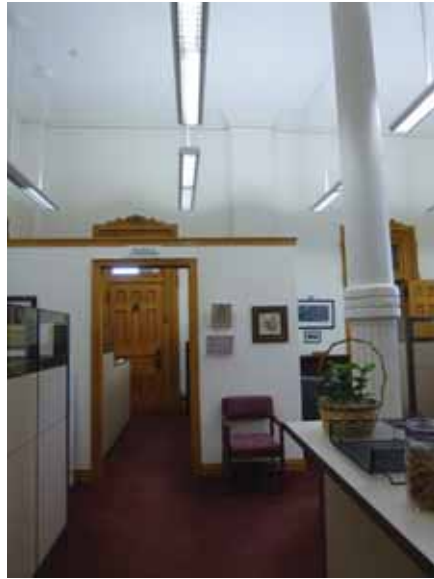
Zone 4 Office Space: Modern dividing wall in an office with historic wood doors, transoms, and trim visible in the background
