CAPITOL COMPLEX MASTER PLAN

FINDINGS & RECOMMENDATIONS (F & R) NEEDS ASSESSMENT

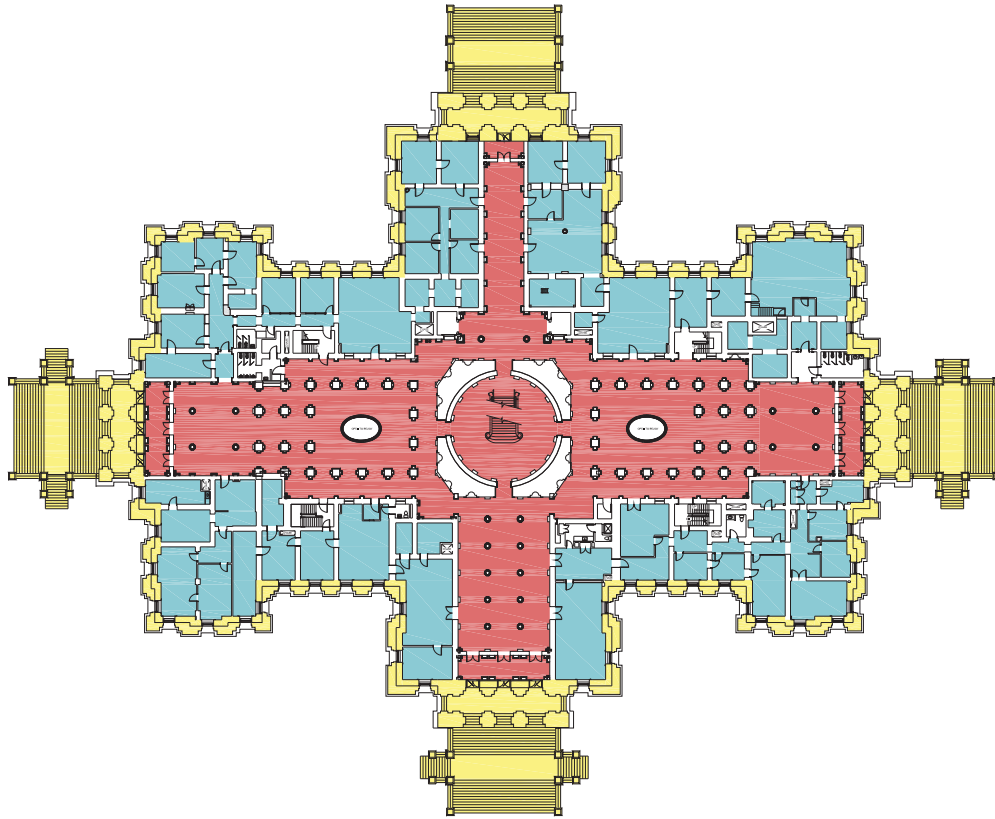
1 FIRST FLOOR ZONING PLAN
1/64" = 1'-0"

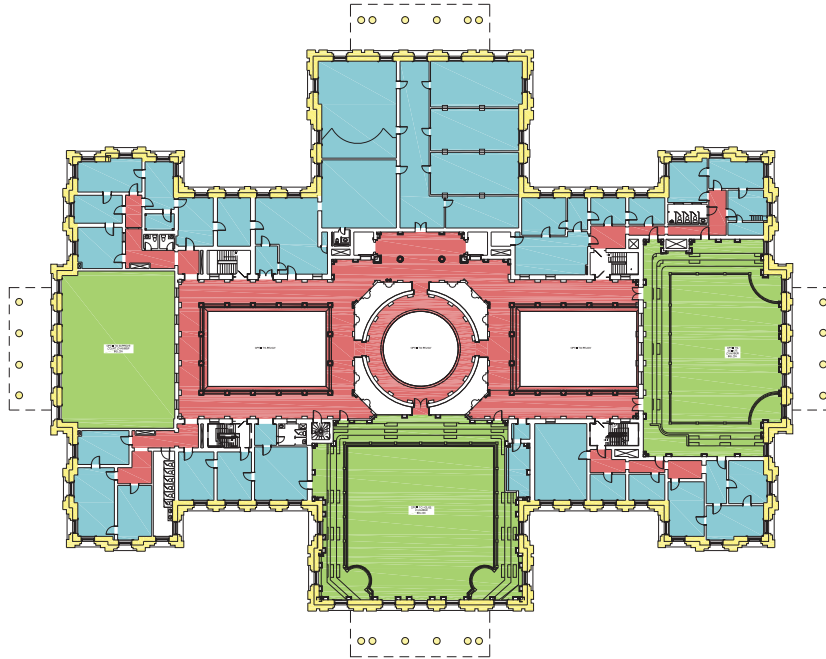
1 THIRD FLOOR ZONING PLAN
1/64" = 1'-0"

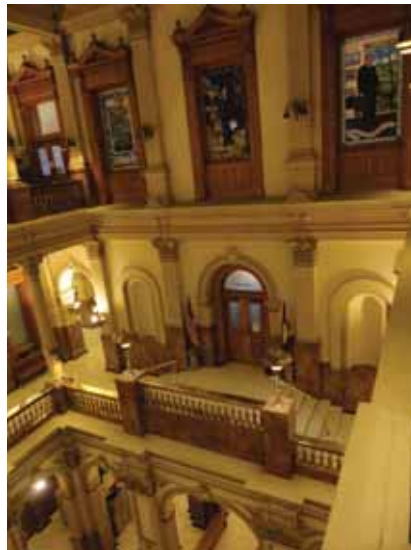
Stained glass artwork found throughout the building.

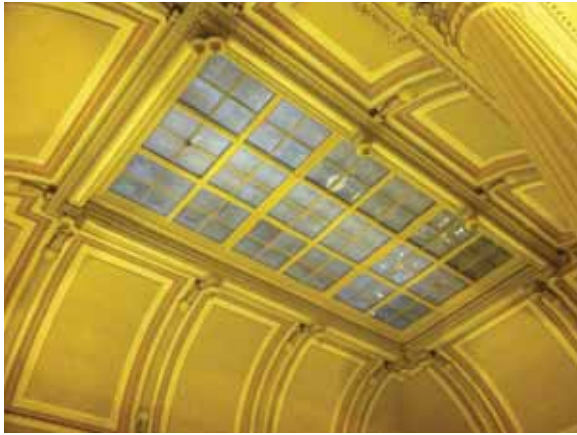
Vaulted ceiling with skylights above the central circulation arcades.

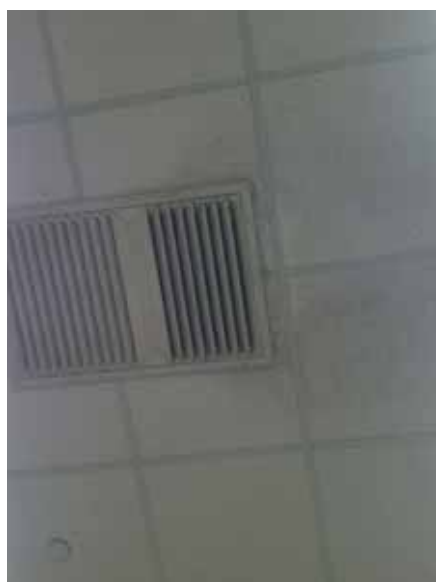
Fig. 3.1.C.1 Soiling of the acoustic ceiling tiles near air diffusers.

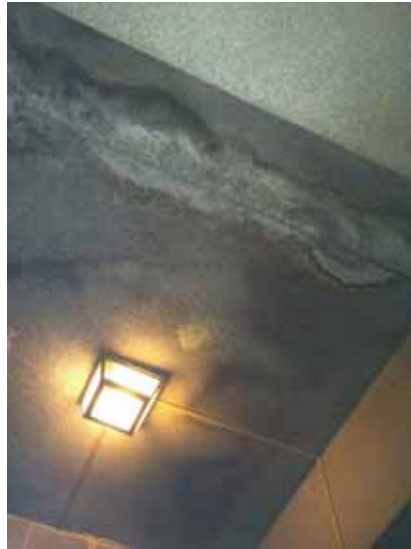
Fig. 3.1.C.2 Water damage noted at the granite cladding on the ceiling of the west emergency exit vestibule on the Basement Floor.

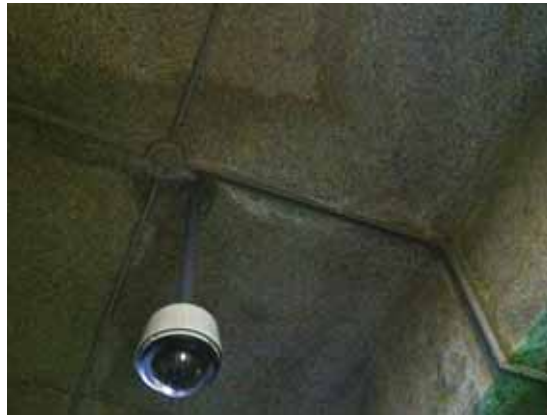
Fig. 3.1.C.3 Water damage noted at the granite cladding on the ceiling of the south accessible entrance vestibule on the Basement Floor.

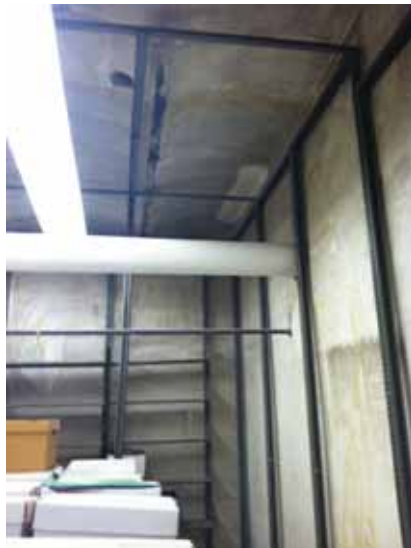
Fig. 3.1.C.4 Evidence of water damage noted in the archive and document storage area on the Sub-basement Floor.

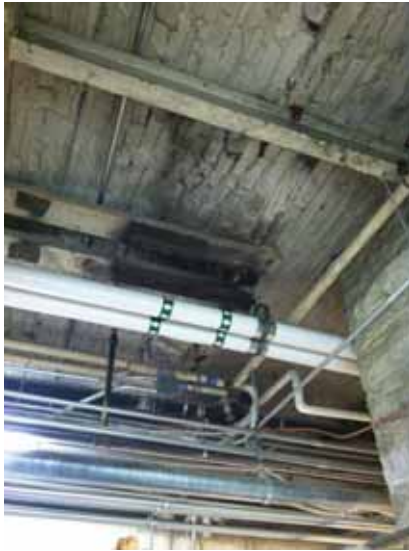
Fig. 3.1.C.5 Areas of deteriorating masonry noted at the ceiling on the Sub-basement Floor.

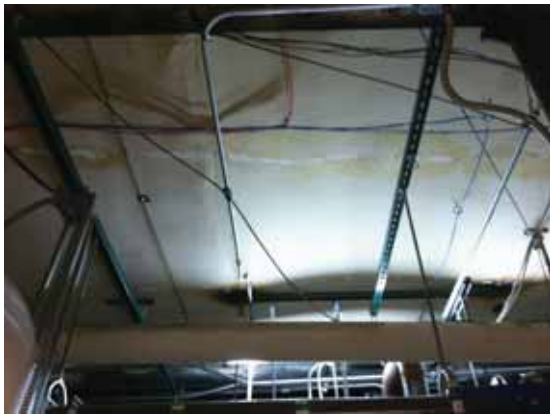
Fig. 3.1.C.6 Evidence of water damage noted at the ceiling on the Sub-basement Floor.

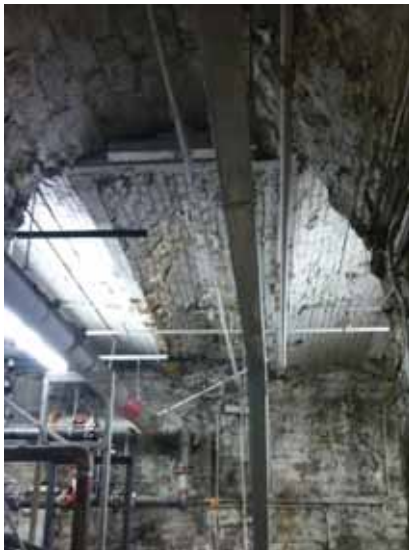
Fig. 3.1.C.7 Evidence of water damage, corrosion, and deterioration at the vaulted masonry ceilings of the areas of the tunnels included in the site survey visit.

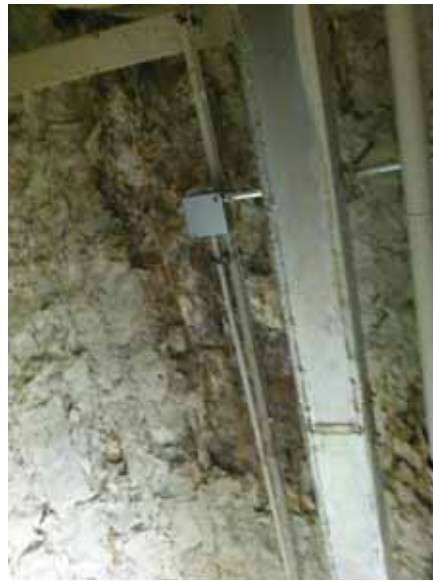
Fig. 3.1.C.8 Evidence of water damage, corrosion, and deterioration at the vaulted masonry ceilings of the areas of the tunnels included in the site survey visit.

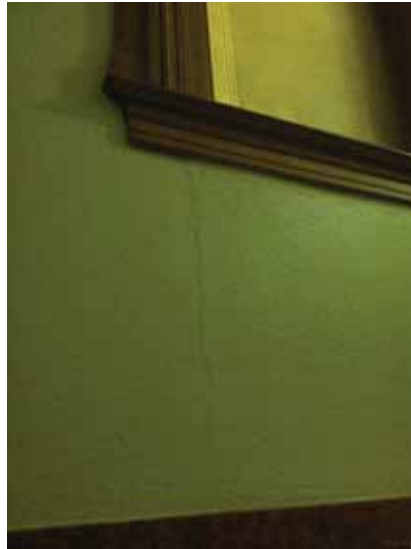
Fig. 3.1.C.9 Cracking plaster noted in areas throughout the building, especially on the Third Floor.

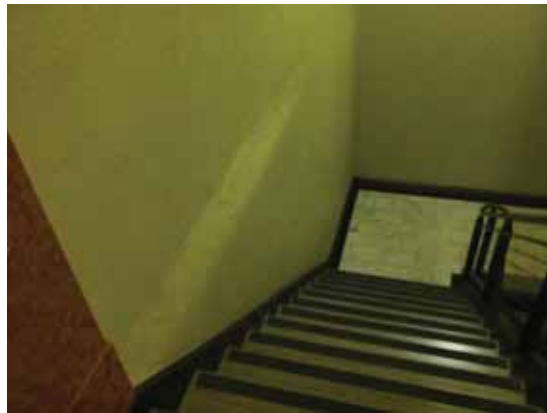
Fig. 3.1.C.10 Area of damaged plaster or gypsum board noted in the northwest stairway between the Basement Floor and the Sub-basement Floor.

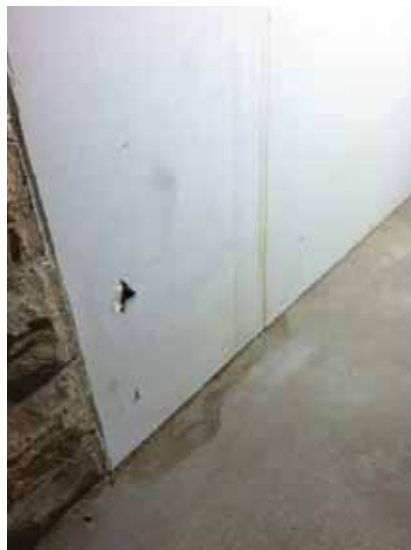
Fig. 3.1.C.11 Damaged gypsum board walls noted throughout the Sub-basement Floor.

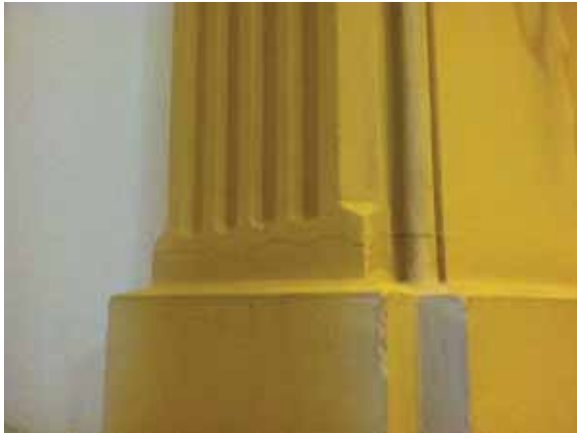
Fig. 3.1.C.12 Typical damage and deterioration noted to the decorative plaster throughout.

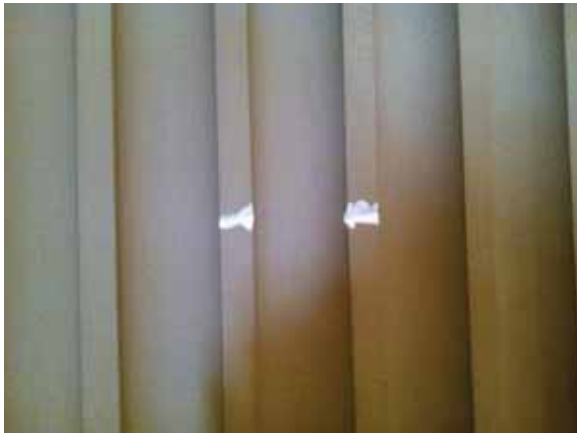
Fig. 3.1.C.13 Typical damage and deterioration noted to the decorative plaster throughout.

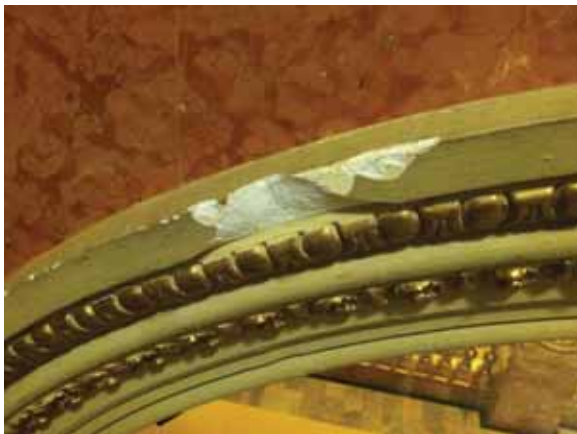
Fig. 3.1.C.14 Damaged decorative plaster noted in the northwest stairway.

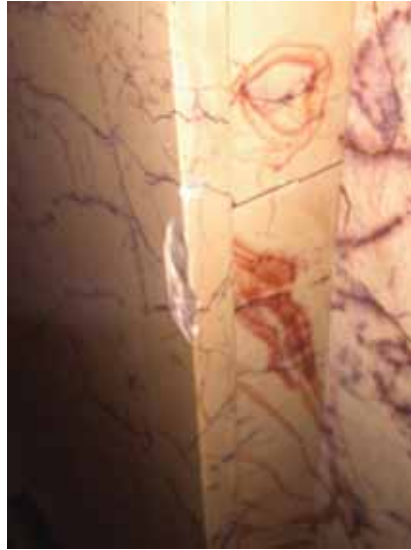
Fig. 3.1.C.15 Typical instance of damaged stone wainscoting observed during the site survey visit.

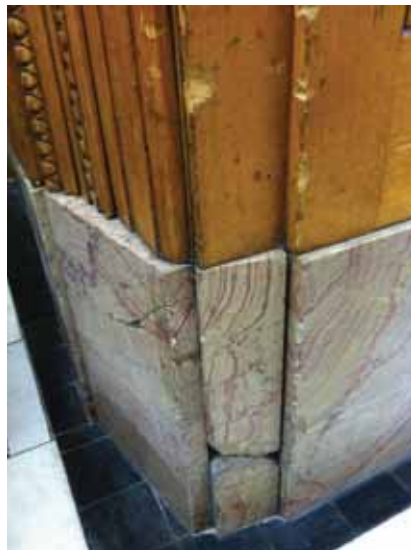
Fig. 3.1.C.16 Areas of damaged and deteriorating stone baseboard and wood wainscoting noted during the site survey visit.

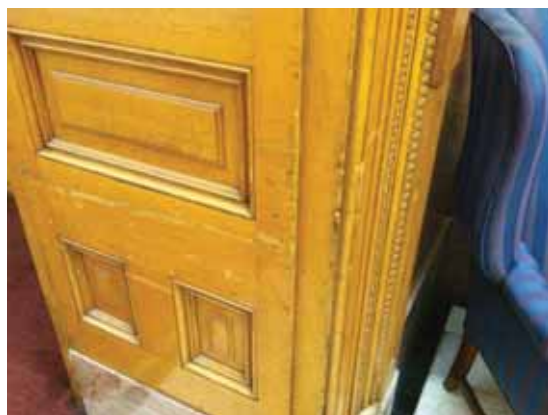
Fig. 3.1.C.17 Areas of damaged wood wainscoting noted during the site survey visit.

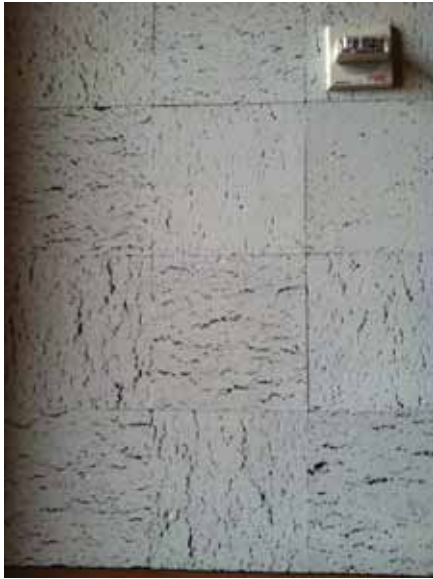
Fig. 3.1.C.18 Acoustic tiles on the walls and ceilings of the Senate Gallery and House of Representatives Gallery.

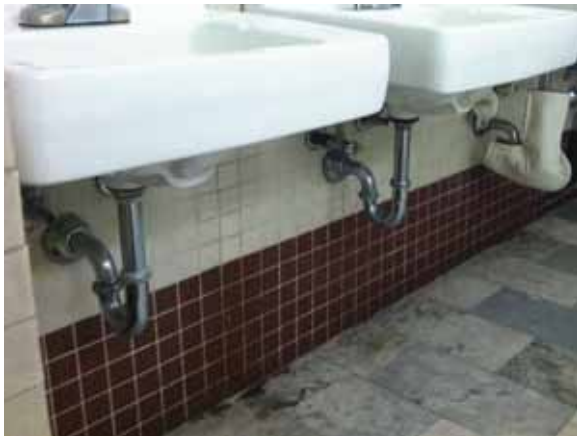
Fig. 3.1.C.19 Generally soiled wall tile noted in the public accessible restrooms on the Basement Floor.

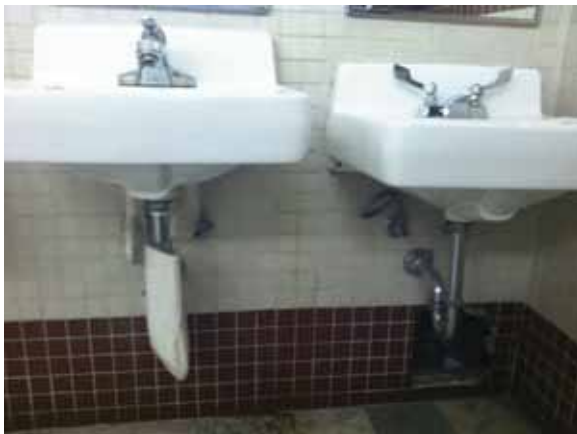
Fig. 3.1.C.20 Damage to the wall observed in the Women's Accessible Restroom on the Basement Floor.

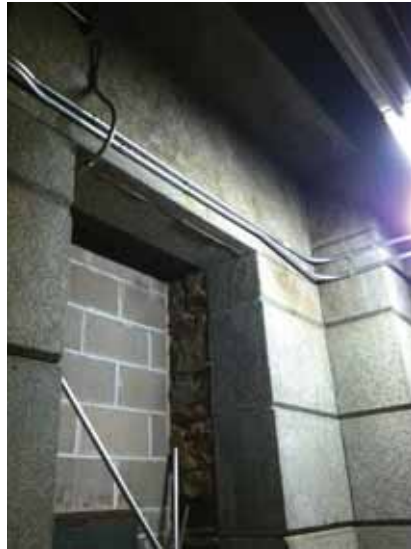
Fig. 3.1.C.21 Water damage noted at the granite cladding on the walls of the west emergency exit vestibule on the Basement Floor.

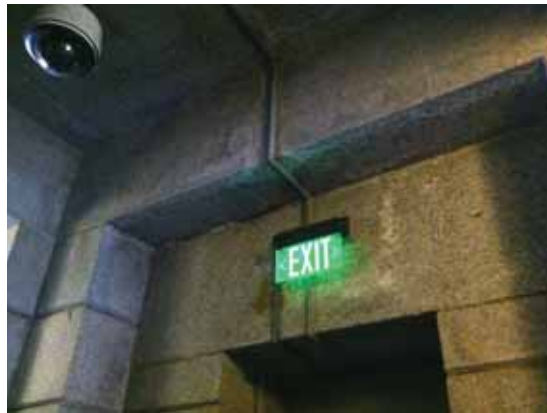
Fig. 3.1.C.22 Water damage noted at the granite cladding on the walls of the south accessible entrance vestibule on the Basement Floor.

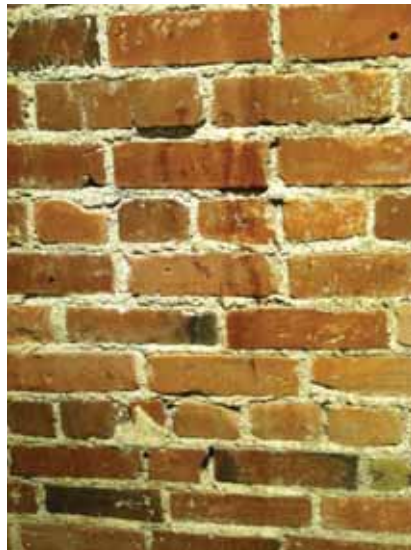
Fig. 3.1.C.23 Deteriorating mortar noted at the brick walls observed in Mr. Brown's Attic.

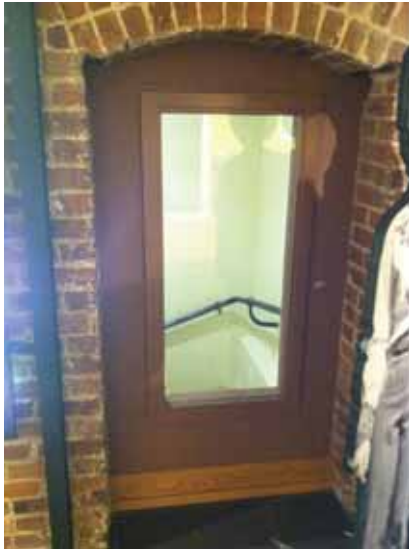
Fig. 3.1.C.24 Deteriorating and damaged brick walls observed in Mr. Brown's Attic.

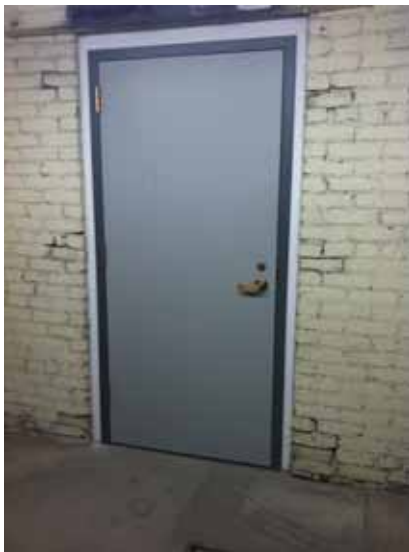
Fig. 3.1.C.25 Damaged and deteriorating brick walls observed on the Sub-basement Floor.

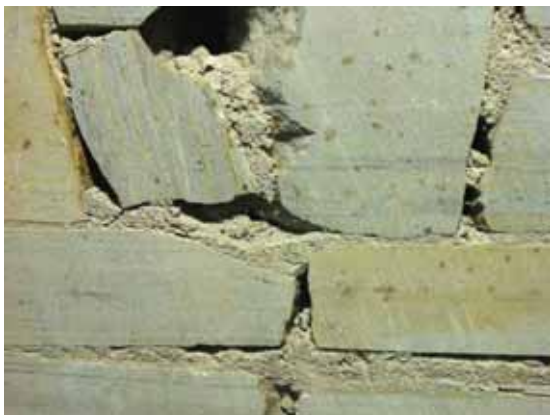
Fig. 3.1.C.26 Spalling stone walls and deteriorating or missing mortar observed on the Sub-basement Floor.

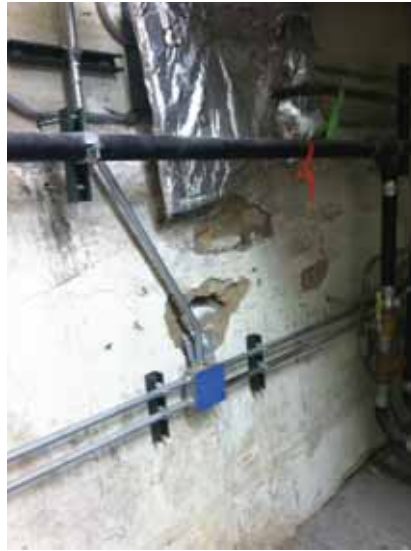
Fig. 3.1.C.27 Spalling and deteriorating concrete walls observed on the Sub-basement Floor.

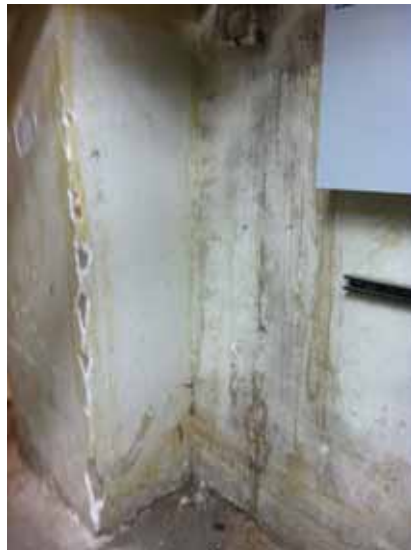
Fig. 3.1.C.28 Evidence of water damage noted in areas throughout the Sub-basement Floor.

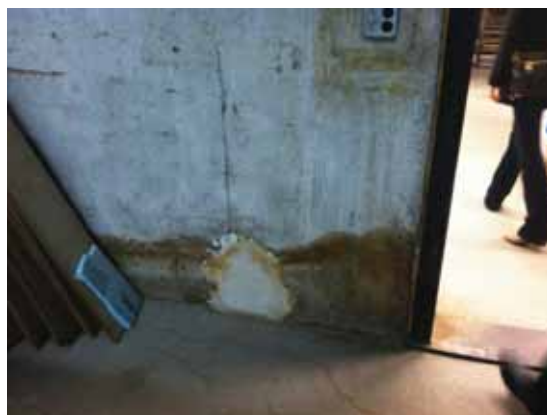
Fig. 3.1.C.29 Evidence of water damage noted in areas throughout the Sub-basement Floor.

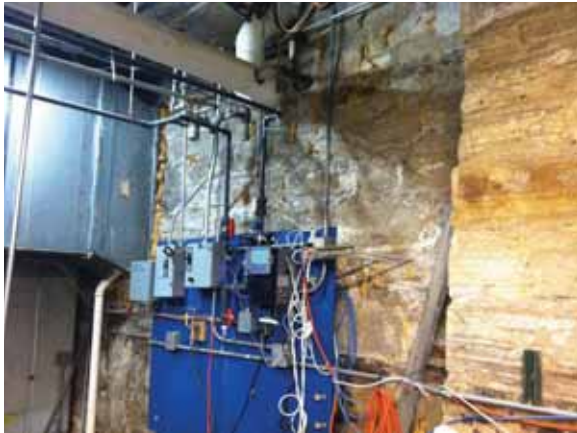
Fig. 3.1.C.30 Equipment located at a wall that appears to have issues with water infiltration and has been temporarily repaired in spots with a foaming waterproofing material.

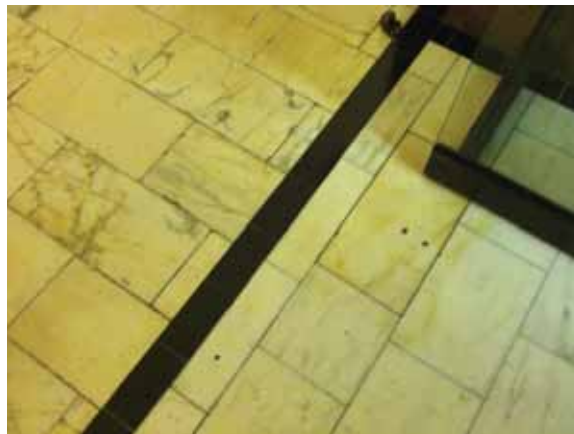
Fig. 3.1.C.31 Areas of soiled stone flooring noted throughout.

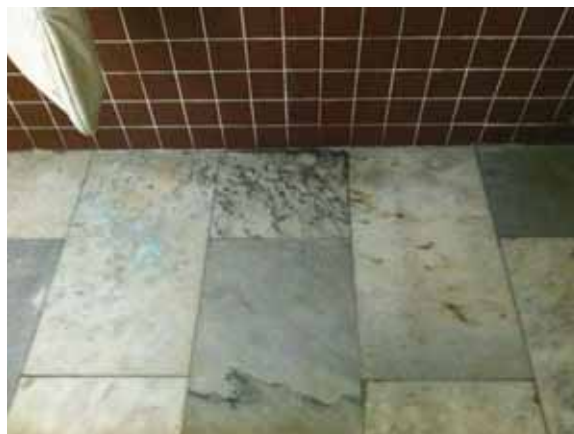
Fig. 3.1.C.32 Soiled stone flooring noted in the public accessible restrooms on the Basement Floor.

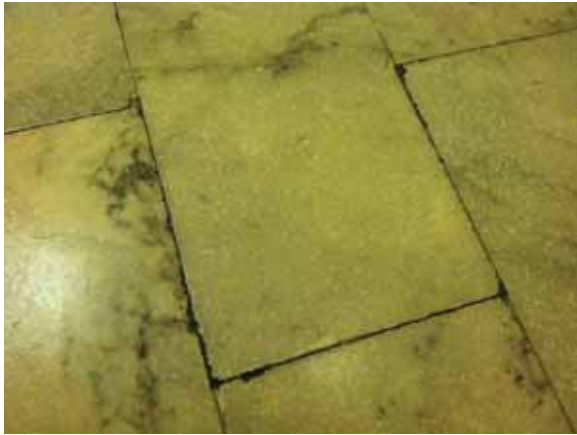
Fig. 3.1.C.33 Typical deterioration of the marble flooring observed throughout.

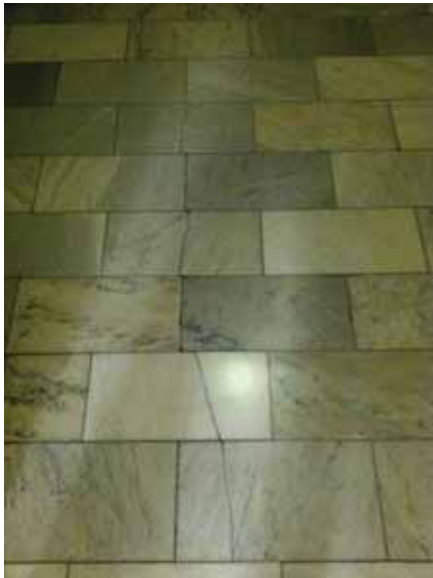
Fig. 3.1.C.34 Cracked and scuffed marble flooring.

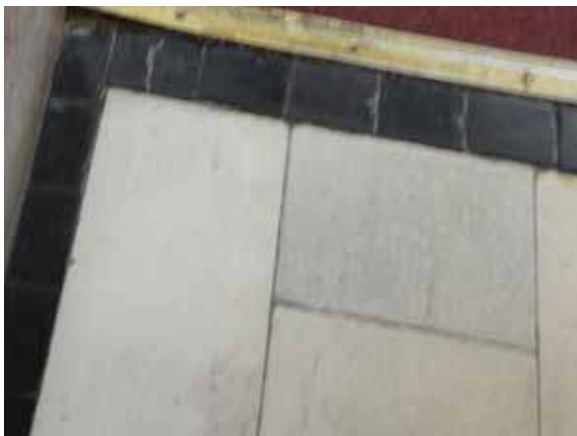
Fig. 3.1.C.35 Cracked and deteriorating black stone flooring border.

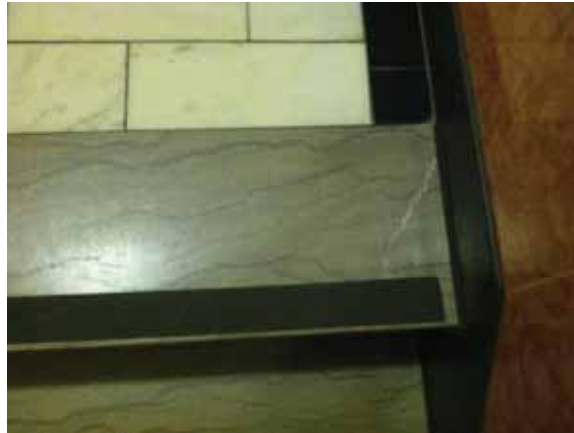
Fig. 3.1.C.36 Cracked stone flooring observed in the northwest stairway.

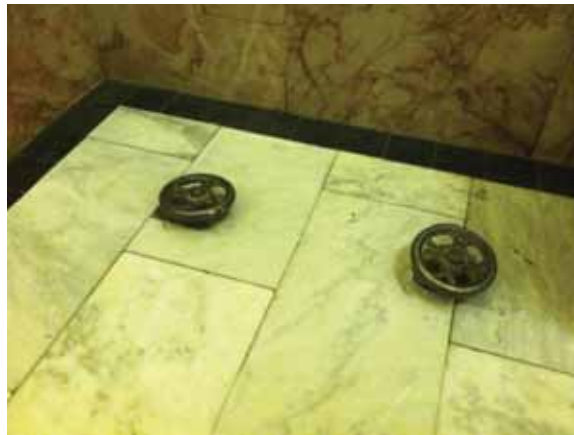
Fig. 3.1.C.37 Two metal valve wheels projecting above the marble flooring and creating a potential tripping hazard on the Second Floor outside of the Offices of the General Assembly.

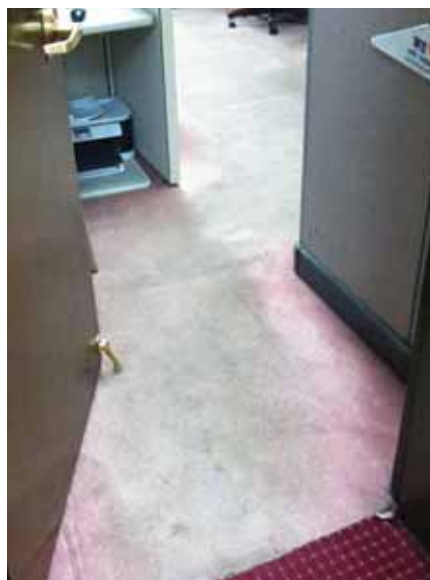
Fig. 3.1.C.38 Areas of soiling and deteriorating carpet observed in the office areas included in the site survey visit.

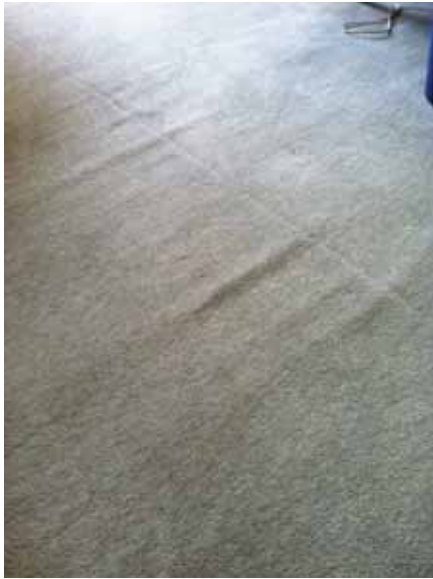
Fig. 3.1.C.39 Areas of carpet coming loose and creating a potential tripping hazard.

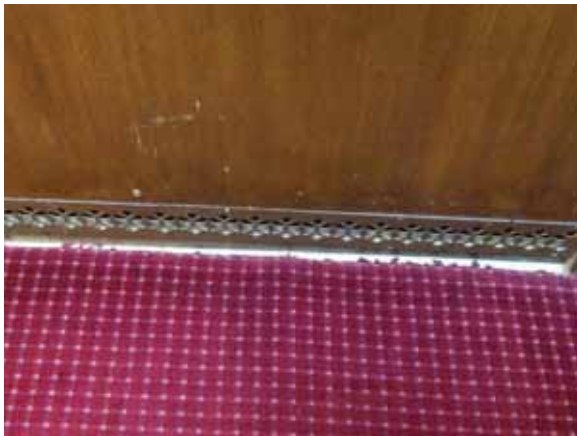
Fig. 3.1.C.40 Areas of carpet flooring observed to be coming loose along the perimeter of the floor.

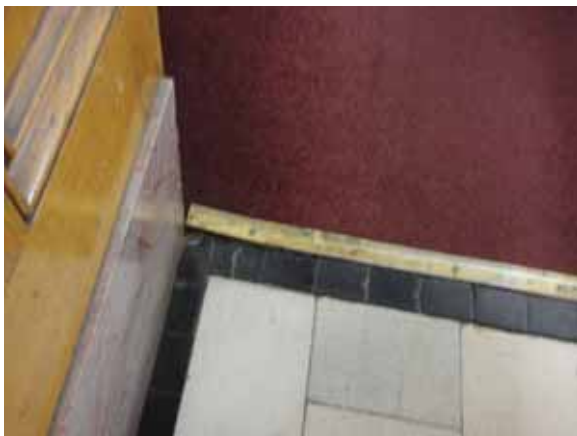
Fig. 3.1.C.41 A threshold coming loose and creating a potential tripping hazard noted during the site survey visit.

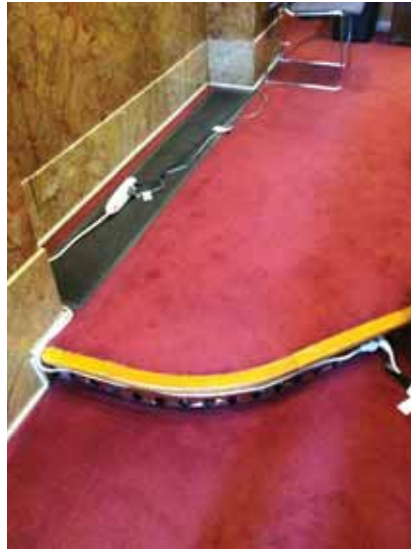
Fig. 3.1.C.42 Electrical cords running loosely across the floor of the Old Supreme Court Chambers and creating a potential tripping hazard.

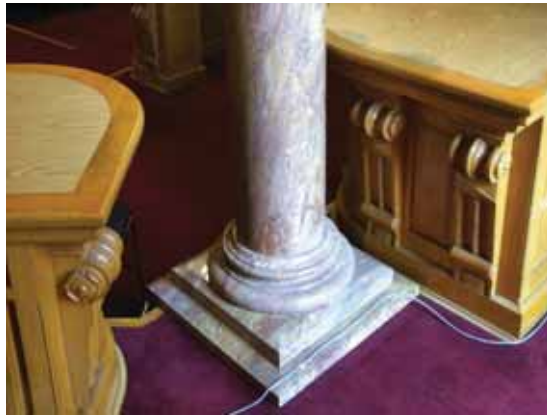
Fig. 3.1.C.43 Electrical cords running loosely across the floor of the Old Supreme Court Chambers and creating a potential tripping hazard.

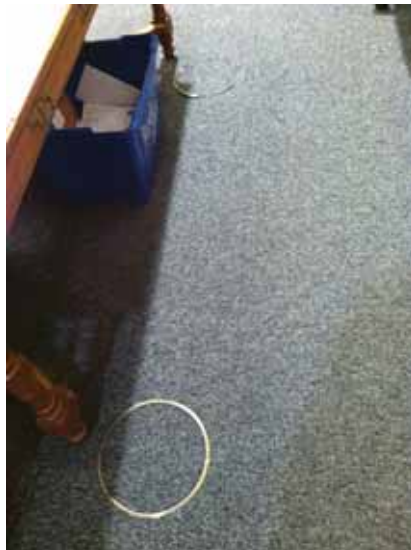
Fig. 3.1.C.44 Round panel noted at the carpet flooring in the Offices of the General Assembly on the Second Floor.

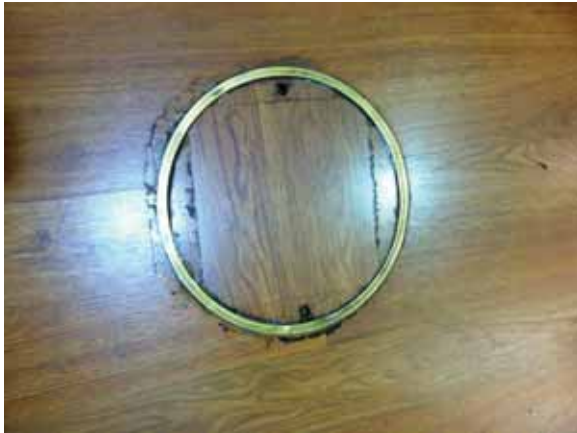
Fig. 3.1.C.45 Round panel noted at the laminate or vinyl hardwood flooring in the Offices of the General Assembly on the Second Floor.

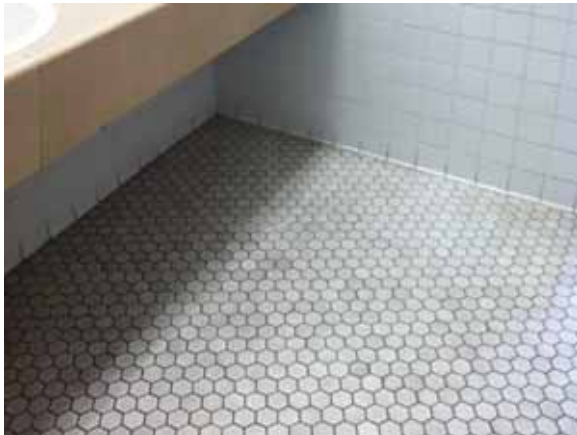
Fig. 3.1.C.46 Generally soiled floor tile observed in the Men's Restroom in the southeast corner of the Second Floor.

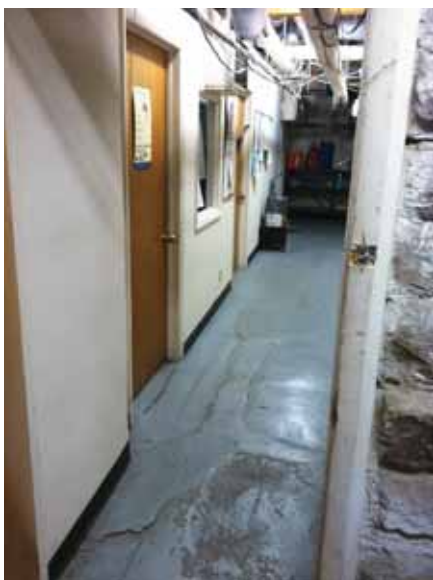
Fig. 3.1.C.47 Spalling and deteriorating concrete flooring with the paint wearing off observed on the Sub-basement Floor.

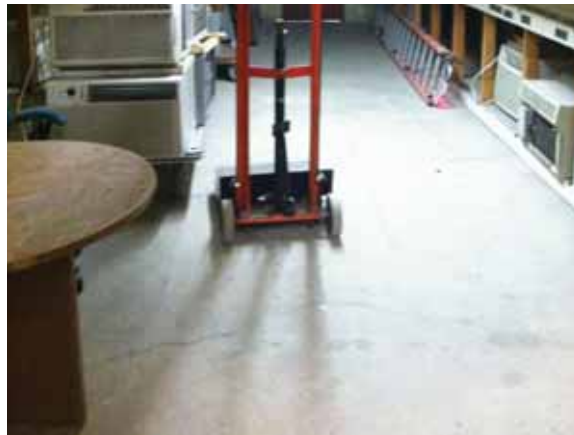
Fig. 3.1.C.48 Areas of cracked concrete flooring observed throughout the Sub-basement Floor.

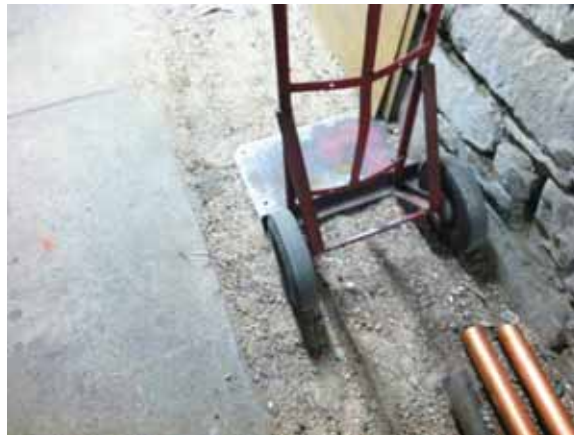
Fig. 3.1.C.49 Missing concrete pavers observed in a few locations throughout the Sub-basement Floor.

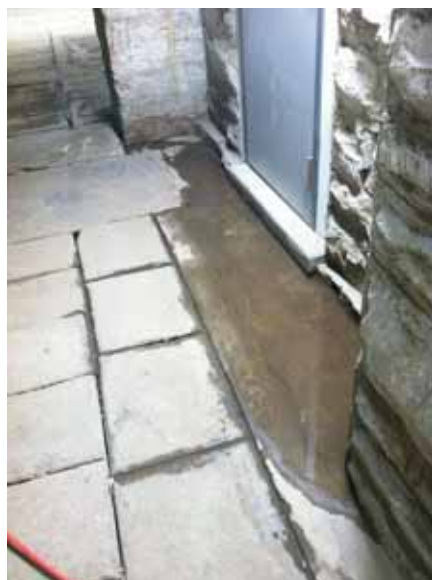
Fig. 3.1.C.50 Standing water observed in a few locations throughout the Sub-basement Floor.

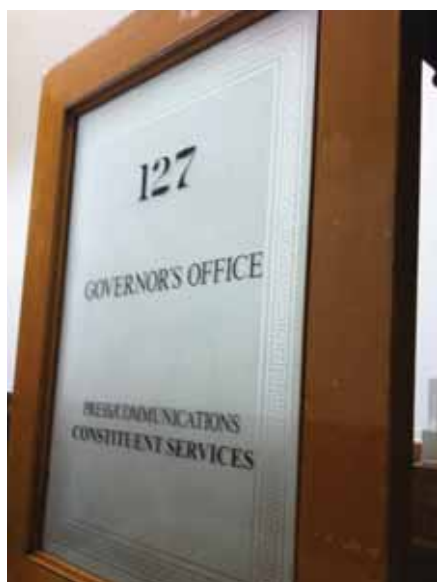
Fig. 3.1.C.51 General wear-and-tear noted at the white oak doors.

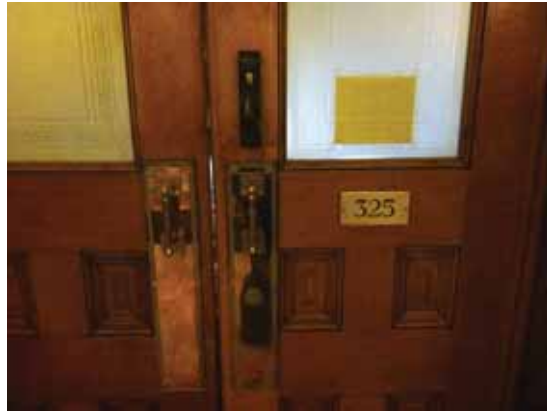
Fig. 3.1.C.52 Areas of tarnishing noted at the historic door knobs.

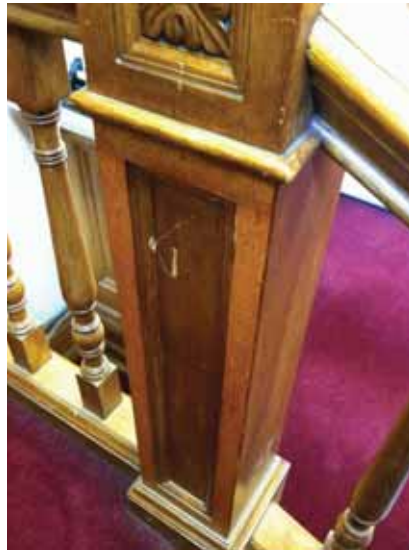
Fig. 3.1.C.53 Damage noted at the wood railing in the room located at the southeast corner of the Senate Gallery.

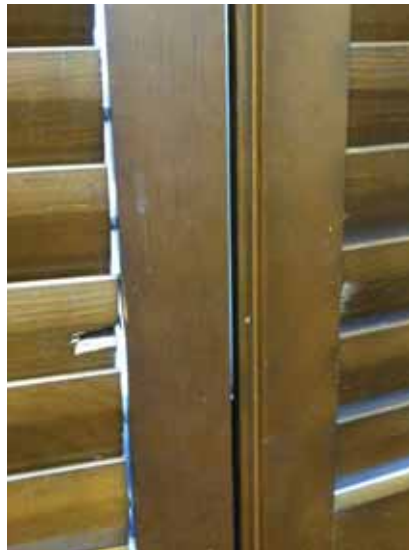
Fig. 3.1.C.54 General wear-and-tear noted at the wood shutters.

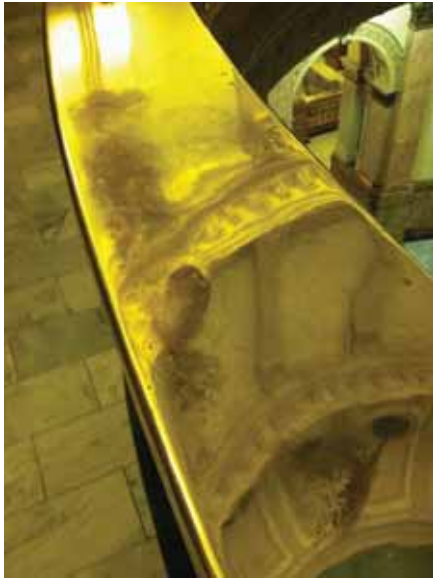
Fig. 3.1.C.55 Areas of tarnishing noted at the brass railings throughout.

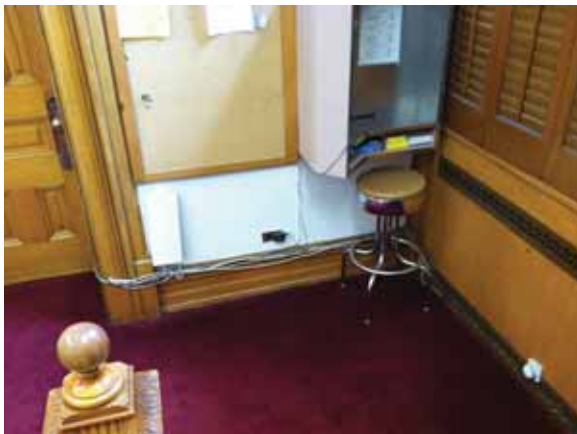
Fig. 3.1.C.56 A bundle of exposed cables run along the base of a wall in a room adjacent to the Senate Gallery.

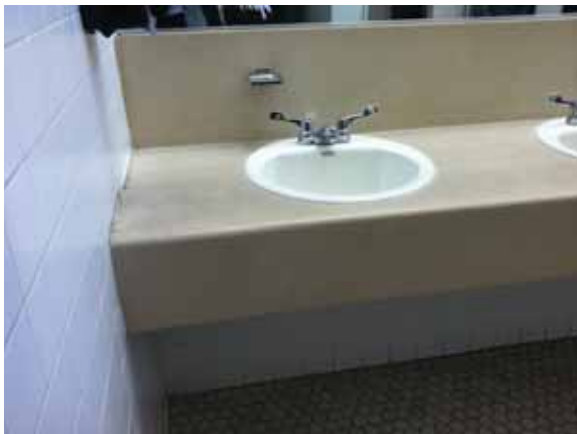
Fig. 3.1.C.57 Countertop in the Men's Restroom in the southeast corner of the Second Floor noted to be aging and worn.
