CAPITOL COMPLEX MASTER PLAN

FINDINGS & RECOMMENDATIONS (F & R) NEEDS ASSESSMENT

NORTH CAMPUS NORTH BUILDING, 6321 NORTH DOWNING STREET (DENVER)

NOVEMBER 2014

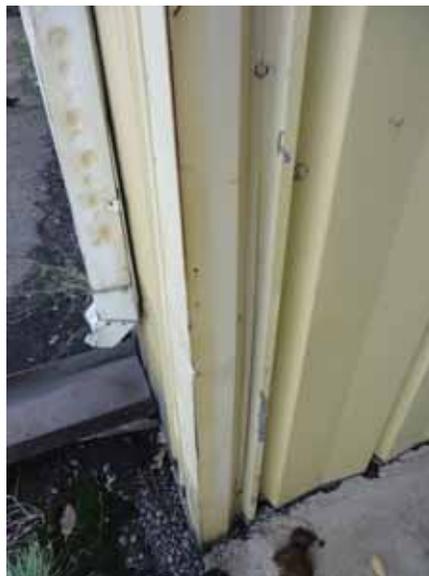
The metal panels on the exterior walls of the original engineered metal building are in poor condition overall. Areas of peeling paint and areas with evidence of corrosion were observed around the exterior of the original building (see Fig. 2.1.A.1, Fig. 2.1.A.2, and Fig. 2.1.A.3). There were holes and gaps readily observable in the metal panels from the inside of the building (see Fig. 2.1.A.4). Other damaged areas of the metal panels were observed around the building (see Fig. 2.1.A.5 and Fig. 2.1.A.6). The damage is likely from vehicles running into the building. It was noted that there are no concrete guard posts/bollards placed around the original building to protect the structure from vehicle damage in and around the loading dock doors and parking areas. There was dirt and debris observed to be collecting along the north side of the building (see Fig. 2.1.A.7).

Fig. 2.1.A.1 Areas of peeling paint observed at the metal panels around the exterior of the original building.

- Remove the building skin around the exterior of the original building and replace with a new building skin, including new insulation.
- Install concrete guard posts/bollards along parking areas and around overhead rolling doors around the exterior of the original building to protect the structure from future vehicular damage.

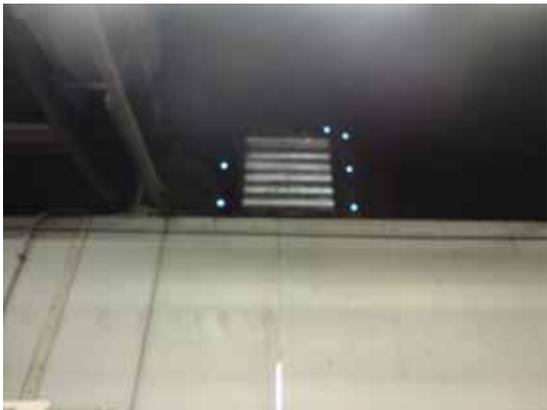
Fig. 2.1.A.4 Holes and gaps in the metal panels readily observable from the inside of the original building.

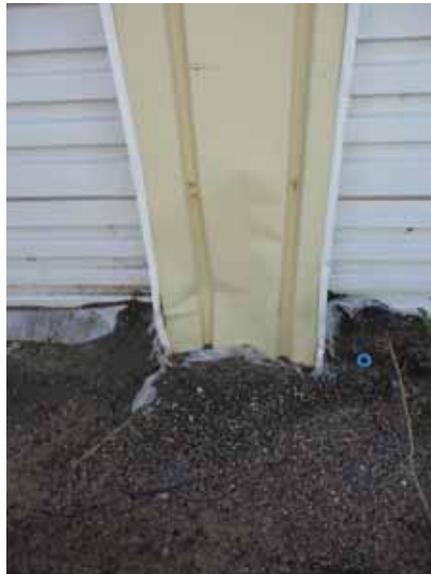
Fig. 2.1.A.5 Damaged metal panels observed around loading areas at overhead rolling doors around the exterior of the original building.

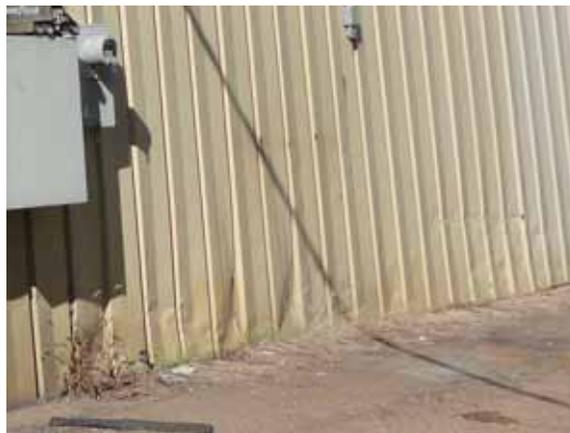
Fig. 2.1.A.6 Damaged metal panels observed at parking areas around the exterior of the original building.

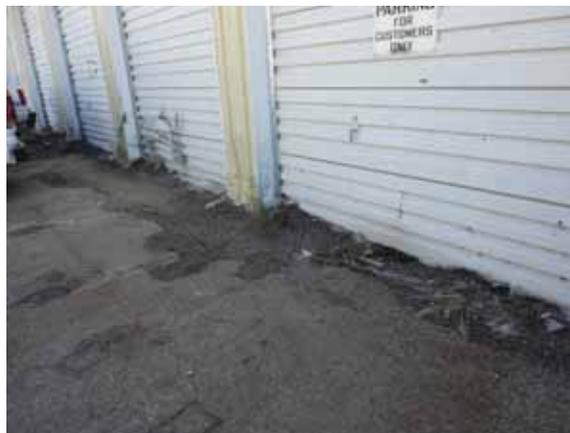
Fig. 2.1.A.7 Dirt and debris collecting along the north side of the original building.

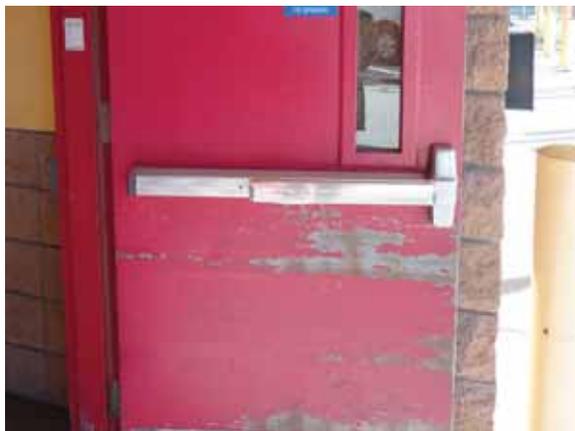
The double entrance doors on the south side of the west addition have evidence of extensive wear-and-tear along the bottom halves of the doors with the paint scraped off and exposing the metal (see Fig. 2.1.A.8). Deteriorating weatherstripping was noted at the door on the north side of the west addition with air gaps observed along the base of the door (see Fig. 2.1.A.9).

Fig. 2.1.A.8 Entrance doors with extensive wear-and-tear on the south side of the west addition.

- Refurbish or replace the entrance doors on the south side of the west addition. Add bumpers to the base of both doors as necessary to protect them from future damage.
- Replace the weatherstripping around the entrance doors on the north and south sides of the west addition as necessary to prevent air leakage from the building.

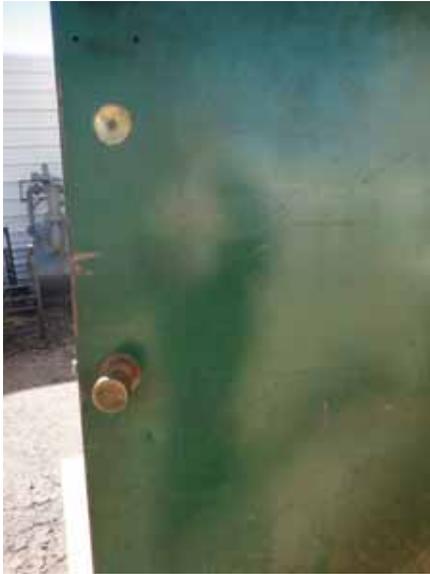
Fig. 2.1.A.12 Typical wear-and-tear and corrosion observed at the doors around the exterior of the original building.

- Replace existing windows around the exterior of the original building with new energy efficient windows and frames.
- Replace entrance doors and overhead rolling doors around the exterior of the original building with new doors and frames and new lever-style door handles.

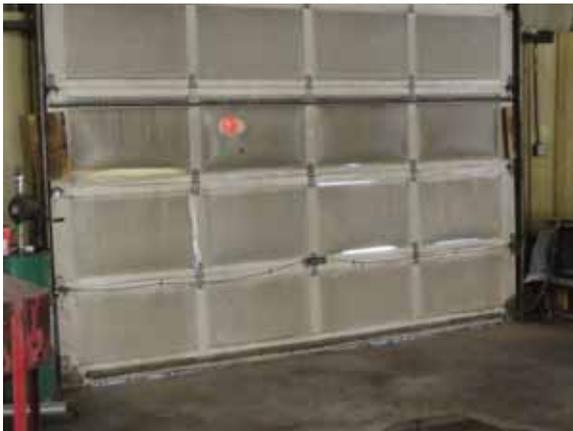
Fig. 2.1.A.13 Wear-and-tear and holes observed at the overhead rolling doors around the exterior of the original building.

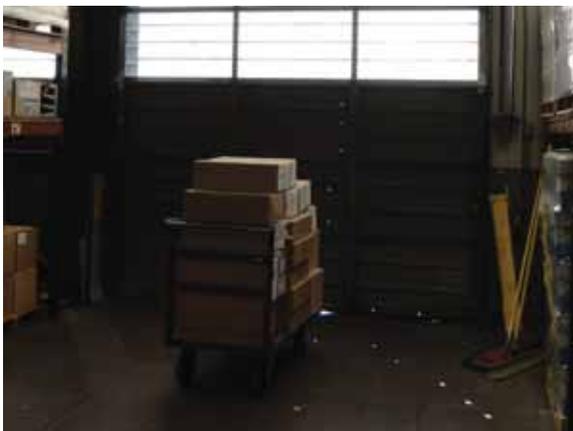
Fig. 2.1.A.14 Wear-and-tear and holes observed at the overhead rolling doors around the exterior of the original building.

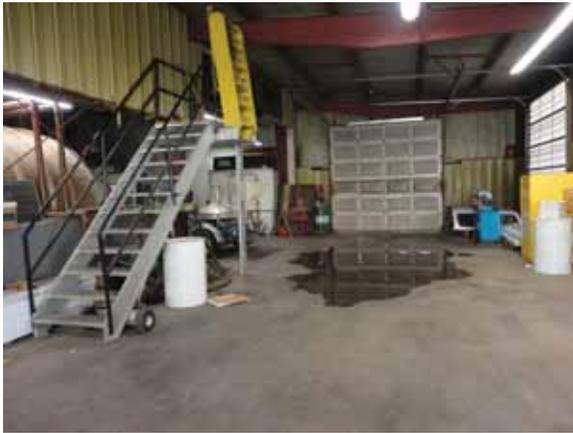
The roof over the original building and over the west addition both consist of an EPDM roofing membrane in generally poor condition overall. The exact age of the roof over both sides of the building is unknown. It was reported that the roof over the original building is known to leak but that the roof over the west addition does not have any known leaking issues. Standing water was observed during the site survey visit inside of the northeast corner of the original building (see Fig. 2.1.A.15). It is unknown if the water intrusion occurred from the roof or from the overhead rolling door to the west of the standing water. The EPDM labels show that the membrane is 45 millimeters thick over the west addition and 60 millimeters thick over the original building. Both sides of the roof have deteriorating EPDM with evidence of widespread patching (see Fig. 2.1.A.16 and Fig. 2.1.A.17). The sealant between the seams of the EPDM sheeting and along the edges of the roof was noted to be widely deteriorating or missing entirely (see Fig. 2.1.A.18, Fig. 2.1.A.19, and Fig. 2.1.A.20). A few areas of standing water were observed near the edges around the perimeter of the roof (see Fig. 2.1.A.21). Corrosive dust shedding off of pipes above the roof was noted

Fig. 2.1.A.15 Standing water observed during the site survey visit at the northeast corner of the original building.

- A complete roof tear-off and replacement is recommended for the original building, including replacement of the metal roof panels that span between the steel purlins.

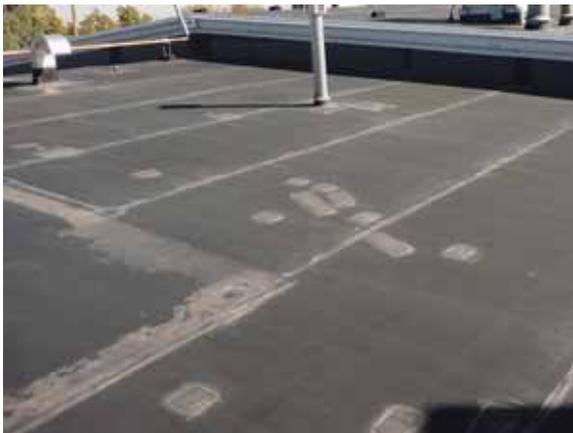
Fig. 2.1.A.16 Generally deteriorating EPDM roofing membrane with widespread patching.

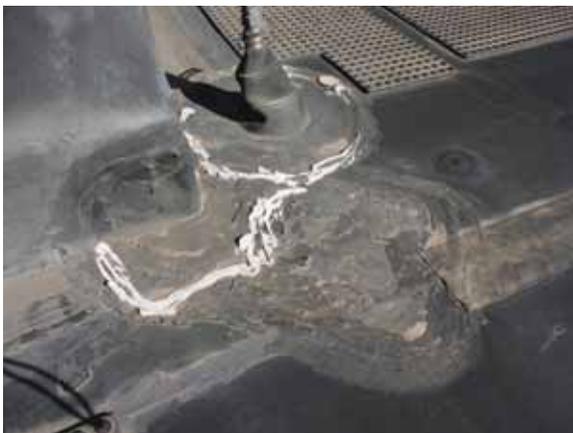
Fig. 2.1.A.17 Typical patching observed around the roof.

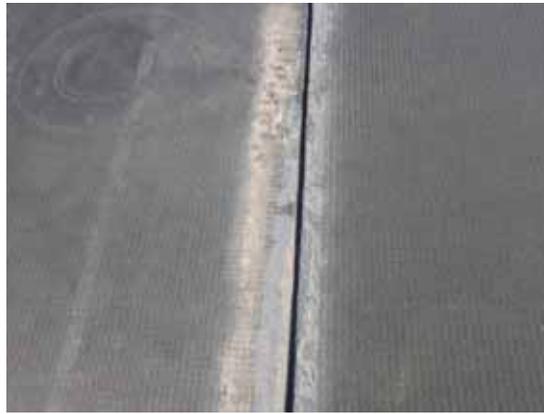
Fig. 2.1.A.19 Typical instance of sealant missing entirely from the seam between the EPDM roofing membrane sheets.

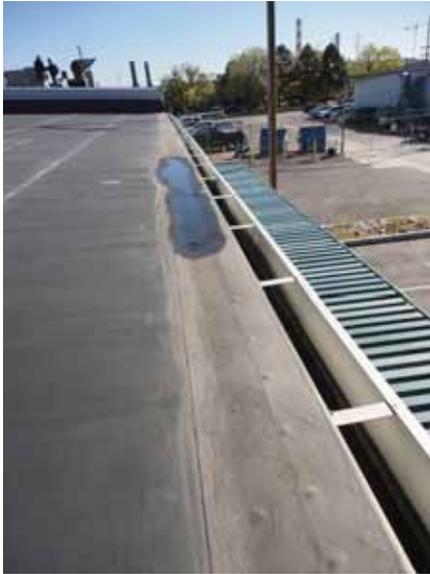
Fig. 2.1.A.21 Standing water observed along the edge of the roof.

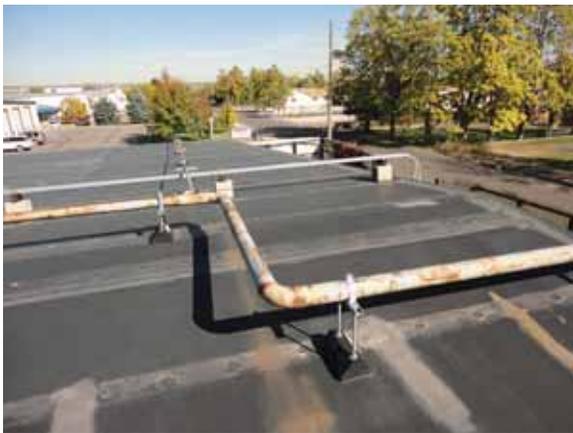
to be collecting on the EPDM roofing membrane under the pipes (see Fig. 2.1.A.22). It was reported that replacement of the roof is on the Capitol Complex list of projects that need to be addressed.

Fig. 2.1.A.22 Corrosive dust observed on the EPDM roofing membrane under corroding pipes.

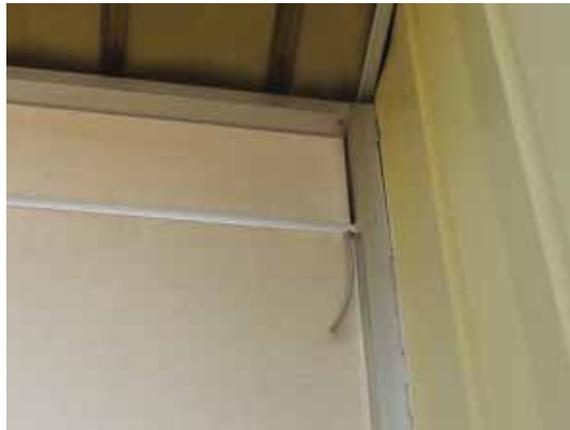
Fig. 2.1.A.23 Deteriorating and missing sealant and weatherstripping observed around the metal panels of the entrance canopy at the northwest corner of the original building.

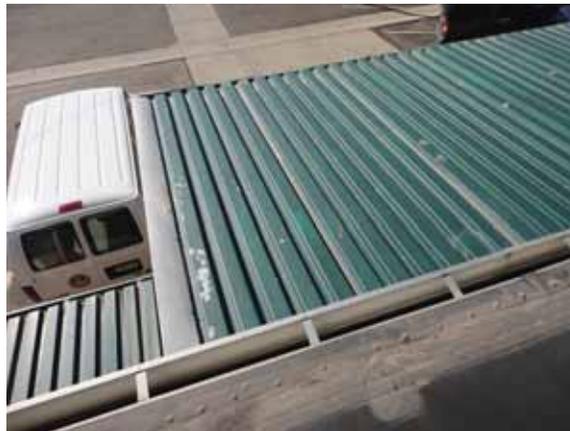
Fig. 2.1.A.24 Deteriorating paint noted along the top of the metal entrance canopy along the south facade of the west addition.

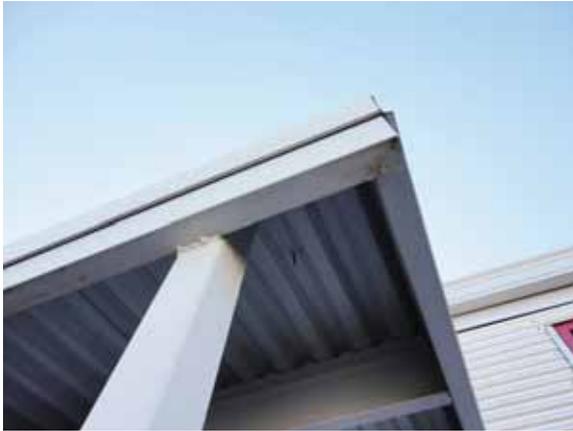
Corrosion was observed at the metal entrance canopy on the north side of the west addition (see Fig. 2.1.A.25).

Fig. 2.1.A.25 Corrosion observed at the metal entrance canopy on the north side of the west addition.

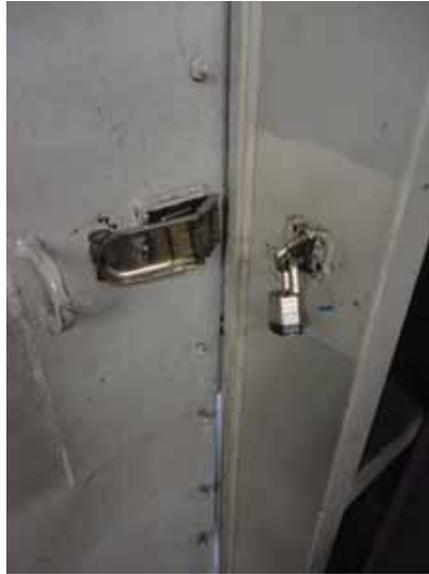
Fig. 2.1.B.11 A latch-style lock used in conjunction with a padlock observed on an egress door on the west end of the south side of the Community College of Denver's welding shop.

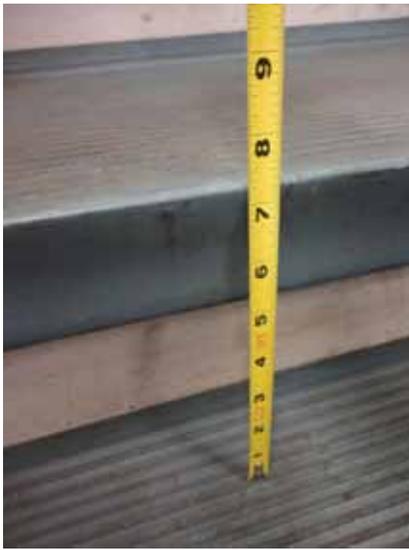
Fig. 2.1.B.13 Existing stair riser heights observed at the stairway leading to the mezzanine in the IDS Shipping & Receiving space on the southwest side of the original building.

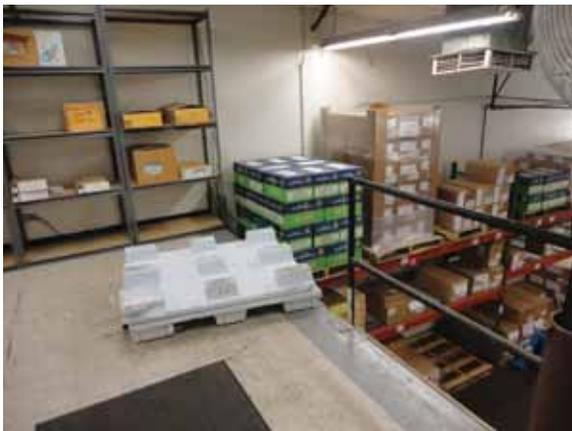
Fig. 2.1.B.19 A section of the IDS Shipping & Receiving mezzanine observed without a guardrail system along the outside edge.

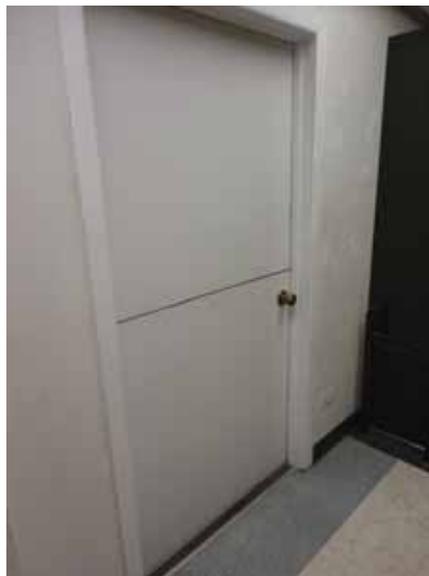
The majority of the interior doors observed throughout the original building are equipped with lever-style door handles. A few interior doors were observed to have knob-style door handles throughout the original building (see Fig. 2.1.B.20). A number of the egress doors throughout the spaces occupied by the Community College of Denver are equipped with knob-style door handles (see Fig. 2.1.B.21). According to Section 309.4 of the 2003 edition of ICC/ANSI A117.1, the knob-style handles do not meet the requirement that: operating mechanisms shall be operable with one hand and shall not require tight grasping, pinching, or twisting of the wrist. Section 309.4 further states that the force required to activate operable parts shall be 5.0 pounds (22.2 N) maximum.

Fig. 2.1.B.20 Typical knob-style door handle observed on a few of the interior doors throughout the original building.

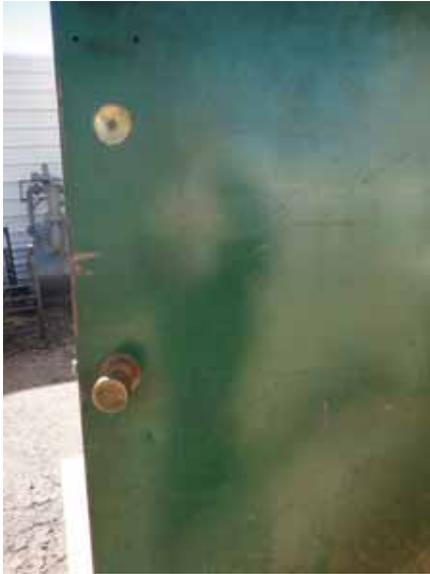
Fig. 2.1.B.21 Typical knob-style door handle observed on a number of the egress doors throughout the spaces occupied by the Community College of Denver.

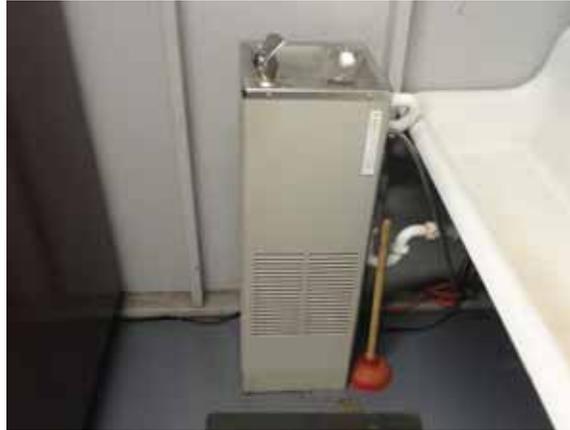
Fig. 2.1.C.1 Typical non-accessible drinking fountain observed throughout the original building.

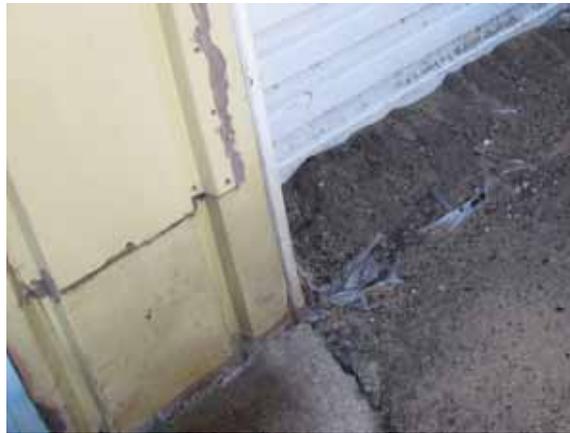
Fig. 2.2.A.1

The exterior of the structure was in fair condition. The lowest portions of metal wall panels at the building's north side have some corrosion. The roll-up doors at the north side are obstructed with approximately 2-4" of deposited sediment (Fig. 2.2.A.1).

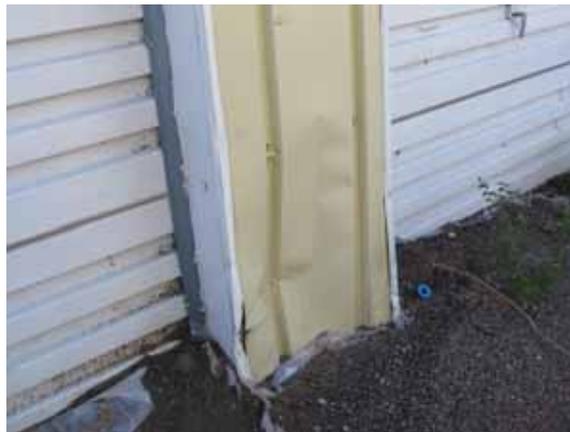
Fig. 2.2.A.2

There was some damage to the exterior metal panel skin, likely due to a vehicle colliding with the structure (Fig. 2.2.A.2).

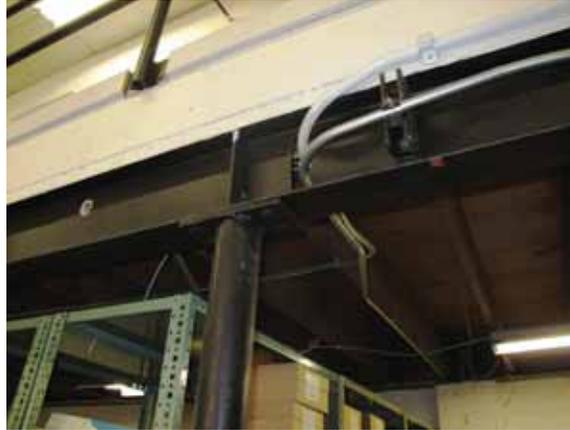
Fig. 2.2.B.1

An interior steel beam supporting a landing in the eastern half of the building has a proportionally large hole cut through the beam web (Fig. 2.2.B.1).

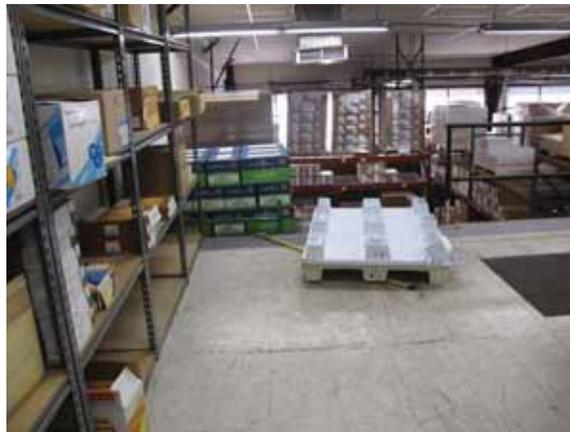
Fig. 2.2.B.2

At the easternmost end of the landing referenced in Fig. 2.2.A.1, a portion of guardrail is missing (Fig. 2.2.B.2).

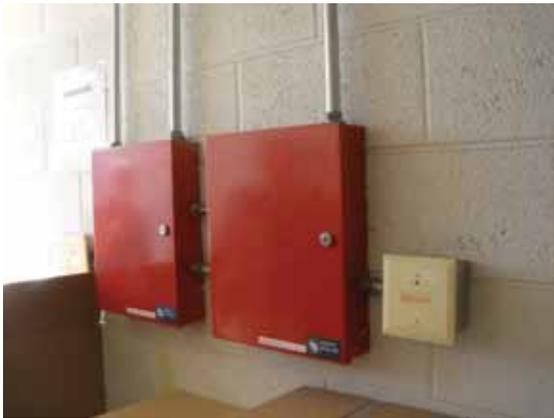
Fig. 2.4.A.12 – Fire alarm panels

The fire alarm system is an older Fire Lite system with full detection and pull stations. The devices are functioning. The facility's staff member stated during the walk that this system needs to be replaced to be brought up to the new standard Notifier fire alarm system.

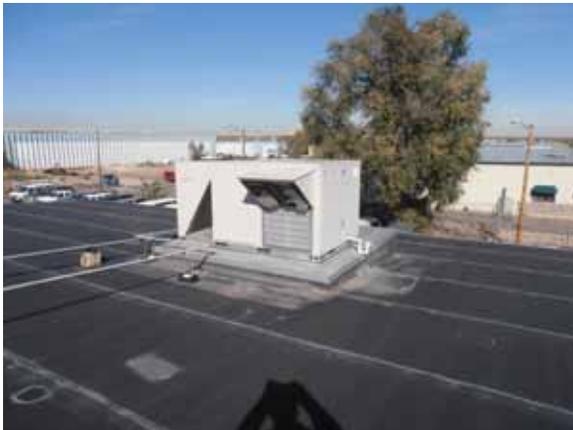
Fig. 2.4.A.30 – Existing unit, outside air filter damaged

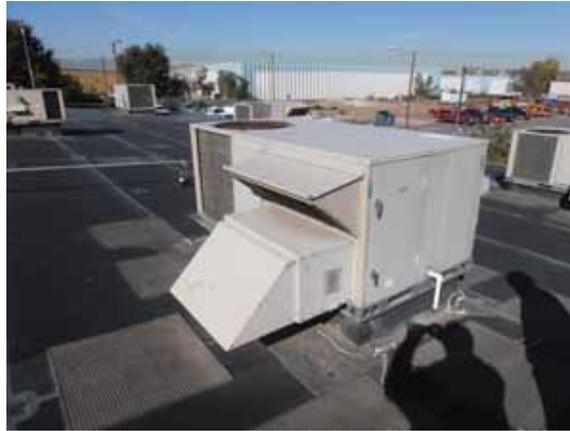
Fig. 2.4.A.32 – No trap on condensate drain

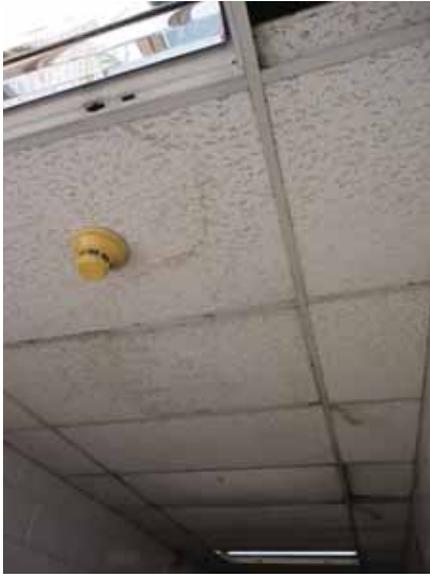
Fig. 3.0.C.1 Deteriorating 2x4 acoustic ceiling tiles with evidence of water damage observed in the north-south corridor on the west side of the original building and adjacent to the west addition.

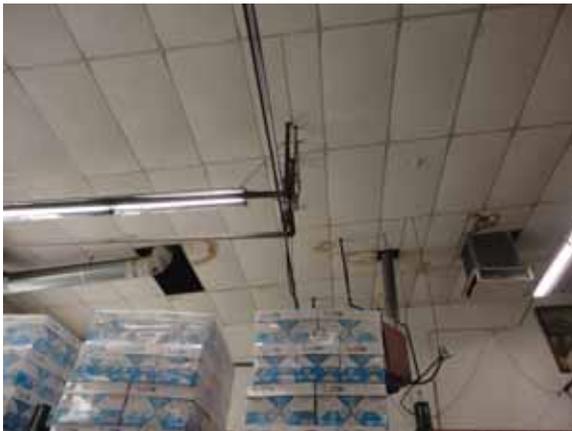
Fig. 3.0.C.2 Deteriorating and sagging acoustic ceiling tiles with evidence of water damage in the IDS Shipping and Receiving area in the southwest corner of the original building.

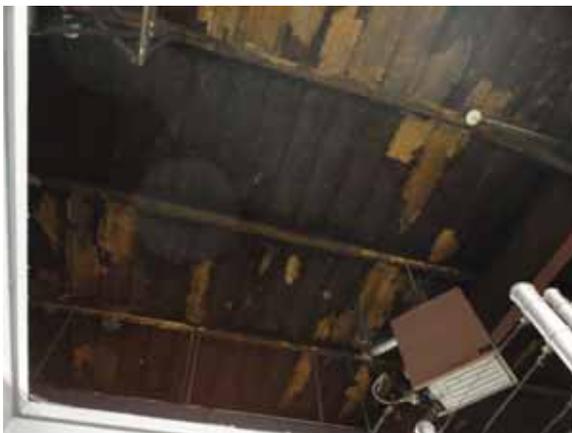
Fig. 3.0.C.3 Typical deterioration noted at the open ceilings throughout the areas occupied by the Community College of Denver.

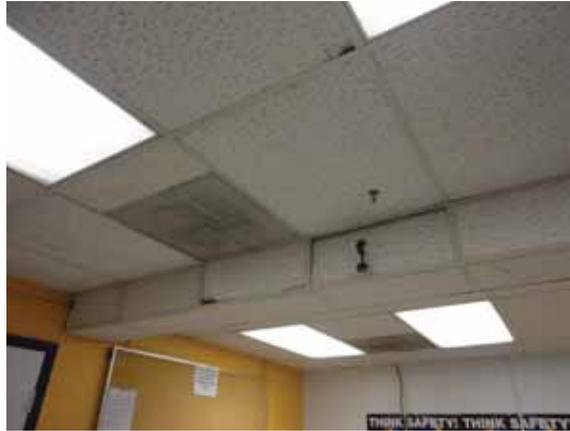
Fig. 3.0.C.4 Deteriorating acoustic ceiling tiles noted in the areas occupied by the Community College of Denver.

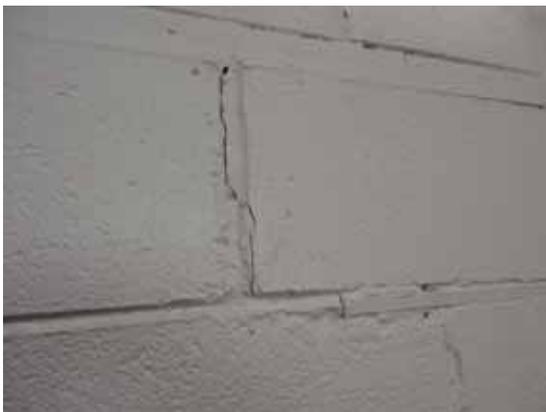
Fig. 3.0.C.7 Cracking observed at a concrete block wall in the IDS Shipping & Receiving area located in the southwest corner of the original building.

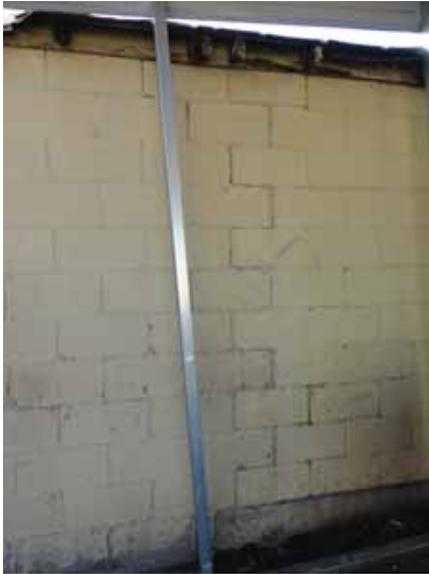
Fig. 3.0.C.11 Cracking observed at a concrete block wall in an area occupied by the Community College of Denver.

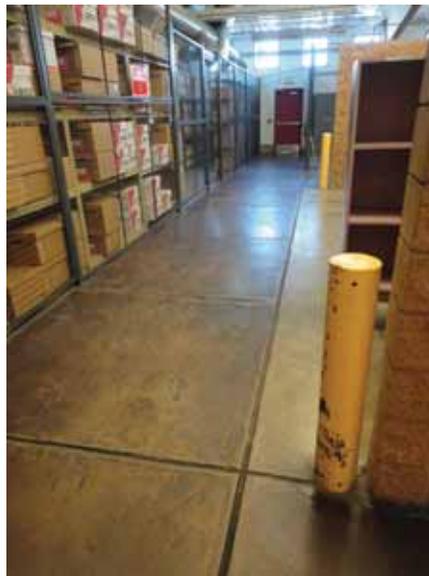
Fig. 3.0.C.12 Generally soiled concrete flooring observed throughout the west addition.

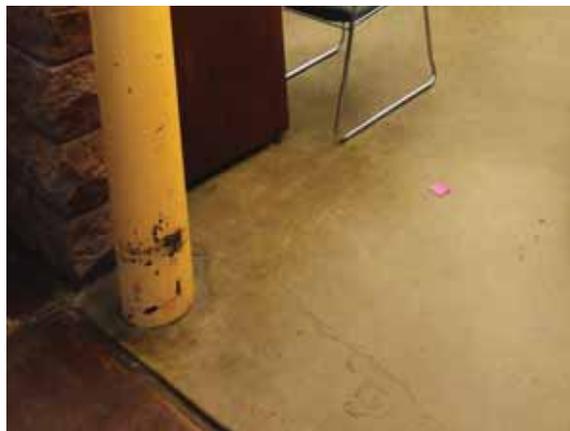
Fig. 3.0.C.13 Cracking concrete flooring observed in areas of the west addition.

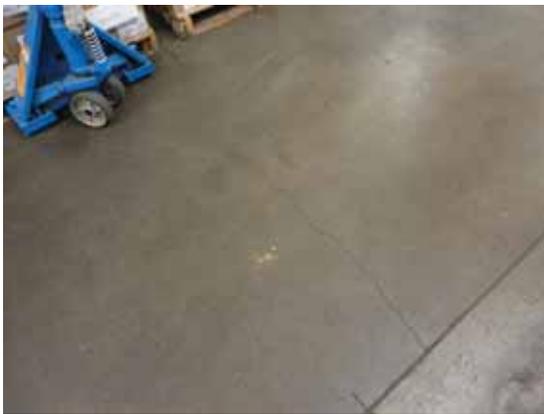
Fig. 3.0.C.15 Typical instance of cracking concrete flooring observed in the north-south corridor on the west side of the original building and throughout the IDS Shipping & Receiving area located in the southwest corner of the original building.

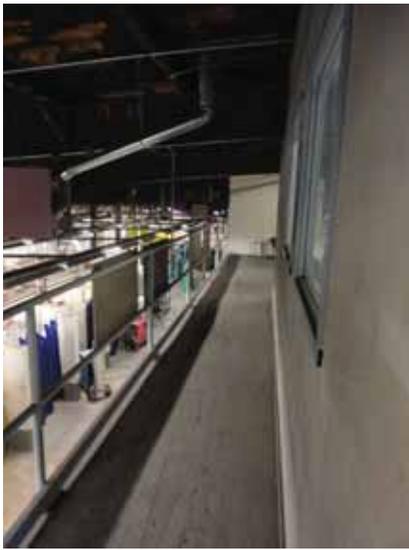
Fig. 3.0.C.21 The painted plywood floors appear to be warping and deteriorating at the mezzanine walkways included in the site survey visit of the original building.

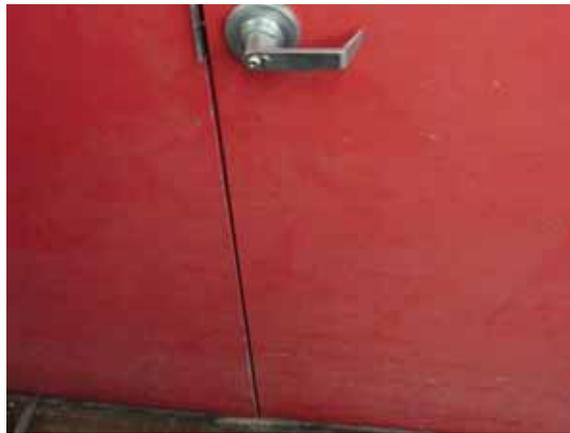
Fig. 3.0.C.23 General wear-and-tear observed at the doors throughout the west addition.

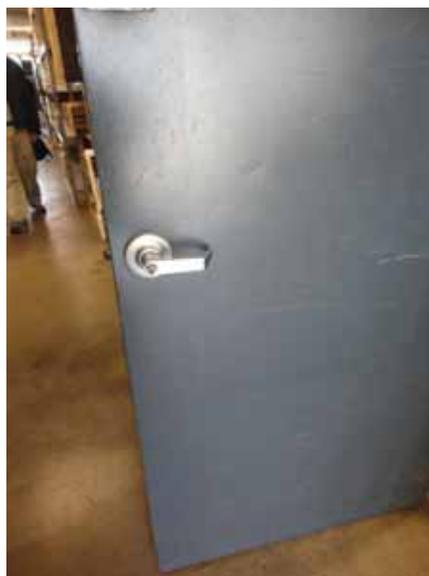
Fig. 3.0.C.24 General wear-and-tear observed at the doors throughout the original building.
