CAPITOL COMPLEX MASTER PLAN
FINDINGS & RECOMMENDATIONS (F & R) NEEDS ASSESSMENT
1570 GRANT BUILDING, 1570 GRANT STREET (DENVER)

NOVEMBER 2014

FINDINGS & RECOMMENDATIONS (F&R) NEEDS ASSESSMENT

1570 GRANT BUILDING
1570 GRANT STREET (DENVER)

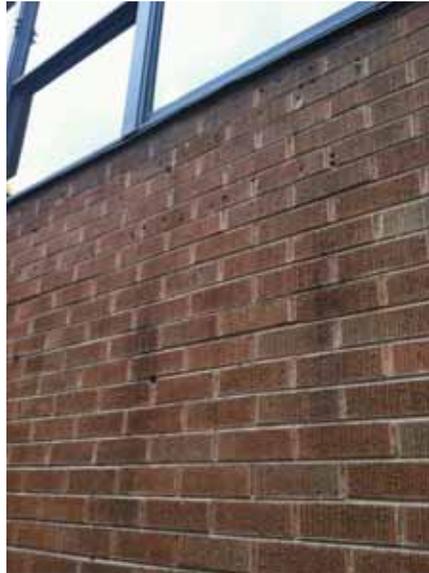
The brick cladding the majority of the building is in fair condition overall. A number of holes in the brick were noted at the north side of the building under the First Floor windows at the west end (see Fig. 2.1.A.1 and Fig. 2.1.A.2). Cracking along the joints between the brick was also noted at the north side of the east building entrance (see Fig. 2.1.A.3) and at the south side of the building just above grade level (see Fig. 2.1.A.4). Minor spalling was noted at the south side of the building, on the east end (see Fig. 2.1.A.5).

Fig. 2.1.A.1 Holes in the brick at the north side of the building under the First Floor windows.

- Clean soiled/stained brick around the building exterior, including at the Penthouse level.
- Repair or replace brick with any cracks, spalling, or holes around the building exterior and at the Penthouse level.

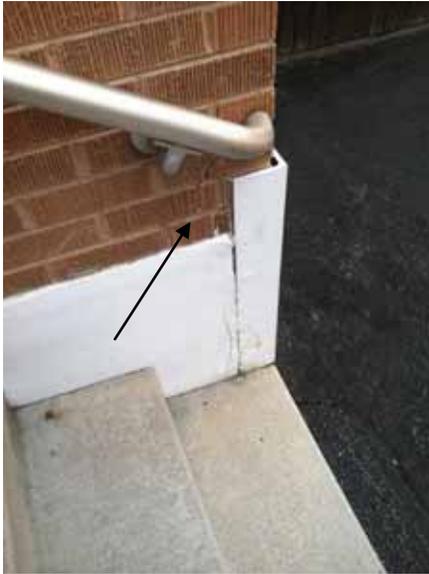
Fig. 2.1.A.3 Cracking along brick joints at the north side of the east building entrance.

- Tuck point the brick around the exterior of the building, including at the Penthouse level.
- Repair any cracks along the joints between the bricks.
- Repair or replace the damaged concrete foundation and mortar located at the south side of the building, on the east end and the cracking in the concrete foundation located along the East Entrance.

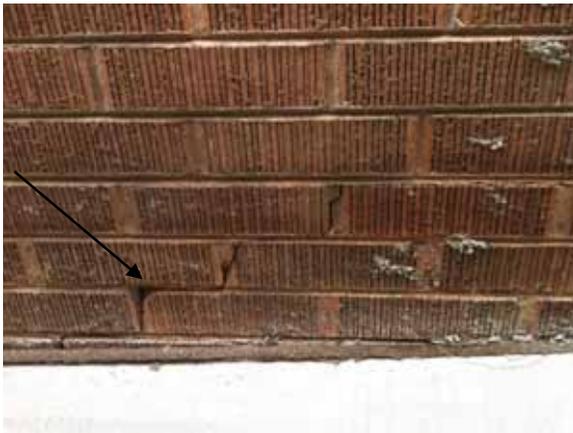
Fig. 2.1.A.4 Cracking along the joints between the brick at the south side.

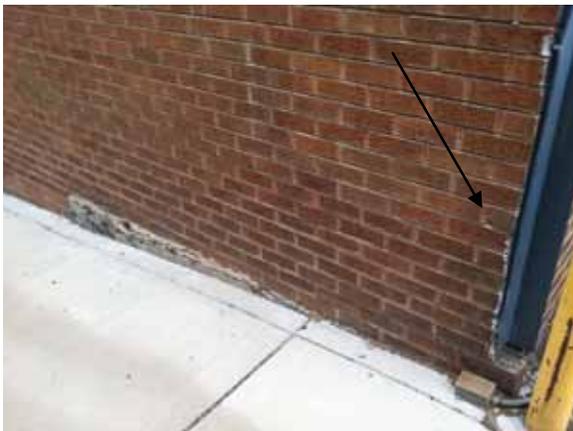
Fig. 2.1.A.5 Minor spalling at the south side of the building, on the east end.

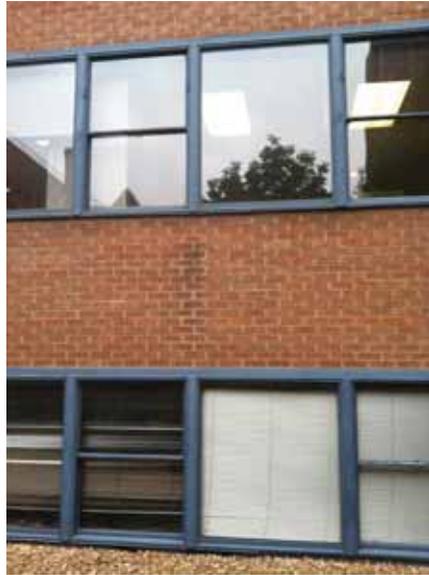
The brick is soiled in a number of locations around the building. In many instances the soiled brick exists under windows (see Fig. 2.1.A.6). There was also soiled brick noted on the south side of the building at grade level (see Fig. 2.1.A.7).

Fig. 2.1.A.6 Typical instance of soiled brick found under the windows.

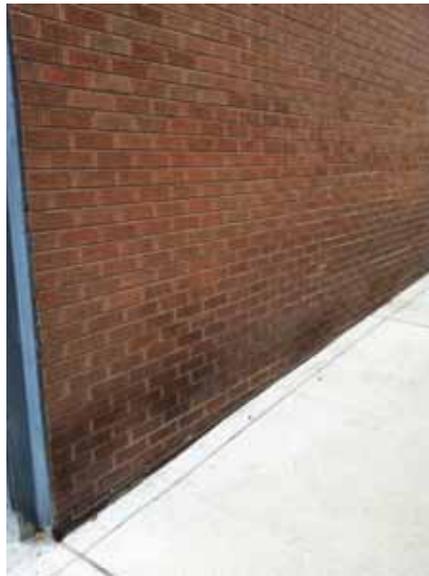
Fig. 2.1.A.7 Soiled brick at the south side of the building at grade level.

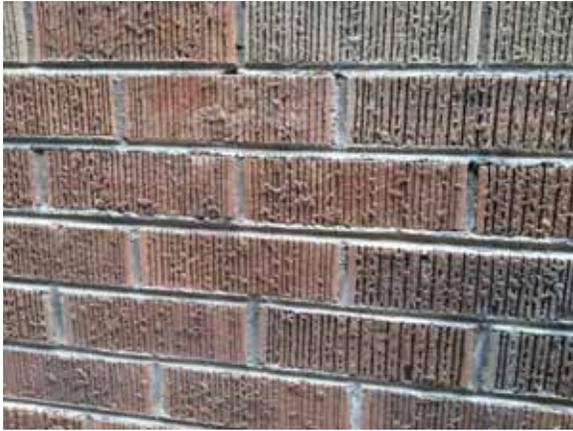
The mortar between the bricks exhibited a minor amount of deterioration in general (see Fig. 2.1.A.8). Specific deterioration was noted at the south side of the building just above grade level (see Fig. 2.1.A.9 and Fig. 2.1.A.10) and at the Penthouse walls on the roof (see Fig. 2.1.A.11 and Fig. 2.1.A.12).

Fig. 2.1.A.8 Minor deterioration of the mortar between the bricks.

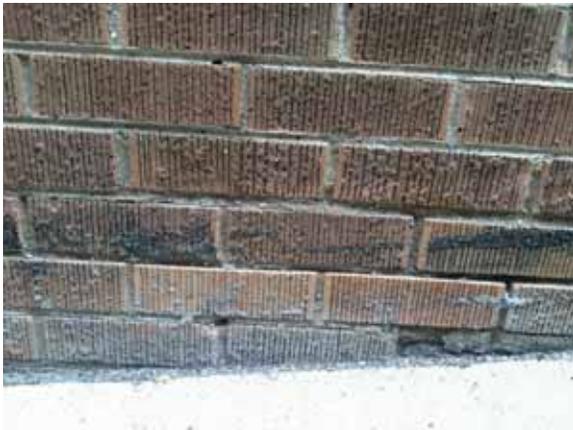
Fig. 2.1.A.9 Deterioration of the mortar at the south side.

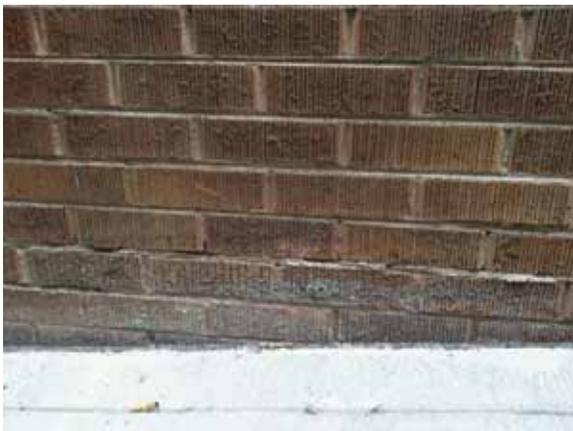
Fig. 2.1.A.10 Deterioration of the mortar at the south side.

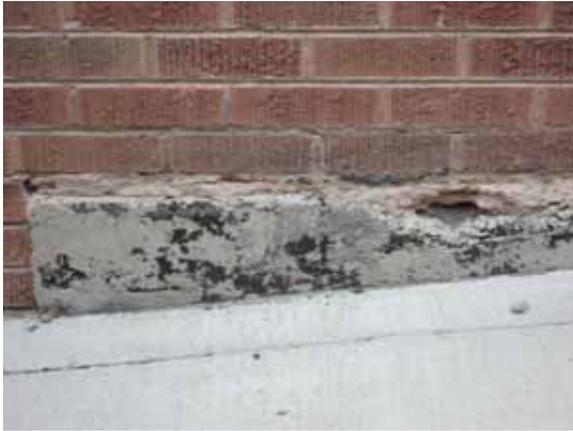
Deterioration of the mortar and spalling was further noted at the concrete foundation located at the south side of the building, on the east end (see Fig. 2.1.A.13 and Fig. 2.1.A.14).

Fig. 2.1.A.13 Deterioration of the mortar and spalling of the concrete foundation at the south side.

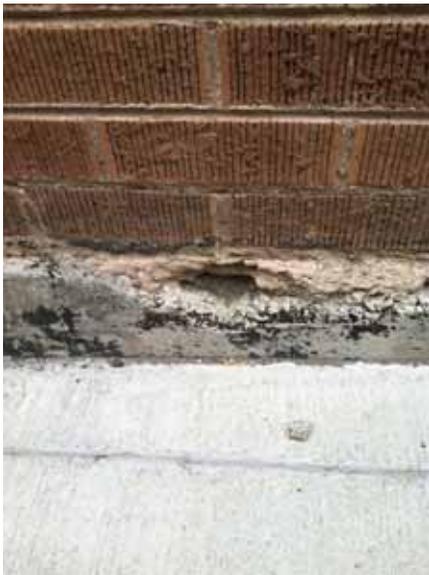
Fig. 2.1.A.14 Deterioration of the mortar and spalling of the concrete foundation at the south side.

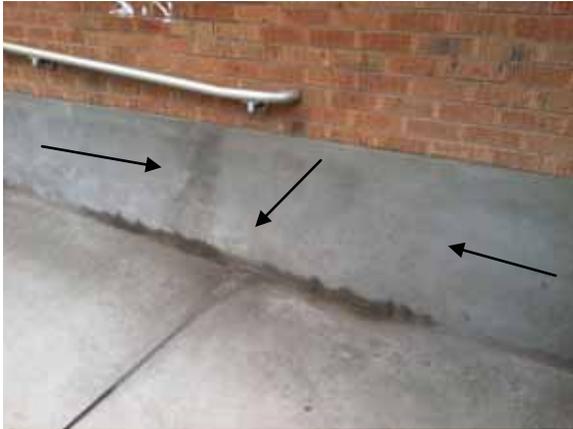
Cracks in the concrete panels were noted at the northwest, southeast, and southwest corners of the building (see Fig. 2.1.A.15, Fig. 2.1.A.16, and Fig. 2.1.A.17). Cracks in the concrete foundation were also noted at the north side of the building, on the east end, and at the east entrance ramp where there also appeared to be evidence of standing water (see Fig. 2.1.A.18).

Fig. 2.1.A.18 Cracks in concrete foundation along the ramp at the east entrance where there also appeared to be evidence of standing water.

- Repair or replace the damaged or missing light-colored masonry veneer on either side of the Grant Street Entrance.
- Water appears to be pooling along the ramp at the East Entrance. Verify the cause of the pooling and repair as necessary.

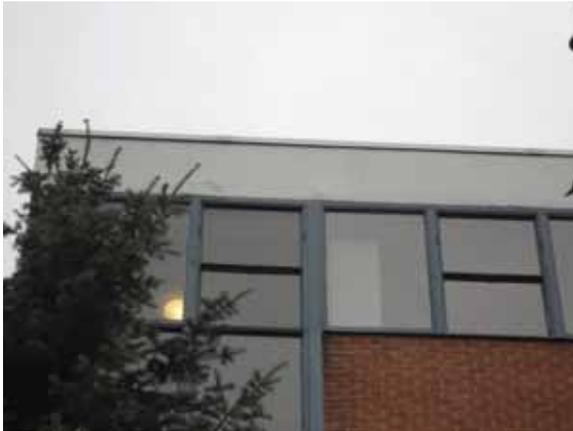
The painted concrete around the exterior of the building is peeling in numerous locations including the concrete cap around the perimeter of the roof (see Fig. 2.1.A.19) and the concrete around the top perimeter of the Penthouse (see Fig. 2.1.A.20).

Fig. 2.1.A.19 Peeling paint at the concrete cap around the perimeter of the roof.

- Repair or replace the cracked concrete panels located at the northwest, southeast, and southwest corners of the building.
- Remove loose paint from painted concrete surfaces around the building and Penthouse and repaint all painted concrete surfaces using appropriate materials and methods for an exterior application.

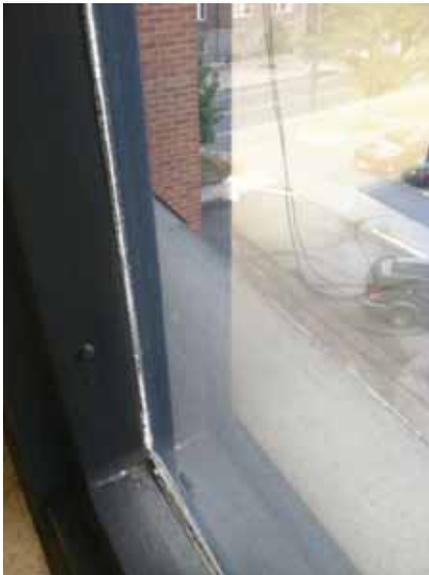
The windows are operable and are single pane with no thermal break (see Fig. 2.1.A.22). It was reported that film has been added to the windows due to the fact that half of the building gets too hot and half of the building gets too cold. The paint is generally peeling off of the window frames around the exterior of the building and appears to be the cause of the minor corrosion that was noted during the site visit (see Fig. 2.1.A.23 and Fig. 2.1.A.24).

Fig. 2.1.A.22 Single pane window with no thermal break.

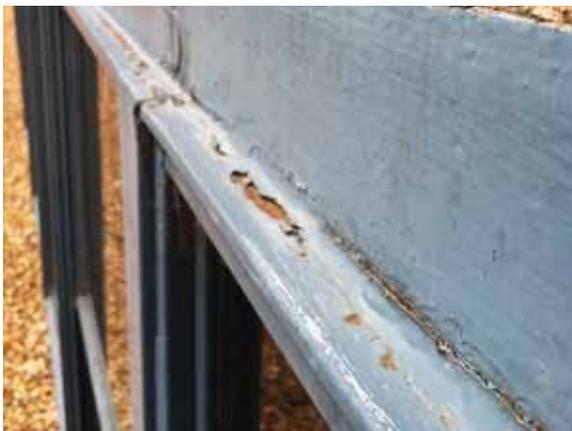
Fig. 2.1.A.23 Corroded window frame with peeling paint.

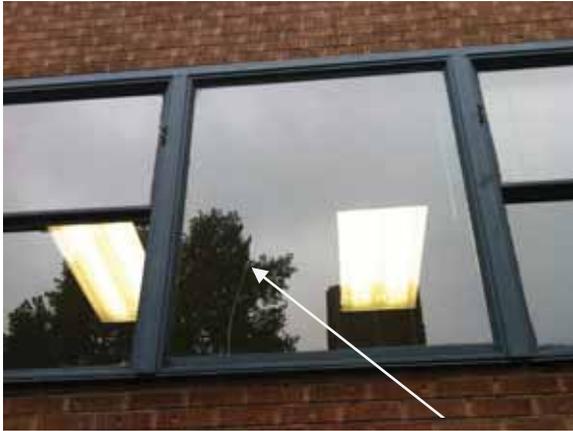
There were also broken windows that were observed, especially on the north side of the building, with cracked glazing (see Fig. 2.1.A.25, Fig. 2.1.A.26, Fig. 2.1.A.27, and Fig.2.1.A.28), fogged glazing (see Fig. 2.1.A.29), and a bent window frame (see Fig. 2.1.A.30).

Fig. 2.1.A.27 Broken window at the north side.

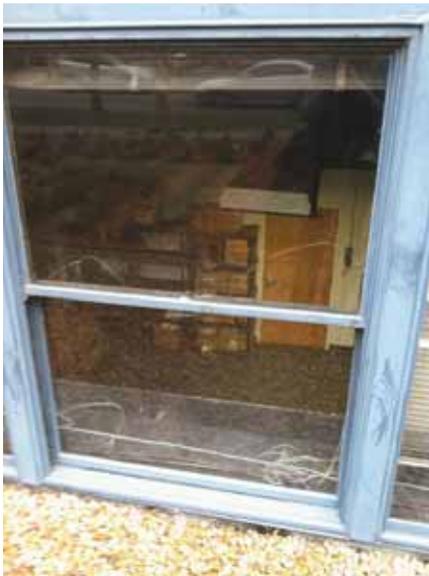
Fig. 2.1.A.28 Broken window at the north side.

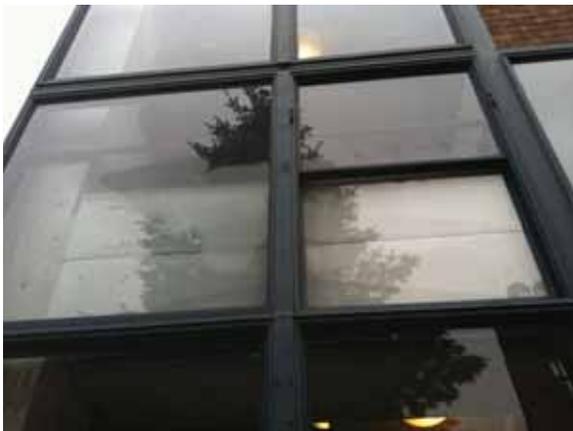
Fig. 2.1.A.29 Fogged glazing at the north side.

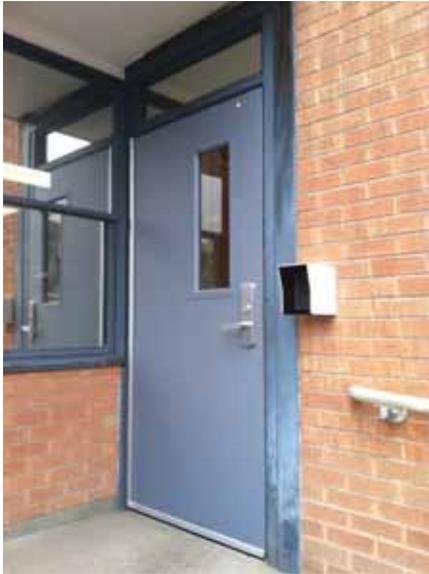
Fig. 2.1.A.32 Soiled and damaged door frame at the north end of the east entrance.

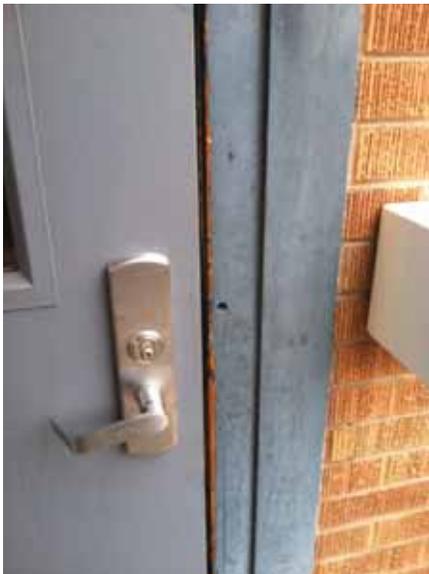
Fig. 2.1.A.33 Soiled and damaged door frame at the north end of the east entrance.

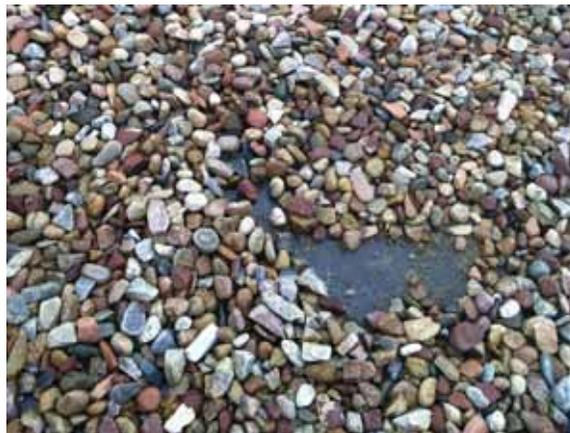
Fig. 2.1.A.34 Area of thin ballast leaving the roof membrane exposed on the roof.

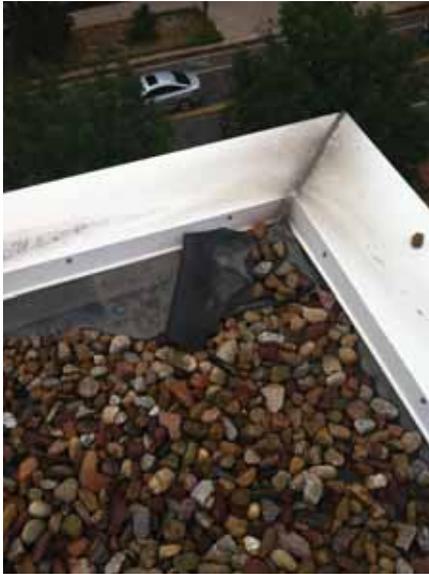
Fig. 2.1.A.36 Spot where the membrane is loose on the roof.

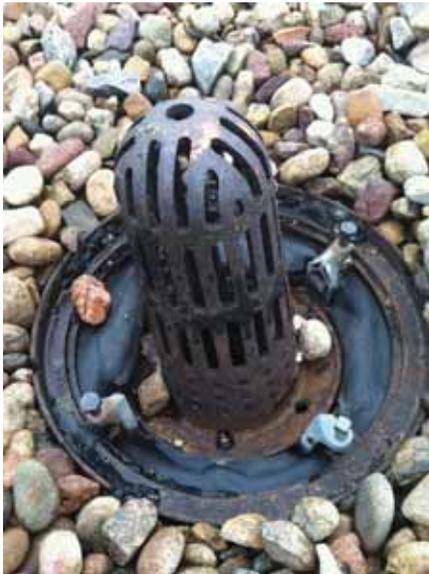
It was noted that there are currently no overflow drains. Some of the drain covers are in good condition and some are showing signs of corrosion (see Fig. 2.1.A.37).

Fig. 2.1.A.37 Drain cover showing signs of corrosion.

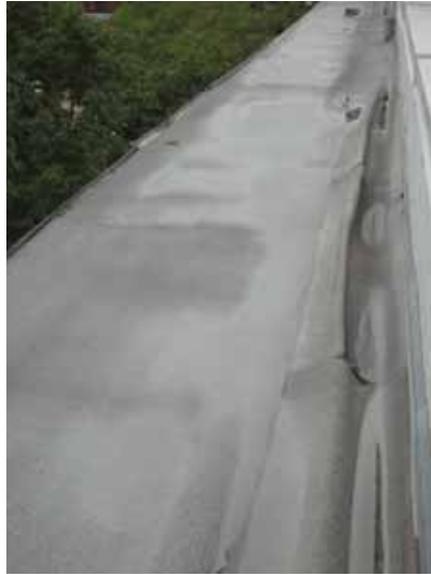
The asphalt covering an area of an extended outer edge on east and west sides of the building is deteriorating (see Fig. 2.1.A.38).

Fig. 2.1.A.38 Deteriorating asphalt covering extended outer edges.

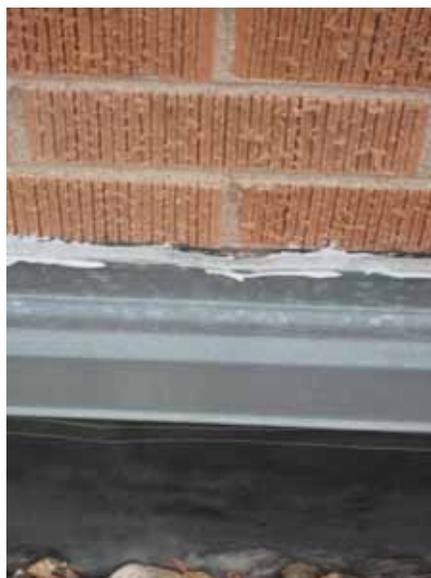
The sealant along the flashing and parapet coping is generally deteriorating (see Fig. 2.1.A.39 and Fig. 2.1.A.40). The parapet coping also exhibits signs of standing water (see Fig. 2.1.A.41) and appear to be warping along the south end of the west side of the building and along the south side of the building (see Fig. 2.1.A.42).

Fig. 2.1.A.39 Typical deteriorating sealant found along the flashing.

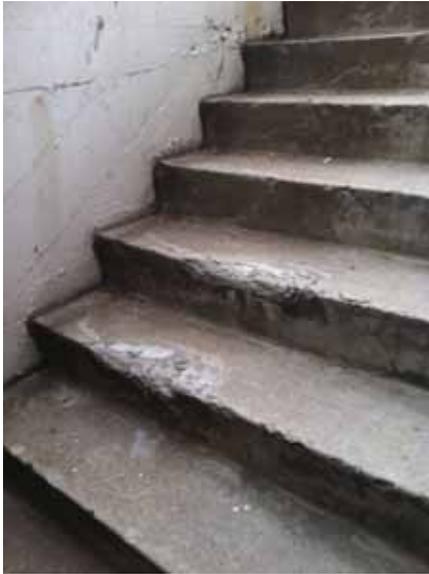
Fig. 2.1.A.54 Damage to exterior concrete stairway on the east side of the building.

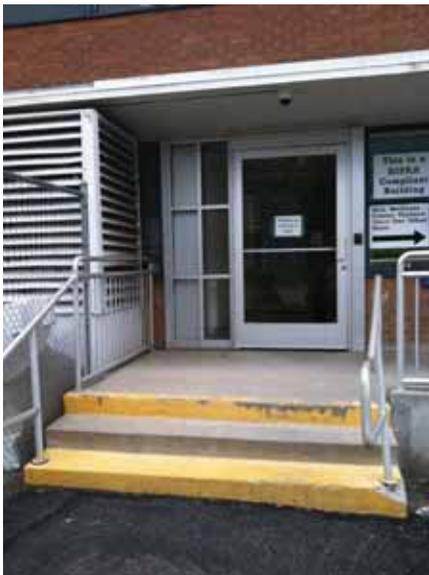
The stairway leading up to the exterior door at the south end of the East Entrance has spalling at the edge of the lower step which has resulted in a loose railing (see Fig. 2.1.A.55).

Fig. 2.1.A.55 Spalling of the concrete step outside of the exterior door at the south end of the East Entrance.

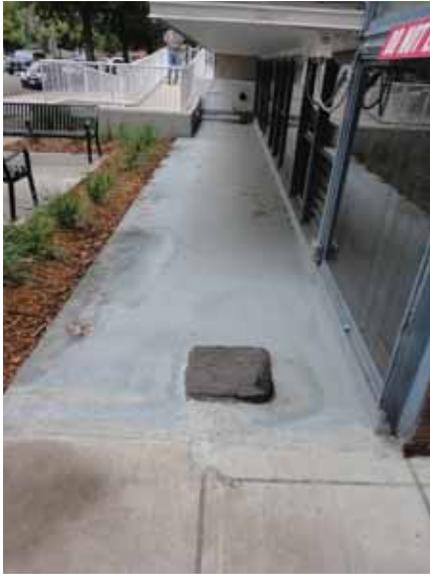
Fig. 2.1.A.58 Lid near the front of the building that is exposed to water.

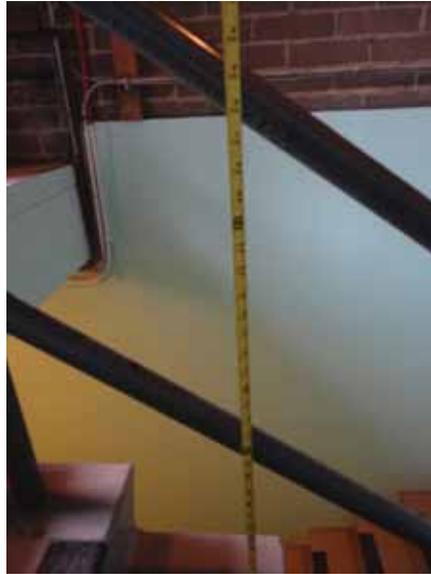
Fig. 2.1.B.4 Measurement to top of railing above the stair nosing is approximately 29-1/2 inches.

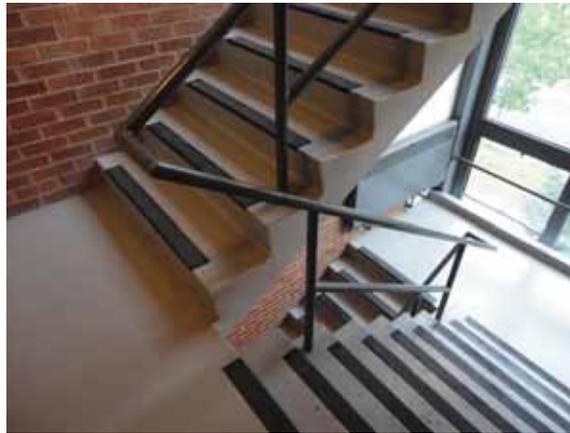
Fig. 2.1.B.5 The spacing between the handrail posts, or guardrails, is not to code, easily allowing passage of a sphere 4 inches in diameter.

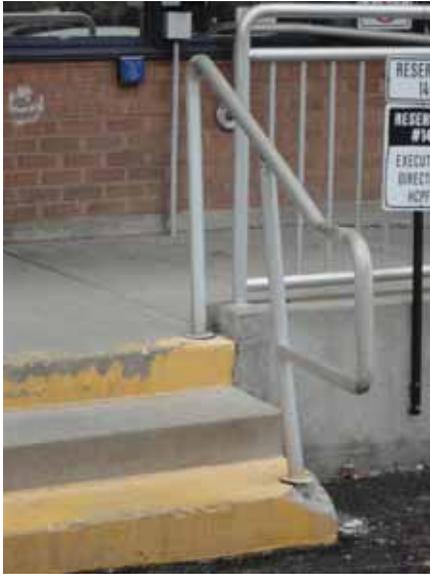
The railing at the south exterior stair of the East Entrance is loose due to spalling of the concrete stair tread at the base of the handrail post (see Fig. 2.1.B.6). According to Section 1012.1 of the IBC (2012), handrails for stairways and ramps shall be adequate in strength and attachment in accordance with Section 1607.8.

Fig. 2.1.B.6 Loose railing at the south exterior stair of the East Entrance.

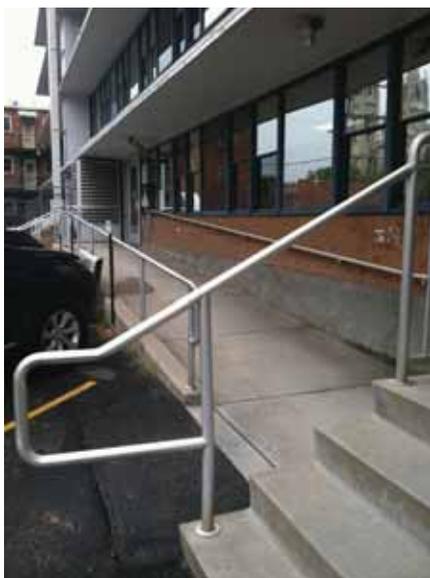
There appears to be evidence of water pooling along the East Entrance ramp (see Fig. 2.1.B.7). According to Section 1010.8.2 of the IBC (2012), outdoor ramps and outdoor approaches to ramps shall be designed so that water will not accumulate on walking surfaces.

Fig. 2.1.B.7 Water accumulating at the East Entrance ramp.

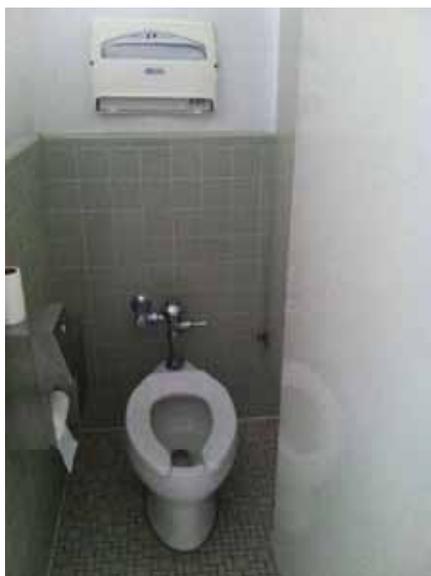
Fig. 2.1.C.1 Non-accessible toilet stall.

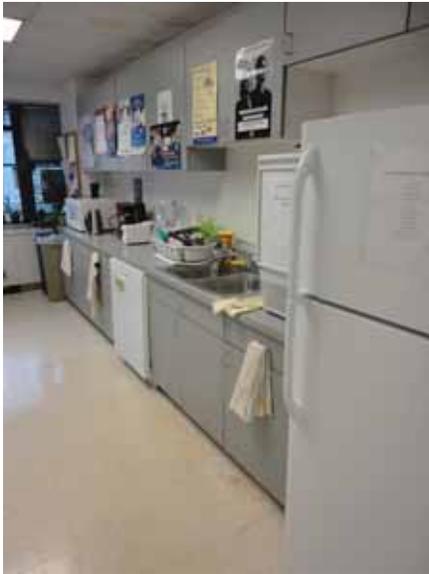
The sinks in the break rooms on each floor were typically non-accessible (see Fig. 2.1.C.5).

Fig. 2.1.C.5 Typical non-accessible sink found in the break rooms throughout.

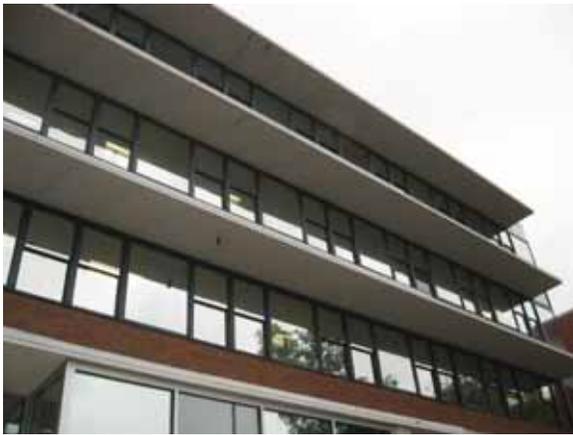
Fig. 2.2.A.1

The concrete canopies at each floor are showing signs of water damage. Several cracks and spalls were observed on the underside of the canopies (Fig. 2.2.A.1). The cracks appear to be relatively uniformly spaced and are likely due to temperature changes and shrinkage. Water has penetrated into the cracks, causing corrosion and spalling of the concrete.

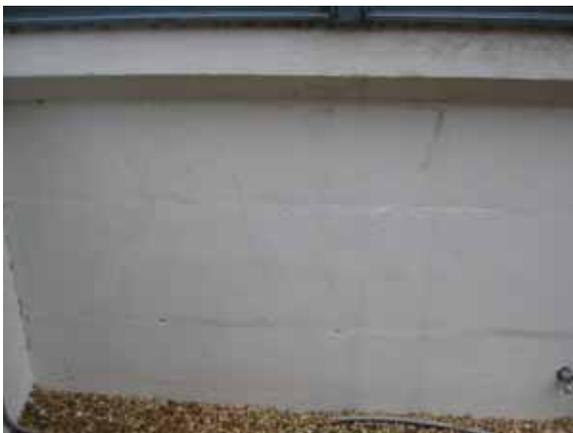
Fig. 2.2.A.2

Cracks in the foundation wall at the northeast corner were observed (Fig 2.2.A.2). The cracks have been previously patched and are very minor at this time.

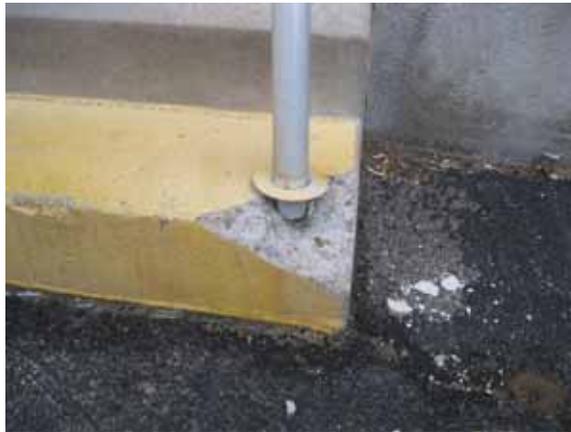
Fig. 2.2.A.3

The concrete on the east entrance stairs has spalled at the handrail post (Fig. 2.2.A.3). No reinforcing is present in the concrete and the post is only embedded about 2 inches. The railing is very loose and is noticeably leaning.

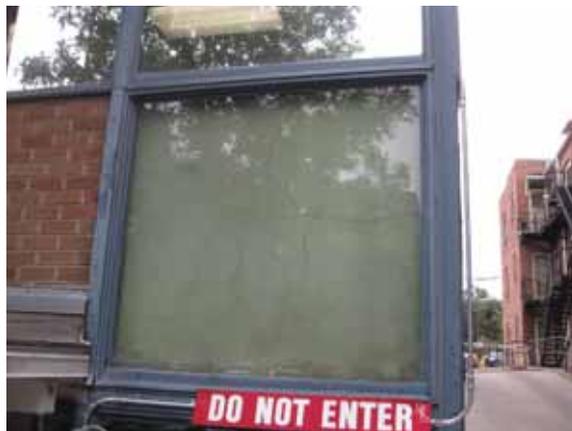
Fig. 2.2.A.4

Significant cracks were observed in the concrete panels at the northwest, southwest, and southeast corners of the building (Fig. 2.2.A.4). After further investigation, the panels were believed to be non-structural (veneer) and do not pose a structural concern. The cracking was likely caused by differential temperature changes due to the glass panels directly in front of them.

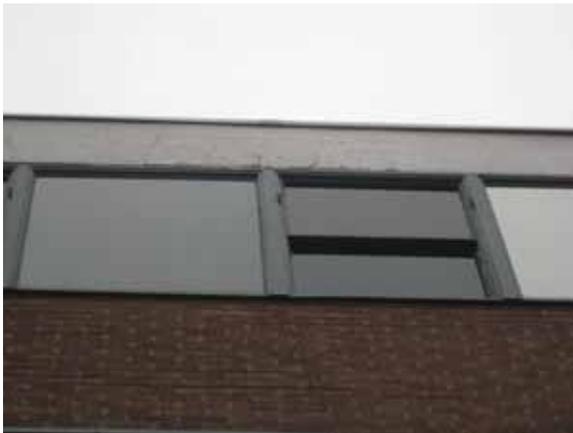
Fig. 2.2.A.5

Cracks were observed along the concrete beam at the roof level on the south face (Fig. 2.2.A.5). The cracks will allow water into the concrete and cause additional deterioration. To prevent further moisture intrusion and deterioration, the cracks should be sealed.

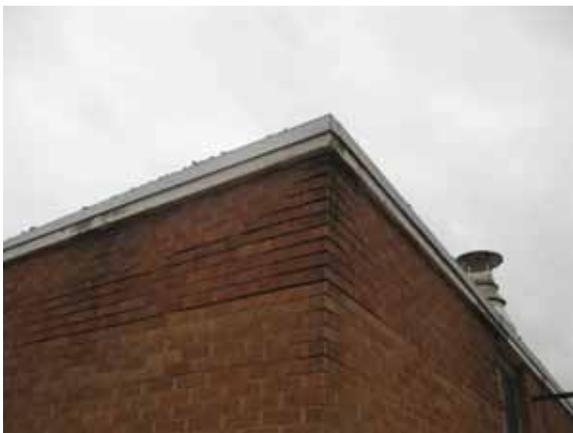
Fig. 2.2.A.6

The mortar joints in the penthouse walls were deteriorated (Fig. 2.2.A.6). The joints in the brick masonry bearing wall are showing signs of deterioration due to the elements and should be re-pointed.

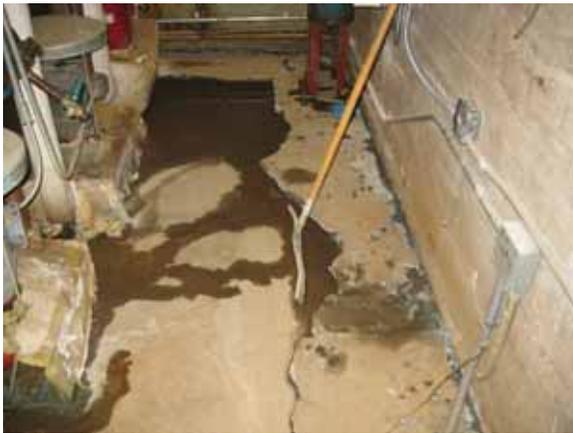
Fig. 2.2.B.2

Standing water was observed in the mechanical room and the concrete overlay is cracked and loose (Fig. 2.2.B.2). The water does not flow towards a drain and sits on the concrete slab. The concrete overlay is deteriorated and should be removed.

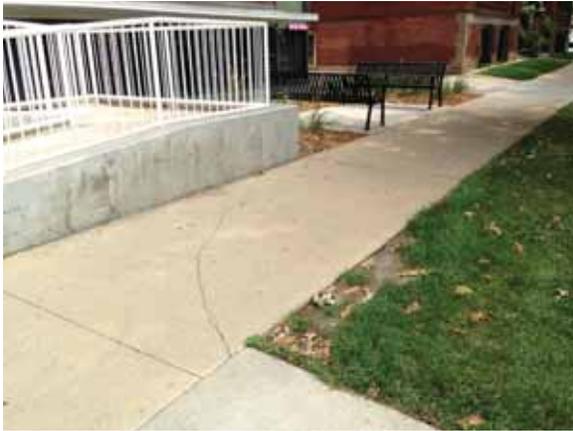
Fig. 2.3.A.7 Sidewalk Crack, Recommended for Replacement

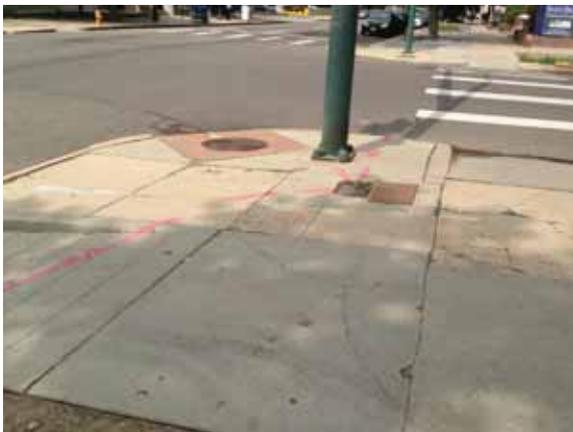
Fig. 2.3.A.8 Broken Site Concrete, Recommended for Replacement

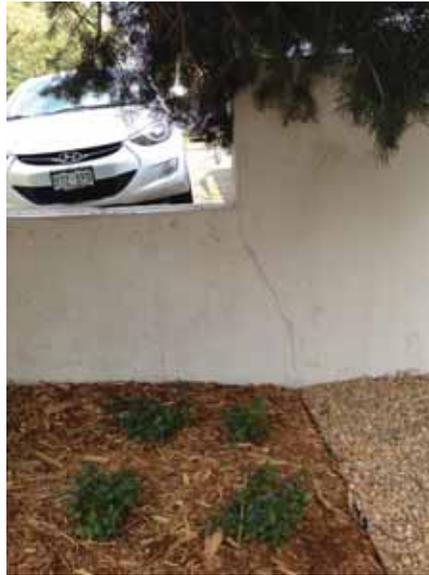
There is a large crack in the retaining wall on the east side of the site along the parking area (Fig. 2.3.B.1). The crack is of concern and the wall should be analyzed for stability. The wall may need replacement.

Figure Fig. 2.3.B.1 Crack in Retaining Wall

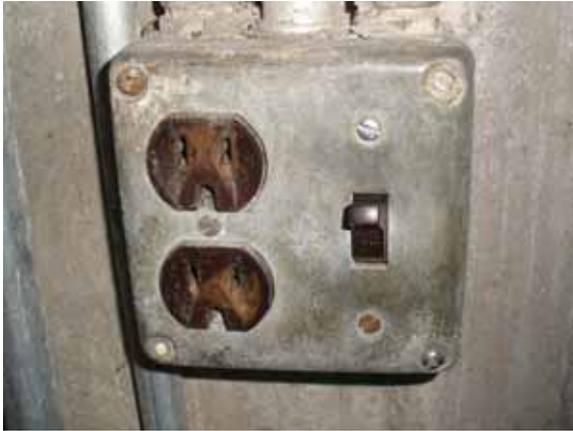
Fig. 2.4.A.6 – Receptacle and switch past useful life

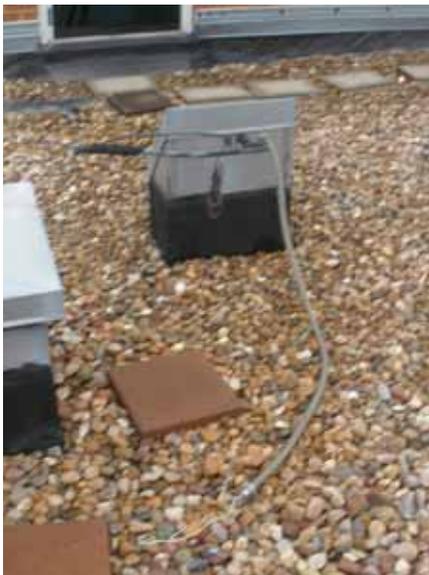
The elevator appears to be due for a cab upgrade. Some out of service equipment has been abandoned and will decay over time.

Fig. 2.4.A.7 – Abandoned conduit

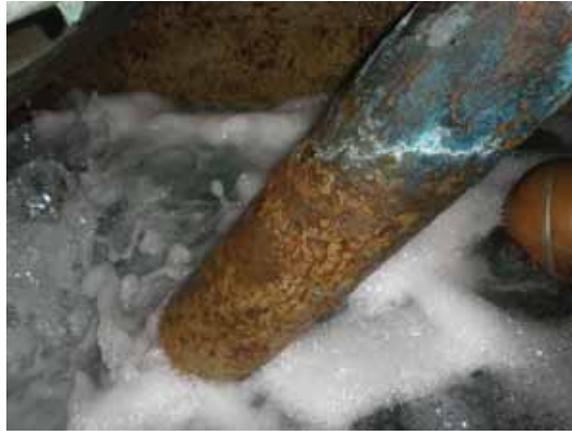
Fig. 2.4.A.9 - Inside view of tower sump

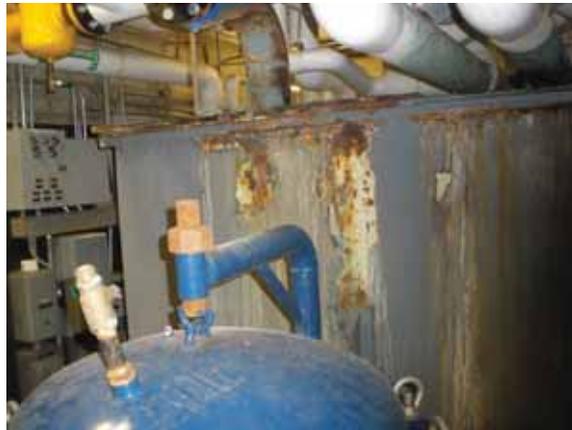
Fig. 2.4.A.10 - Rusting on outside of tower sump

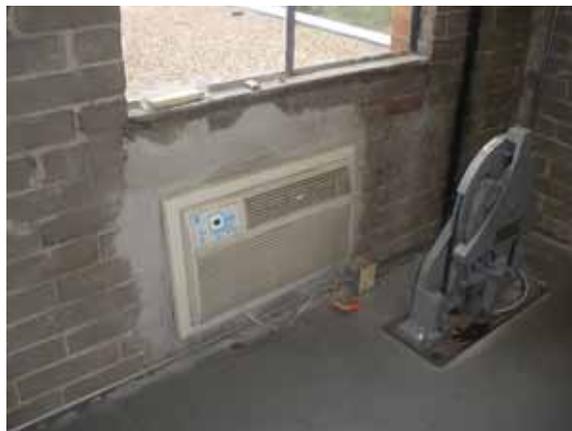
Fig. 2.4.A.11 - Existing window ac unit

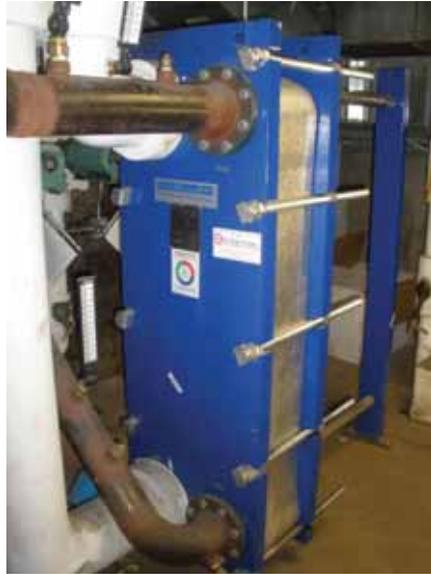
Fig. 2.4.A.15 - Missing insulation on Heat Exchanger Piping

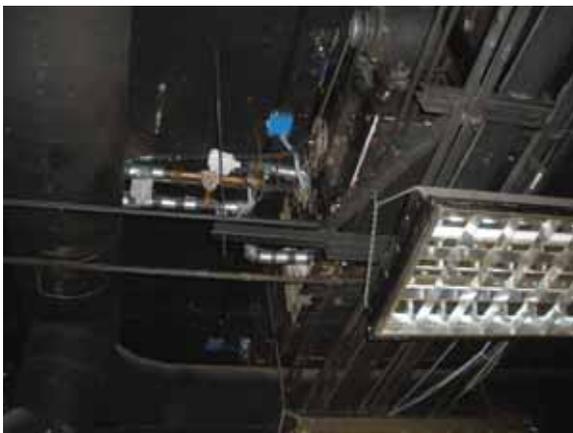
Fig. 2.4.A.20 - No belt guard provided for AHU

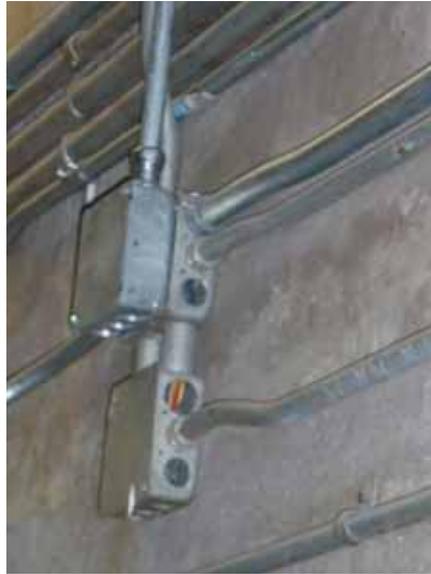
Fig. 2.4.B.5 – Open junction boxes

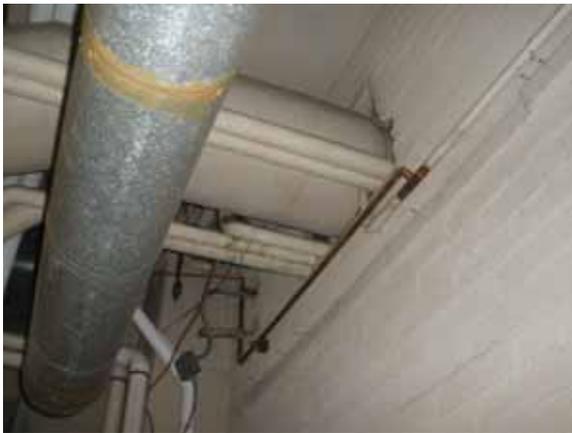
- It is our understanding that all fire/smoke protection systems have been inspected by Denver Fire Department and the building fire protection system is acceptable to AHJ.
- Provide fire sprinkler system.
- Air distribution in the building and minimum outside air required in all spaces is not adequate.
- The openings around duct and pipes passing through rated wall are not sealed with fire rated material (see Fig. 2.4.B.7).

Fig. 2.4.B.7 – Opening in walls around duct and pipe penetrations

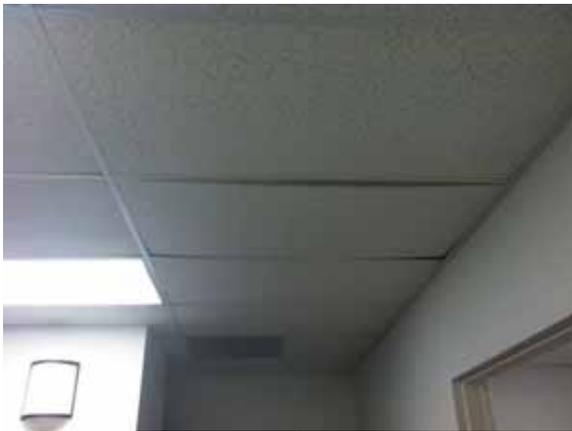
Fig. 3.0.C.1 Sagging 2x4 acoustic ceiling tiles.

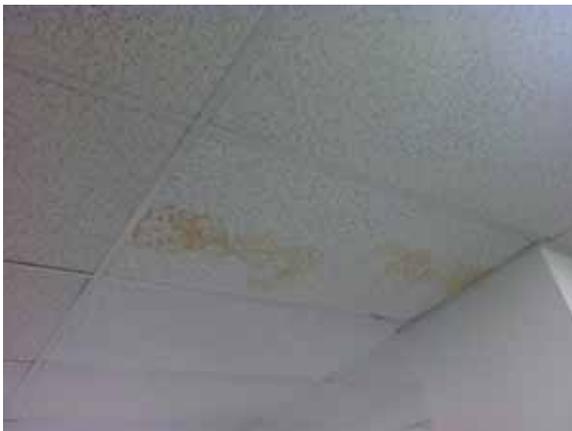
Fig. 3.0.C.2 Stained 2x4 acoustic ceiling tiles.

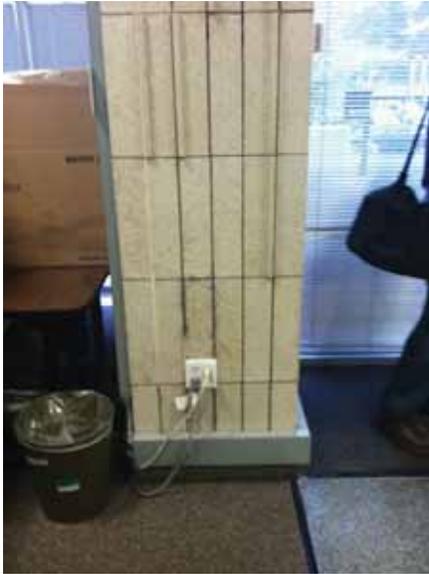
Fig. 3.0.C.5 Dirty masonry veneer cladding the Grant Street Entrance lobby walls.

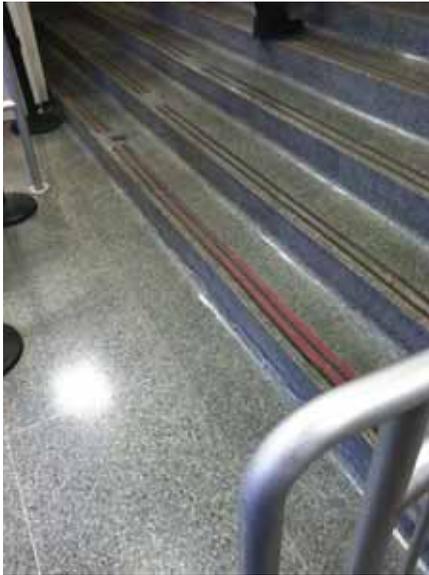
Fig. 3.0.C.10 Worn terrazzo floor at the base of the first step in the Grant Street Entrance lobby.

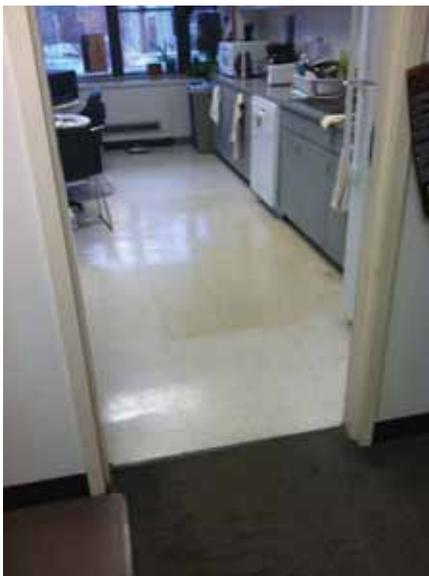
Fig. 3.0.C.11 Discolored linoleum tile in noted in a Break Room.

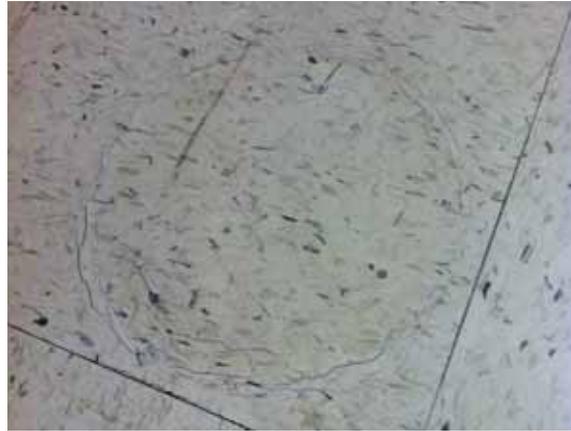
Fig. 3.0.C.12 Damaged linoleum tile noted in the entryway of a Break Room.

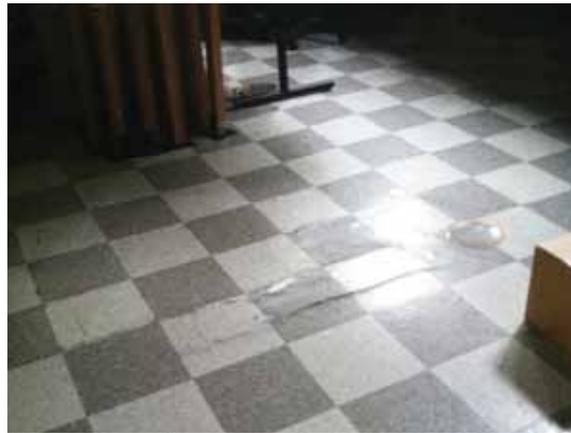
Fig. 3.0.C.13 Damaged flooring in Room 013 C Vending/Storage in the basement.

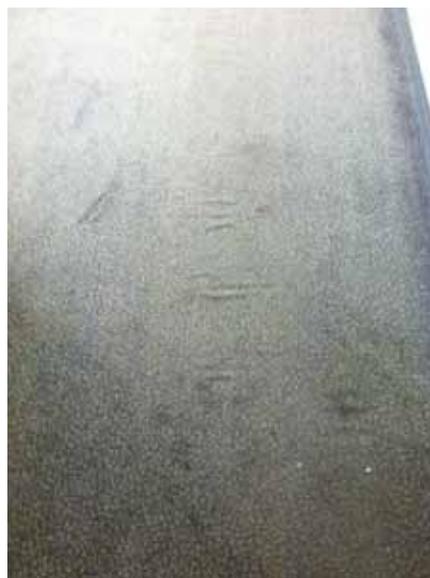
Fig. 3.0.C.14 Typical carpet flooring in generally poor condition.

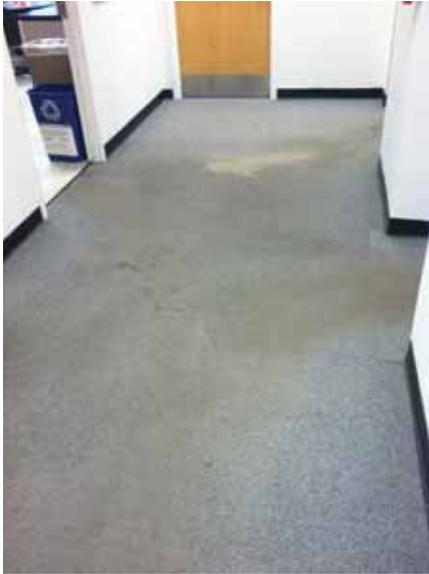
Fig. 3.0.C.15 Typical soiled and stained carpet flooring.

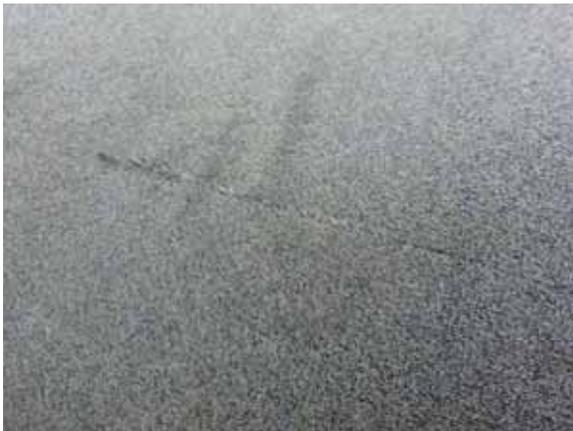
Fig. 3.0.C.16 Typical carpet flooring pulling loose at the seams.

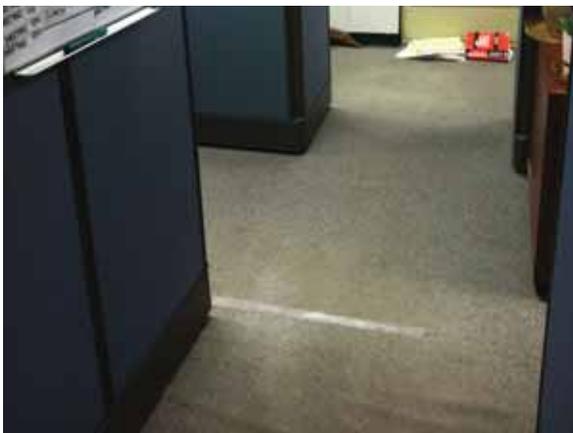
3.0.C.14, Fig. 3.0.C.15 and Fig. 3.0.C.16). Some of the areas with loose seams have been taped, also creating a potential tripping hazard (see Fig. 3.0.C.17). The vinyl baseboard is pulling away from the wall in spots on the Basement Floor (see Fig. 3.0.C.18).

Fig. 3.0.C.17 Typical carpet flooring in generally poor condition and with tape covering the loose seams.

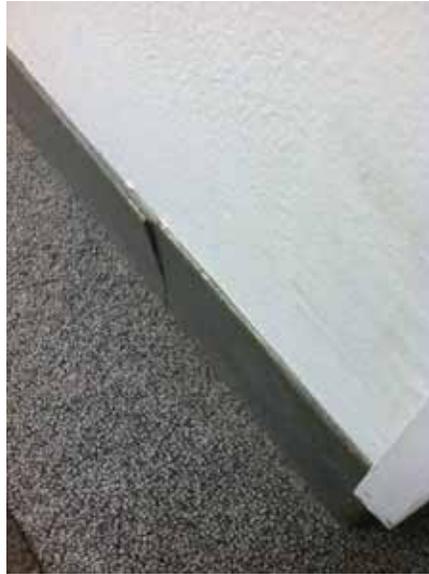
Fig. 3.0.C.18 Vinyl baseboard pulling away from the wall on the Basement Floor.

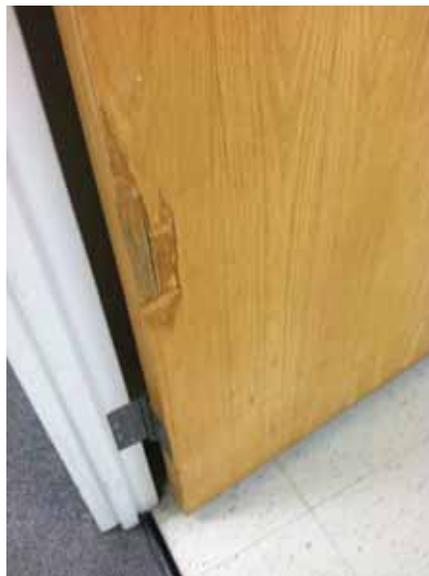
General damage to the doors of the Break Rooms was noted during the site survey visit (see Fig. 3.0.C.19).

Fig. 3.0.C.19 Damaged door noted at a Break Room.
