CAPITOL COMPLEX MASTER PLAN
FINDINGS & RECOMMENDATIONS (F & R) NEEDS ASSESSMENT
NORTH CAMPUS WEST BUILDING, 1001 EAST 62ND AVENUE (DENVER)

NOVEMBER 2014

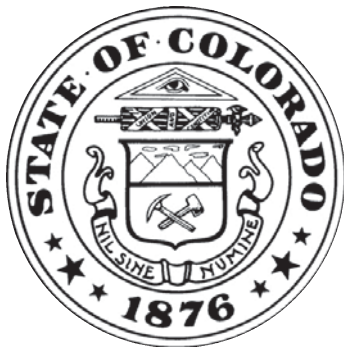
1.0-E VOICE AND DATA OVERVIEW

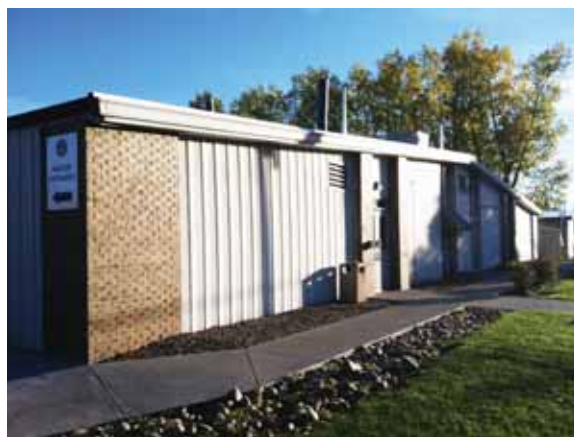
Front/South Elevation of the North Campus West Building

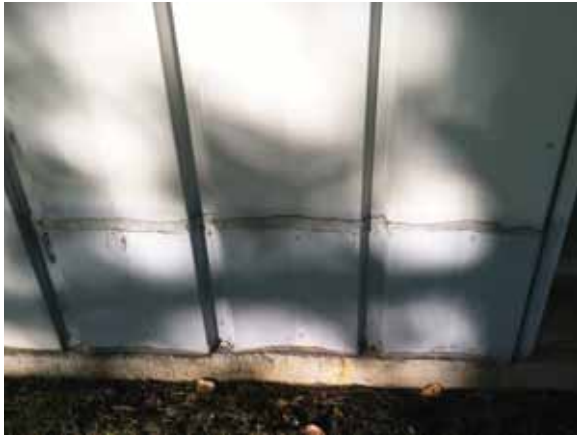
Fig. 2.1.A.1 Deteriorating areas of previously repaired metal panels observed around the exterior of the building.

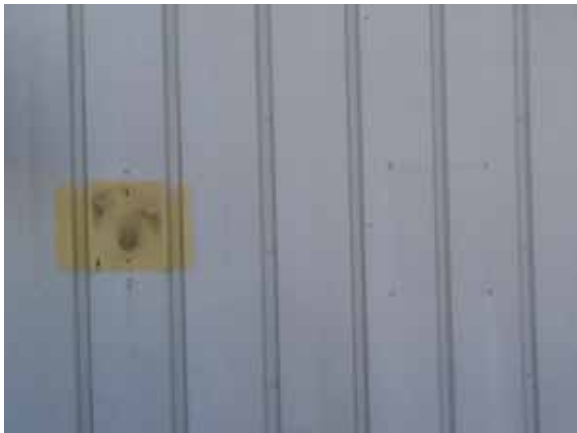
Fig. 2.1.A.2 Unrepaired holes leaving the building envelope vulnerable to water penetration and discoloration of the metal panels observed in areas around the exterior of the building.

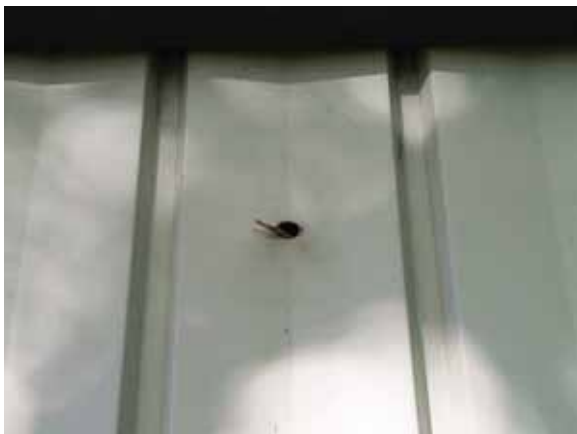
Fig. 2.1.A.3 An unrepaired hole observed with loose wires sticking out.

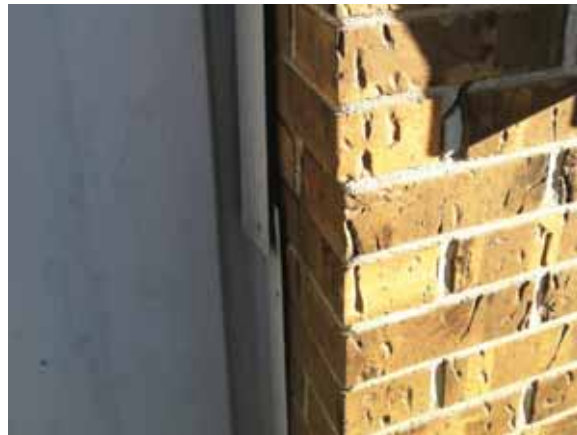
Fig. 2.1.A.4 Metal trim observed to be coming loose around the exterior of the building.

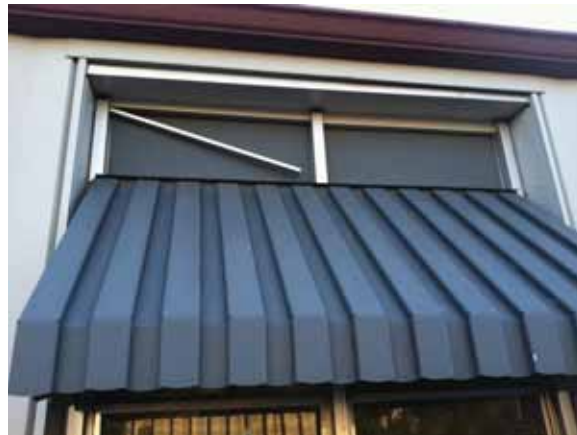
Fig. 2.1.A.5 Metal trim observed to be coming loose around the exterior of the building.

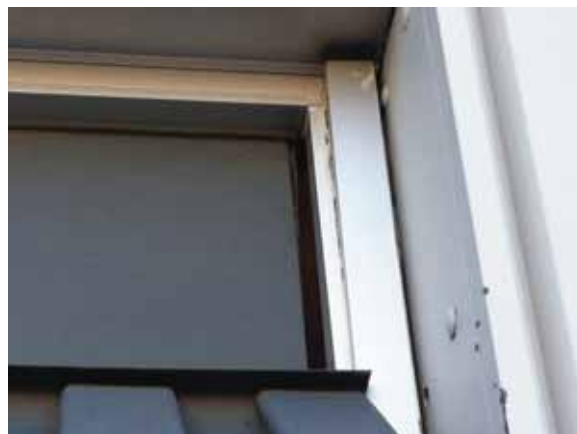
Fig. 2.1.A.6 Sealant observed to be deteriorating or missing entirely at the metal trim around the exterior of the building.

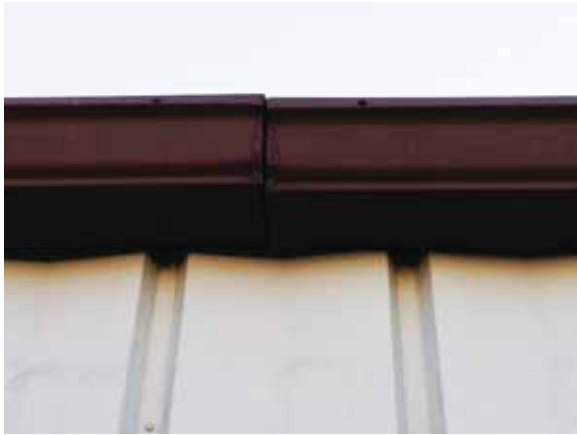
Fig. 2.1.A.7 Corrosion observed at the top of the metal panels around the exterior of the building.

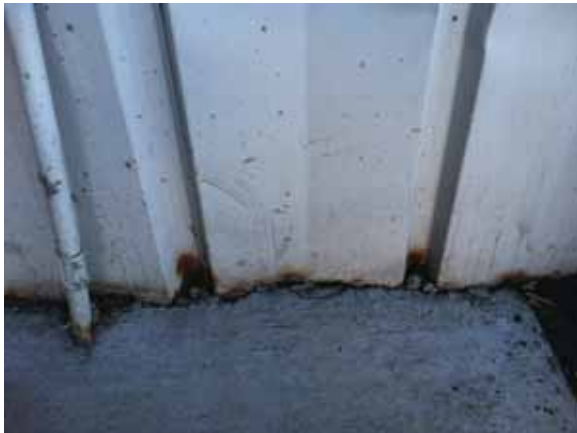
Fig. 2.1.A.8 Corrosion observed at the base of the metal panels around the exterior of the building.

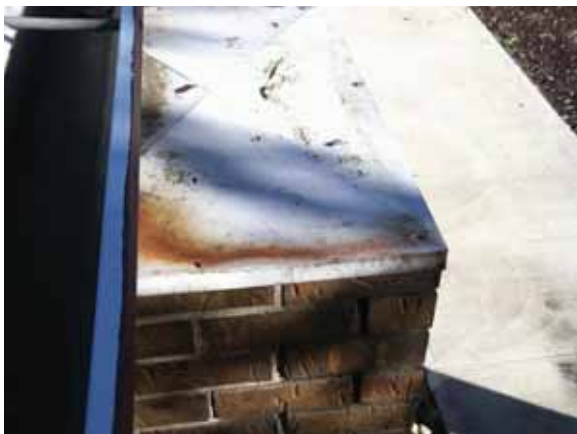
Fig. 2.1.A.9 Corrosion of a metal capping piece noted above a portion of a brick infill wall.

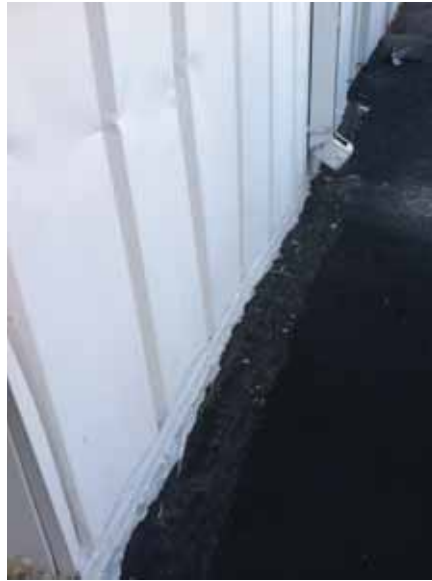
Fig. 2.1.A.10 Damaged metal panels observed along parking and loading dock areas around the exterior of the building.

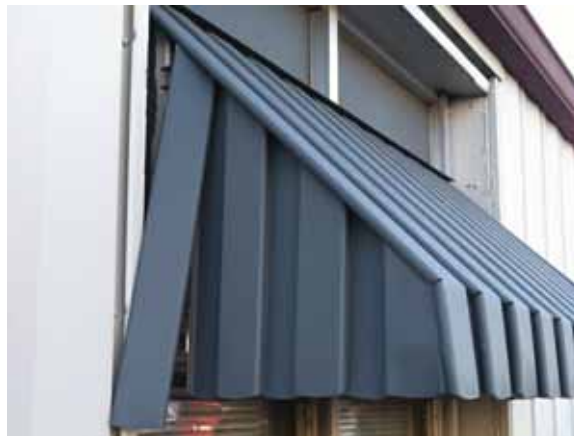
Fig. 2.1.A.11 Damaged and deteriorating metal canopies observed around the exterior of the building.

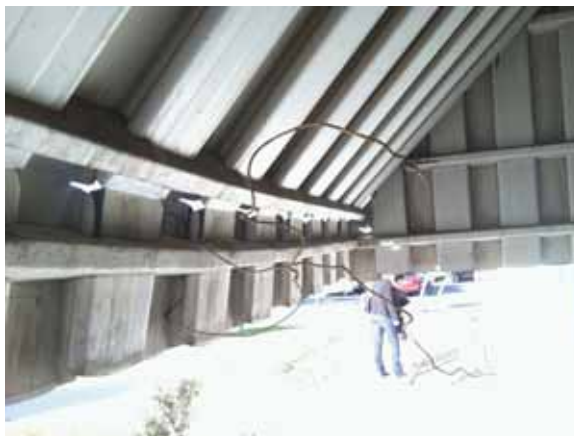
Fig. 2.1.A.12 Generally soiled and deteriorating metal canopies observed around the exterior of the building.

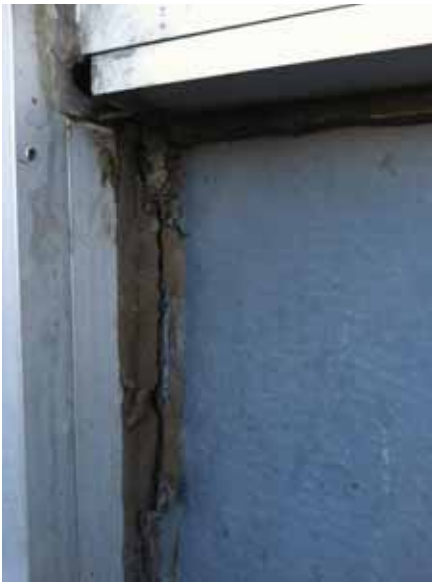
Fig. 2.1.A.13 Sealant observed to be deteriorating or missing entirely around the edges of the transite panels.

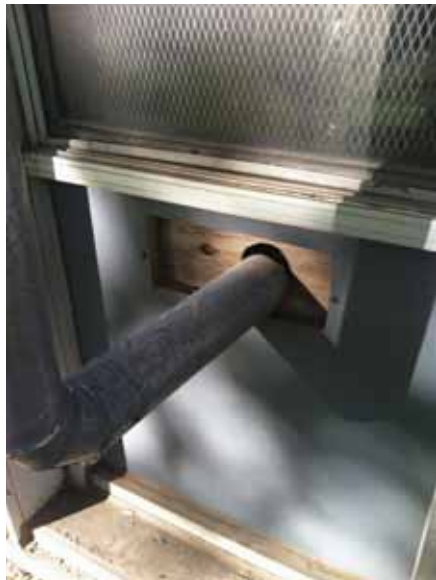
Fig. 2.1.A.14 An improperly waterproofed hole created through a transite panel which may be exposing the asbestos fibers within the panel.

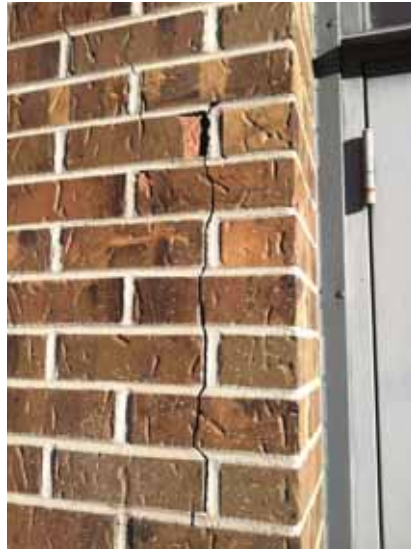
Fig. 2.1.A.15 Areas of damaged and deteriorating brick and mortar observed around the exterior of the building.

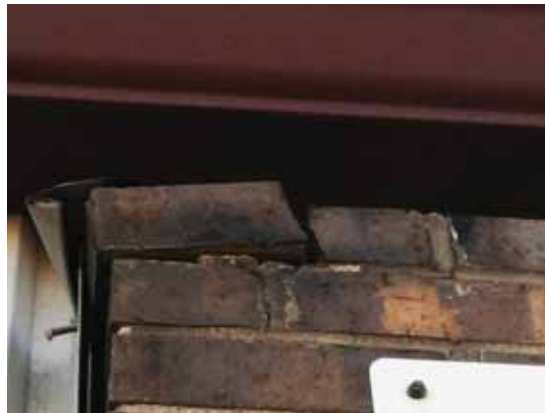
Fig. 2.1.A.16 Areas of damaged and deteriorating brick and mortar observed around the exterior of the building.

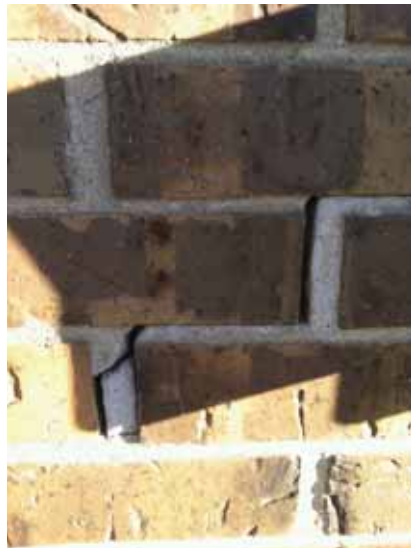
Fig. 2.1.A.17 Mortar observed to be deteriorating and leaving gaps in areas of the brick infill walls around the exterior of the building.

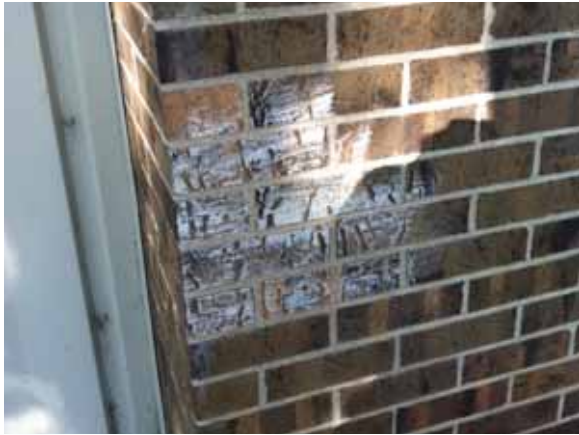
Fig. 2.1.A.18 White residue observed at a brick wall on the east side of the building.

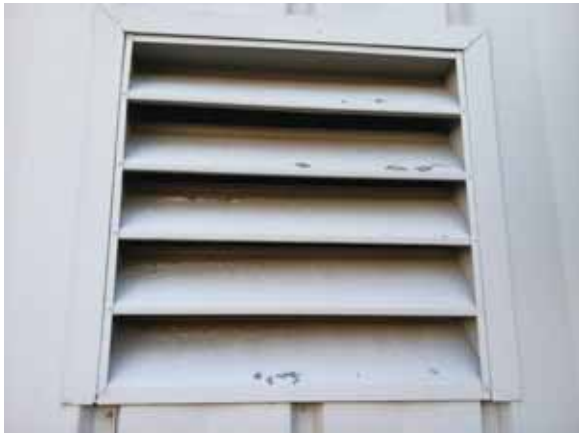
Fig. 2.1.A.19 Peeling paint observed at a metal grille cover.

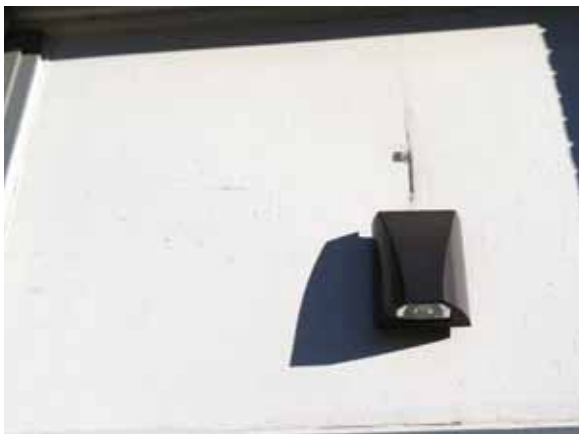
Fig. 2.1.A.20 Deteriorating paint observed at a wall panel.

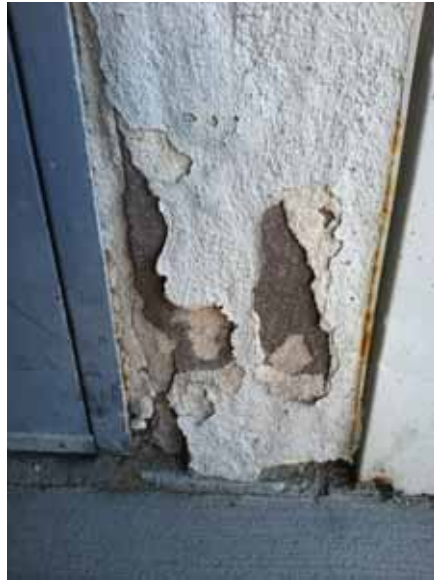
Fig. 2.1.A.21 Deteriorating stucco observed around the door to the visitor's entrance on the west side of the building.

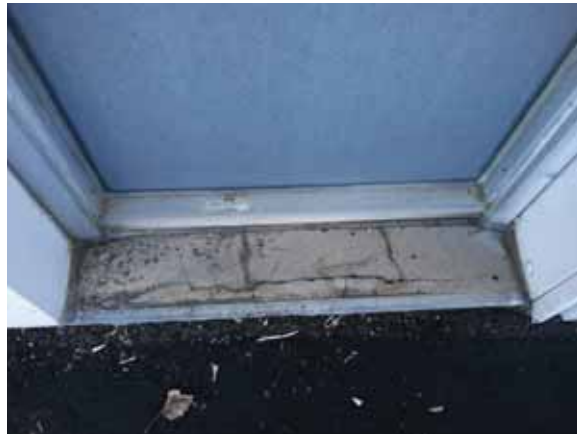
Fig. 2.1.A.22 Cracked and spalling concrete observed along the building's foundation.

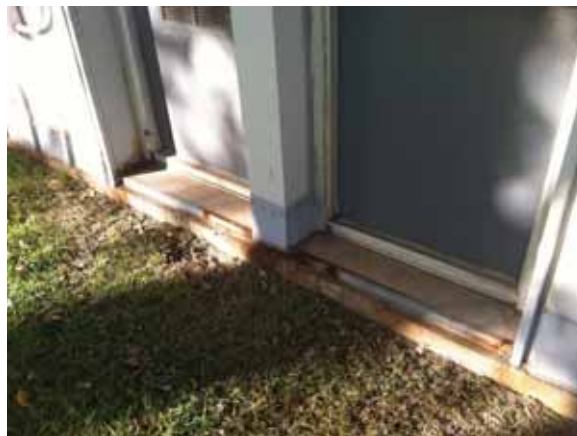
Fig. 2.1.A.23 Corrosion observed at a metal sill plate along the base of the building and staining the concrete foundation.

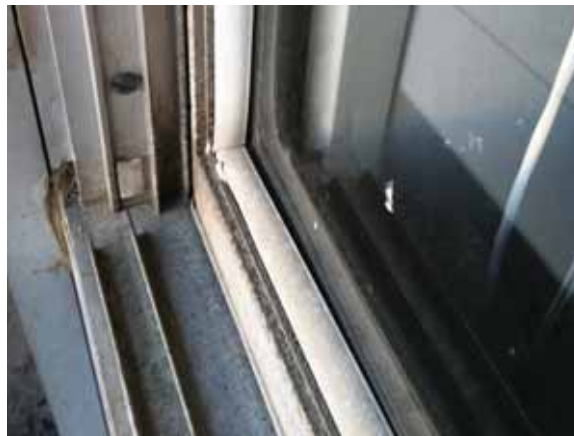
Fig. 2.1.A.24 General deterioration of the window frames noted around the exterior of the building.

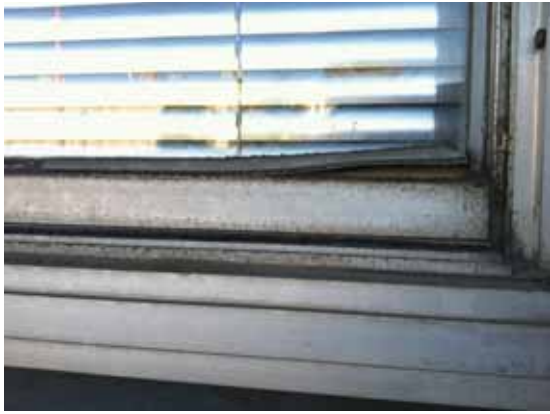
Fig. 2.1.A.25 General deterioration of the window frames noted around the exterior of the building.

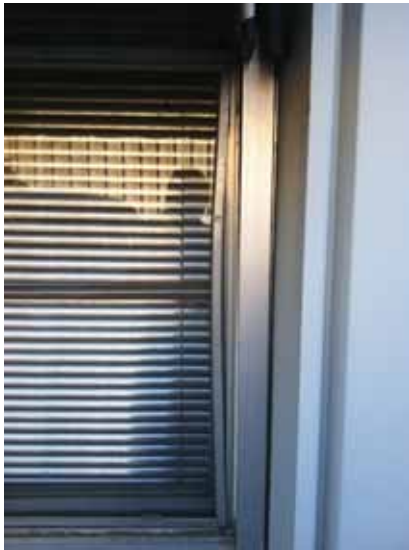
Fig. 2.1.A.26 General deterioration of the window frames noted around the exterior of the building.

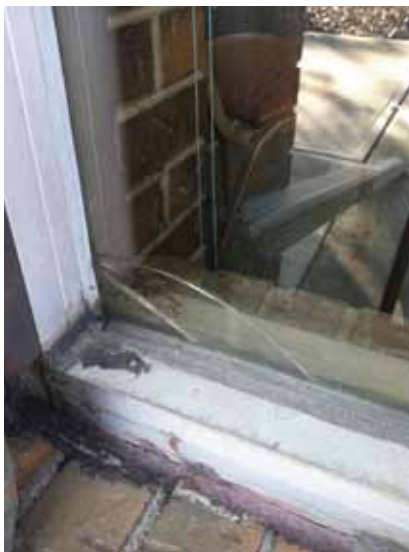
Fig. 2.1.A.27 Broken glass observed at a few windows, especially along the east side of the building.

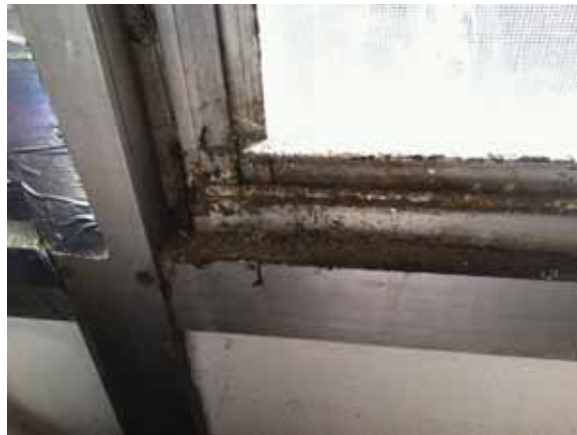
Fig. 2.1.A.28 Evidence of deterioration and water intrusion observed on the interior side of the windows.

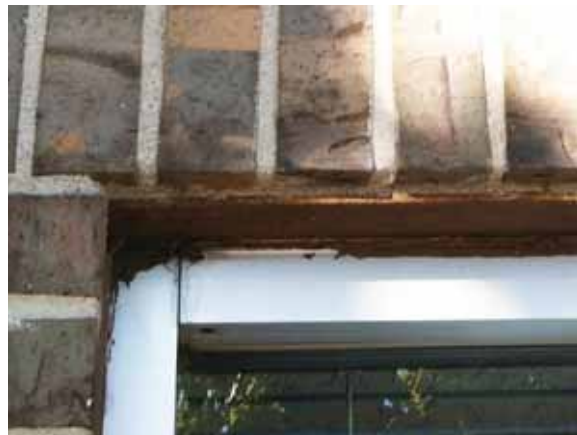
Fig. 2.1.A.29 Corrosion observed at a metal header above a window on the east side of the building.

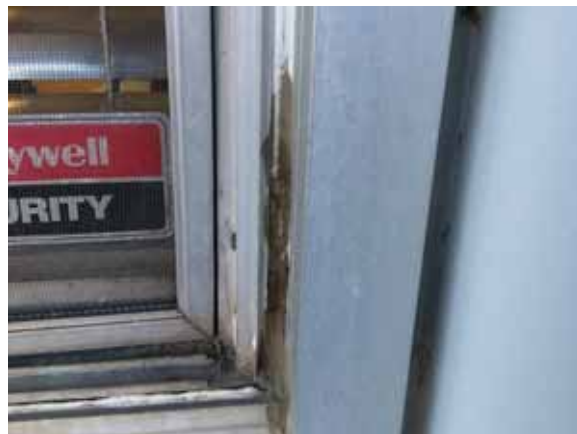
Fig. 2.1.A.30 Typical instance of deteriorating sealant observed at the windows around the exterior of the building.

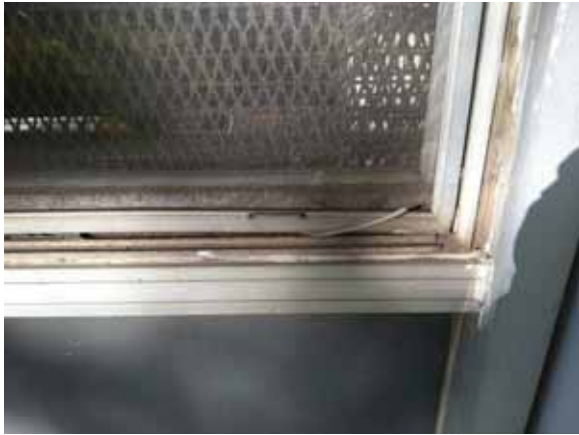
Fig. 2.1.A.31 Typical instance of deteriorating weatherstripping observed at the windows around the exterior of the building.

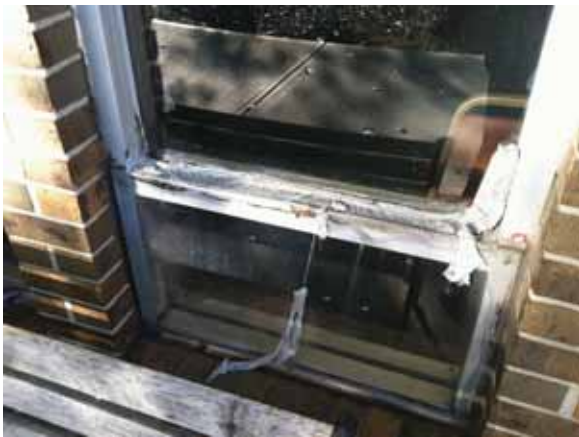
Fig. 2.1.A.32 Duct tape appears to have been applied along the base of a few windows on the east side of the building in a likely attempt to mitigate the issues with the deteriorating sealant and weatherstripping.

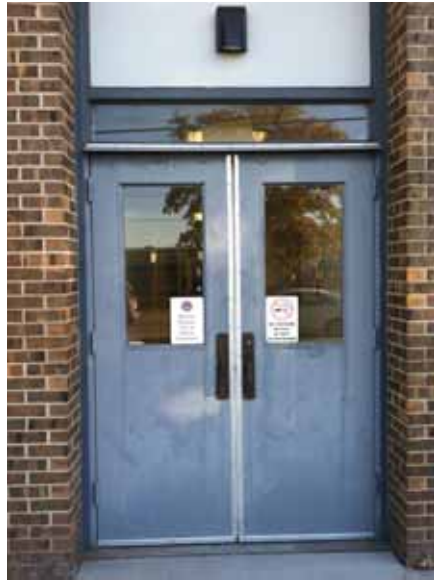
Fig. 2.1.A.33 General wear-and-tear noted at the doors around the exterior of the building.

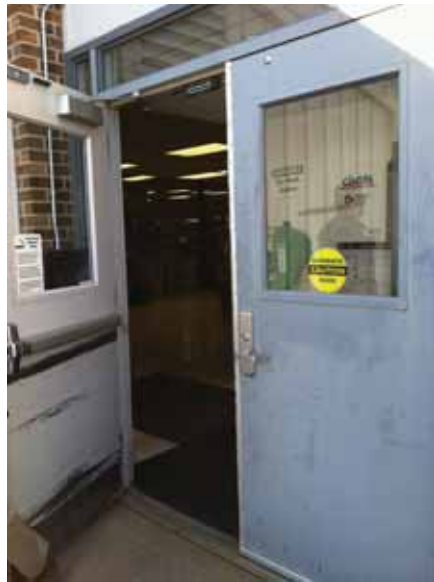
Fig. 2.1.A.34 General wear-and tear noted to the inside and outside face of the exterior doors around the building.

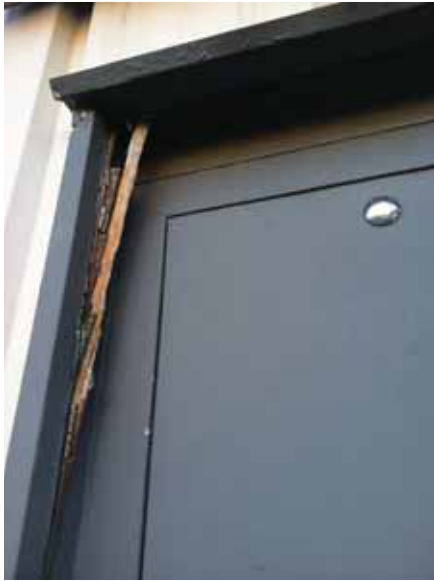
Fig. 2.1.A.35 Deterioration of the door frame noted at a door located on the west side of the building to the north of the visitor's entrance.

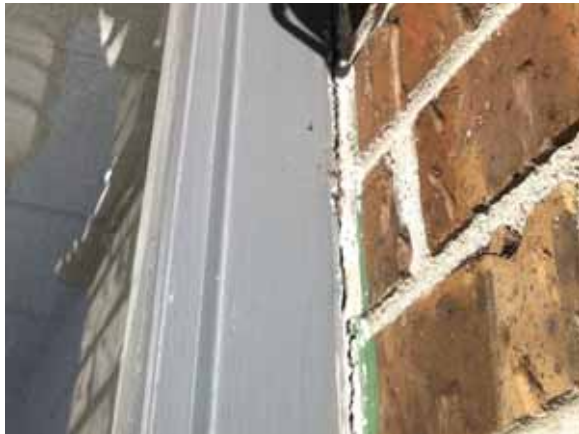
Fig. 2.1.A.36 Deterioration of the sealant noted at the door assembly on the south end of the east side of the building leading to the exterior courtyard.

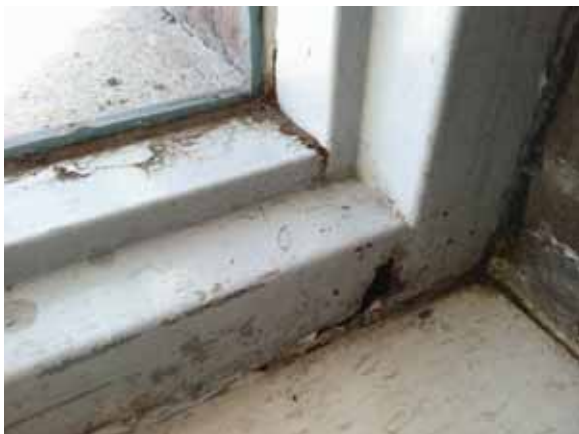
Fig. 2.1.A.37 Evidence of water damage observed on the interior side of the sidelight of the door and sidelight assembly on the south end of the east side of the building.

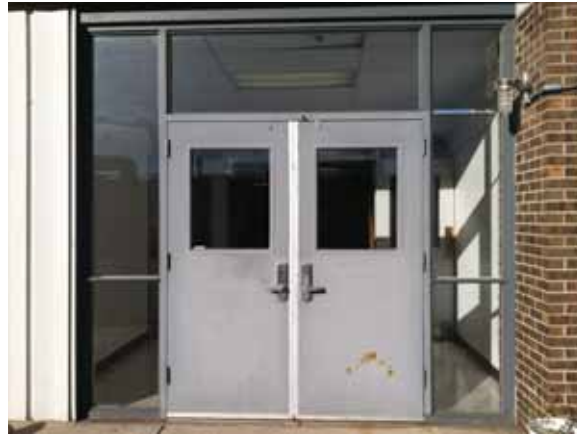
Fig. 2.1.A.38 Evidence of corrosion observed at the pair of doors on the north end of the east side of the building.

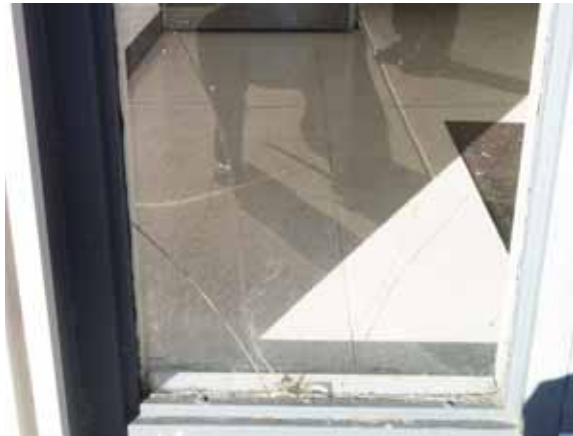
Fig. 2.1.A.39 Cracked glass observed at the sidelight south of the pair of doors on the north end of the east side of the building.

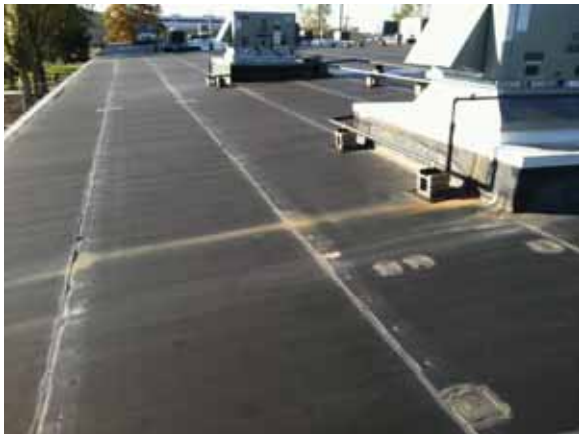
Fig. 2.1.A.40 Rubber membrane roof in fair to poor condition overall.

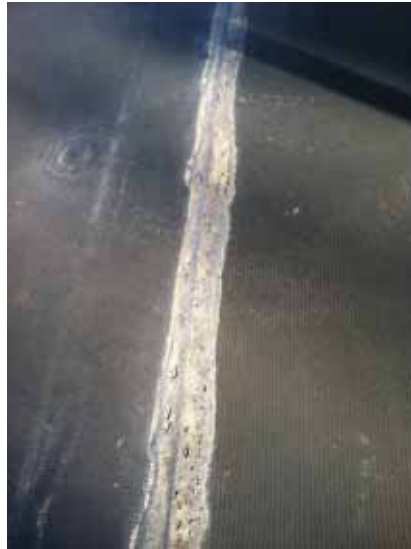
Fig. 2.1.A.41 Typical instance of deteriorating sealant along the seams of the rubber roofing membrane.

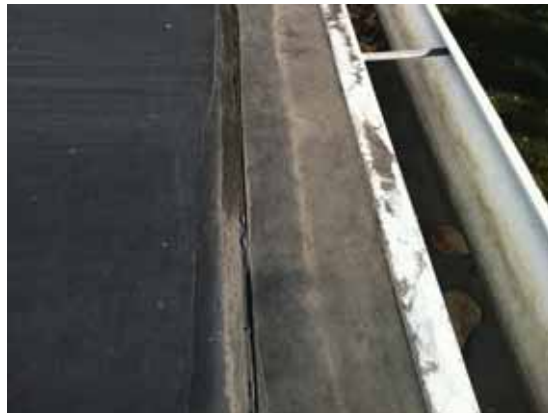
Fig. 2.1.A.42 Typical instance of sealant missing entirely along the seams of the rubber membrane and exposing the roof system to water penetration.

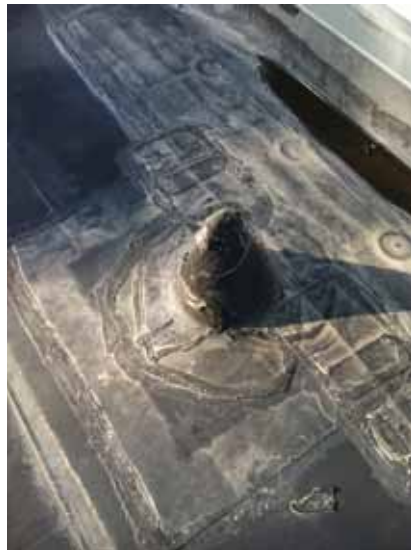
Fig. 2.1.A.43 Typical instance of deteriorating sealant at patched areas of the rubber roofing membrane.

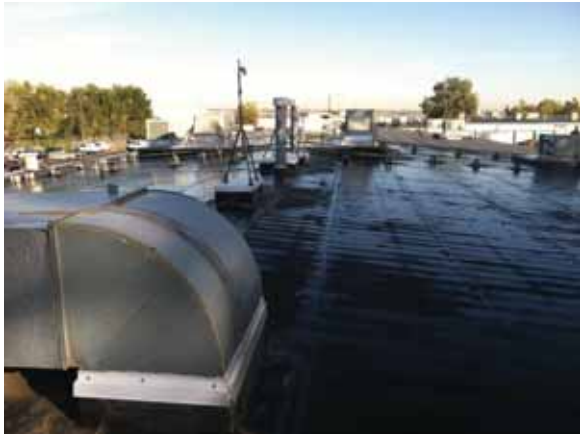
Fig. 2.1.A.44 Large areas of the roof observed to be wet at the time of the site survey visit.

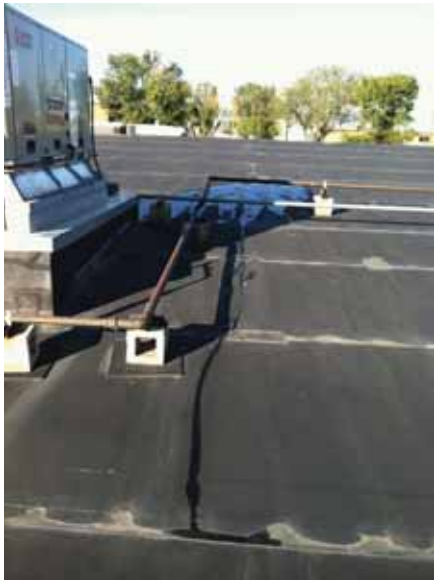
Fig. 2.1.A.45 Areas of standing water observed during the site survey visit.

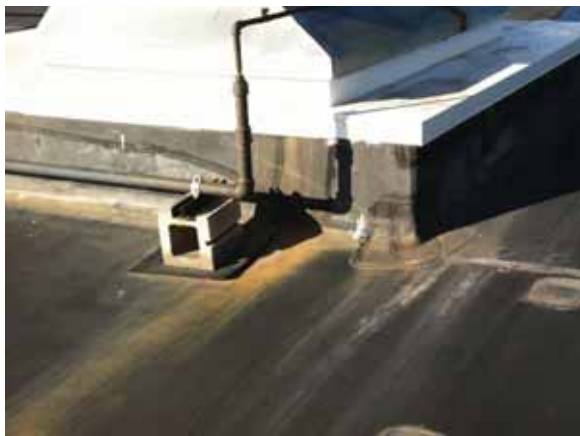
Fig. 2.1.A.46 Corrosive dust observed on the rubber roofing membrane near metal equipment and roof components.

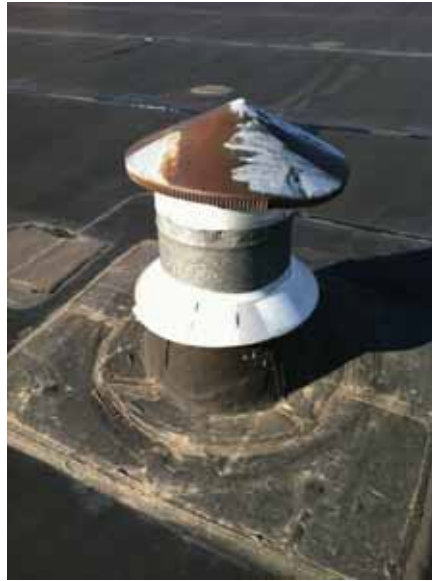
Fig. 2.1.A.47 Evidence of corrosion noted at a roof vent cover.

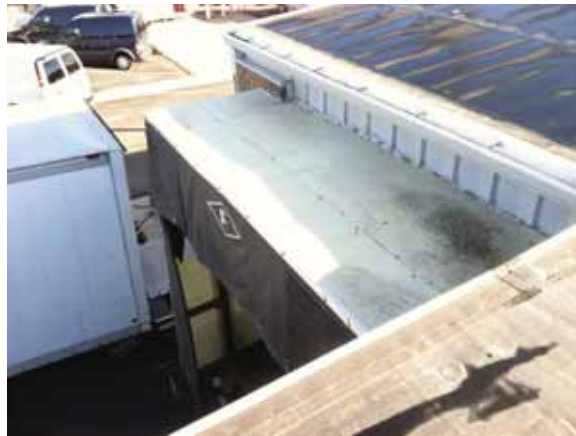
Fig. 2.1.A.48 The top of the canopy at the northeast corner of the building was observed to be generally soiled and to have deteriorating sealant along the wall of the building.

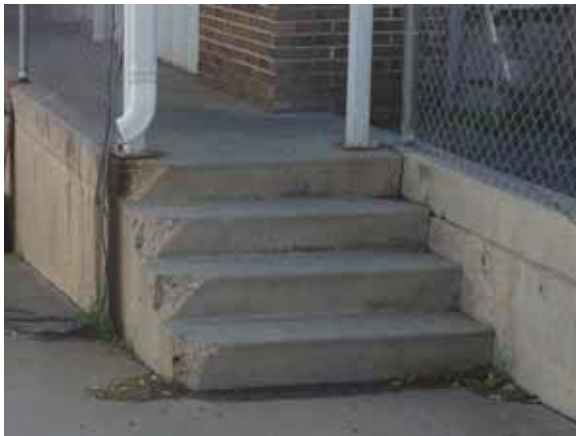
Fig. 2.1.A.49 Spalling concrete observed at the exterior stairway at the northwest loading dock.

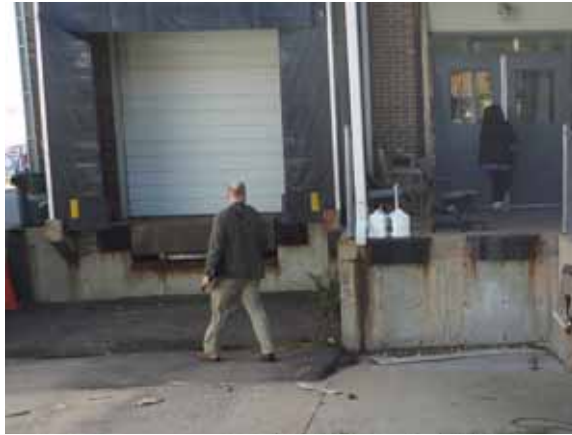
Fig. 2.1.A.50 Corrosion observed at the northwest loading dock.

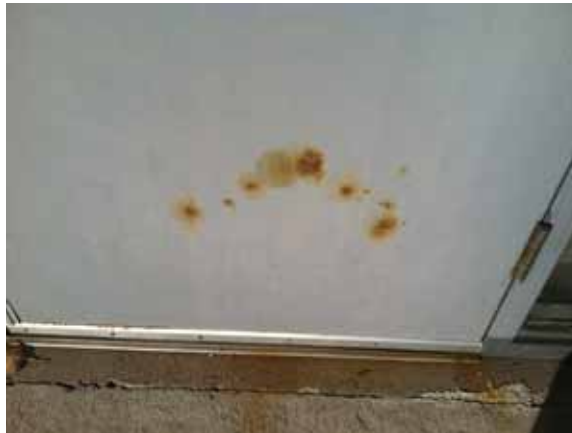
Fig. 2.1.A.51 Deterioration of the concrete paver observed along the base of the doors on the north end of the east side of the building.

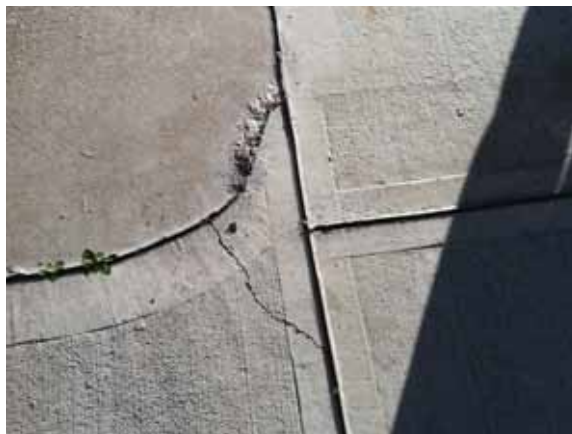
Fig. 2.1.A.52 Spalling and cracking concrete pavers observed throughout the east courtyard.

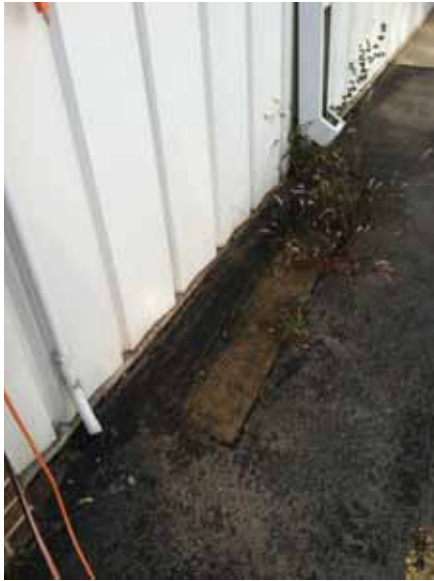
Fig. 2.1.A.53 A corroding metal panel embedded within the asphalt observed near the back (north side) of the building.

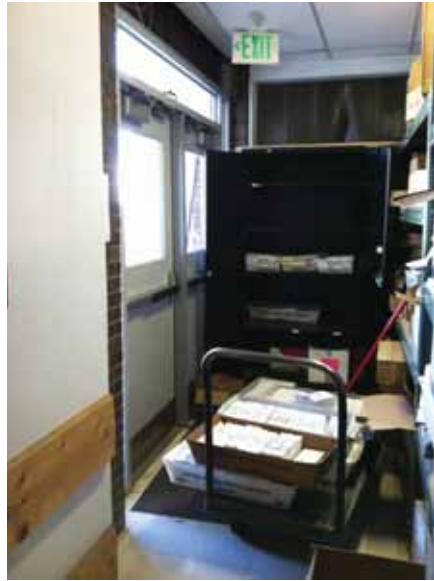
Fig. 2.1.B.1 Items blocking the corridor leading to the northwest exit from the print shop.

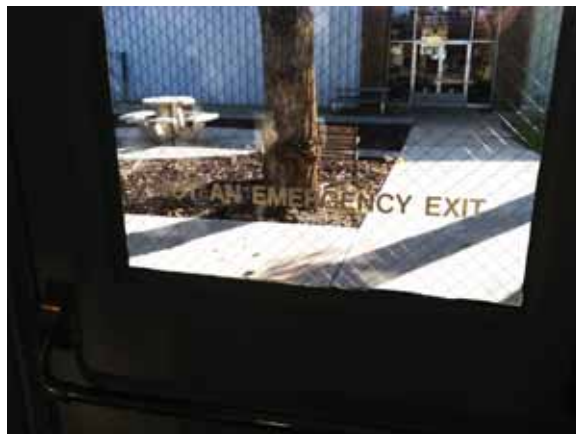
Fig. 2.1.B.3 Signage noted on the pair of exit doors leading to the fenced courtyard on the south end of the east side of the building.

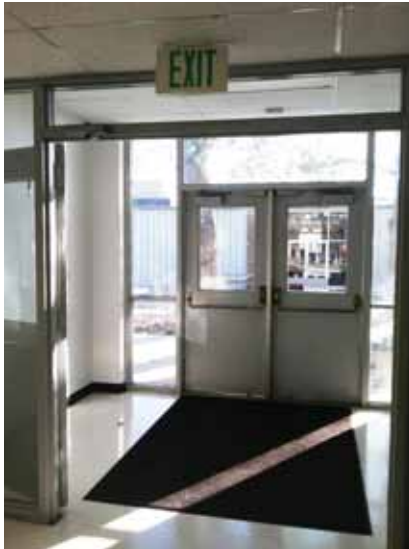
Fig. 2.1.B.4 Exit sign noted at the ceiling in front of the vestibule leading to the pair of doors on the south end of the east side of the building.

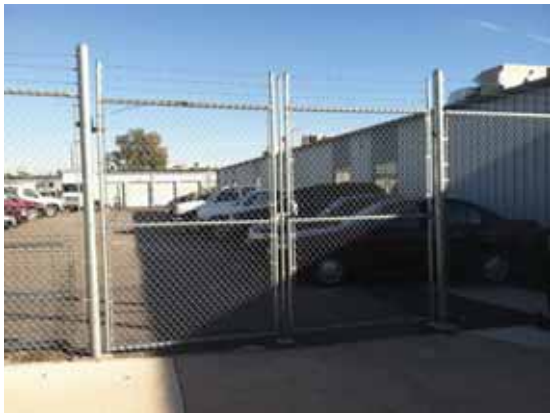
Fig. 2.1.B.5 Gate located on the north side of the east courtyard.

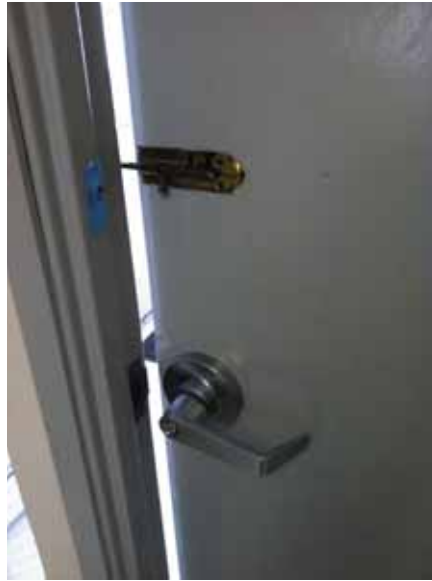
Fig. 2.1.B.7 A bolt-style lock observed on a door leading from the Oil & Public Safety Lab to the west exit corridor.

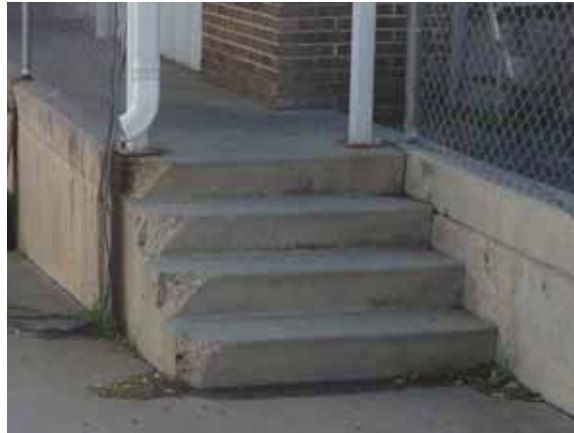
Fig. 2.1.B.8 The stairway at the northwest loading dock is not equipped with handrails as required by code.

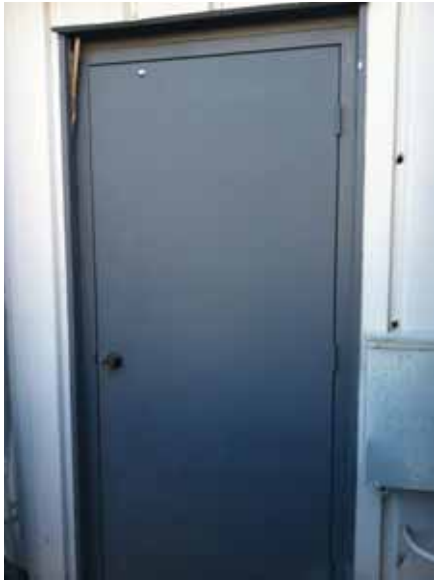
Fig. 2.1.B.9 Typical knob-style door handle found on an exterior door.

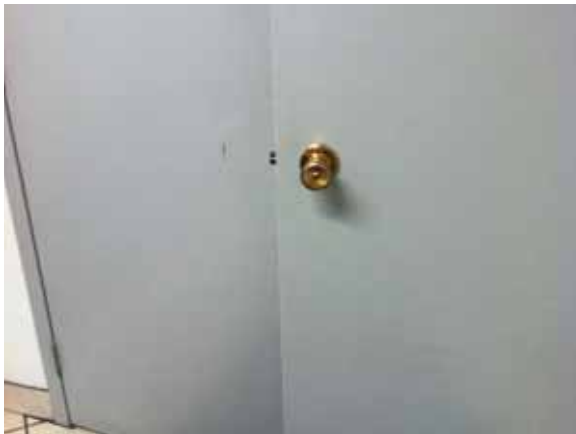
Fig. 2.1.B.10 Typical knob-style door handle found on an interior door.

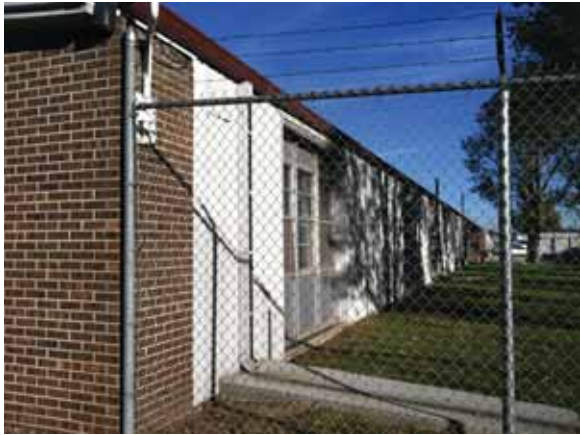
Fig. 2.1.B.11 South fence between the North Campus West Building and the North Campus East Building with barbed wire along the top.

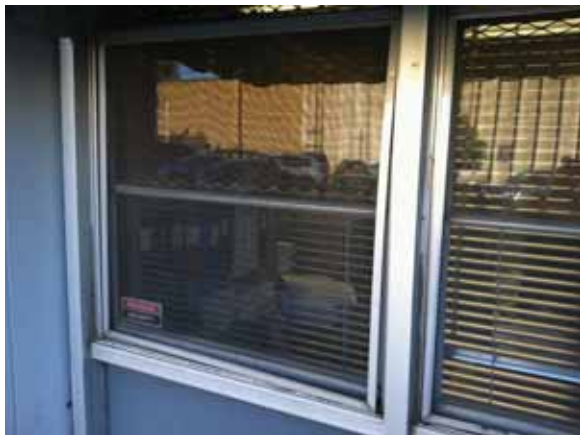
Fig. 2.1.B.12 Honeywell Security sign observed on a few windows around the exterior of the building.

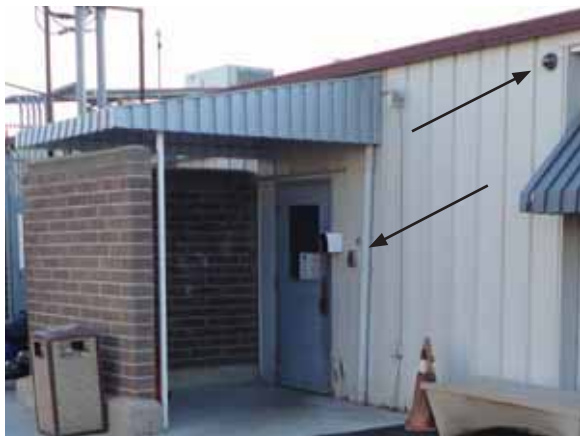
Fig. 2.1.B.13 Key code entry system and intercom/ buzzer system observed at the visitor's entrance on the west side of the building with a security camera noted south of the entrance.

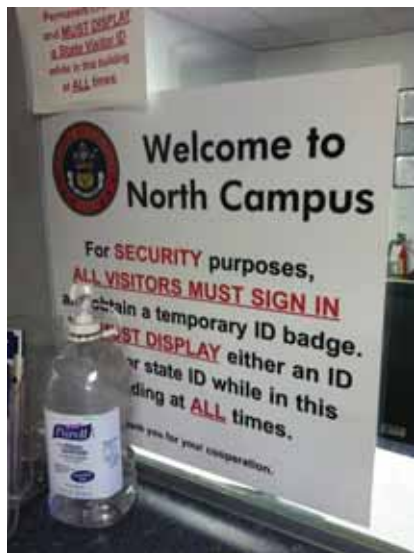
Fig. 2.1.B.14 Visitors are required to check-in with the guard stationed behind glass inside of the visitor's entrance lobby and must be escorted by a permanent North Campus employee at all times.

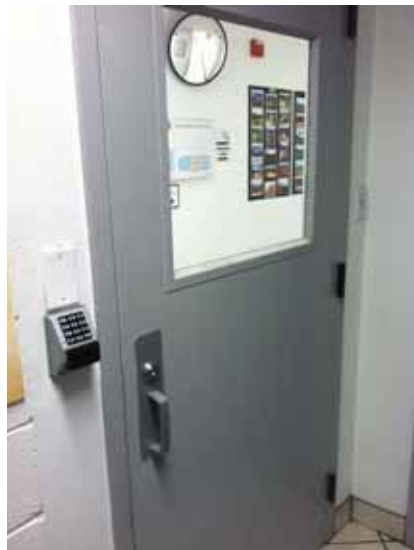
Fig. 2.1.B.15 Key code entry system observed at the door leading from the visitor's entrance lobby to the rest of the building.

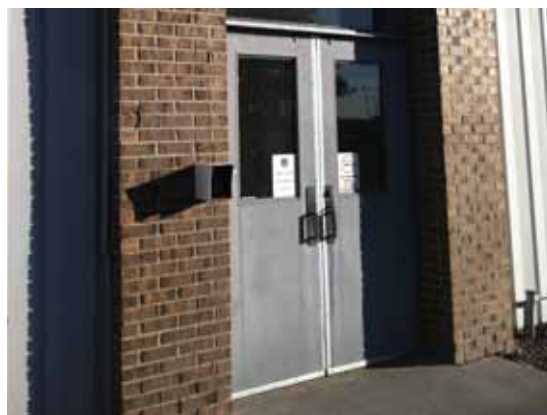
Fig. 2.1.B.16 Employee entrances are generally equipped with key code entry systems.

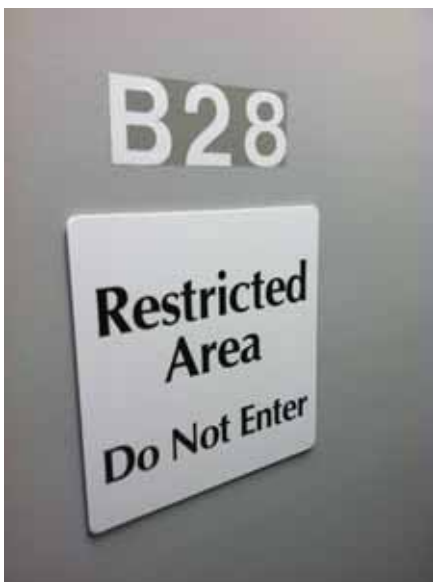
Fig. 2.1.B.19 Restricted areas observed throughout the interior of the building with "Do Not Enter" signs.

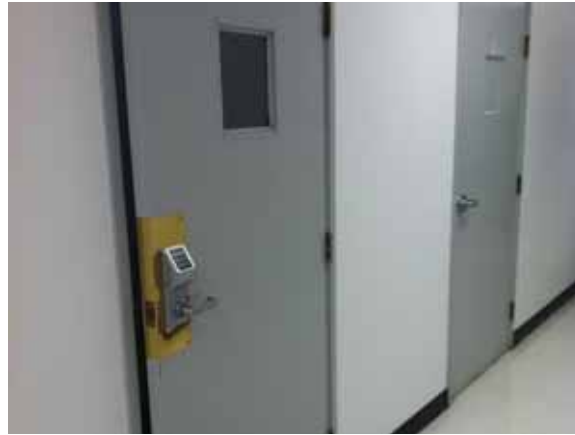
Fig. 2.1.B.20 Restricted areas observed throughout the interior of the building with key code entry systems.

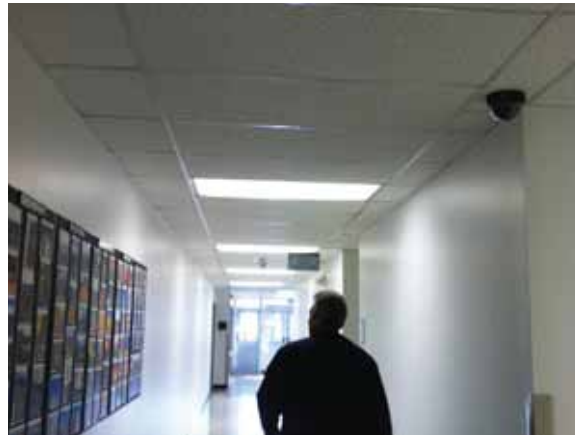
Fig. 2.1.B.21 Typical security camera observed in areas throughout the interior of the building.

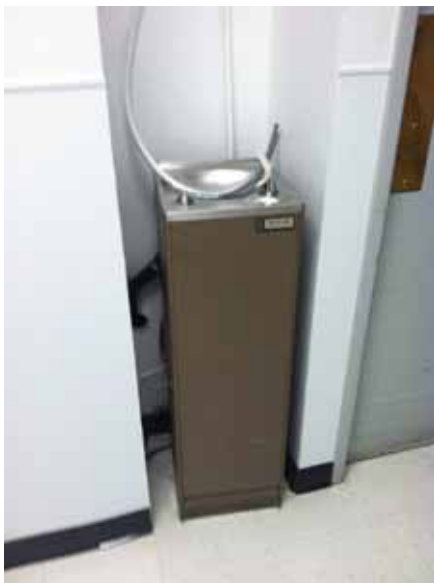
Fig. 2.1.C.1 Typical non-accessible drinking fountain observed throughout the building and loose tubing observed on top of the fountain.

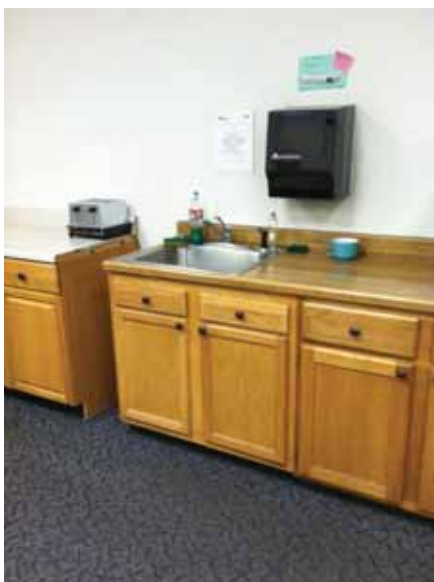
Fig. 2.1.C.2 Non-accessible sink observed in the Break Room on the south side of the building.

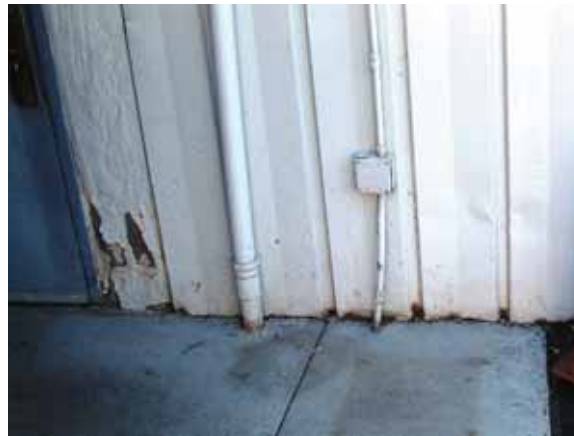
The exterior of the structure was in fair condition. The overhang at the west building entry showed evidence of water damage to a stucco infill piece, along with corrosion at the base of the metal panel skin (Fig. 2.2.A.1).

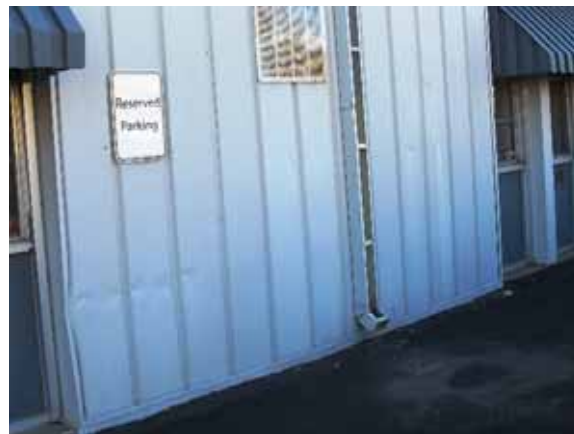
There was some damage to the exterior metal panel skin, likely due to a vehicle colliding with the structure (Fig. 2.2.A.2). Exterior downspouts were observed to empty within 1'-0" of the building line (Fig. 2.2.A.2). From conversations with on-site personnel, at least one downspout and adjacent parking block had caused backflow and water damage to the interior of the building recently. The specific location we observed had been addressed in recent renovations.

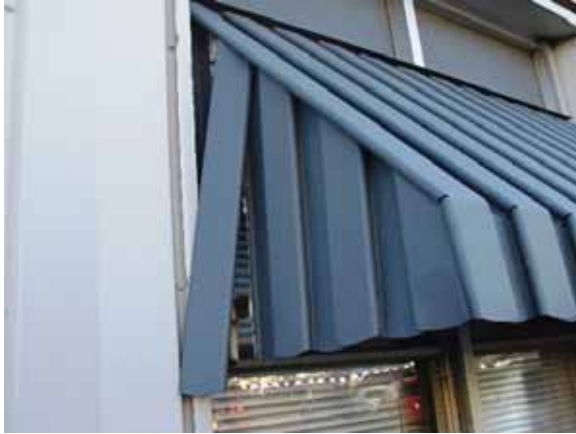
One section of break metal at a window overhang near the building's southwest corner was observed to be loose (Fig. 2.2.A.3).

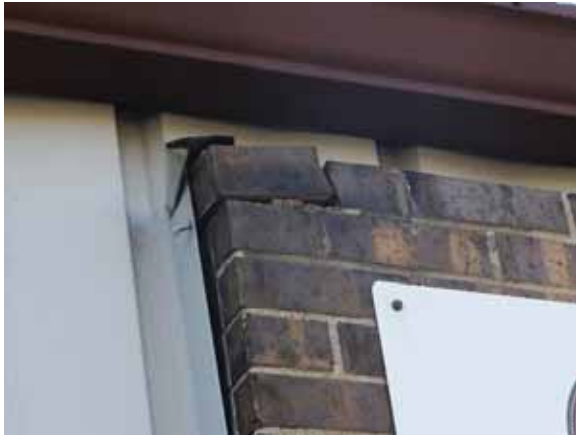
The upper course of brick at the southwest and southeast corners of the building has some loose bricks (Fig. 2.2.A.4 and 2.2.A.5), and the southwest corner appears to be missing some flashing elements.

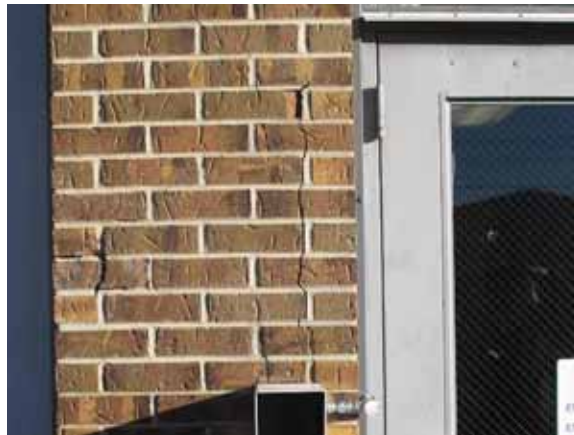
Some cracks were observed in the brick at the south entry (Fig. 2.2.A.7).

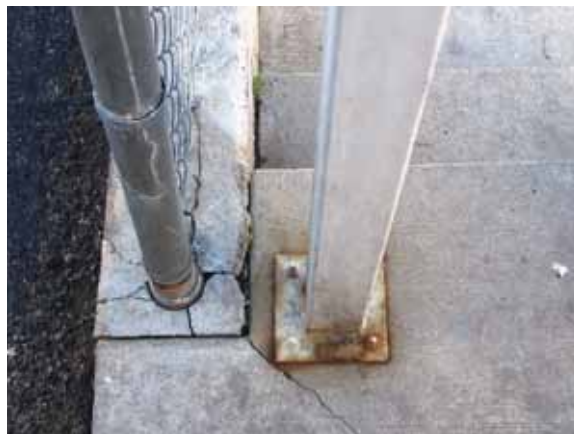
The base of posts supporting the canopy over the loading dock at the northwest corner of the building are corroding (Fig. 2.2.A.8).

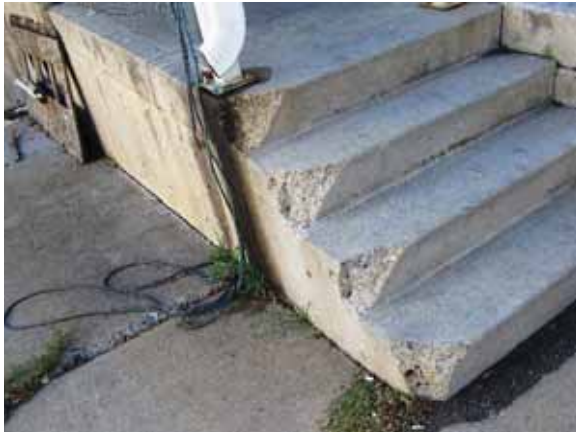
The stair at the northwest loading dock has no handrail, the adjacent downspout drains essentially on top of a canopy post base plate (contributing to corrosion), and the concrete stairs have spalled the majority of their corners (Fig. 2.2.A.9).

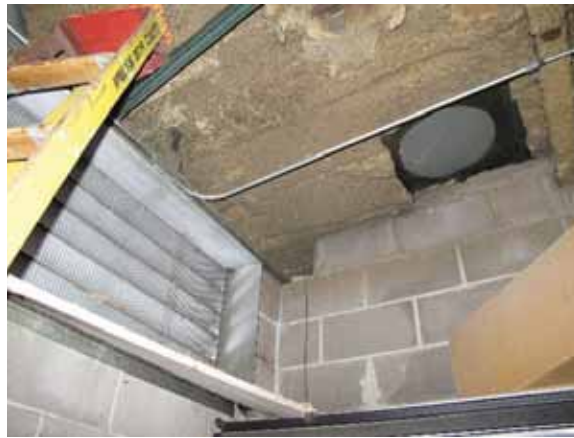
The structural framing that was readily observable is in fair condition. The majority of the steel framing appears to have been coated with some sort of thermal spray-on insulation. This coating prevented close examination of significant portions of the structure. The anchorage of this coating is beginning to fail, and subsequently small to medium pieces of insulation are falling from the structure. Exposed steel in the ceiling plenum appears to be corroding (Fig. 2.2.B.1). It is unknown if the corrosion is occurring only at exposed steel, or is the typical condition beneath the insulating coating.
