CAPITOL COMPLEX MASTER PLAN
FINDINGS & RECOMMENDATIONS (F & R) NEEDS ASSESSMENT
NORTH CAMPUS WEST BUILDING, 1001 EAST 62ND AVENUE (DENVER)

NOVEMBER 2014

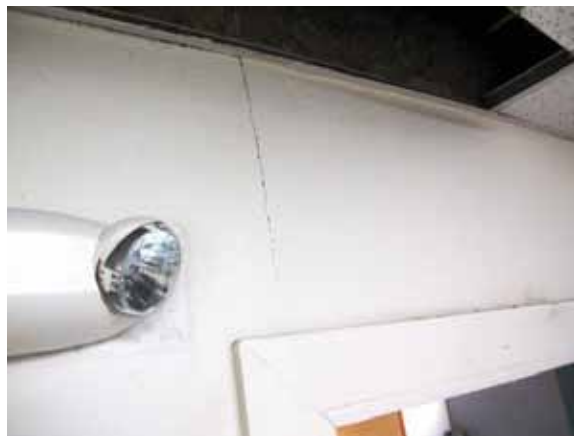
One section of interior partition framing has some cracking (Fig. 2.2.B.2). The observable partition framing above the ceiling in this location is fastened tight to the metal building structure. Given the Metal Building Manufacturer's Association's (MBMA's) drift and deflection limits for most engineered metal buildings, this cracking can likely be attributed to movement of the main building frame within its structural limit. The cracking observed is not a structural concern.

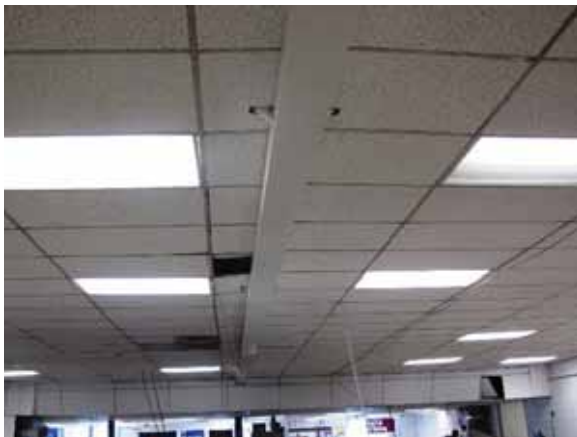
Portions of suspended ceiling grid in the print shop are anchored directly to metal building frames. Some of the ceiling tiles are falling away from the supporting grid, and the grid itself appears to be distorted or loose in some locations (Fig. 2.2.B.3). . Given the Metal Building Manufacturer's Association's (MBMA's) drift and deflection limits for most engineered metal buildings, this condition can likely be attributed to movement of the main building frame within its structural limit. This movement is not a structural concern; however, dislodged ceiling tiles represent a potential hazard to workers or equipment below.

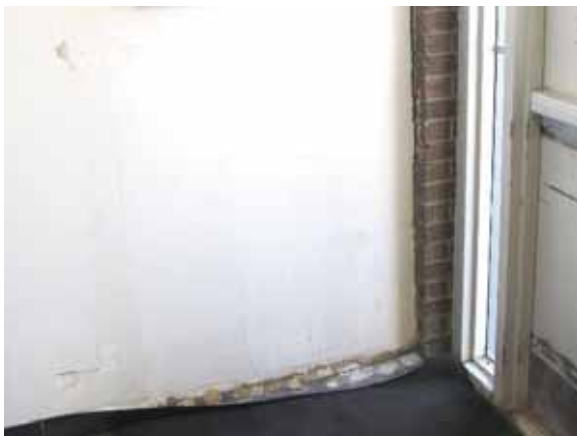
The joint between partition framing and exterior brick infill at the northeast exit from the print room has cracked and measures approximately 0" at grade to over 3/4" at the ceiling (Fig. 2.2.B.4). This crack is telegraphed to the exterior of the building at the exit as well. Again, given the Metal Building Manufacturer's Association's (MBMA's) drift and deflection limits for most engineered metal buildings, this condition can likely be attributed to movement of the main building frame within its structural limit. The crack is not a structural concern, but presents a possible failure of the building's envelope.

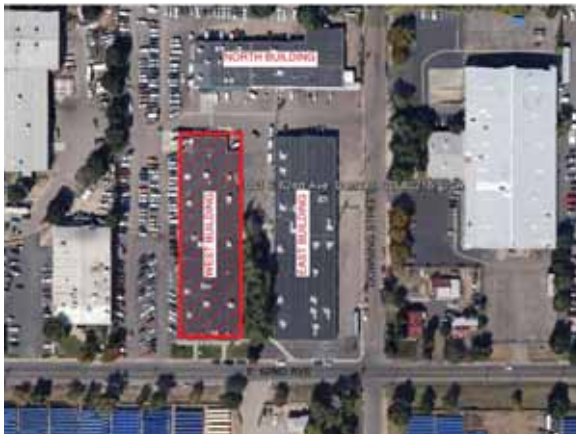
Figure 2.3.A.1 – West Building of North Campus Vicinity Map

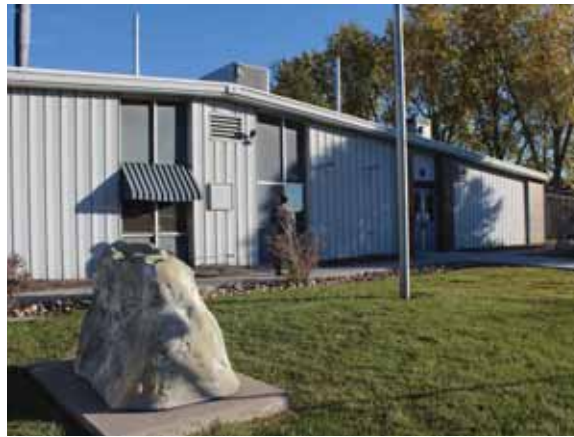
Figure 2.3.A.2 – West Building, South Entrance

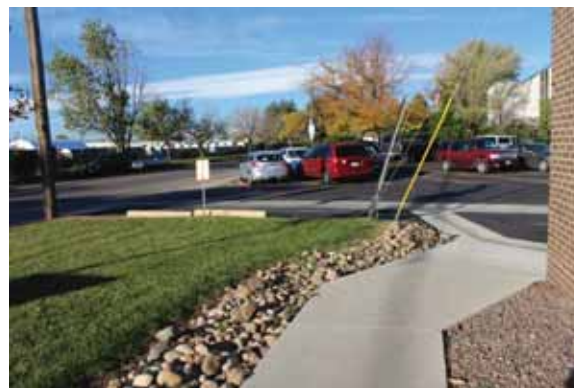
Figure 2.3.A.3 –West Entrance Walkway

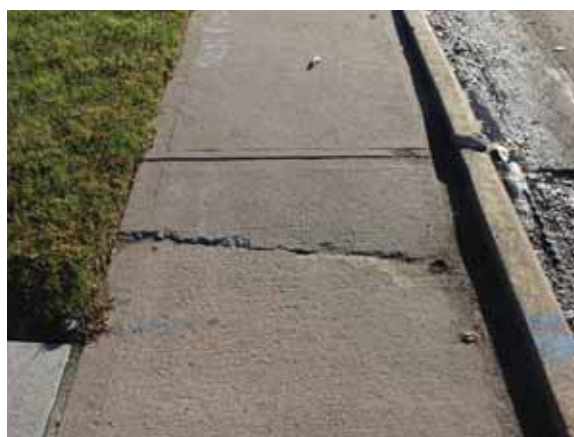
Figure 2.3.A.5 – Site Concrete Crack, Recommended for Replacement

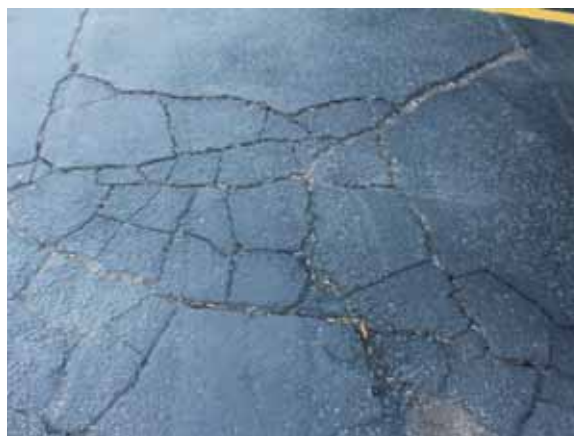
Figure 2.3.A.6 – Poor Site Asphalt Condition

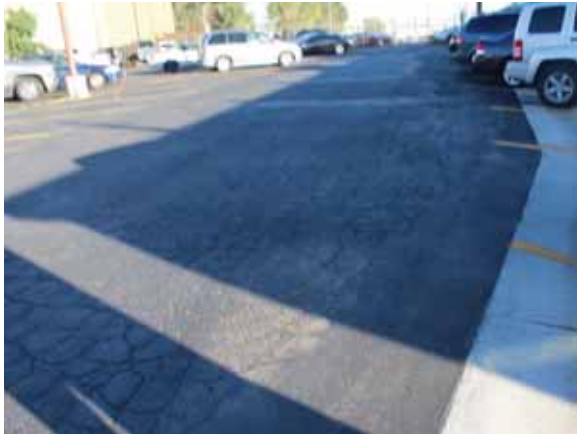
Figure 2.3.A.7 – Poor Site Asphalt Condition

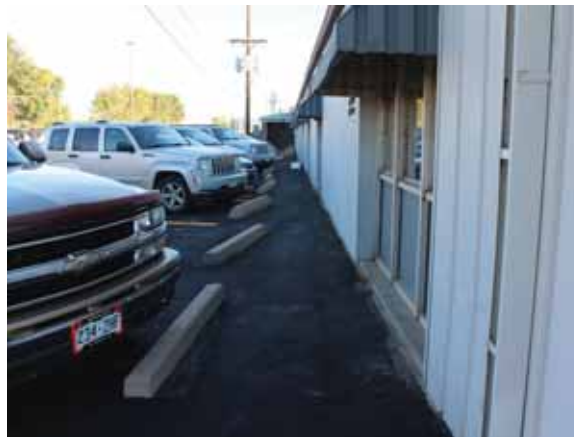
Figure 2.3.B.1 – Building Perimeter, Slopes Away

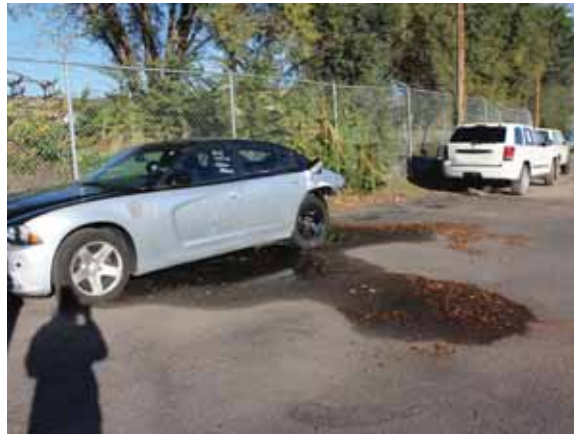
Figure 2.3.B.2 – Standing Water

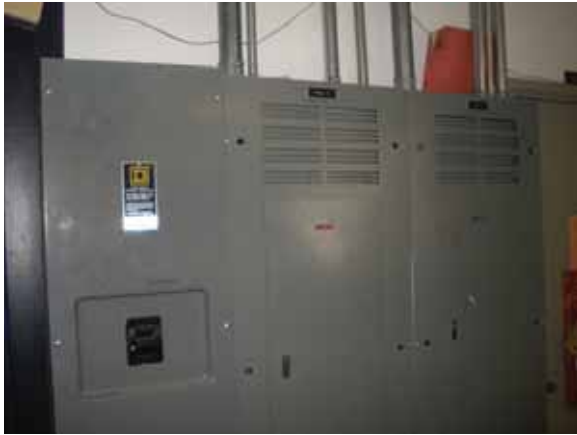
Fig. 2.4.A.4 – Secondary electrical room

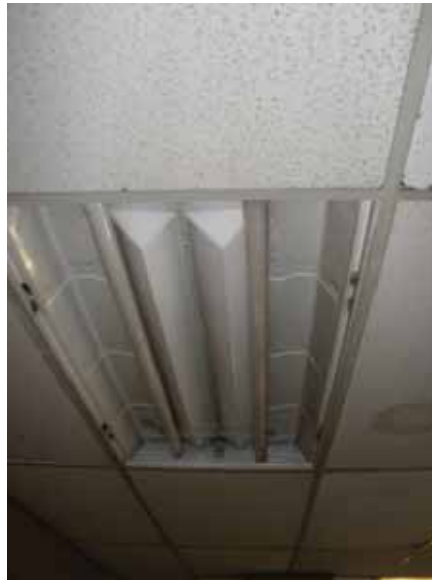
Fig. 2.4.A.5 – Recessed luminaire

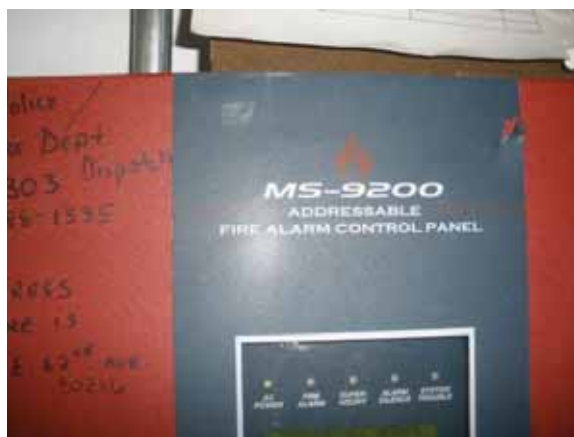
Fig. 2.4.A.10 – Fire alarm control panel

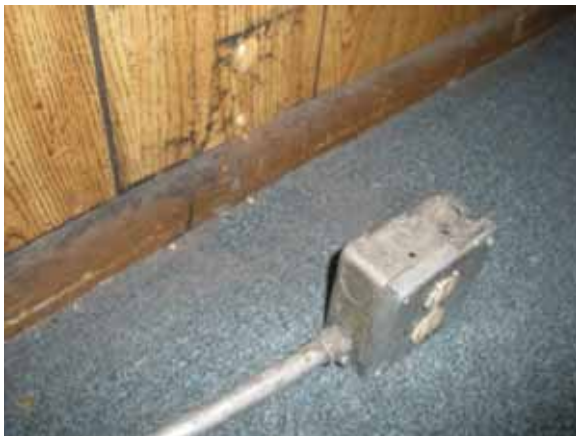
Fig. 2.4.A.12 – GFI receptacle

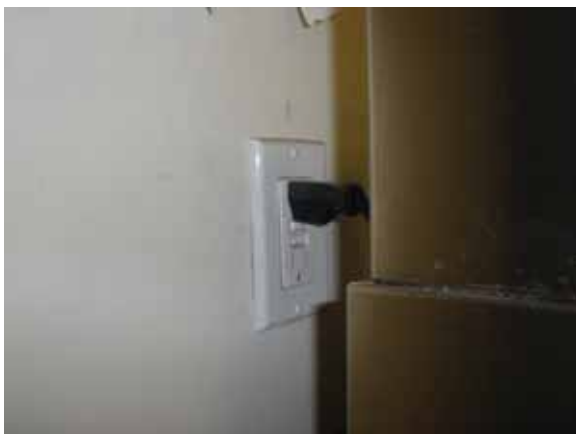
Fig. 2.4.A.13 – Receptacle not connected to wall

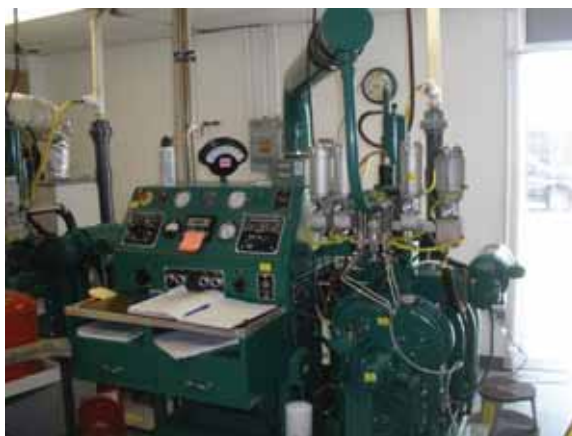
Fig. 2.4.A.14 – Fuel testing engine

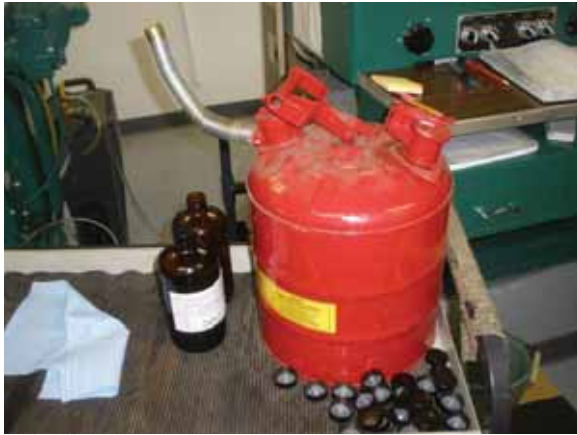
Fig. 2.4.A.15 – Fuel tank

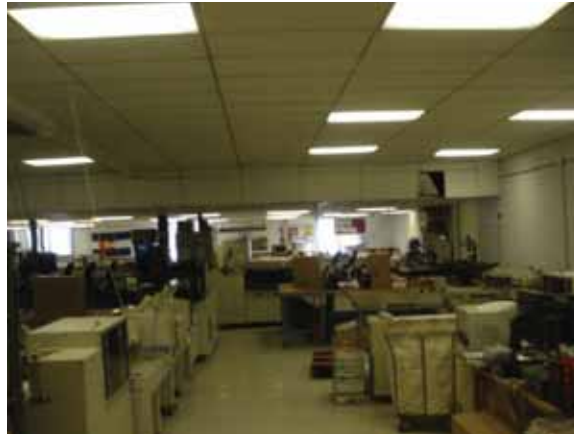
Fig. 2.4.A.16 – Printing area

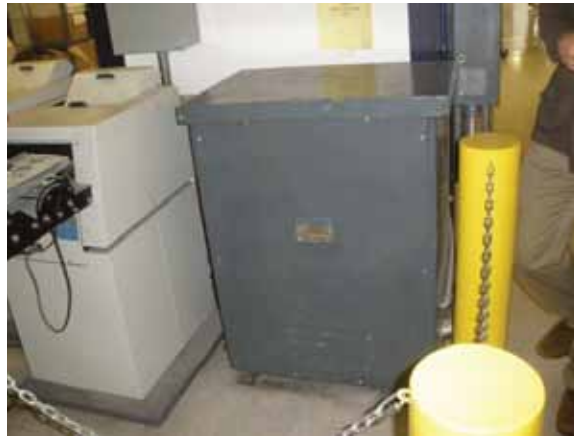
Fig. 2.4.A.17 – Transformer in printing area

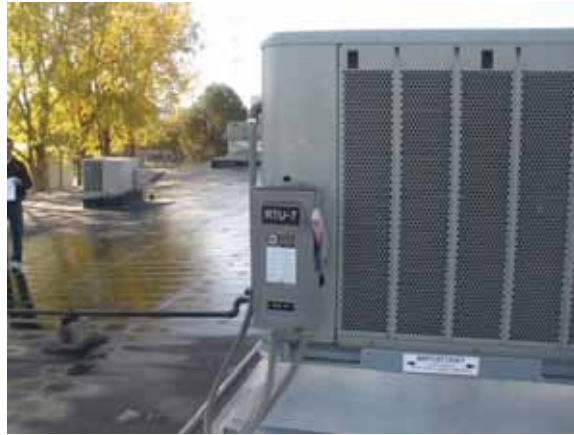
Fig. 2.4.A.14 – Rooftop units

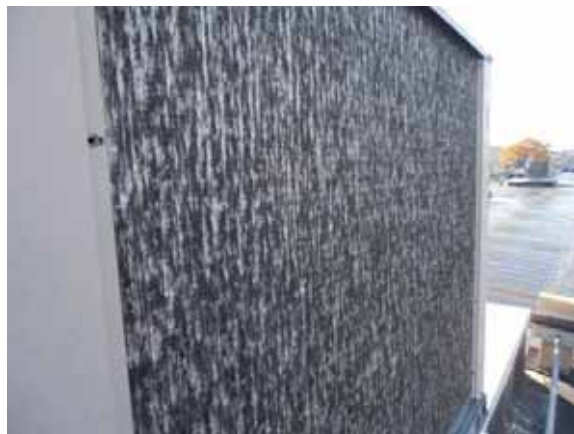
Fig. 2.4.A.16 – Condenser fins damaged

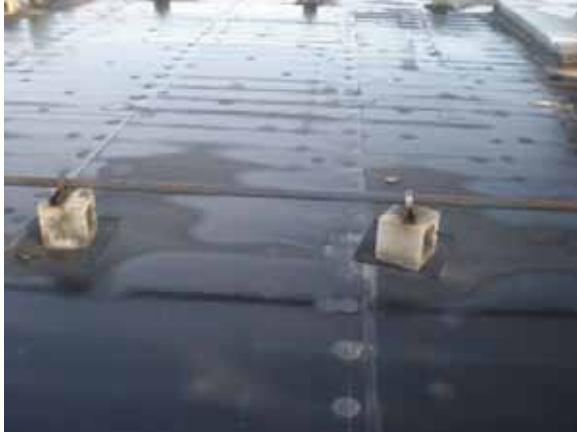
Fig. 2.4.A.17 – Gas piping on roof

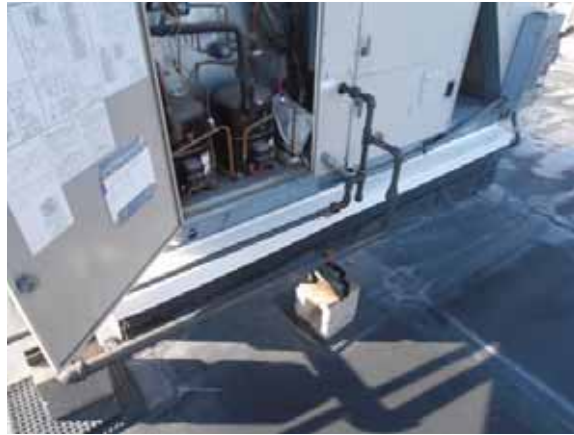
Fig. 2.4.A.20 – Gas piping connection at RTU

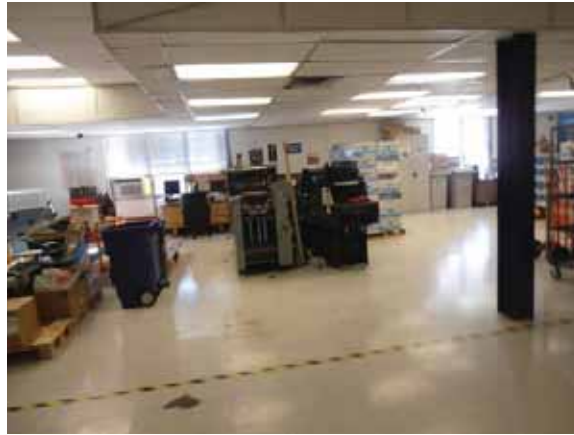
Fig. 2.4.A.30 – Overall production area

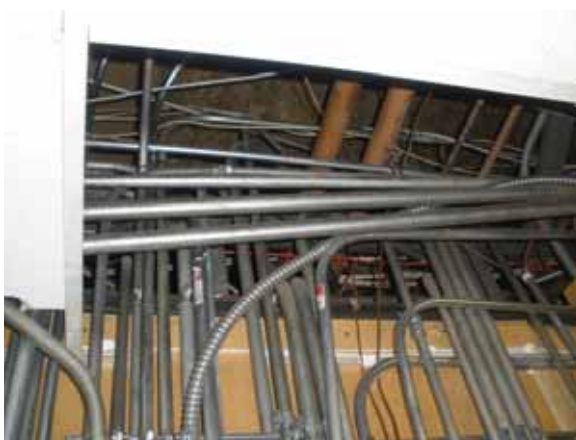
Fig. 2.4.B.1 – No sealed penetrations in electrical room

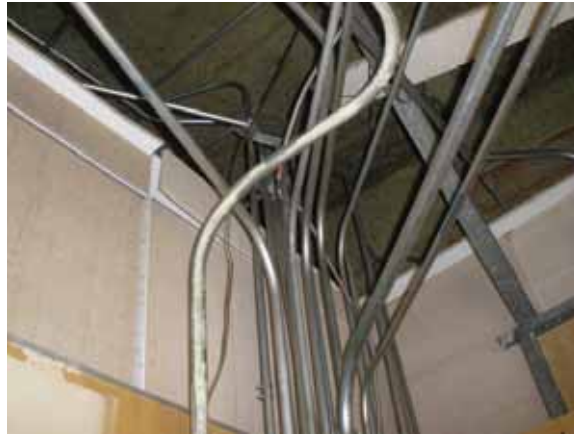
Fig. 2.4.B.2 – No sealed penetrations in electrical room

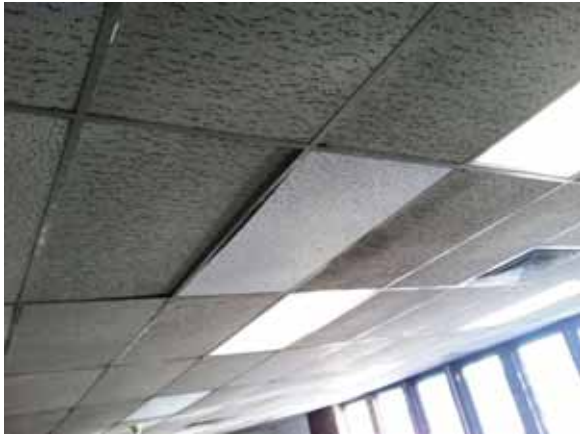
Fig. 3.0.C.1 Sagging, soiled, and deteriorating 2x4 acoustic ceilings observed in areas of the building.

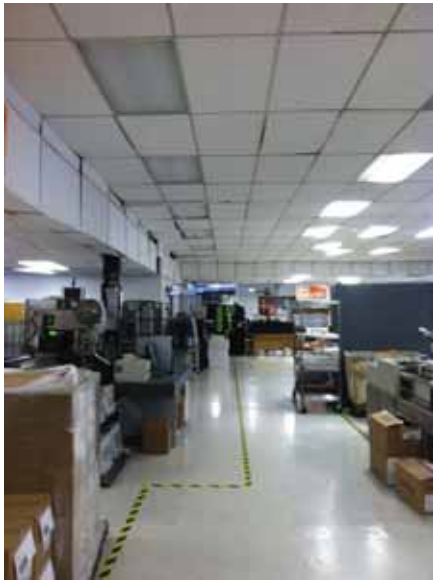
Fig. 3.0.C.2 Sagging and deteriorating 2x4 acoustic ceilings observed throughout the IDS Print Shop.

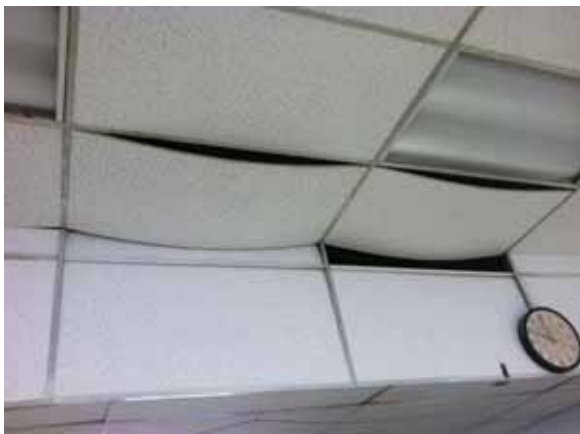
Fig. 3.0.C.3 Sagging of the individual 2x4 acoustic ceiling tiles observed throughout the IDS Print Shop.

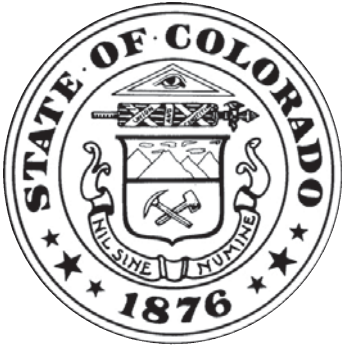
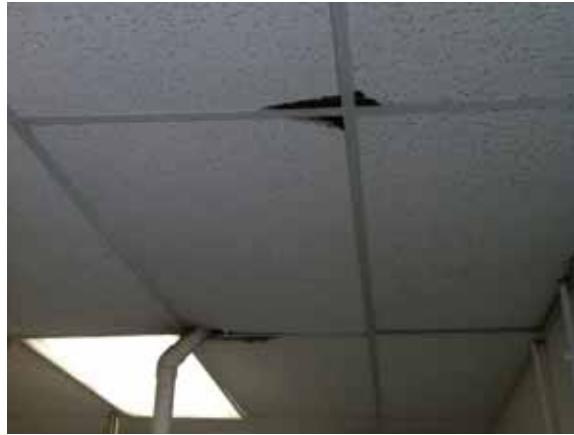
Fig. 3.0.C.4 Typical instance of deterioration of the 2x4 acoustic ceiling observed during the site survey visit.

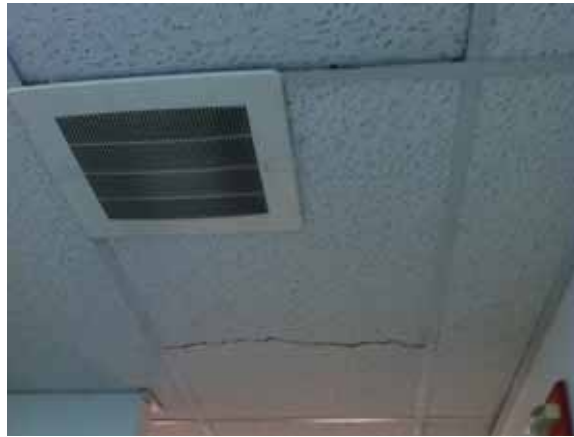
Fig. 3.0.C.5 Typical instance of a cracked 2x4 acoustic ceiling tile observed during the site survey visit.

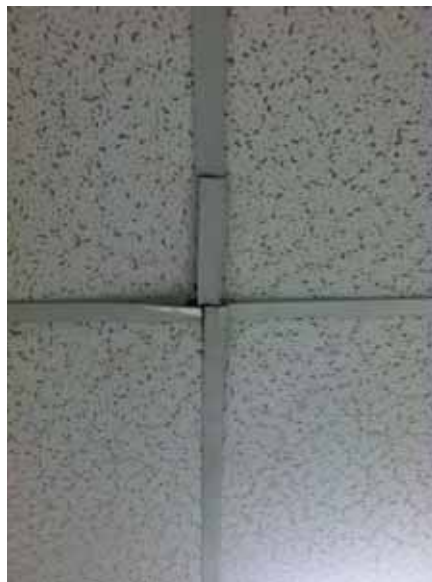
Fig. 3.0.C.6 General deterioration of the acoustic ceiling noted throughout.

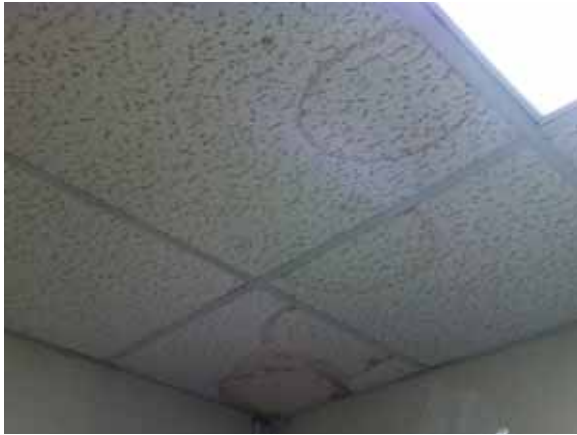
Fig. 3.0.C.7 Typical instance of soiled and deteriorating 2x4 acoustic ceiling tiles with evidence of water damage observed throughout the building.

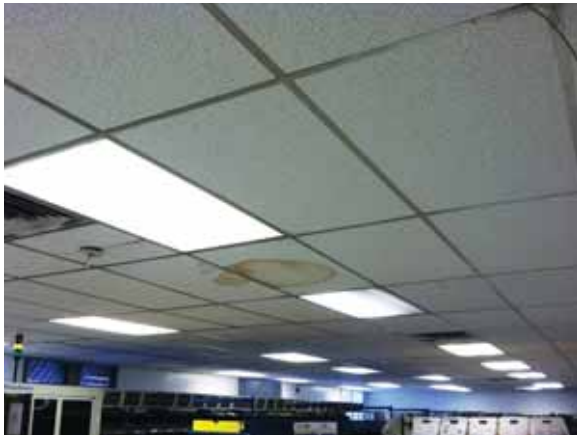
Fig. 3.0.C.8 Soiled and deteriorating 2x4 acoustic ceiling tiles with evidence of water damage observed in the IDS Print Shop.

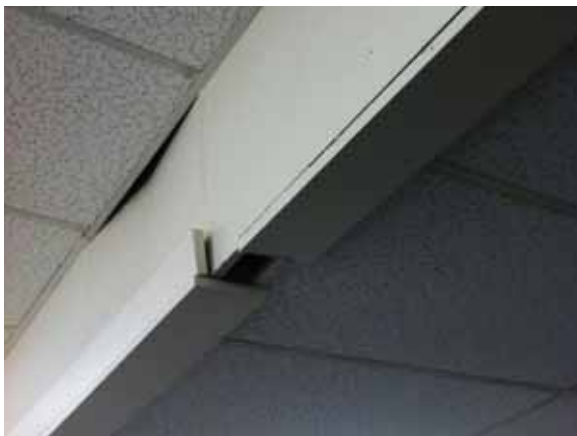
Fig. 3.0.C.9 Cracked and damaged material covering a beam observed at the ceiling in the office space located at the southern central portion of the building.

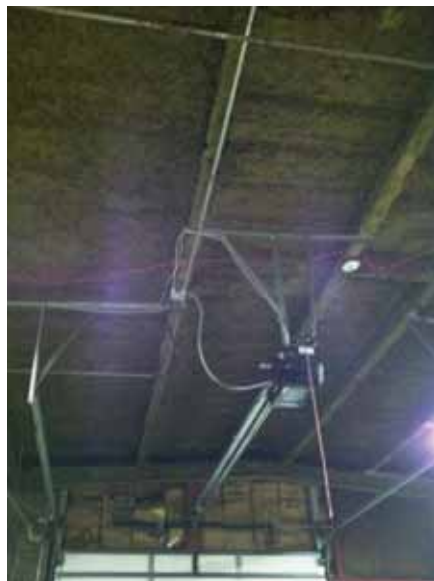
Fig. 3.0.C.10 Open ceiling observed with deteriorating spray-on insulation in the north loading dock and storage room.

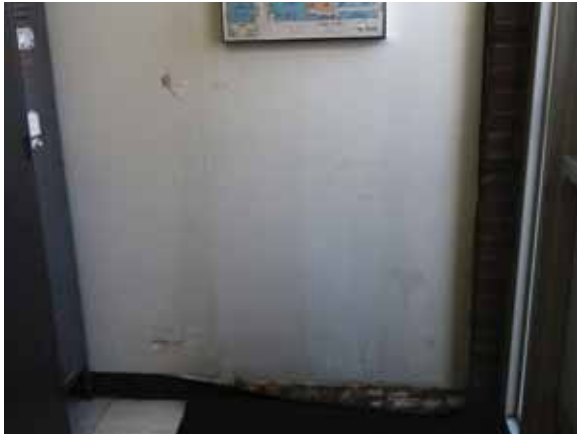
Fig. 3.0.C.11 Wear-and-tear and cracking of the gypsum board wall observed in the northeast entry vestibule.

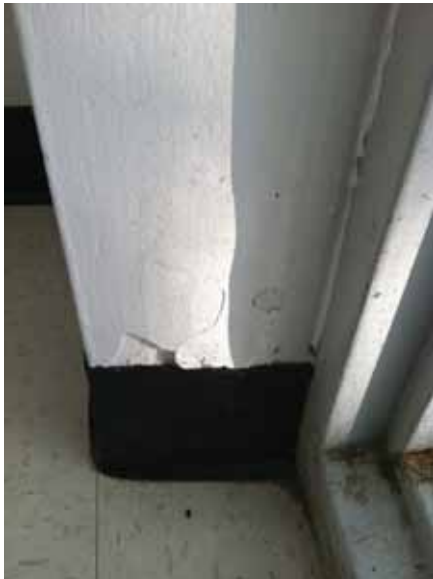
Fig. 3.0.C.12 Deterioration of the gypsum board observed during the site survey visit.

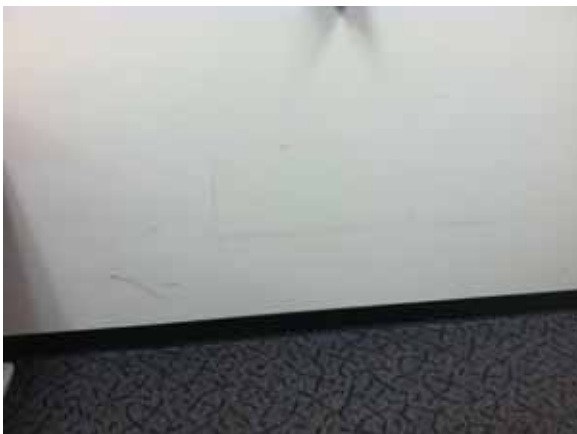
Fig. 3.0.C.13 Typical wear-and-tear noted at the gypsum board walls throughout.

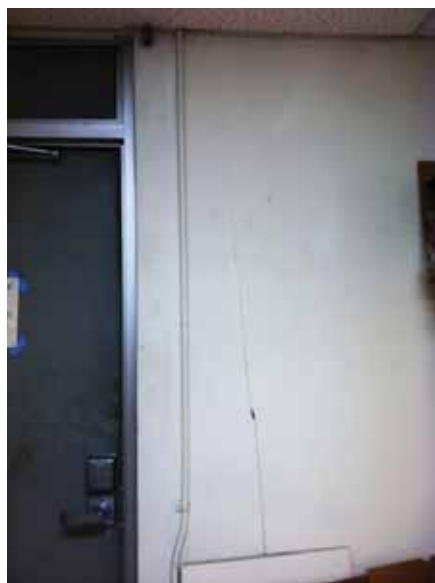
Fig. 3.0.C.14 A cracked section of the gypsum board wall observed near the Oil & Gas Lab exit door on the south side of the building.

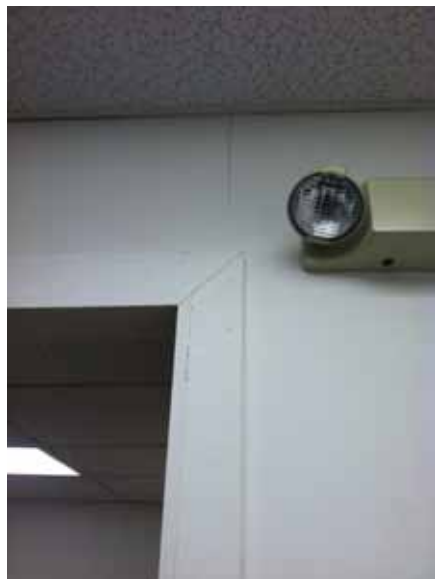
Fig. 3.0.C.15 Cracking of the gypsum board walls observed above some of the door openings throughout.

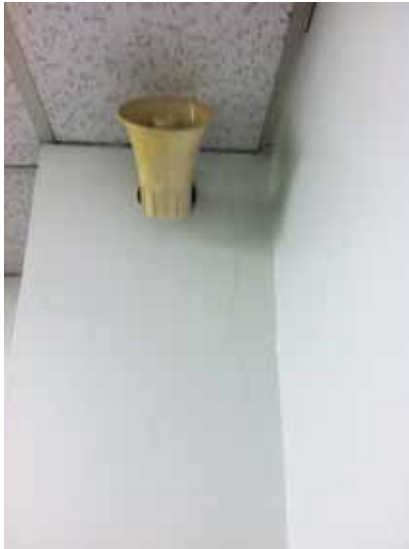
Fig. 3.0.C.16 Cracking of the gypsum board walls observed near the ceiling in areas throughout the building.

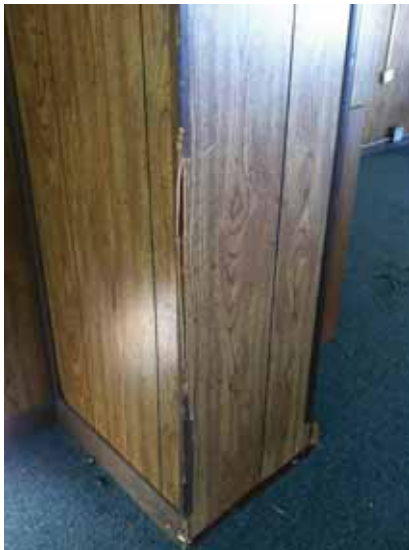
Fig. 3.0.C.17 General wear-and-tear and damage noted to the laminated wood paneling throughout the areas included in the site survey visit.

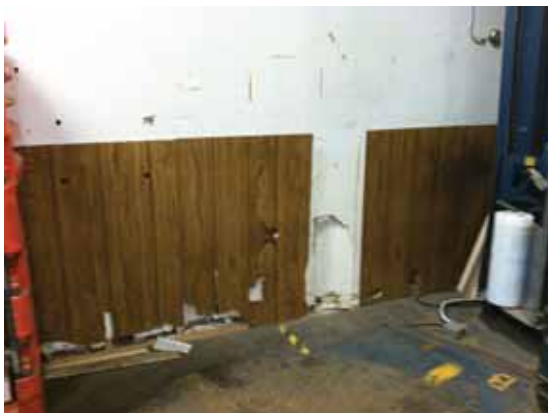
Fig. 3.0.C.18 Extensive damage to the laminated wood paneling wainscoting and the gypsum board wall observed in the north loading dock and storage room.

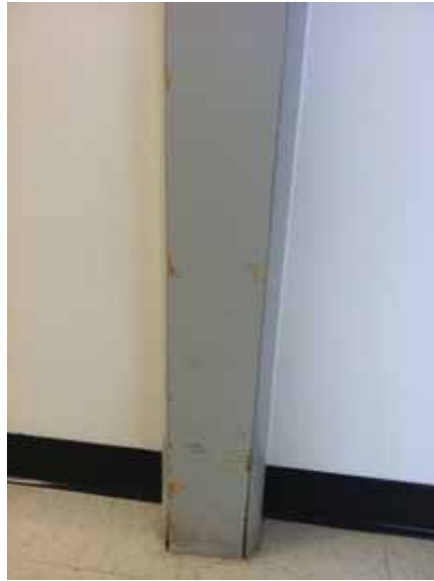
Fig. 3.0.C.19 General wear-and-tear to the wood trim observed in areas throughout the building.

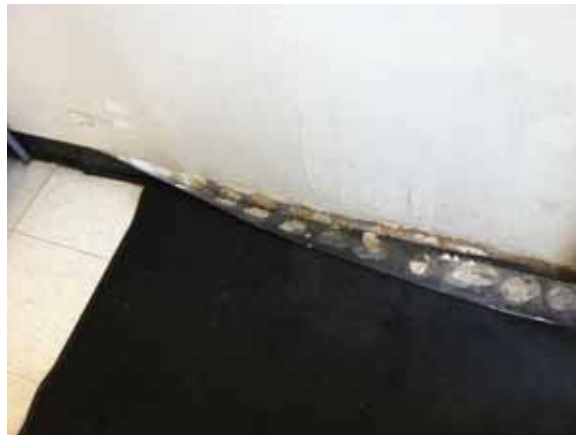
Fig. 3.0.C.20 Deteriorating vinyl baseboard observed in areas throughout the building.

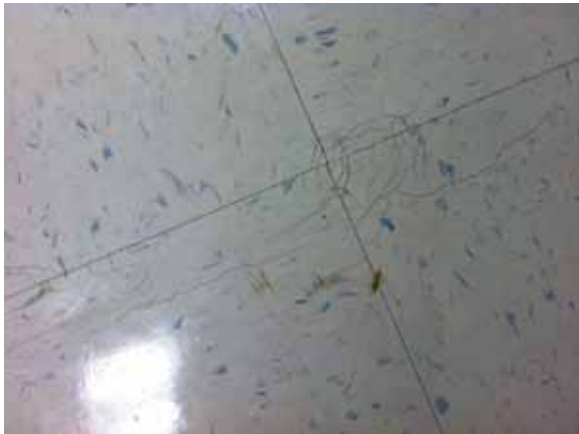
Fig. 3.0.C.21 Damaged vinyl tile flooring observed throughout the building.

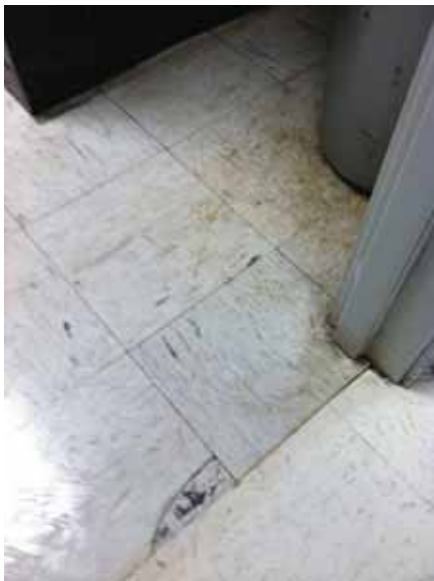
Fig. 3.0.C.22 Deteriorating and soiled vinyl tile flooring observed throughout the building.

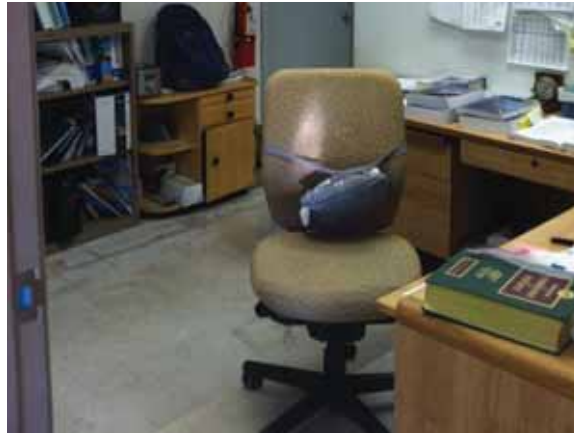
Fig. 3.0.C.23 Extensive soiling observed at areas of the vinyl tile floors.

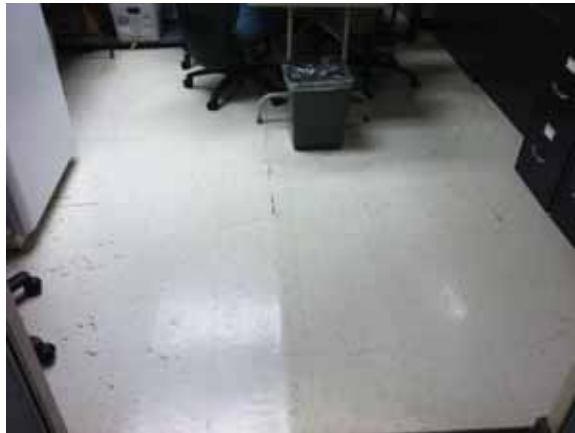
Fig. 3.0.C.24 An area of the vinyl tile flooring observed to be buckling during the site survey visit.

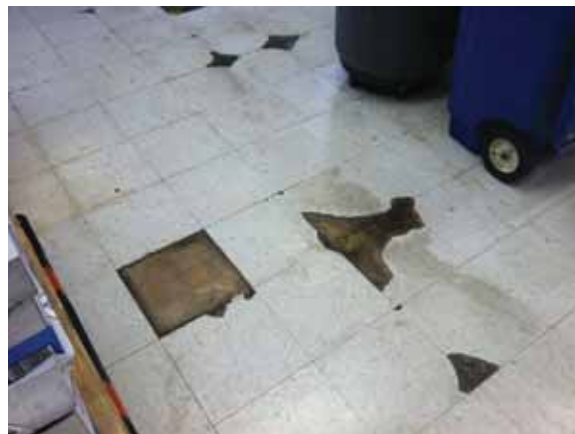
Fig. 3.0.C.25 The vinyl tile flooring throughout the IDS Print Shop is in poor condition with spalling and missing tiles creating a potential tripping hazard.

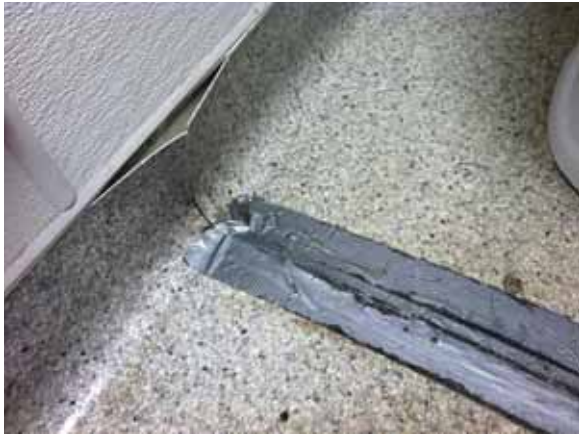
Fig. 3.0.C.26 The vinyl sheet flooring in Room B-9: Women's Restroom is in especially poor condition with deterioration and taped seams observed throughout.

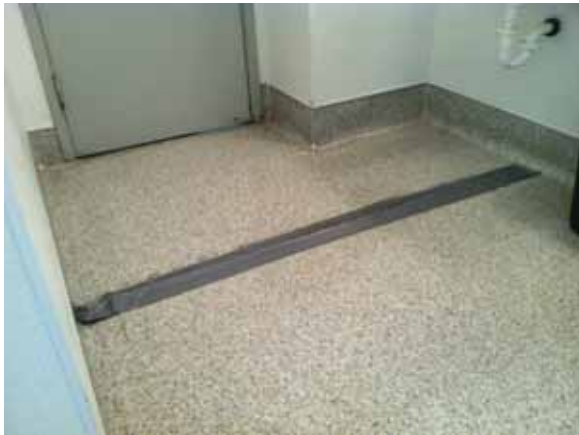
Fig. 3.0.C.27 The deterioration of the seams of the vinyl sheet flooring in Room B-9: Women's Restroom is creating a potential tripping hazard.

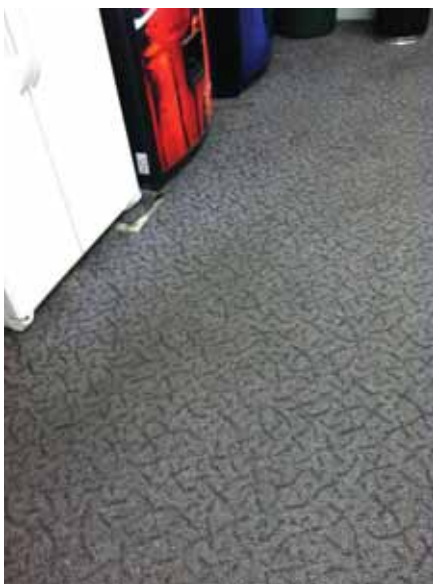
Fig. 3.0.C.28 General deterioration and soiling observed at the carpet flooring throughout.

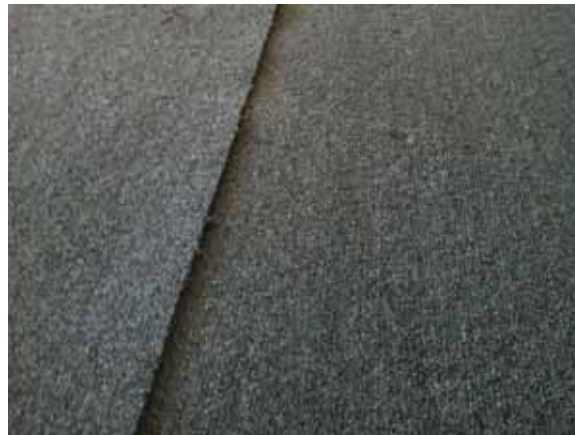
Fig. 3.0.C.29 Carpet seams that have come loose and are creating a potential tripping hazard.

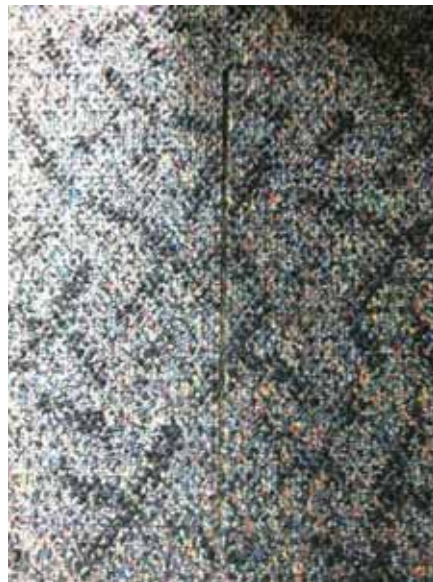
Fig. 3.0.C.30 Deterioration of the carpet seams observed during the site survey visit are creating a potential tripping hazard.

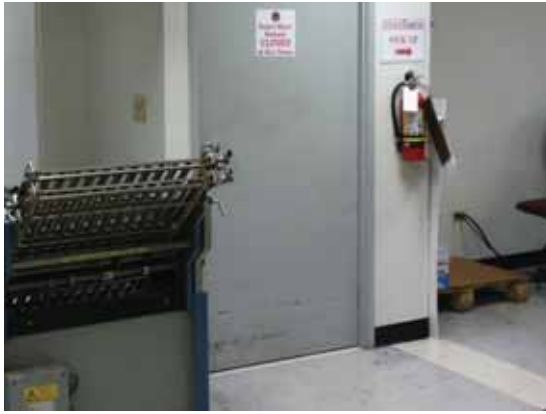
Fig. 3.0.C.31 General wear-and-tear observed at the doors throughout.

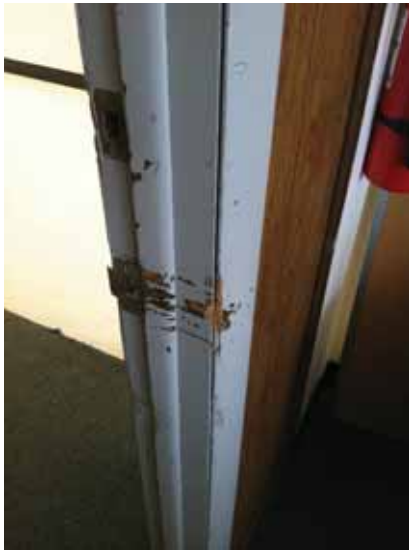
Fig. 3.0.C.32 Wear-and-tear observed at a door frame during the site survey visit.

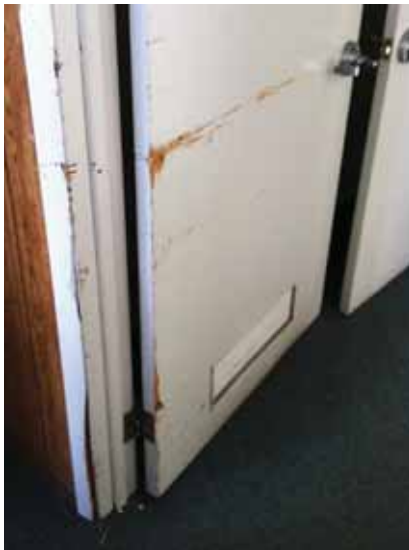
Fig. 3.0.C.33 Extensive damage observed at a wood door and frame during the site survey visit.

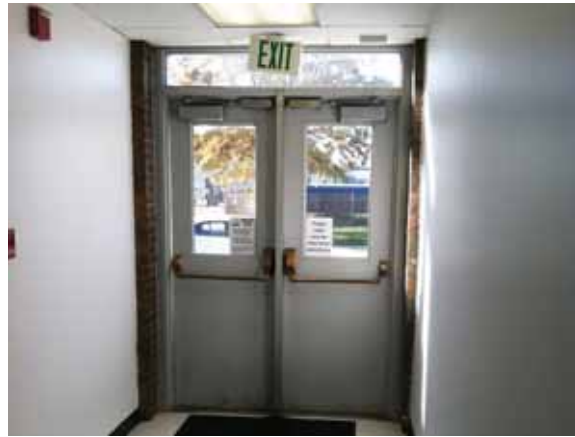
Fig. 3.0.C.34 An inadequately secured exit sign observed at the exit on the east end of the south side of the building poses a life-safety hazard to building occupants who pass underneath.
