CAPITOL COMPLEX MASTER PLAN
FINDINGS & RECOMMENDATIONS (F & R) NEEDS ASSESSMENT
1881 PIERCE BUILDING, 1881 PIERCE STREET (LAKEWOOD)

NOVEMBER 2014

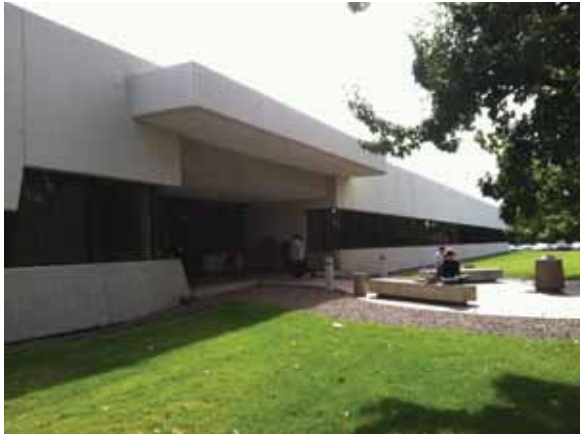
West Elevation of the south wing of the 1881 Pierce Building standing at the northern side of the south wing and looking southeast.

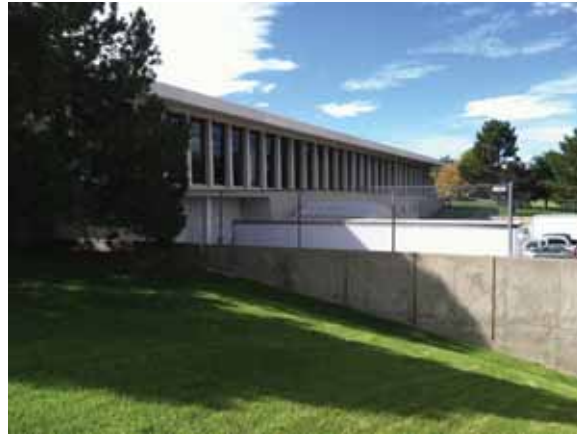
North Elevation of the 1881
Pierce Building

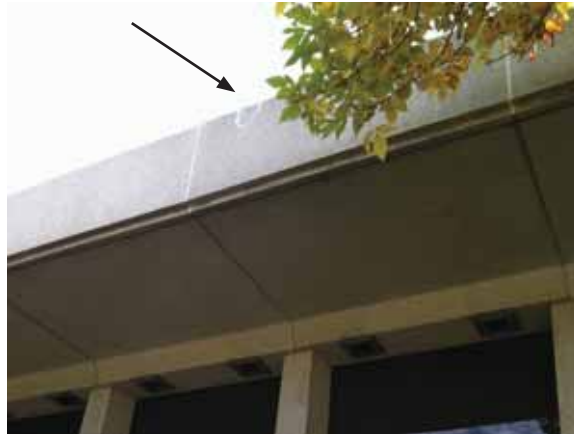
Fig. 2.1.A.1 Areas of spalling noted at the precast aggregate panels.

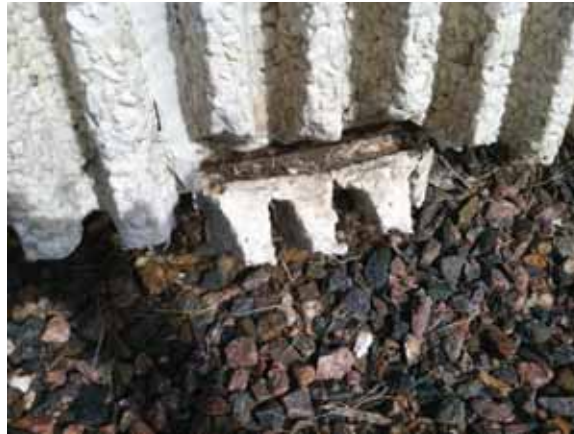
Fig. 2.1.A.2 Damaged areas of the precast aggregate panels noted around the building.

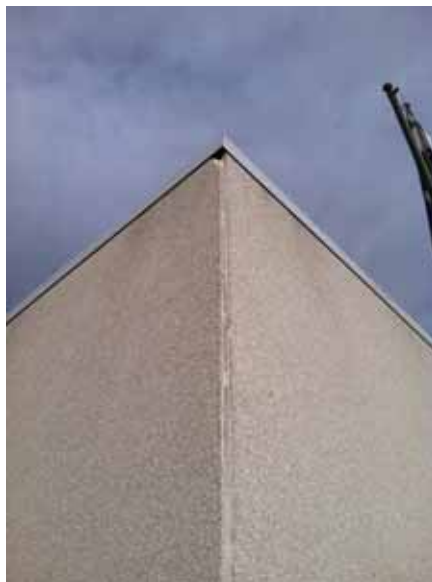
Fig. 2.1.A.3 Spalling noted at the North Penthouse.

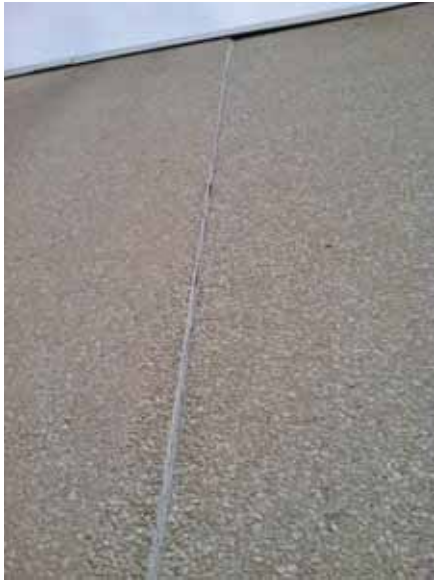
Fig. 2.1.A.4 Precast panel appears to be moving out of flush at the South Penthouse.

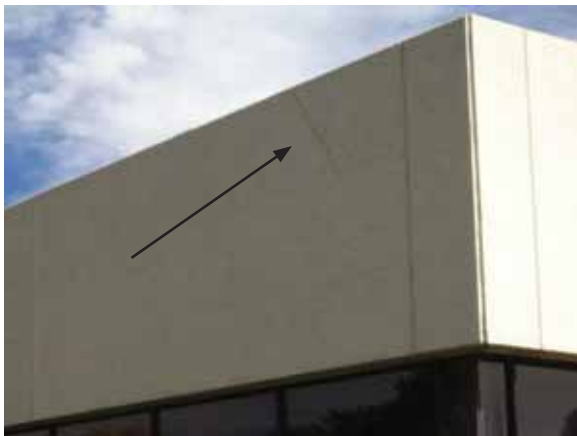
Fig. 2.1.A.5 Cracked areas of the precast aggregate panels noted around the building.

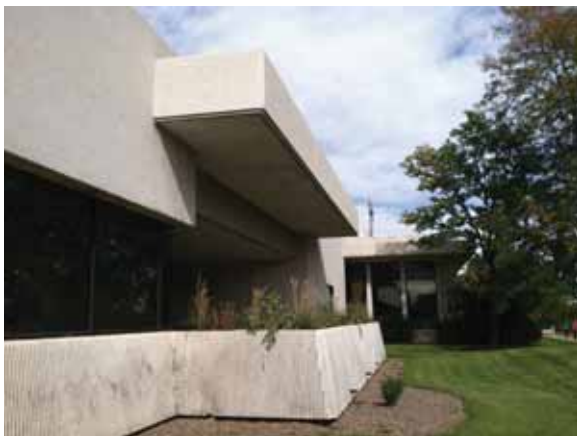
Fig. 2.1.A.6 Soiled precast aggregate panels noted around the building.

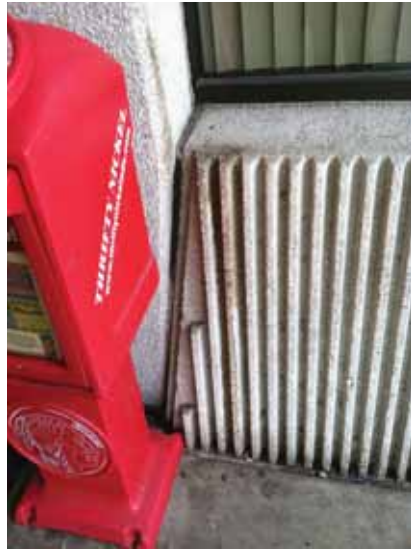
Fig. 2.1.A.7 Soiled precast aggregate panels noted around the building.

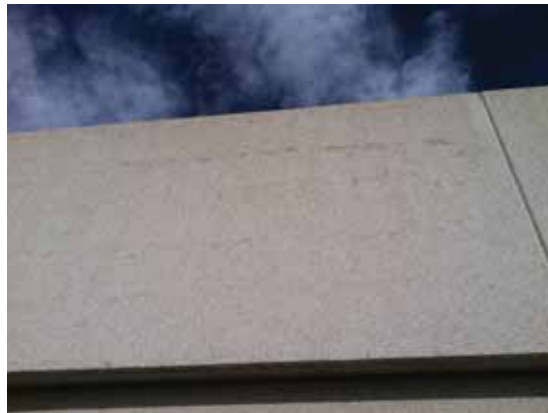
Fig. 2.1.A.8 Soiled precast aggregate panels noted around the building.

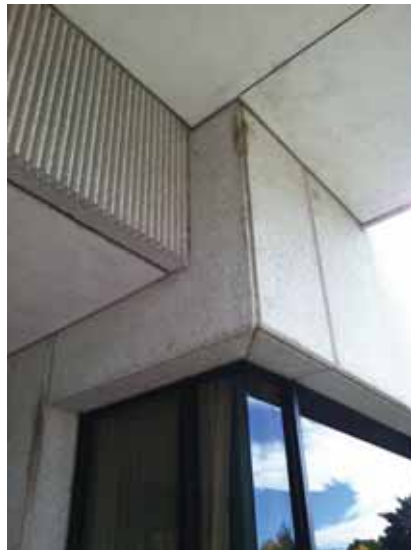
Fig. 2.1.A.9 Soiled precast aggregate panels noted around the building.

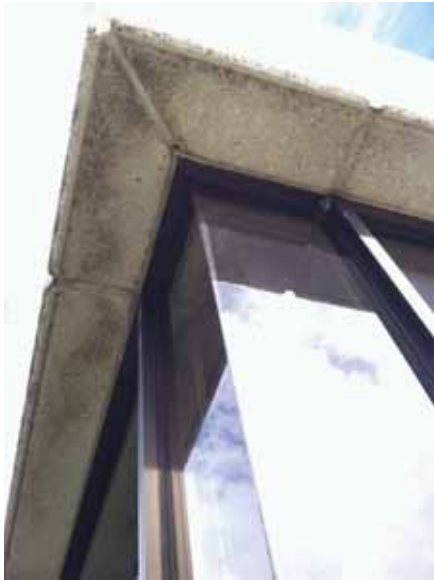
Fig. 2.1.A.10 Soiled precast aggregate panels along the bottom edge located above the windows.

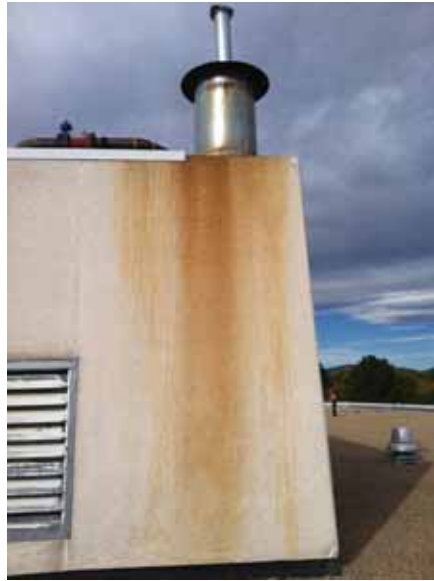
Fig. 2.1.A.13 Precast aggregate panels at the North Penthouse soiled due to corrosion and cracked and spalling at the top and bottom corners.

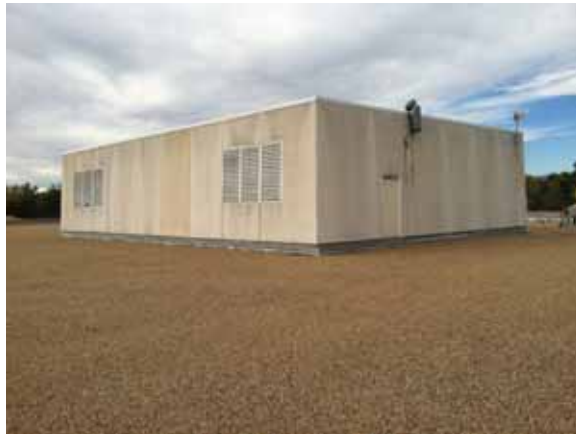
Fig. 2.1.A.14 Generally soiled precast aggregate panels at the South Penthouse.

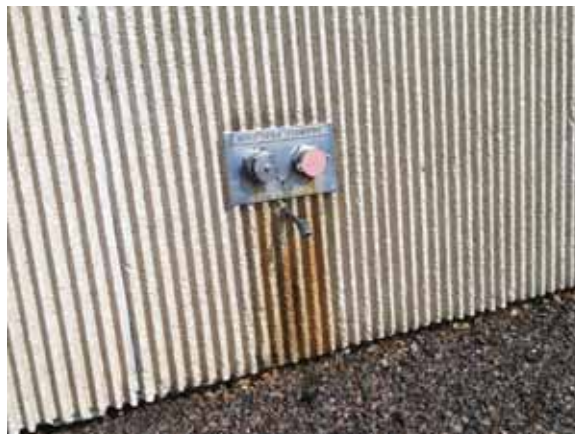
Fig. 2.1.A.15 Staining of a precast aggregate panel at a corroding fire department connection.

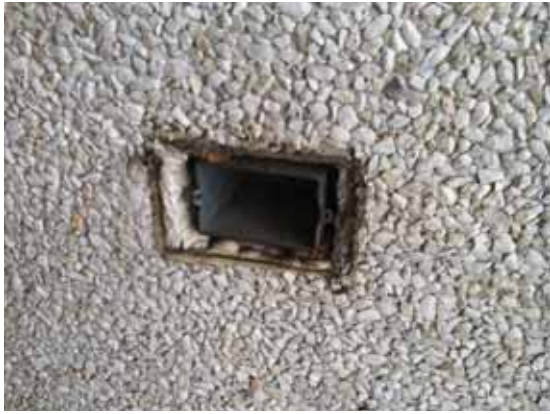
Fig. 2.1.A.16 Exposed empty electrical outlet box at the exterior porch on the east side of the building.

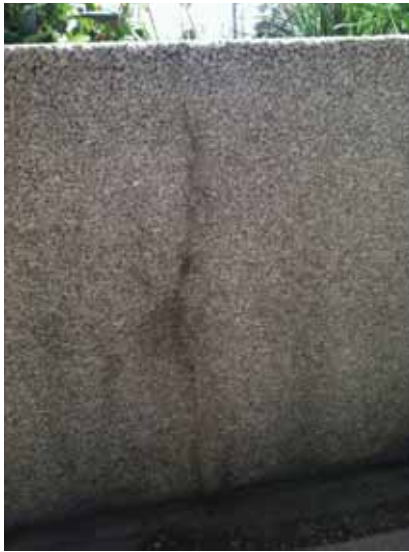
Fig. 2.1.A.17 Large cracking noted in the precast aggregate wall at the outside edge of the exterior porch.

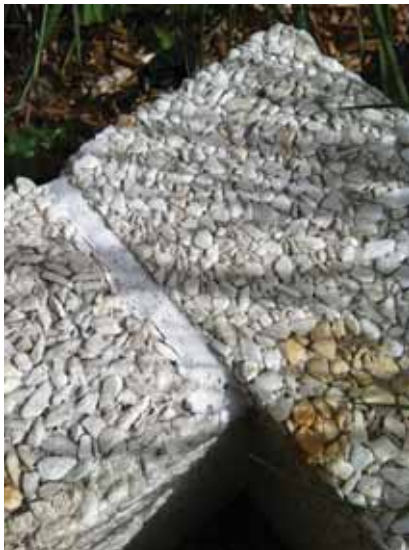
Fig. 2.1.A.18 Soiled precast aggregate wall with deteriorating sealant at the outside edge of the exterior porch.

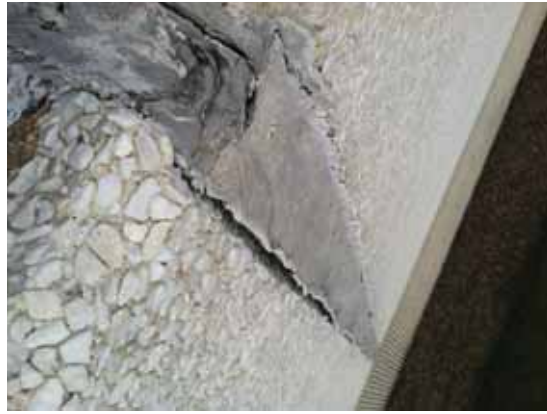
Fig. 2.1.A.19 Deterioration of the sealant between the precast panels.

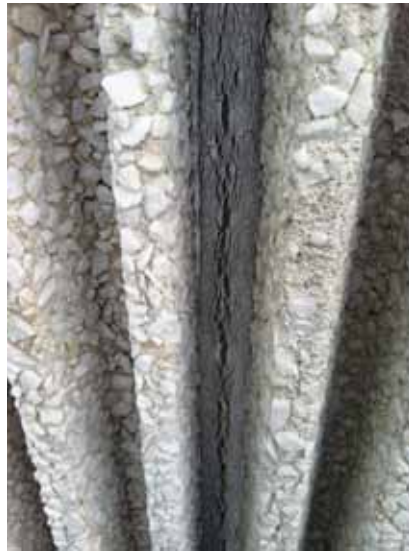
Fig. 2.1.A.20 Deterioration of the sealant between the precast panels.

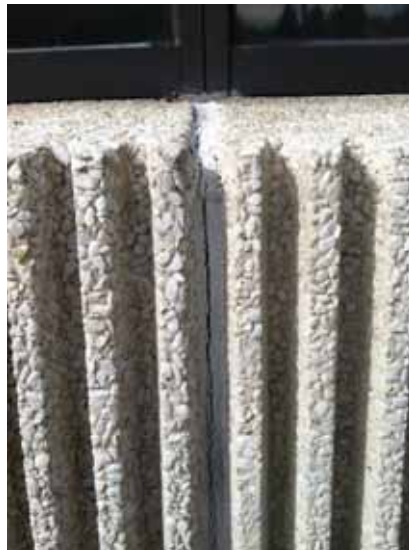
Fig. 2.1.A.21 Deterioration of the sealant between the precast panels.

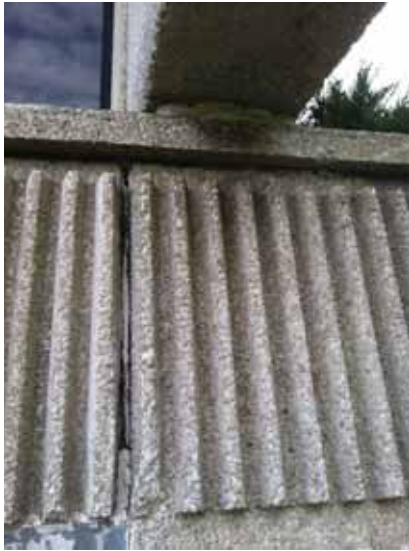
Fig. 2.1.A.22 Deterioration of the sealant between the precast panels.

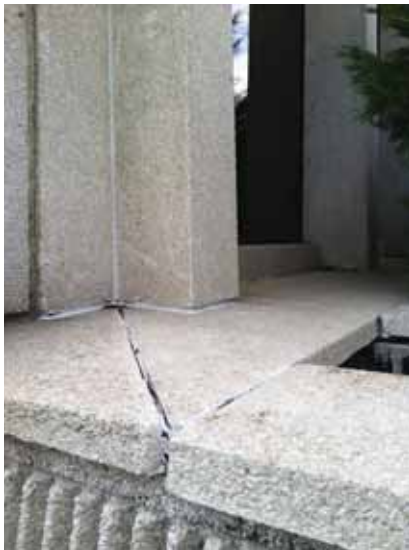
Fig. 2.1.A.23 Deterioration of the sealant along the window ledge.

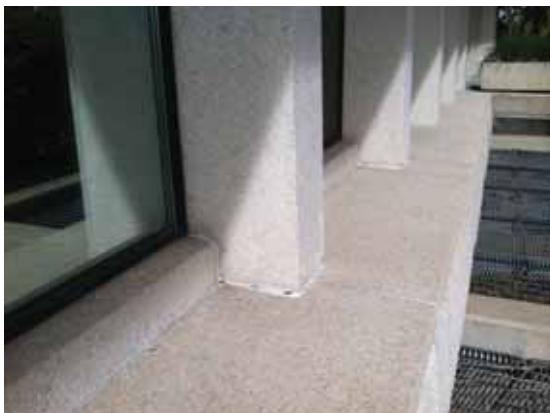
Fig. 2.1.A.24 Deterioration of the sealant around the base of the precast columns.

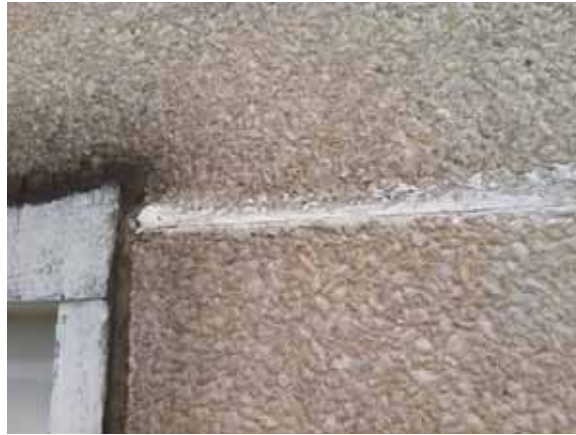
Fig. 2.1.A.25 Typical deterioration of the sealant at the two Penthouses on the roof.

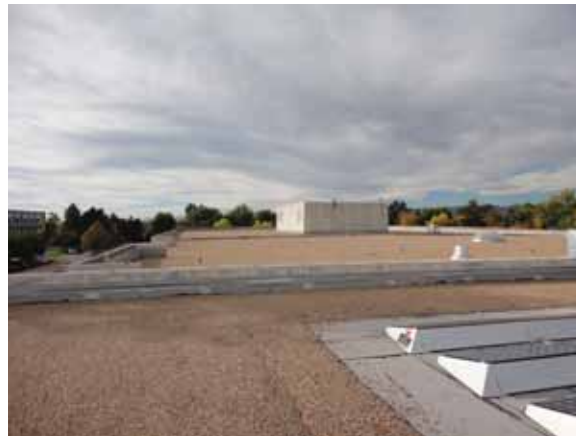
Fig. 2.1.A.26 Generally soiled and worn concrete parapets.

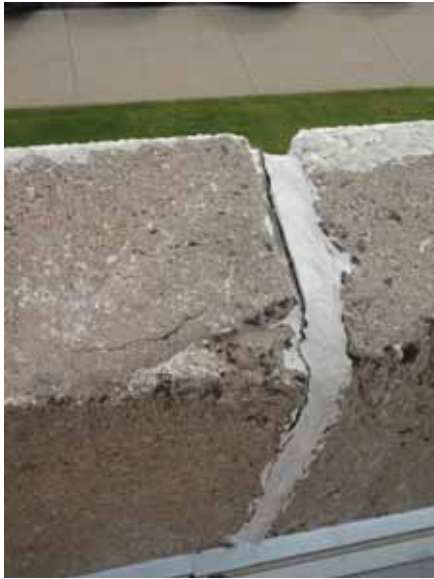
Fig. 2.1.A.27 Spalling and cracking areas of the parapet noted during the site visit.

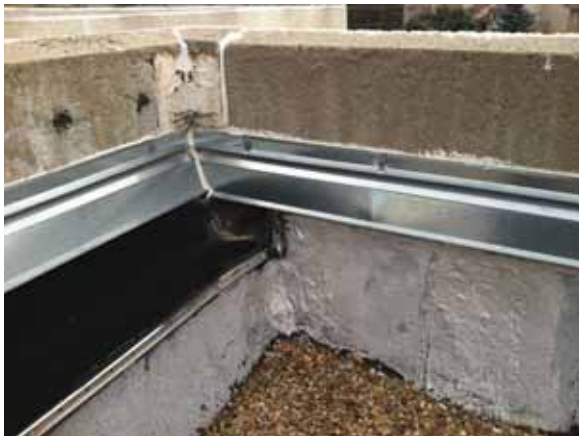
Fig. 2.1.A.28 Deterioration of the concrete parapet around a corroding metal corner connection.

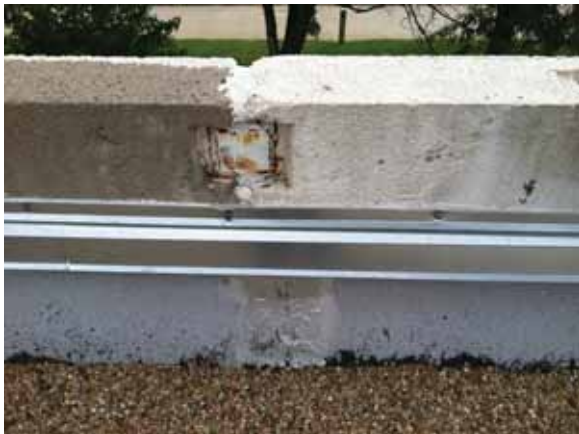
Fig. 2.1.A.29 Deterioration of the concrete parapet around a corroding metal plate.

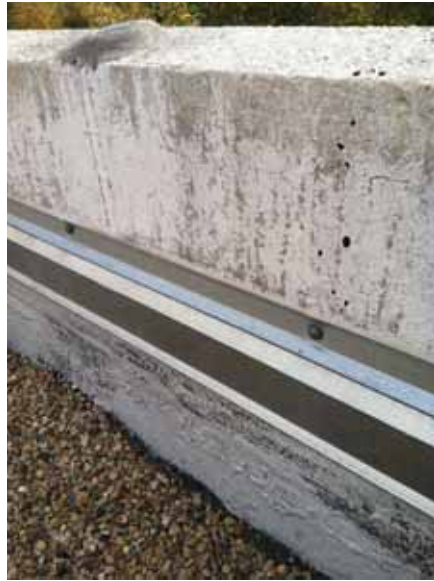
Fig. 2.1.A.30 Areas where the protective coating sealing the concrete parapet is wearing off.

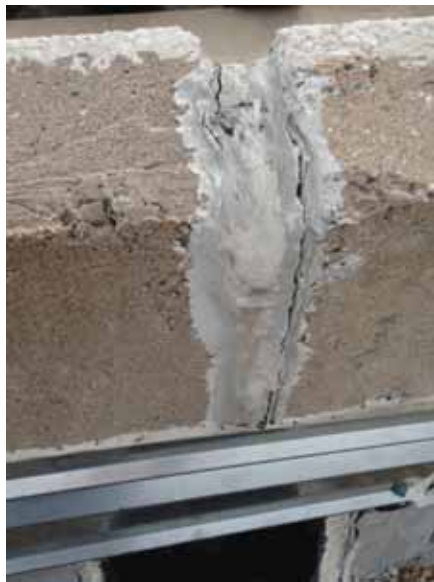
Fig. 2.1.A.31 Deteriorating sealant typical around the concrete parapets.

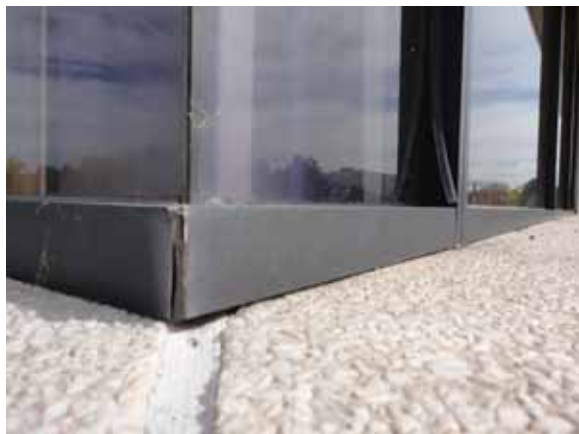
Fig. 2.1.A.32 General deterioration of the sealant and weatherstripping surrounding the windows.

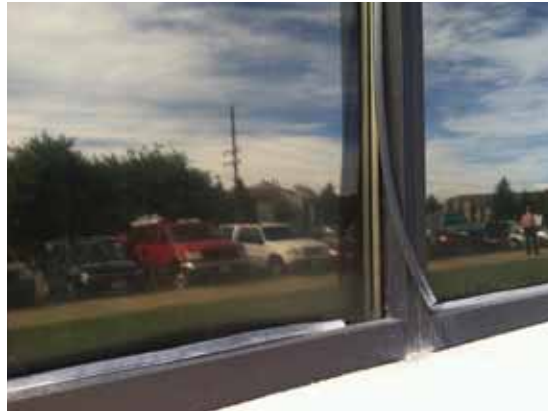
Fig. 2.1.A.33 General deterioration of the weatherstripping surrounding the windows.

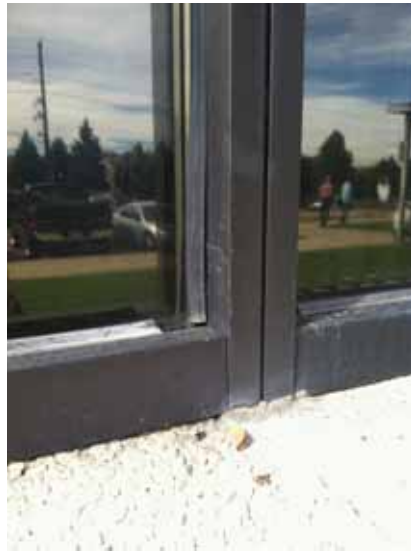
Fig. 2.1.A.34 General deterioration of the weatherstripping surrounding the windows.

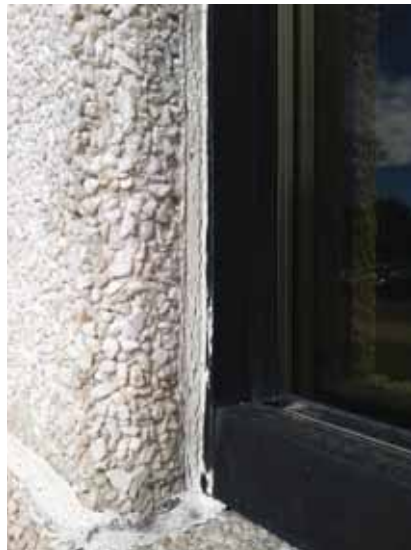
Fig. 2.1.A.35 Typical deterioration of the sealant surrounding the windows.

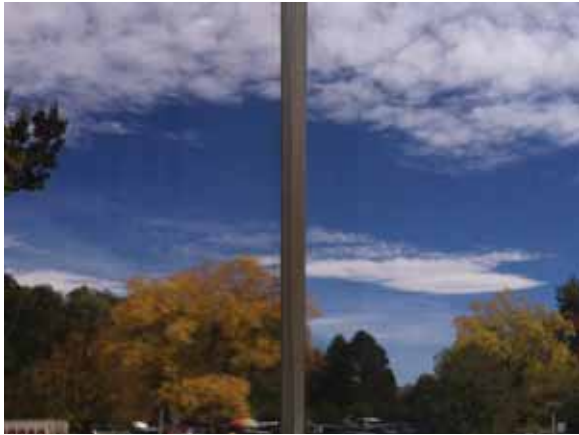
Fig. 2.1.A.36 Typical areas of corrosion noted to the metal window frames.

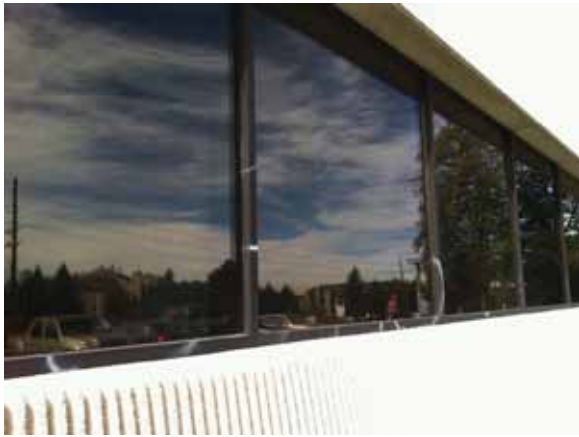
Fig. 2.1.A.37 Window frames that appear to have spots that were spray painted with white paint.

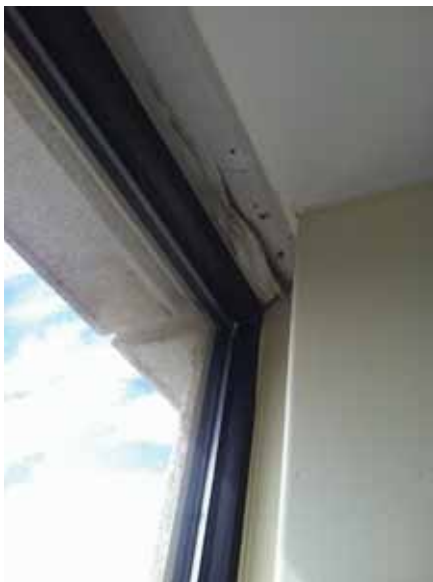
Fig. 2.1.A.38 Water damage noted along the top of a window from the interior side of the building.

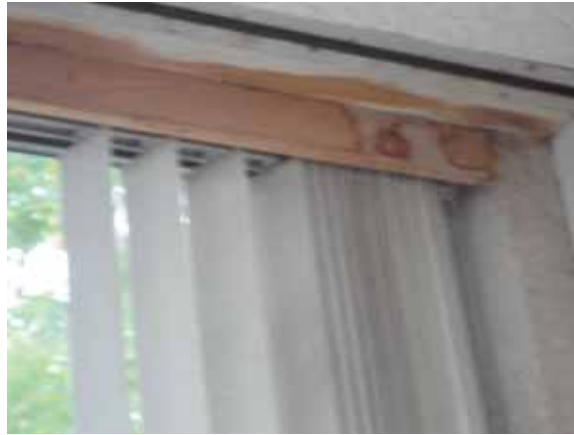
Fig. 2.1.A.39 Water damage noted along the top of a window from the interior side of the building.

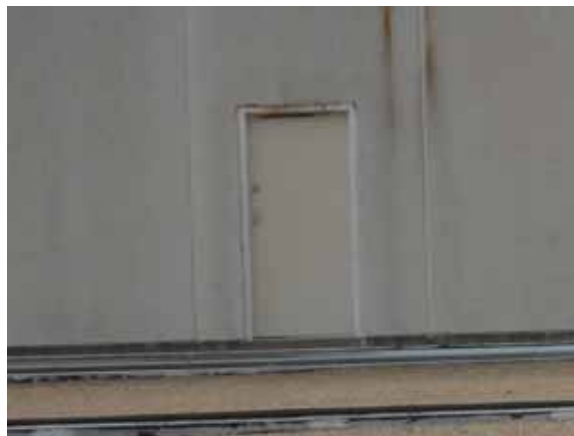
Fig. 2.1.A.40 Corroding frame around the door to the South Penthouse.

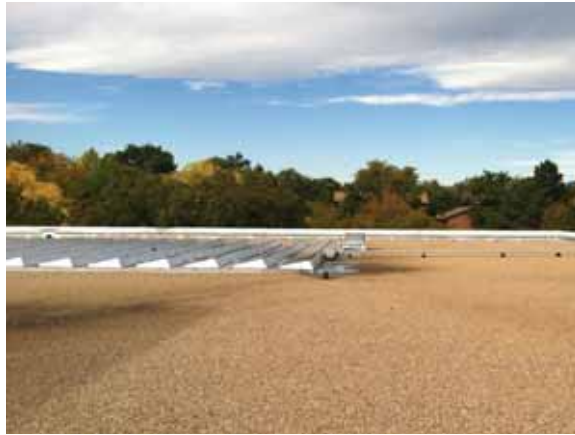
Fig. 2.1.A.41 Areas of pooling water noted around the roof.

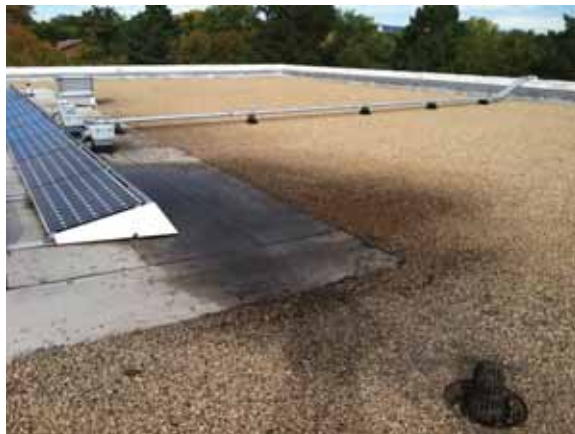
Fig. 2.1.A.42 Areas of pooling water noted around the roof.

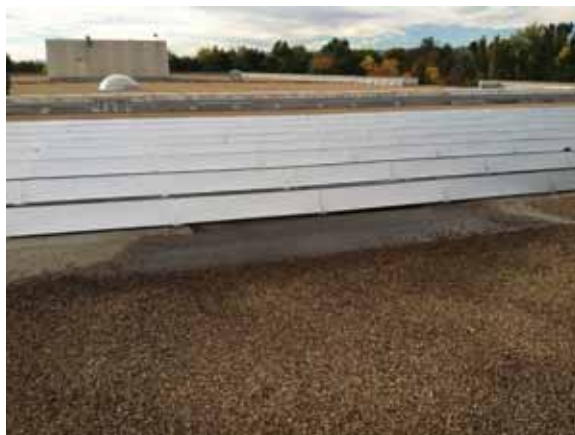
Fig. 2.1.A.43 Areas of pooling water noted around the roof.

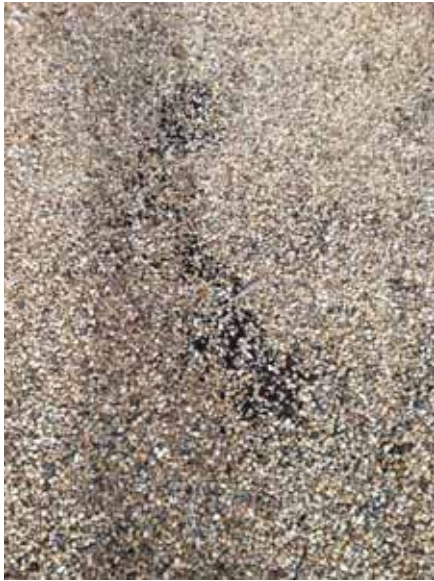
Fig. 2.1.A.44 Typical area of thin ballast.

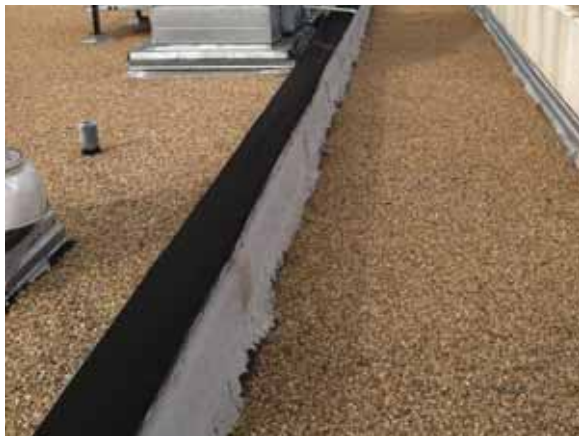
Fig. 2.1.A.45 Deteriorating waterproofing membrane at the roof.

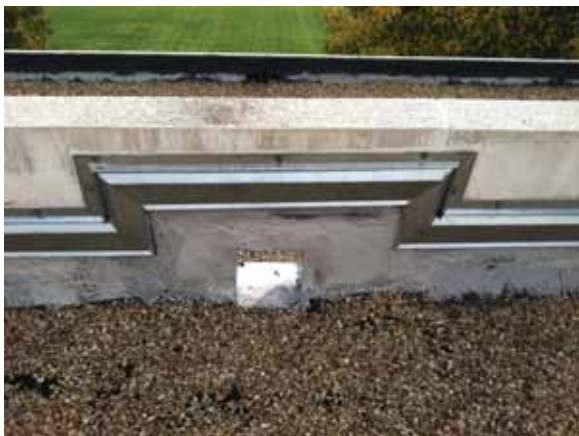
Fig. 2.1.A.46 Deteriorating waterproofing membrane at the roof.

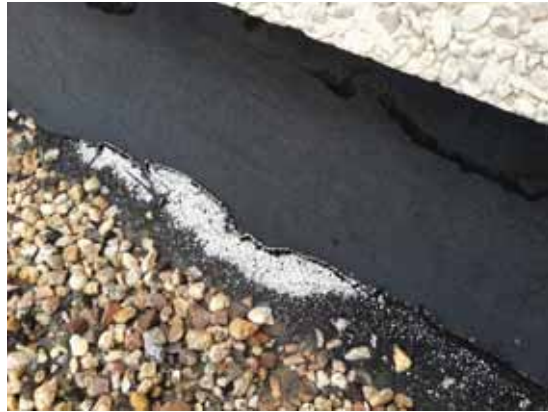
Fig. 2.1.A.47 Deteriorating waterproofing membrane at the roof.

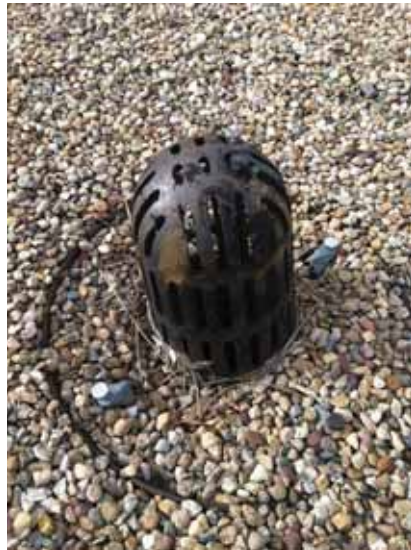
Fig. 2.1.A.48 Typical corroded drain cover, also filled in with ballast, noted at the roof.

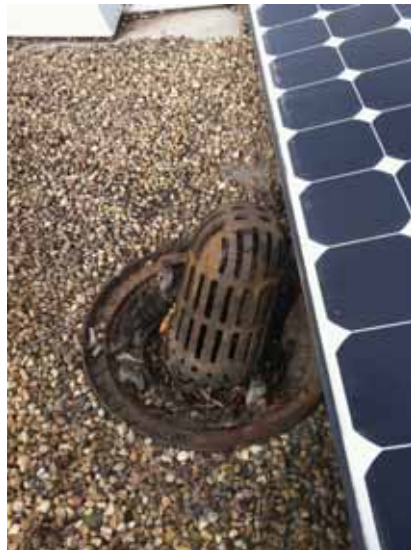
Fig. 2.1.A.49 Photovoltaic cell located directly next to a roof drain cover.

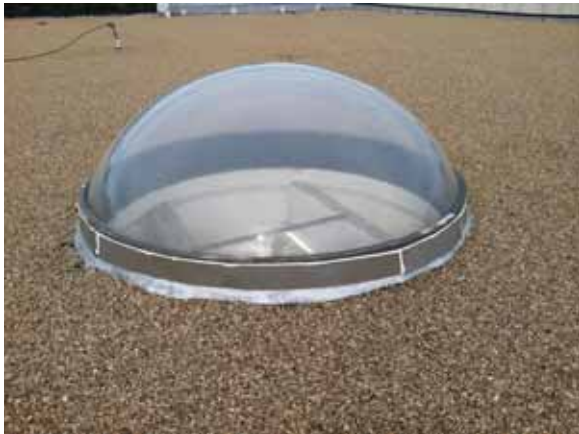
Fig. 2.1.A.51 Deteriorating sealant at the skylight near the middle of the roof.

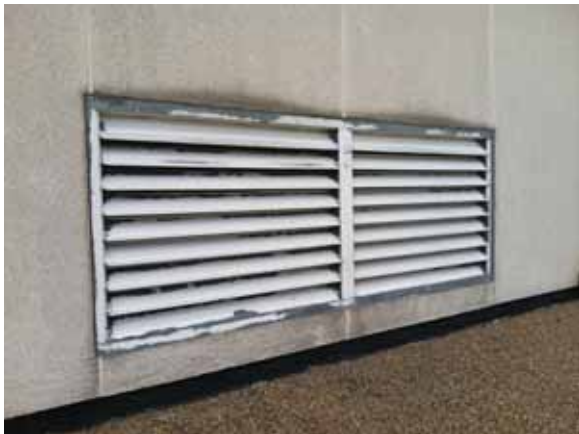
Fig. 2.1.A.52 Paint deteriorating and peeling off the louvers at the North Penthouse.

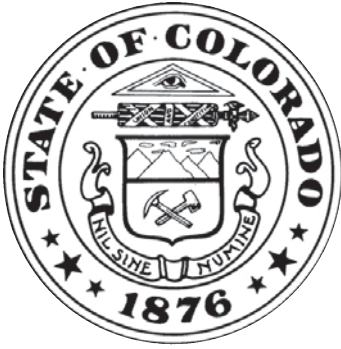
2.0 OVERALL BUILDING ASSESSMENT FINDINGS & RECOMMENDATIONS

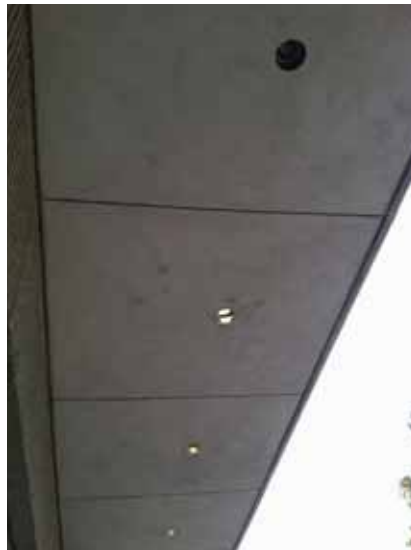
Fig. 2.1.A.53 Typical soiling noted at the exterior canopies.

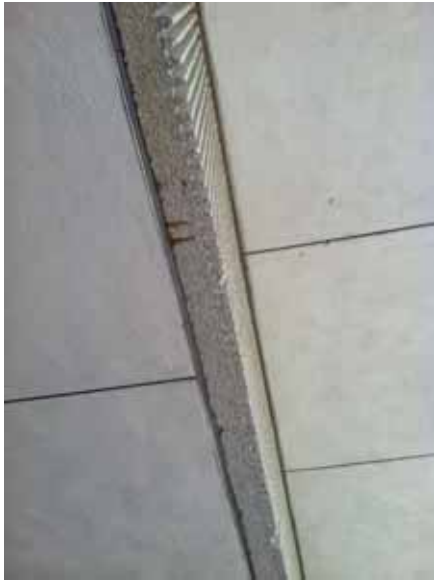
Fig. 2.1.A.54 Brown substance leaking out from behind a precast panel covering the front edge of the canopy at Entrance A.

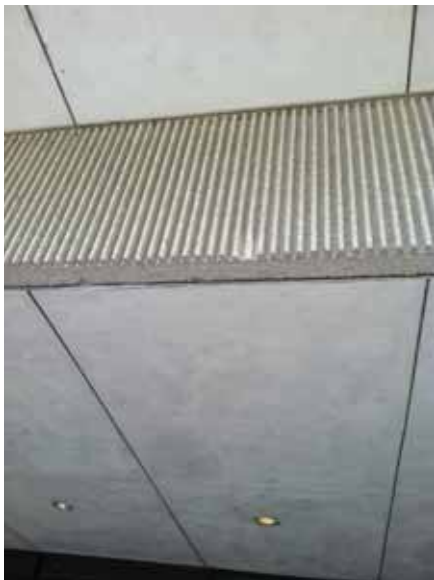
Fig. 2.1.A.55 Areas of minor spalling noted at the precast panels covering the front edges of the entrance canopies.

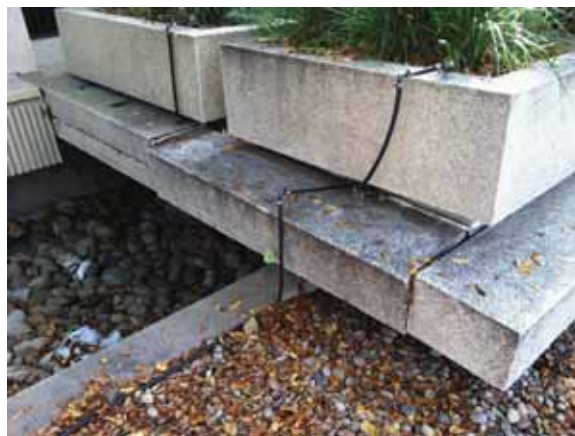
Fig. 2.1.A.56 Cracked aggregate beam and aggregate beams pulling away from the north side of the raised platform at Entrance B.

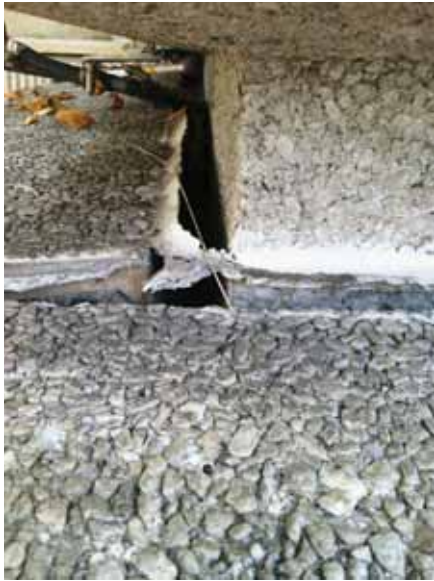
Fig. 2.1.A.57 Close up of the aggregate beams pulling away from the north side of the platform at Entrance B.

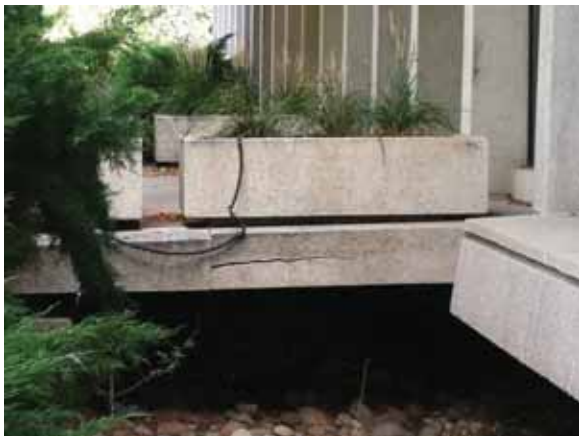
Fig. 2.1.A.58 Cracked aggregate beam and aggregate beams pulling away from the south side of the raised platform at Entrance B.

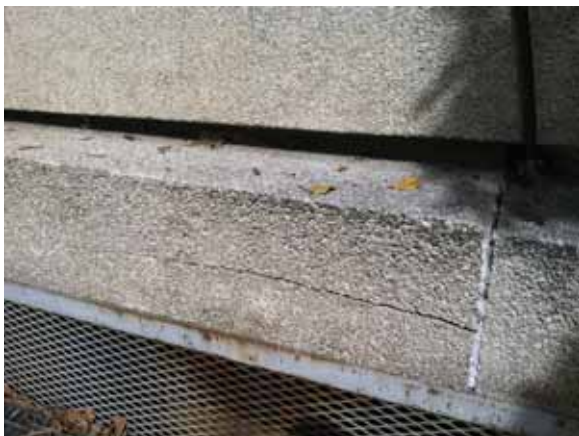
Fig. 2.1.A.59 Cracked aggregate beam at the raised platform at the East Employee Entrance.

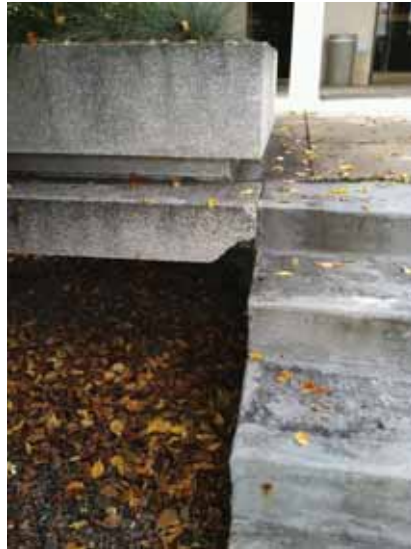
Fig. 2.1.A.60 Spalling aggregate beam at the raised platform at the East Employee Entrance.

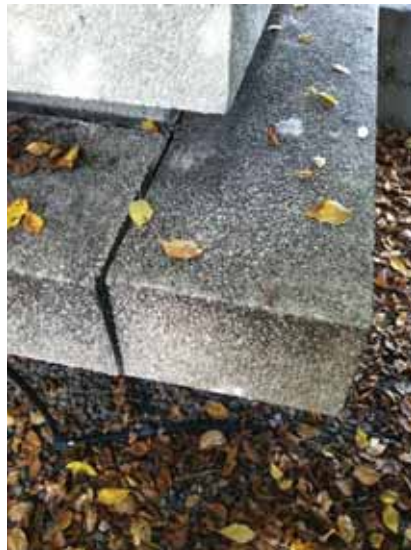
Fig. 2.1.A.61 Aggregate beam that appears to be pulling away from the platform at the East Employee Entrance.

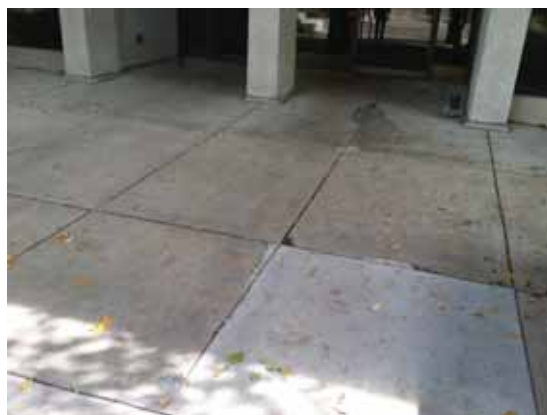
Fig. 2.1.A.62 Minor spalling and deterioration of the concrete pavers at Entrance B on the west side of the building.

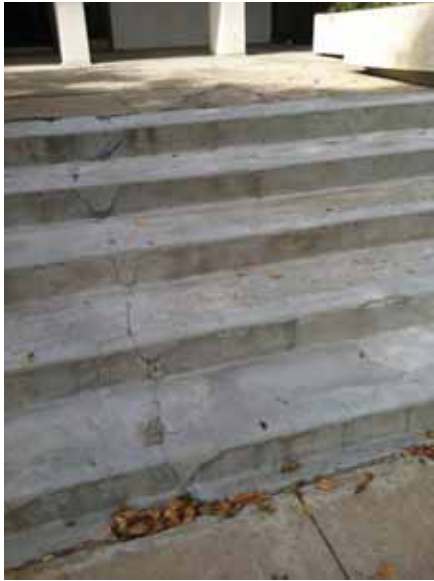
Fig. 2.1.A.63 Spalling and cracking of the concrete stairs at the East Employee Entrance.

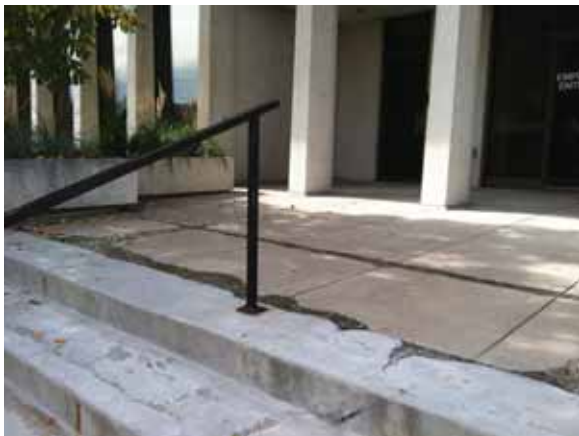
Fig. 2.1.A.64 Spalling and cracking of the concrete pavers at the East Employee Entrance.

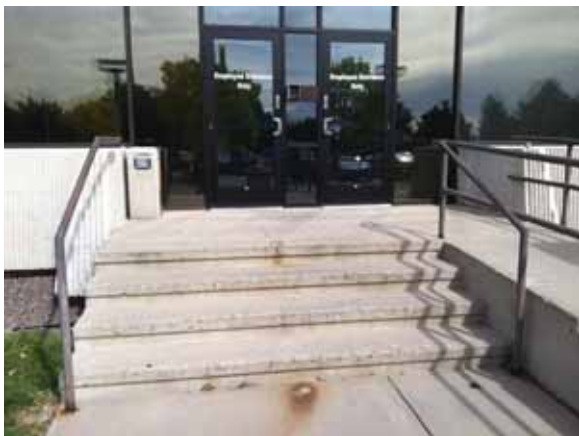
Fig. 2.1.A.65 Minor spalling of the concrete stairs and holes left in the concrete surface where guardrail posts were previously removed at the South Employee Entrance.

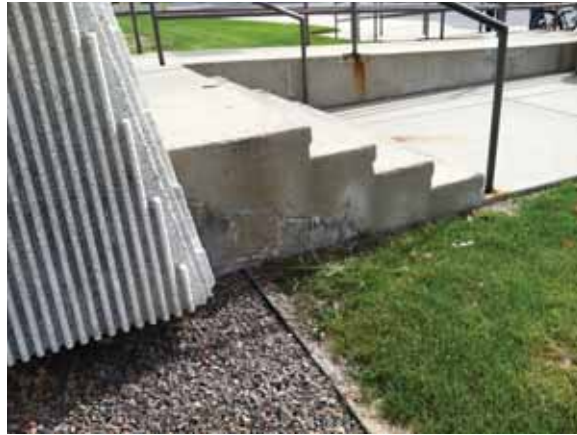
Fig. 2.1.A.66 Spalling and cracked concrete at the exterior stairway to the South Employee Entrance.

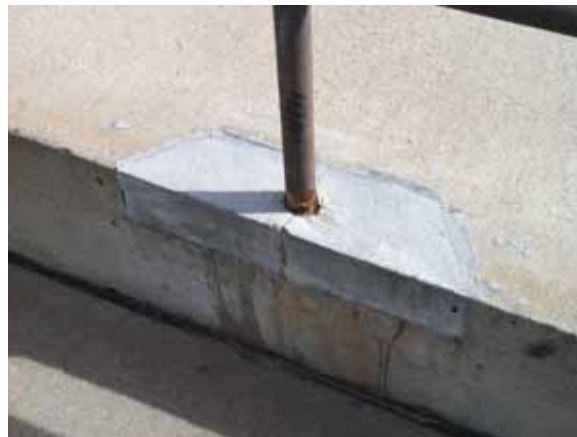
Fig. 2.1.A.67 Cracked concrete causing the corroding guardrail posts to become loose along the ramp to the South Employee Entrance.

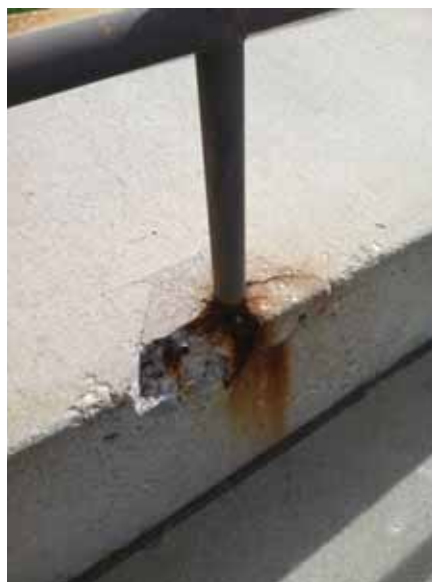
Fig. 2.1.A.68 Spalling and cracked concrete causing the guardrail posts to become loose along the ramp to the South Employee Entrance.

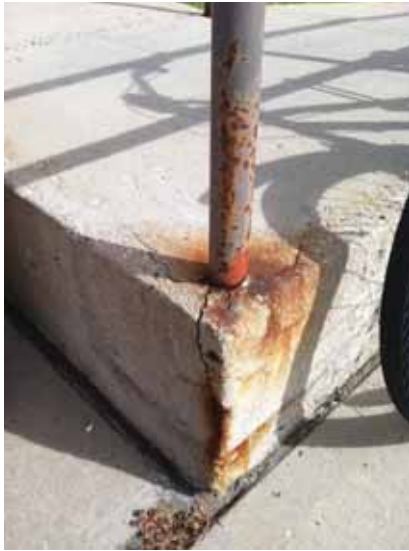
Fig. 2.1.A.69 Cracked concrete causing the corroding guardrail posts to become loose along the ramp to the South Employee Entrance.

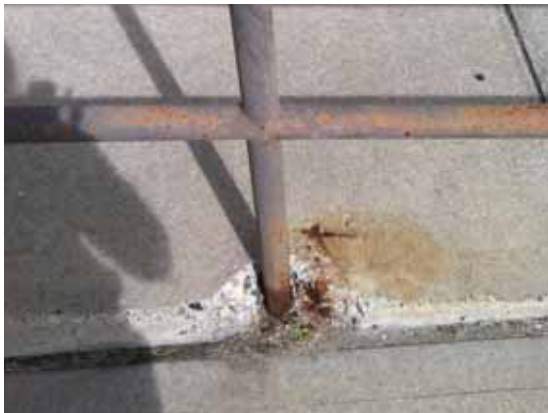
Fig. 2.1.A.70 Spalling concrete causing the corroding guardrail posts to become loose along the ramp to the South Employee Entrance.

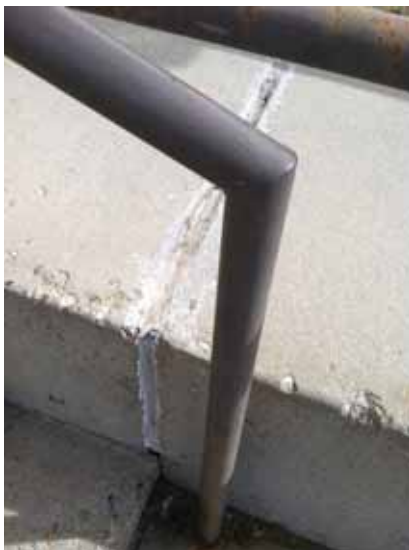
Fig. 2.1.A.71 Deteriorating sealant between the concrete slabs at the ramp to the South Employee Entrance.

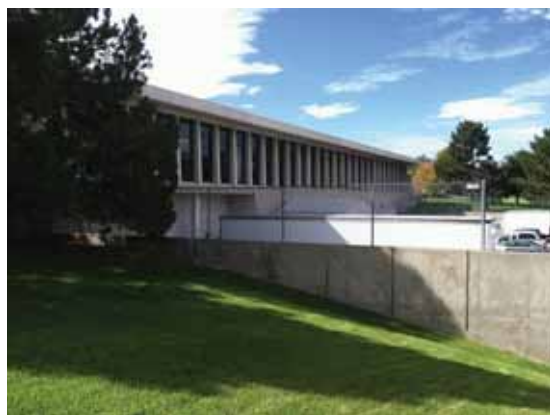
Fig. 2.1.A.72 Typical soiling of the concrete retaining wall on the north side of the building.

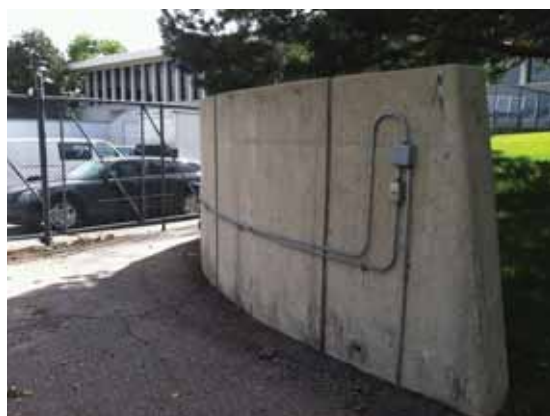
Fig. 2.1.A.73 Soiled, cracking, and spalling concrete retaining wall on the north side of the building.

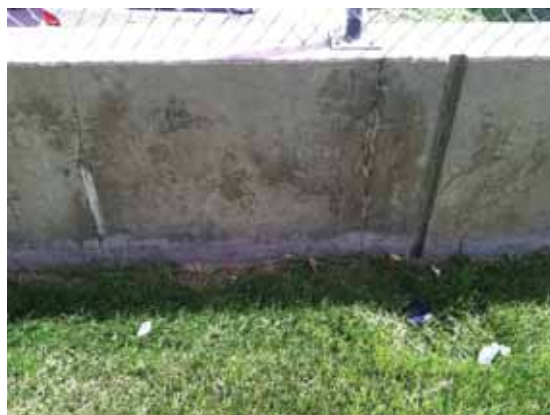
Fig. 2.1.A.74 Soiled, cracking, and spalling concrete retaining wall on the north side of the building.

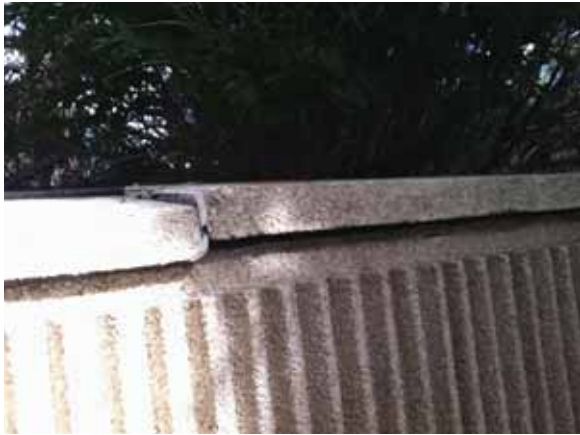
Fig. 2.1.A.75 Capping piece of the north retaining wall on the east side of the building moving out of place and with deteriorating sealant.

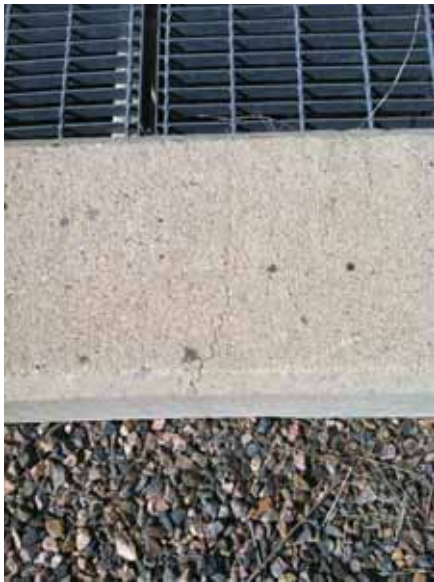
Fig. 2.1.A.76 Cracked concrete at a low window well wall.

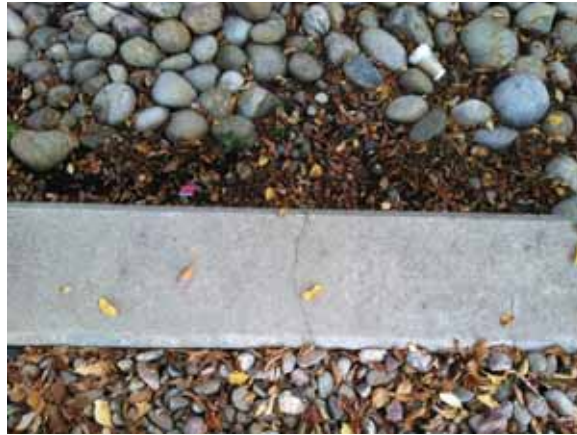
Fig. 2.1.A.77 Cracked concrete at a low landscaping wall.

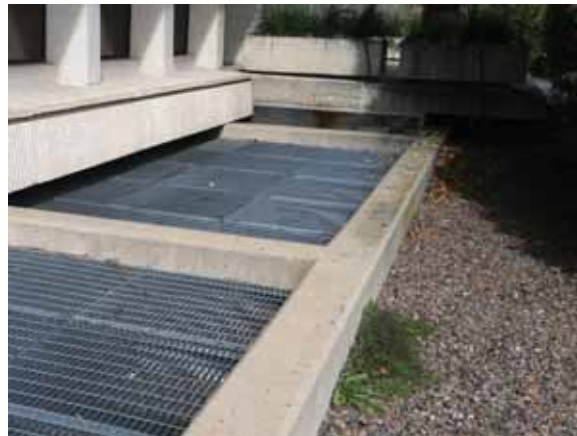
Fig. 2.1.A.78 Moss and/or mold growing on the low concrete window well wall south of the East Employee Entrance.

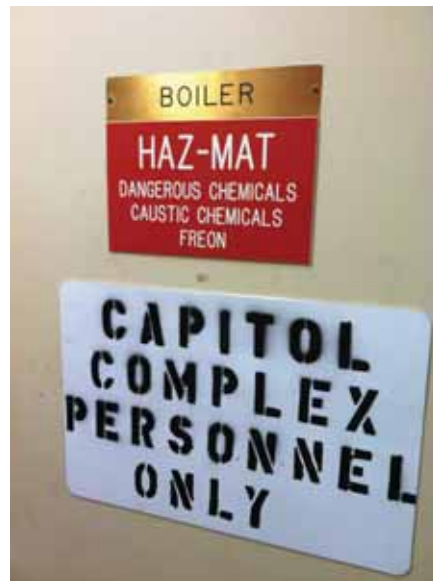
Fig. 2.1.B.1 Area in the northeast corner of the Basement labeled for hazardous materials.

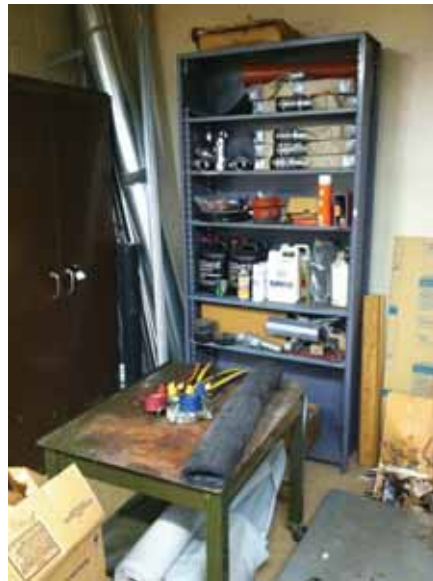
Fig. 2.1.B.2 Area in the northeast corner of the Basement with flammable materials being stored on open shelves.

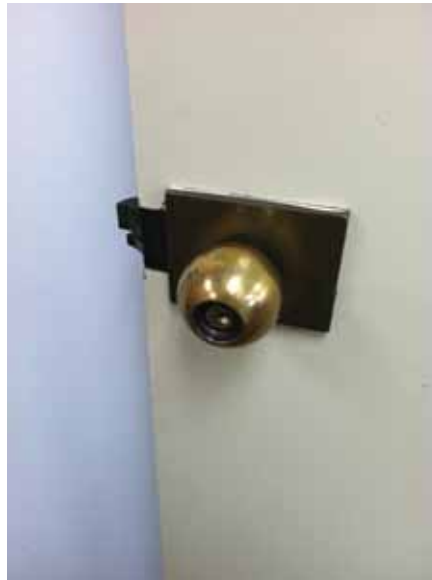
Fig. 2.1.B.6 Typical knob-style door handle found in a few locations throughout the building.

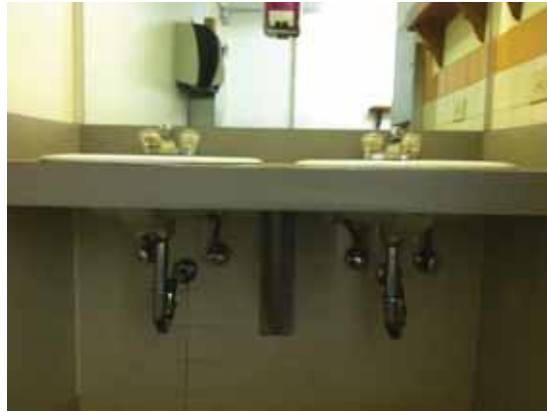
Fig. 2.1.C.3 Lavatories with knob-style faucet controls and without insulation wrapped around the pipes in the Women's Restroom on the Basement Floor.

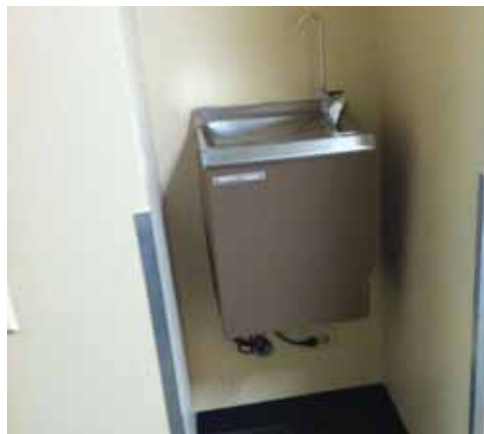
Fig. 2.1.C.5 Typical instance of a non-accessible drinking fountain observed during the site visit.

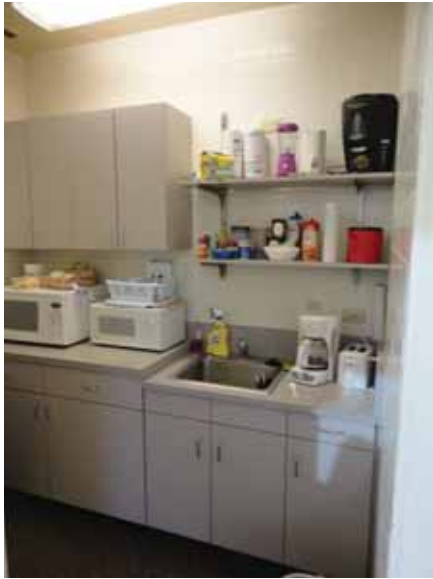
Fig. 2.1.C.6 Typical non-accessible sink found in the Break Rooms throughout.

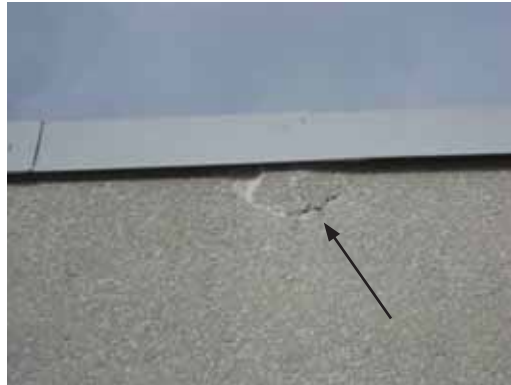
The building's exterior is in good condition with a few exceptions. Spalls and cracks were observed in the precast concrete panel walls at the penthouse (Fig. 2.2.A.1 and Fig. 2.2.A.2). Cracks should be sealed and the spalls repaired to prevent water from penetrating the concrete and causing additional deterioration.

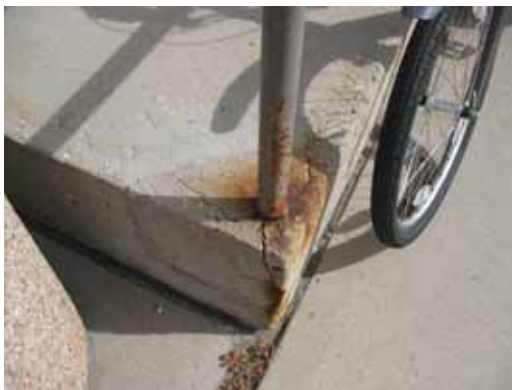
Spalls were observed on the concrete ramp at the south employee entrance (Fig. 2.2.A.4). The spalled concrete and corroded guardrails likely will not be able to resist the code required design loading. It appears the guardrail was installed some time after the ramp was cast and the connections were not properly designed and detailed. The guardrail and concrete ramp should be repaired with properly detailed connections.
