CAPITOL COMPLEX MASTER PLAN
FINDINGS & RECOMMENDATIONS (F & R) NEEDS ASSESSMENT
1881 PIERCE BUILDING, 1881 PIERCE STREET (LAKEWOOD)

NOVEMBER 2014

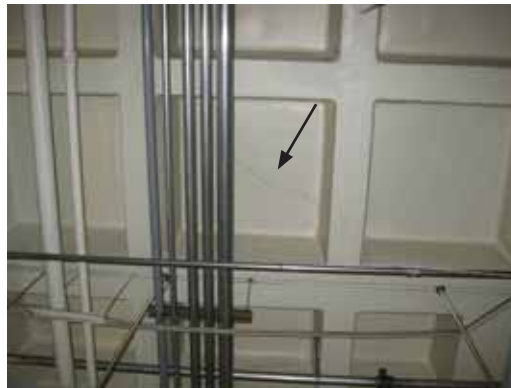
The overall condition of the structural framing that was readily observable was good. Minor cracks were observed in the concrete slab between the joists on the first floor (fig. 2.2.B.1). The cracks are not a structural concern at this time.

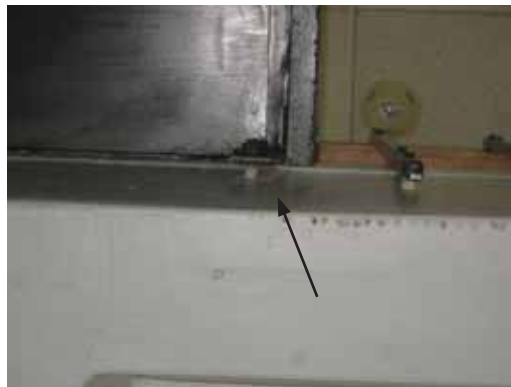
The interior metal stairs at the south west corner of the north wing are improperly attached to the concrete joists (fig. 2.2.B.2). The stringer is not framed tight to the concrete support and induces bending into the bolt that is not designed for this condition. The condition should be repaired to prevent failure of the bolt.

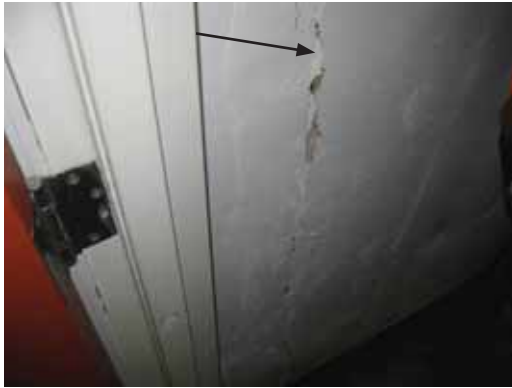
A moderate vertical crack was observed on the concrete wall in the southeast corner of the basement (Fig. 2.2.B.3). The room with the crack appears to be added after original construction. The crack should be injected with a urethane grout to seal the joint.

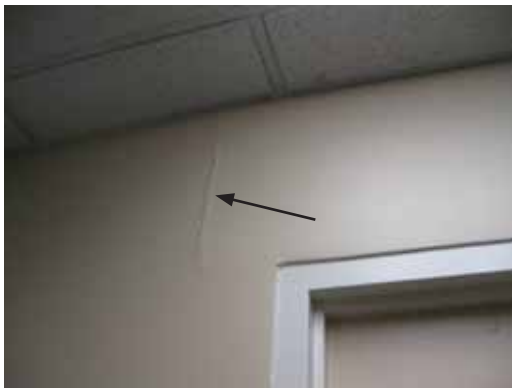
Many cracks were observed in the drywall partitions throughout the north wing (Fig. 2.2.B.4 and Fig 2.2.B.5). The cracks appear to be a reoccurring problem based number of drywall joints tooled in the walls. We observed that the interior partition walls were framed tight to the structural slab above. Deflection of the structural slab will cause additional cracking in the walls.

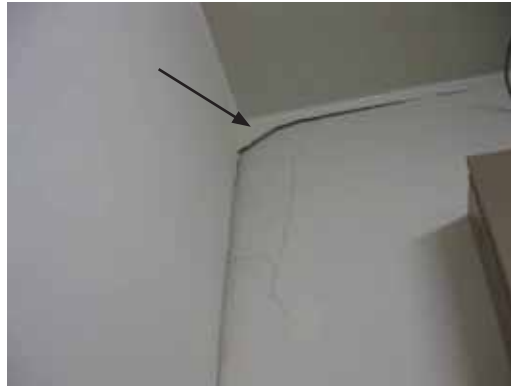
2.0 OVERALL BUILDING ASSESSMENT FINDINGS & RECOMMENDATIONS

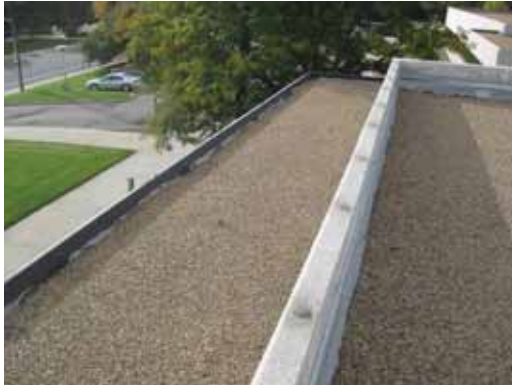
Inadequate parapet heights were observed at the roof level (Fig. 2.2.C.1). Parapets should be at least 42 inches tall or fall protection provided for access near the exposed edges to meet current safety codes.

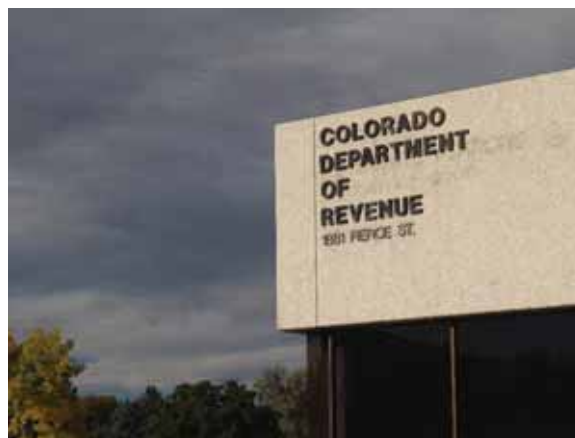
Figure 2.3.A.1 – Colorado Department of Revenue Building Exterior

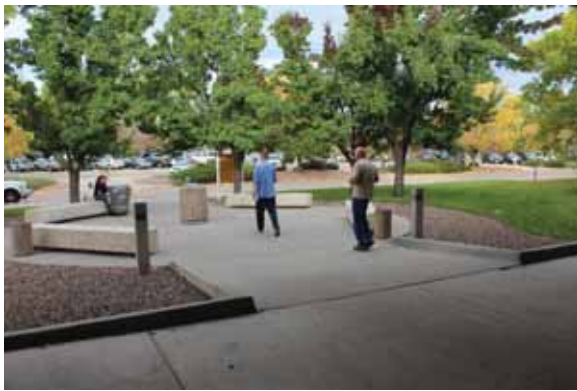
Figure 2.3.A.2 – West Entrance Concrete Walkway

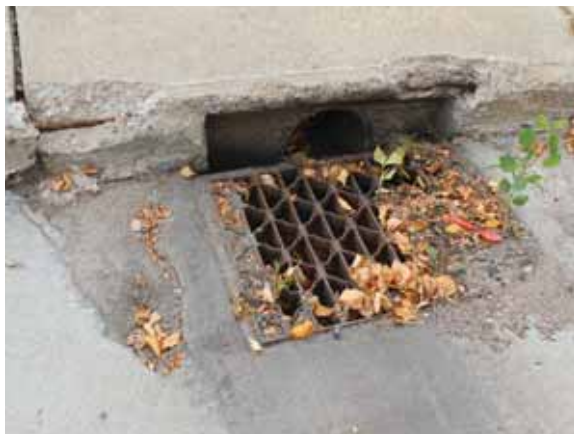
Figure 2.3.A.5 – Parking Lot Inlet

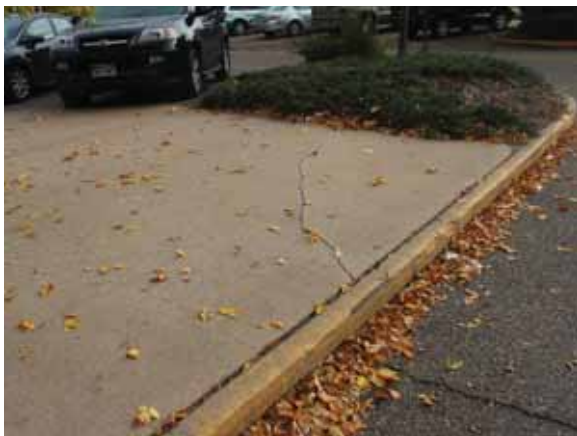
Figure 2.3.A.7 Site Concrete Crack, Recommended for Replacement

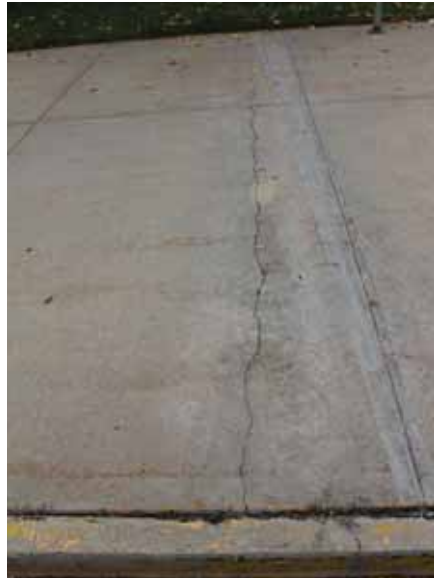
Figure 2.3.A.8 Site Concrete Crack,
Recommended for Replacement

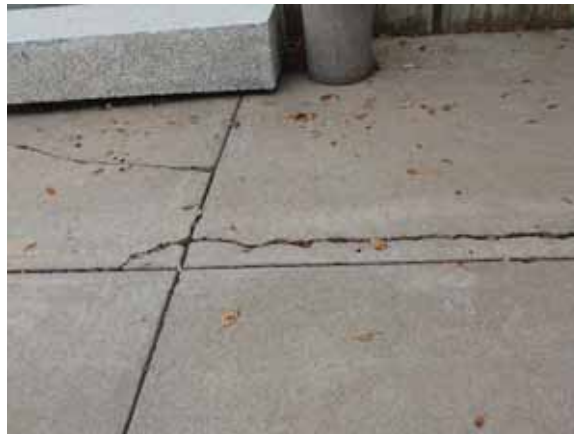
Figure 2.3.A.9 Site
Concrete Crack,
Recommended for
Replacement

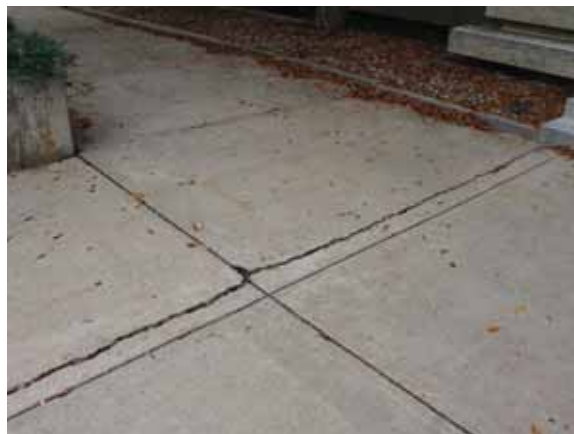
Figure 2.3.A.10 Site
Concrete Crack,
Recommended for
Replacement

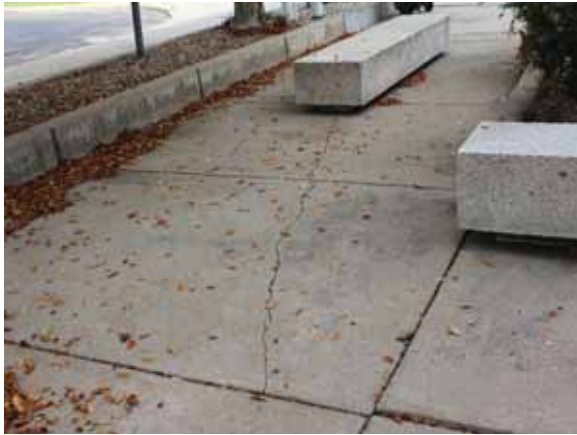
Figure 2.3.A.11 Site Concrete Crack, Recommended for Replacement

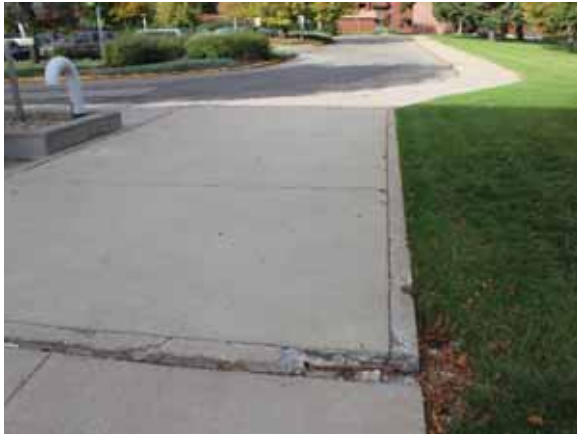
Figure 2.3.A.12 Broken Site Concrete, Recommended for Replacement

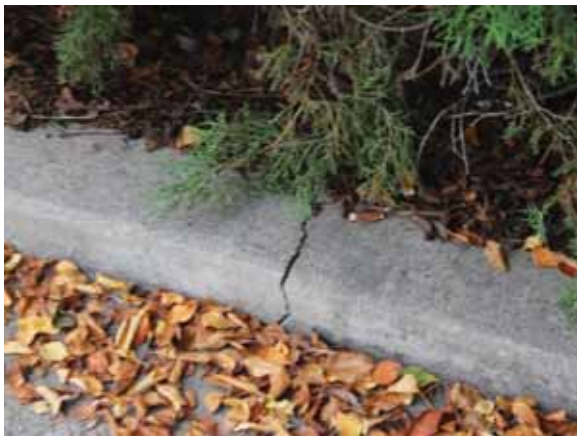
Figure 2.3.A.13 Broken Site Concrete, Recommended for Replacement

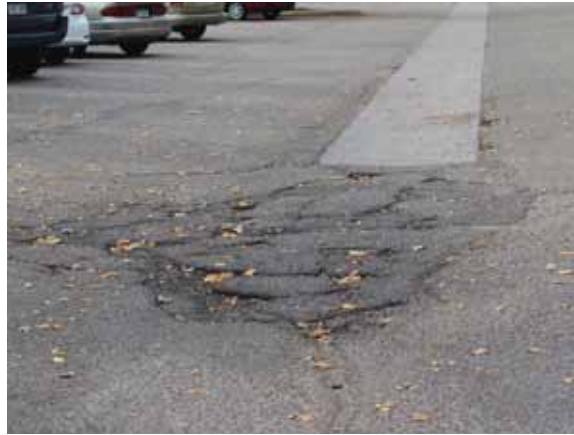
Figure 2.3.A.14 Poor Site Asphalt Condition

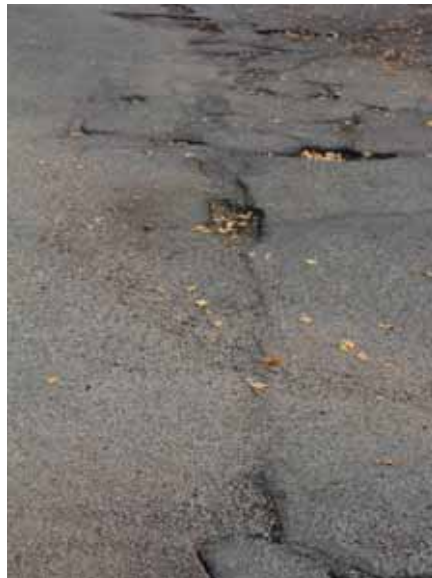
Figure 2.3.A.15 Poor Site Asphalt Condition

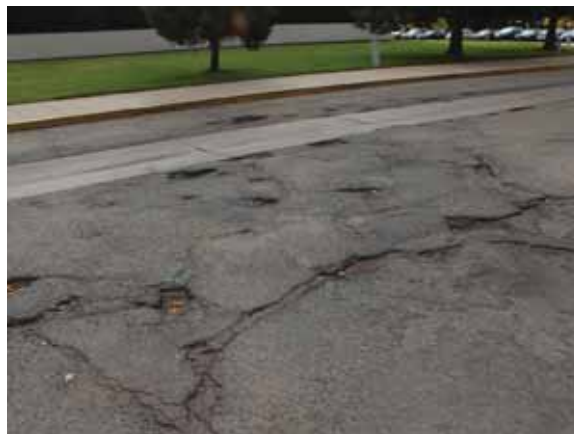
Figure 2.3.A.16 Poor Site Asphalt Condition

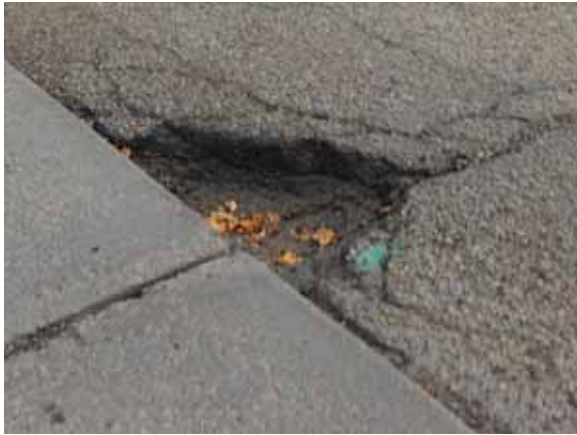
Figure 2.3.A.17 Poor Site Asphalt Condition

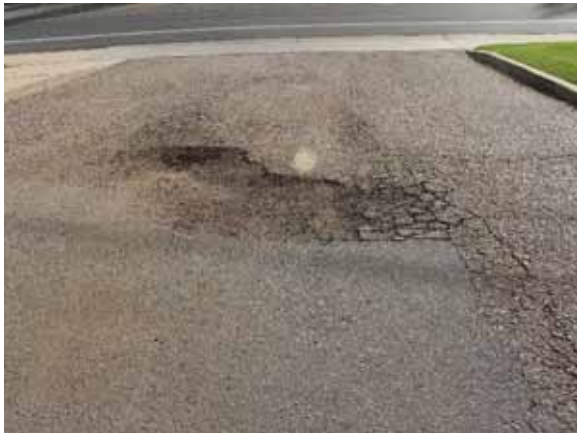
Figure 2.3.A.18 Poor Site Asphalt Condition

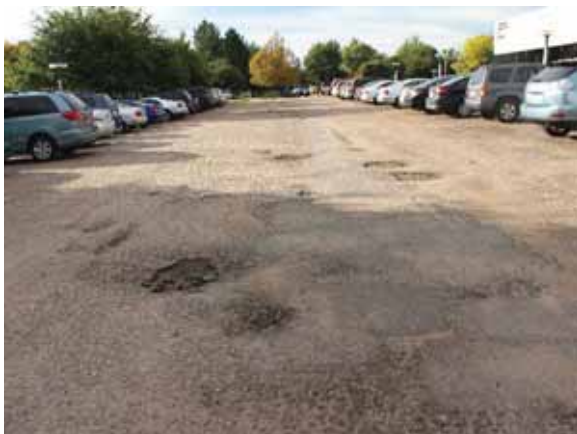
Figure 2.3.A.19 Poor Site Asphalt Condition

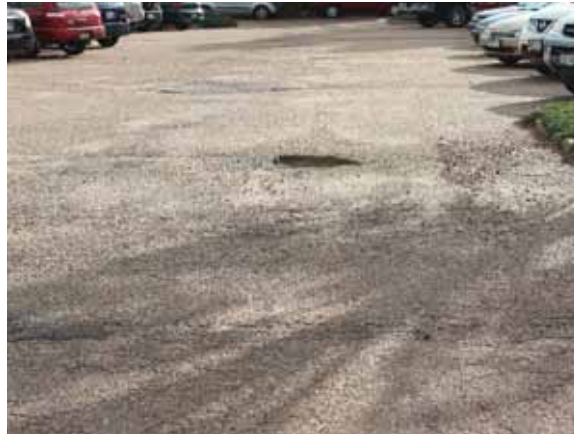
Figure 2.3.A.20 Poor Site Asphalt Condition

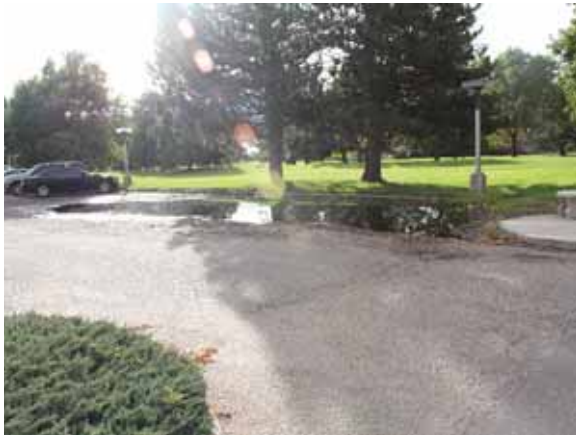
Figure 2.3.B.1 Ponding Water

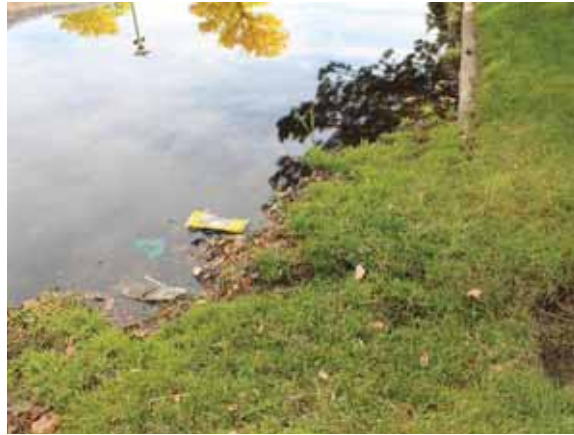
Figure 2.3.B.3 Curb Overtopping

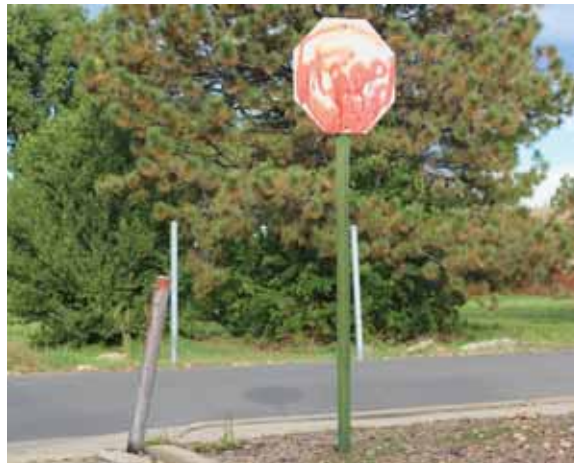
Figure 2.3.B.4 Site Signage

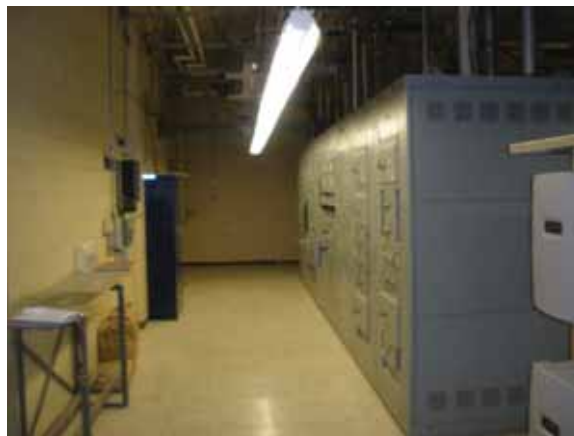
Fig. 2.4.A.1 – Main electrical gear

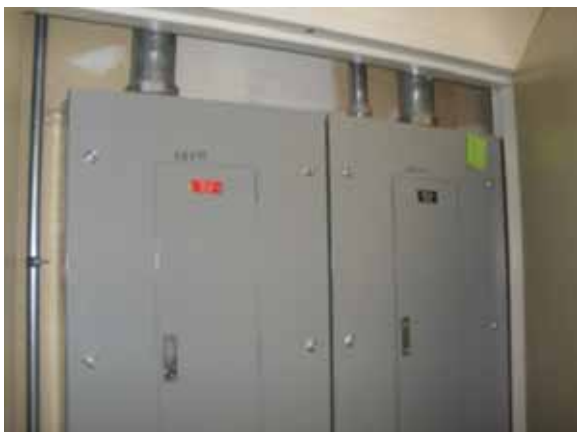
Fig. 2.4.A.4 – Panels in the electrical closets

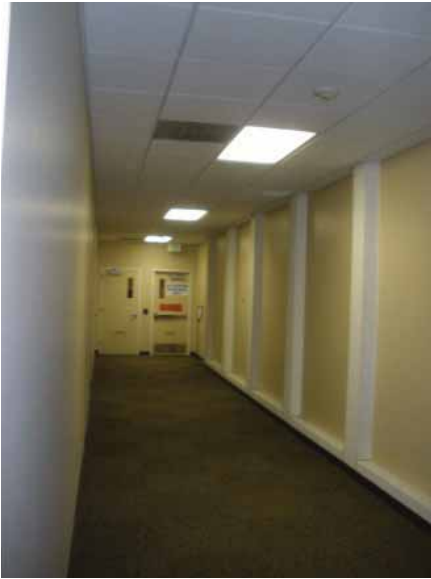
Fig. 2.4.A.5 – Hallway luminaires

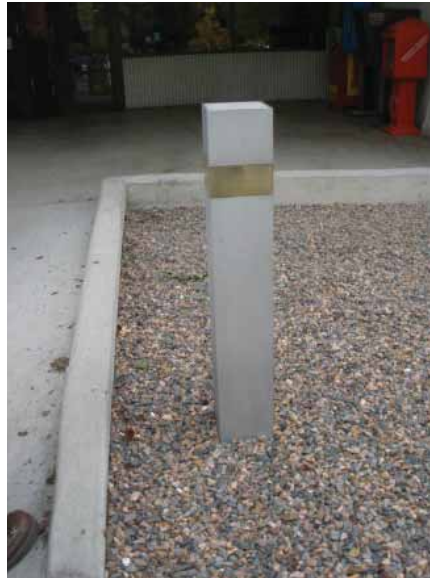
Fig. 2.4.A.8 – Bollard luminaires

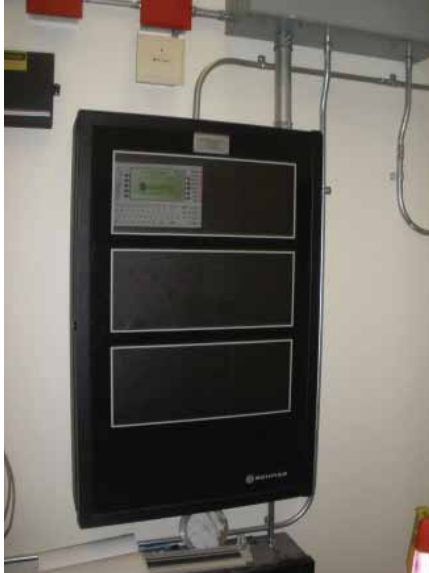
Fig. 2.4.A.11 – Fire alarm control panel

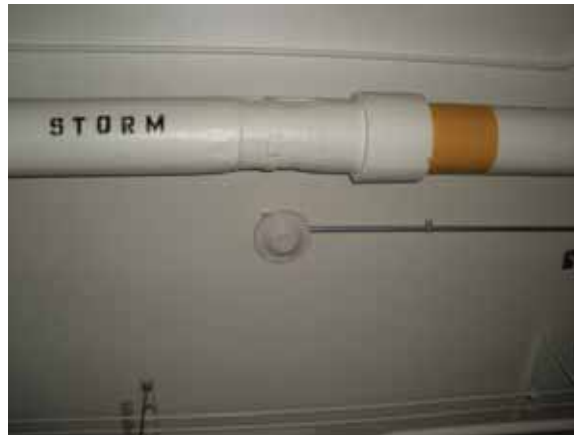
Fig. 2.4.A.12 – Smoke detector

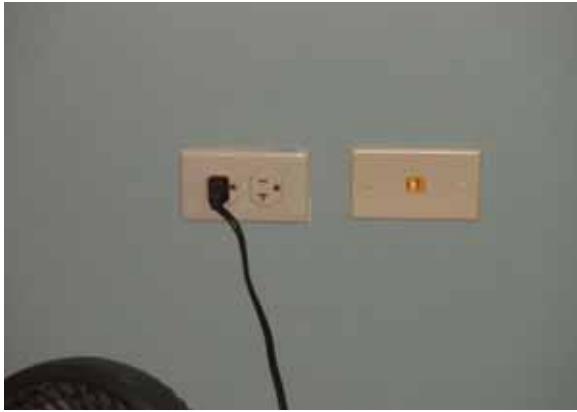
Fig. 2.4.A.14 – Updated receptacle

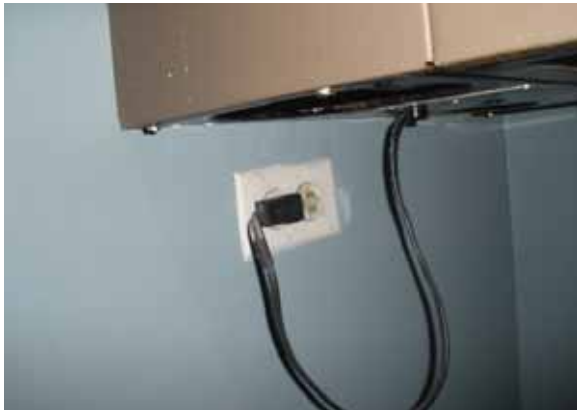
Fig. 2.4.A.16 – No GFI receptacle

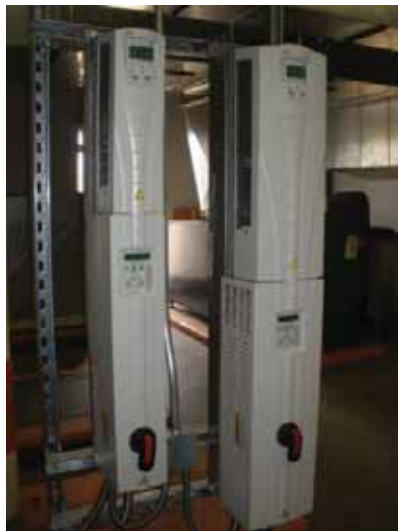
Fig. 2.4.A.17 – VFDs for motors

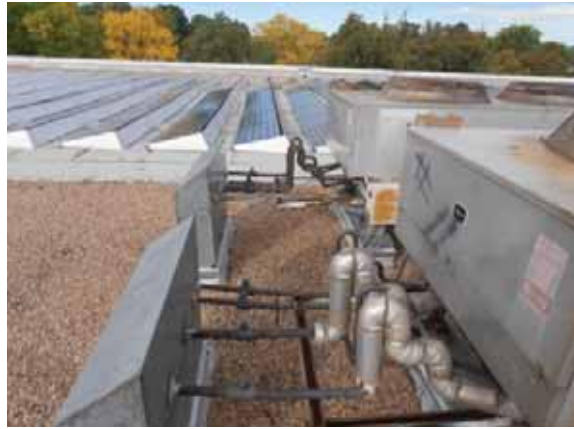
Fig. 2.4.A.18 – Missing insulation on refrigerant piping

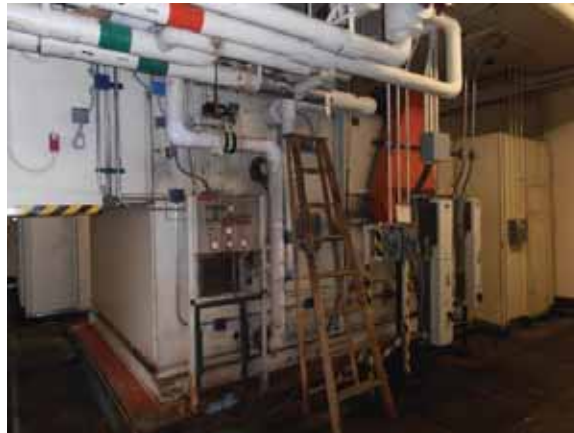
Fig. 2.4.A.19 – North building Trane units

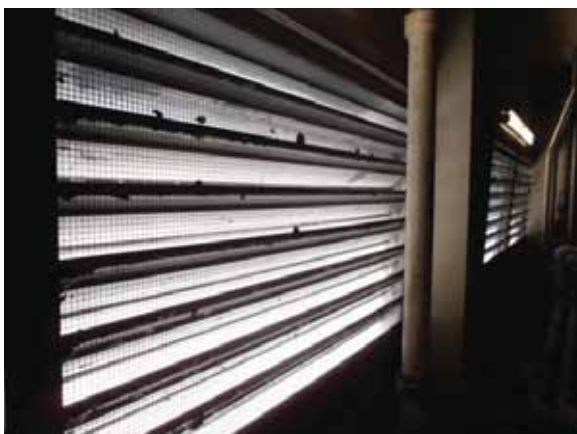
Fig. 2.4.A.23 – Outside air dampers for cooling tower

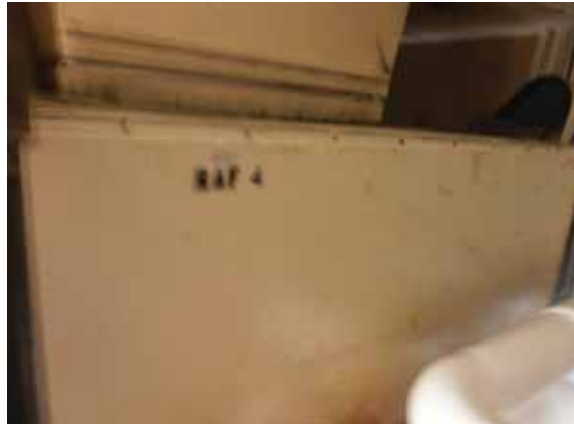
Fig. 2.4.A.24 – Basement AHU -Return Air Fan

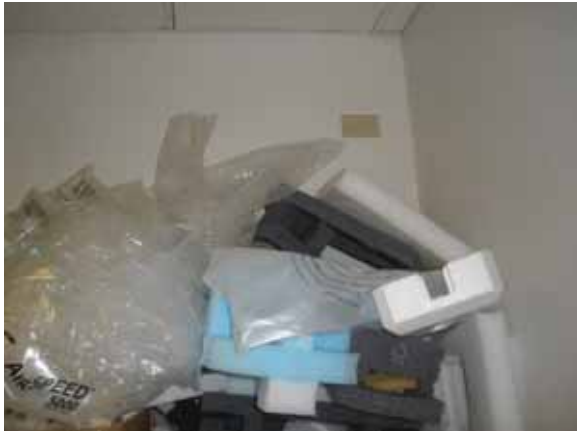
Fig. 2.4.A.27 – Material stored is a fire hazard

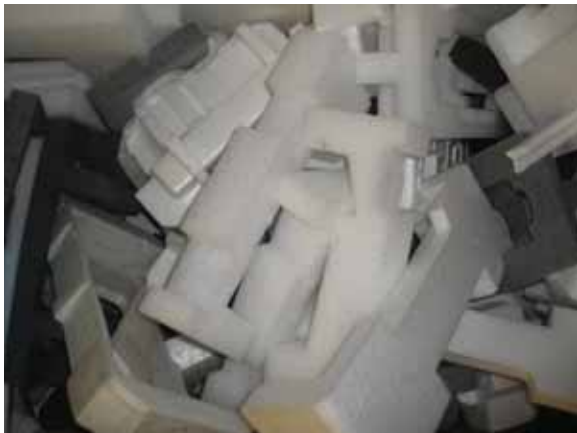
Fig. 2.4.A.28 – Packaging material

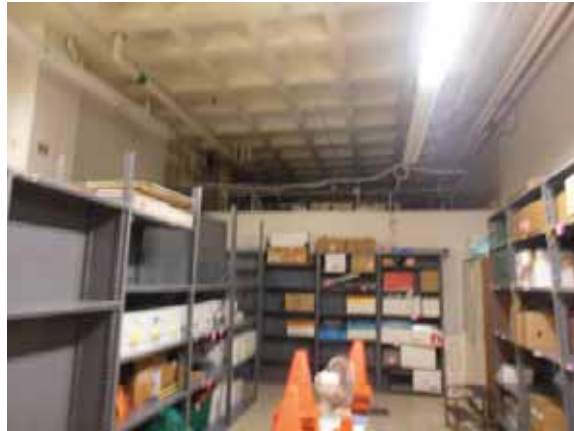
Fig. 2.4.A.30 – Material in storage area

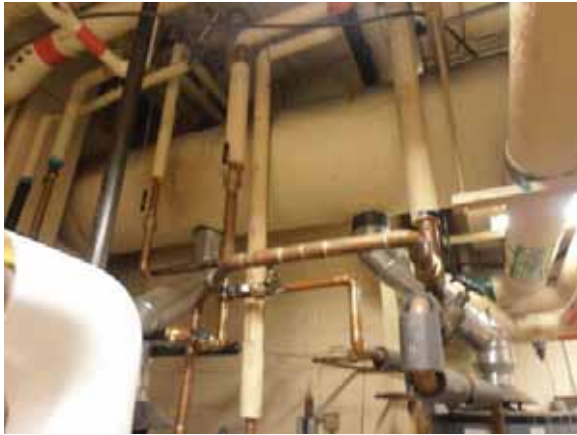
Fig. 2.4.A.33 – Missing insulation on hot water piping

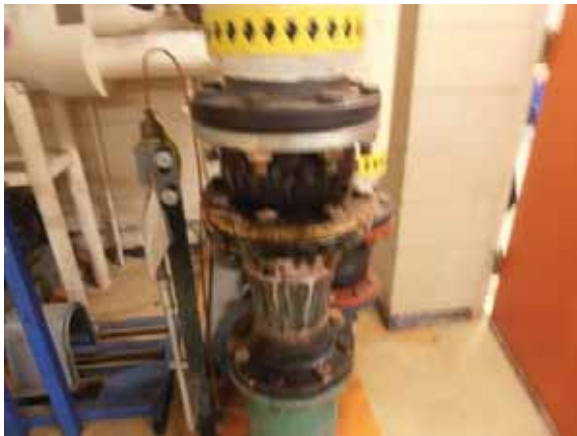
Fig. 2.4.A.34 – Pump flexible connection

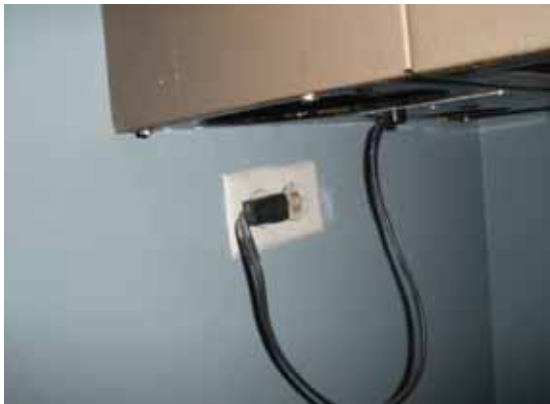
Fig. 2.4.B.1– GFI required

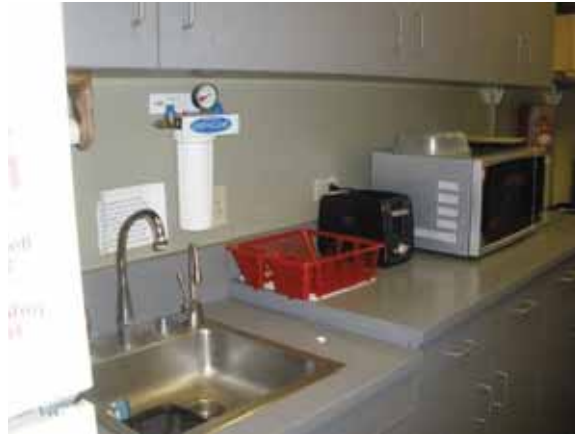
Fig. 2.4.B.2 – GFI required

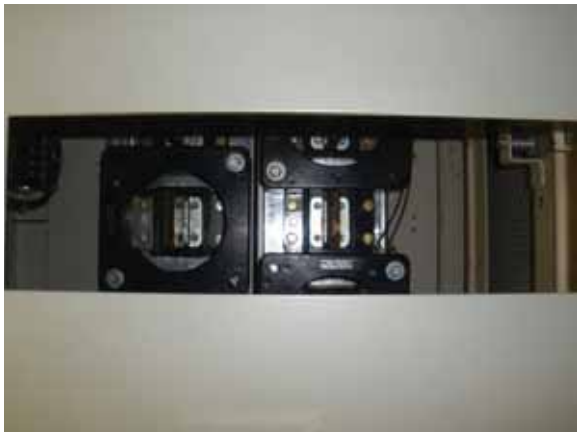
Fig. 2.4.B.6 – Open bus in main electrical gear

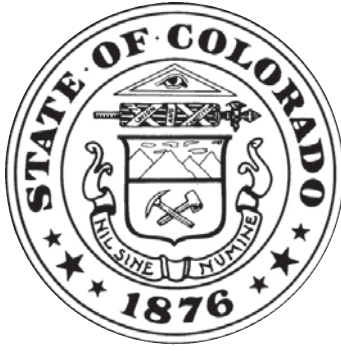
door hardware requirements for each controlled door location are to be coordinated with the State. The ACS shall also serve as the primary security management system for monitoring intrusion alarms. Intrusion alarms such as door status and motion detection alarms are to be integrated with and monitored through the access control security management system. Alarm device additions and modifications shall be coordinated with State during the design phase. Security personnel shall be able to monitor security system alarm notification devices through network connected client workstations, where authorized.

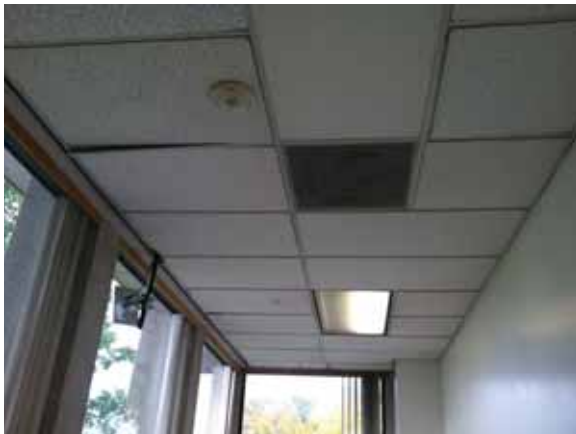
Fig. 3.0.C.1 General deterioration and poor condition of the acoustic ceilings throughout.

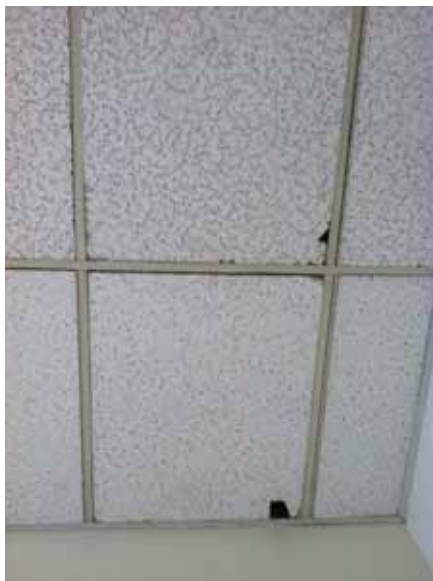
Fig. 3.0.C.2 Typical instance of deterioration of the acoustic ceiling tiles.

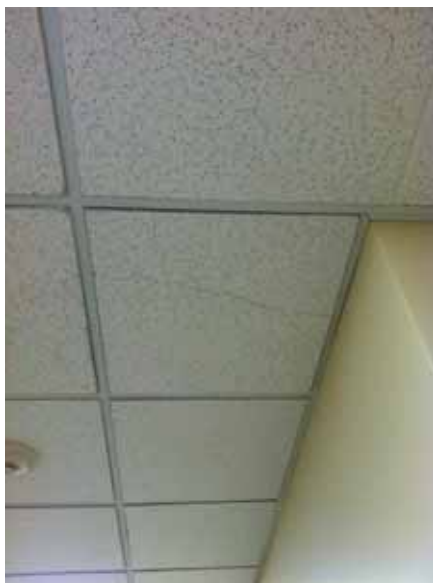
Fig. 3.0.C.3 Typical instance of damaged and cracked acoustic ceiling tiles.

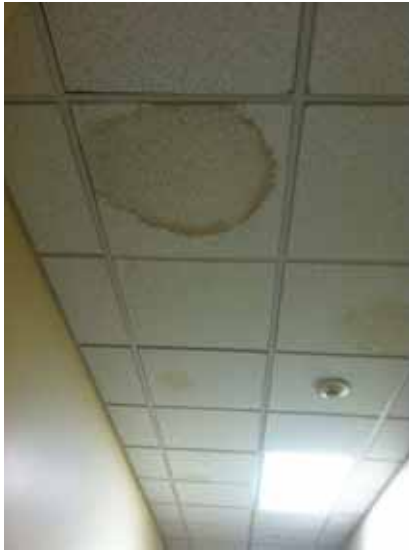
Fig. 3.0.C.4 Typical instance of soiled acoustic ceiling tiles.

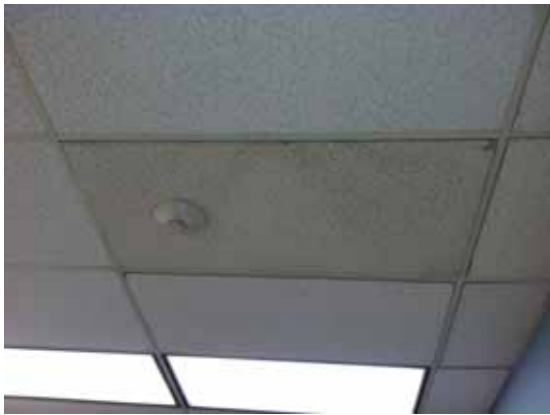
Fig. 3.0.C.5 Acoustic ceiling tiles do not appear to have been updated or replaced during the recent remodeling of Room 118 or in other remodeled spaces included in the site survey.

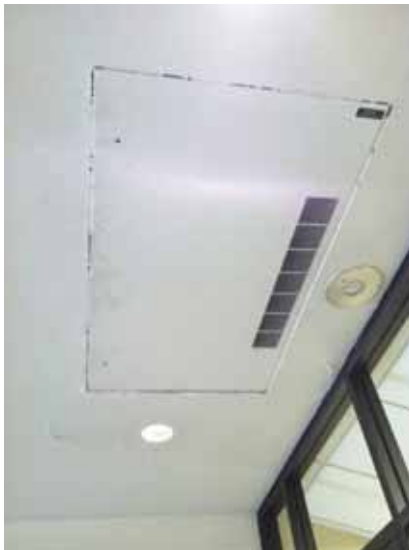
Fig. 3.0.C.6 Water damage at the gypsum board ceiling around the ceiling panel in the vestibule of Entrance B.

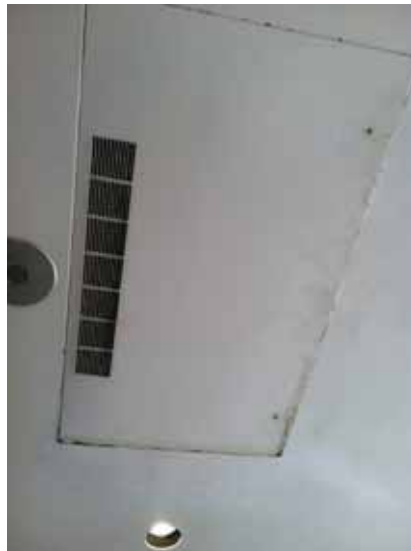
Fig. 3.0.C.7 Water damage at the gypsum board ceiling around the ceiling panel in the vestibule of the East Employee Entrance.

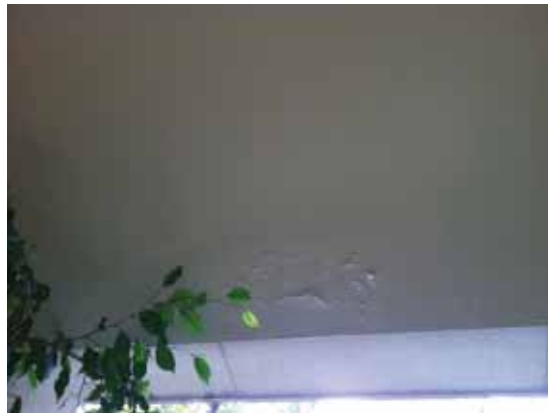
Fig. 3.0.C.8 Water damage at the gypsum board ceiling in the Women's First Floor Restroom on the west side of the north wing.

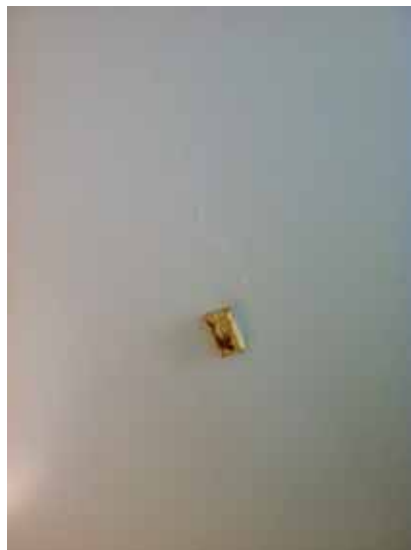
Fig. 3.0.C.9 Water damage at the gypsum board ceiling in the Women's First Floor Restroom on the west side of the north wing.

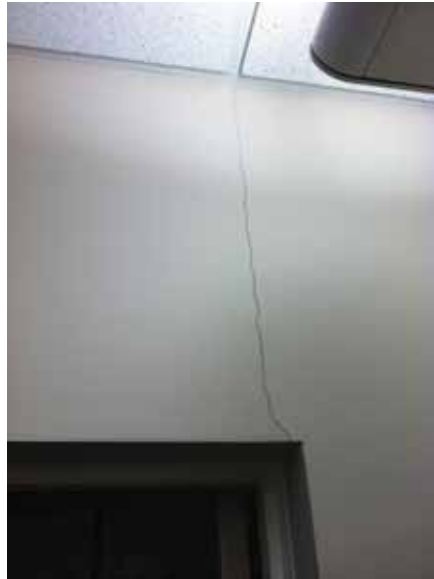
Fig. 3.0.C.10 Cracking in the gypsum board walls noted throughout the north wing.

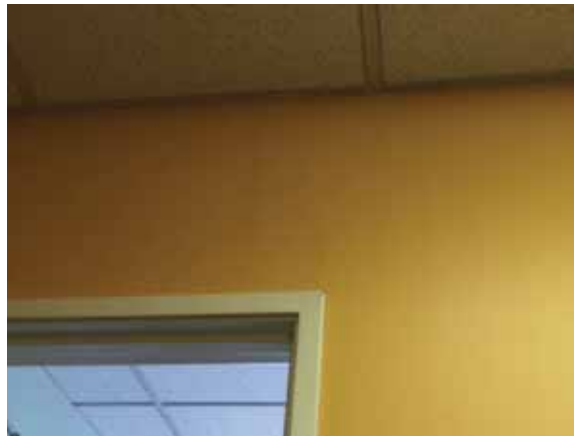
Fig. 3.0.C.11 Cracking in the gypsum board walls noted throughout the north wing.

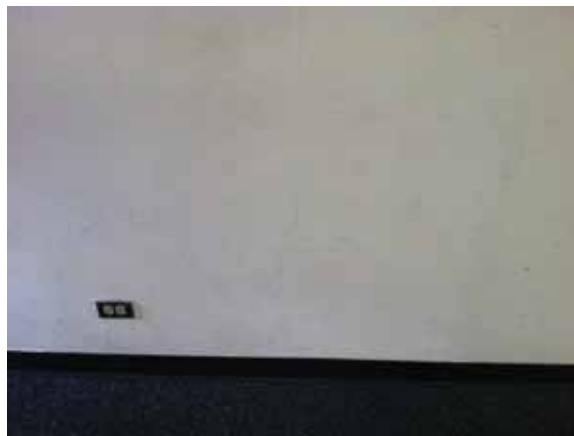
Fig. 3.0.C.12 General wear and tear noted at the gypsum board walls in the entry vestibules.

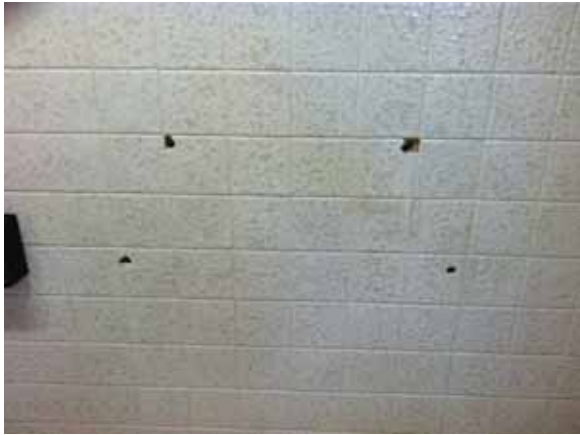
Fig. 3.0.C.13 Typical instance of discolored, soiled, and damaged four-inch square wall tile observed in the restrooms throughout the north wing.

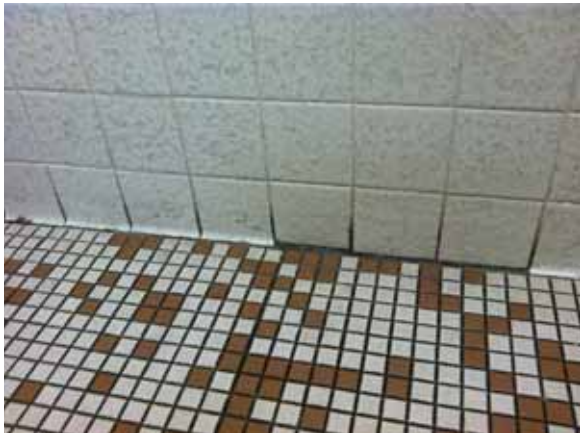
Fig. 3.0.C.14 Typical instance of soiled four-inch square wall tile observed in the restrooms.

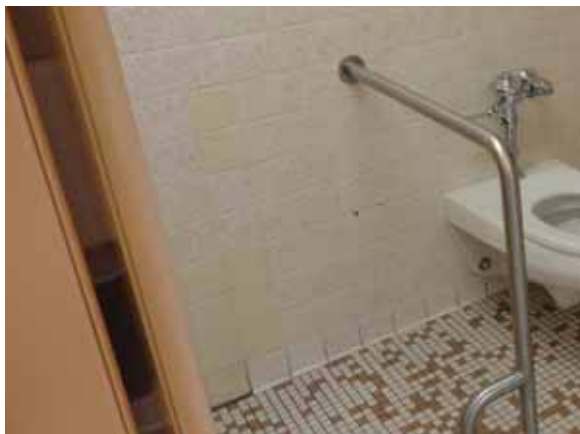
Fig. 3.0.C.15 Areas that were repaired with four-inch square wall tile that does not match the original wall tile.

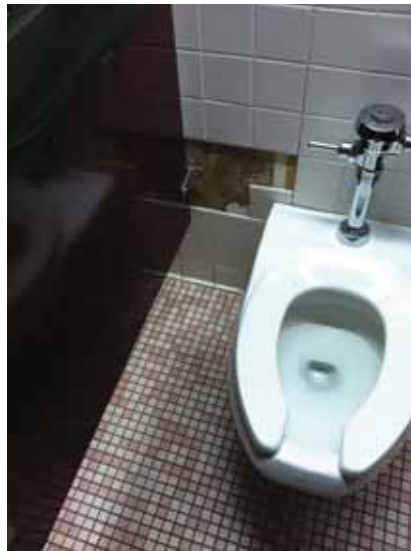
Fig. 3.0.C.16 Missing four-inch square wall tile from the Women's First Floor Restroom on the west side of the south wing.

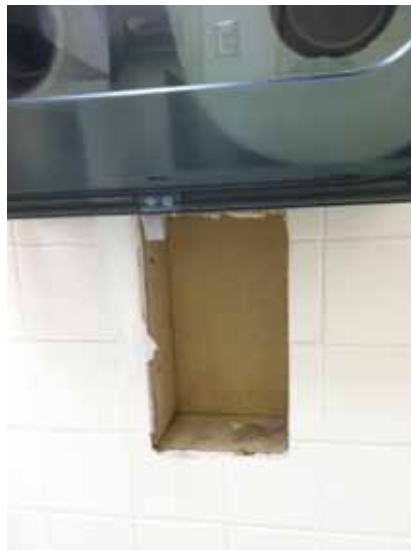
Fig. 3.0.C.17 Unrepaired hole from a former toilet paper dispenser in the Men's and Women's Restrooms at the northeast corner of the south wing.

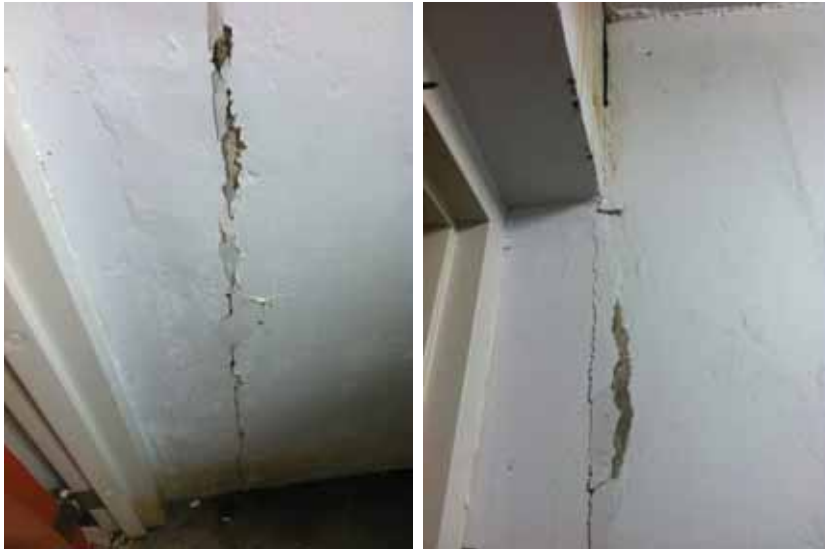
Fig. 3.0.C.19 Large crack in the concrete wall noted in the southwest portion of the basement.

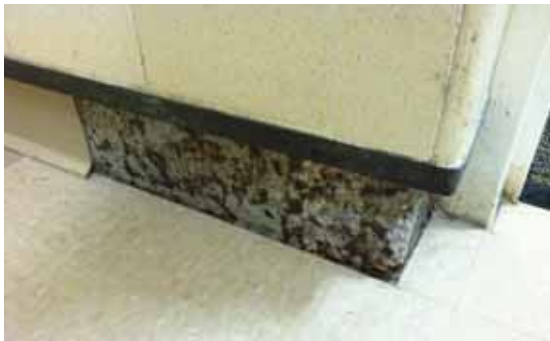
Fig. 3.0.C.20 Vinyl baseboard missing from a wall in the east stairway.

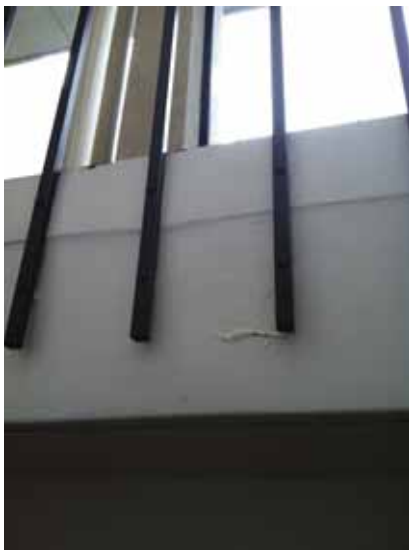
Fig. 3.0.C.21 Water damage noted at the gypsum board in the west stairway.

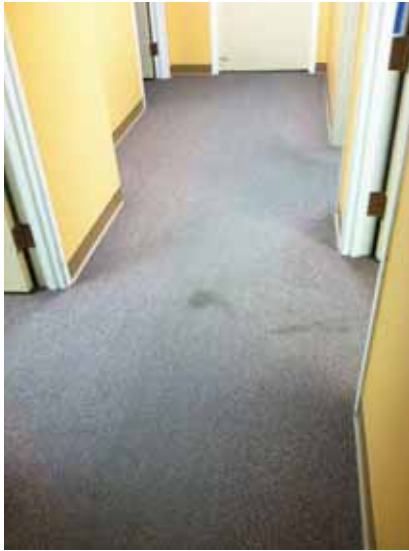
Fig. 3.0.C.22 Typical instance of worn and soiled carpet noted on the First Floor of the north wing.

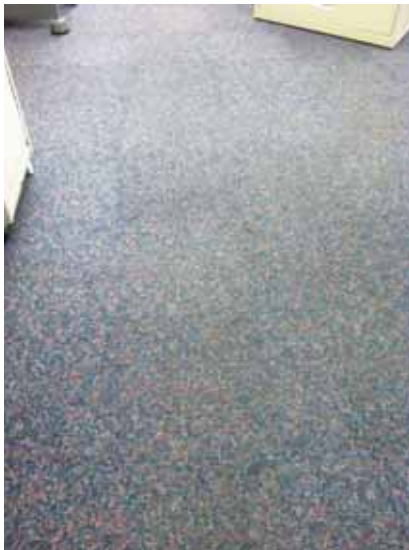
Fig. 3.0.C.23 Typical instance of worn and soiled carpet noted on the First Floor of the south wing.

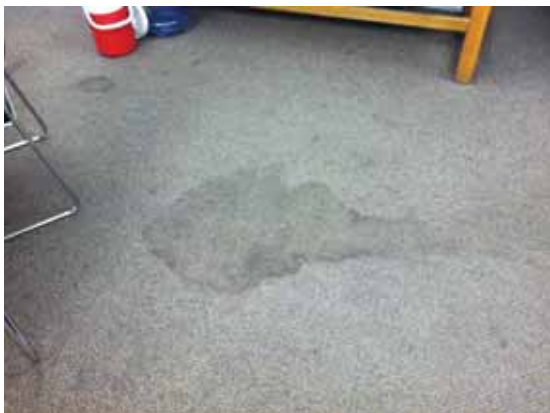
Fig. 3.0.C.24 Typical instance of worn and soiled carpet noted on the Basement Floor of the north wing.

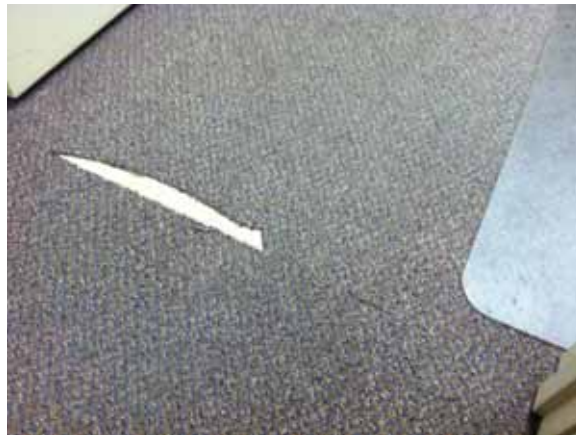
Fig. 3.0.C.25 Instance of worn and deteriorating carpet noted during the site survey visit.

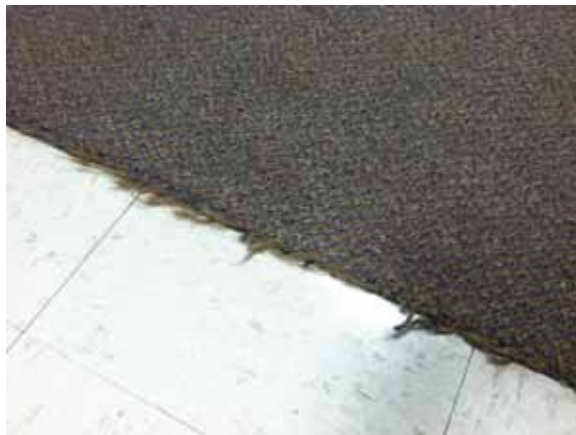
Fig. 3.0.C.26 Instance of worn and deteriorating carpet noted during the site survey visit.

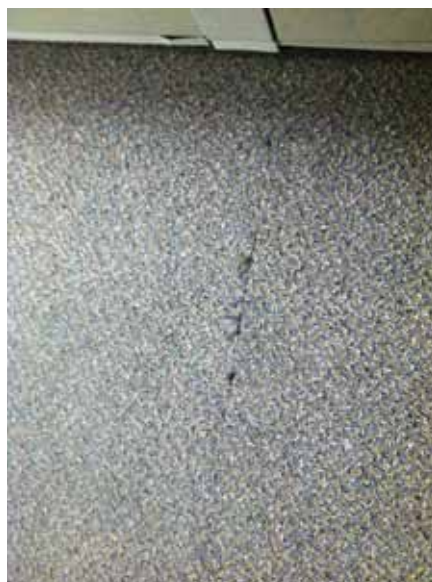
Fig. 3.0.C.27 Typical instance of carpet pulling loose along a seam and creating a potential tripping hazard.

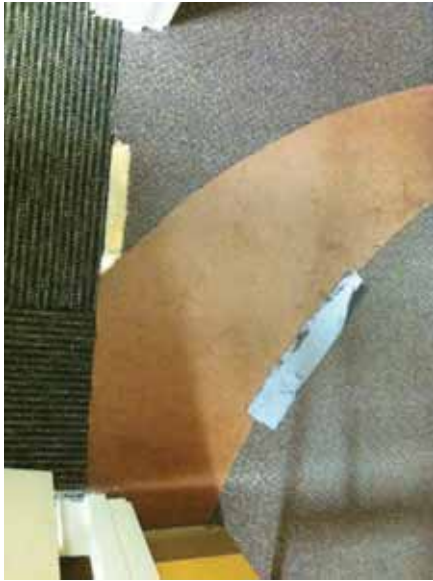
Fig. 3.0.C.28 Typical instance of tape placed over damaged portions of the original carpet in the north wing known to have asbestos in the mastic. This is also creating a potential tripping hazard.

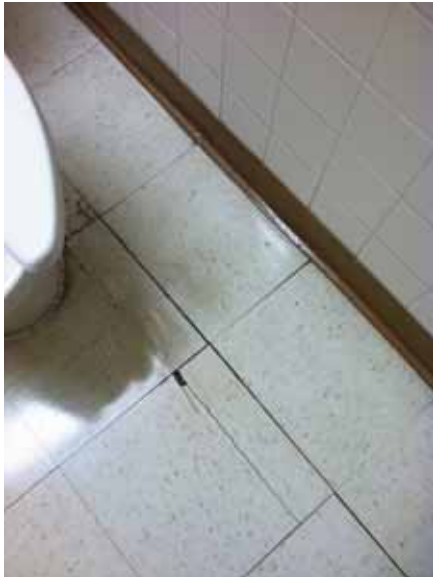
Fig. 3.0.C.29 Damaged linoleum flooring noted in the Women's First Floor Restroom at the northeast corner of the south wing.

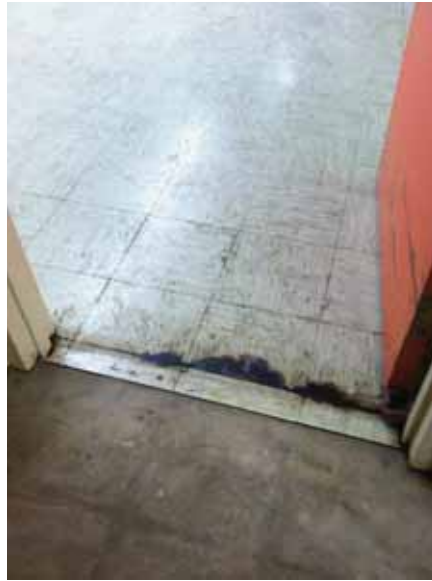
Fig. 3.0.C.30 Damaged and soiled linoleum flooring noted on the Basement Floor.

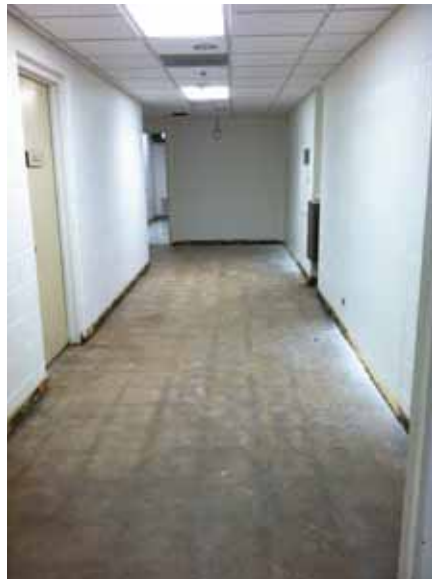
Fig. 3.0.C.31 Flooring mastic with asbestos throughout the basement corridors was abated as of the date of the site survey visit.

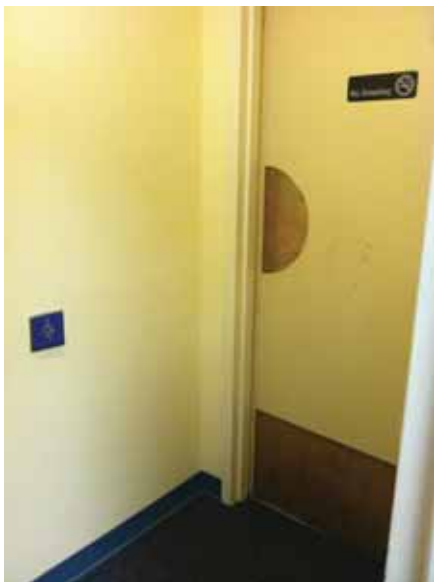
Fig. 3.0.C.33 Typical instance of minor wear and tear noted at a few of the doors throughout the building.

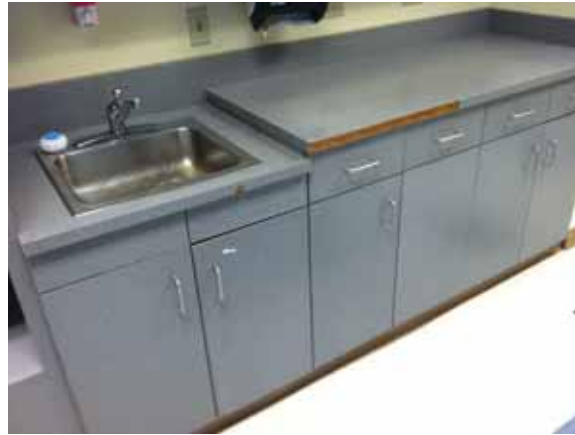
Fig. 3.0.C.34 Damage and wear and tear noted to this particular style of cabinets in the break rooms throughout the building.
