CAPITOL COMPLEX MASTER PLAN
FINDINGS & RECOMMENDATIONS (F & R) NEEDS ASSESSMENT
STATE OFFICE BUILDING, 201 EAST COLFAX AVENUE (DENVER)

NOVEMBER 2014

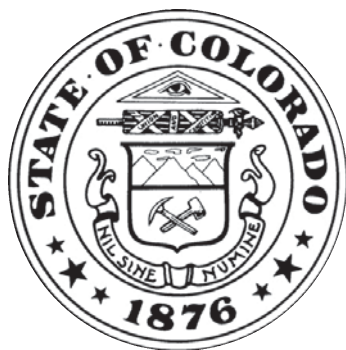
1.0-F SECURITY SYSTEMS OVERVIEW

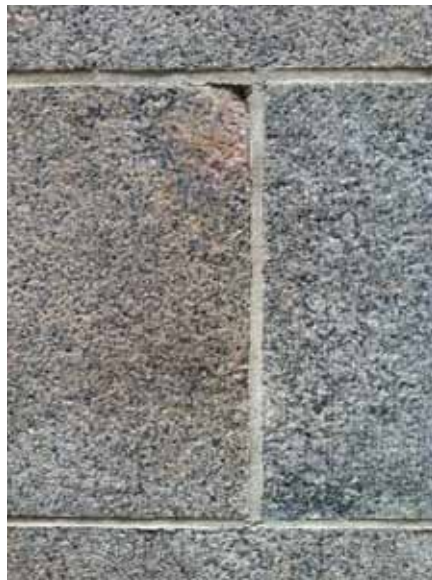
Fig. 2.1.A.1 Spalling of the granite.

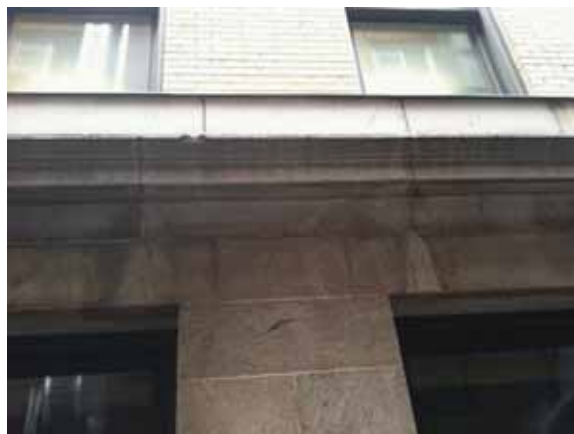
Fig. 2.1.A.2 Spalling of the granite along an exterior ledge.

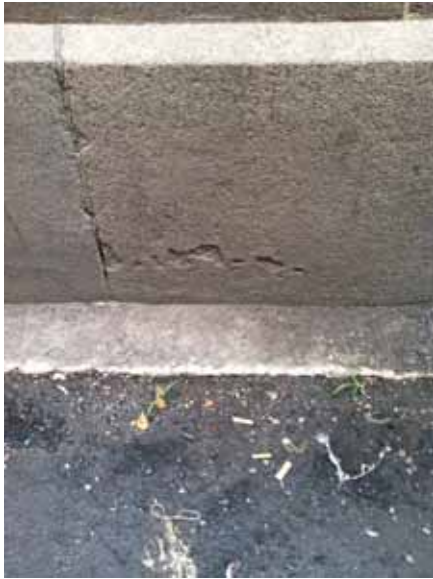
Fig. 2.1.A.3 Spalling of the granite at the base of the building.

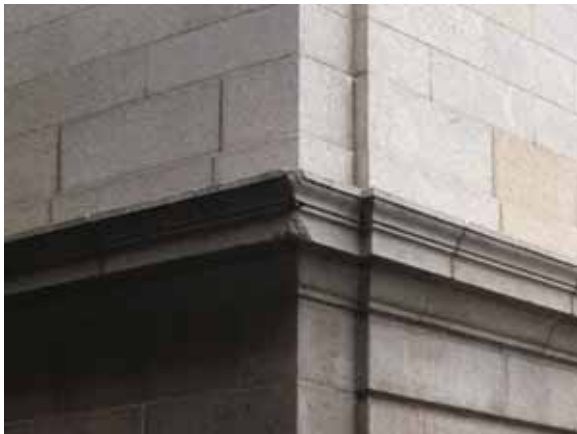
Fig. 2.1.A.4 Spalling of the granite at a corner ledge.

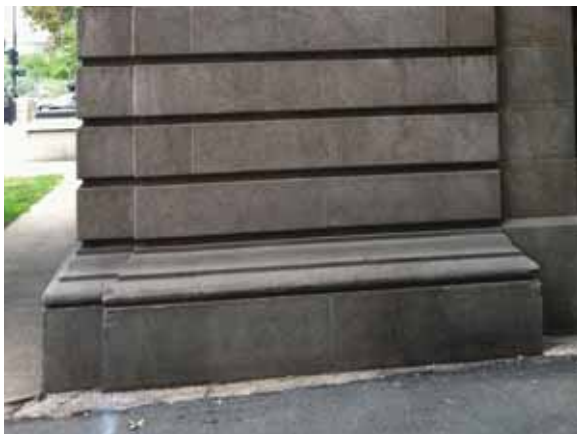
Fig. 2.1.A.5 Spalling of the granite along the base of the building.

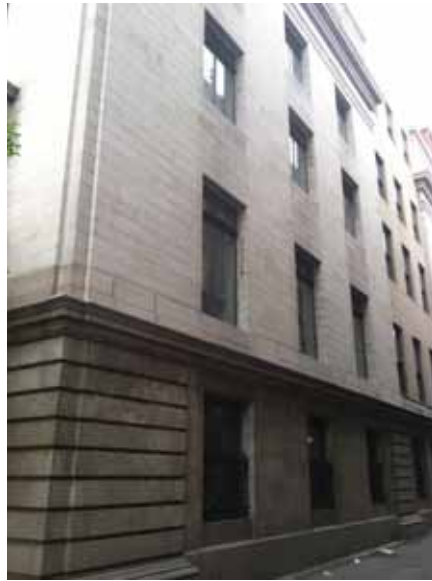
Fig. 2.1.A.6 Typical soiled granite blocks cladding the building.

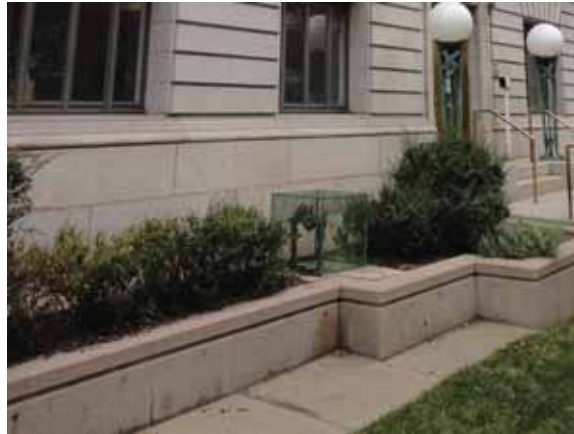
Fig. 2.1.A.11 Cracked and soiled granite along the low landscaping retaining wall.

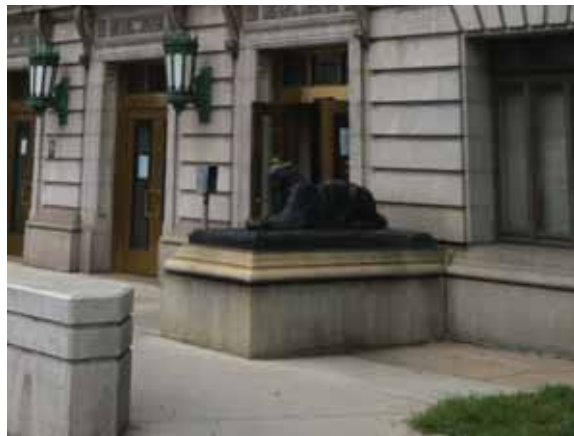
Fig. 2.1.A.12 Soiled low granite pedestals under the bronze mountain lion sculptures.

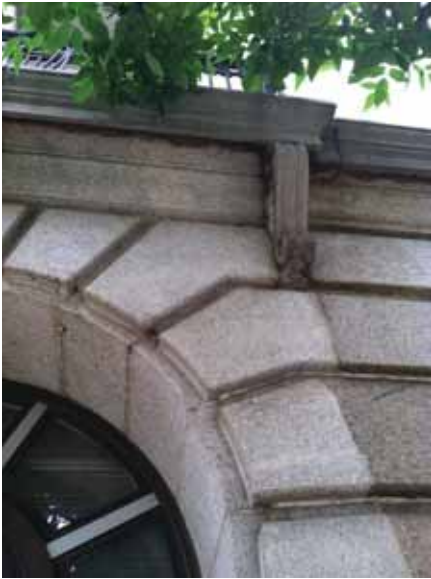
Fig. 2.1.A.13 Deteriorated grout between granite blocks.

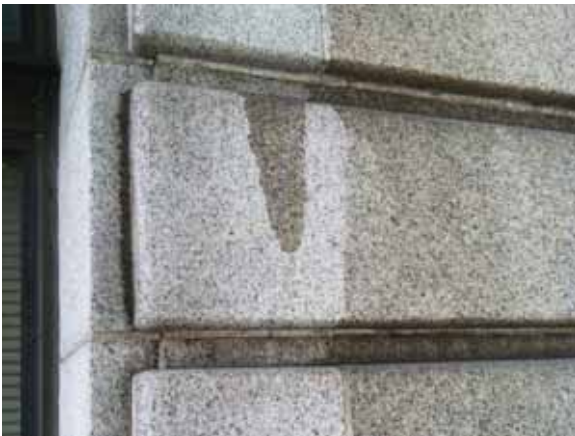
Fig. 2.1.A.14 Deteriorated grout between granite blocks.

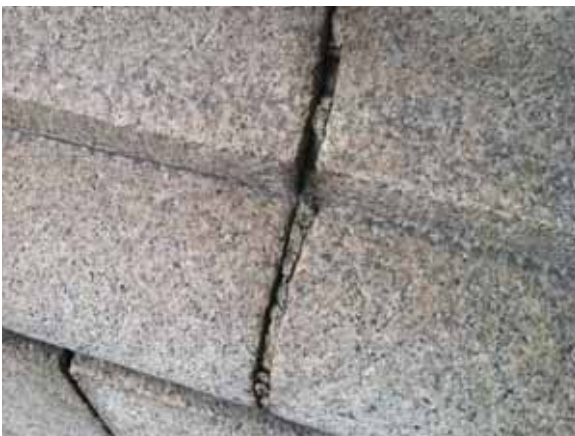
Fig. 2.1.A.15 Deteriorated grout between granite blocks.

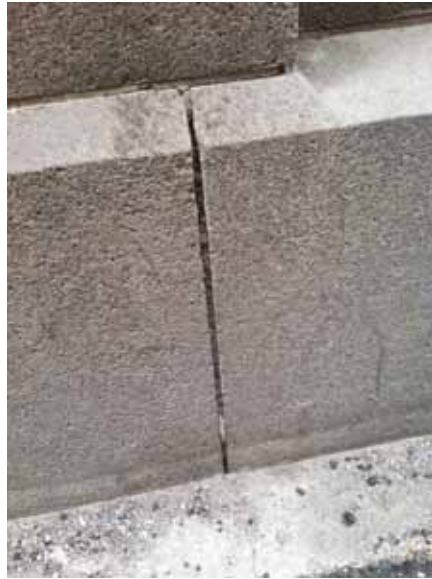
Fig. 2.1.A.16 Deteriorated grout between granite blocks.

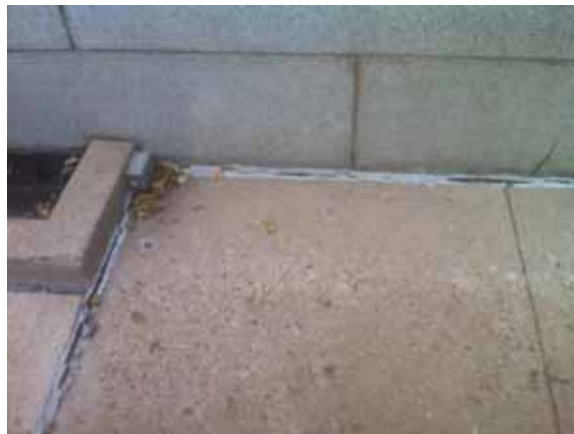
Fig. 2.1.A.17 Deteriorated sealant along the base of the building.

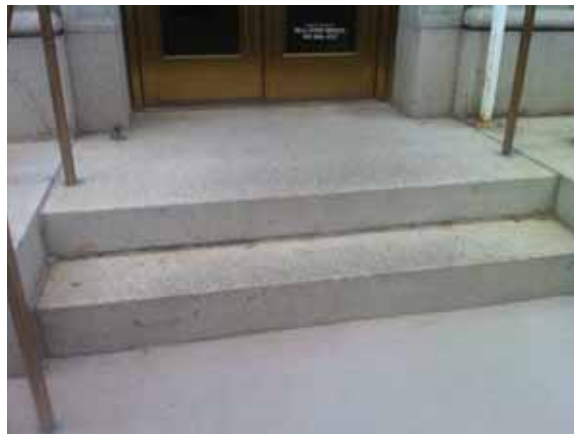
Fig. 2.1.A.18 Deteriorated sealant at the exterior granite stairway.

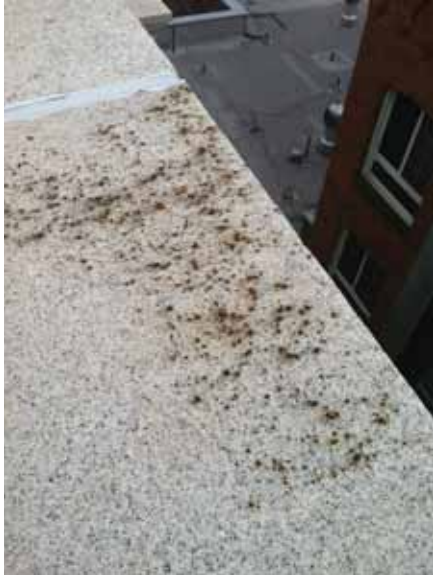
Fig. 2.1.A.19 Pitting of the granite stone blocks along the top edge of the parapet.

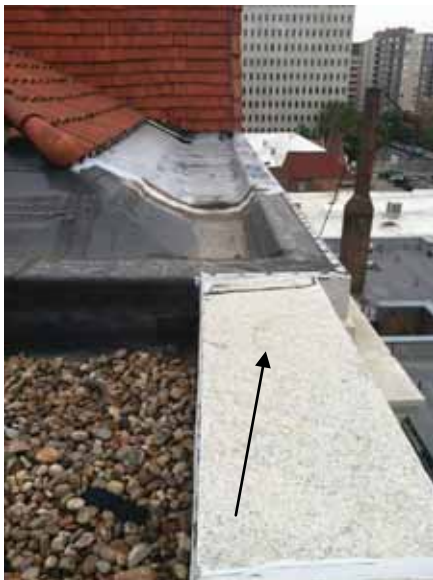
Fig. 2.1.A.20 Evidence of water pooling on the granite stone blocks along the top edge of the parapet.

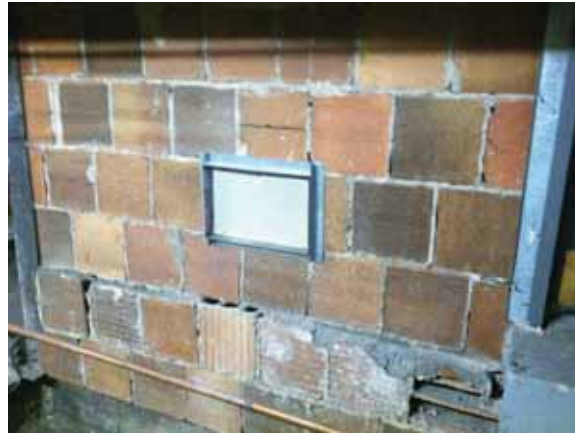
Fig. 2.1.A.21 Deteriorating masonry wall observed from the inside of the attic space.

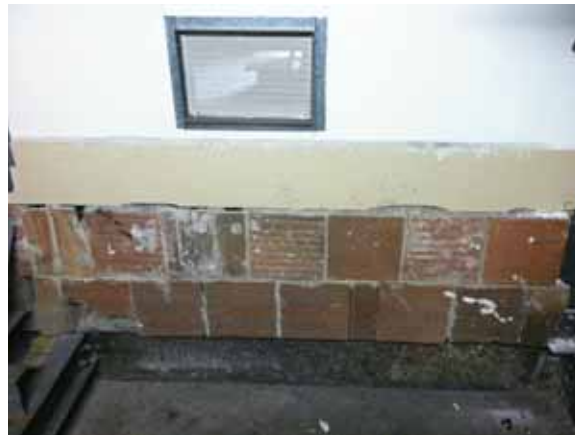
Fig. 2.1.A.22 Deteriorating masonry wall observed from the inside of the attic space.

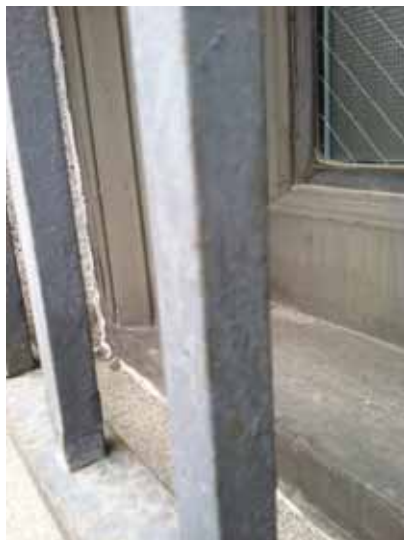
Fig. 2.1.A.23 Corroding metal window frame.

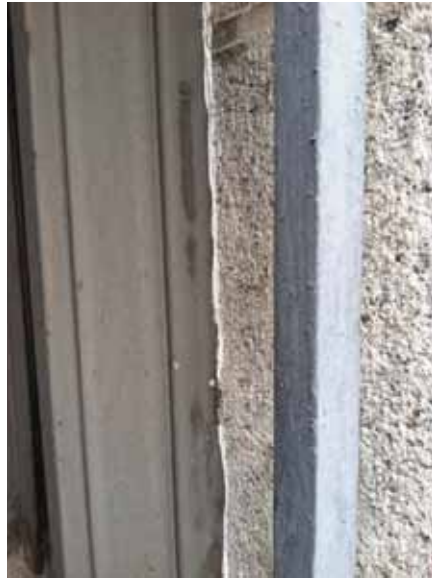
Fig. 2.1.A.24 Corroding metal window frame.

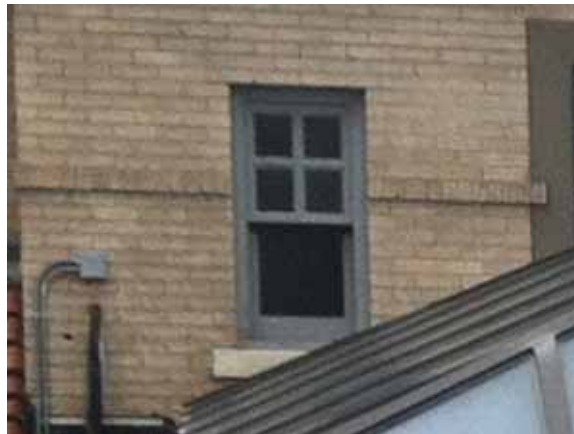
Fig. 2.1.A.25 Corroding metal window frame at the Penthouse.

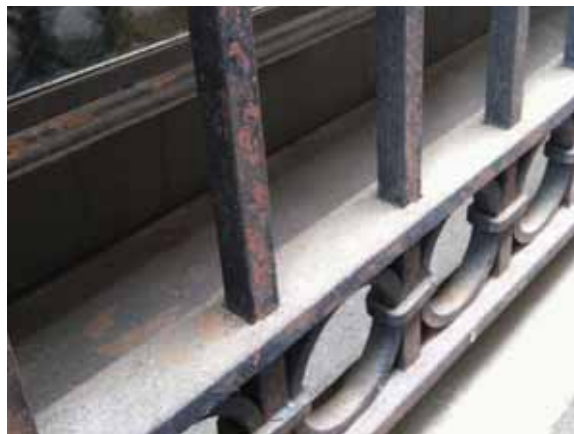
Fig. 2.1.A.26 Corroding window grilles outside of the First Floor windows.

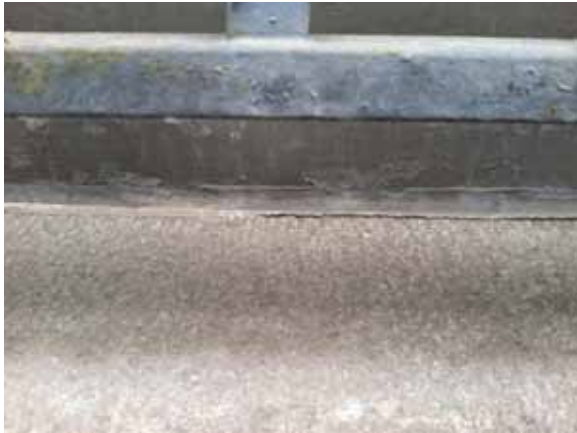
Fig. 2.1.A.27 Deteriorating sealant surrounding window frames.

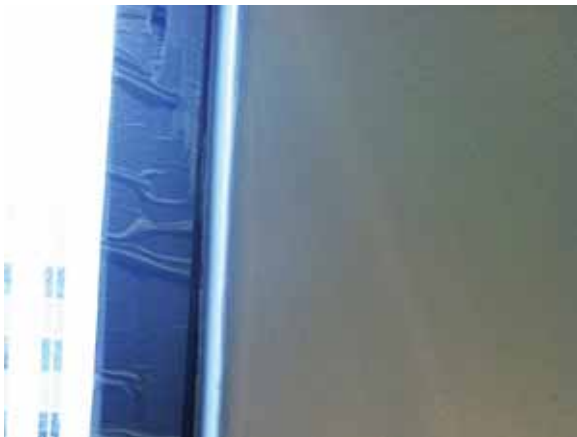
Fig. 2.1.A.28 Duct tape placed around the interior-side of the windows to prevent air leakage.

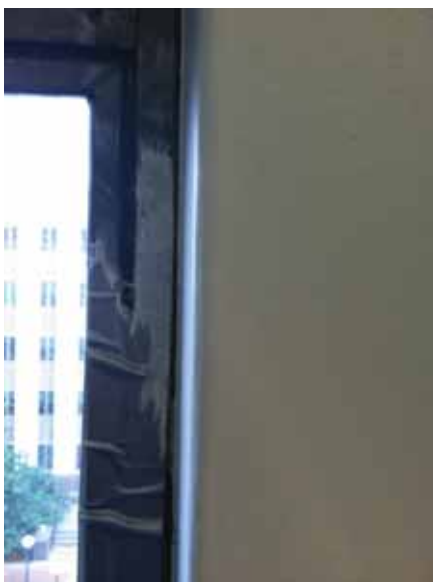
Fig. 2.1.A.29 Duct tape placed around the interior-side of the windows to prevent air leakage.

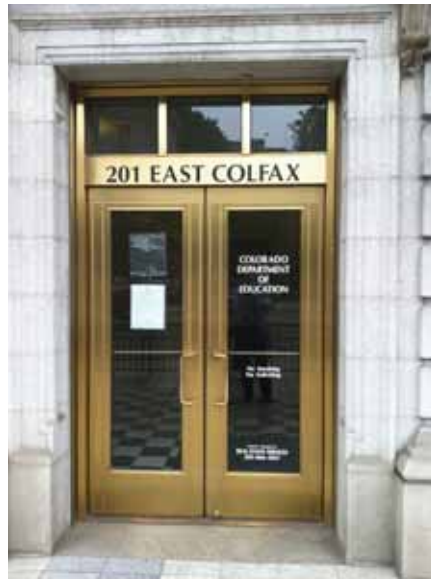
Fig. 2.1.A.30 Bronze double doors typical to the East Colfax Avenue Entrance and the Sherman Street Entrance.

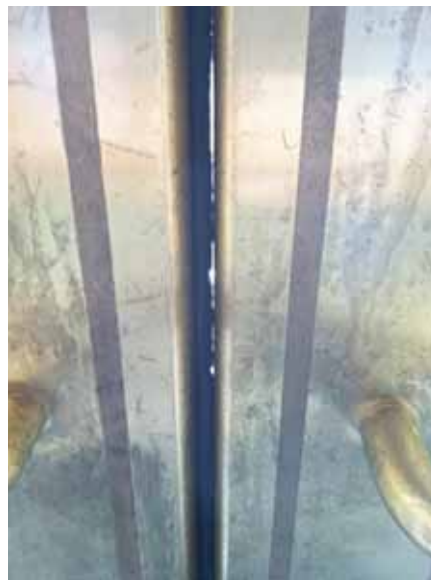
Fig. 2.1.A.31 Gaps at the exterior doors allowing air leakage.

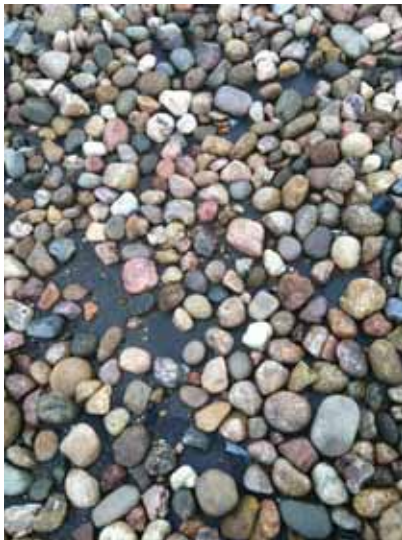
Fig. 2.1.A.32 Typical area of thin ballast and accumulation of dirt.

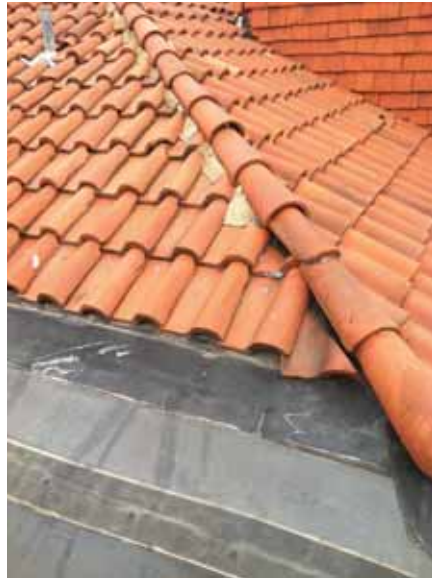
Fig. 2.1.A.33 Area where the membrane is beginning to tear.

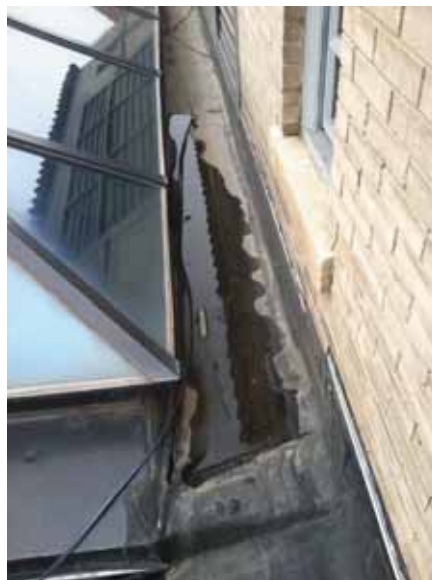
Fig. 2.1.A.34 Issues with ponding on the roof.

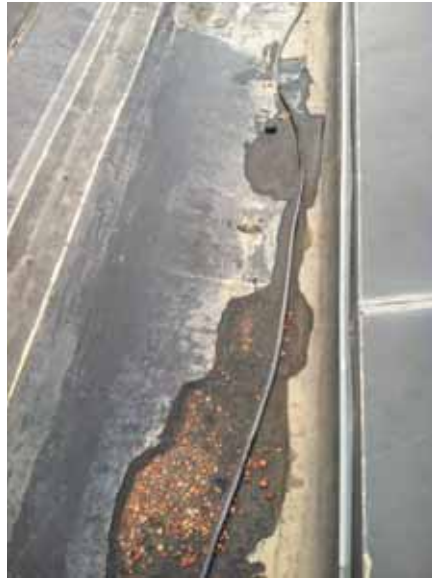
Fig. 2.1.A.38 Sharp debris collecting on the roof membrane.

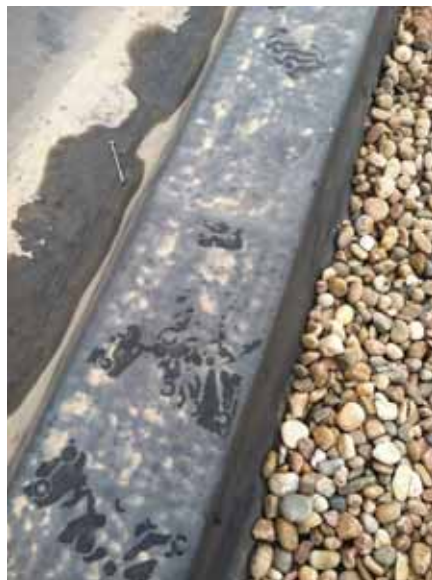
Fig. 2.1.A.40 Sharp debris collecting on the roof membrane. All loose nails should be discarded.

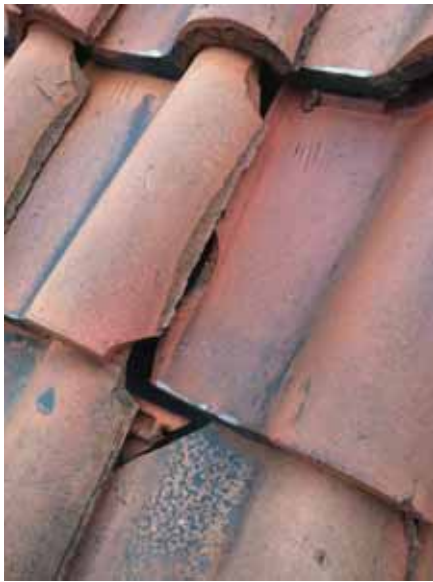
Fig. 2.1.A.41 Cracked terra cotta tiles.

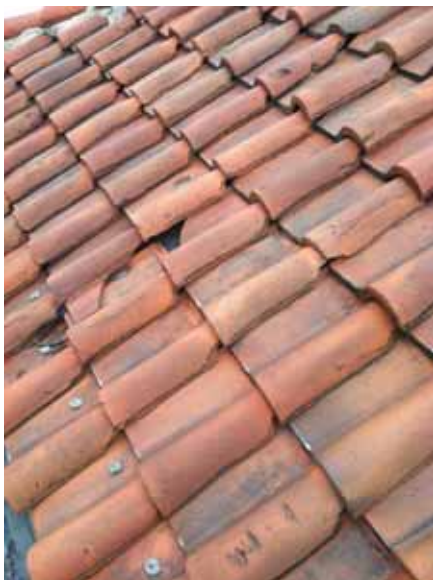
Fig. 2.1.A.42 Cracked terra cotta tiles.

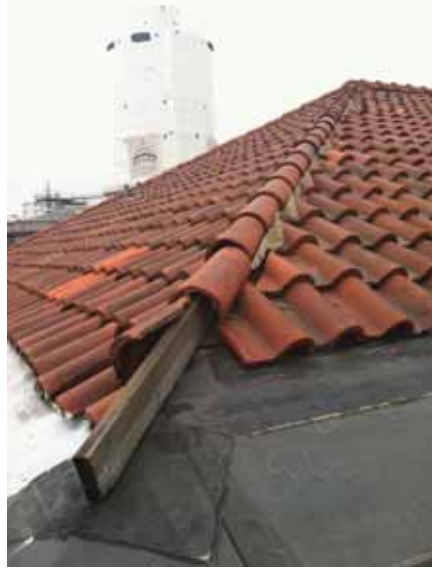
Fig. 2.1.A.43 Missing terra cotta tiles.

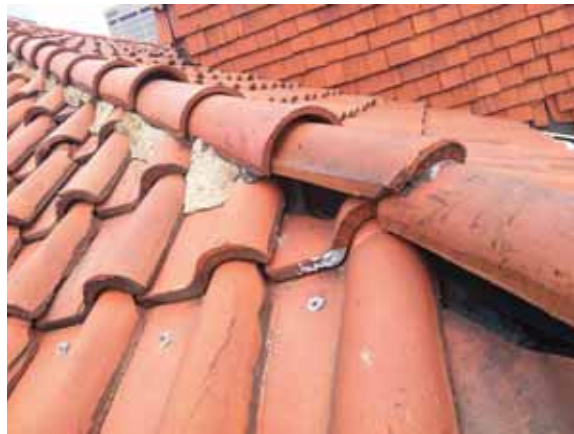
Fig. 2.1.A.44 Missing grout at openings between terra cotta tiles.

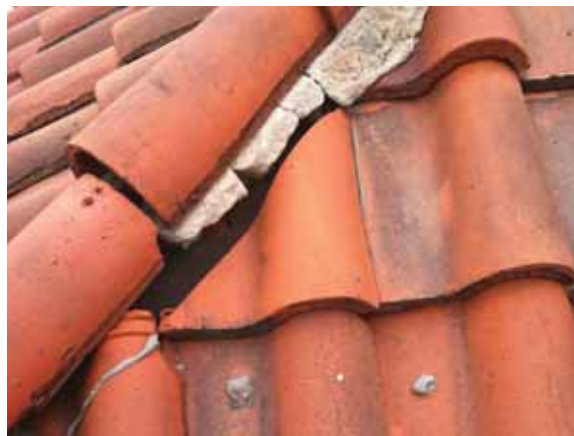
Fig. 2.1.A.45 Missing grout at openings between terra cotta tiles.

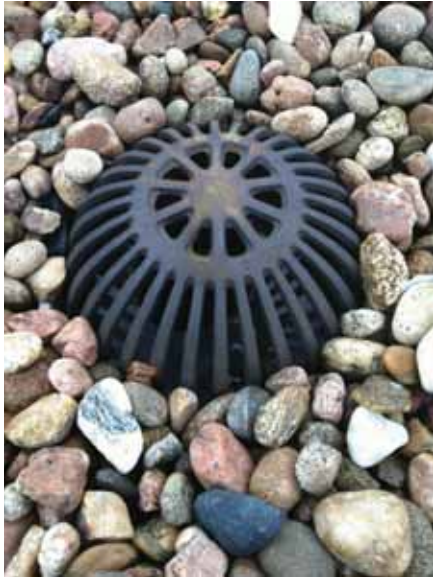
Fig. 2.1.A.46 Drain cover with signs of corrosion.

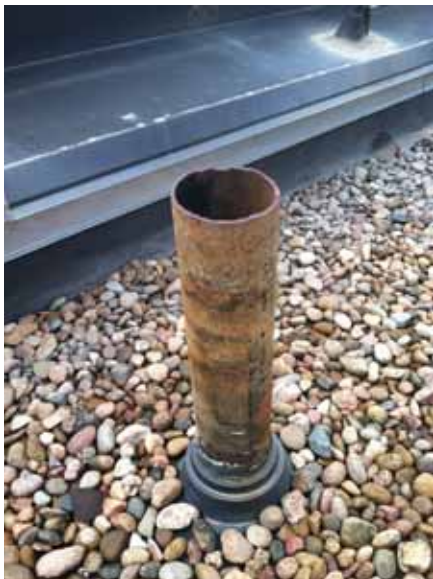
Fig. 2.1.A.47 Exhaust pipe with signs of corrosion.

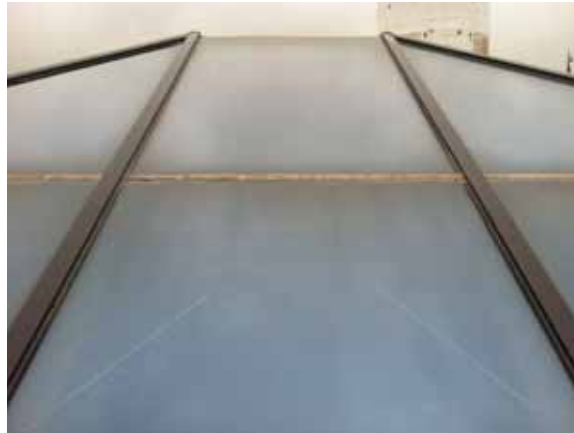
Fig. 2.1.A.48 Deteriorated sealant at the skylight.

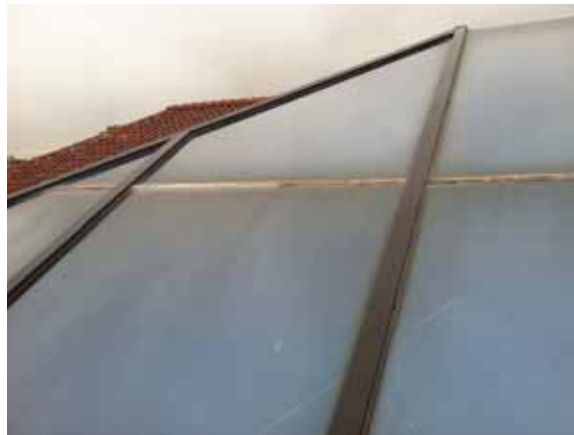
Fig. 2.1.A.49 Deteriorated sealant at the skylight.

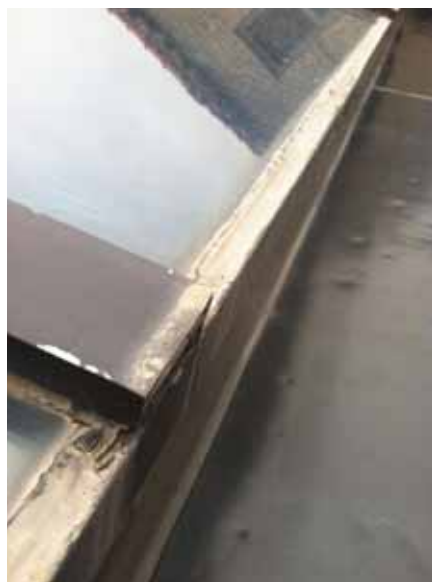
Fig. 2.1.A.50 Deteriorated sealant at the skylight.

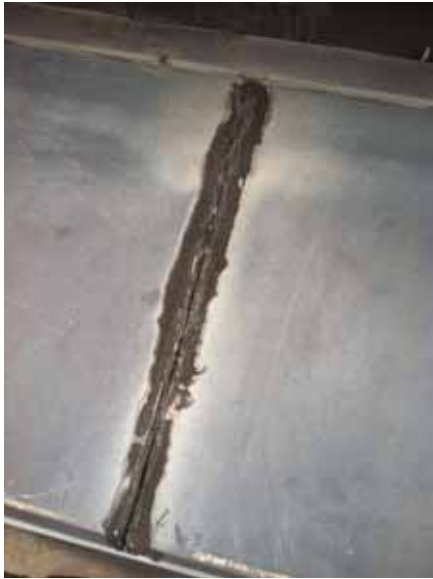
Fig. 2.1.A.51 Deteriorated sealant at membrane surrounding base of skylight.

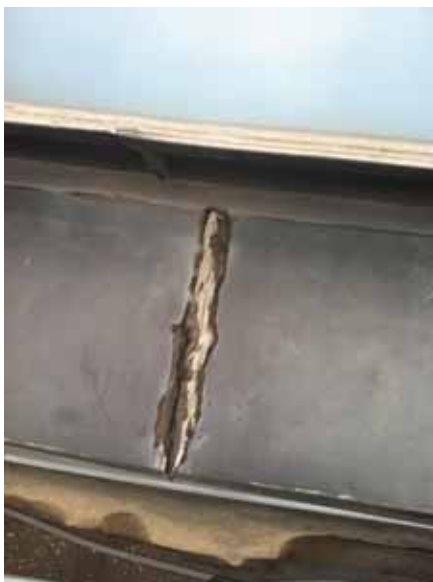
Fig. 2.1.A.52 Deteriorated sealant at membrane surrounding base of skylight.

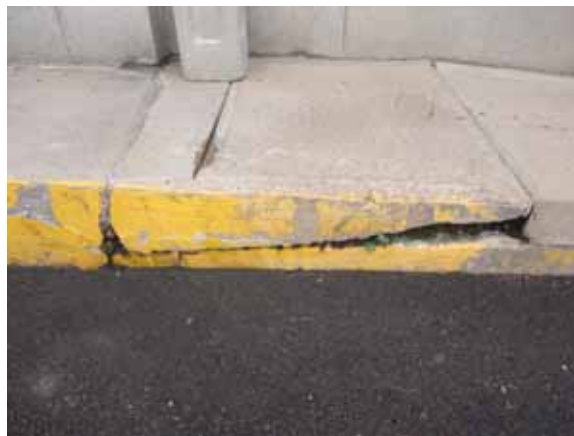
Fig. 2.1.A.53 Broken slab of concrete at the north side of the building.

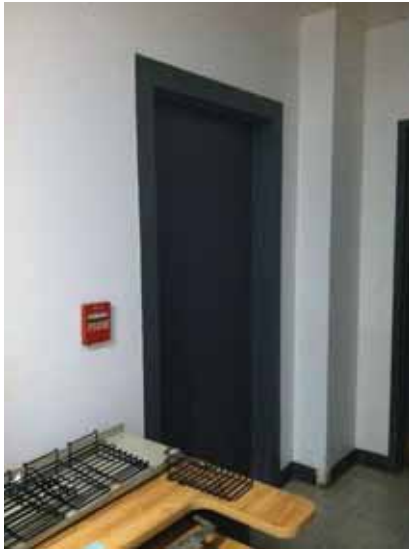
Fig. 2.1.B.1 Unlabeled exit stairway door to the southwest stair from the Basement Floor.

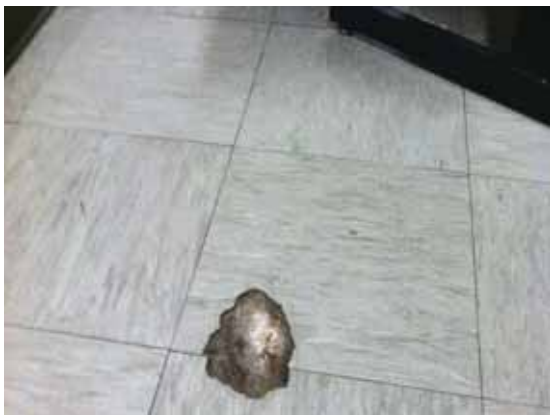
Fig. 2.1.B.3 Uneven corridor floor creates a tripping hazard leading to the southwest exit stairway at the Basement Floor.

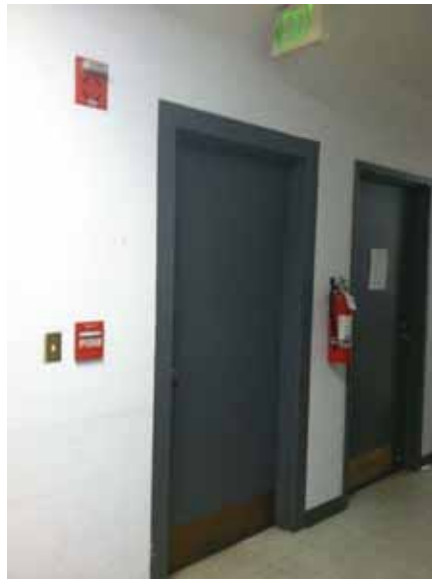
Fig. 2.1.B.4 Unmarked exit stairway door to the northeast stair from the Basement Floor.

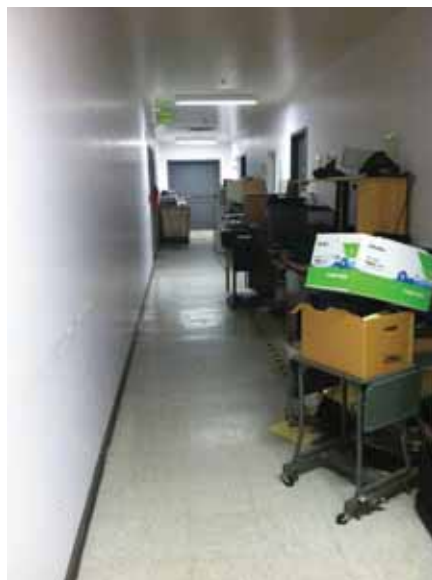
Fig. 2.1.B.5 Furniture intruding into the exit corridor, beyond the marked storage areas, leading to the northeast stair at the Basement Floor.

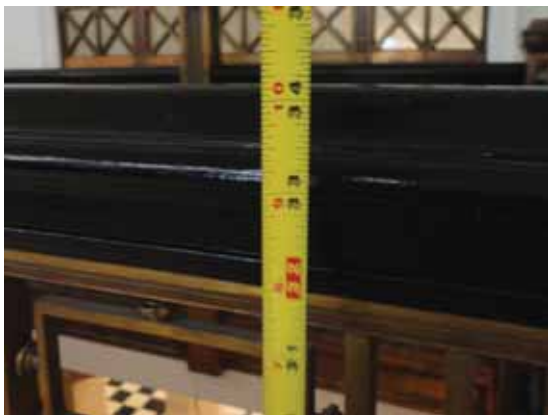
Fig. 2.1.B.10 The height to the top of the guardrail along the edge of the Second Floor and overlooking the First Floor vaulted atrium.

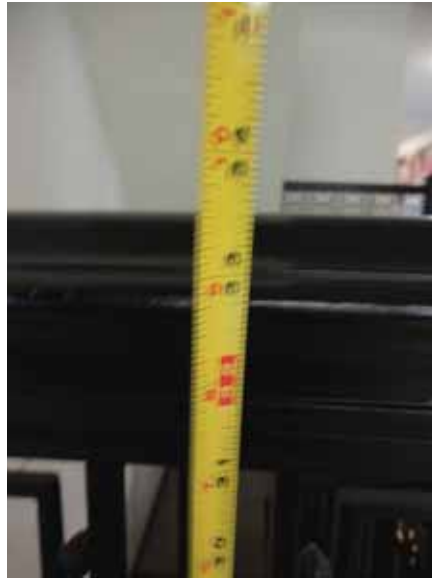
Fig. 2.1.B.11 The height to the top of the guardrail along the edge of the unenclosed northwest stairway.

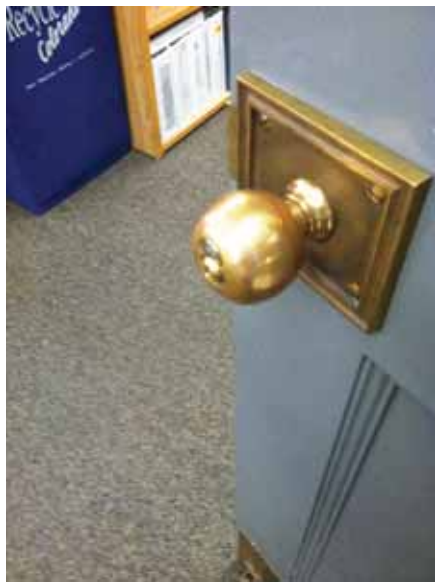
Fig. 2.1.B.12 Typical knob-style door handle found throughout the building.

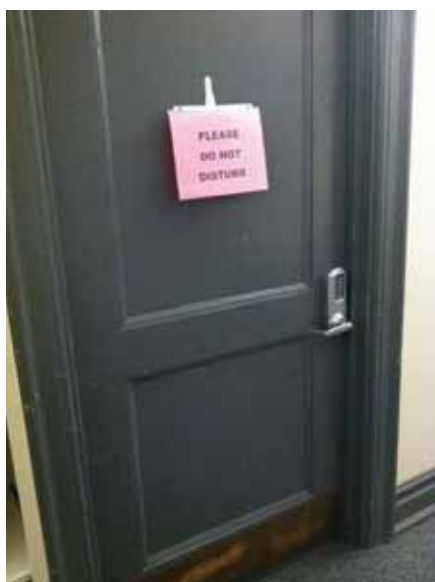
Fig. 2.1.B.13 Key code access system with an integrated lever-style door handle.

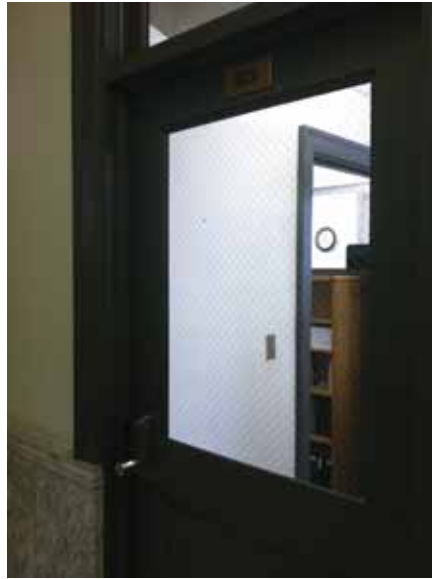
Fig. 2.1.B.14 Key code access system with an integrated knob-style door handle.

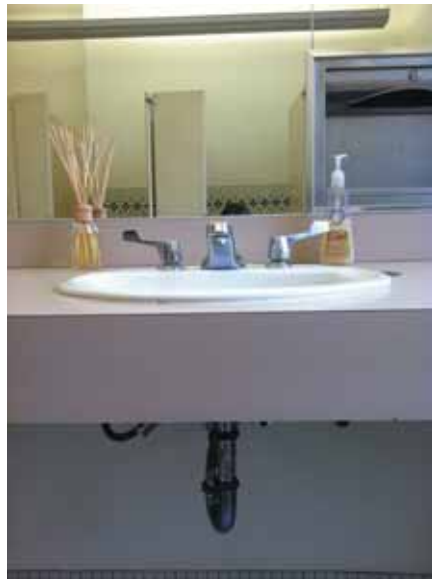
Fig. 2.1.C.1 Insulation missing from around the lavatory pipes in the Women's Restroom on the First Floor.

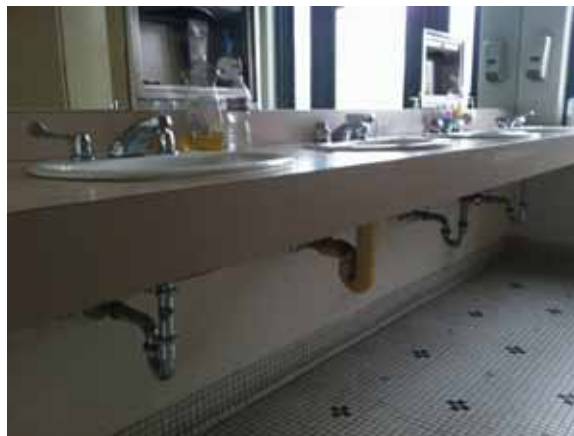
Fig. 2.1.C.2 Insulation is wrapped around the pipes of the non-accessible lavatory with knob-style faucet controls in the Women's Restroom on the Third Floor.

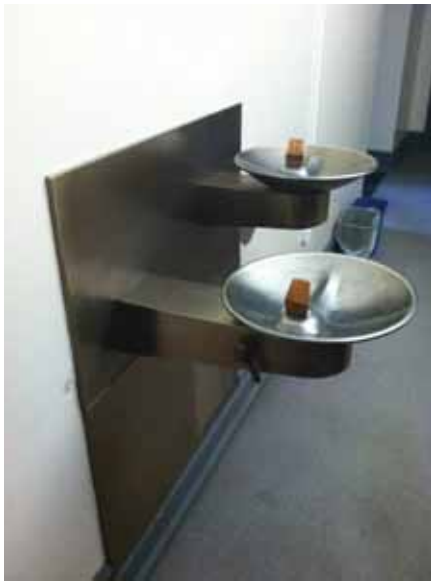
Fig. 2.1.C.5 Typical non-accessible drinking fountain.

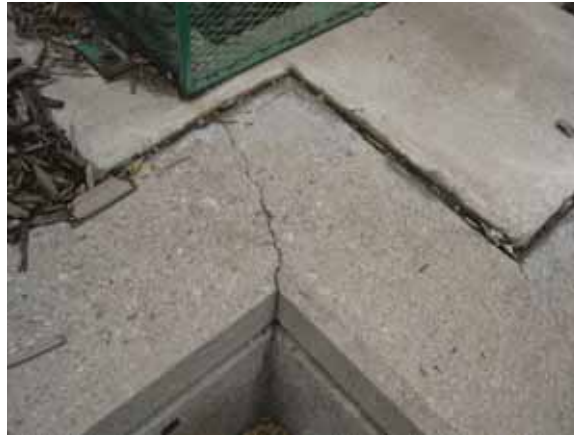
A crack was observed in the west side retaining wall (Fig. 2.2.A.1). The crack allows water to enter and cause additional deterioration.

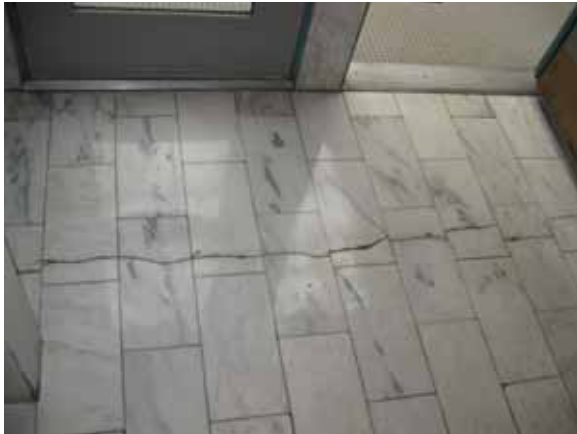
crack is likely due to poor detailing for the connection between the two structures. It is not a structural concern at this time.

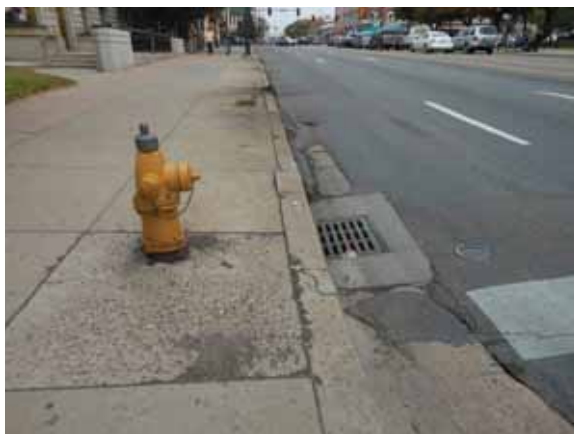
Figure 2.3.A.2 – Street Inlet

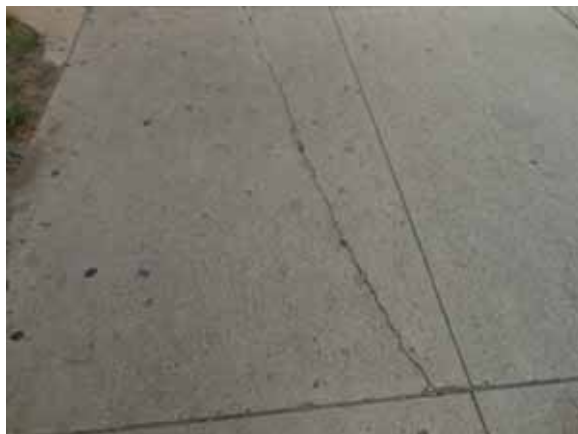
Figure 2.3.A.8 – Site Concrete Crack

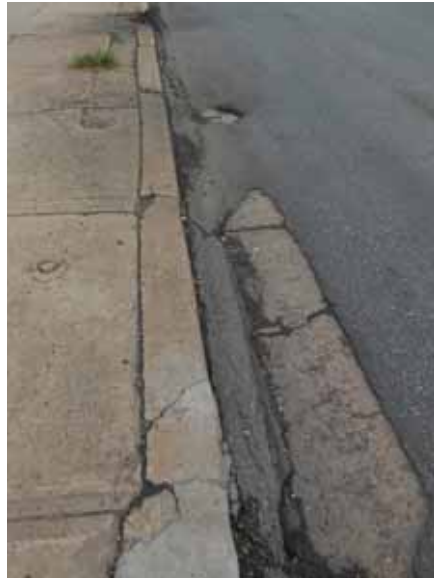
Figure 2.3.A.9 – Broken Curb, Recommended for Replacement

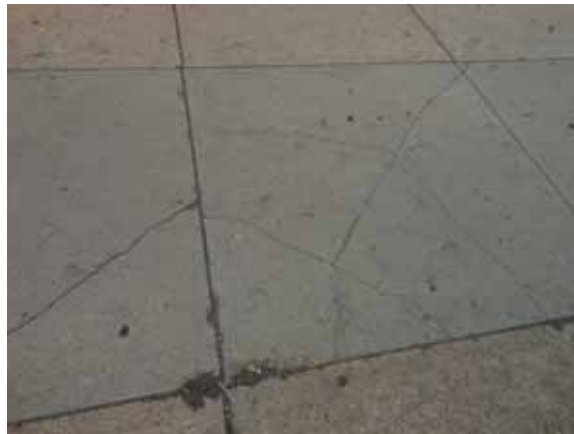
Figure 2.3.A.10 – Broken Site Concrete, Recommended for Replacement

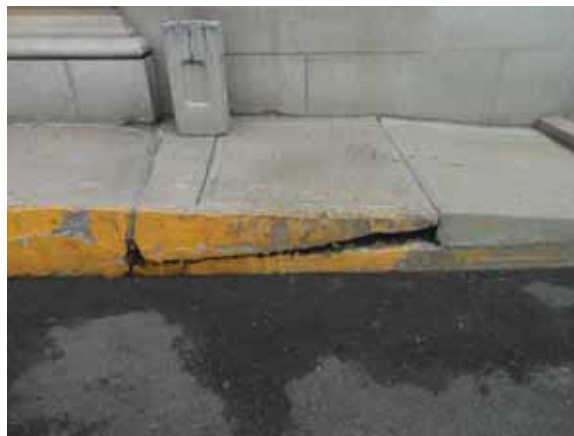
Figure 2.3.A.11 – Broken Concrete Slab, Recommended for Replacement

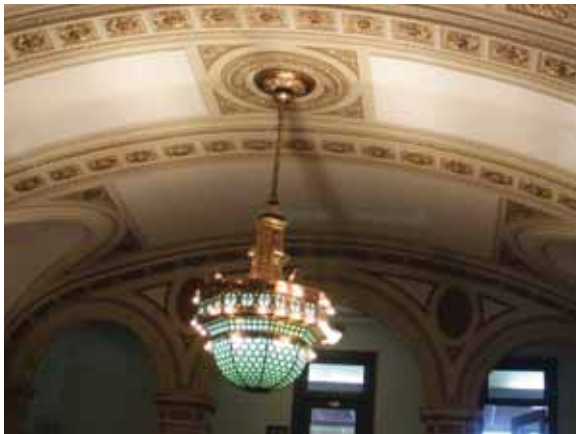
Fig 2.4.A.1 – Historic fixtures

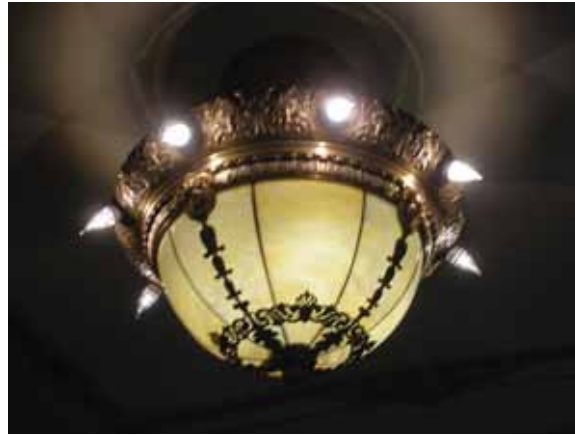
Fig 2.4.A.2 – Historic fixtures

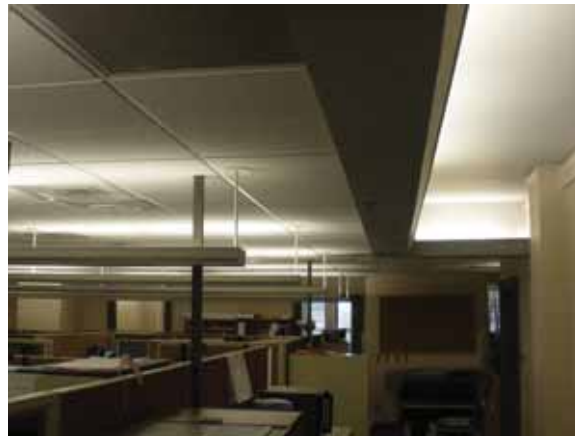
Fig 2.4.A.3 – Indirect office lighting

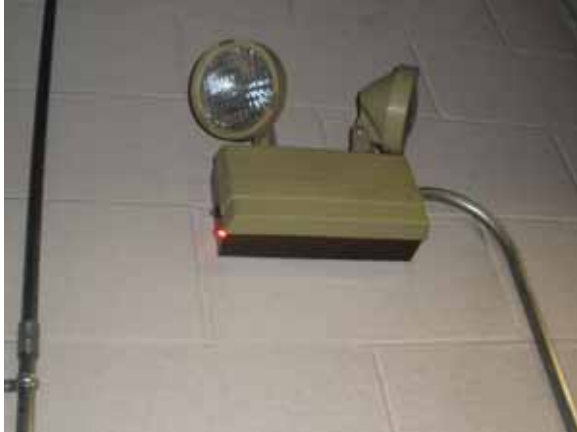
Fig 2.4.A.5 – Frog eye

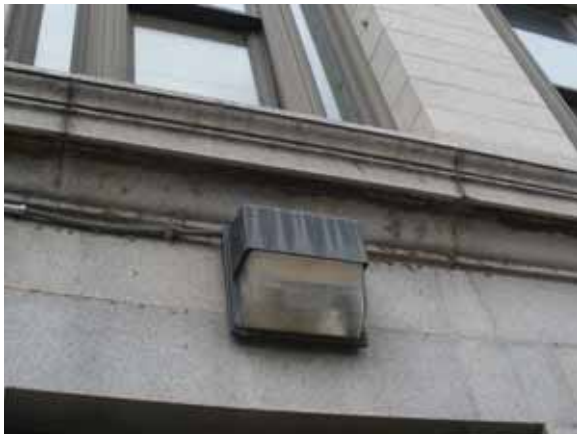
Fig 2.4.A.6 – Exterior fixture

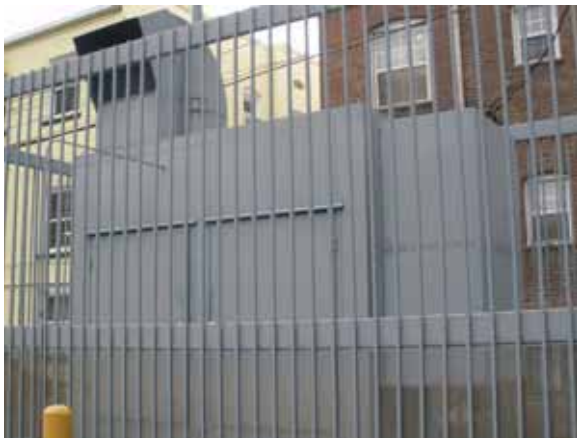
Fig 2.4.A.9 - Generator

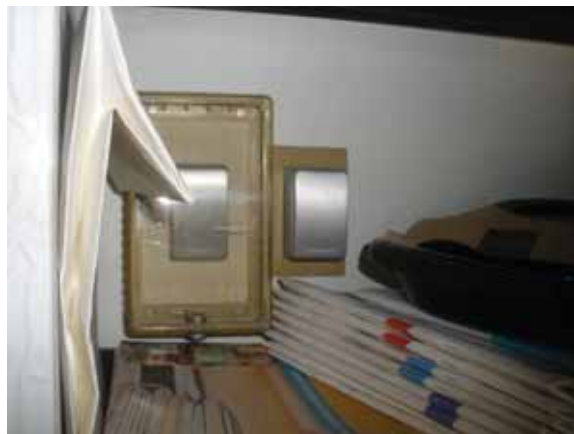
Fig 2.4.A.10 - Thermostat within cubicle cabinet

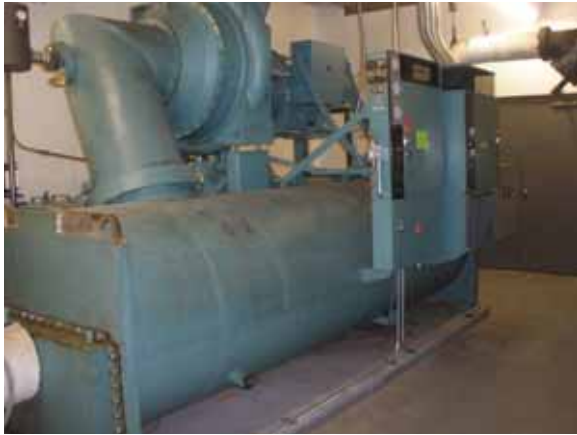
Fig 2.4.A.11 - Building Chiller

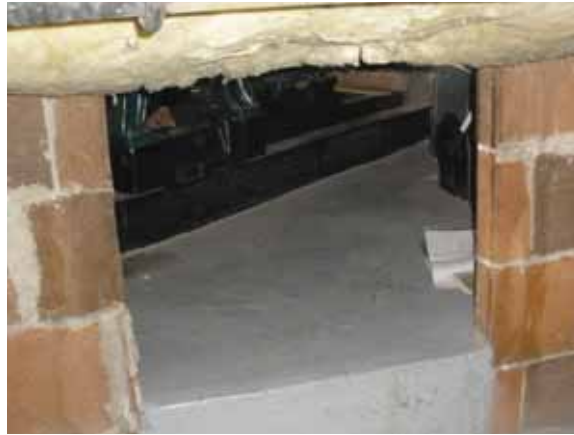
Fig 2.4.B.1 - 3' x 3'
opening for elevator motor

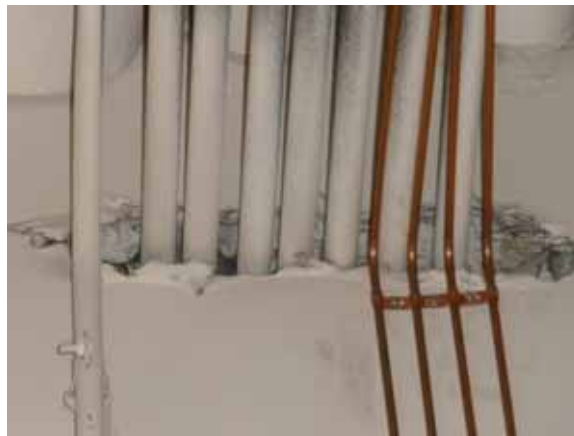
Fig 2.4.B.2 – Penetrations
not sealed

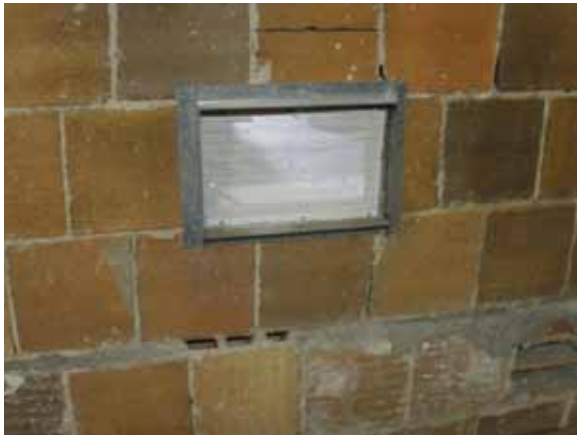
Fig 2.4.B.3 - Elevator machine room wall

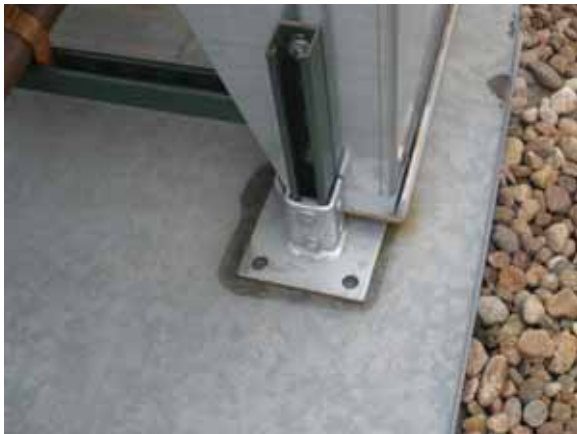
Fig 2.4.B.4 – Unit not bolted to structure

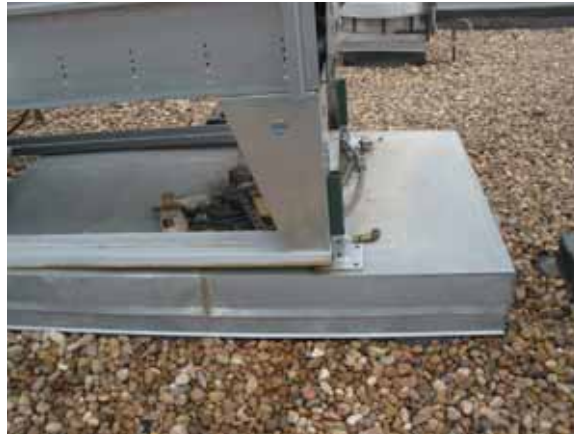
Fig 2.4.B.5 - Condenser unit on the roof not bolted

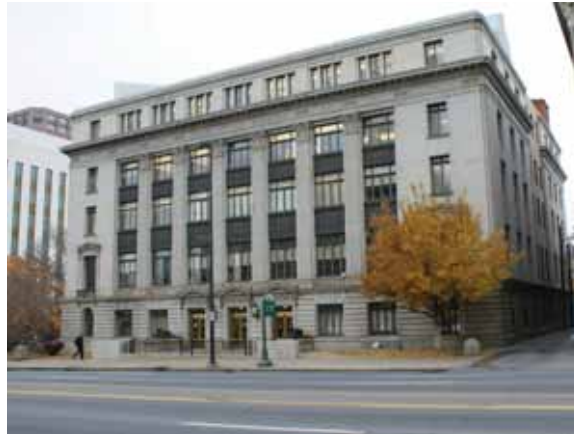
Zone 1 Exterior Facade:
South and east elevations

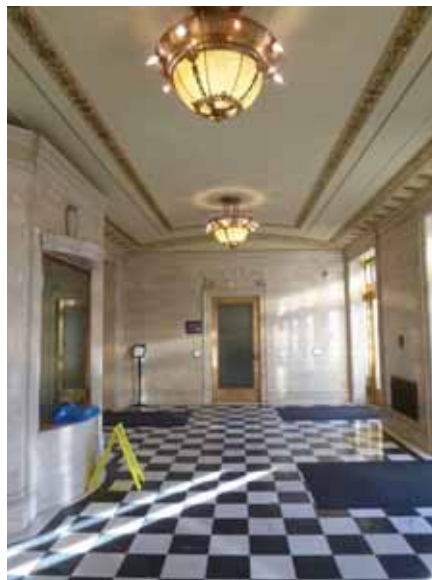
Zone 2 Interior Corridors & Circulation:
South entry vestibule

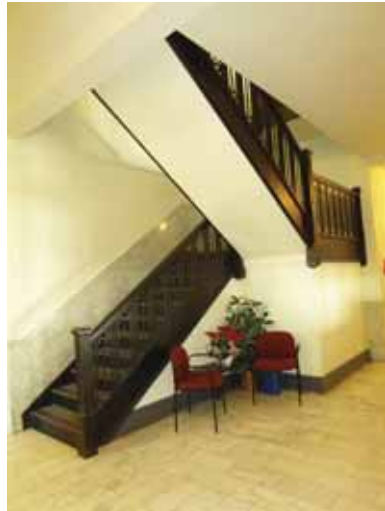
Zone 2 Interior Corridors & Circulation:
Open stair leading from the fourth floor to the fifth

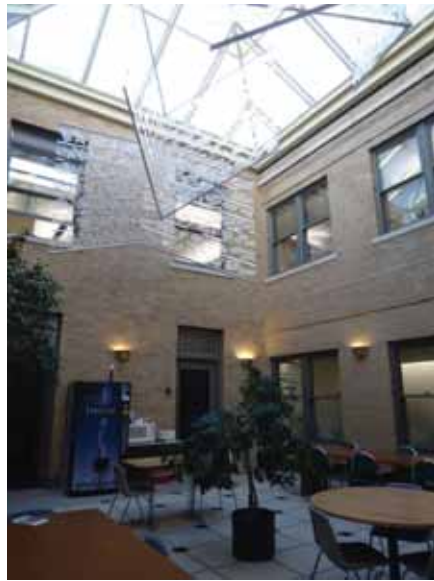
Zone 3 Central Atrium: Historic brick wall (right) and modern infill wall (left) in the atrium

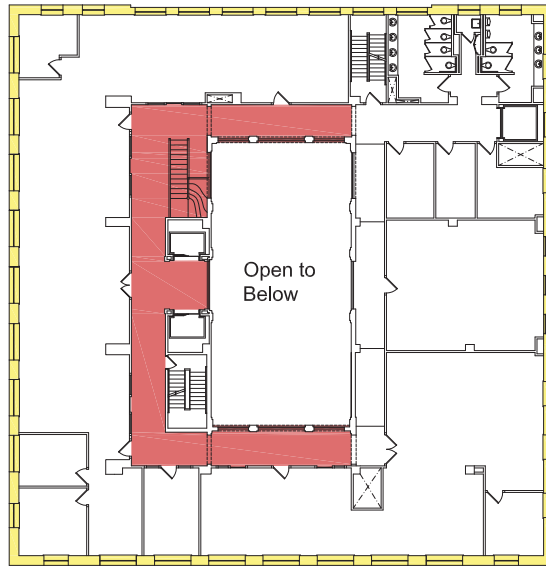
1 SECOND FLOOR ZONING PLAN
1/32" = 1'-0"

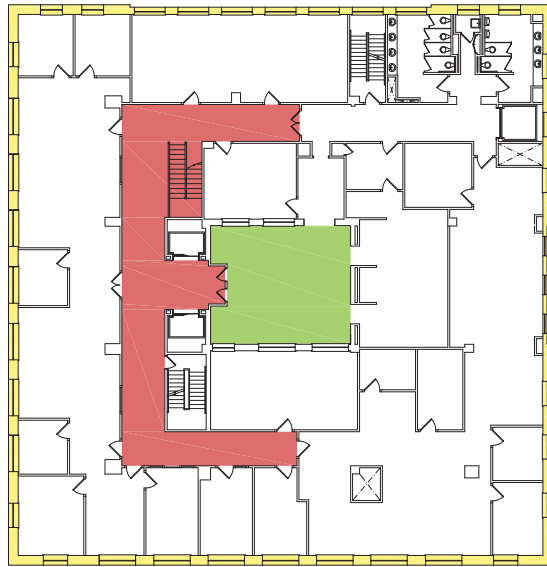
1 FOURTH FLOOR ZONING PLAN
1/32" = 1'-0"

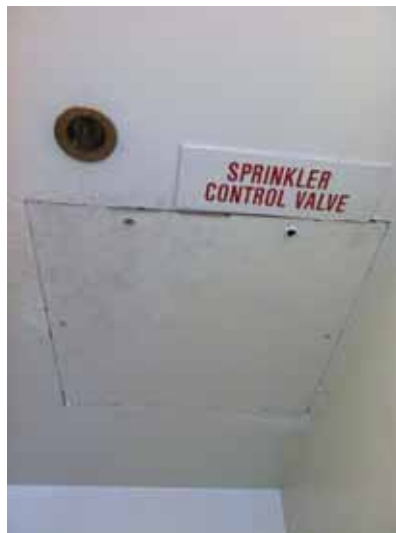
Fig. 3.1.C.1 Soiled access panel observed in the Women's Restroom on the Fourth Floor.

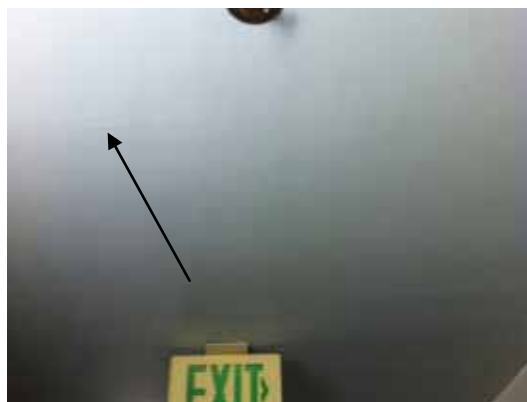
Fig. 3.1.C.2 Crack across the plaster ceiling in the main corridor on the Fifth Floor.

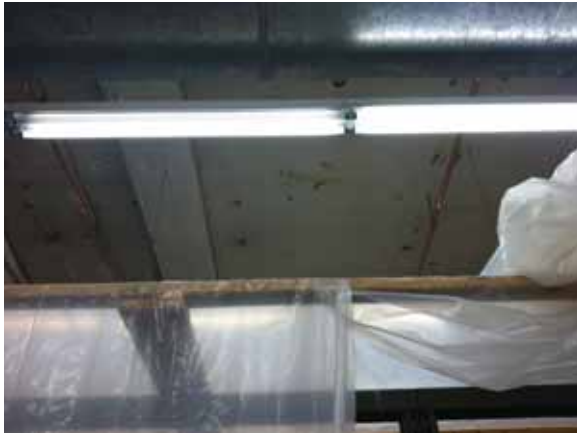
Fig. 3.1.C.3 Damaged ceiling and plastic sheeting covering the storage shelves in Room B-13 Library Stacks.
