CAPITOL COMPLEX MASTER PLAN
FINDINGS & RECOMMENDATIONS (F & R) NEEDS ASSESSMENT
STATE OFFICE BUILDING, 201 EAST COLFAX AVENUE (DENVER)

NOVEMBER 2014

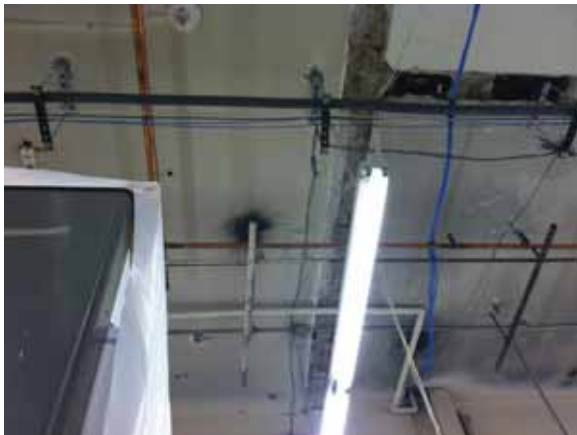
Fig. 3.1.C.4 Damaged ceiling in Room B-13 Library Stacks.

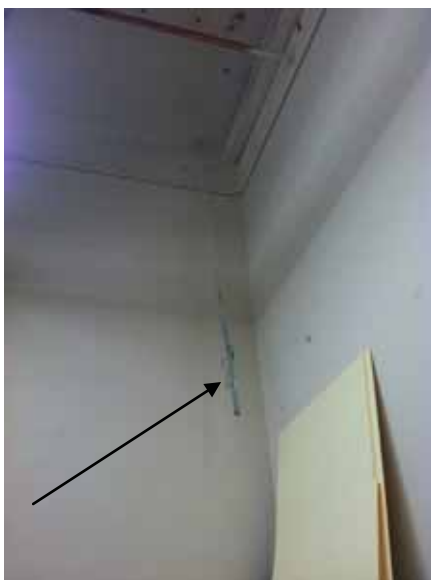
Fig. 3.1.C.5 Metal strapping hanging from the ceiling in Room B-13 Library Stacks.

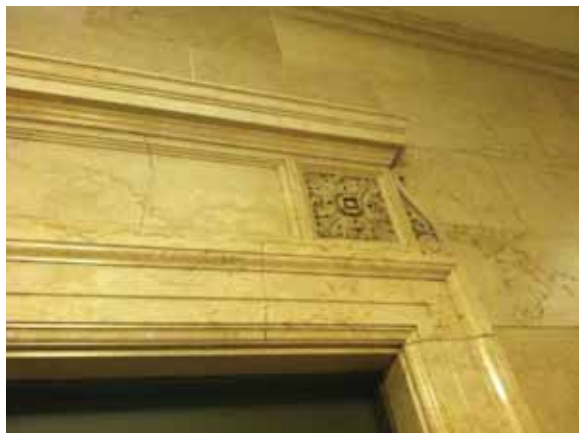
Fig. 3.1.C.6 Cracked stone observed in the central atrium space on the First Floor.

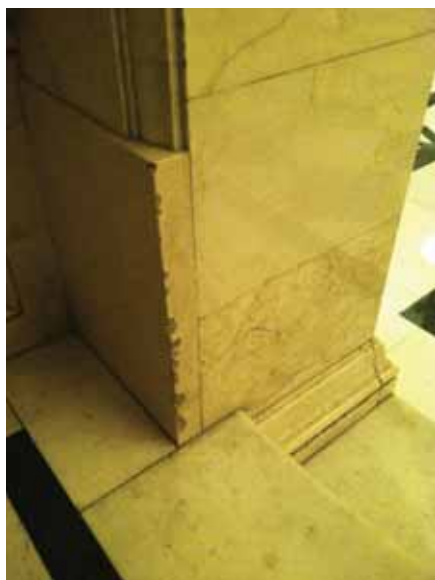
Fig. 3.1.C.7 Damaged stone at the base of the northwest stairway on the First Floor.

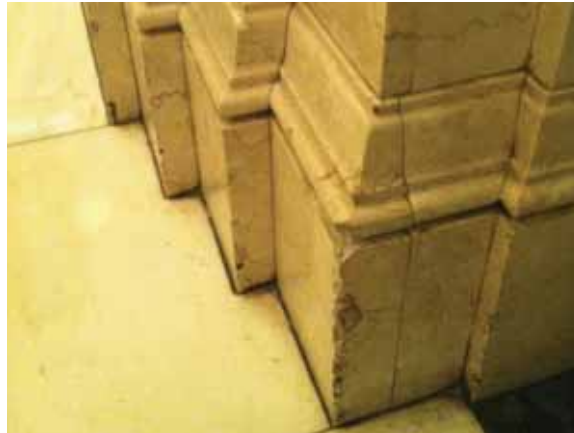
Fig. 3.1.C.8 Damaged stone observed in the central atrium space on the First Floor.

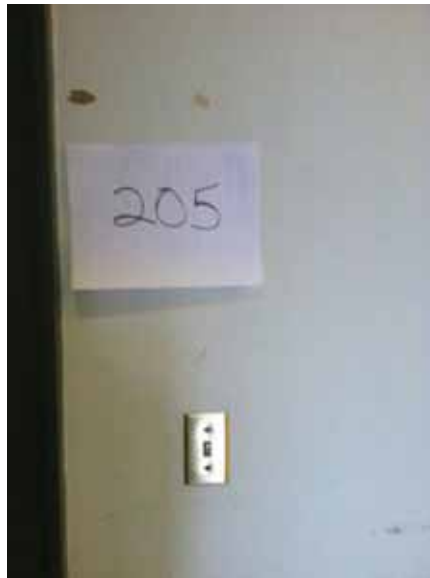
Fig. 3.1.C.9 General wear-and-tear and minor damage to plaster walls.

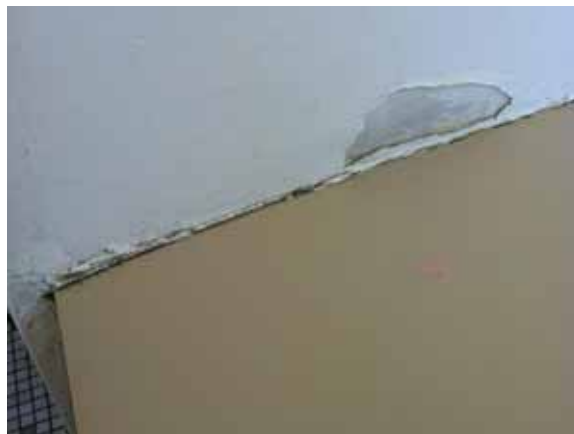
Fig. 3.1.C.10 Damaged plaster wall at the counter in the Women's Restroom on the First Floor.

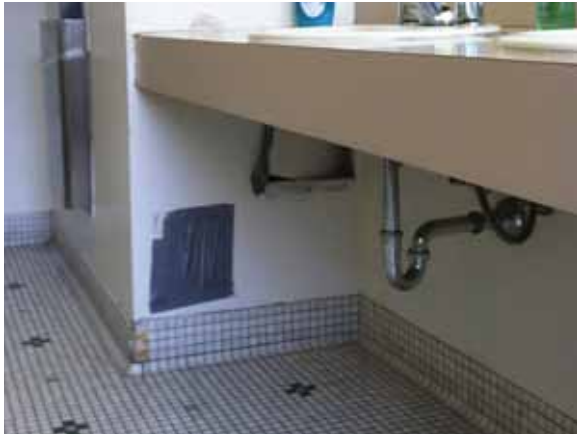
Fig. 3.1.C.11 Holes in the plaster wall under the counter in the Women's Restroom on the First Floor that have not been repaired correctly.

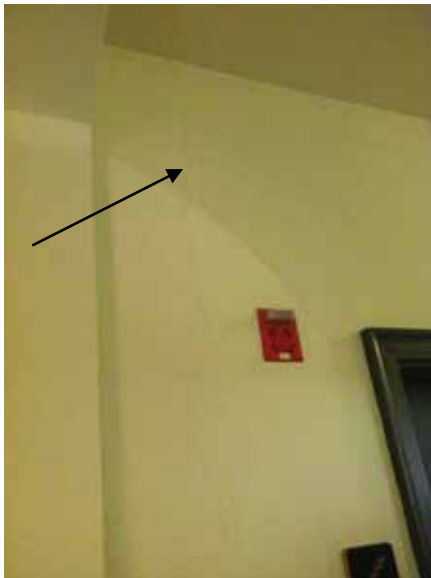
Fig. 3.1.C.12 Large crack in the plaster wall noted in the main corridor area on the Second Floor.

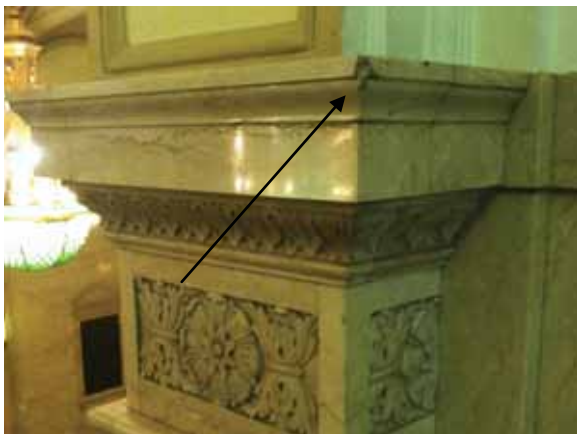
Fig. 3.1.C.13 Typical minor damage to polished stone wainscoting.

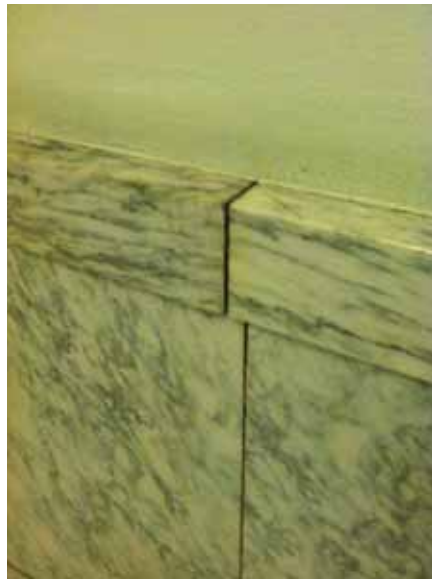
Fig. 3.1.C.14 Areas of grout missing between polished stone wainscoting panels on the Third Floor.

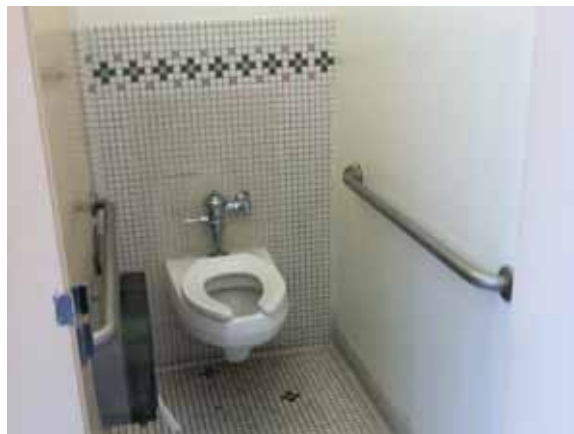
Fig. 3.1.C.15 Areas of discolored one-inch square tile wainscoting noted in the restrooms.

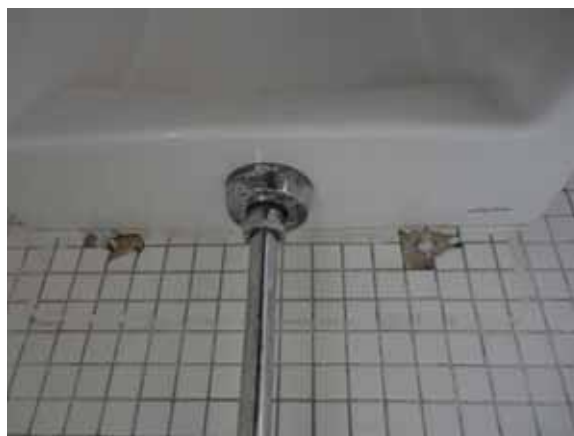
Fig. 3.1.C.16 Damaged one-inch square tile wainscoting under a urinal in the Men's Restroom on the First Floor.

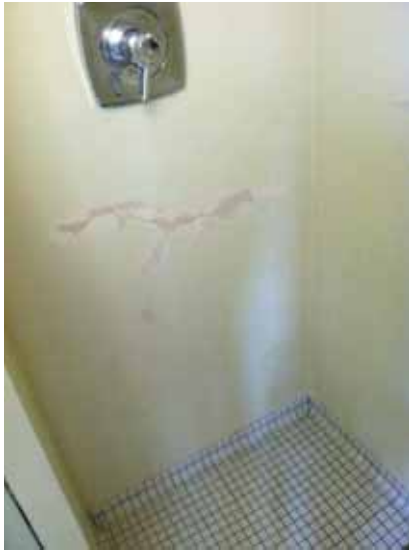
Fig. 3.1.C.17 Damaged shower walls in the Women's Restroom on the Fifth Floor.

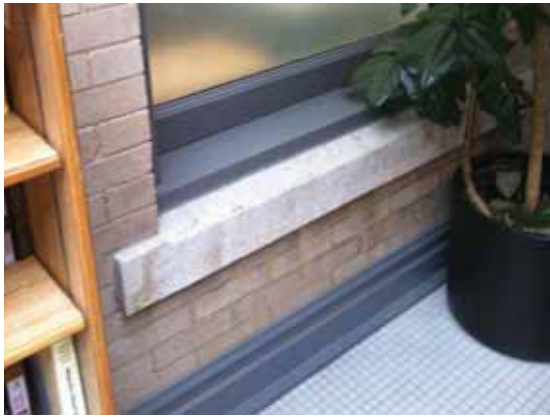
Fig. 3.1.C.18 Deteriorating grout and minor soiling of the brick and stone window sills within the Fourth Floor atrium space.

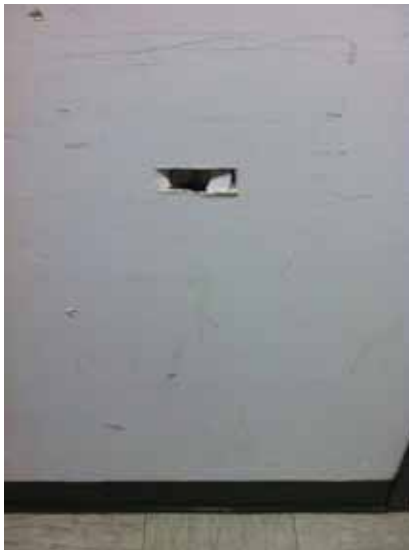
Fig. 3.1.C.19 Damage to gypsum board walls observed in the main corridors throughout the Basement Floor.

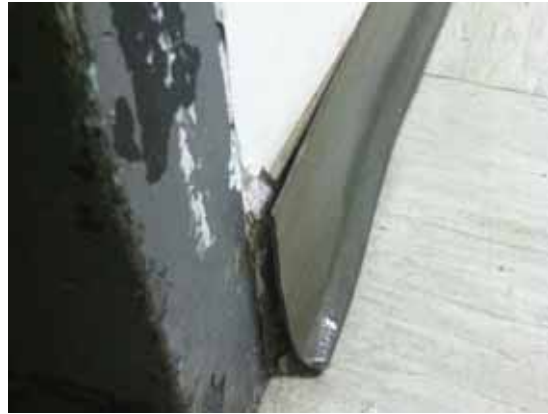
Fig. 3.1.C.20 Damage to vinyl baseboard observed in the main corridors throughout the Basement Floor.

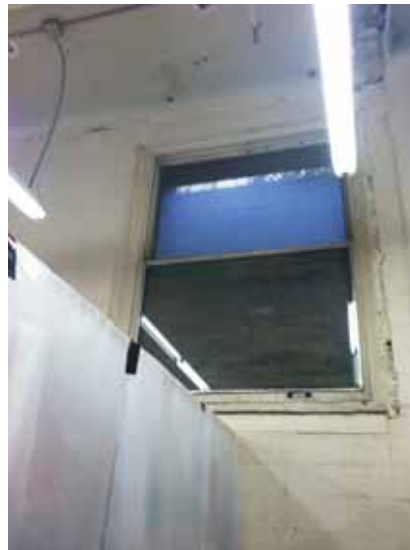
Fig. 3.1.C.21 Spalling and cracking around the windows along the exterior wall in Room B-13 Library Stacks.

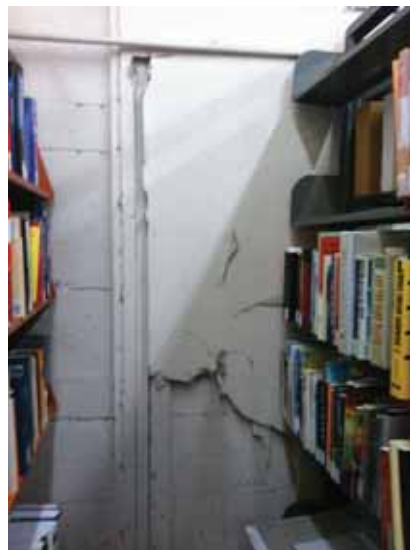
Fig. 3.1.C.22 Damaged gypsum board lining the concrete block walls in Room B-13 Library Stacks.

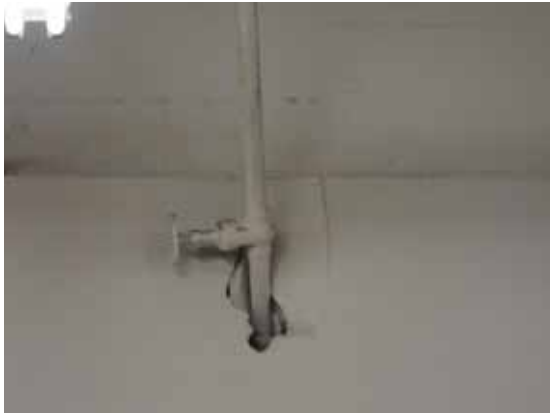
Fig. 3.1.C.23 Unsealed opening around a pipe passing through the wall in Room B-13 Library Stacks.

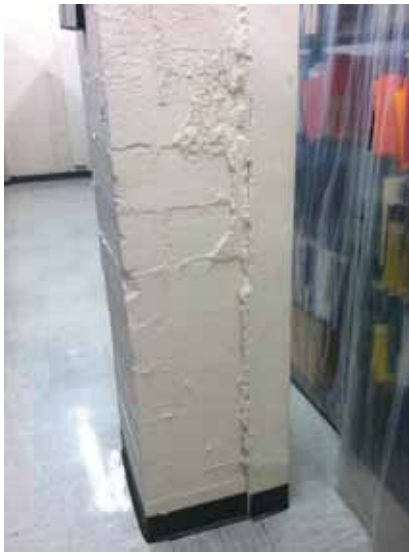
Fig. 3.1.C.24 Typical spalling noted at the columns in Room B-13 Library Stacks.

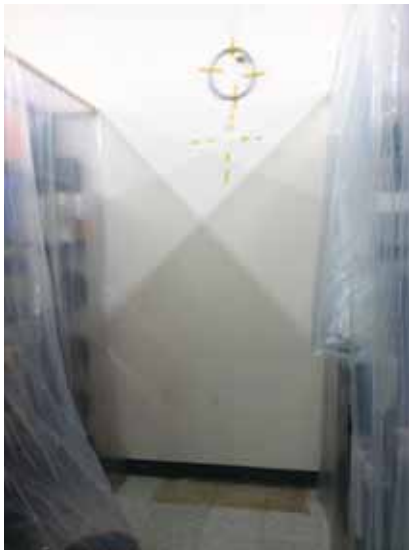
Fig. 3.1.C.25 Coiled wire taped to the wall and discolored one-foot square linoleum tile flooring in Room B-13 Library Stacks.

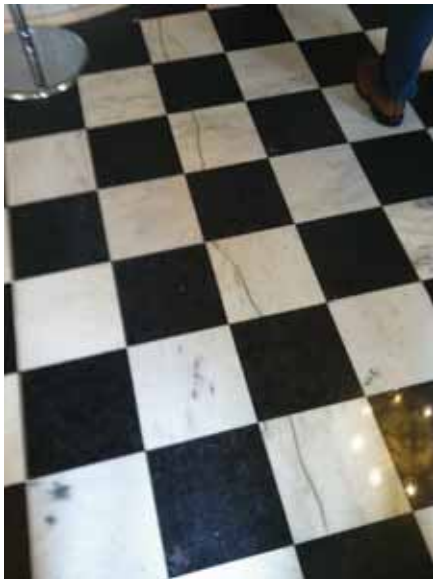
Fig. 3.1.C.26 Large crack across the marble flooring in the East Colfax Entrance Vestibule on the First Floor.

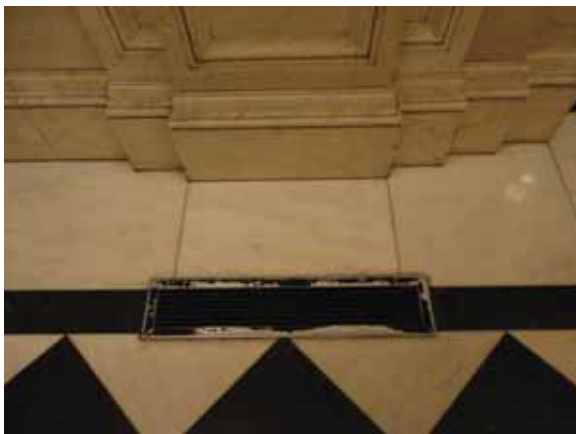
Fig. 3.1.C.27 Floor vent cover missing paint and showing general signs of wear-and-tear in the vaulted atrium space on the First Floor.

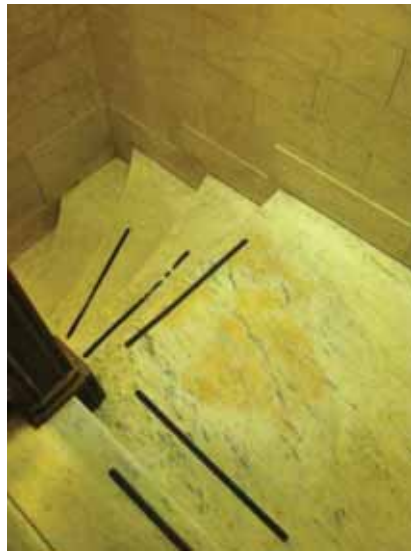
Fig. 3.1.C.28 Soiled areas of polished stone cladding the northwest stairway connecting the First and Second Floor.

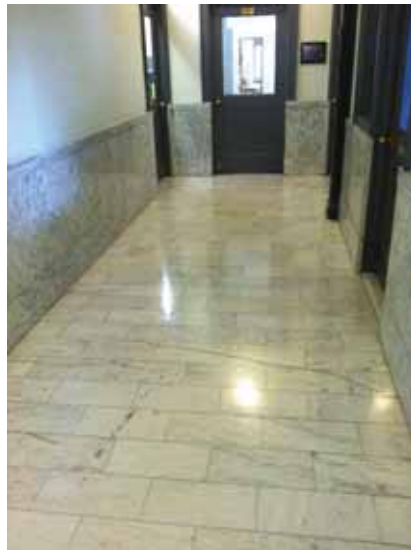
Fig. 3.1.C.29 Typical cracked and soiled stone flooring observed in the main corridors.

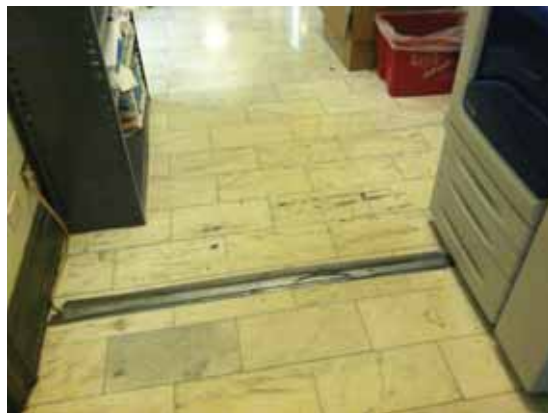
Fig. 3.1.C.30 Electrical cord taped to the floor and an area of generally soiled stone flooring on the Second Floor.

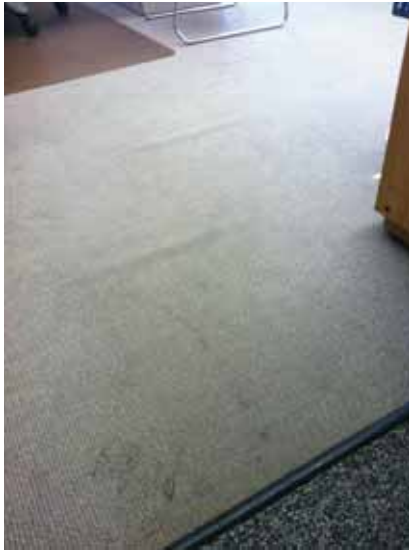
Fig. 3.1.C.31 Typical soiled and worn carpet pulling loose and creating a potential tripping hazard.

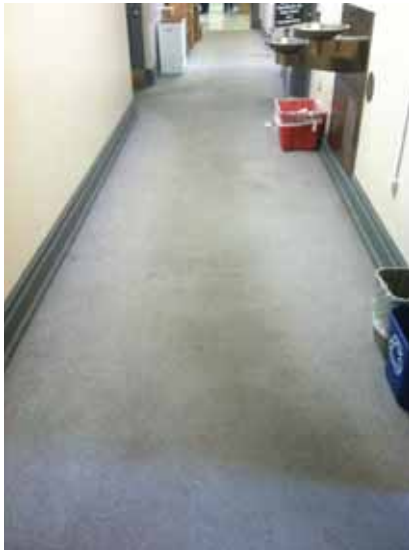
Fig. 3.1.C.32 Typical worn and soiled carpet observed in areas included in the site survey visit.

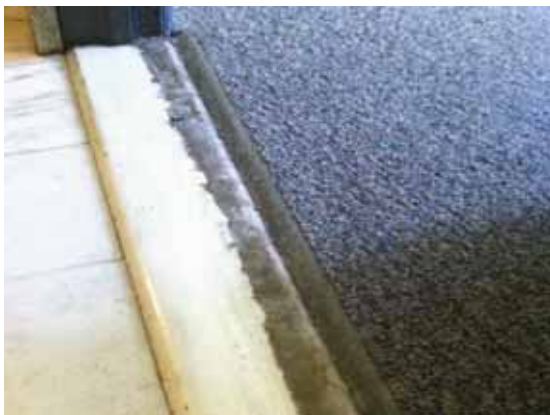
Fig. 3.1.C.33 General wear-and-tear and soiling noted at thresholds.

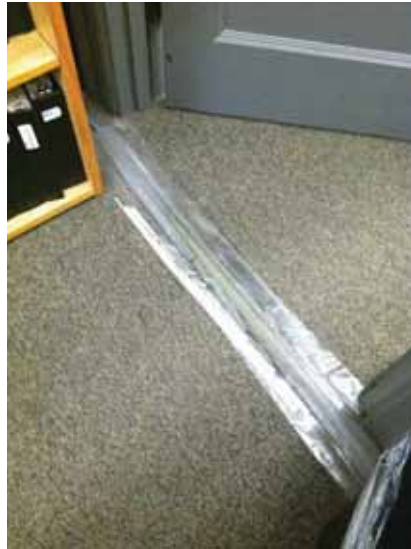
Fig. 3.1.C.34 Electrical cord taped to the floor and creating a potential tripping hazard on the Fifth Floor.

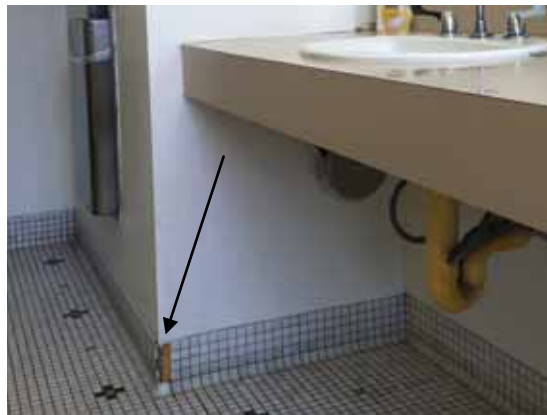
Fig. 3.1.C.35 Typical area of damaged one-inch square tile in the Women's Restroom on the First, Second, and Fourth Floors.

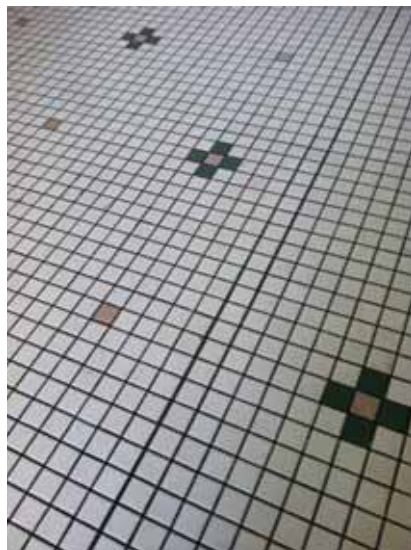
Fig. 3.1.C.36 Generally soiled one-inch square tile flooring in the restrooms.

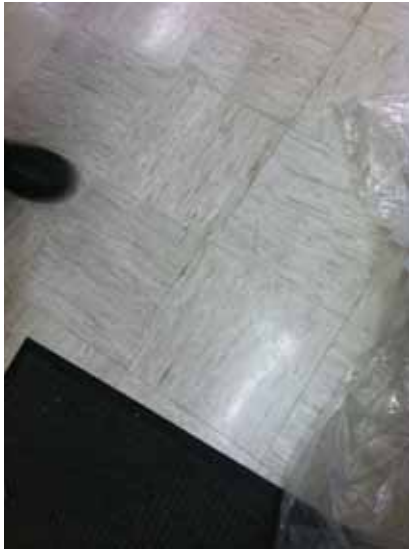
Fig. 3.1.C.37 Cracked one-foot square linoleum tile flooring in Room B-13 Library Stacks in the basement.

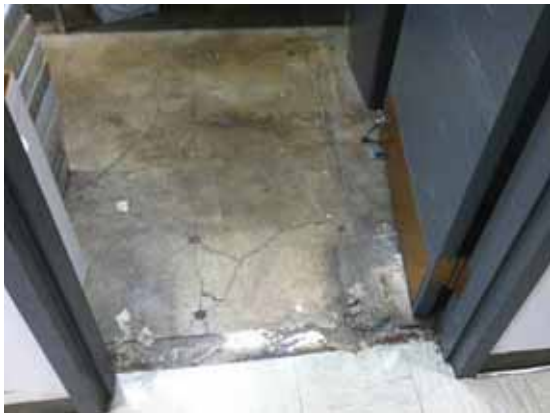
Fig. 3.1.C.38 Cracked and spalling concrete flooring in the CDE Mailroom in the basement.

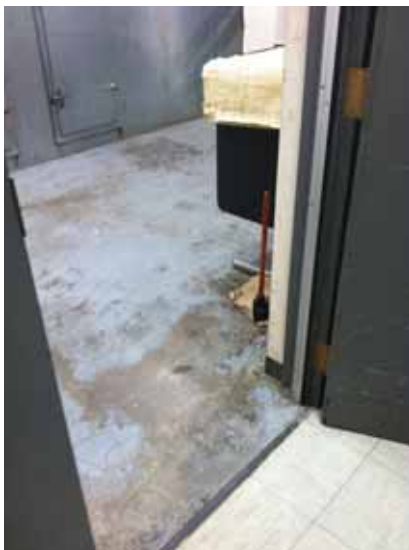
Fig. 3.1.C.39 Worn and cracked paint on the concrete flooring in the Fire Pump Room in the basement.

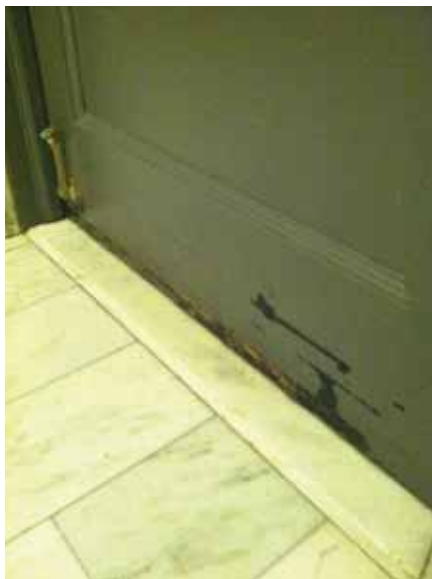
Fig. 3.1.C.40 General wear-and-tear noted at the doors.

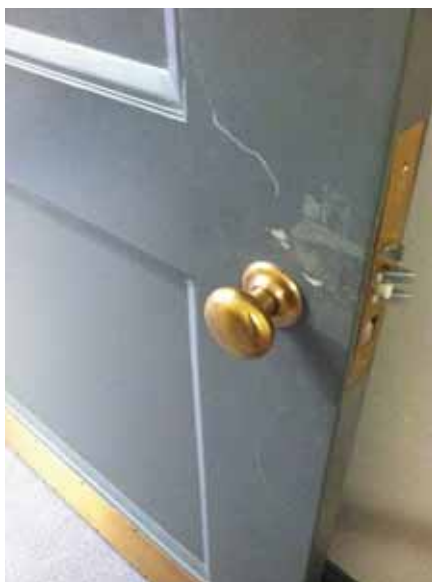
Fig. 3.1.C.41 General wear-and-tear noted at the doors.

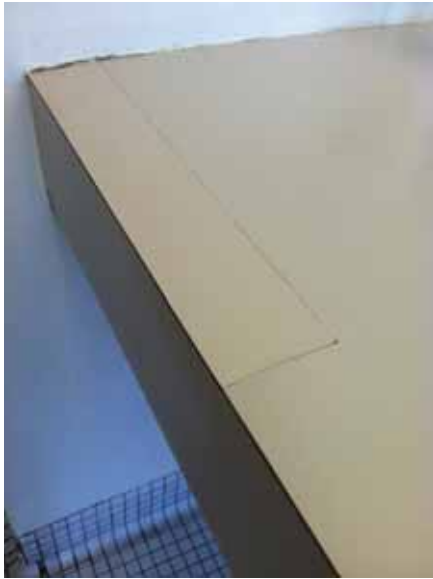
Fig. 3.1.C.42 Previously repaired section of countertop in the Women's Restroom on the Fifth Floor.
