CAPITOL COMPLEX MASTER PLAN
FINDINGS & RECOMMENDATIONS (F & R) NEEDS ASSESSMENT
LEGISLATIVE SERVICES BUILDING, 200 EAST 14TH AVENUE (DENVER)

NOVEMBER 2014

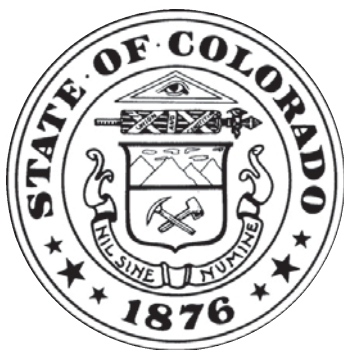
1.0-F SECURITY SYSTEMS OVERVIEW

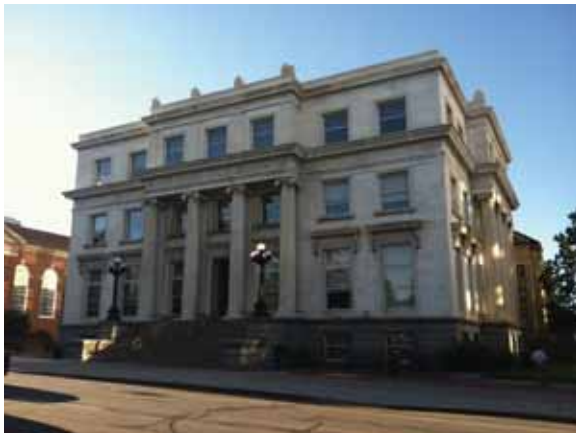
Front/North Elevation of the Legislative Services Building

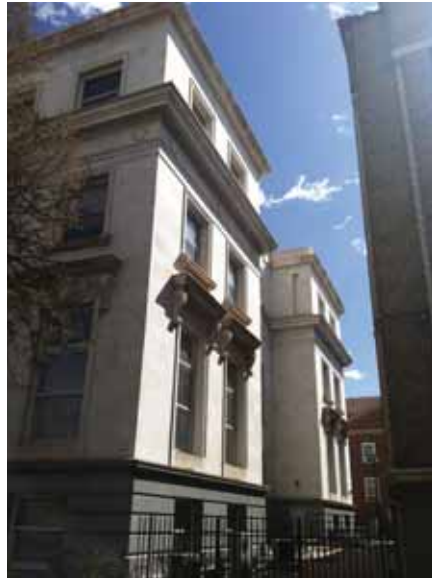
Back/South Elevation of the Legislative Services Building

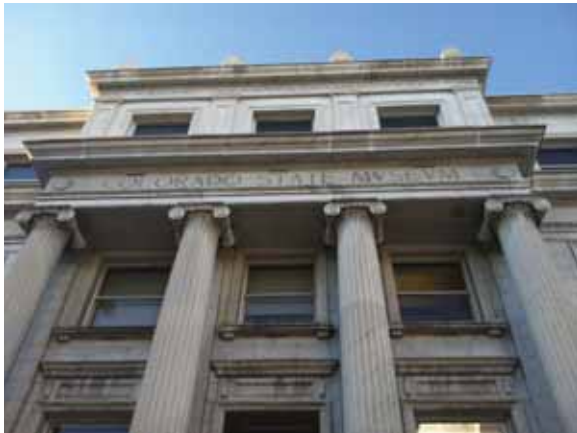
Fig. 2.1.A.1 Generally soiled marble cladding around the building's exterior.

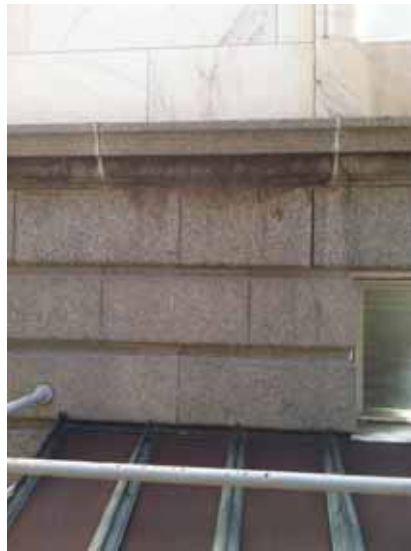
Fig. 2.1.A.3 Generally soiled granite veneer panels.

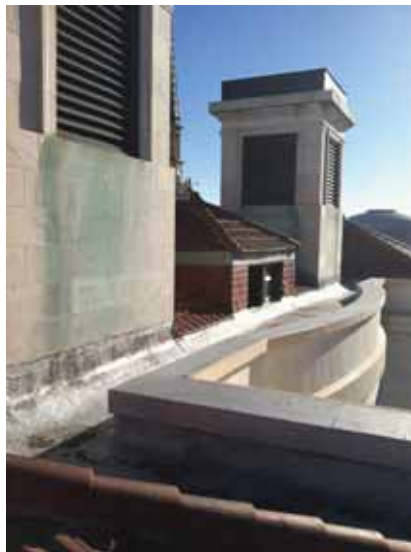
Fig. 2.1.A.4 Soiled marble veneer panels observed at the roof level.

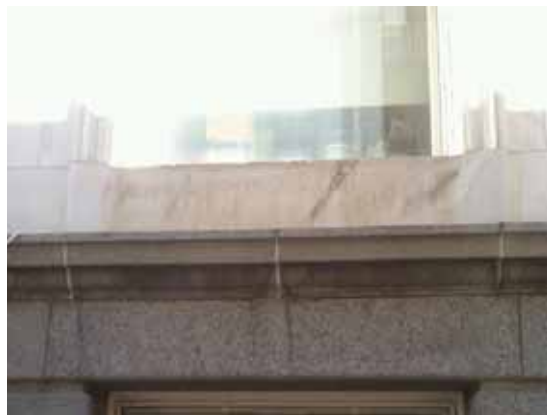
Fig. 2.1.A.5 Damaged marble observed on the south side of the building.

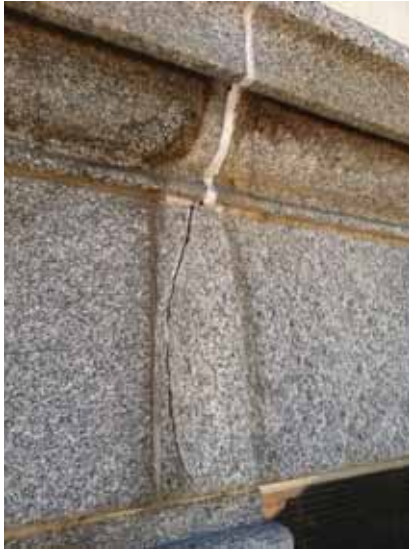
Fig. 2.1.A.6 Cracked granite observed on the east end of the north side of the building.

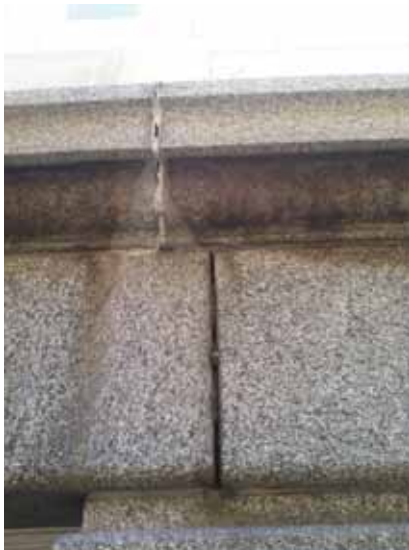
Fig. 2.1.A.7 Typical instance of deteriorated and missing sealant observed around the building.

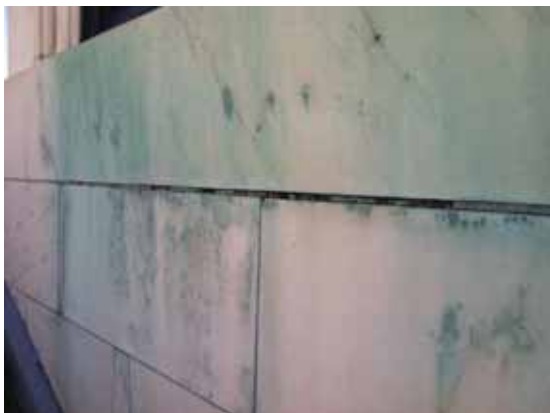
Fig. 2.1.A.8 Typical instance of deteriorated and missing mortar observed at the roof level.

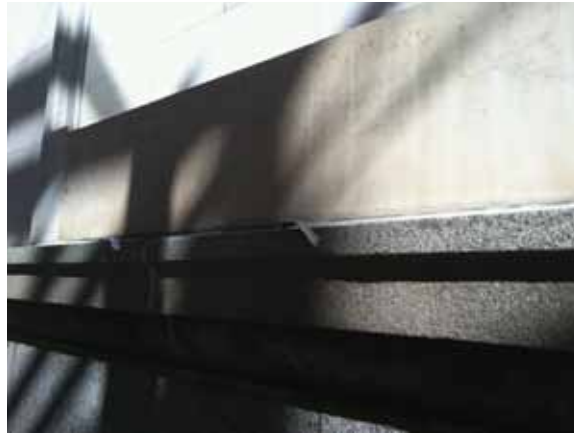
Fig. 2.1.A.9 Newer-looking sealant observed to be peeling away from the building.

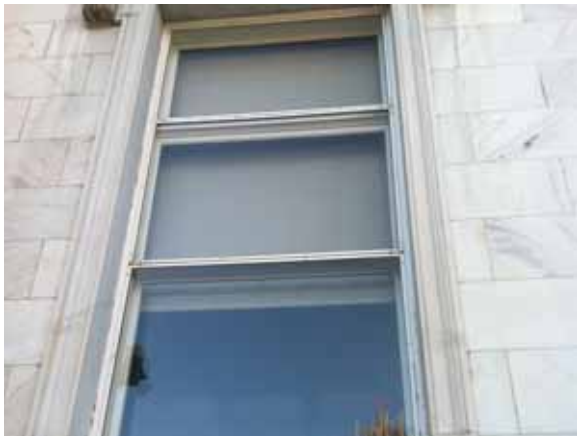
Fig. 2.1.A.10 Storm windows placed over the existing windows around the exterior of the building.

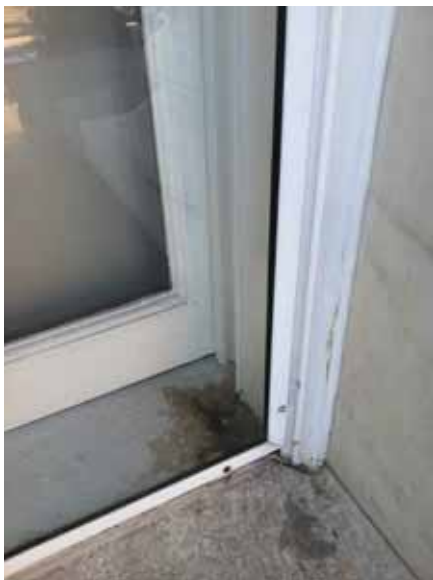
Fig. 2.1.A.11 Deterioration noted at a window sill and wear-and tear of a window frame.

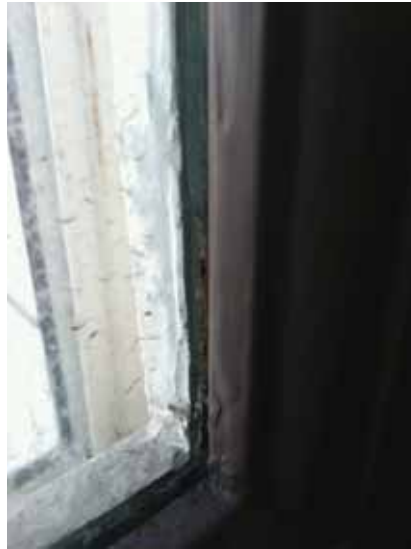
Fig. 2.1.A.12 Deteriorating original window observed during the site survey visit.

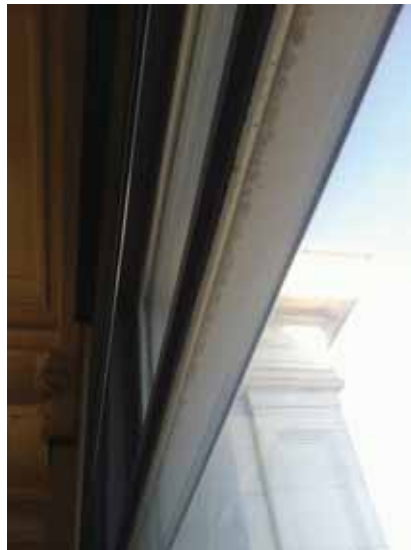
Fig. 2.1.A.13 Water damage and deterioration of the existing windows does not appear to have been addressed as part of the storm window installation project.

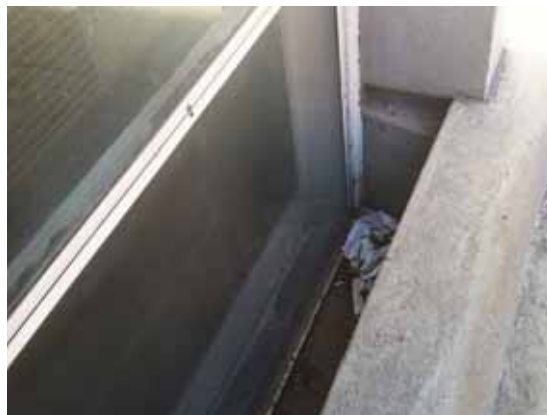
Fig. 2.1.A.14 Debris observed in window wells of the Ground Floor windows during the site survey visit.

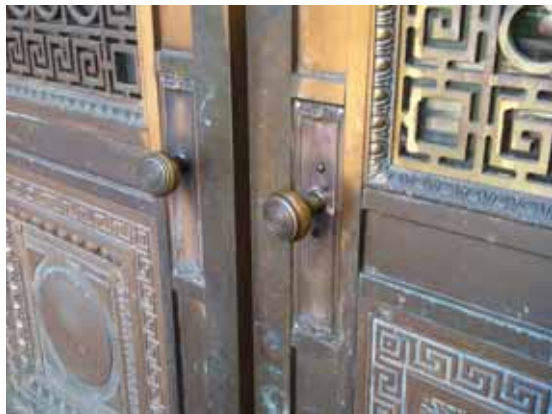
Fig. 2.1.A.15 Knob-style door handles with the State seal on the main East 14th Avenue Entrance doors.

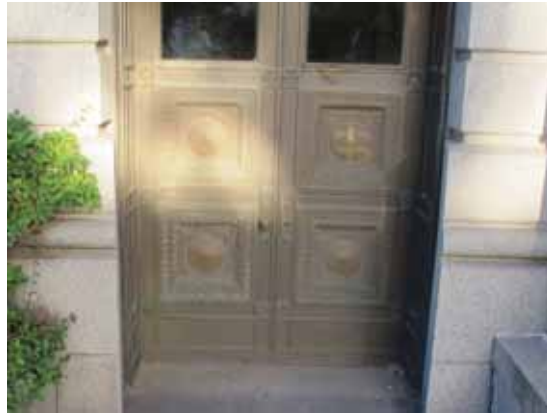
Fig. 2.1.A.17 Pair of doors on the north end of the west side of the building missing a door handle and spray-painted with graffiti.

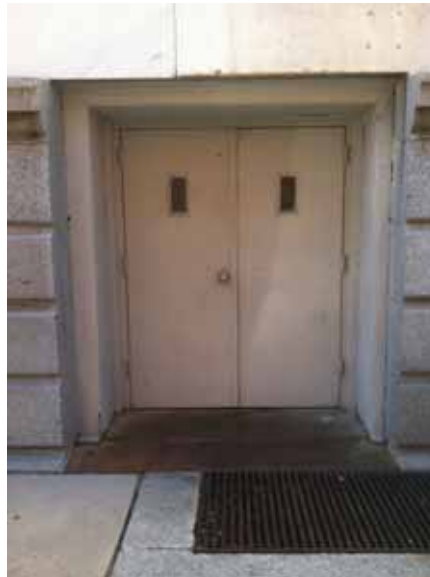
Fig. 2.1.A.18 Corroding metal sill plate noted at the pair of double doors leading to the freight elevator at the south end of the east side of the building.

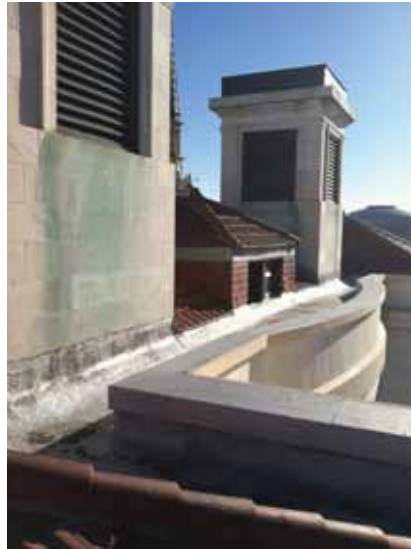
Fig. 2.1.A.19 Parapets surrounding the perimeter of the roof are lower than required by code.

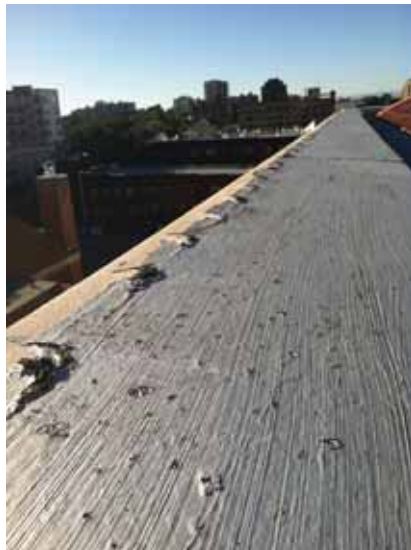
Fig. 2.1.A.20 Deterioration of the painted roofing membrane noted along the outer edge of the parapet.

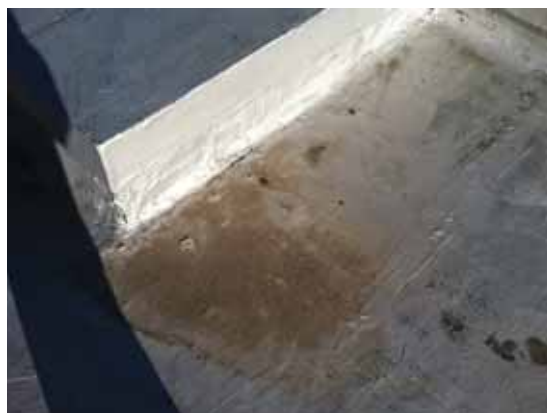
Fig. 2.1.A.21 Generally deteriorated painted roofing membrane is bubbling and cracking.

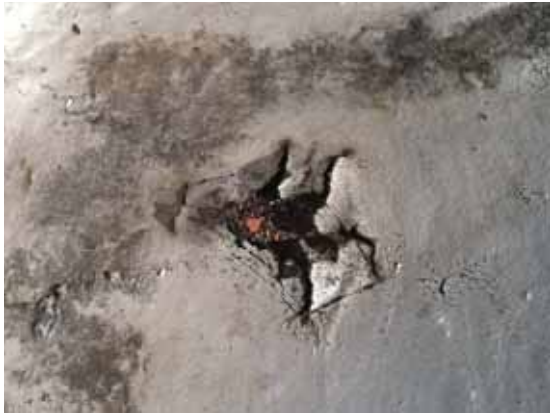
Fig. 2.1.A.22 Cracking of the painted roofing membrane.

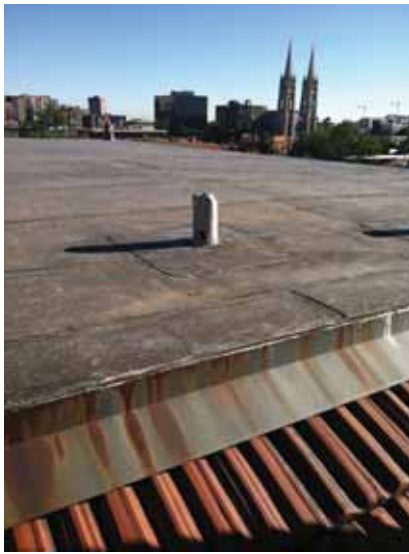
Fig. 2.1.A.23 General deterioration of the roofing materials at the flat central portion of the roof.

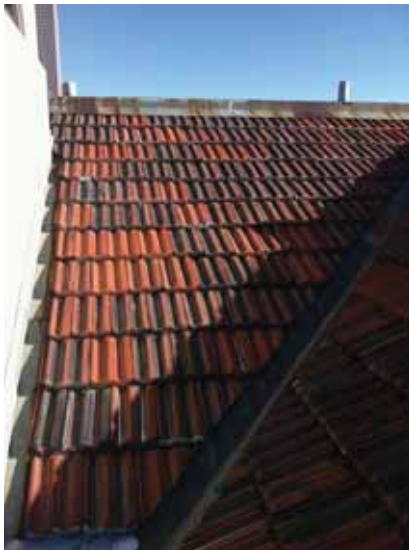
Fig. 2.1.A.24 Typical soiling noted of the clay tiles covering the shallow hipped sections of the roof.

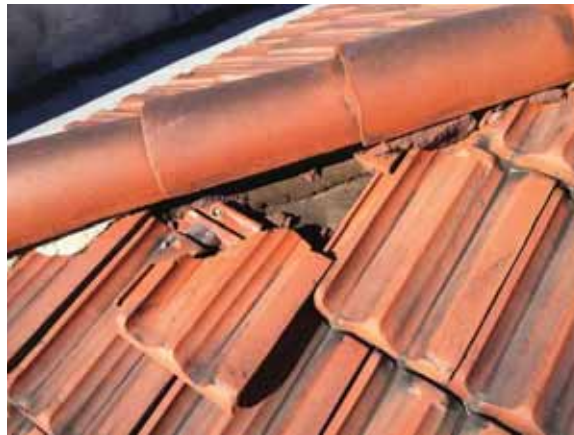
Fig. 2.1.A.25 Broken and loose clay tiles sliding down the side of the roof.

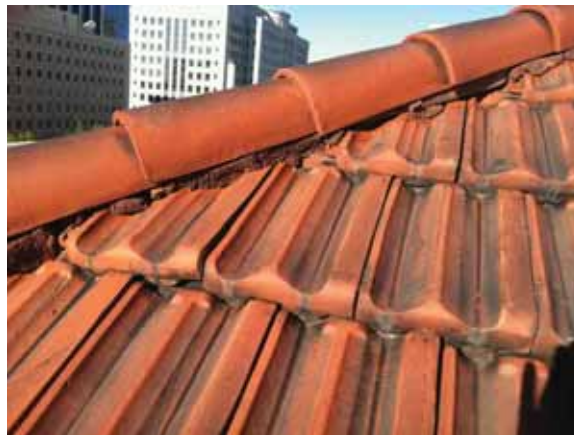
Fig. 2.1.A.26 Deterioration of the masonry along the corners of the roof is providing points by which water can penetrate the roofing membrane.

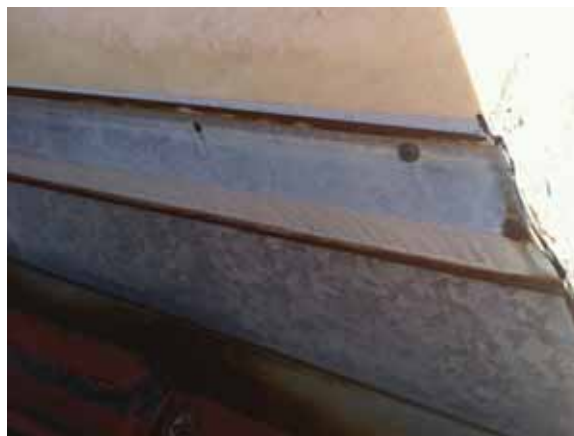
Fig. 2.1.A.27 Widespread corrosion of the flashing was observed around the roof.

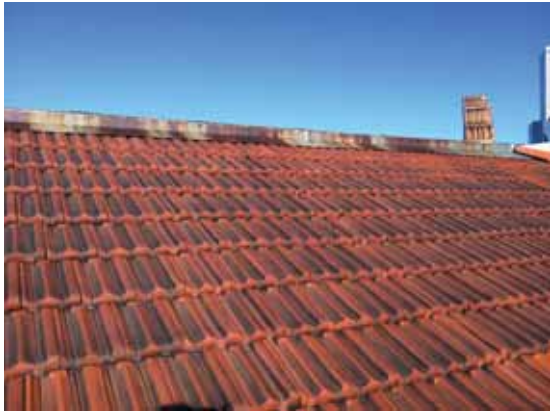
Fig. 2.1.A.28 Widespread corrosion of the flashing was observed around the roof.

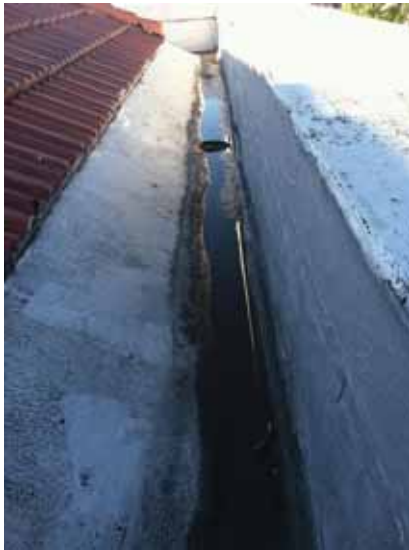
Fig. 2.1.A.29 Ponding water in the areas of the roof adjacent to the parapets.

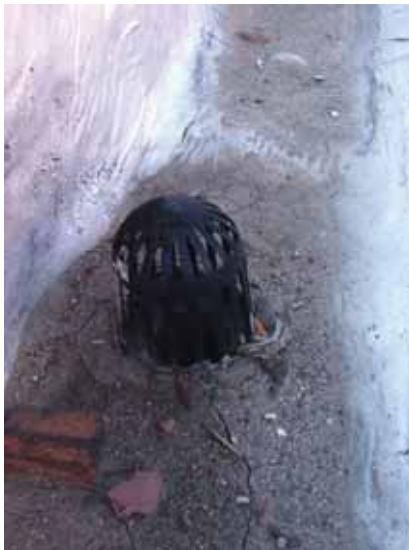
Fig. 2.1.A.30 Dirt and debris accumulating in the areas of the roof adjacent to the parapets.

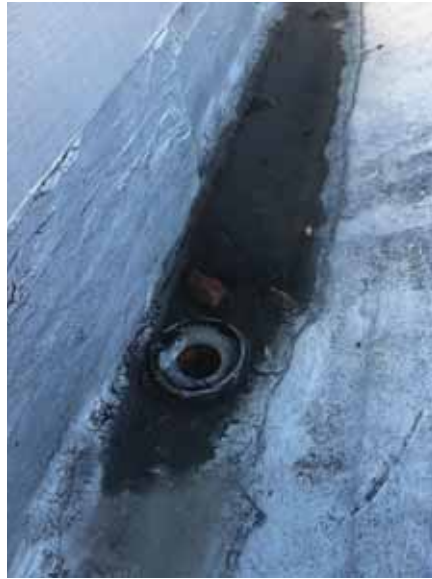
Fig. 2.1.A.31 Missing roof drain covers noted in spots around the perimeter of the roof.

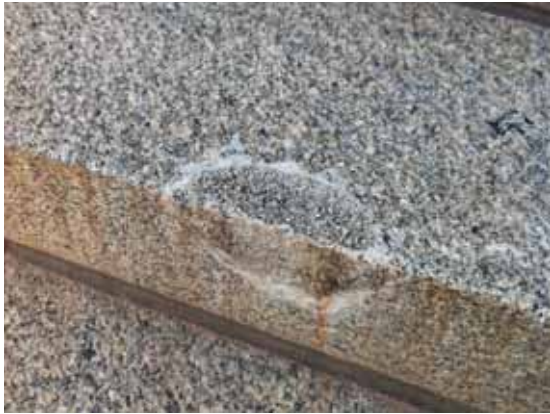
Fig. 2.1.A.32 Previously repaired damage to the granite staircase at the main East 14th Avenue Entrance.

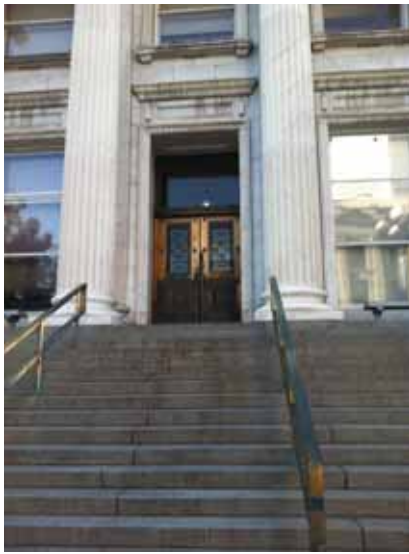
Fig. 2.1.A.33 Soiling of the granite staircase at the main East 14th Avenue Entrance.

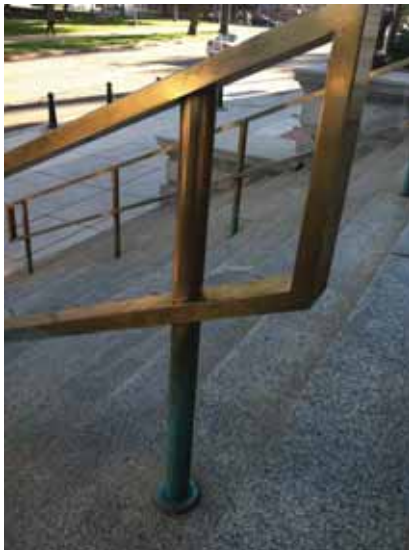
Fig. 2.1.A.34 Corroding metal railings at the East 14th Avenue exterior stairway.

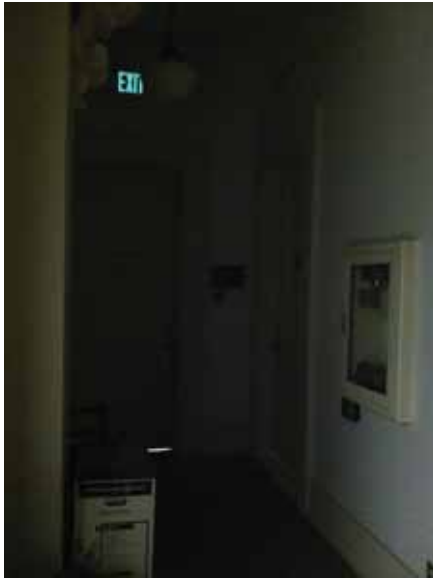
Fig. 2.1.B.1 Exit access corridor at the southwest corner of the building on the Grade Floor with inadequate illumination and with items blocking the corridor space.

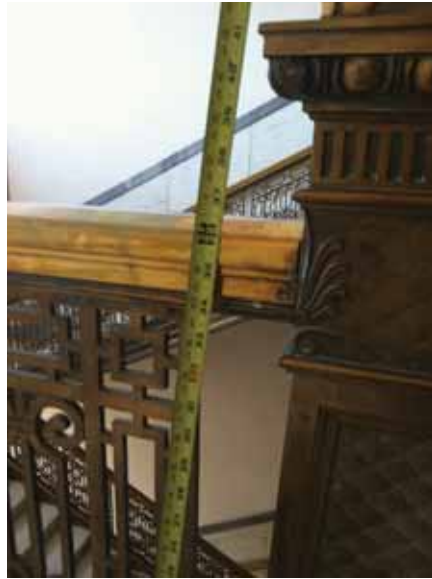
Fig. 2.1.B.4 The height to the top of the guardrails of the open central staircase on the south side of the building.

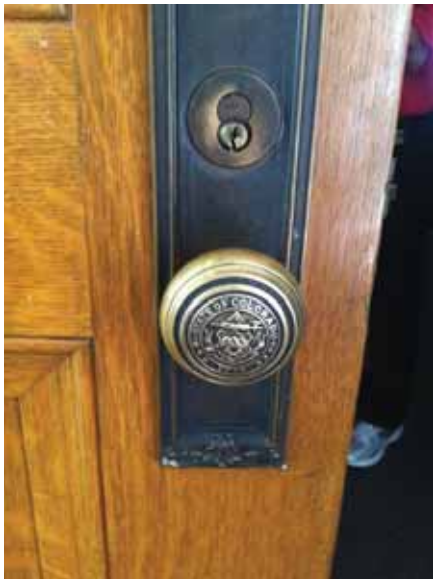
Fig. 2.1.B.5 Typical historic knob-style door handle found throughout the building.

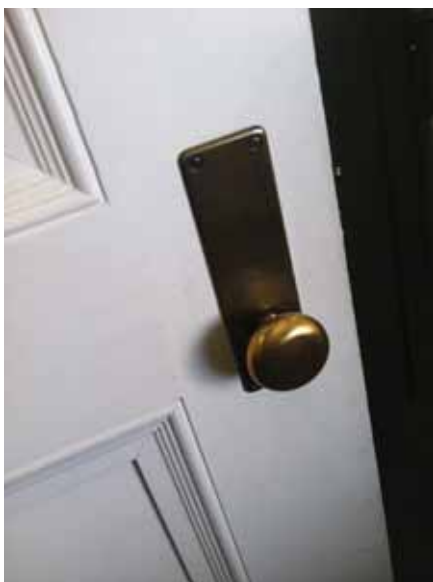
Fig. 2.1.B.6 Typical knob-style door handle found on the doors to the interior exit stairways and to other spaces throughout the building.

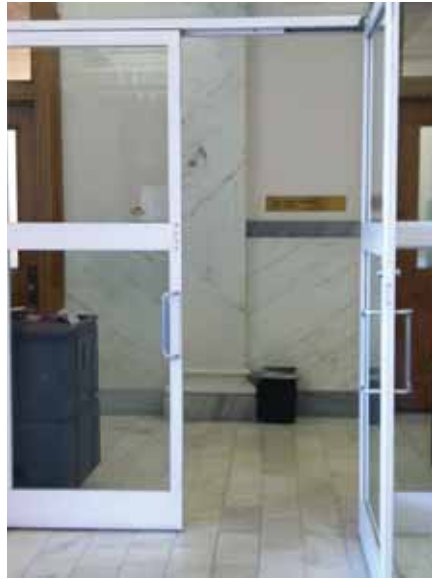
Fig. 2.1.B.7 Pull-style door handles between the lobby and office spaces found at the Second and Third Floors.

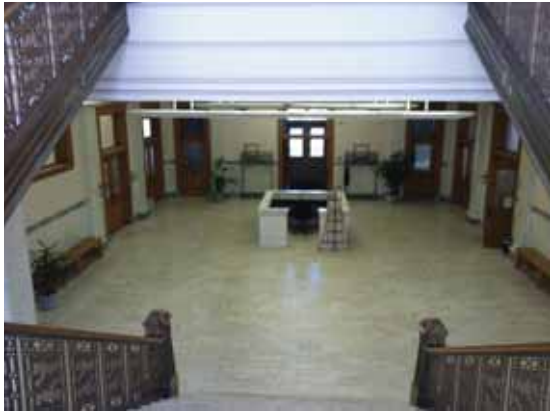
Fig. 2.1.B.8 Reception desk located in the First Floor lobby.

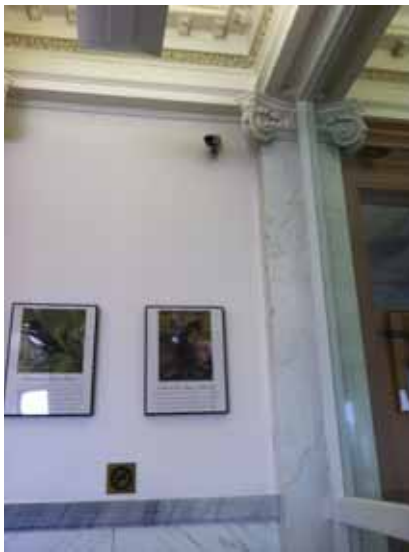
Fig. 2.1.B.9 Typical security cameras noted during the site survey visit.

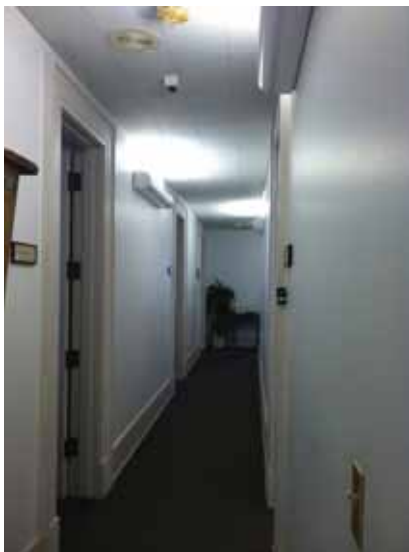
Fig. 2.1.B.10 Typical security camera noted in some of the corridors and office spaces.

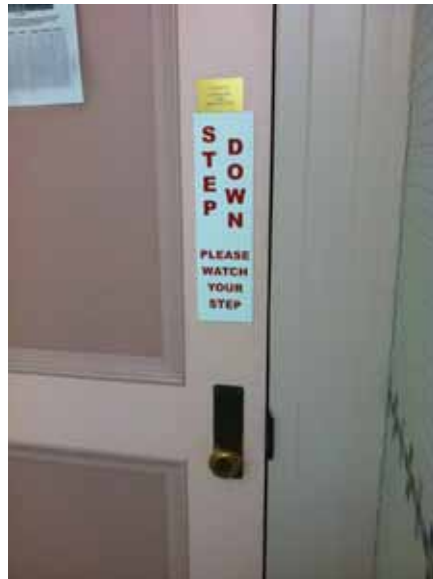
Fig. 2.1.C.4 Thresholds at the restrooms create a change in level of floor surfaces of greater than 1/2 inch high and do not comply with code requirements.

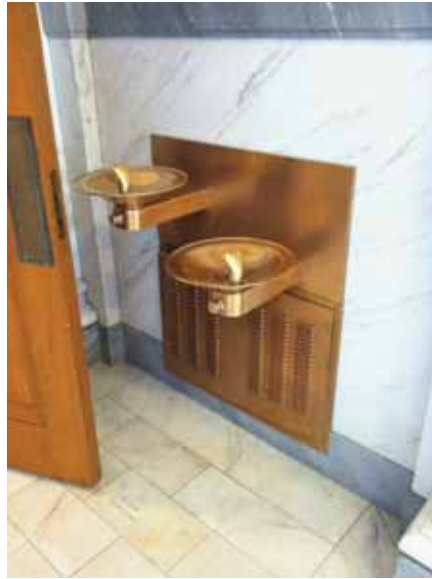
Fig. 2.1.C.9 A door appears to swing into the clear floor space of the drinking fountains on the Second Floor.

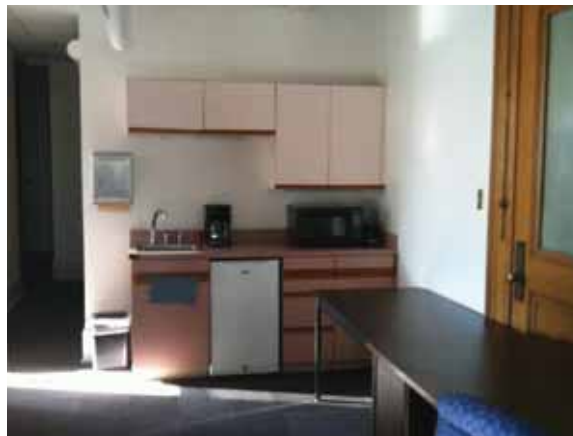
Fig. 2.1.C.10 Typical non-accessible sink found in the Break Rooms throughout.

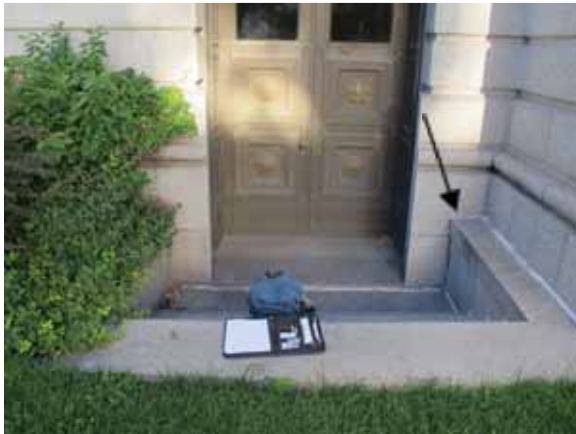
The building's exterior appears to be in relatively good condition with the exception of a few areas. A small recessed concrete stair at grade on the building's western face shows evidence of possible settlement (Fig. 2.2.A.1 and Fig. 2.2.A.2). Existing sealant joints at the interface of the recessed stair with the building have begun to separate and should be monitored for additional movement.

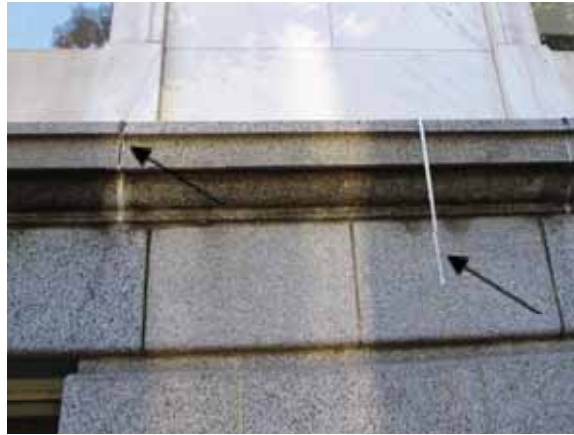
2.0 OVERALL BUILDING ASSESSMENT FINDINGS & RECOMMENDATIONS

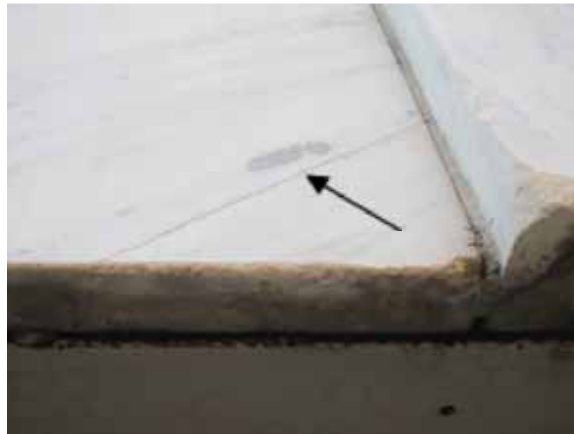
Some cracking of exterior marble panels was observed (Fig. 2.2.A.4).

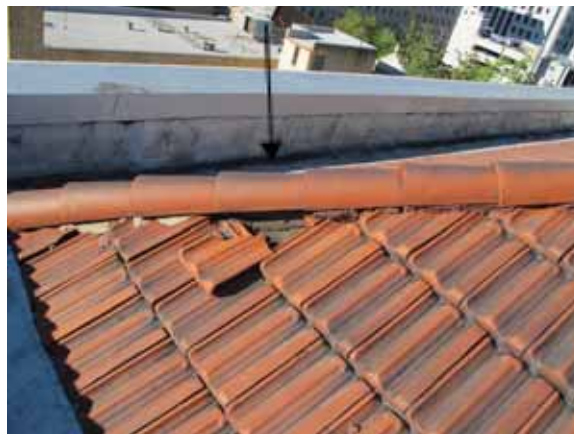
Some clay tiles on the roof have begun to crack and slide down the roof (Fig. 2.2.A.4).

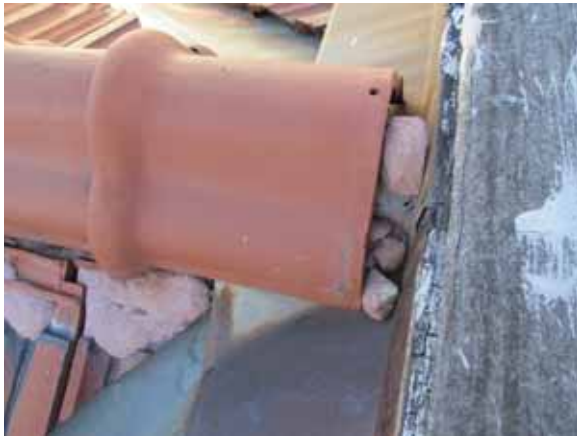
The intersection of the southern dormer window's ridge tile and flat roof is currently open to water penetration (Fig. 2.2.A.6). The introduction of a cricket on the flat roof with flashing and sealant will divert water away from this entry point and prevent structural deterioration.

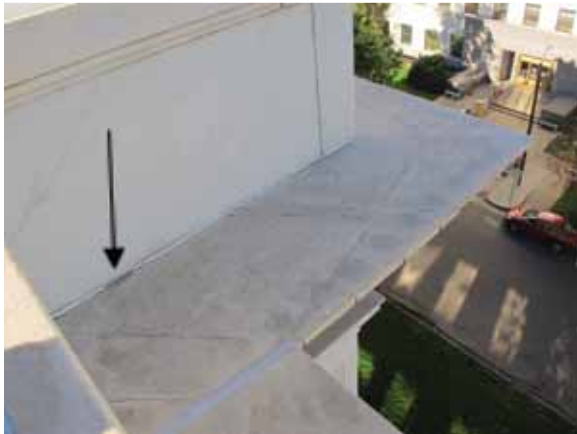
Sealants at reentrant corners on the exterior side of the parapet have failed and should be replaced (Fig. 2.2.A.7).

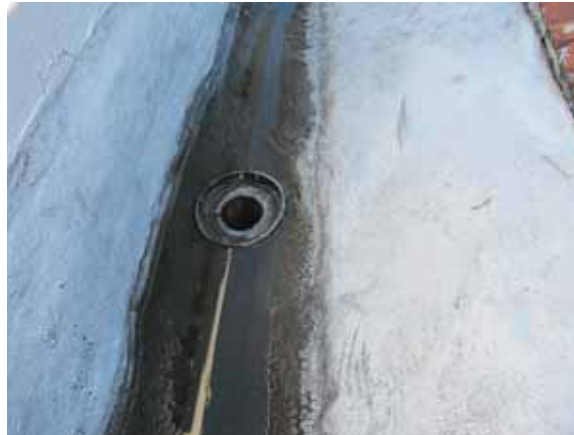
2.0 OVERALL BUILDING ASSESSMENT FINDINGS & RECOMMENDATIONS

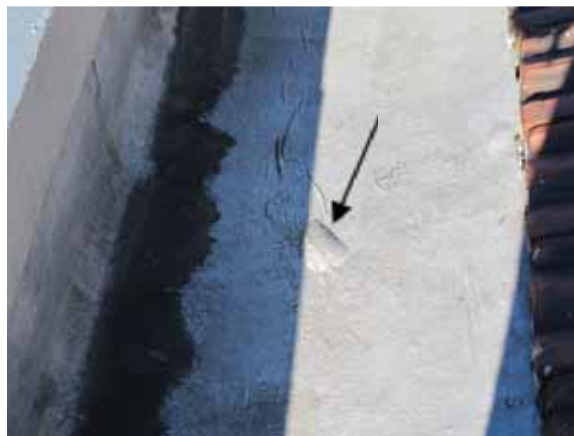
The roofing below the tiled roof has failed in multiple locations (cracking and bubbling, see Fig. 2.2.A.9).

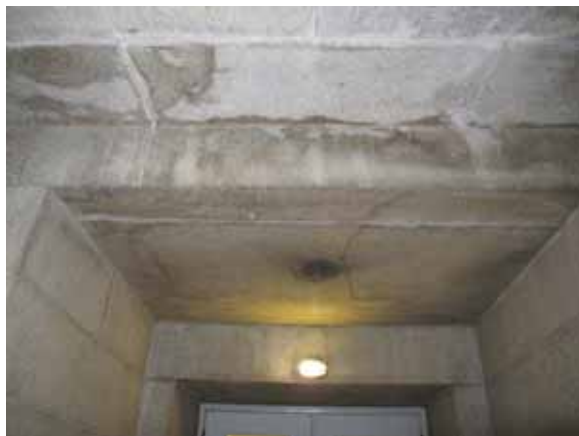
Water penetration and possible corrosion staining was observable at the southern vault ceiling (Fig. 2.2.B.1). It is our understanding the stairs have been replaced recently, so the observed staining may not be of immediate concern.

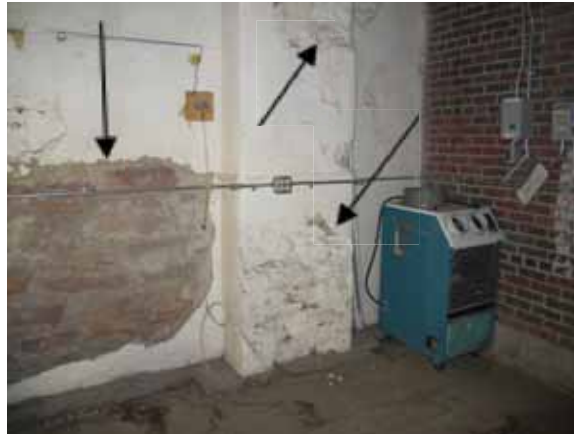
2.0 OVERALL BUILDING ASSESSMENT FINDINGS & RECOMMENDATIONS

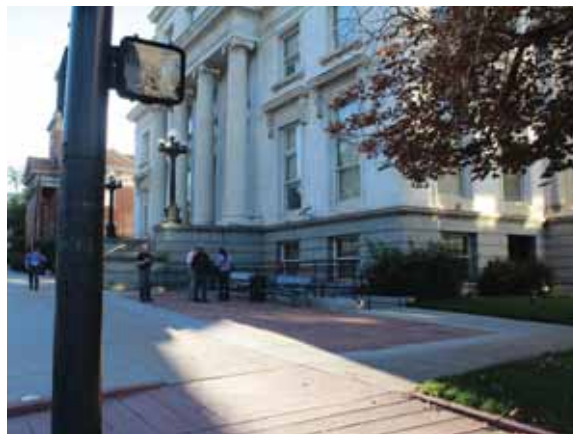
Figure 2.3.A.1 – Legislative Services Building E. 14th Ave. Entrance

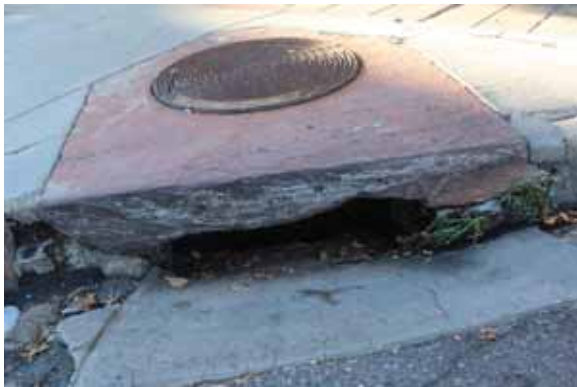
Figure 2.3.A.2 – Street Inlet

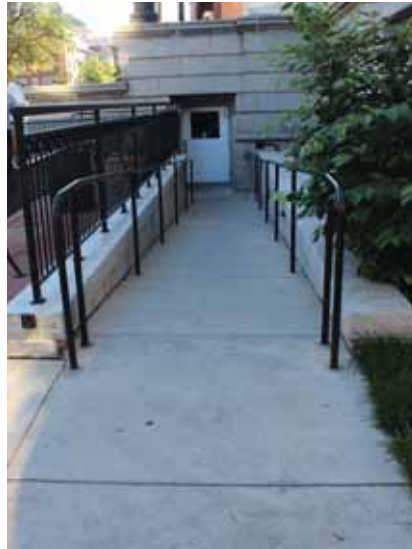
Figure 2.3.A.4 – Accessible Entrance to the West of the Main Entrance

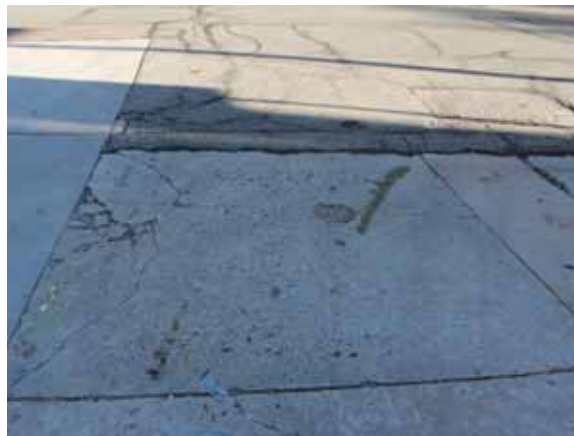
Figure 2.3.A.7 Broken Site Concrete, Recommended for Replacement

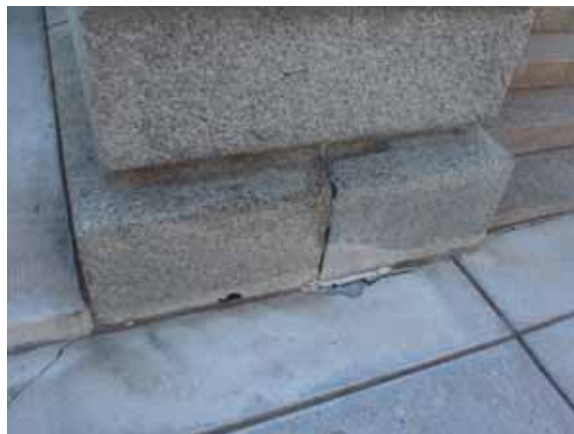
Figure 2.3.A.8 Site Concrete Crack along the Building, Recommended for Repair or Replacement

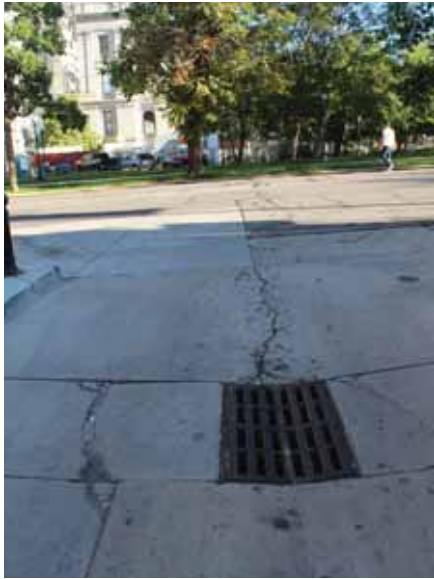
Figure 2.3.A.9 Broken Site Concrete, Recommended for Replacement

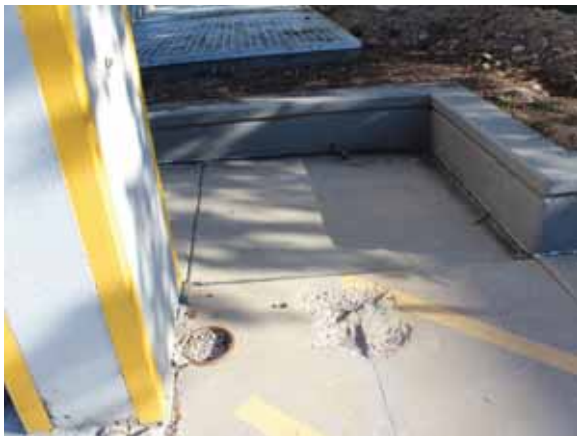
Figure 2.3.A.10 Broken Site Concrete, Recommended for Replacement

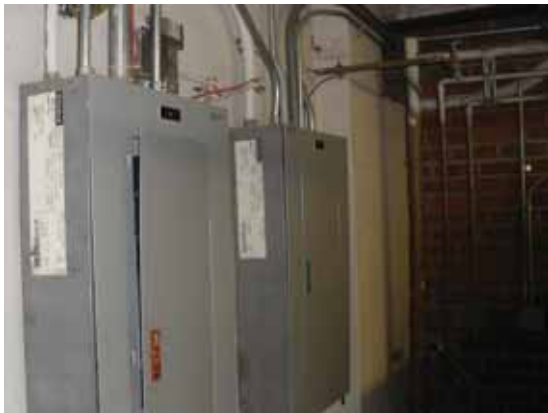
Fig. 2.4.A.2 – Panelboards in sub-basement

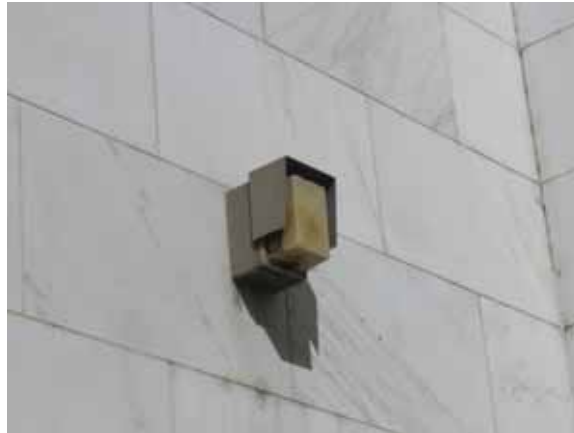
Fig. 2.4.A.7 – Exterior light

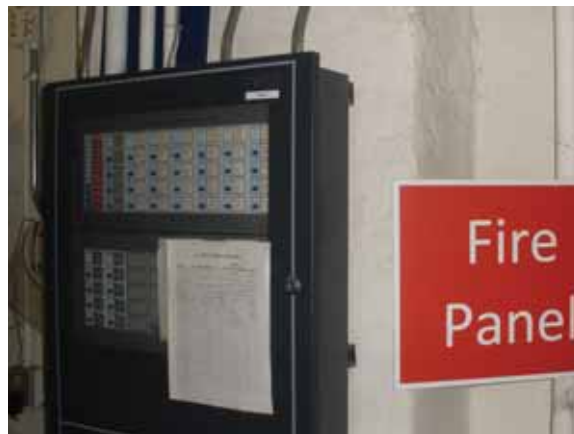
Fig. 2.4.A.8 – Fire panel in sub-basement

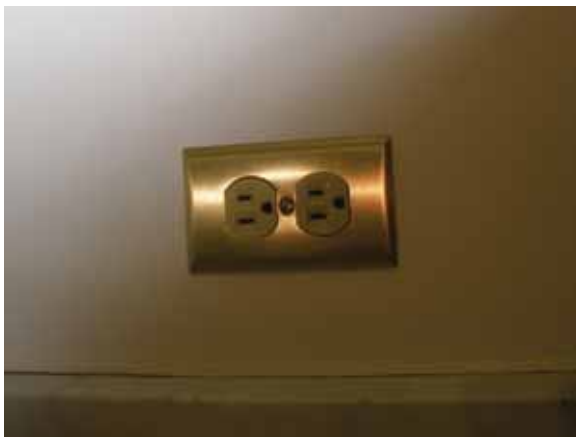
Fig. 2.4.A.9 - Receptacle

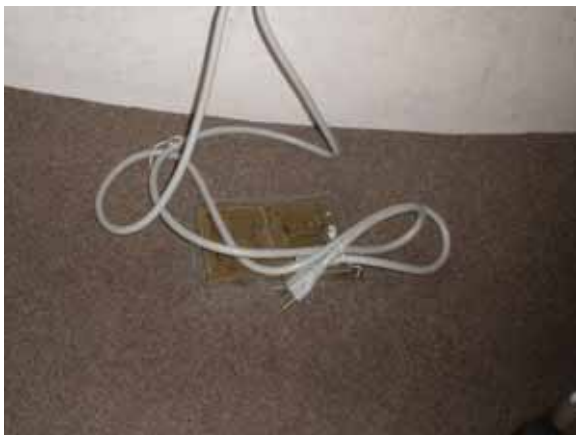
Fig. 2.4.A.10 – In-floor receptacle

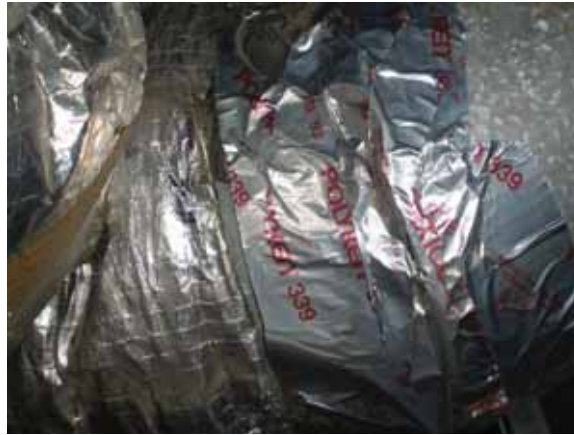
Fig. 2.4.A.12 – Air leakage from duct joint

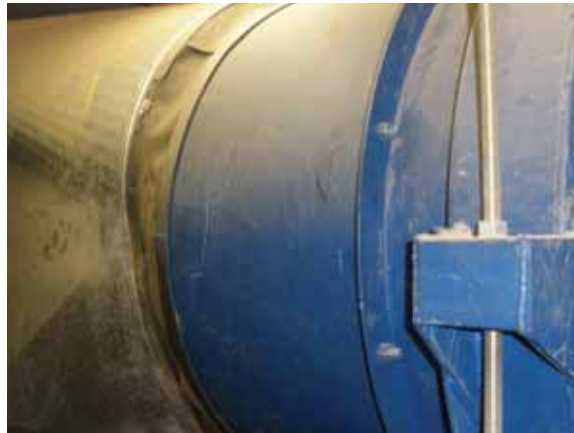
Fig. 2.4.A.13 – Return air fans

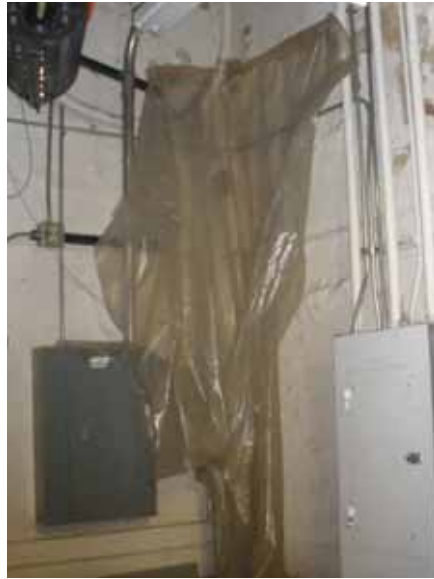
Fig. 2.4.B.1 – Plastic to control water

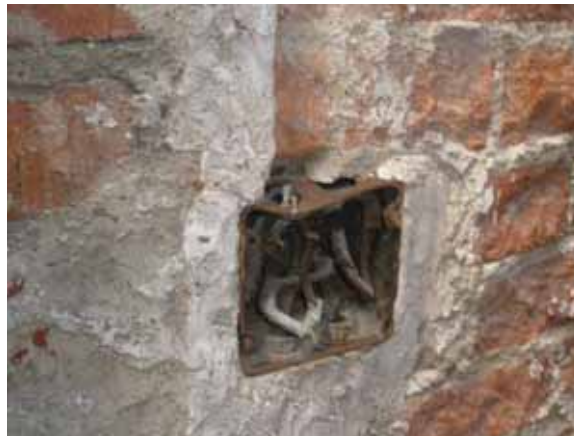
Fig. 2.4.B.2 – Exterior box open

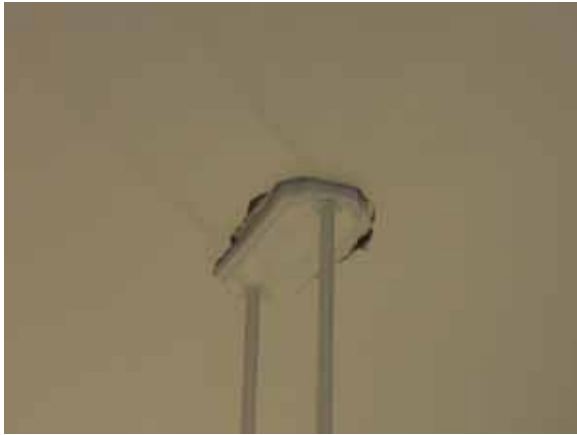
Fig. 2.4.B.3 – Cracked sheetrock around light fixture base

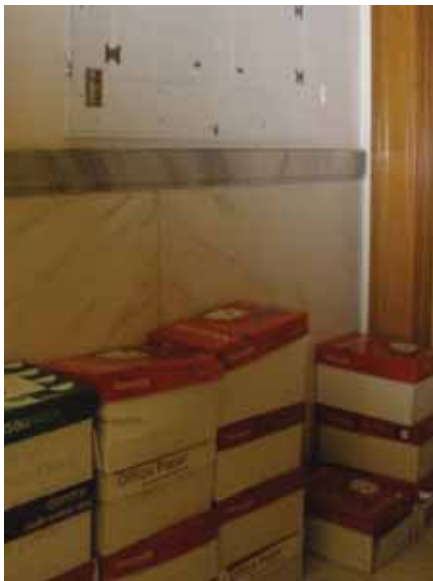
Fig. 2.4.B.4 – Boxes in front of panels

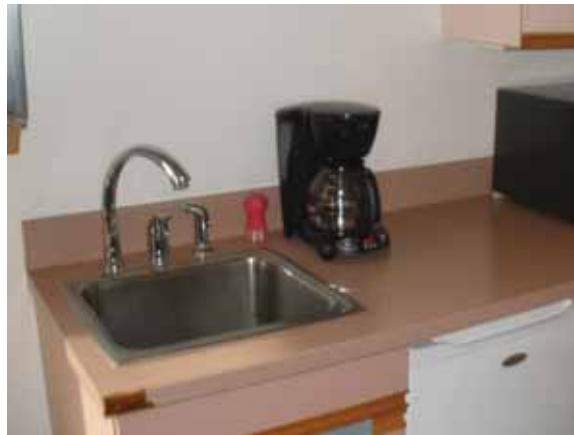
Fig. 2.4.B.5 – No GFI protection by sink

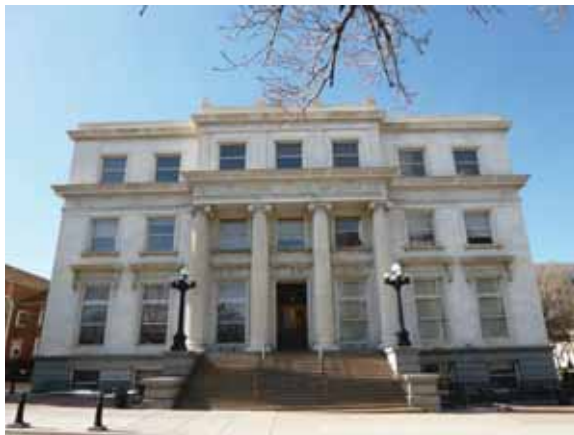
Zone 1 Exterior Facade:
North elevation

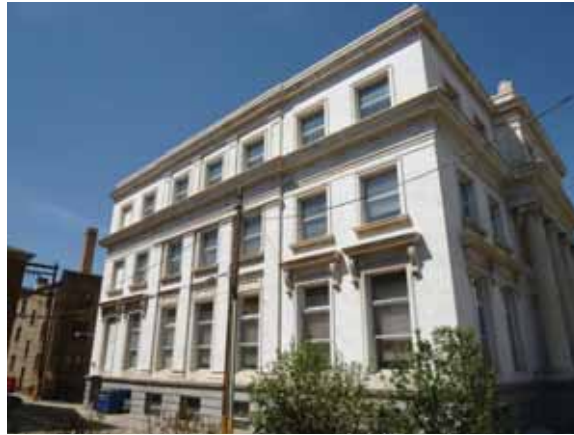
Zone 1 Exterior Facade:
East elevation

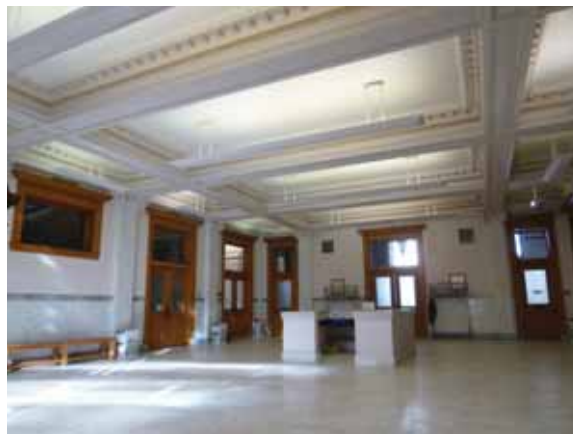
Zone 2 Interior Circulation:
First floor lobby

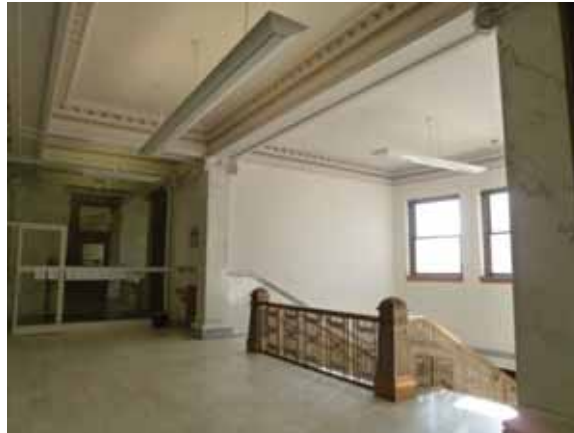
Zone 2 Interior Circulation:
Third floor lobby

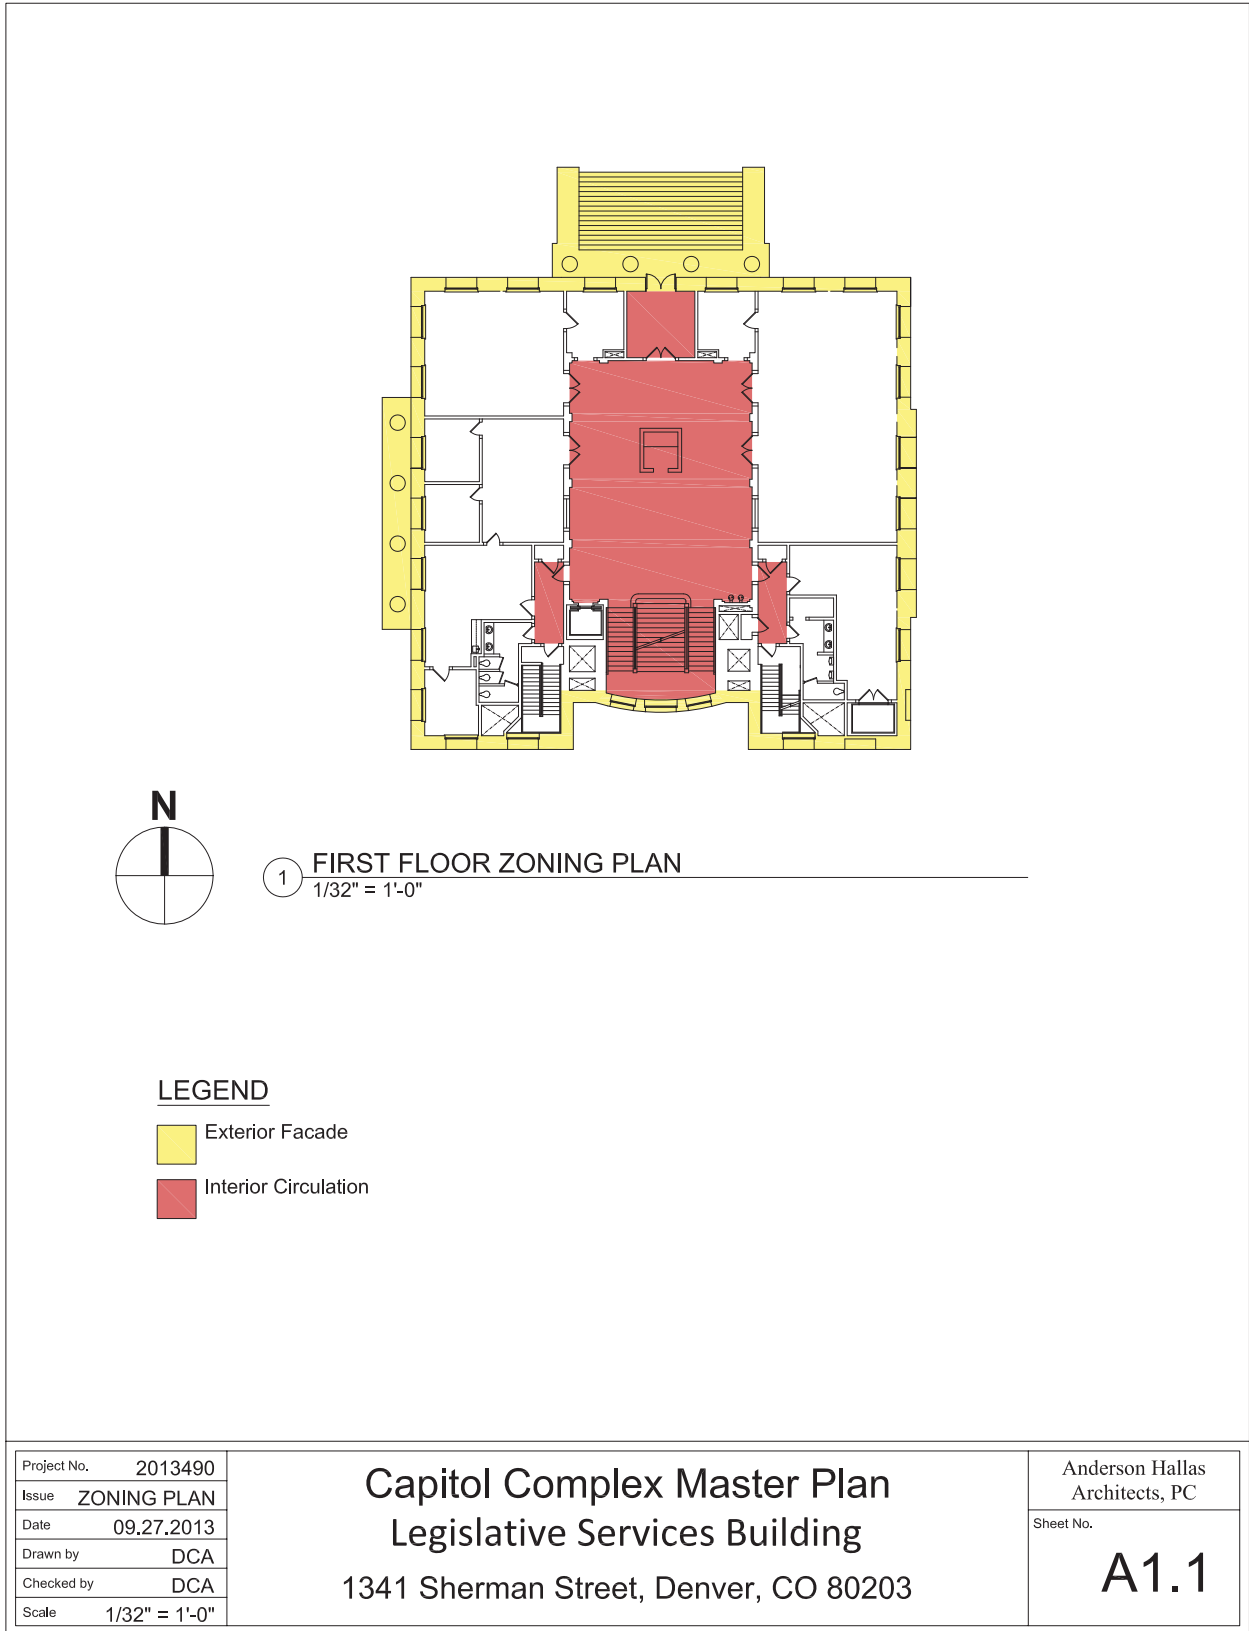
3.0 FLOOR-BY-FLOOR ASSESSMENT FINDINGS & RECOMMENDATIONS
