CAPITOL COMPLEX MASTER PLAN
FINDINGS & RECOMMENDATIONS (F & R) NEEDS ASSESSMENT
LEGISLATIVE SERVICES BUILDING, 200 EAST 14TH AVENUE (DENVER)

NOVEMBER 2014

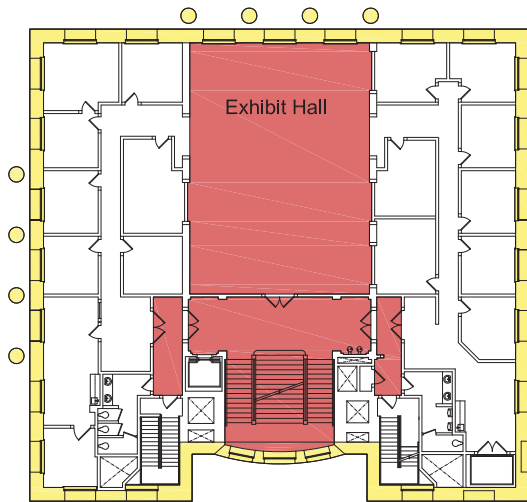
① SECOND FLOOR ZONING PLAN
1/32" = 1'-0"

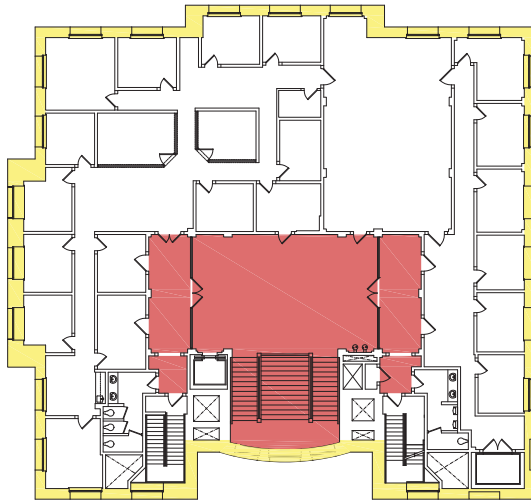
1 THIRD FLOOR ZONING PLAN
1/32" = 1'-0"

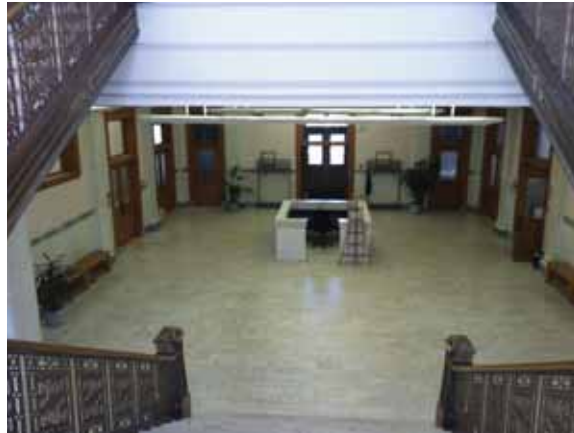
First Floor central lobby, looking north from the grand central stairway.

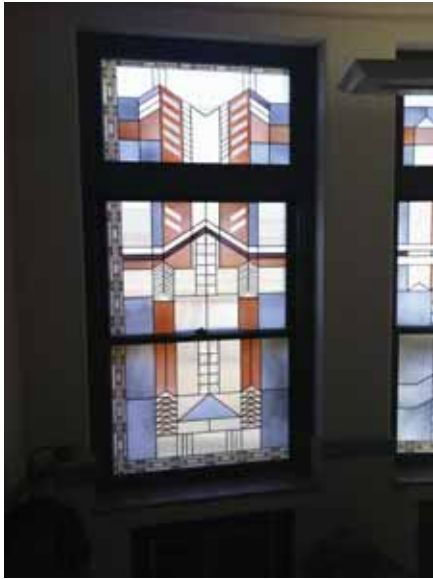
Stained glass installation by J. Gorsuch Collins at the grand central stairway windows located at the landing between the First and Second Floors.

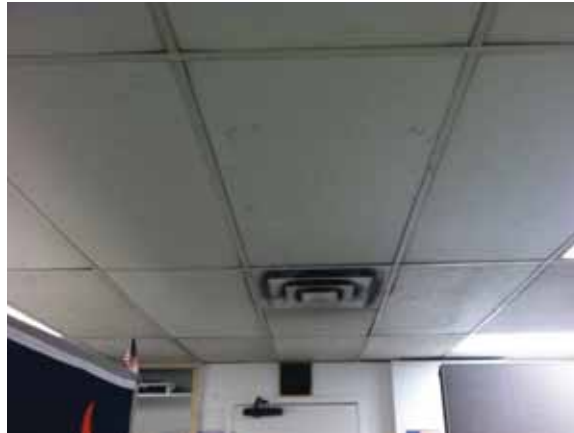
Fig. 3.1.C.1 Damaged and soiled 2x4 acoustic ceiling tiles noted throughout the Basement Floor.

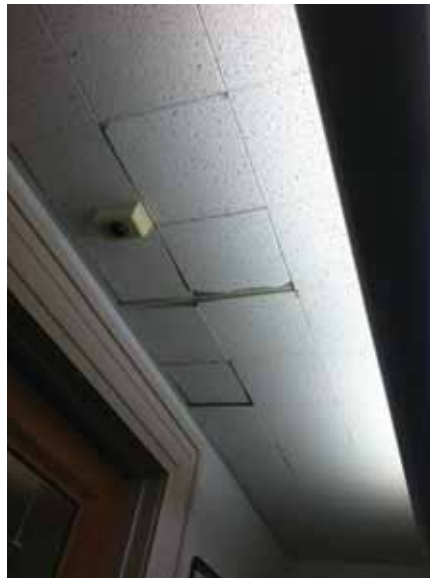
Fig. 3.1.C.2 Deteriorating and damaged 1x1 square acoustic ceiling tiles.

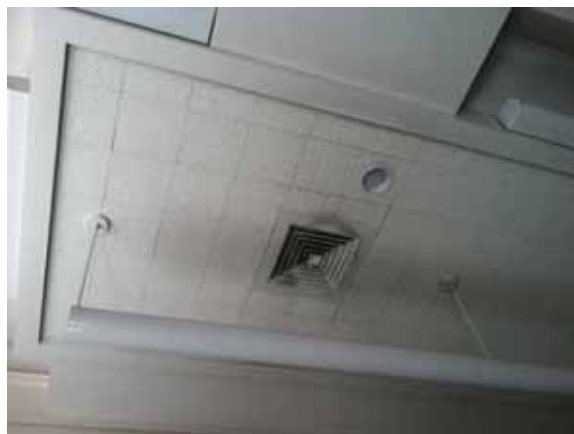
Fig. 3.1.C.3 Soiled 1x1 square acoustic ceiling tiles near air diffusers.

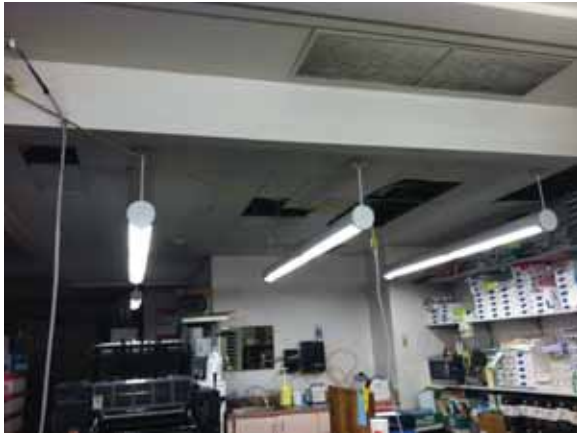
Fig. 3.1.C.4 Deteriorating, damaged, and missing 1x1 square acoustic ceiling tiles noted in the Print Shop on the Ground Floor.

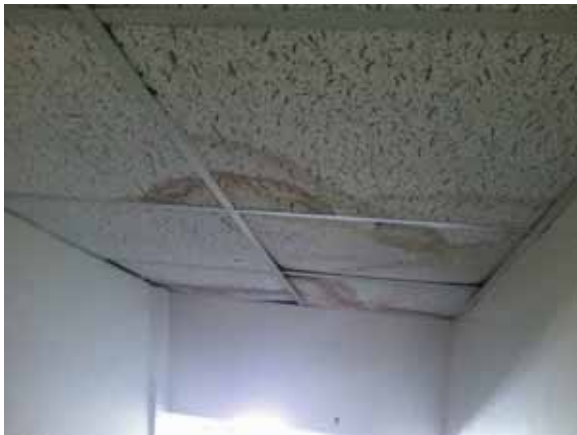
Fig. 3.1.C.5 2x4 acoustic ceiling tiles in poor condition within the interior exit stairway at the attic landing.

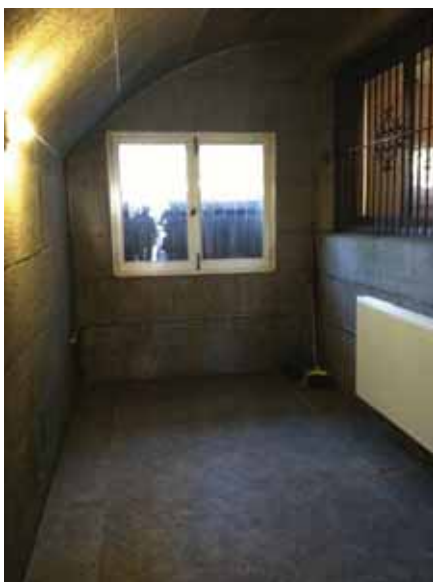
Fig. 3.1.C.6 Signs of water damage note to the granite cladding on the ceilings and walls in the Ground Floor accessible entrance vestibule on the north side of the building.

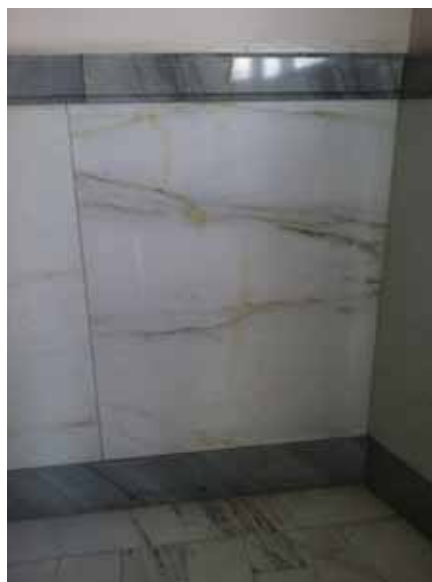
Fig. 3.1.C.7 Areas of soiled marble wainscoting noted throughout the building.

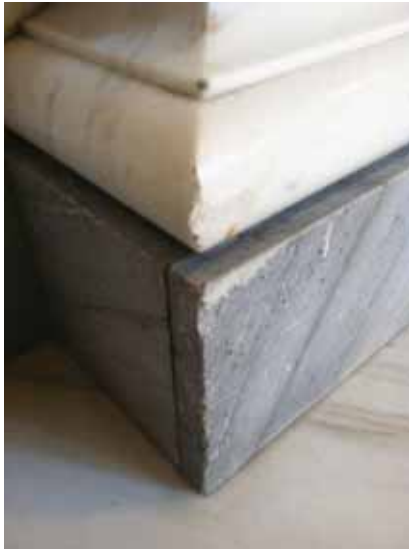
Fig. 3.1.C.8 Areas of damaged marble wainscoting and cladding noted throughout the building.

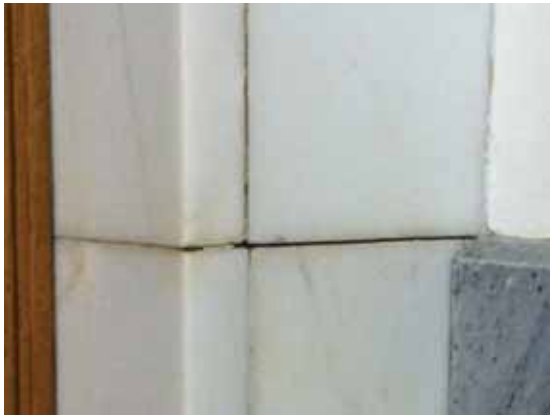
Fig. 3.1.C.9 Areas of deteriorating or missing grout at the marble wainscoting throughout.

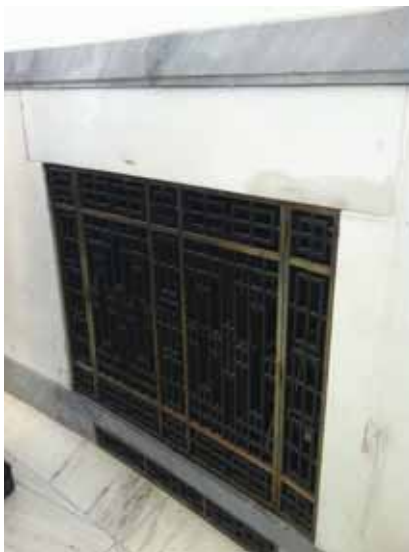
Fig. 3.1.C.10 Damage and wear-and-tear noted to the marble wainscoting around a metal grill at the grand central stairway.

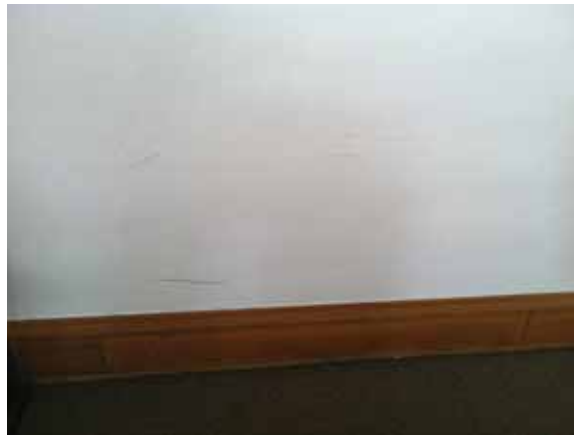
Fig. 3.1.C.11 Minor wear-and-tear noted to the plaster and gypsum board walls throughout the offices, hearing rooms, and corridors included in the site survey visit.

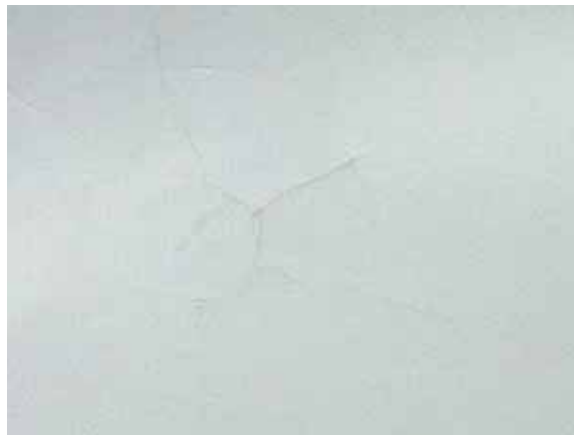
Fig. 3.1.C.12 Area of damaged plaster or gypsum board wall noted in a corridor on the Third Floor.

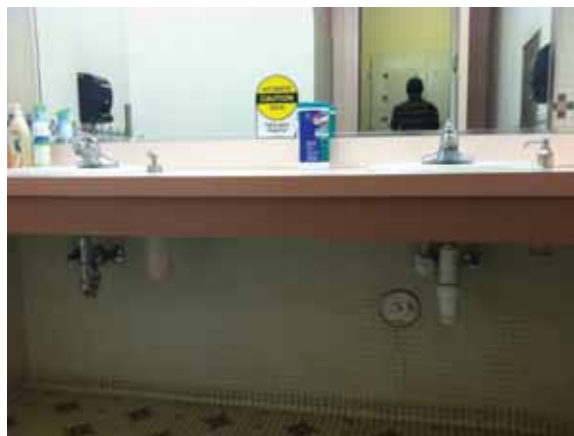
Fig. 3.1.C.13 Soiling noted to the one-inch square tile wainscoting in the restrooms throughout.

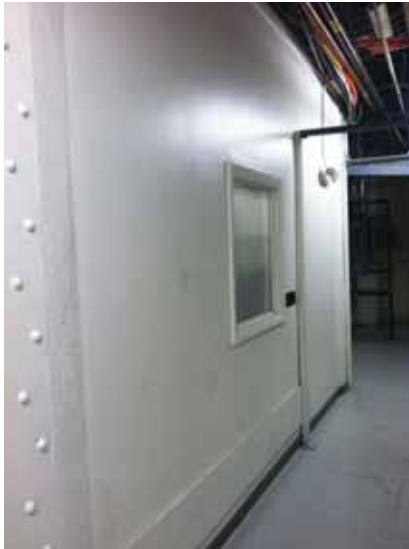
Fig. 3.1.C.14 Wear-and-tear noted to the gypsum board walls in areas of the Basement Floor included in the site survey visit.

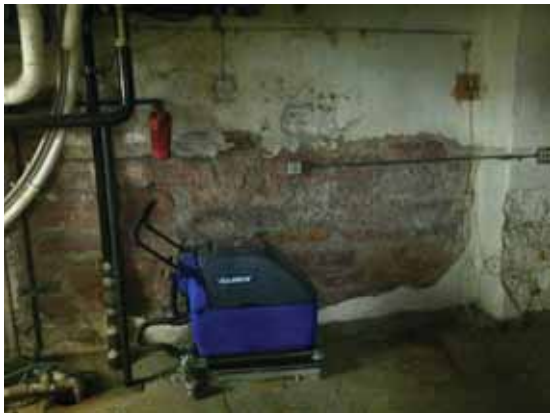
Fig. 3.1.C.15 Deterioration and damage noted to the protective brick coating in areas of the Basement Floor included in the site survey visit.

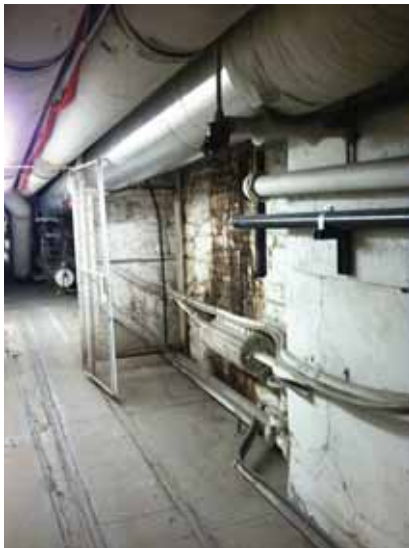
Fig. 3.1.C.16 A brown substance was noted to be dripping down a wall of the Basement Floor near the old coal tracks.

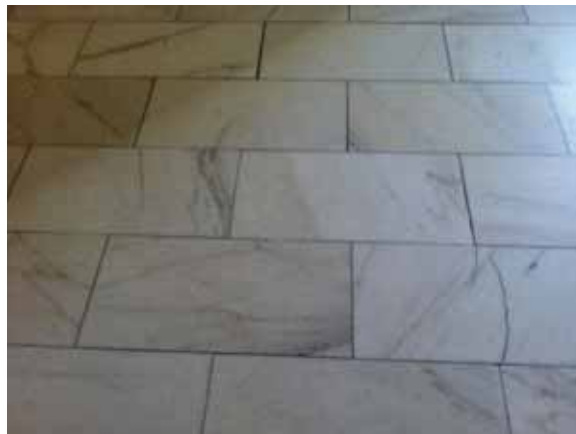
Fig. 3.1.C.17 Cracking noted to the marble flooring throughout.

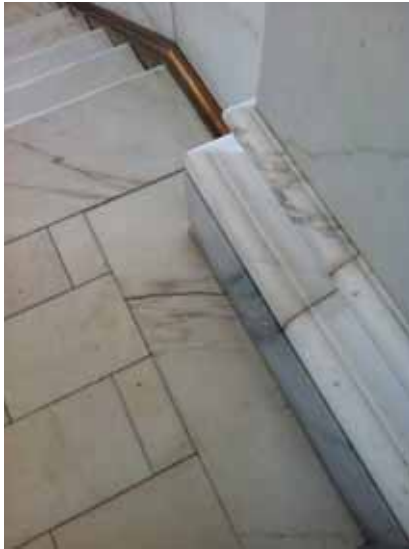
Fig. 3.1.C.18 Cracking noted to the marble flooring throughout.

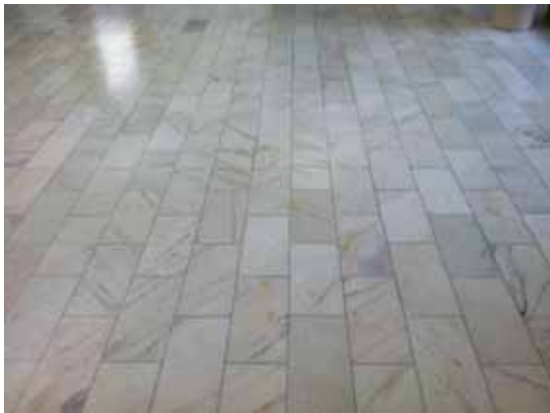
Fig. 3.1.C.19 Soiling and wear-and-tear noted to the marble flooring, especially at the First and Ground Floors.

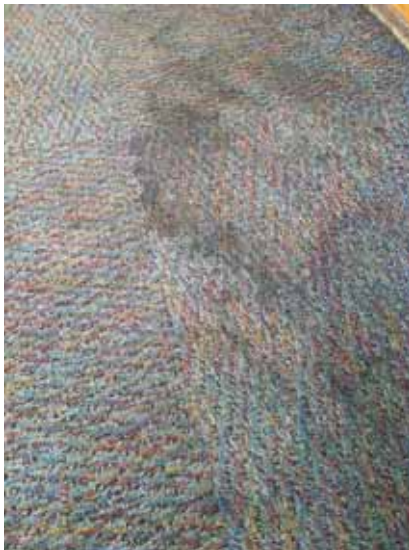
Fig. 3.1.C.20 Soiled and deteriorating carpet noted in areas throughout the building.

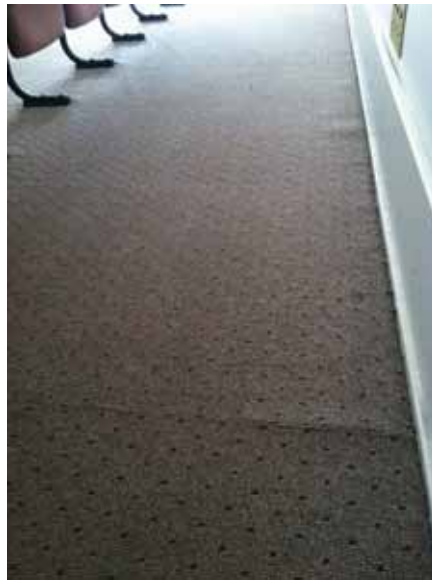
Fig. 3.1.C.21 Carpet flooring pulling loose at the seams and creating a potential tripping hazard.

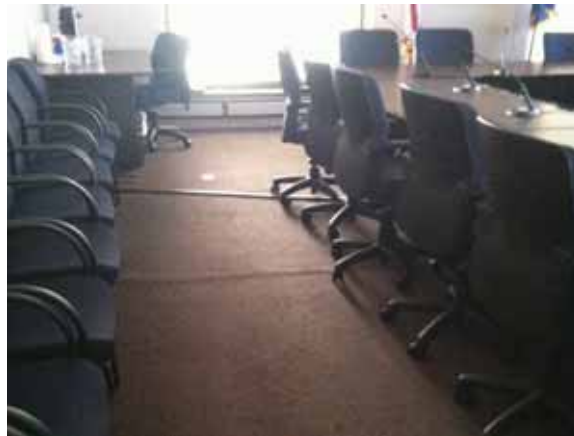
Fig. 3.1.C.22 Carpet flooring pulling loose and bunching together, creating a potential tripping hazard.

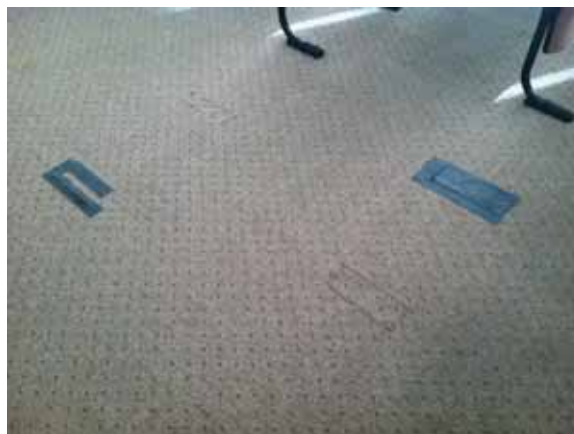
Fig. 3.1.C.23 Tape on the carpet flooring creating a potential tripping hazard in the hearing room at the northeast corner of the First Floor.

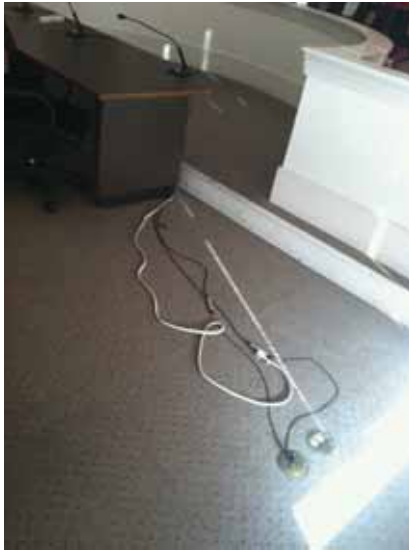
Fig. 3.1.C.24 Electrical cord creating a potential tripping hazard in the hearing room at the northeast corner of the First Floor.

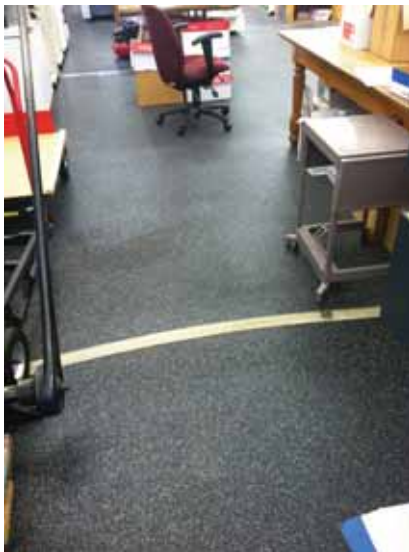
Fig. 3.1.C.25 Electrical cords spanning the Print Shop aisles and creating potential tripping hazards.

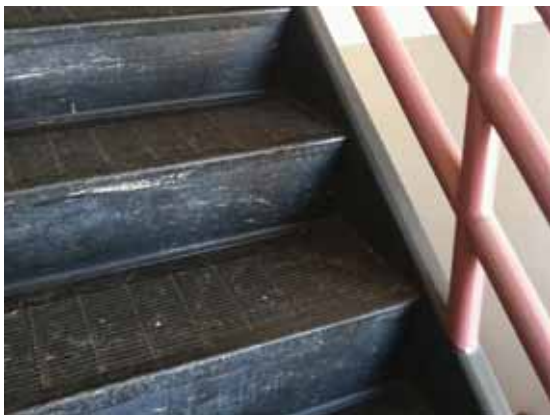
Fig. 3.1.C.26 The rubber flooring covering the stairs in the interior exit stairways has signs of general wear-and-tear throughout.

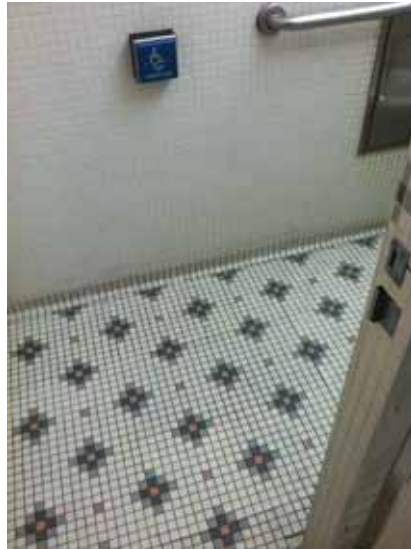
Fig. 3.1.C.27 Soiled one-inch square tile flooring noted in the restrooms throughout.

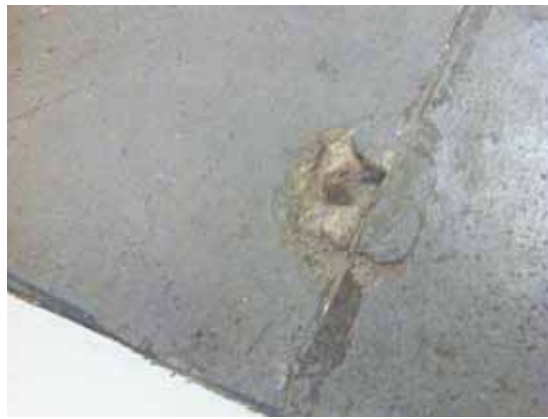
Fig. 3.1.C.28 Spalling concrete flooring noted in the basement.

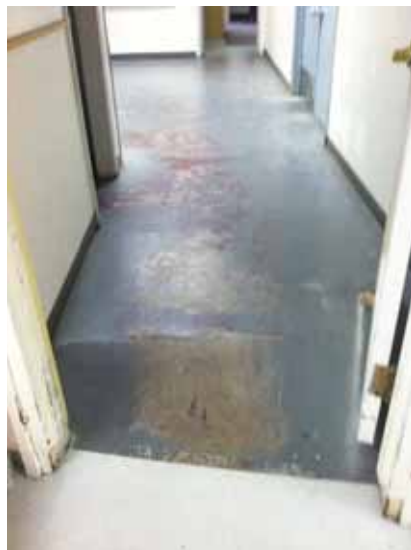
Fig. 3.1.C.29 Paint noted to be wearing off of the concrete flooring in the basement.

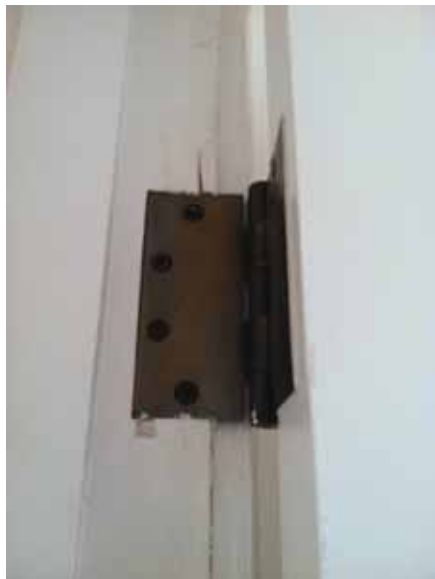
Fig. 3.1.C.30 Cracking door frame at the hinge noted during the site survey visit.

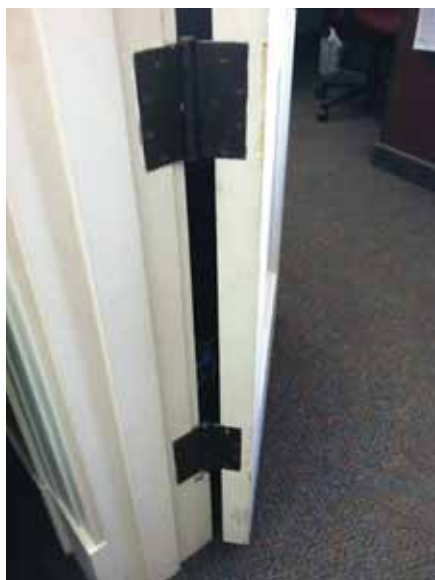
Fig. 3.1.C.31 General wear-and-tear noted at a door during the site survey visit.

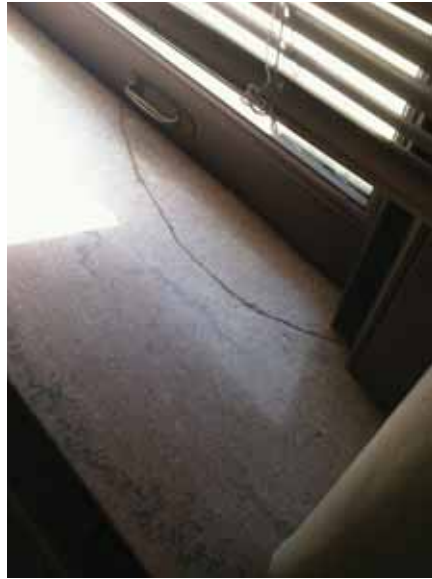
Fig. 3.1.C.32 Cracked stone window sill noted during the site survey visit.
