CAPITOL COMPLEX MASTER PLAN
FINDINGS & RECOMMENDATIONS (F & R) NEEDS ASSESSMENT
HUMAN SERVICES BUILDING, 1575 SHERMAN STREET (DENVER)

NOVEMBER 2014

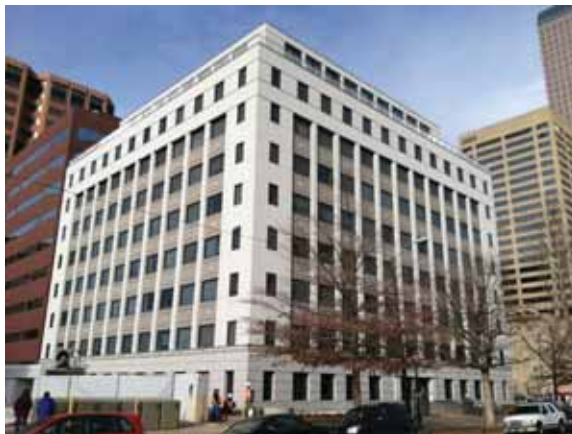
Front & Side/East & South Elevations of the Human Services Building

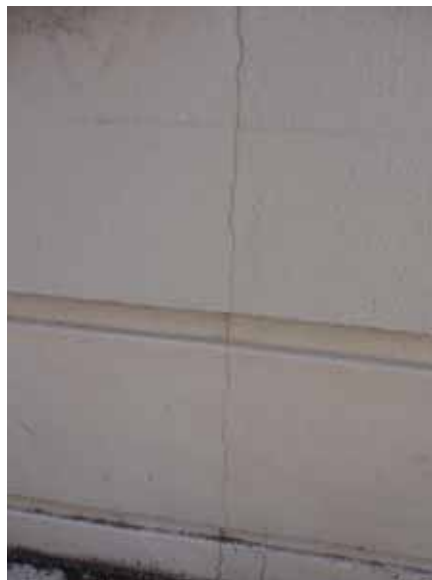
Fig. 2.1.A.1 Cracking of the stucco panels noted around the exterior of the building.

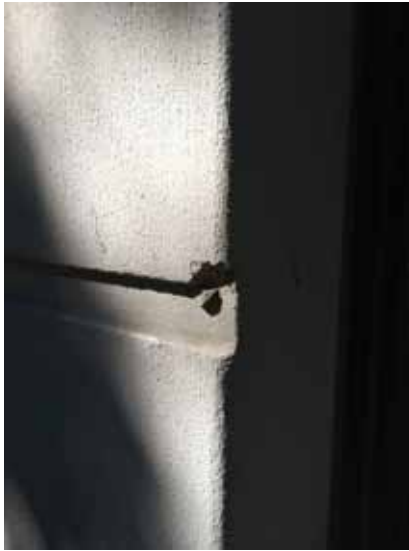
Fig. 2.1.A.2 Spalling of the stucco panels noted around the exterior of the building.

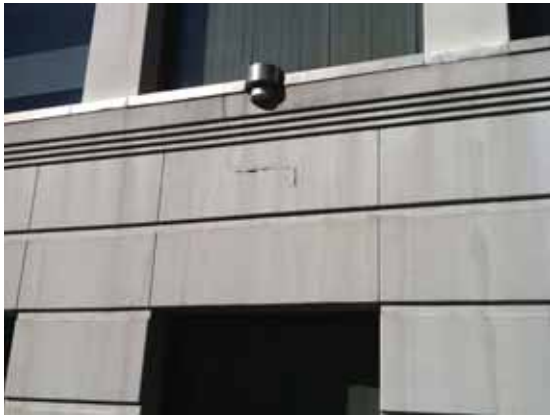
Fig. 2.1.A.3 Damaged, cracked, and soiled stucco noted around the exterior of the building.

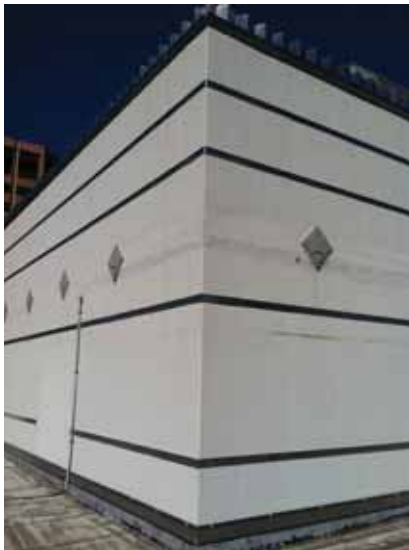
Fig. 2.1.A.4 Cracked and worn stucco noted at the Penthouse on the roof.

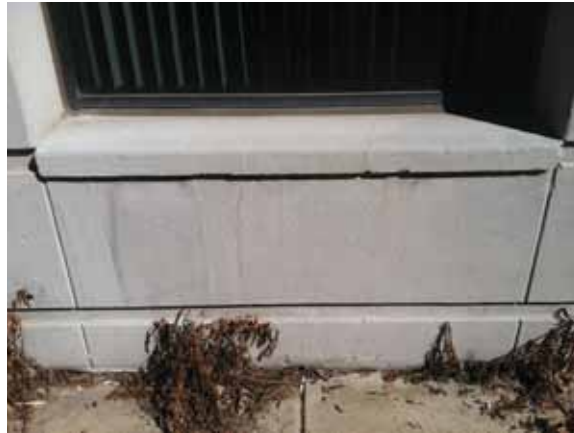
Fig. 2.1.A.5 Soiled, cracked, and spalled stucco noted around the exterior of the building.

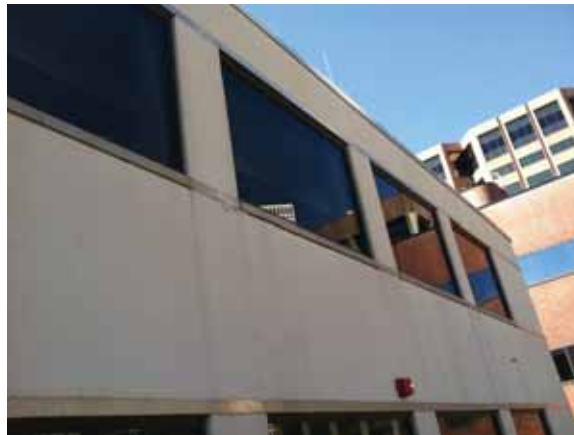
Fig. 2.1.A.6 Soiled stucco panels noted around the exterior of the building.

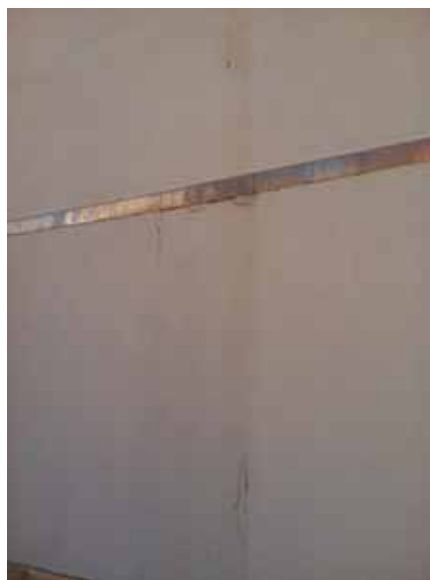
Fig. 2.1.A.7 Corroding metal capping pieces and strips of banding noted in spots around the exterior of the building.

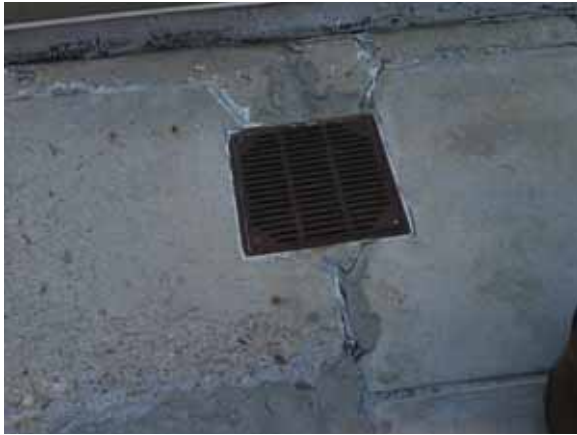
Fig. 2.1.A.8 Spalling concrete pavers located at the Ninth Floor patio and creating a potential tripping hazard.

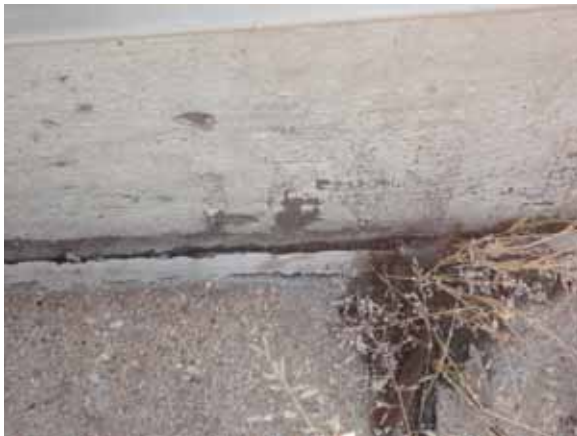
Fig. 2.1.A.9 Deteriorating sealant between the building's walls and the concrete pavers at the Ninth Floor patio.

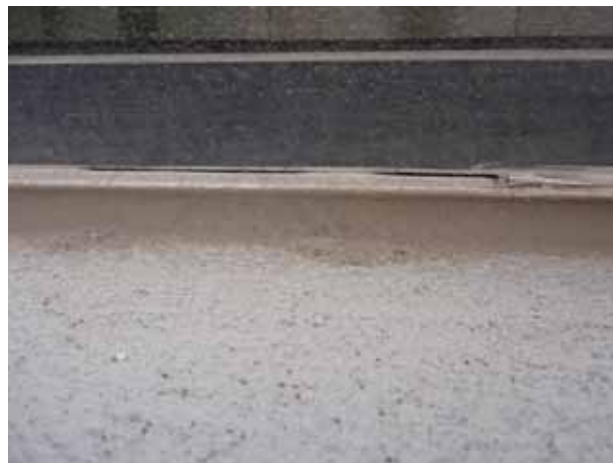
Fig. 2.1.A.10 Typical gaps observed due to deteriorating sealant at the bottom of a window frame, exposing the building envelope to the elements.

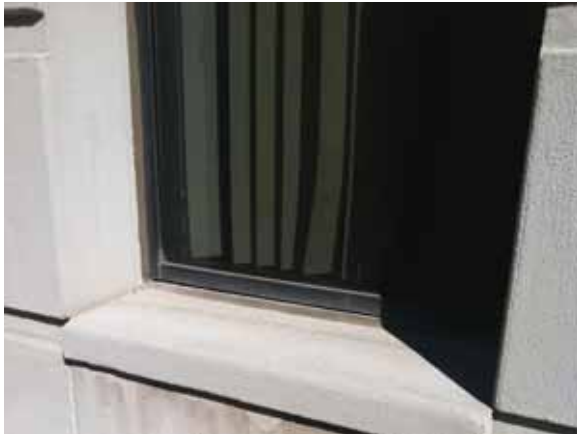
Fig. 2.1.A.11 Typical gaps observed at the bottom of a window frame, exposing the building envelope to the elements.

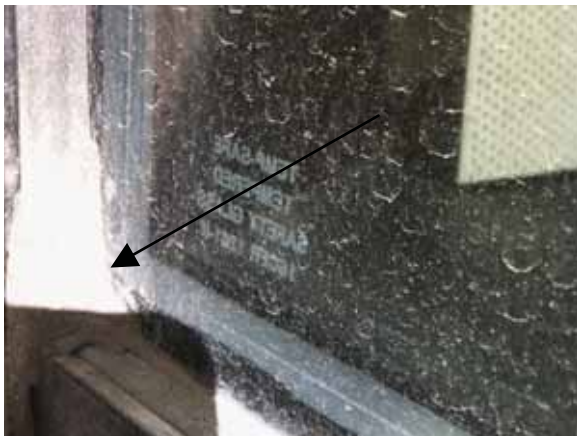
Fig. 2.1.A.12 The material used for previous repairs to the corner joints of the metal window frames appears to be deteriorating.

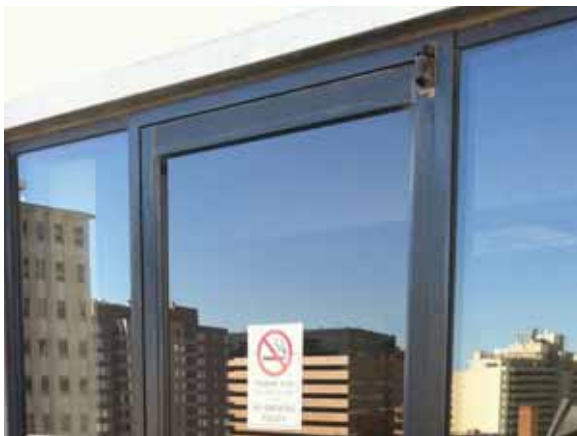
Fig. 2.1.A.13 Minor corrosion noted at the exterior doors.

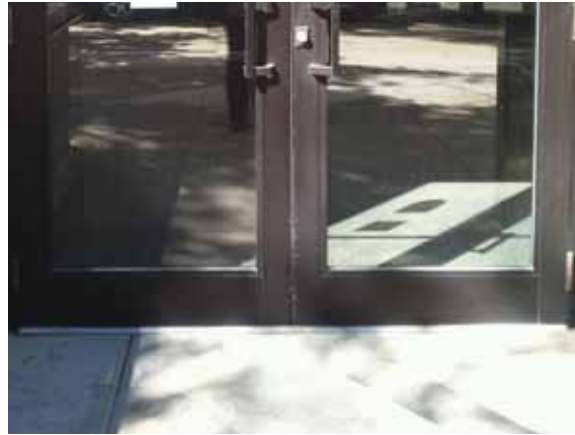
Fig. 2.1.A.14 The weatherstripping at the exterior doors is starting to deteriorate around the building.

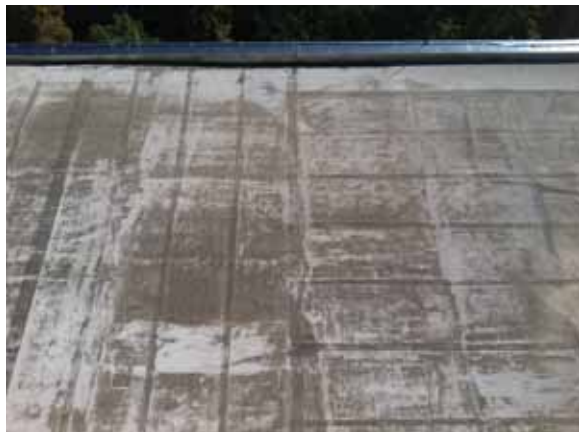
Fig. 2.1.A.15 General deterioration of the roofing membrane noted overall.

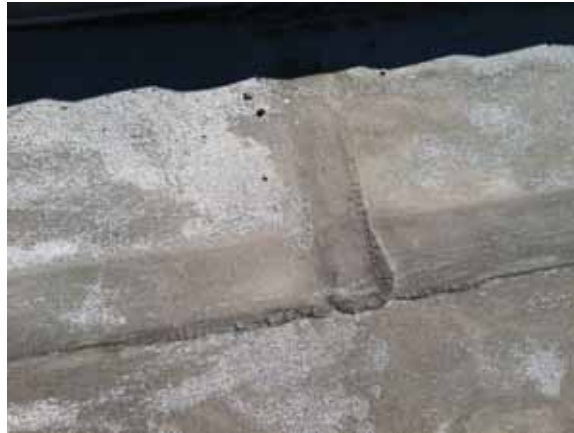
Fig. 2.1.A.16 General deterioration of the roofing membrane noted overall.

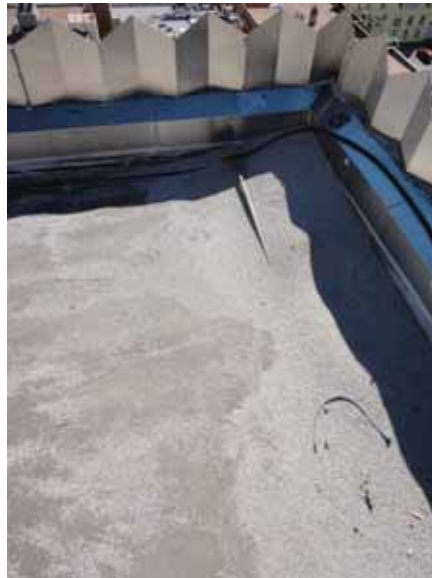
Fig. 2.1.A.17 Piles of aggregate separating from the roofing membrane are collecting at the corners of the roof.

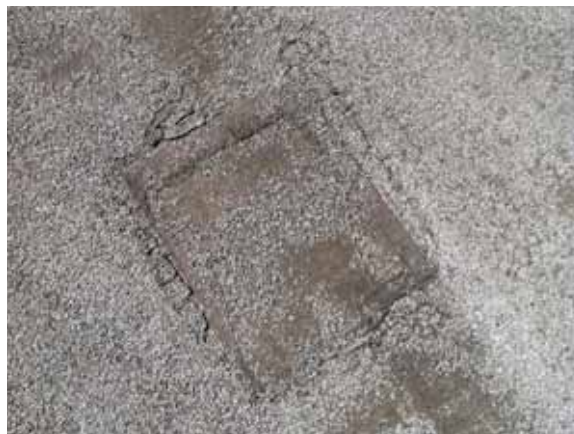
Fig. 2.1.A.18 Previous repairs to the roof membrane were noted to be generally deteriorating throughout.

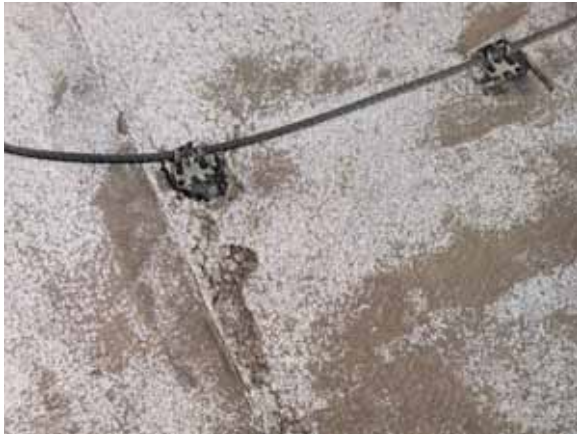
Fig. 2.1.A.19 Deterioration around the metal attachment clips of the lightning protection cable.

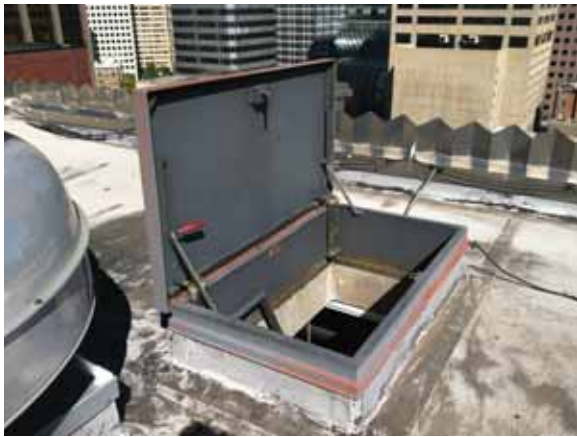
Fig. 2.1.A.20 Corroding access hatch at the Penthouse roof.

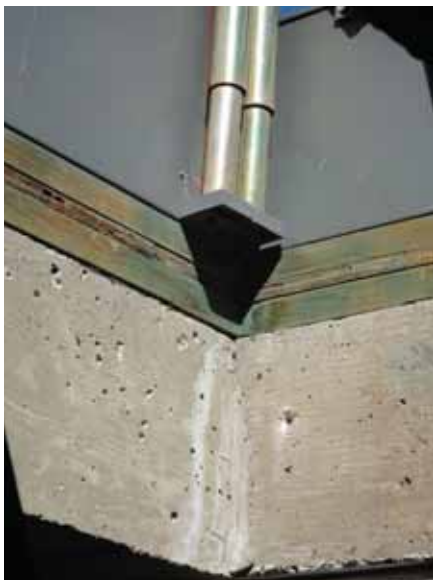
Fig. 2.1.A.21 Spalling concrete and evidence of water infiltration noted just inside the access hatch to the Penthouse roof.

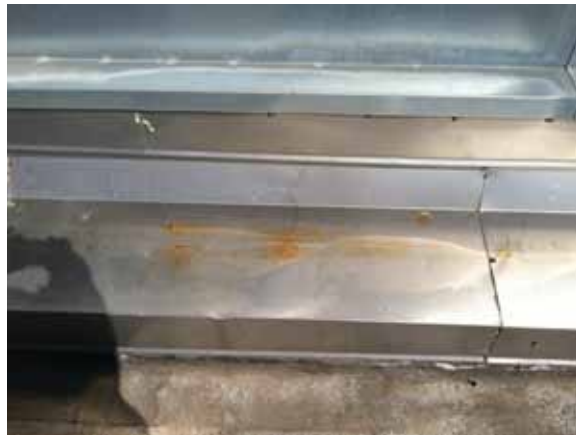
Fig. 2.1.A.22 Corrosion of the flashing noted during the site survey visit.

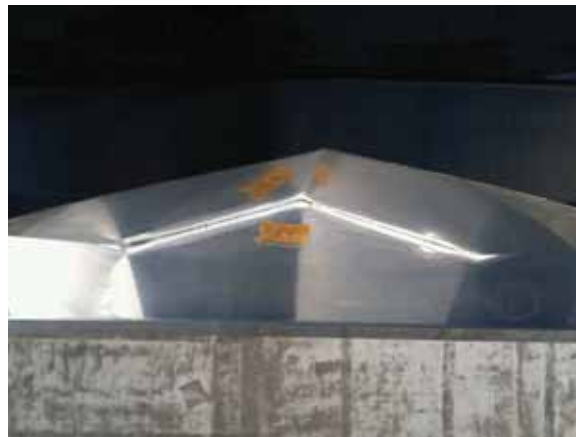
Fig. 2.1.A.23 Spots of corrosion and deteriorating sealant observed around the triangular, folded, decorative metal piece installed around the top perimeter of the Penthouse parapet.

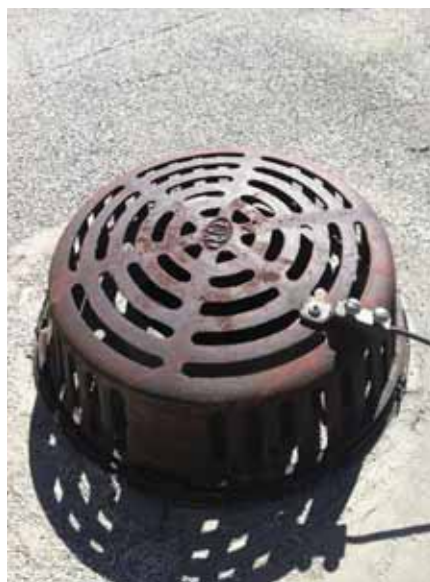
Fig. 2.1.A.24 Typical corroding drain cover noted throughout the roofing areas.

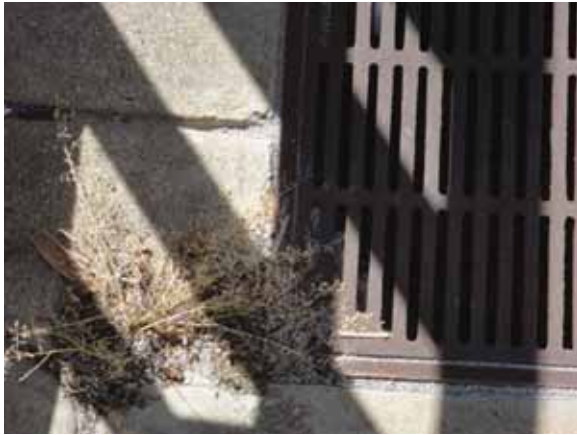
Fig. 2.1.A.25 Corroding drain cover located at the Ninth Floor patio with soil collecting nearby and allowing the growth of weeds.

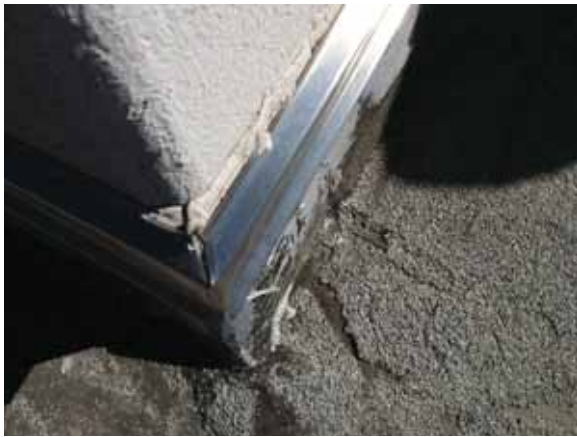
Fig. 2.1.A.26 Typical deterioration of the sealant noted at the flashing around the roof.

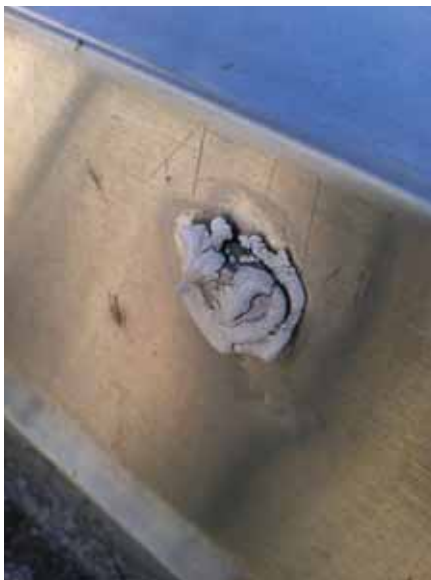
Fig. 2.1.A.27 Typical deterioration of the sealant over the fasteners anchoring the perimeter flashing at the roof parapets.

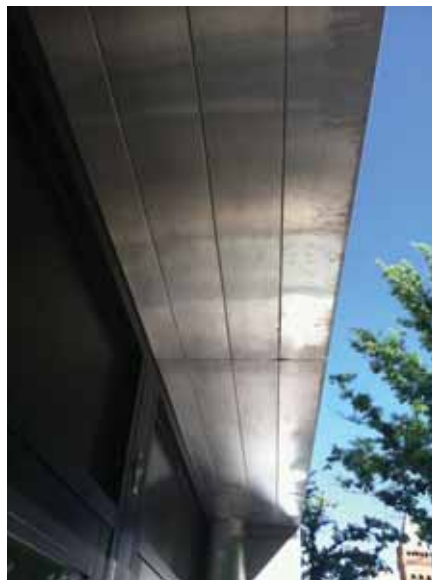
Fig. 2.1.A.28 Water damage and minor spalling of the concrete noted at the canopy of the main Sherman Street Entrance.

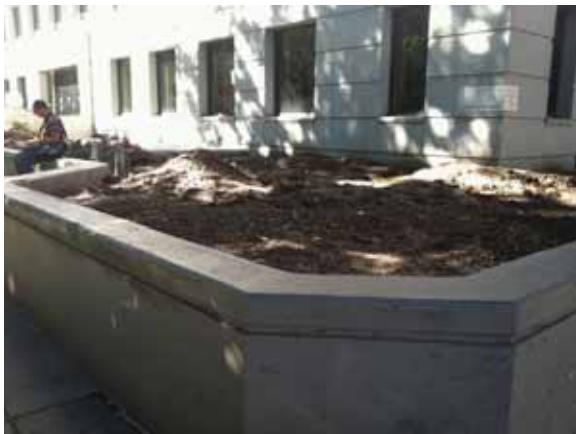
Fig. 2.1.A.29 Typical wear-and-tear and deterioration of the low concrete retaining walls around the exterior of the building.

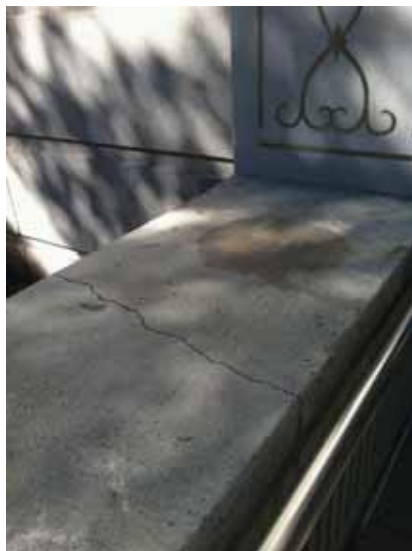
Fig. 2.1.A.30 Cracked concrete coping noted in a few spots along the low retaining walls during the site survey visit.

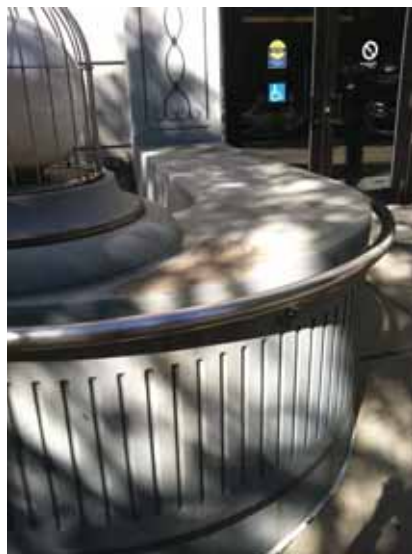
Fig. 2.1.A.31 Typical instance of deteriorating coating noted at the low concrete retaining walls.

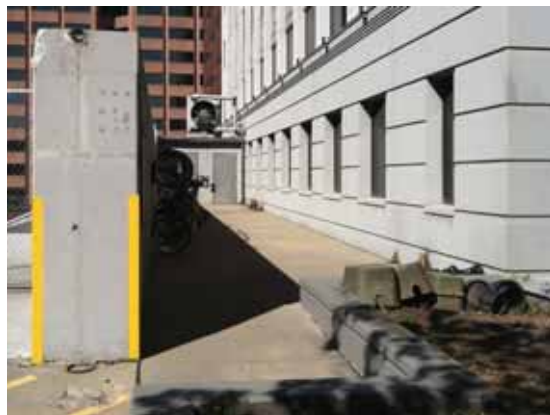
Fig. 2.1.A.32 Spalling and corrosion noted at the east end of the south concrete retaining wall and at the concrete paver located in front of the wall.

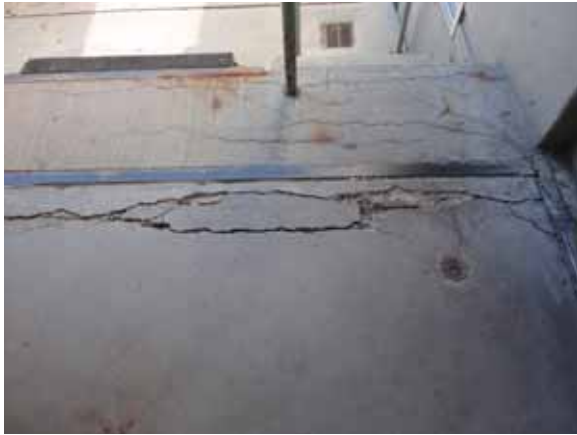
Fig. 2.1.A.33 Spalling and cracking concrete noted at the south loading dock.

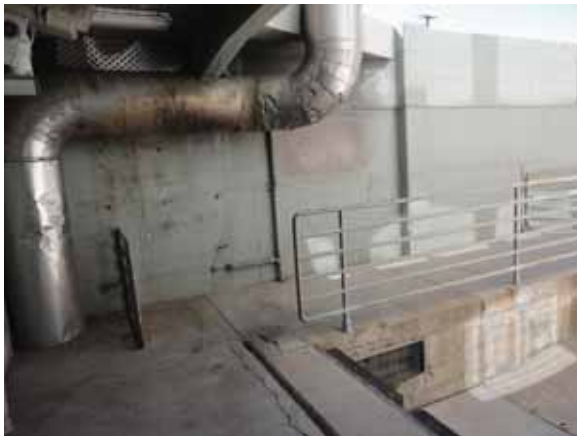
Fig. 2.1.A.34 Spalling and cracking concrete and corroding guardrail noted at the south loading dock.

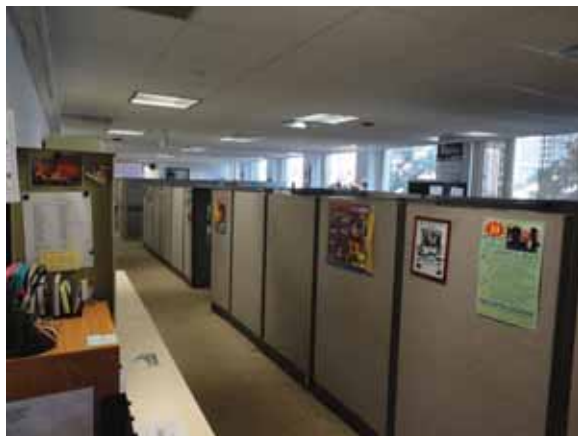
Fig. 2.1.B.1 Furniture that appears to be intruding into the minimum width of the aisle serving as a portion of the exit access.

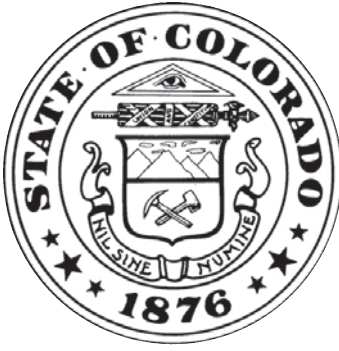
- Remove any furniture intruding into the aisles serving as a portion of the exit access in the means of egress system throughout the building, as necessary, to provide the minimum required corridor widths per code requirements.

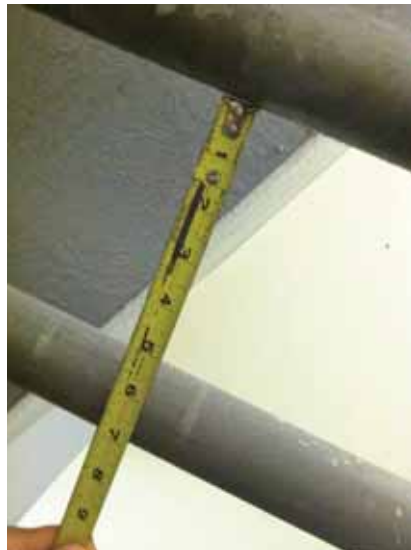
Fig. 2.1.B.2 The distance between the guardrail openings in the interior exit stairways exceeds 4 inches in diameter.

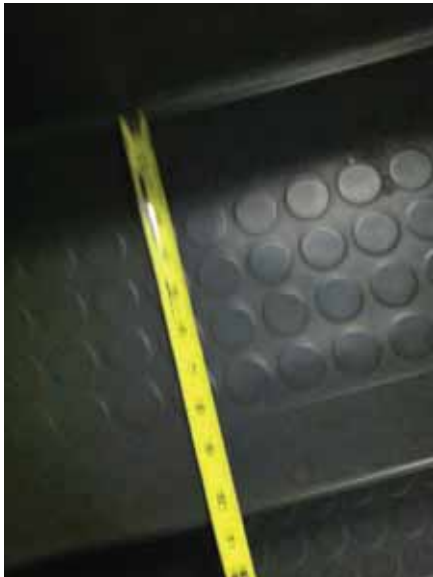
Fig. 2.1.B.4 Existing stair tread depths do not meet current code requirements.

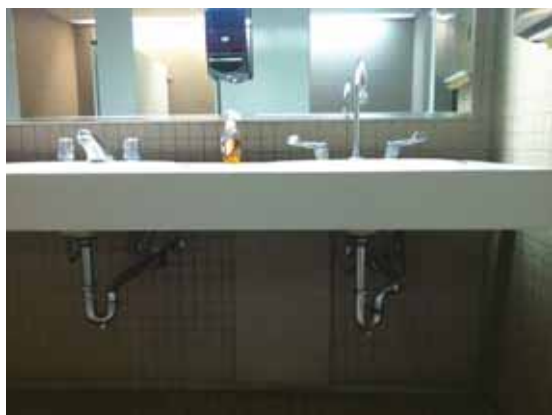
Fig. 2.1.C.1 Typical instance of an accessible lavatory without insulation wrapped around the pipes.

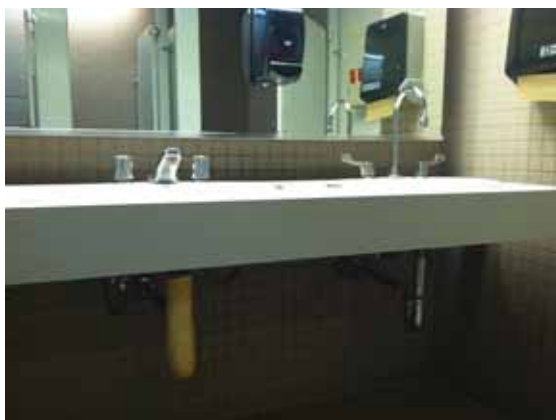
Fig. 2.1.C.2 The non-accessible lavatory in the Women's Ground Floor Restroom is wrapped with insulation around the pipes while the accessible lavatory has no insulation wrapped around the pipes.

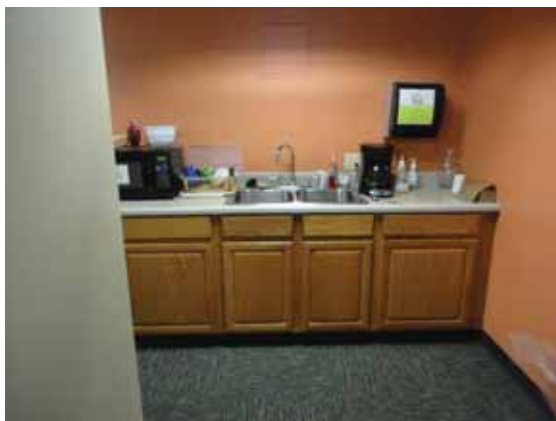
Fig. 2.1.C.4 Typical instance of a non-accessible sink found in a Break Room.

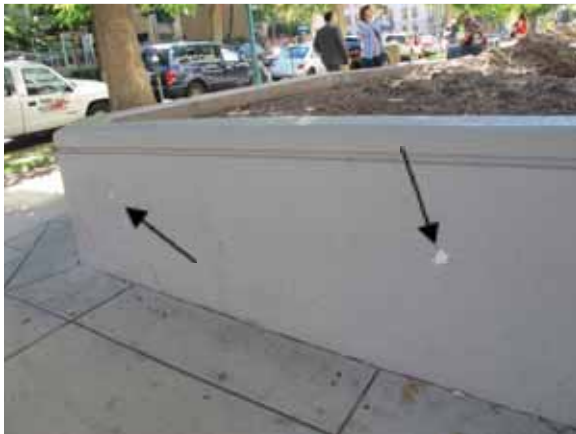
The paint on the outside of the concrete planters is bubbling and peeling in multiple locations. These damaged locations could allow water to penetrate the concrete structure, possibly contributing to corrosion of reinforcing bars and subsequent spalling of the concrete (Fig. 2.2.A.1).

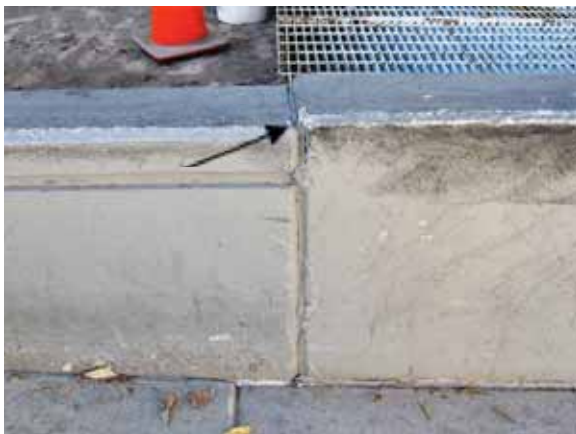
At the north side of the building, one of the planters abuts a mechanical well. There appears to have been some differential movement across a joint in the concrete here, evidenced by differential height and failed sealant joint (Fig. 2.2.A.2).

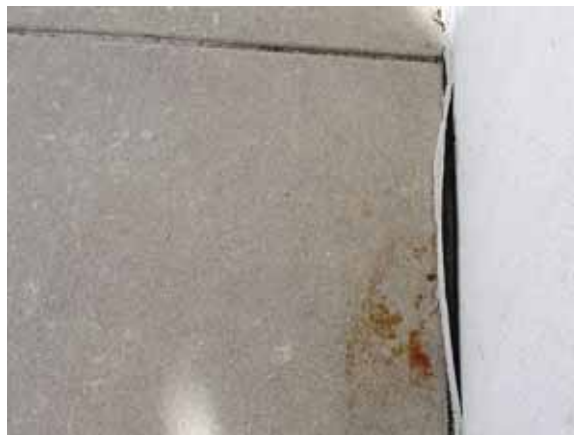
Sealants at the joint between the sidewalk and building exterior have failed along the entire south side of the building (Fig. 2.2.A.4). Any drainage from the downspout noted above could result in water penetration below the sidewalk along this joint.

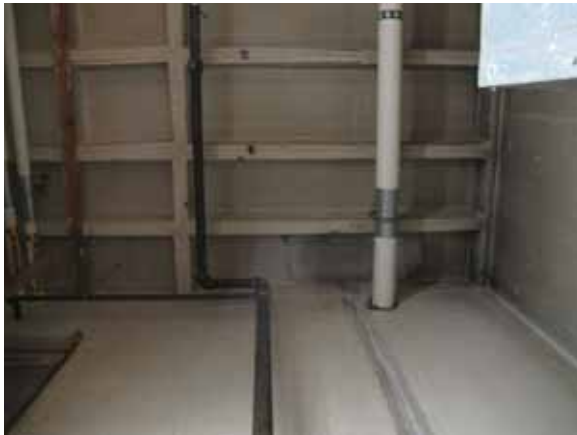
An existing patch through the concrete in the mechanical penthouse roof showed evidence of leakage (Fig. 2.2.A.6).

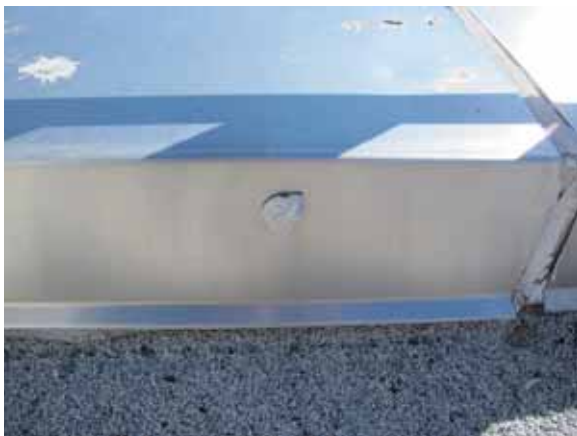
The sealant at joints and over screws anchored through perimeter flashing at roof parapets has failed (Fig. 2.2.A.7).

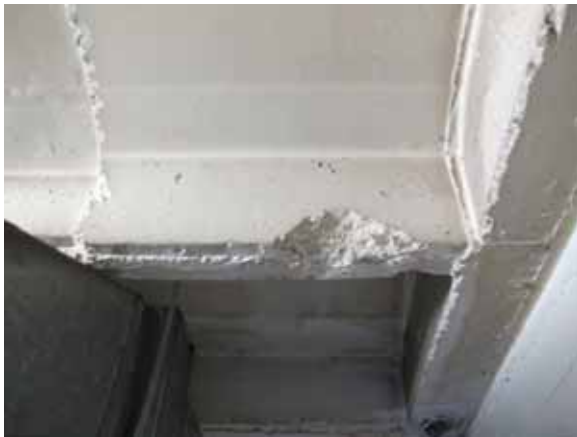
Some cracking and spalling was observed at the cast-in-place concrete at the penthouse and mechanical room roofs (Fig. 2.2.B.1). The cracks are minor, and spalls either appeared to be due to post-installed anchors in the majority of locations, or were not new conditions for the structure as evidenced by paint and lack of staining.

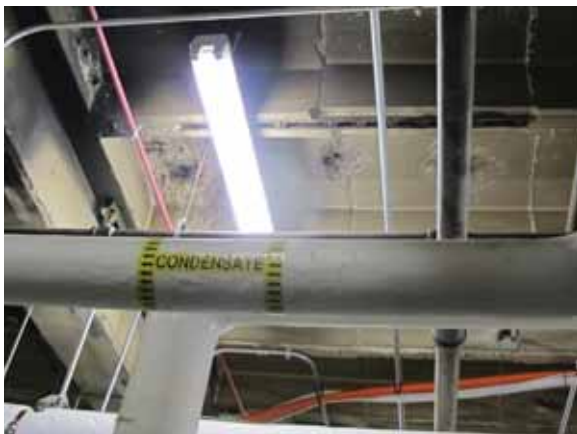
There was also evidence of spalling at the building basement, again, mostly due to post-installed anchors or penetrations through the cast-in-place concrete structure (Fig. 2.2.B.2).

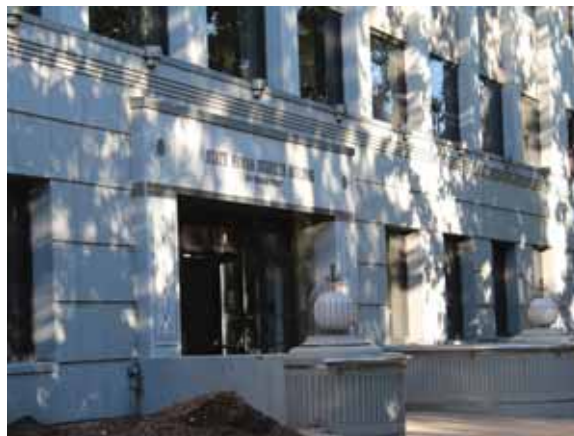
Figure 2.3.A.1 – State Human Services Building Sherman Street Entrance

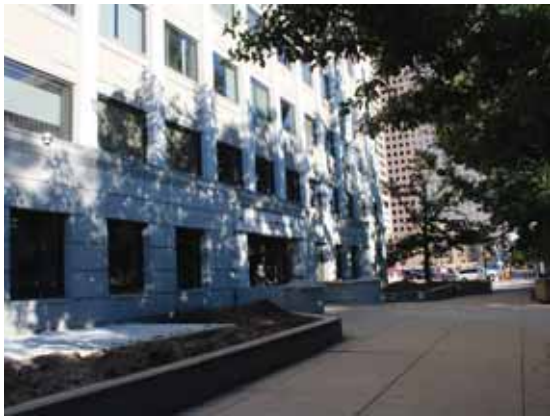
Figure 2.3.A.2 – Sherman Street Entrance Concrete Walkway

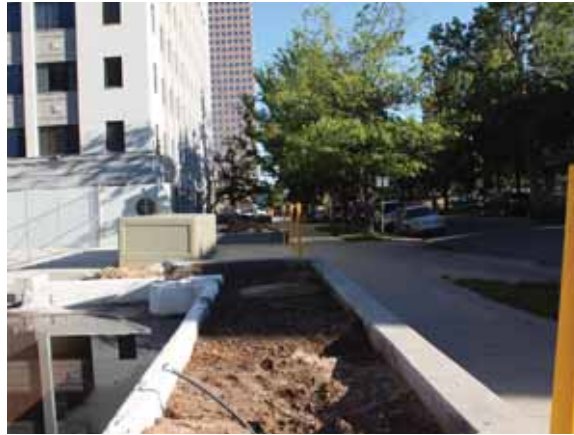
Figure 2.3.A.4 Landscape Beds in the process of improvement

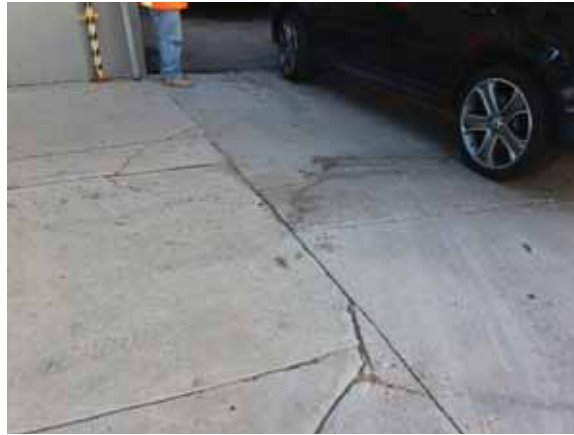
Figure 2.3.A.6 Site Concrete Crack

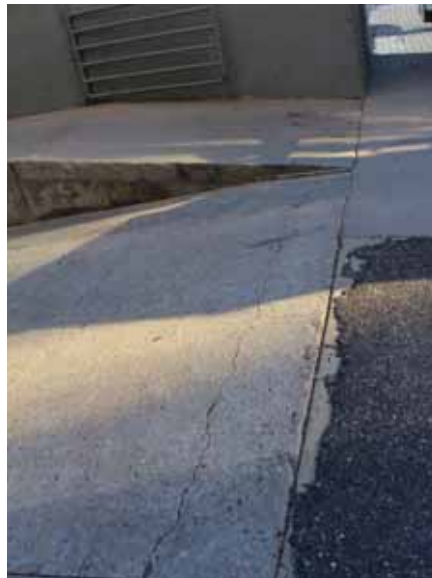
Figure 2.3.A.7 Site Concrete Crack

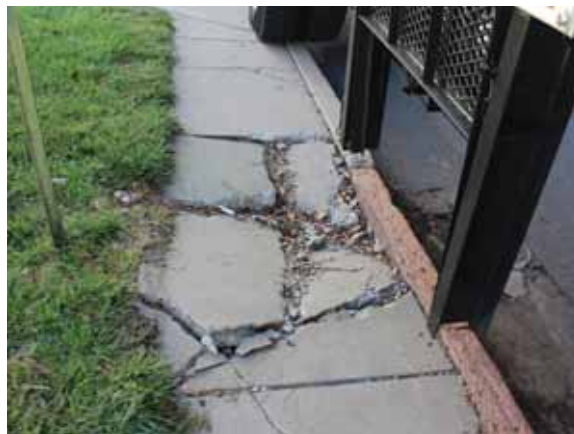
Figure 2.3.A.8 Broken Concrete within ROW, Recommended for Replacement

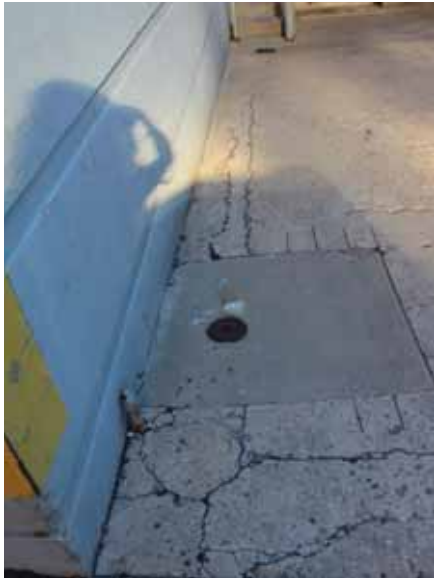
Figure 2.3.A.9 Broken Site Concrete, Recommended for Replacement

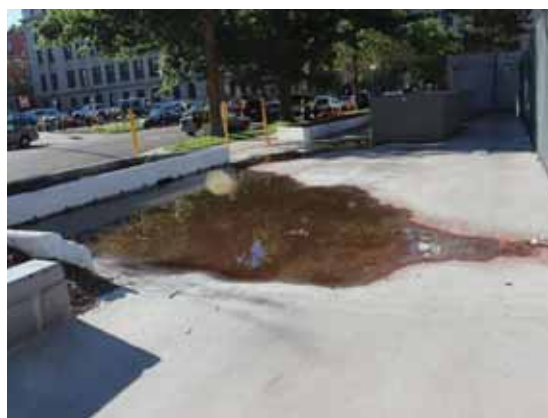
Figure 2.3.B.1 Standing Water

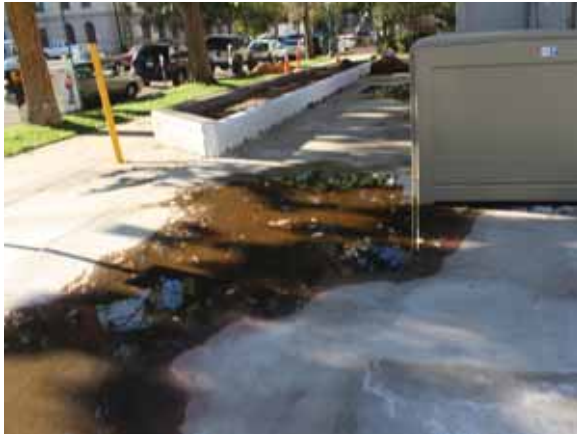
Figure 2.3.B.3 Standing Water

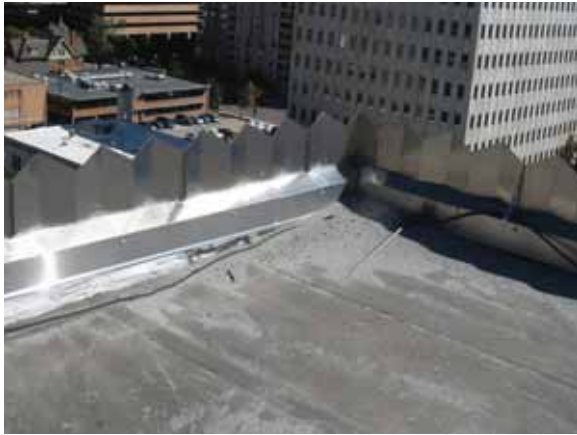
Fig. 2.4.A.1 – Broken air terminals

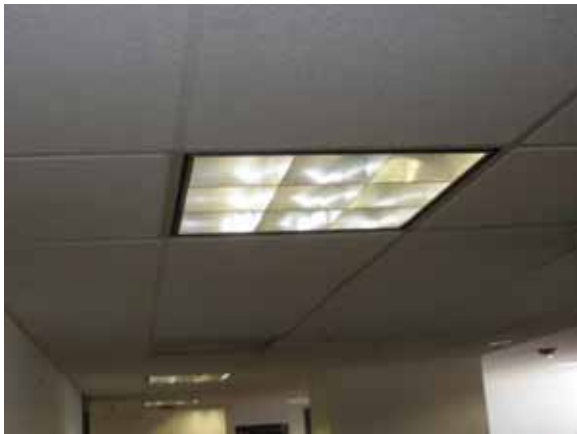
Fig. 2.4.A.2 – Recessed light fixture

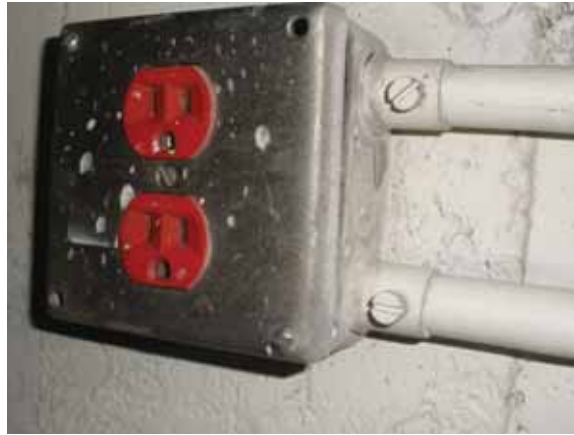
Fig. 2.4.A.6 – Receptacle

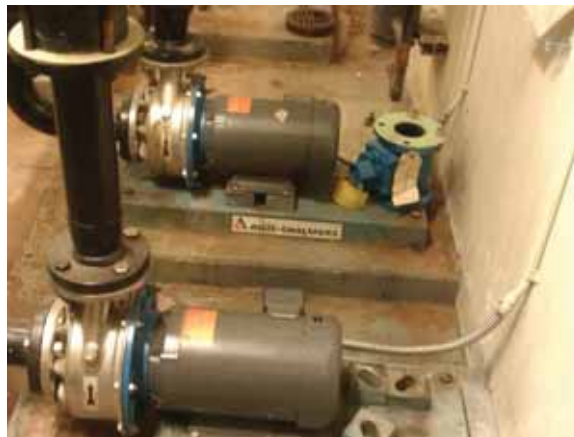
Fig. 2.4.A.9 – Missing insulation on pipes

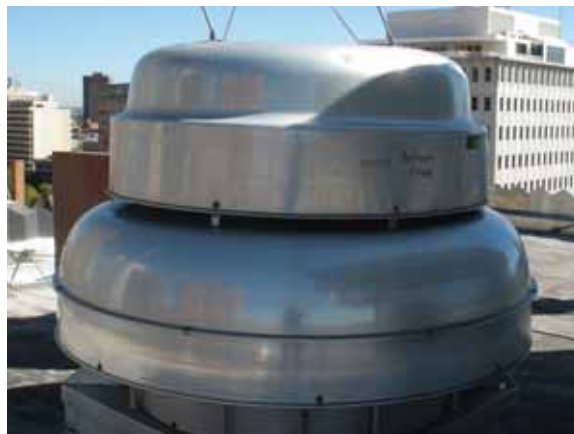
Fig. 2.4.A.10 – Toilet exhaust fan

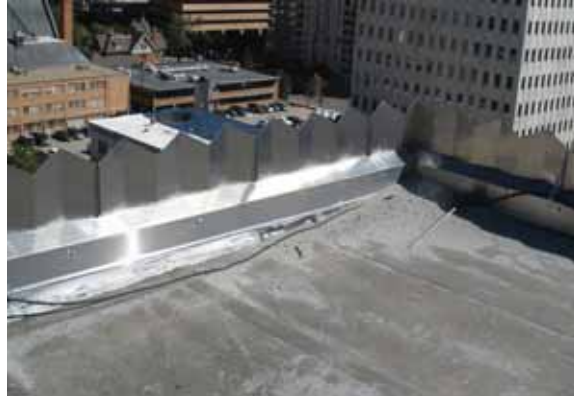
Fig. 2.4.B.1 – Broken air terminals and wire hanging

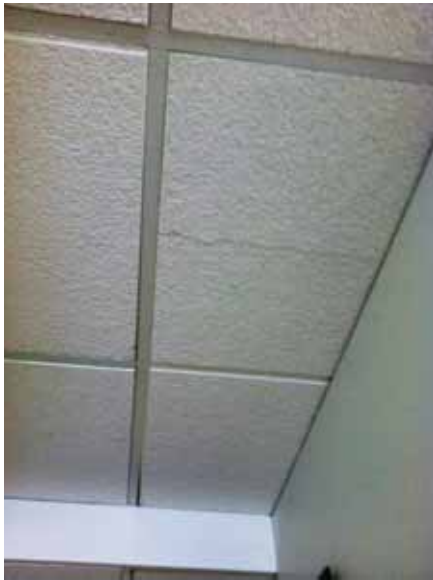
Fig. 3.0.C.1 Typical cracked acoustic ceiling tile noted during the site survey visit.

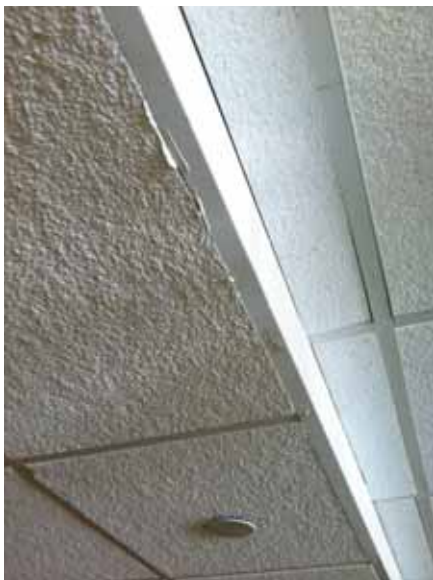
Fig. 3.0.C.2 Deteriorating ceiling tiles noted during the site survey visit.

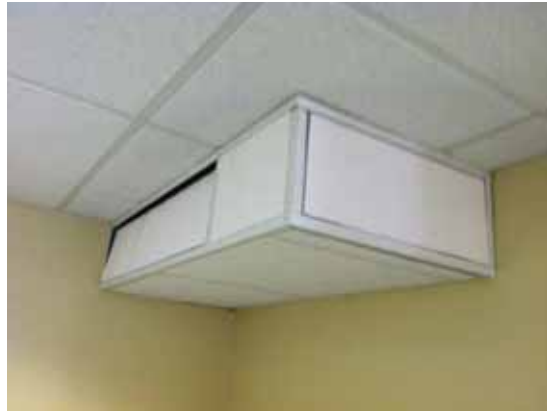
Fig. 3.0.C.3 Deteriorating ceiling tiles noted during the site survey visit.

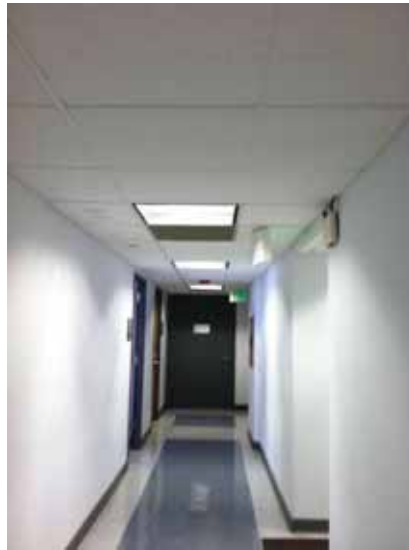
Fig. 3.0.C.4 Sagging ceiling tiles noted during the site survey visit.

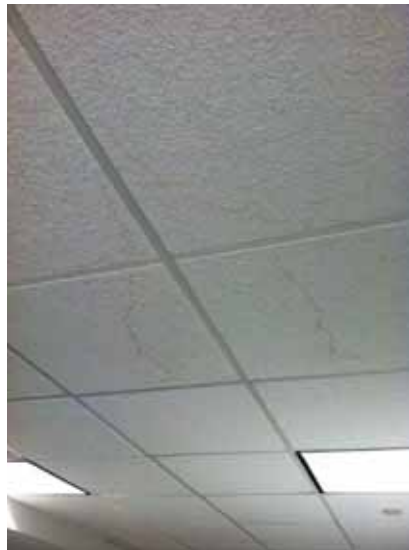
Fig. 3.0.C.5 Water damage noted to acoustic ceiling tiles during the site survey visit.

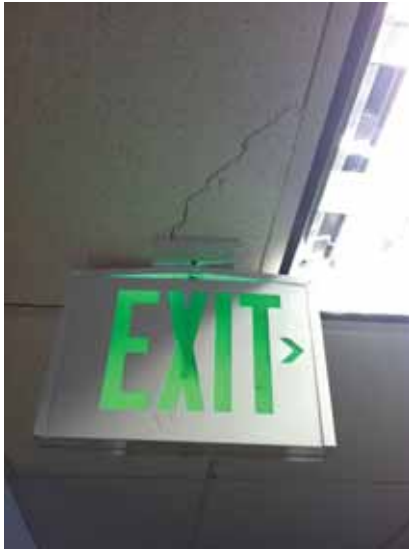
Fig. 3.0.C.6 Typical instance of a cracked acoustic ceiling tile noted at an exit sign that does not appear to be properly secured to the ceiling, creating an unsafe working condition for building occupants.

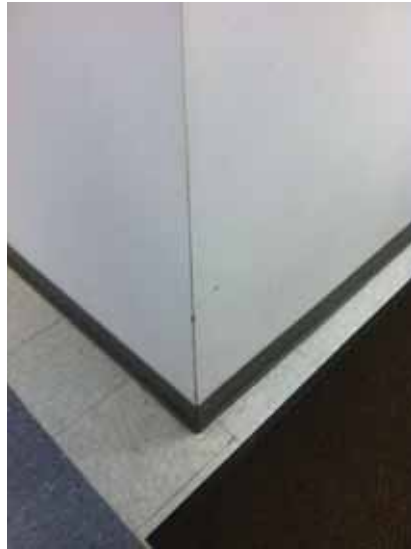
Fig. 3.0.C.7 Typical instance of minor wear-and-tear noted to the gypsum board walls.

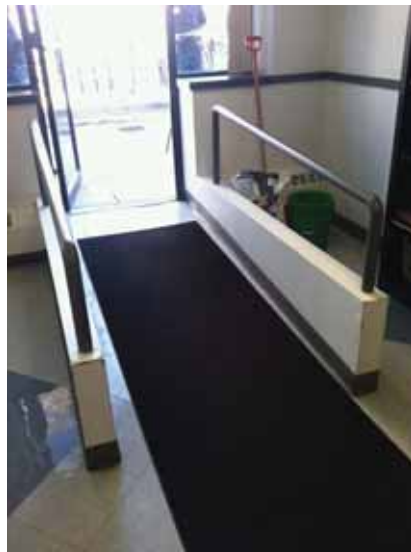
Fig. 3.0.C.8 Wear-and-tear noted to the low gypsum board walls on either side of the ramp to the Ninth Floor patio.

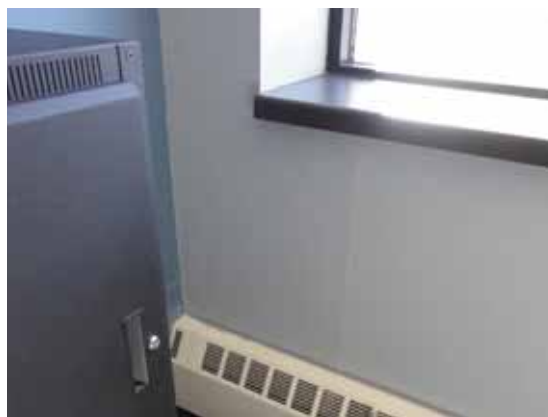
Fig. 3.0.C.9 Cracked gypsum board noted below a window.

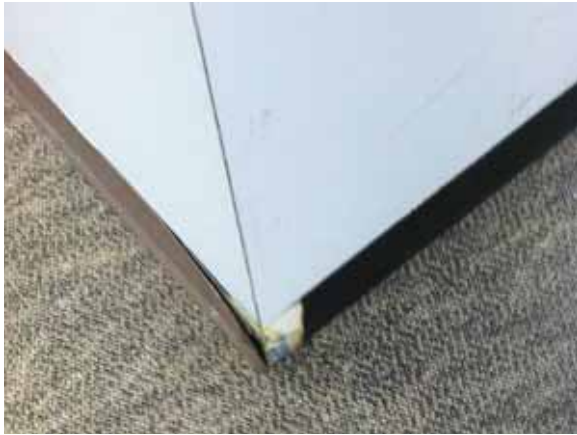
Fig. 3.0.C.10 Instance of damaged vinyl baseboard missing and peeling away from the wall.

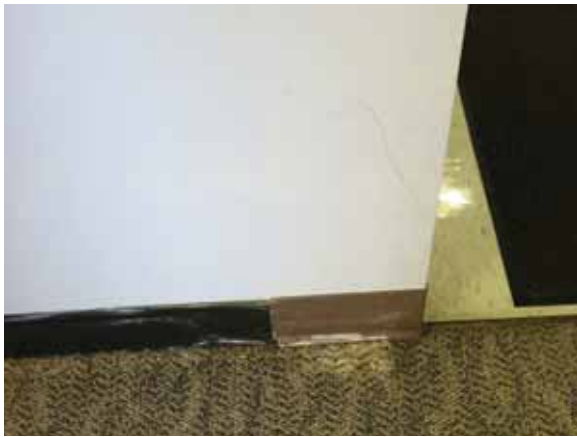
Fig. 3.0.C.11 Instance of mismatched vinyl baseboard noted during the site survey visit.

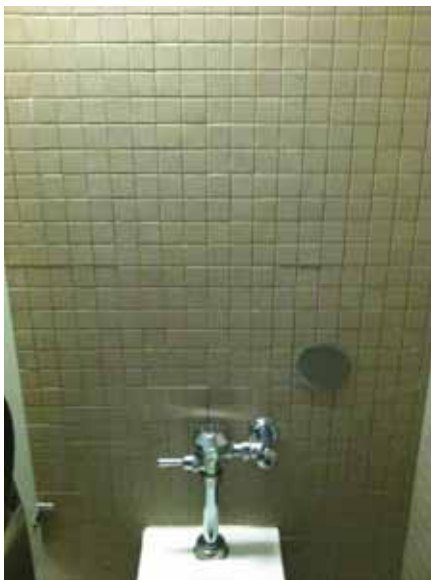
Fig. 3.0.C.12 Pieces of the two-inch square wall tile throughout the restrooms appear to be moving out and away from the wall.

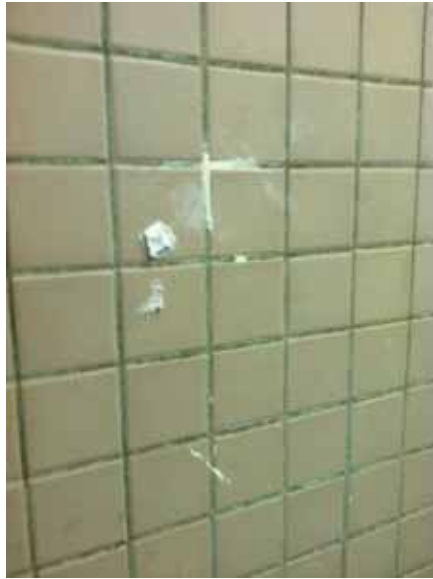
Fig. 3.0.C.13 Generally soiled areas of the two-inch square wall tile noted throughout the restrooms during the site survey visit.

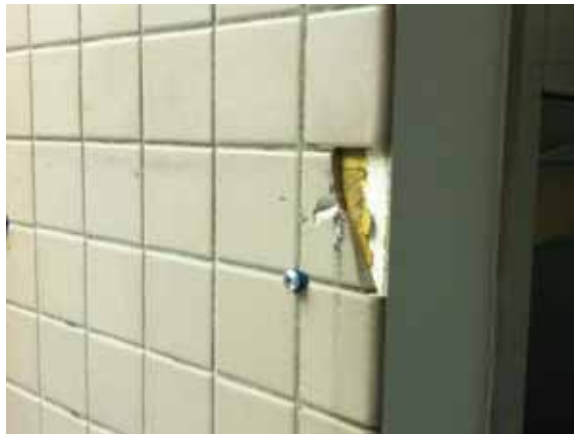
Fig. 3.0.C.14 Damaged and missing two-inch square wall tile noted throughout the restrooms during the site survey visit.

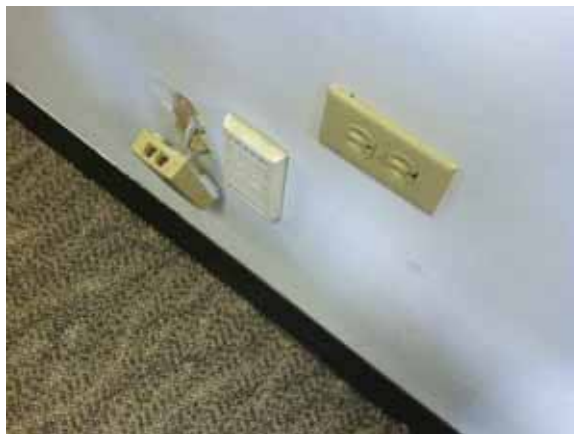
Fig. 3.0.C.15 Data outlet not secured to the wall observed in the Fourth Floor office area.

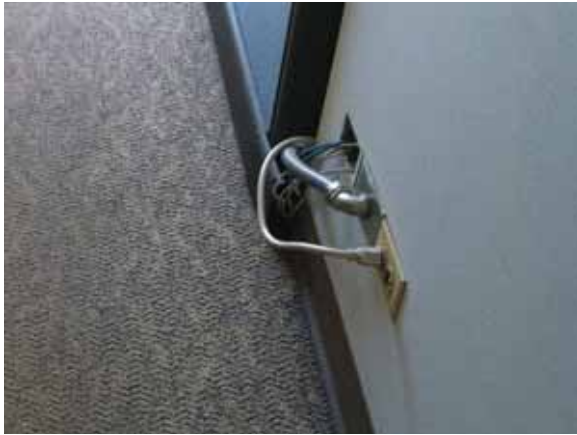
Fig. 3.0.C.16 Cables observed coming out of an unfinished hole in the wall in the Tenth Floor office area.

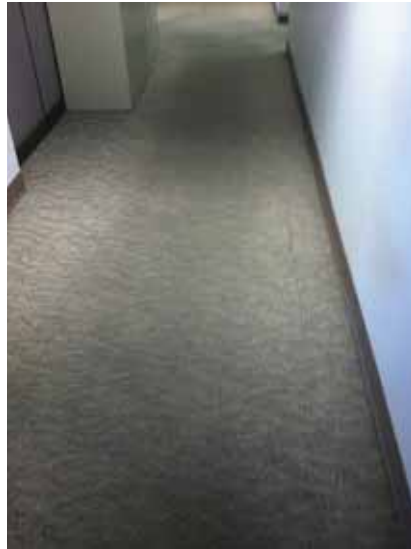
Fig. 3.0.C.17 Soiled carpet with seams pulling loose and creating a potential tripping hazard.

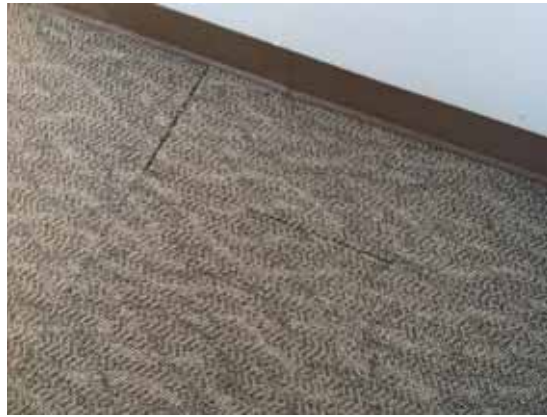
Fig. 3.0.C.18 Worn carpet with seams pulling loose and creating a potential tripping hazard.

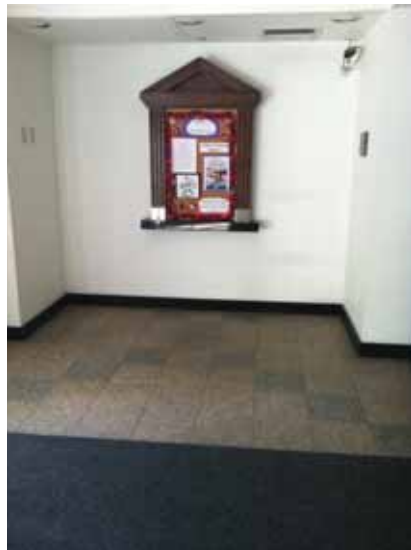
Fig. 3.0.C.19 Soiled granite tile flooring noted at the Sherman Street Entrance vestibule.

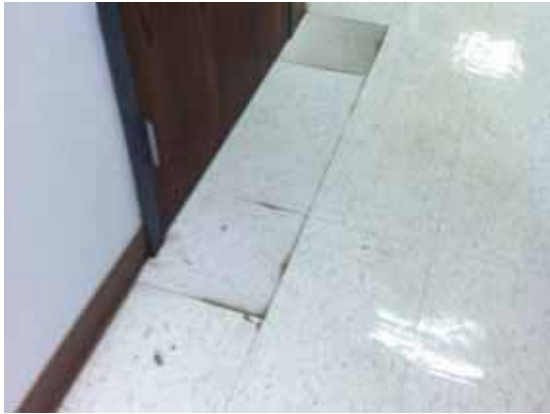
Fig. 3.0.C.20 An instance of soiled and damaged linoleum tile observed during the site survey visit.

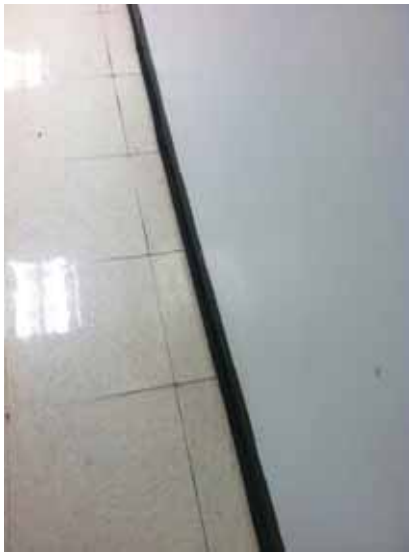
Fig. 3.0.C.21 An instance of deteriorating and soiled linoleum along the edges of the tiles.
