CAPITOL COMPLEX MASTER PLAN
FINDINGS & RECOMMENDATIONS (F & R) NEEDS ASSESSMENT
HUMAN SERVICES BUILDING, 1575 SHERMAN STREET (DENVER)

NOVEMBER 2014

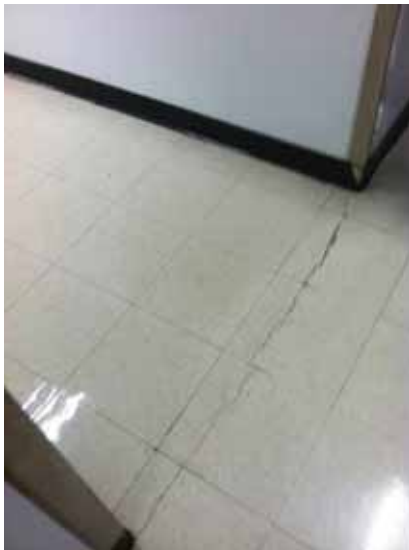
Fig. 3.0.C.22 An instance of cracked linoleum tile observed during the site survey visit.

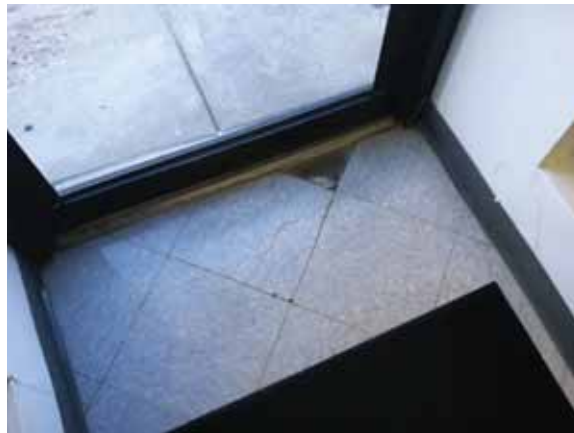
Fig. 3.0.C.23 Deteriorating and damaged linoleum tile noted at the ramp leading to the Ninth Floor patio.

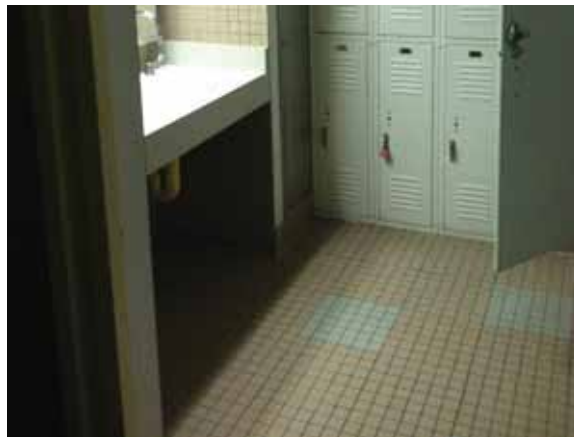
Fig. 3.0.C.24 Generally soiled 2-inch square floor tile noted in the restrooms throughout.

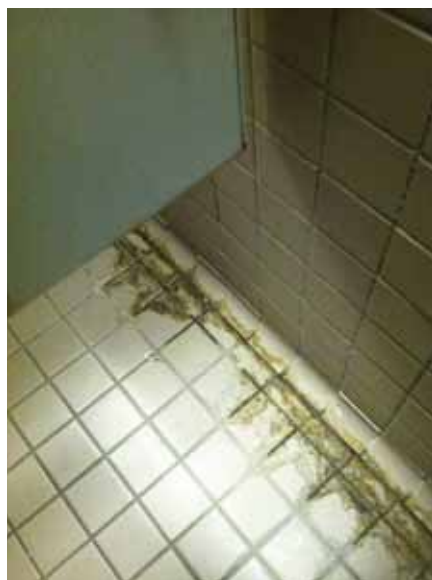
Fig. 3.0.C.25 Soiled floor tile with a mold-like substance noted in a few of the restrooms throughout.

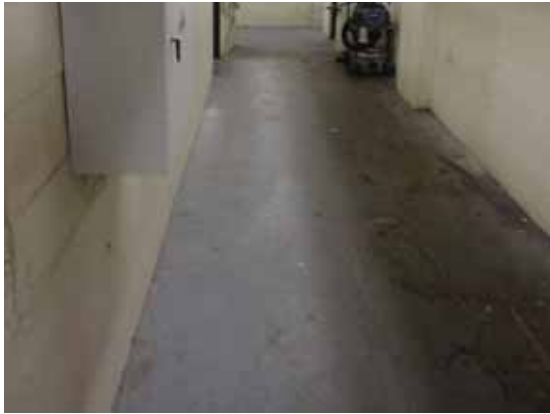
Fig. 3.0.C.26 Generally worn and spalling concrete flooring with signs of water damage on the Basement Floor.

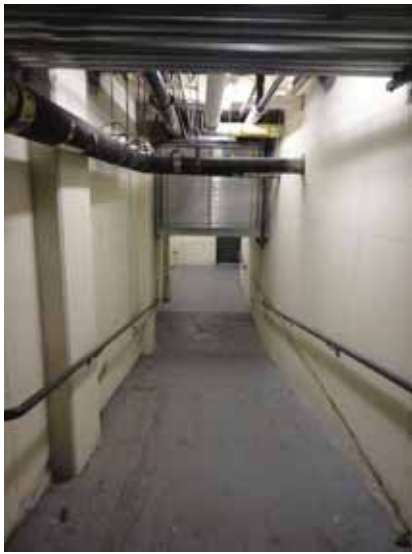
Fig. 3.0.C.27 Generally worn, cracking, and spalling concrete flooring with signs of water damage on the Basement Floor.

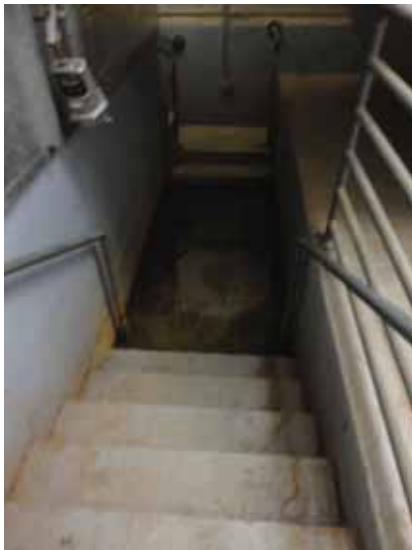
Fig. 3.0.C.28 Evidence of water damage noted on the Basement Floor.

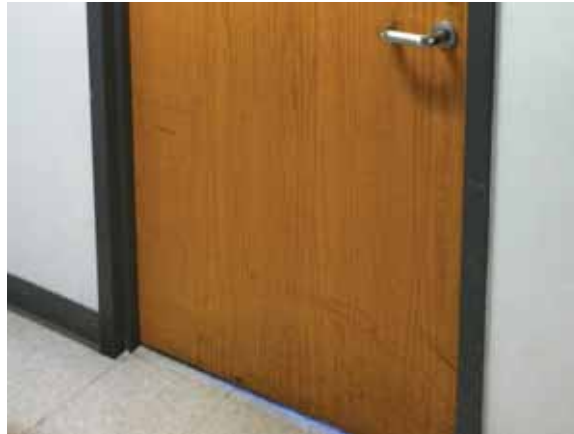
Fig. 3.0.C.29 Minor wear-and-tear observed to some of the doors throughout the building.

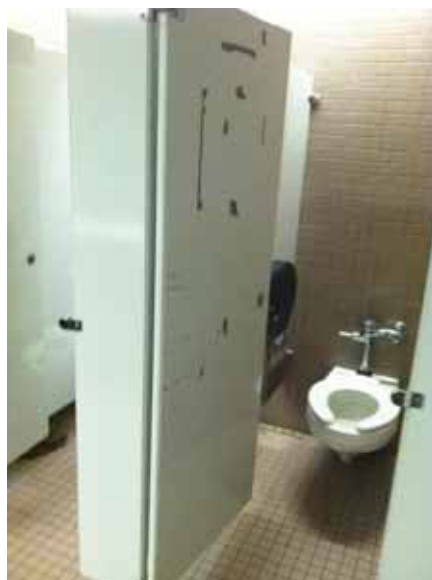
Fig. 3.0.C.30 Instance of wear-and-tear noted to toilet stall partitions during the site survey visit.

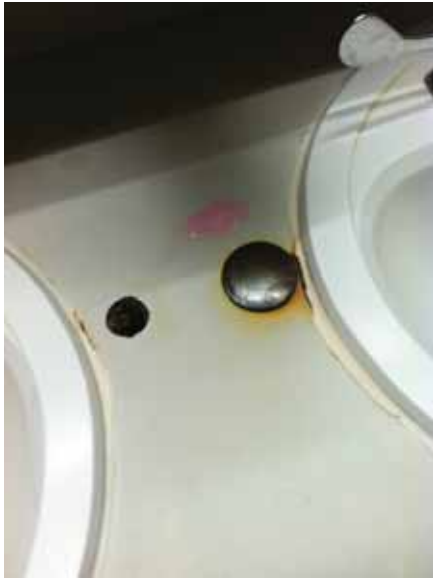
Fig. 3.0.C.31 Typical wear-and-tear and deterioration due to aging of the restroom countertops.

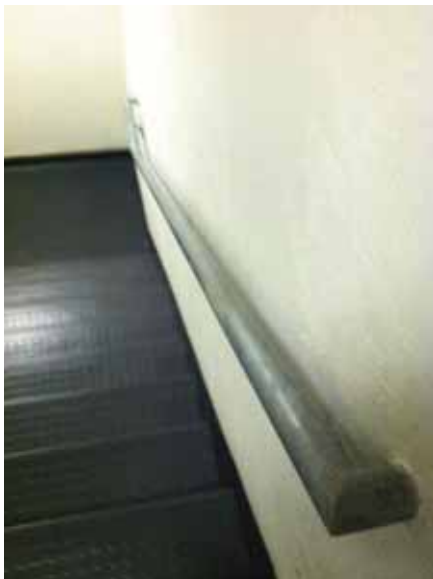
Fig. 3.0.C.32 Minor corrosion noted to the railings throughout the stairways.
