CAPITOL COMPLEX MASTER PLAN
FINDINGS & RECOMMENDATIONS (F & R) NEEDS ASSESSMENT
STATE SERVICES BUILDING, 1525 SHERMAN STREET (DENVER)

NOVEMBER 2014

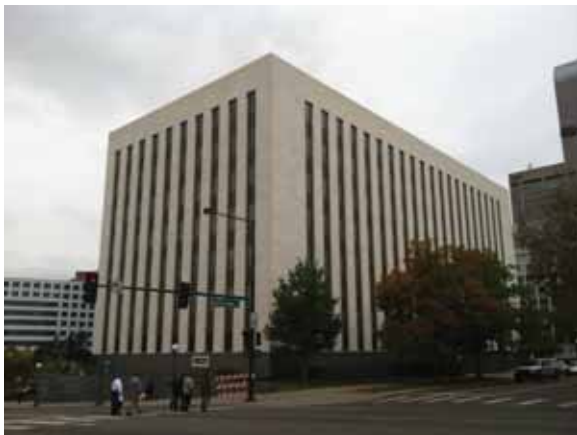
Front & Side/East & South Elevations of the State Services Building

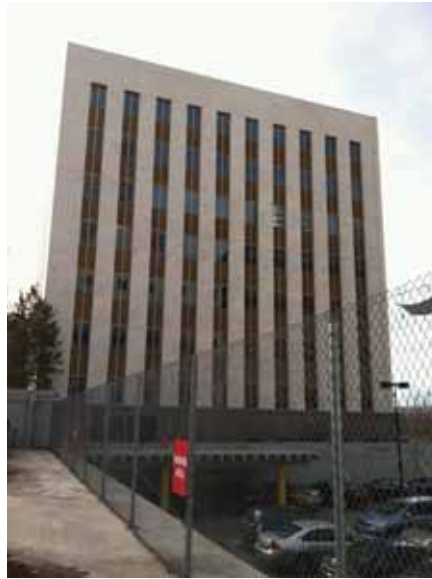
Side/North Elevation of the State Services Building

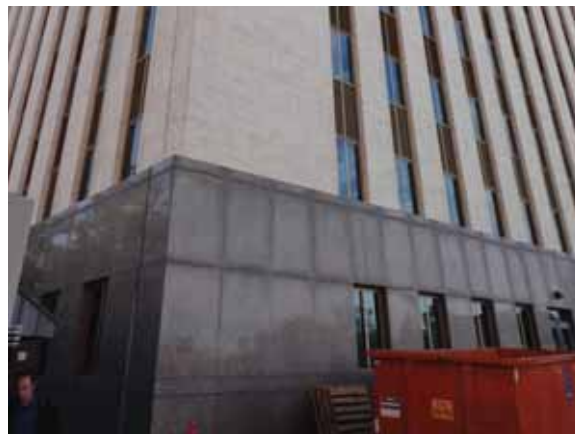
Fig. 2.1.A.1 Generally soiled granite panels noted around the exterior of the building.

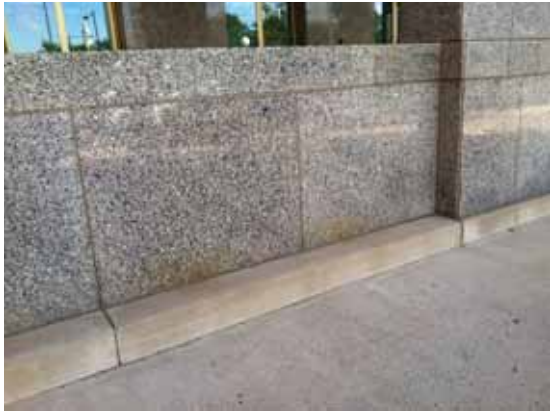
Fig. 2.1.A.2 Soiled granite panels noted around the base of the building, especially on the west side.

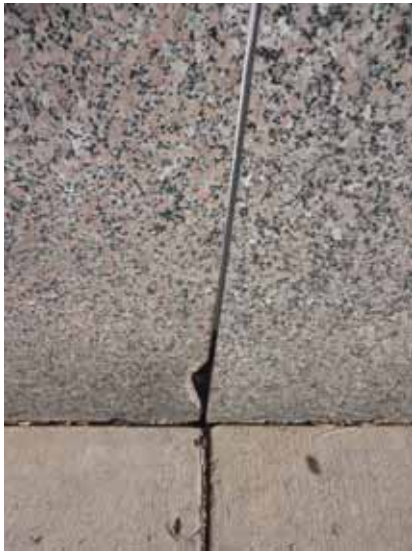
Fig. 2.1.A.3 Damaged granite panel observed during the site survey visit.

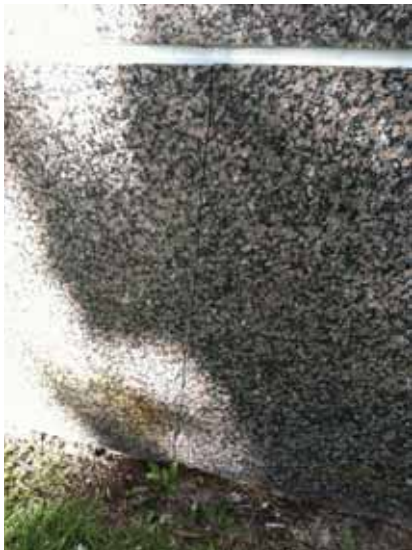
Fig. 2.1.A.4 Cracked granite panel observed during the site survey visit.

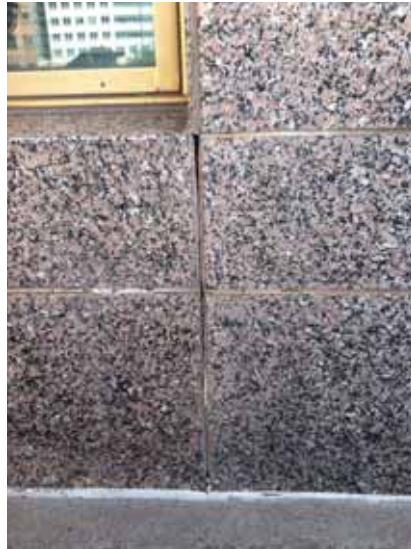
Fig. 2.1.A.5 Typical instance of deteriorating and missing sealant noted at the granite panels around the exterior of the building.

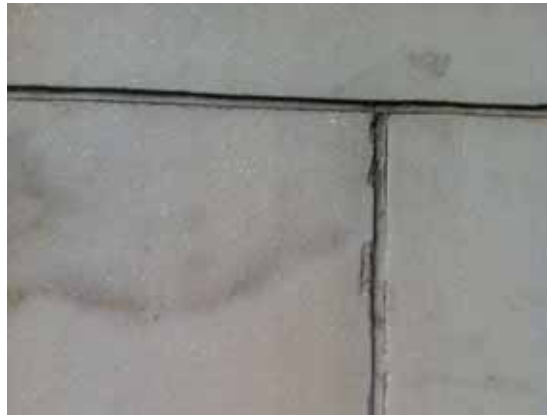
Fig. 2.1.A.6 Typical instance of deteriorating and missing sealant noted at the marble panels around the exterior of the building.

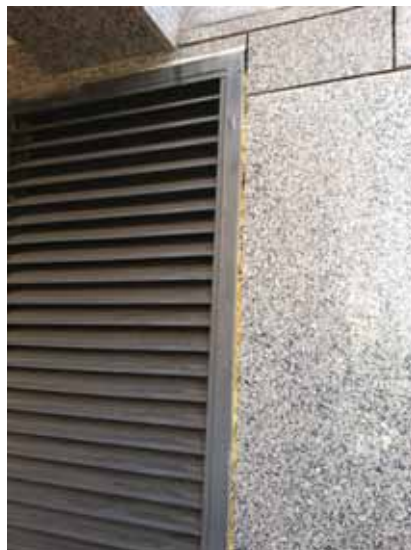
Fig. 2.1.A.7 Deterioration and missing material around an air grille at the exterior of the building.

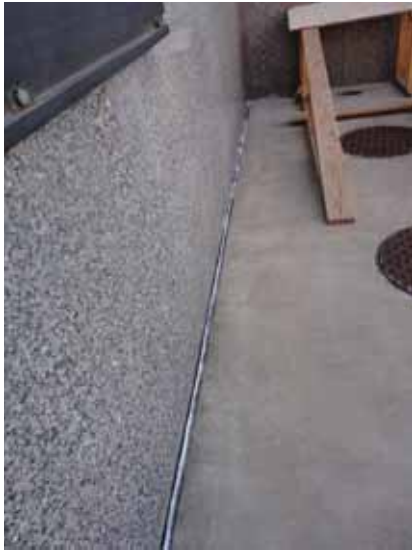
Fig. 2.1.A.8 Sealant deteriorating and missing along the base of the building, allowing water penetration.

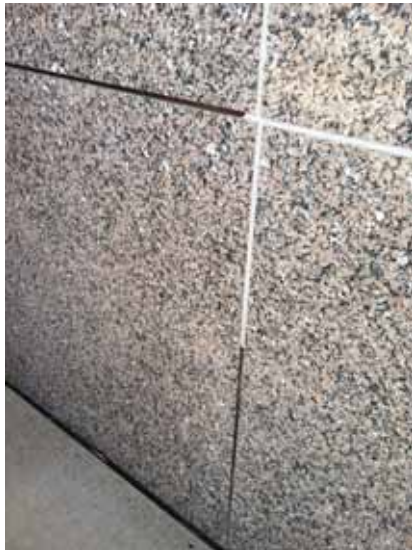
Fig. 2.1.A.9 New sealant that abruptly stops, leaving large gaps between the stone and the base of the building exposed to water penetration.

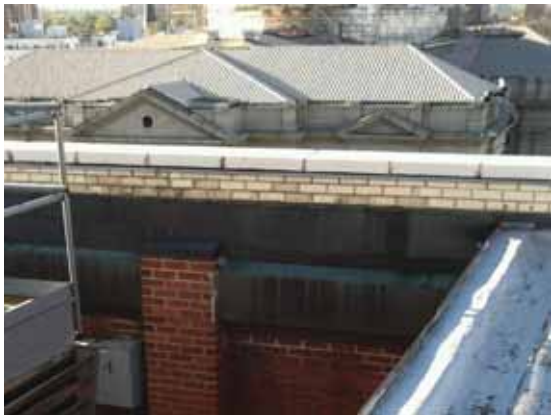
Fig. 2.1.A.10 Deteriorating and spalling brick observed along the west side of the Penthouse roof.

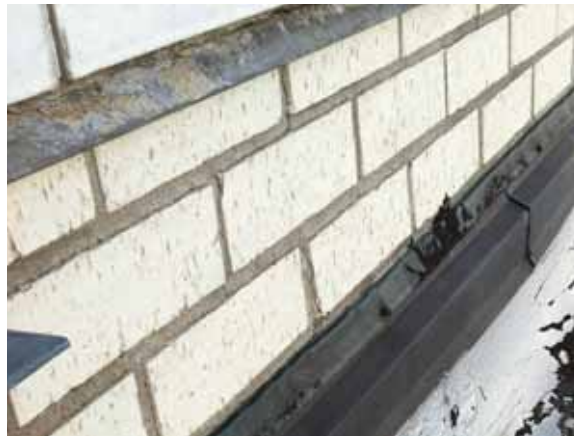
Fig. 2.1.A.11 Areas of cracking mortar noted along the brick joints around the roof and Penthouse roof parapets.

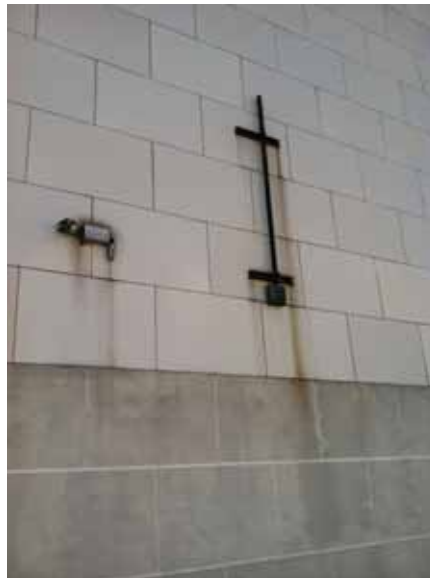
Fig. 2.1.A.12 Soiling and staining of the tile cladding on the Penthouse walls caused by the corrosion of metal equipment mounted to the walls.

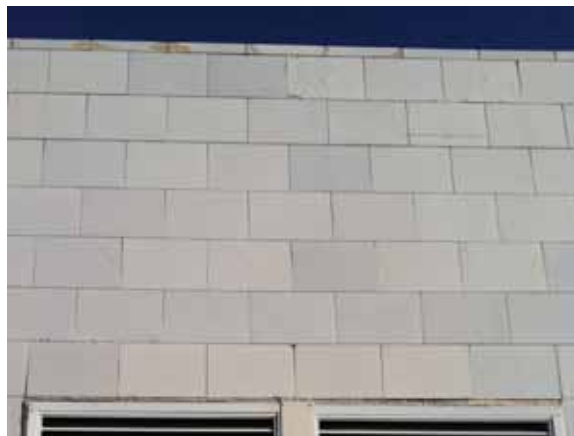
Fig. 2.1.A.13 Damage and deterioration noted at the tile cladding on the Penthouse walls. Deteriorating sealant noted around air grilles and along the base of the walls.

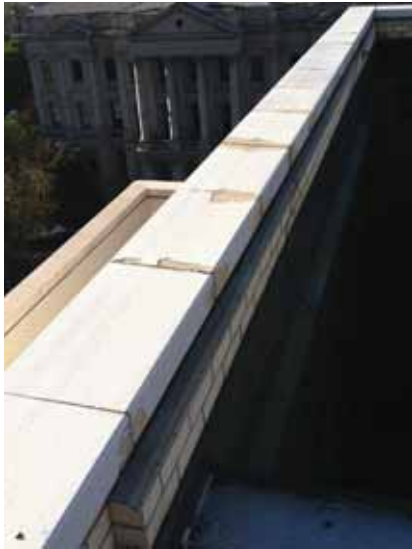
Fig. 2.1.A.14 General deterioration of the masonry blocks observed along the top edge of the Penthouse roof parapet.

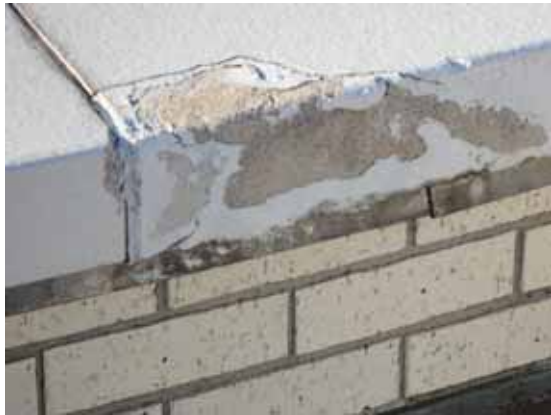
Fig. 2.1.A.15 Sealant deteriorating, or missing entirely, from the joints between the masonry blocks along the top edge of the Penthouse roof parapet, is likely resulting in damage to the coating on the blocks.

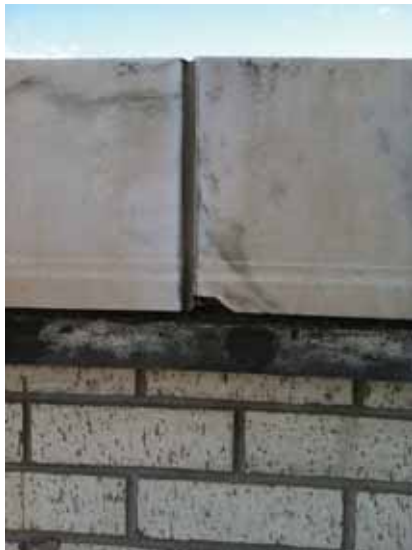
Fig. 2.1.A.16 Damaged marble blocks noted in a few spots around the top edge of the roof parapet.

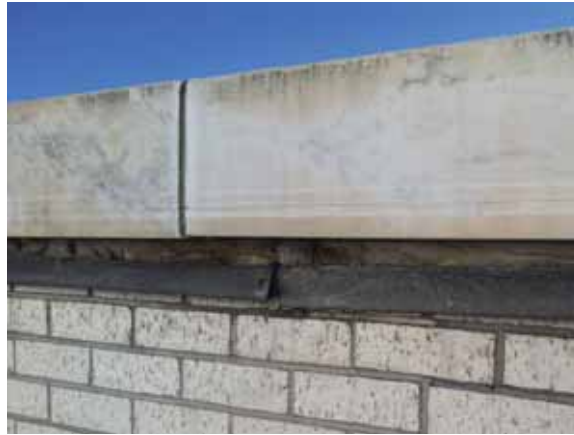
Fig. 2.1.A.17 Deteriorating mortar observed under the marble blocks along the top edge of the roof parapet.

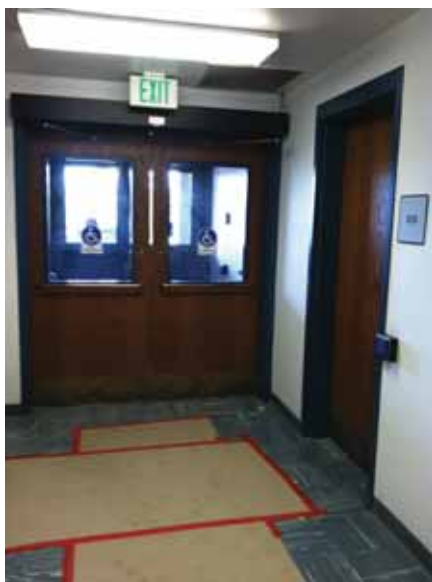
Fig. 2.1.A.18 Interior doors at the accessible entrance vestibule on the south end of the west side of the building have an air gap between the door slabs.

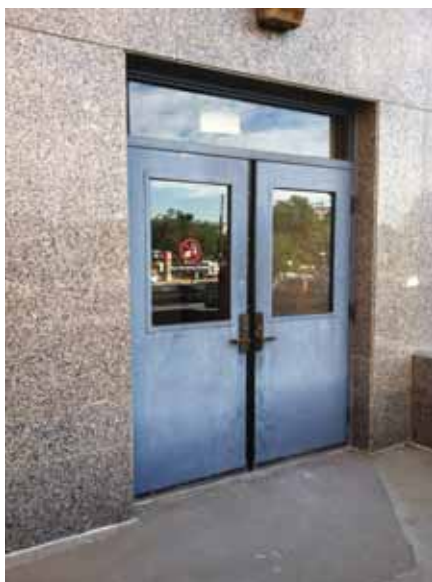
Fig. 2.1.A.19 General signs of aging and wear-and-tear, along with minor signs of corrosion, noted at the service and employee entrance doors on the west side of the building.

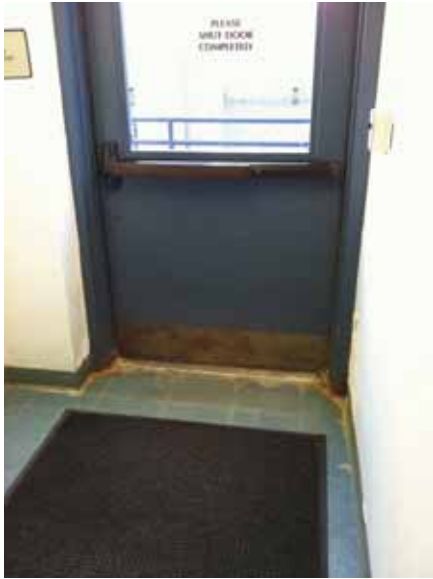
Fig. 2.1.A.20 Water damage observed at the interior side of the emergency door on the west end of the north side of the building.

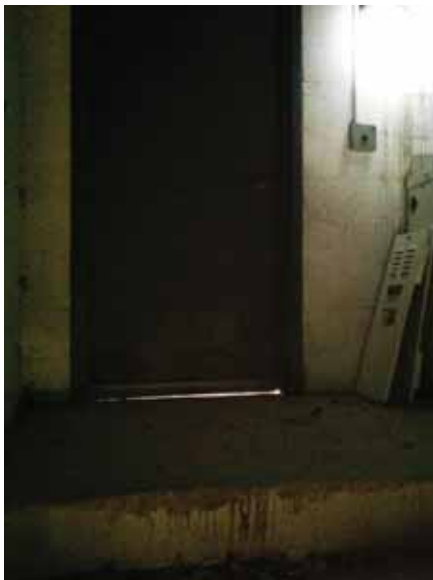
Fig. 2.1.A.21 Daylight is visible along the bottom edge of the emergency door on the east end of the north side of the building and evidence of water damage was observed on the interior side of the door.

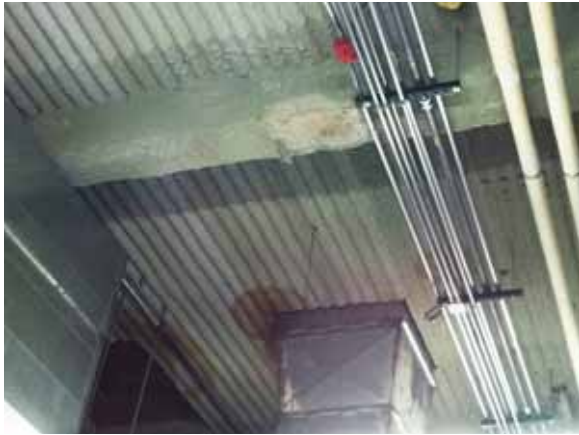
Fig. 2.1.A.22 Evidence of water intrusion at the Penthouse ceiling.

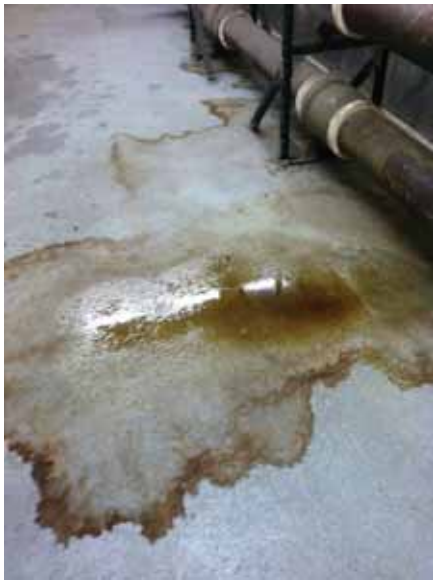
Fig. 2.1.A.23 Water observed on the floor of the Penthouse.

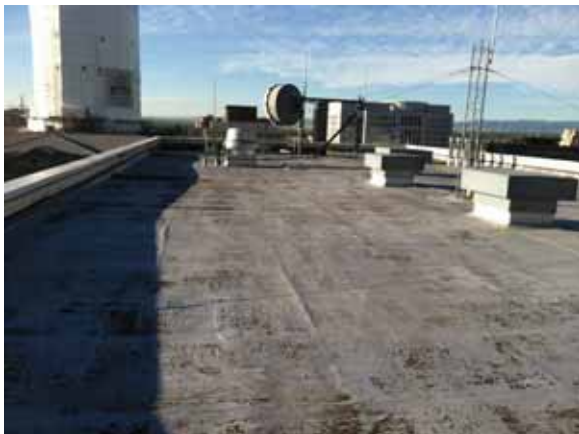
Fig. 2.1.A.24 Typical overall deterioration of the roofing membrane.

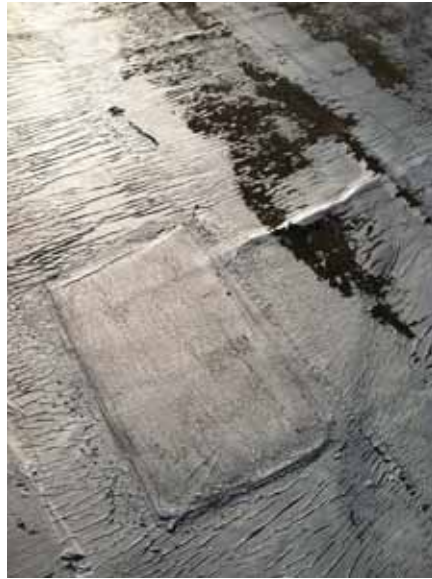
Fig. 2.1.A.25 Typical overall deterioration of the roofing membrane, including at membrane patches.

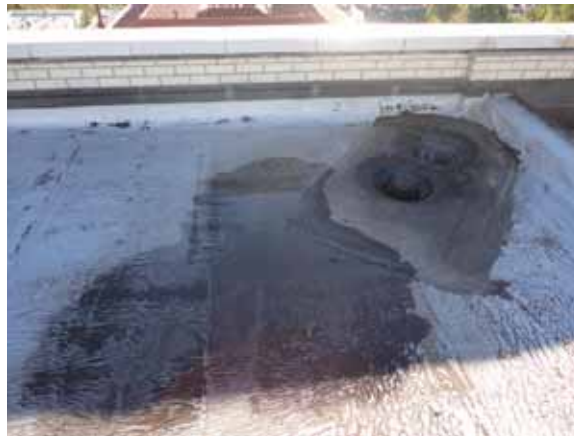
Fig. 2.1.A.26 Ponding observed in several spots near the roof drains.

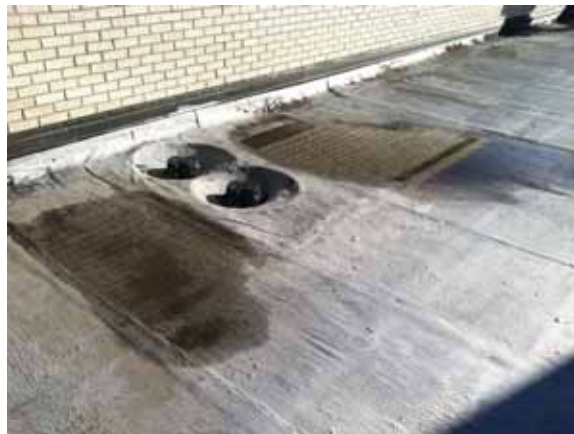
Fig. 2.1.A.27 Ponding observed in several spots near the roof drains.

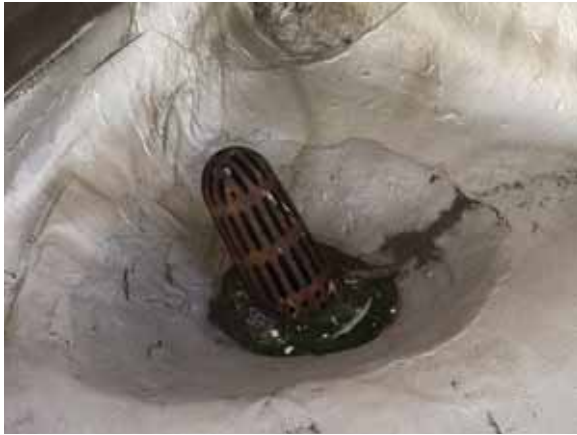
Fig. 2.1.A.28 Drain cover with signs of corrosion and with moss growing near the base.

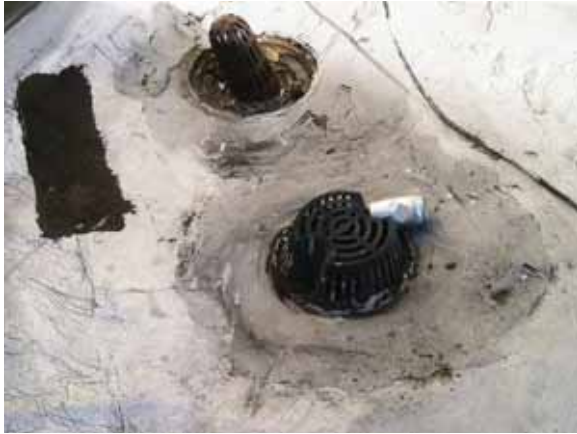
Fig. 2.1.A.29 Debris observed to be collecting near a roof drain.

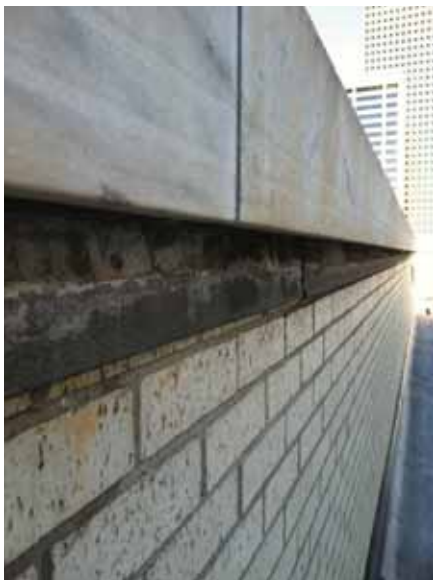
Fig. 2.1.A.30 General corrosion and deterioration of the flashing noted around the roof.

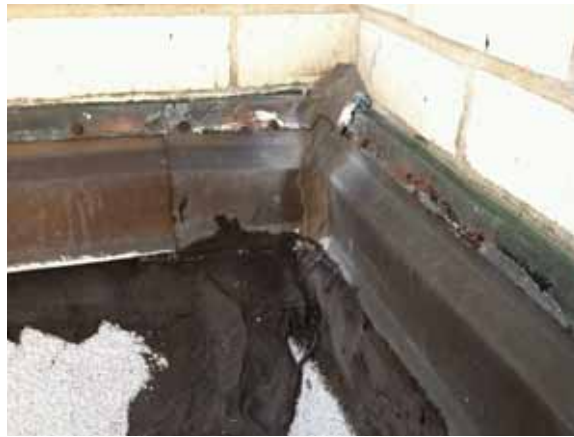
Fig. 2.1.A.31 General corrosion and deterioration of the flashing noted around the roof.

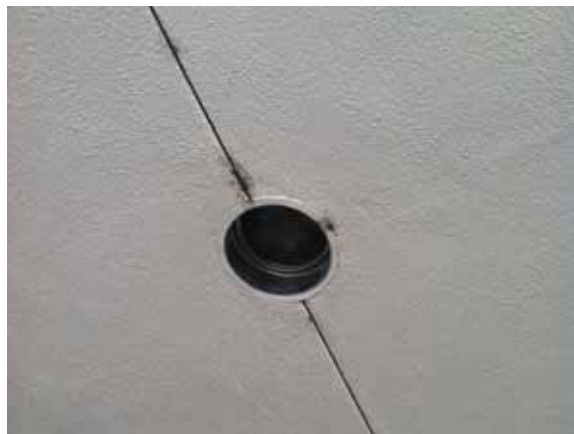
Fig. 2.1.A.32 Minor spalling noted at the accessible entrance canopy at the south end of the west side of the building.

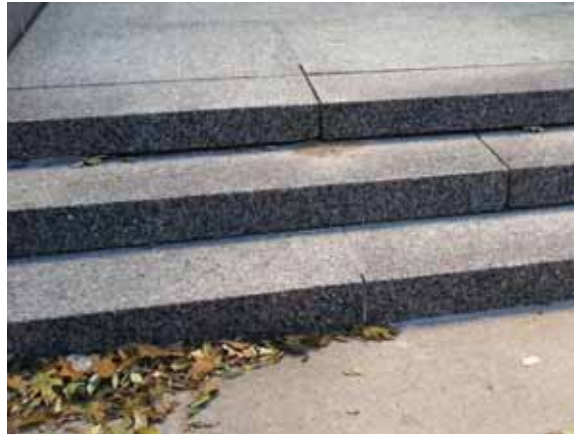
Fig. 2.1.A.33 Sealant deteriorating or missing entirely from the joints between the granite at the Sherman Street Entrance stairway.

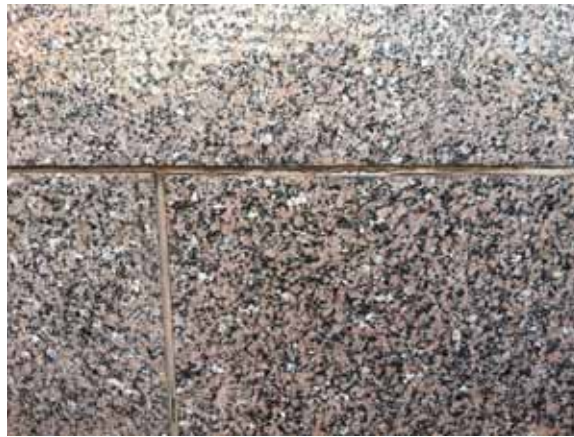
Fig. 2.1.A.34 Typical instance of deteriorating sealant noted at the granite cladding on the low walls around the building.

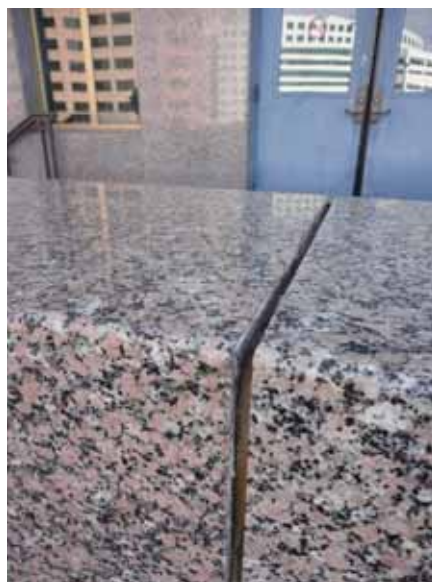
Fig. 2.1.A.35 Typical instance of sealant missing entirely at the granite cladding on the low walls around the building.

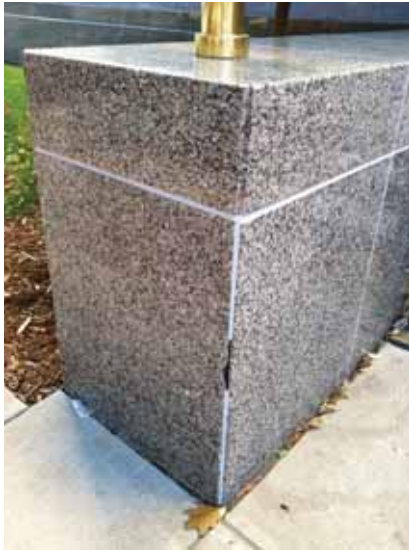
Fig. 2.1.A.36 New sealant that abruptly stops, leaving the wall exposed to water penetration.

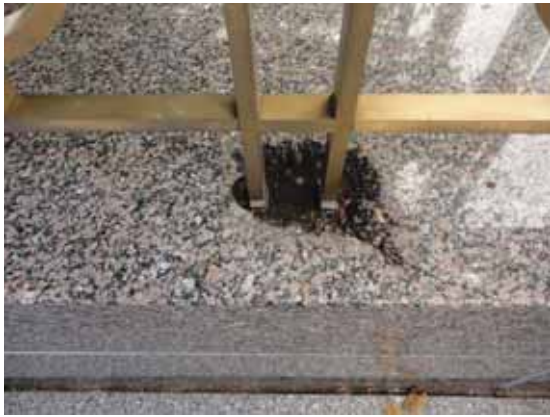
Fig. 2.1.A.37 Sealant or mortar is deteriorating and missing at the guardrail connections to the granite walls at the Sherman Street Entrance and is allowing standing water.

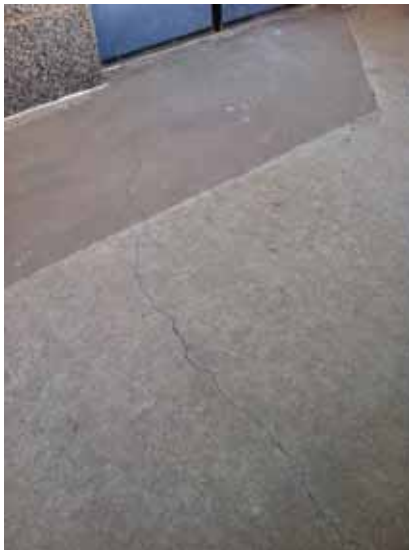
Fig. 2.1.A.38 A large crack noted at the concrete landing of the employee entrance at the north end of the west side of the building.

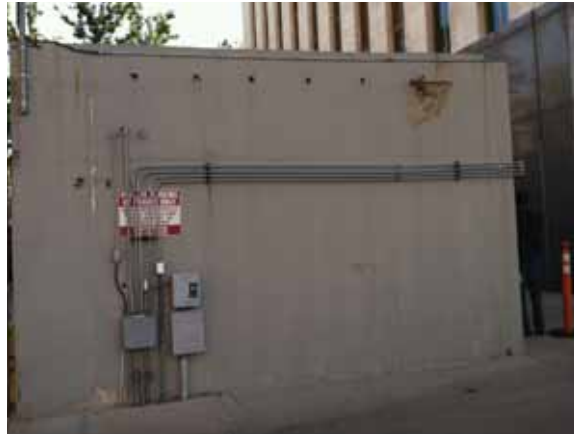
Fig. 2.1.A.39 Spalling and cracking noted at the west wall of the one-story concrete structure along the north side of the building.

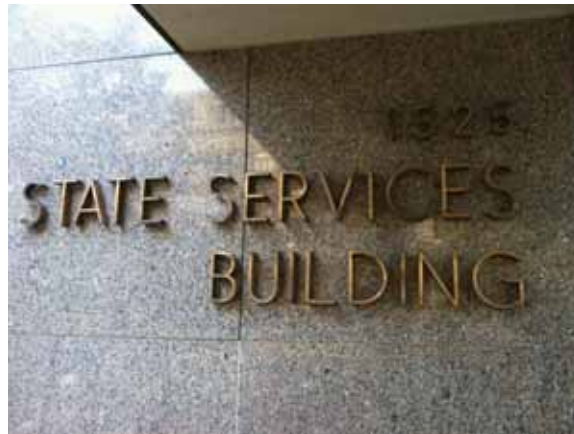
Fig. 2.1.A.40 Soiled brass building signage noted at the Sherman Street Entrance.

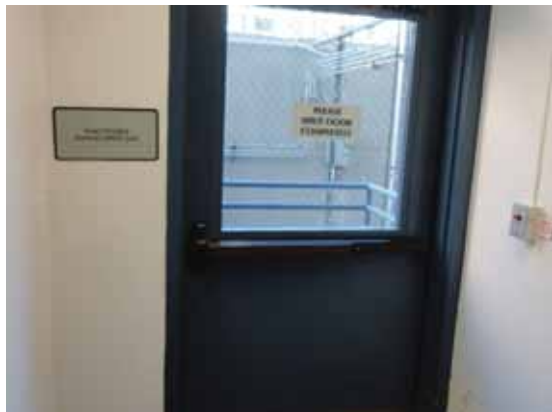
Fig. 2.1.B.1 Pushing the button of a locking device is required to open the Ground Floor emergency exit door located at the west end of the north side of the building.

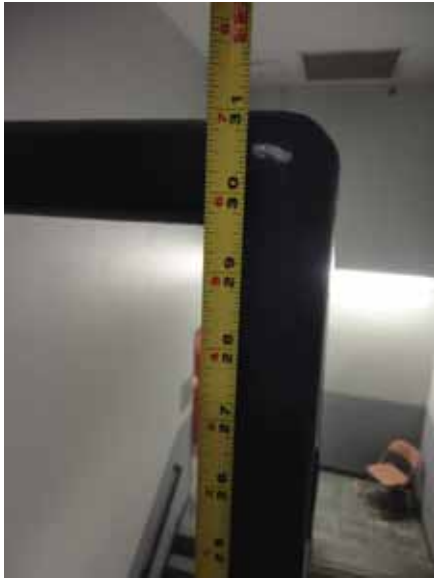
Fig. 2.1.B.3 The height to the top of the railing within the interior exit stairways.

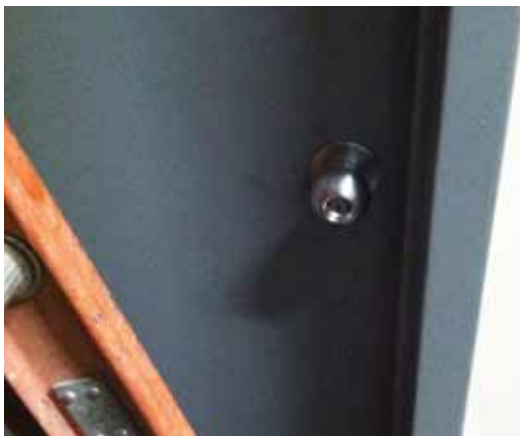
Fig. 2.1.B.4 Typical knob-style door handle found in the Penthouse.

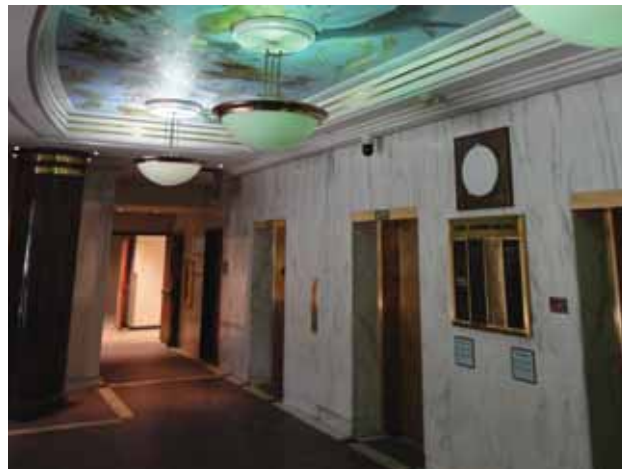
Fig. 2.1.B.5 Security camera noted in the First Floor elevator lobby.

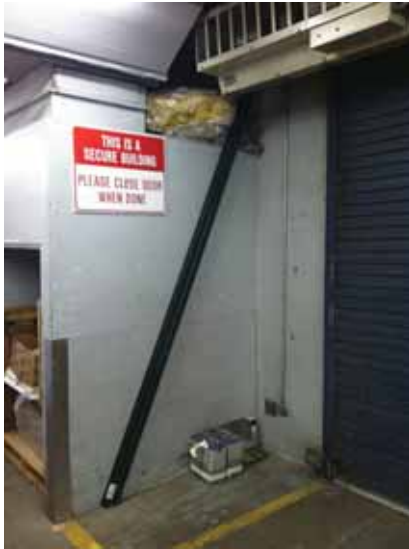
Fig. 2.1.B.6 A sign observed in the loading dock area reminding employees to close the door when not in use.

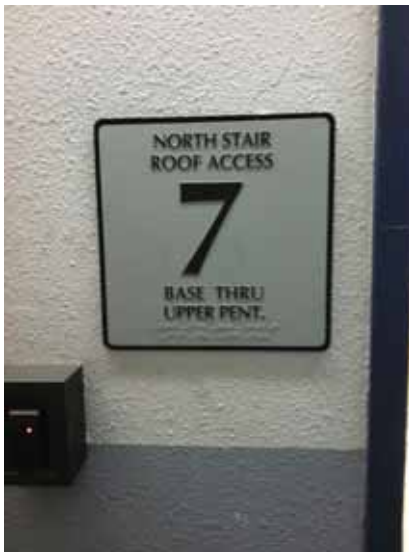
Fig. 2.1.B.7 Card access reader observed at a few of the floors from the interior side of the stairway.

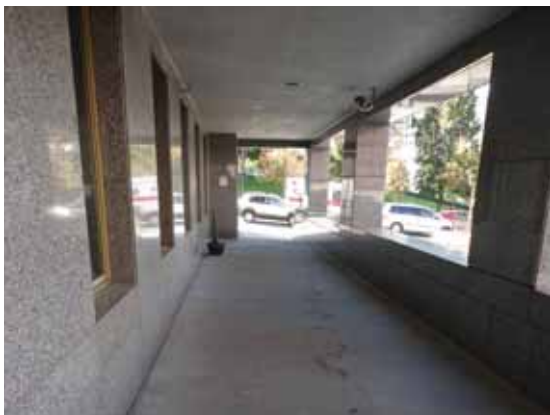
Fig. 2.1.B.8 Security camera noted at the accessible entrance on the south end of the west side of the building.

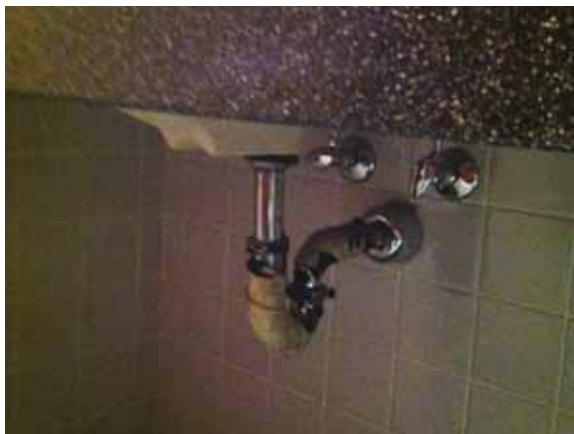
Fig. 2.1.C.1 Generally deteriorating insulation wrapped around the pipes of the accessible lavatories throughout does not appear to be providing adequate protection.

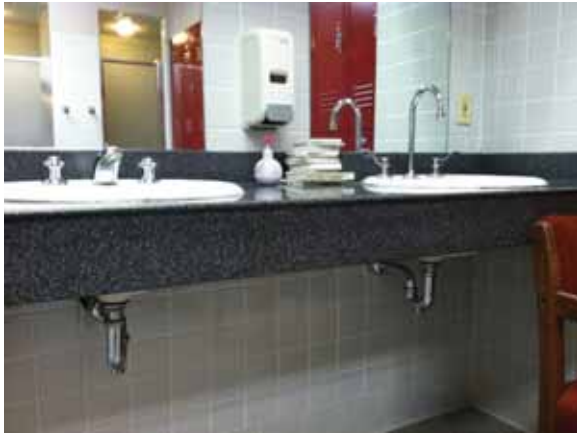
Fig. 2.1.C.2 Typical instance of insulation missing entirely from the pipes of an accessible lavatory.

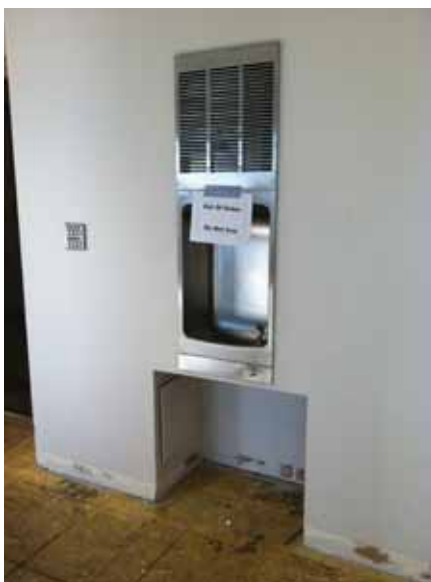
Fig. 2.1.C.3 Generally accessible drinking fountain with the exception of the clear space provided underneath.

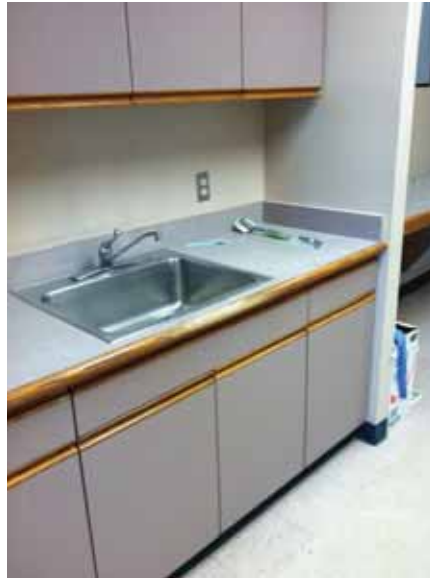
Fig. 2.1.C.4 Typical non-accessible sink found in the Break Rooms throughout.

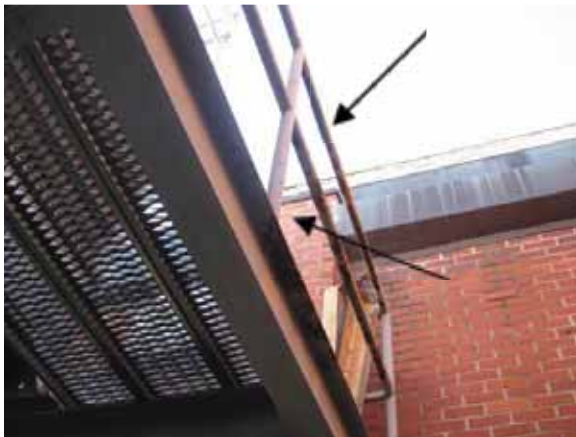
The building's exterior is in good condition with a few minor exceptions. The steel beams supporting the cooling towers and associated guardrail are corroding (Fig. 2.2.A.1). The corrosion is minor, but should be addressed soon to prevent additional deterioration.

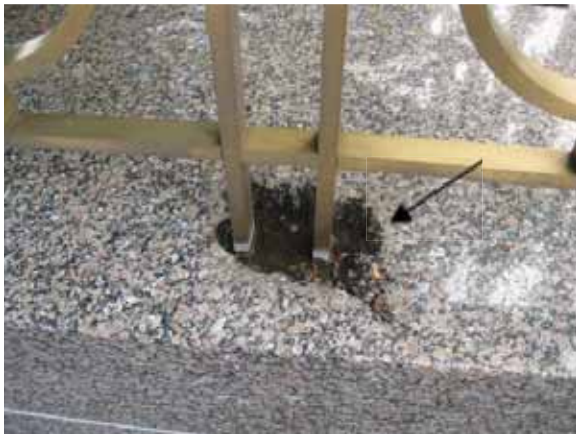
The grout pockets for the guardrail connections to the granite walls at the east entrance are deteriorated or missing grout (Fig. 2.2.A.2). The pockets allow standing water around the railing and the potential for additional deterioration.

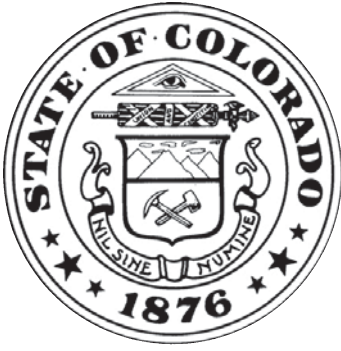
2.0 OVERALL BUILDING ASSESSMENT FINDINGS & RECOMMENDATIONS

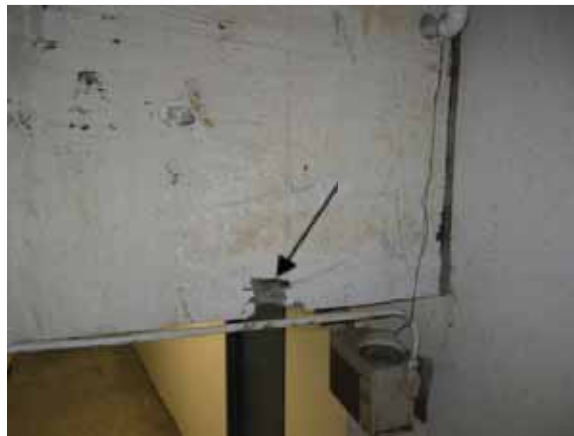
Spalls and cracks were observed on a concrete beam in the sub-basement (Fig. 2.2.B.1). The deterioration appears to be due to long term water leaks from the poorly sealed joints above the beam.

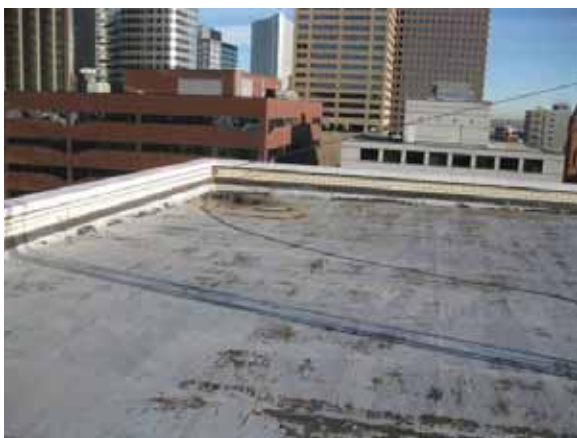
Inadequate parapet heights were observed adjacent to the loading dock and the upper roof levels (Fig. 2.2.C.1). Parapets should be at least 42 inches tall or fall protection provided for access near the exposed edges to meet current safety codes.

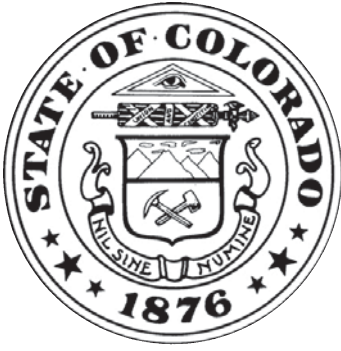
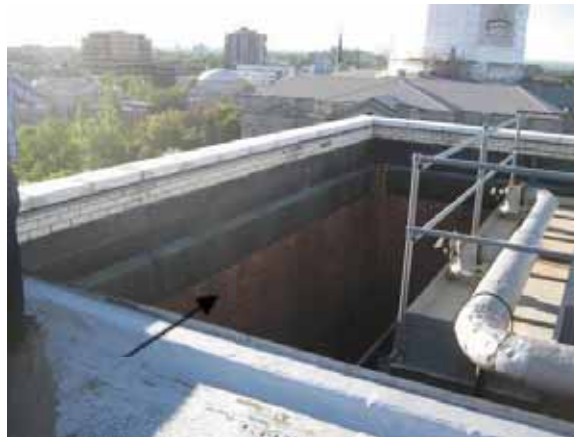
2.0 OVERALL BUILDING ASSESSMENT FINDINGS & RECOMMENDATIONS

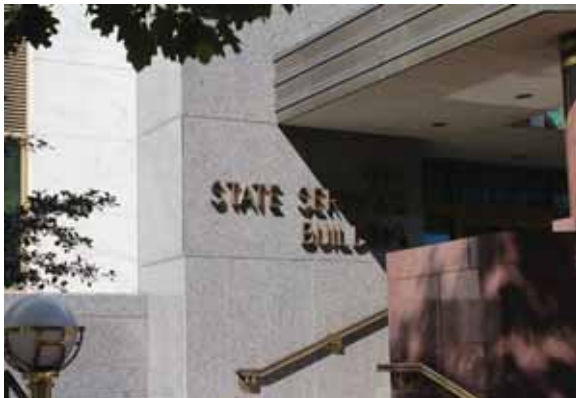
Figure 2.3.A.1 – State Services Building

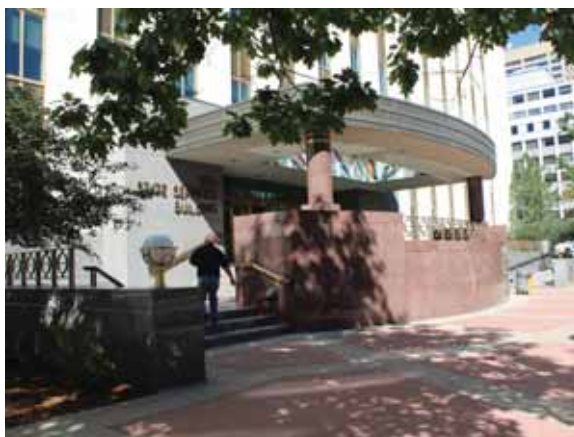
Figure 2.3.A.2 – Sherman Street Entrance, Steps to Left, Ramp to Right

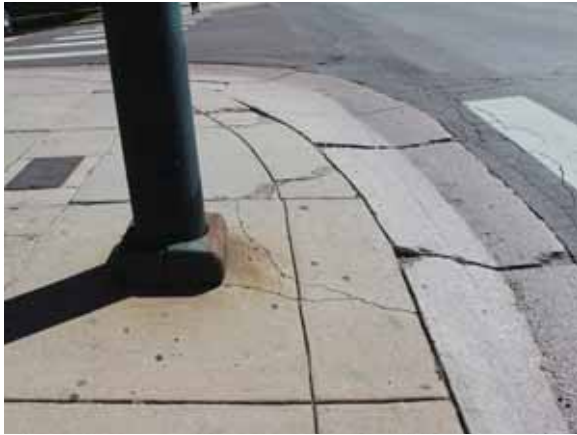
Figure 2.3.A.6 Site
Concrete Crack

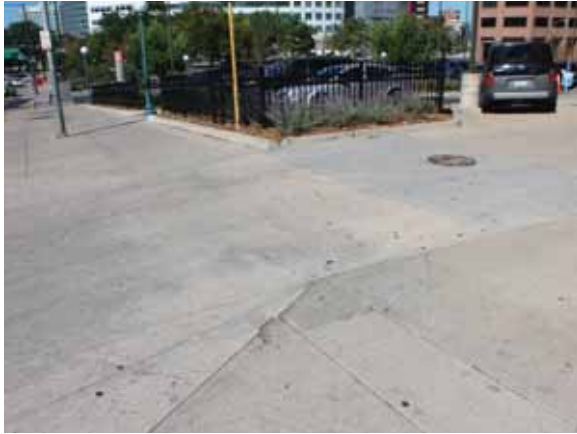
Figure 2.3.A.7 Broken Site
Concrete

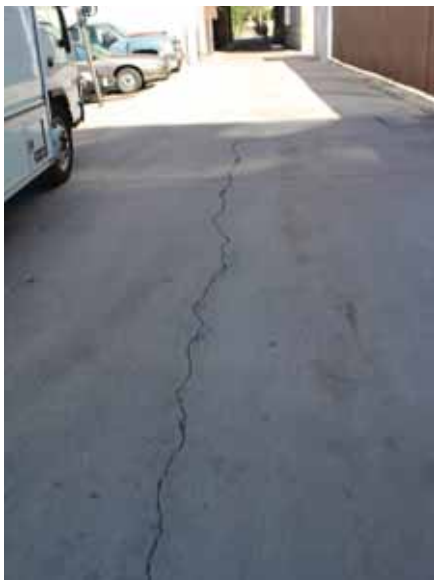
Figure 2.3.A.8 Concrete Crack in
alleyway, Recommended for Repair or
Replacement

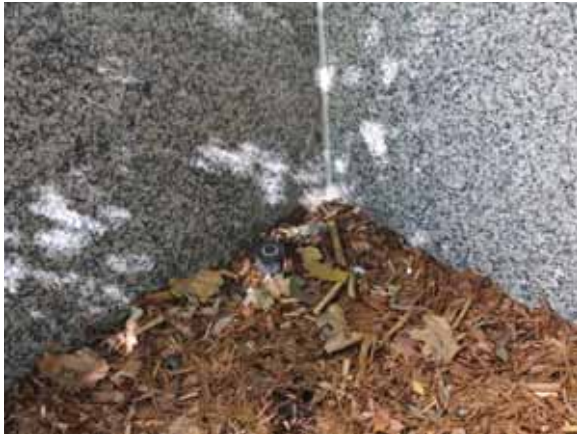
Figure 2.3.B.1 Irrigation
Near Building Foundation

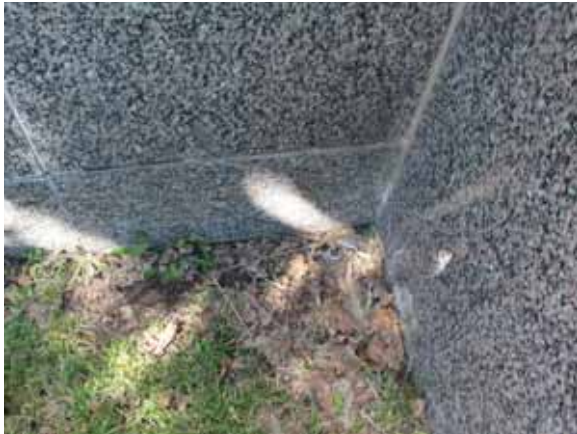
Figure 2.3.B.2 Irrigation
Near Building Foundation

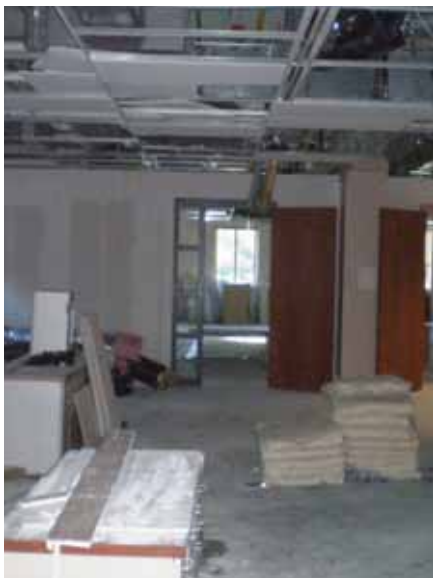
Fig. 2.4.A.1 – Remodel in progress

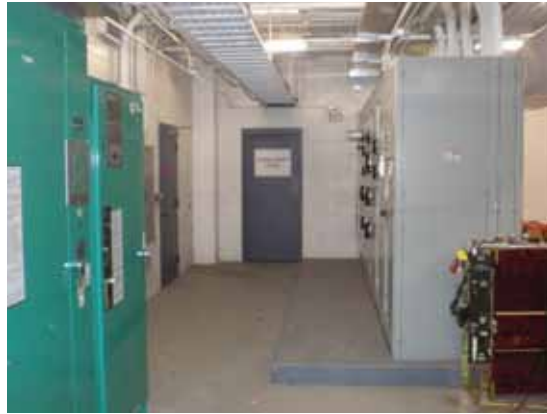
Fig. 2.4.A.2 – Main electrical gear

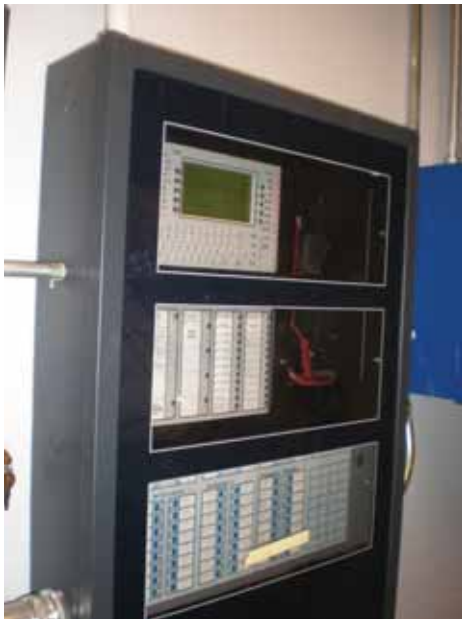
Fig. 2.4.A.6 – Fire alarm control panel

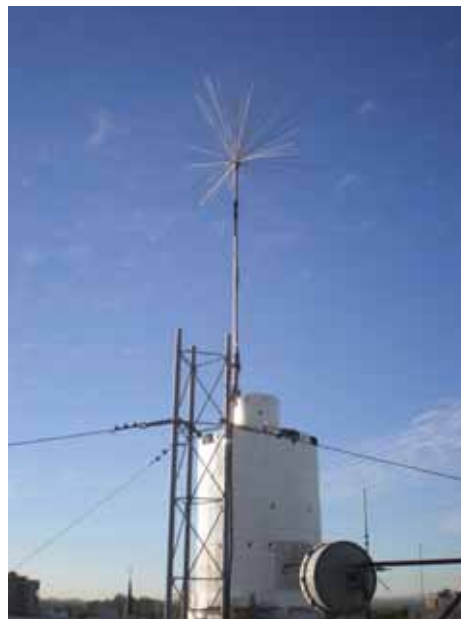
Fig. 2.4.A.8 – Lightning protection

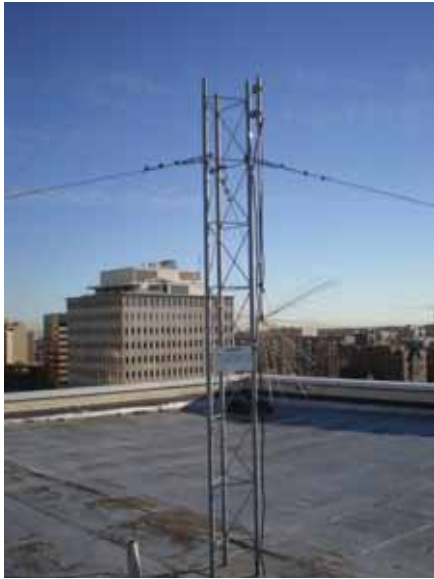
Fig. 2.4.A.9 – Broken lightning protection

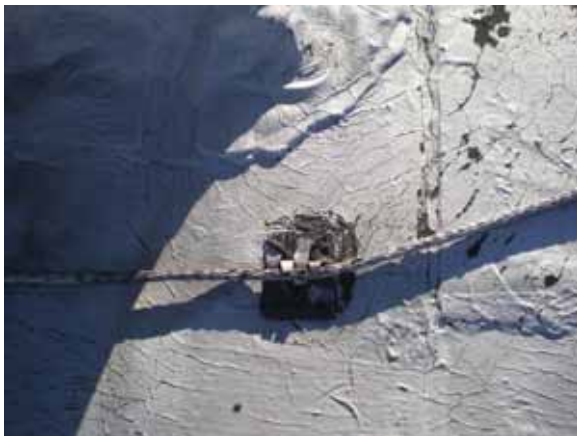
Fig. 2.4.A.10 – Lightning protection wire on roof

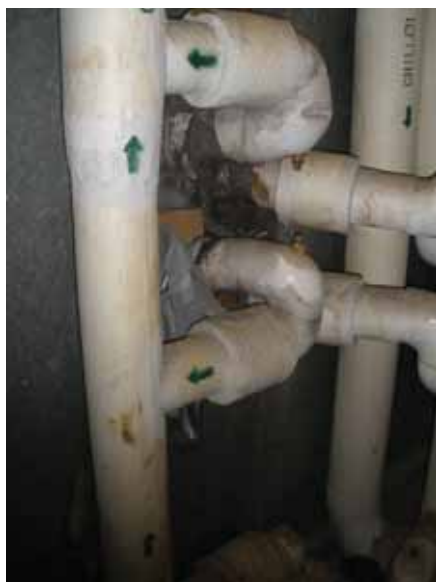
Fig. 2.4.A.11 – Air leakage from opening around pipes

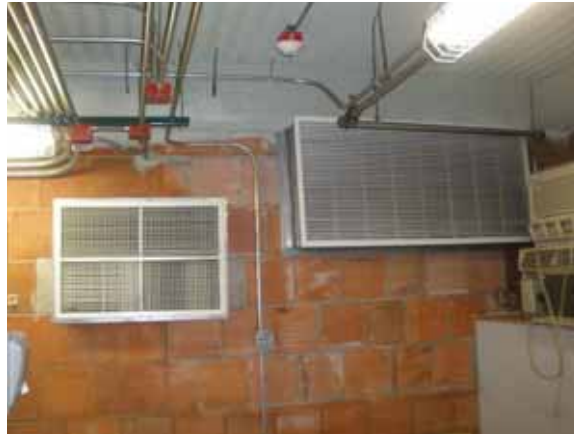
Fig. 2.4.A.12 – Supply and return grilles serving elevator machine room

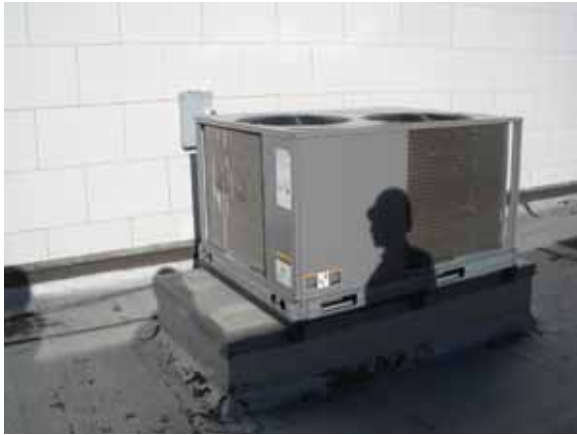
Fig. 2.4.A.15 – Condensing unit with damaged fins

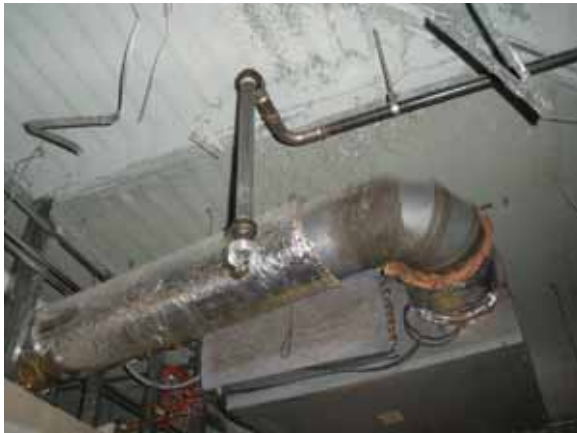
Fig. 2.4.A.16– Pro-press fitting used for sprinkler piping

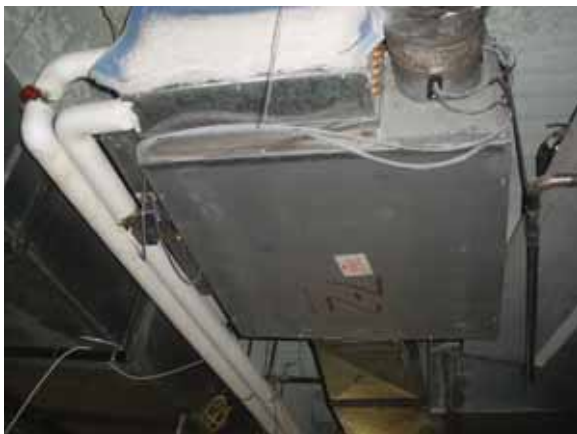
Fig. 2.4.A.17 – VAV filters are clogged

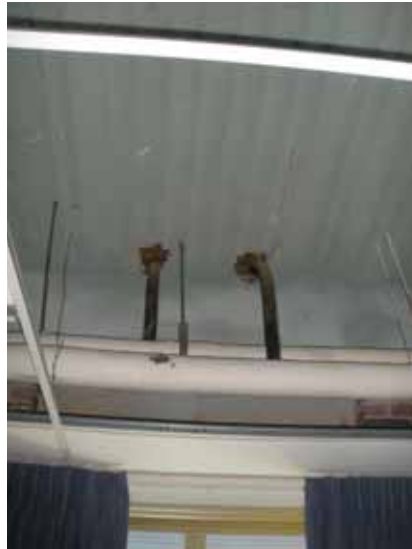
Fig. 2.4.A.18 – Pipes serving upper floor convectors

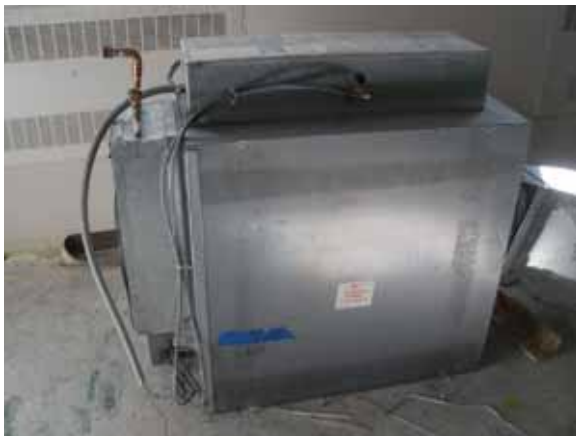
Fig. 2.4.A.22 – Existing VAV box stored in the construction area

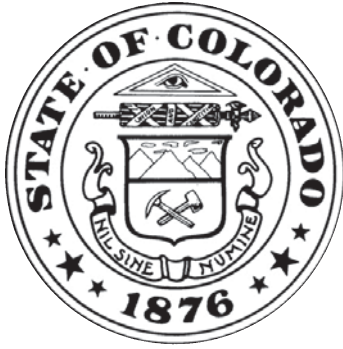
3.0 FLOOR-BY-FLOOR ASSESSMENT FINDINGS AND RECOMMENDATIONS

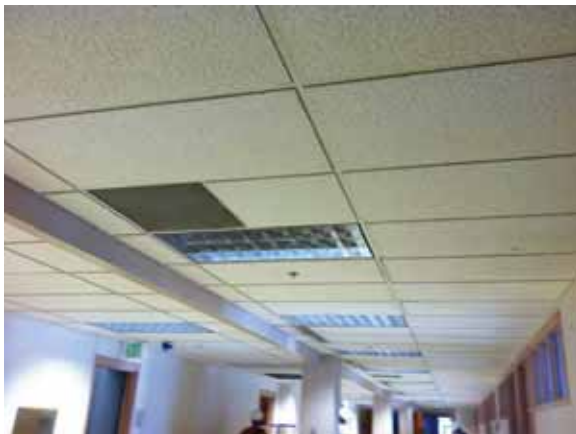
Fig. 3.0.C.1 General deterioration and aging of the acoustic ceilings noted throughout.

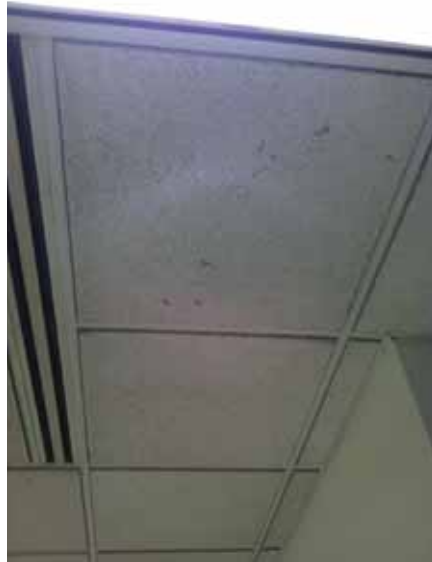
Fig. 3.0.C.2 General wear-and-tear and aging of the acoustic ceilings noted throughout.

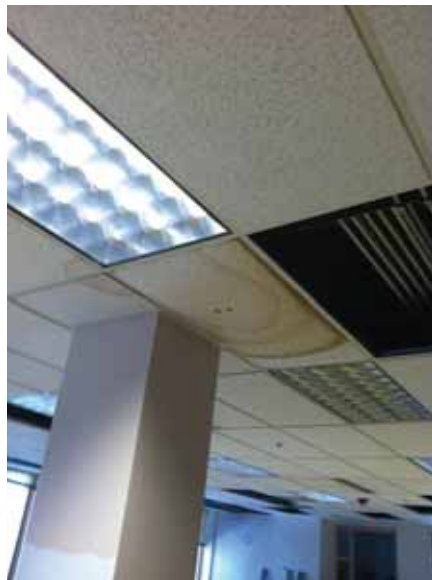
Fig. 3.0.C.3 Water damage to the acoustic ceiling noted in spots throughout the building.

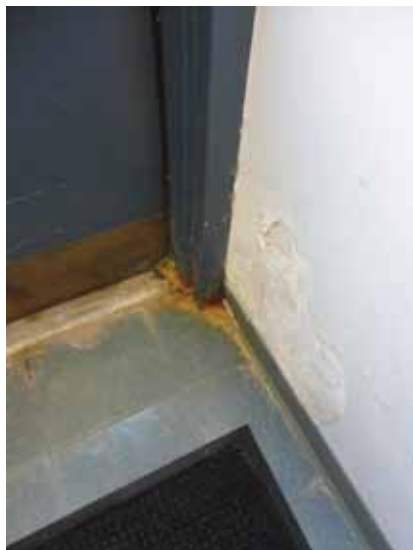
Fig. 3.0.C.4 Water-damaged gypsum board noted near the emergency exit on the west end of the north side of the Ground Floor.

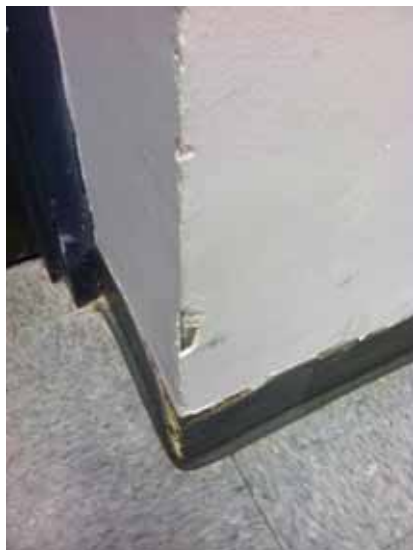
Fig. 3.0.C.5 Damaged gypsum board and vinyl baseboard observed on the Sub-basement Floor.
