CAPITOL COMPLEX MASTER PLAN
FINDINGS & RECOMMENDATIONS (F & R) NEEDS ASSESSMENT
STATE SERVICES BUILDING, 1525 SHERMAN STREET (DENVER)

NOVEMBER 2014

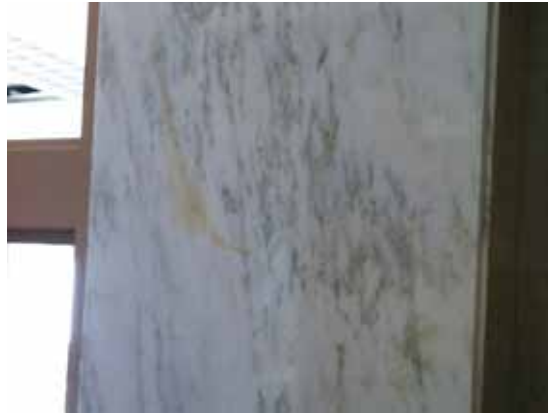
Fig. 3.0.C.6 Areas of soiled marble cladding on the walls noted in the elevator lobbies throughout.

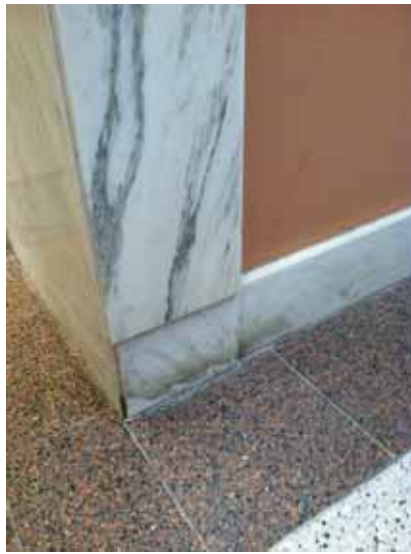
Fig. 3.0.C.7 Areas of soiled marble cladding on the walls noted in the elevator lobbies throughout.

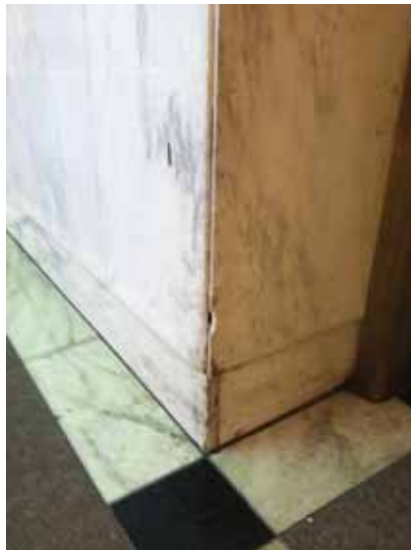
Fig. 3.0.C.8 Damaged marble cladding on the walls noted in the First Floor elevator lobby.

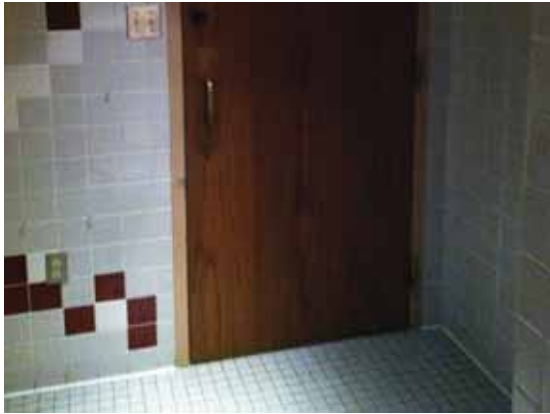
Fig. 3.0.C.9 Soiling of the four-inch square tile wainscoting noted in areas of the restrooms.

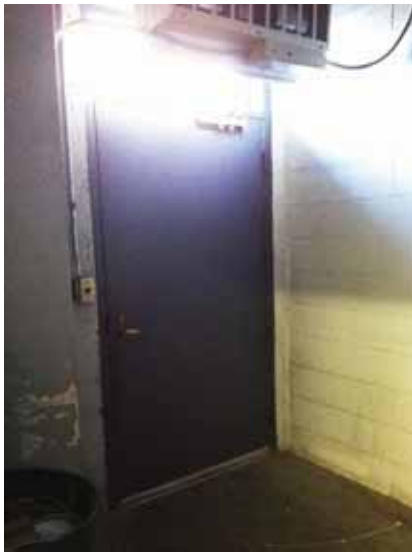
Fig. 3.0.C.10 General wear-and-tear noted at the walls in the loading dock area on the Ground Floor.

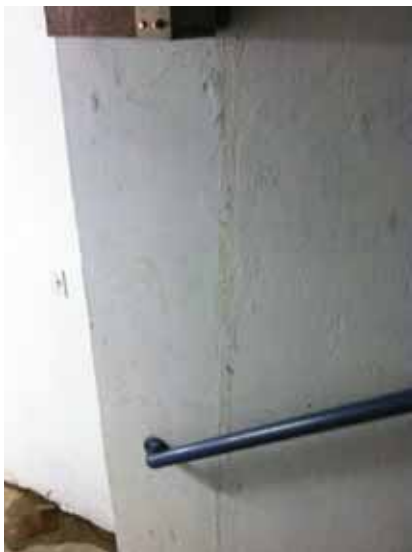
Fig. 3.0.C.11 Water damage noted at the walls near the emergency exit on the Sub-basement Floor.

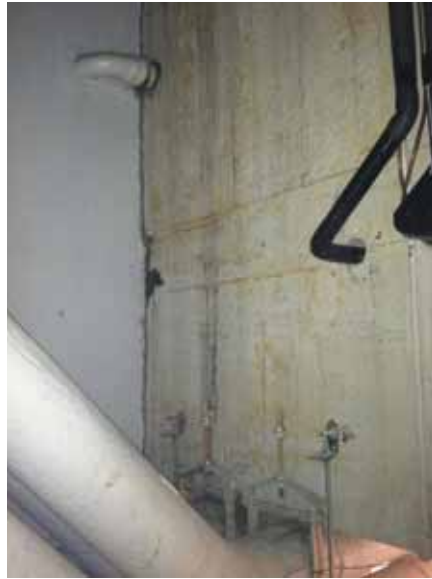
Fig. 3.0.C.12 Water damage noted at the walls near the emergency exit on the Sub-basement Floor.

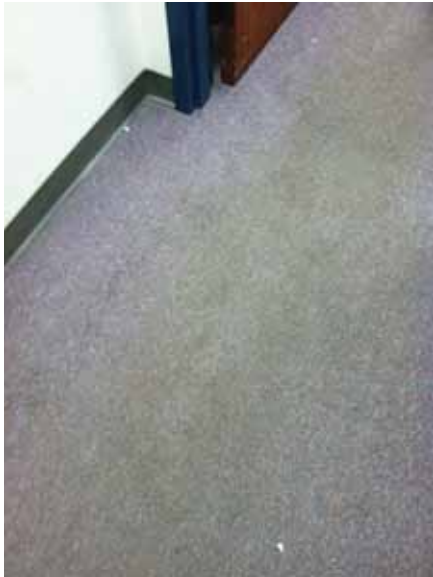
Fig. 3.0.C.13 Deteriorating and soiled carpet noted throughout the Sub-basement Floor.

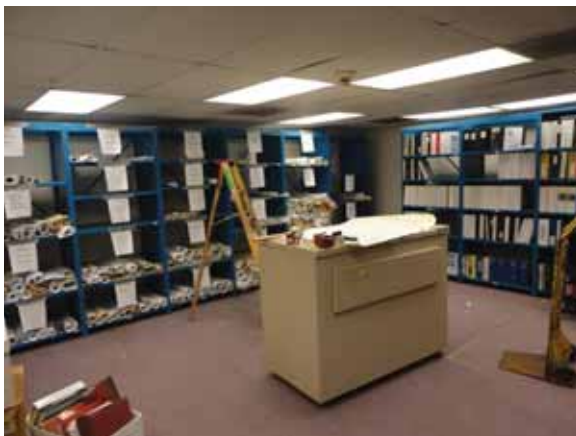
Fig. 3.0.C.14 Deteriorating and soiled carpet noted throughout the Sub-basement Floor.

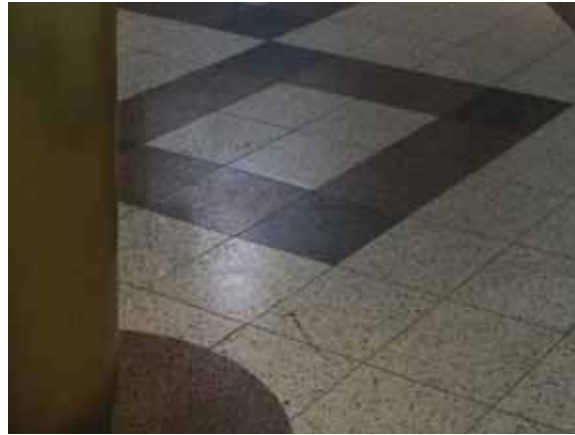
Fig. 3.0.C.15 Areas of soiling and damage noted at the granite tile flooring in the elevator lobbies.

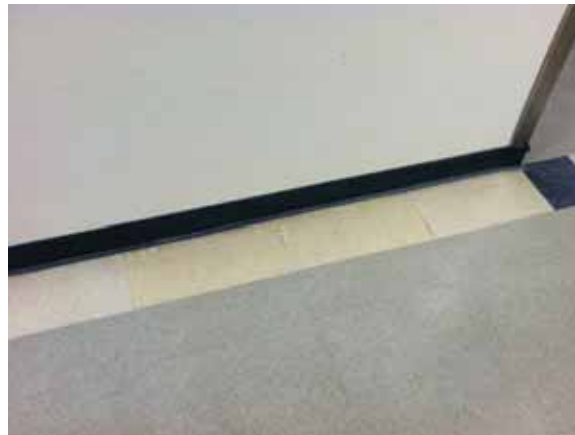
Fig. 3.0.C.16 Discolored 1x1 linoleum tile flooring noted during the site survey visit.

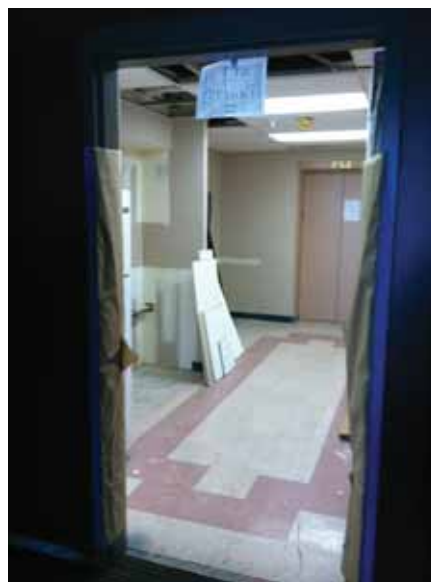
Fig. 3.0.C.17 Damaged and worn 1x1 linoleum tile flooring noted during the site survey visit.

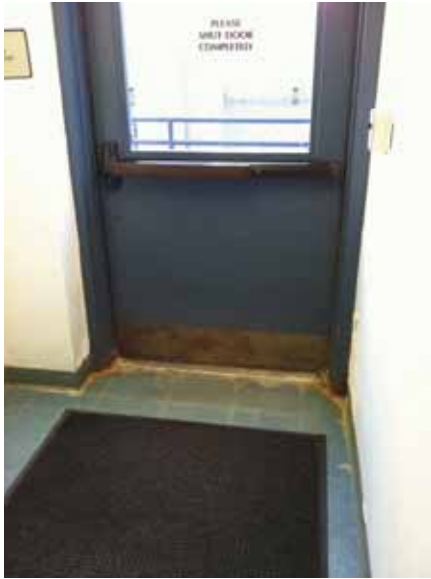
Fig. 3.0.C.18 Water damage noted at the 1x1 floor tile near the emergency exit at the west end of the north side of the Ground Floor.

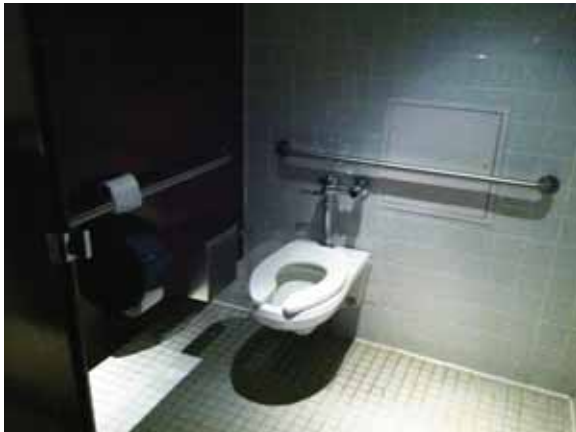
Fig. 3.0.C.19 Areas of soiling noted at the two-inch square floor tile in the restrooms.

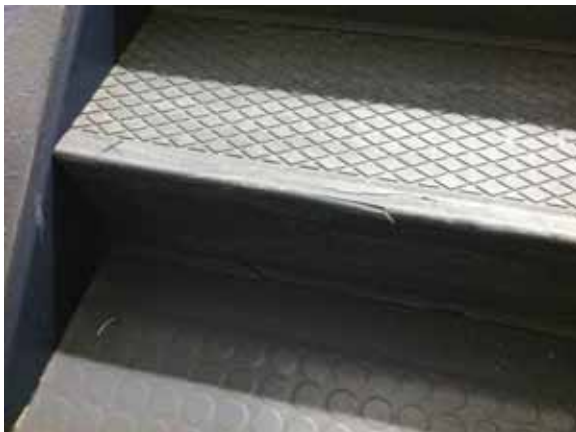
Fig. 3.0.C.20 Deteriorating rubber flooring noted on the stairs.

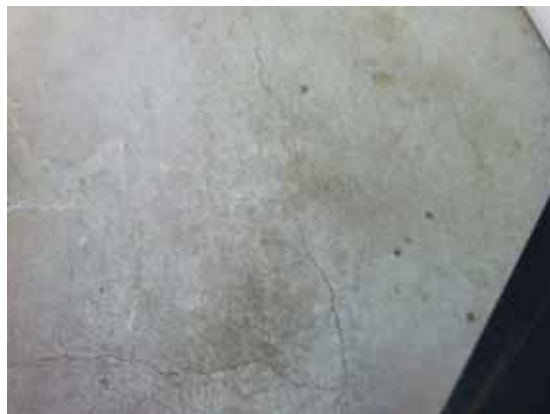
Fig. 3.0.C.21 Cracked concrete flooring observed on the Sub-basement Floor.

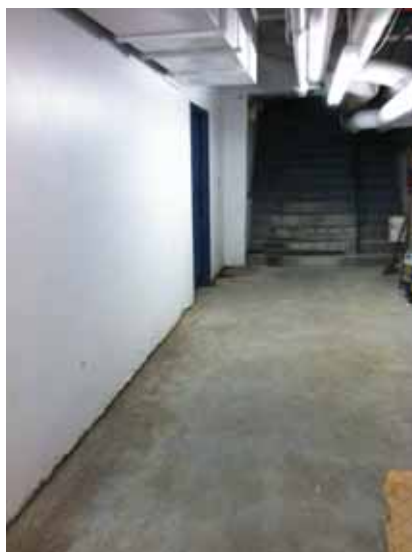
Fig. 3.0.C.22 Water damage observed at the concrete stairs and flooring near the emergency exit on the Sub-basement Floor.

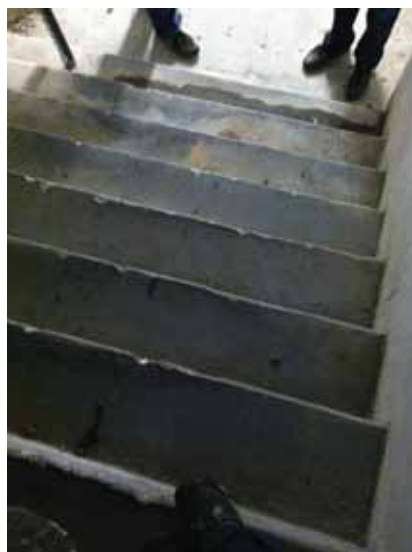
Fig. 3.0.C.23 Spalling concrete stairs and flooring near the emergency exit on the Sub-basement Floor.

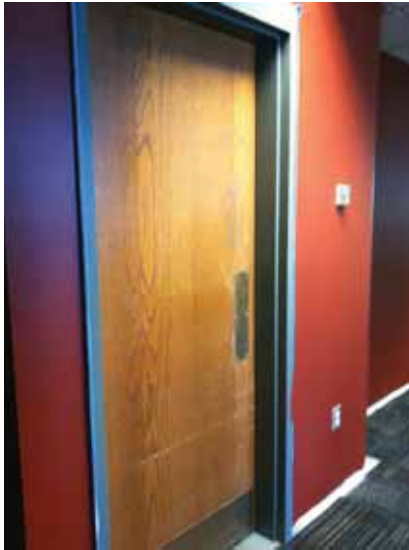
Fig. 3.0.C.24 General wear-and-tear noted at the doors.

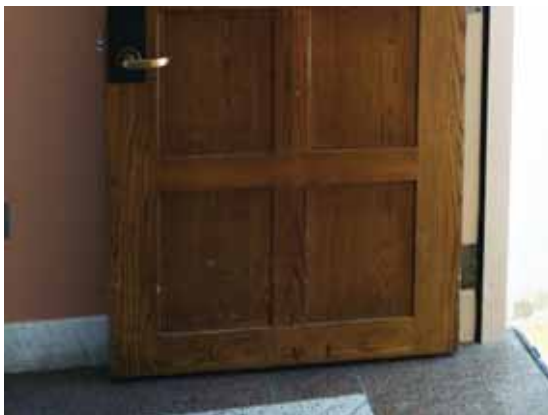
Fig. 3.0.C.25 General wear-and-tear noted at the doors.

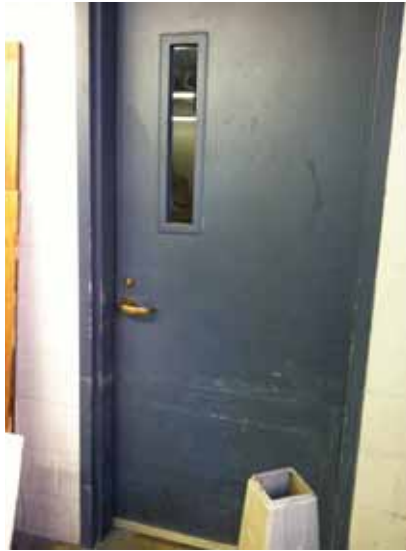
Fig. 3.0.C.26 Wear-and-tear noted at the doors in the loading dock area on the Ground Floor.

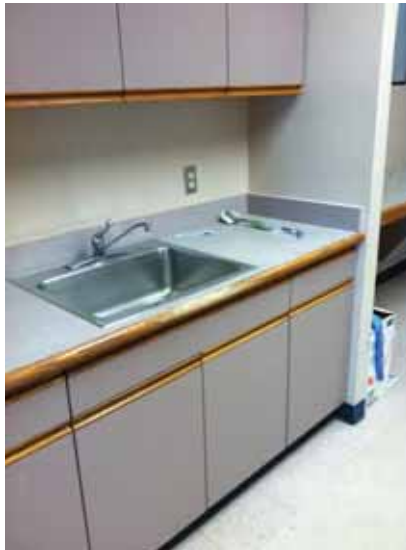
Fig. 3.0.C.27 Generally worn wood trim noted in the Break Rooms throughout.

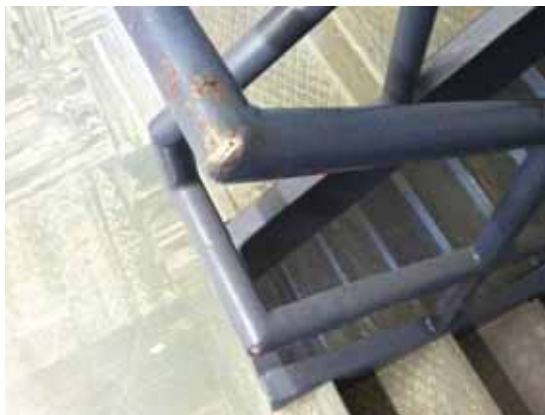
Fig. 3.0.C.28 Wear-and-tear and corrosion noted at the metal railings throughout the stairways.
