CAPITOL COMPLEX MASTER PLAN  
FINDINGS & RECOMMENDATIONS (F & R) NEEDS ASSESSMENT  
DALE TOOLEY BUILDING, 690 KIPLING STREET (LAKEWOOD)

NOVEMBER 2014

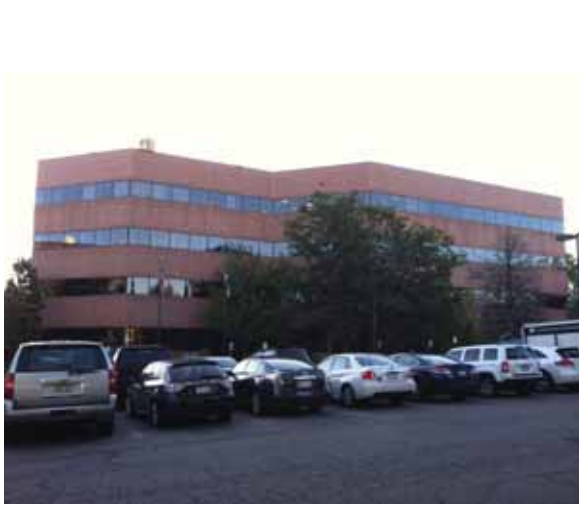
Front/West Elevation the Dale Tooley Building

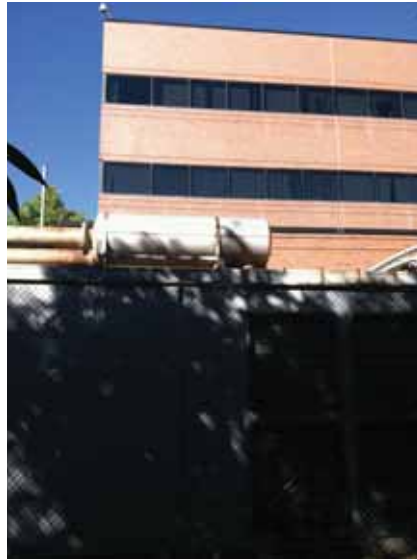
Back/East Elevation (south end) of the Dale Tooley Building

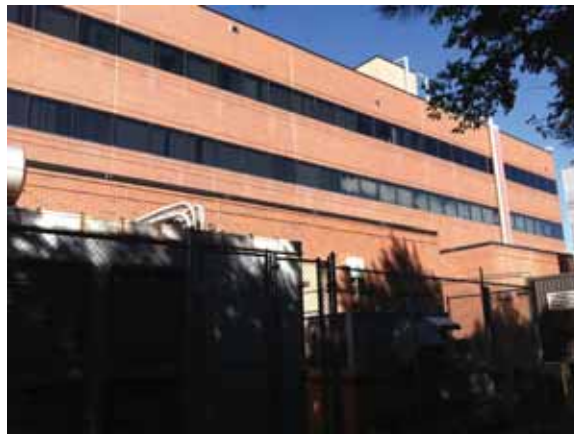
Fig. 2.1.A.1 Typical soiling of the brick observed around the perimeter of the building.

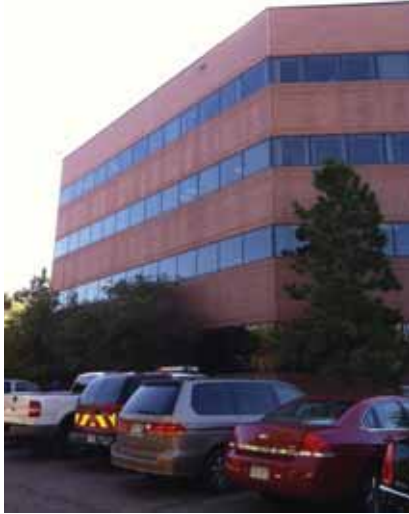
Fig. 2.1.A.2 Typical soiling of the brick observed around the perimeter of the building.

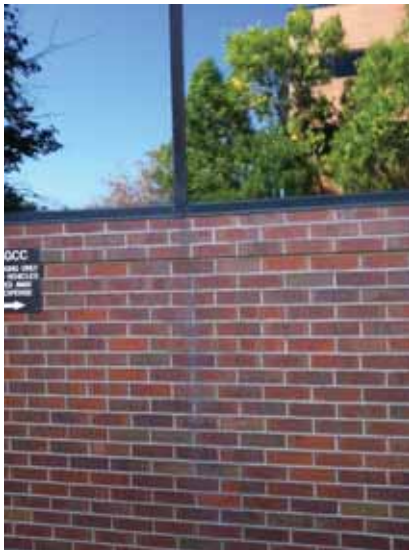
Fig. 2.1.A.3 Soiling of the brick observed under the continuous ribbon windows.

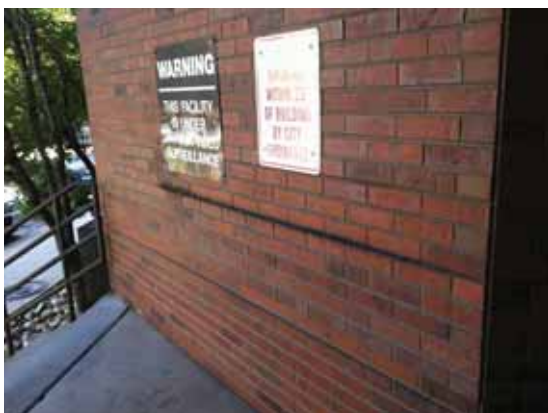
Fig. 2.1.A.4 Area of soiled grout and brick outside of the North Entrance.

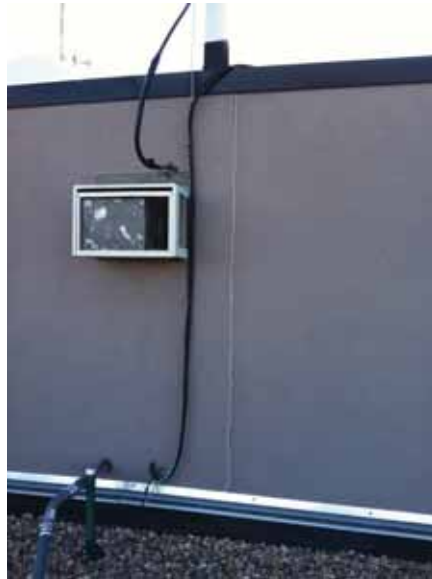
Fig. 2.1.A.5 Stucco panels cladding the Penthouse with expanding space between the panels.

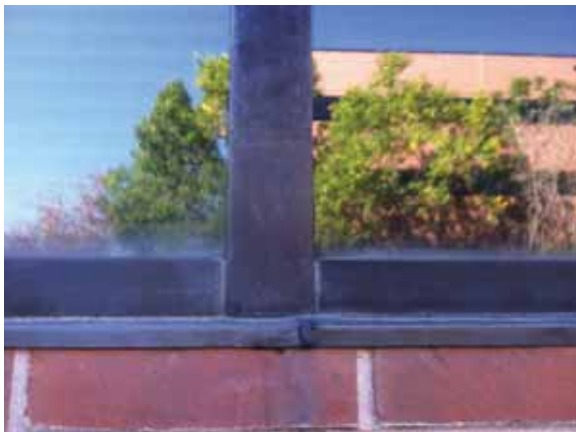
Fig. 2.1.A.7 Typical corrosion noted at the metal window frames.

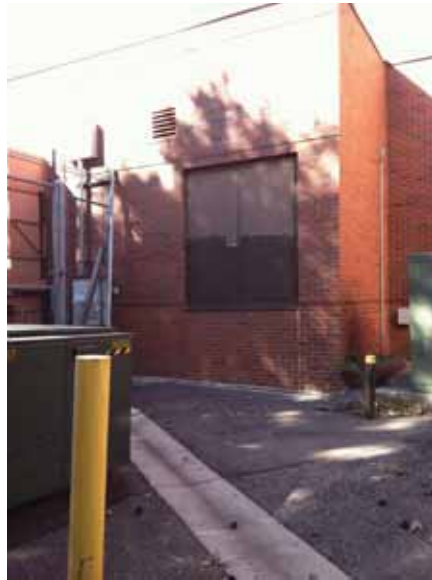
Fig. 2.1.A.8 Emergency exit doors near the middle of the east side of the building.

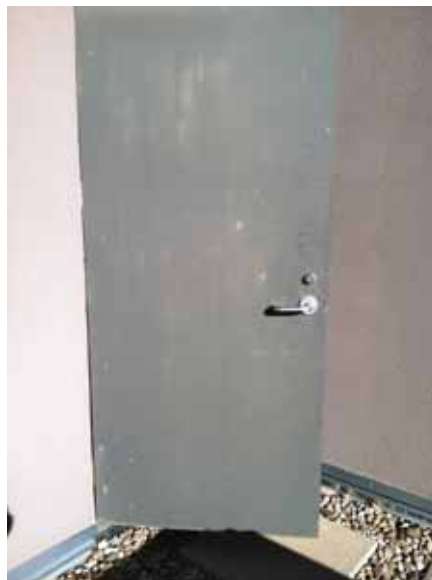
Fig. 2.1.A.9 Penthouse door with minor corrosion and paint wearing thin overall.

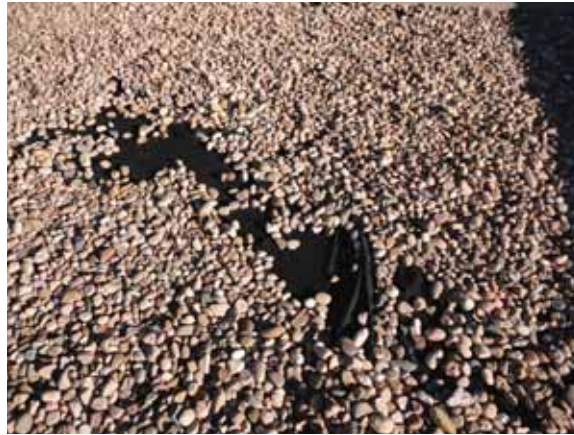
Fig. 2.1.A.10 Typical areas of thin ballast exposing the roof membrane.

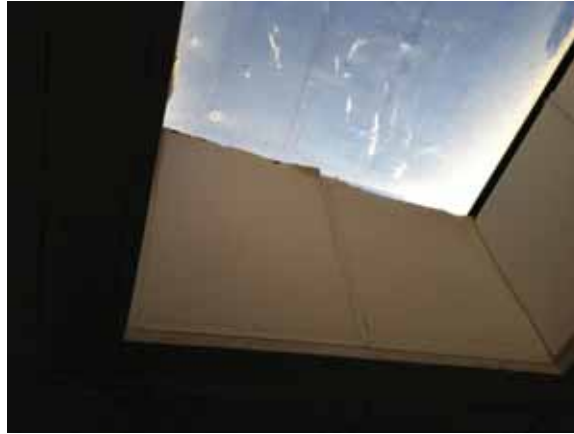
Fig. 2.1.A.11 Water damage noted at the skylight.

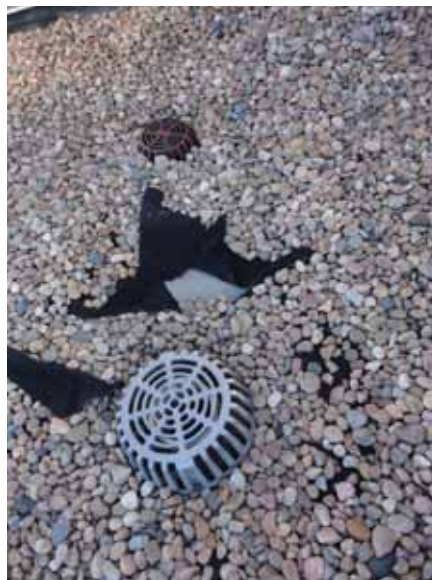
Fig. 2.1.A.12 Roof drain cover in good condition and roof drain cover with evidence of corrosion.

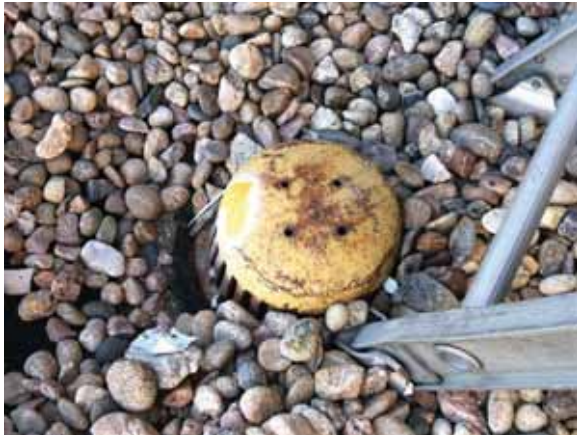
Fig. 2.1.A.13 Corroding roof drain cover.

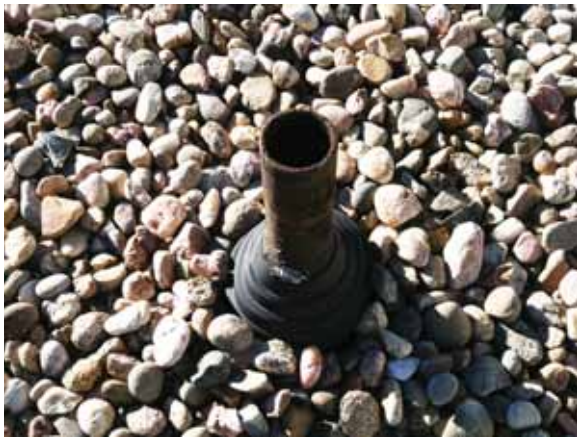
Fig. 2.1.A.14 Corroding roof exhaust vent.

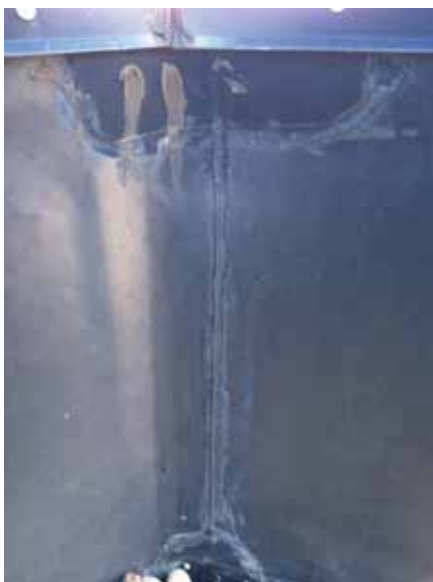
Fig. 2.1.A.15 Deteriorating sealant along the seams of the roofing membrane covering the inside face of the parapet.

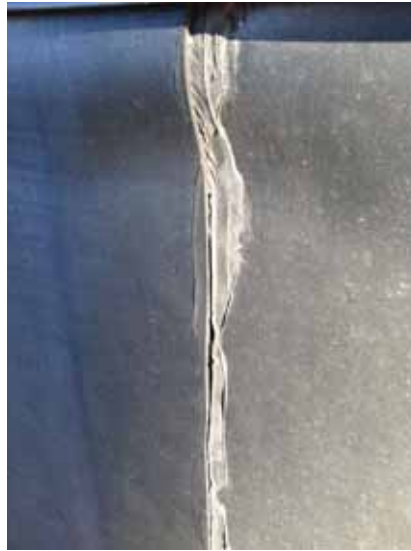
Fig. 2.1.A.16 Deteriorating sealant along the seams of the roofing membrane covering the inside face of the parapet.

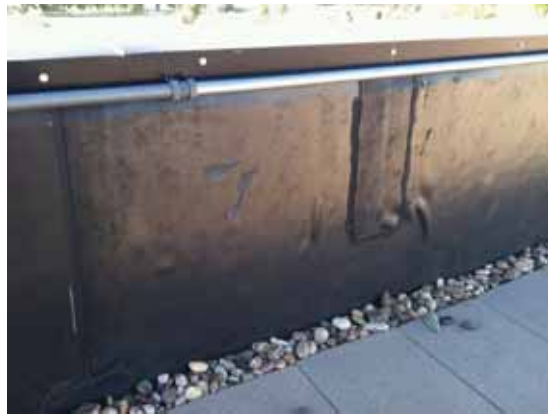
Fig. 2.1.A.17 Deteriorating sealant along the seams of the roofing membrane and bubbling of the roofing membrane covering the inside face of the parapet.

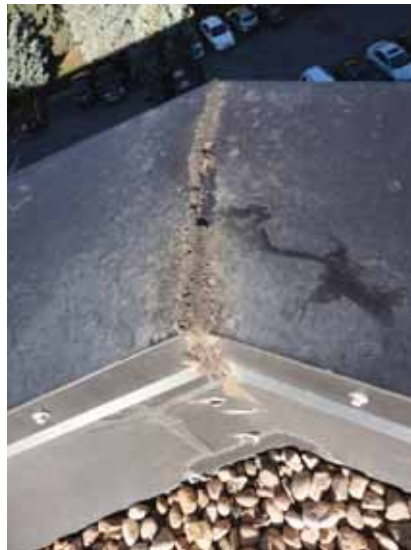
Fig. 2.1.A.18 Poor sealant repair along the seams of the parapet's coping and evidence of pooling water.

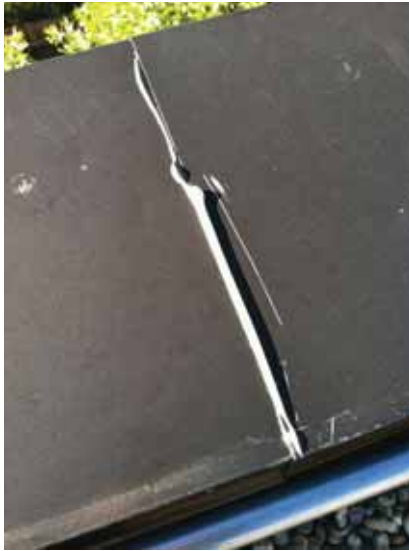
Fig. 2.1.A.19 Poor sealant repair along the seams of the parapet's coping.

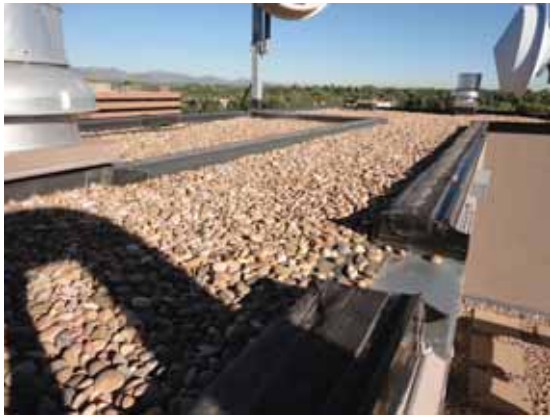
Fig. 2.1.A.20 Evidence of water pooling along the Penthouse parapet's coping.

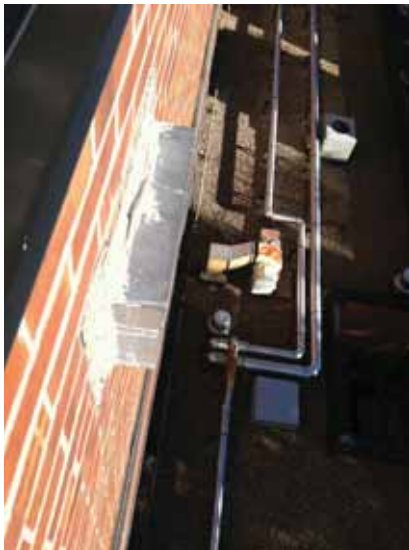
Fig. 2.1.A.21 Deteriorating sealant which has been poorly repaired at the through-parapet drains.

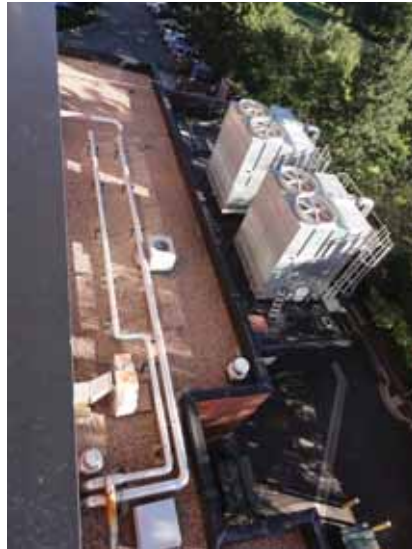
Fig. 2.1.A.22 View of the roof above the two-story section of the building along the east side.

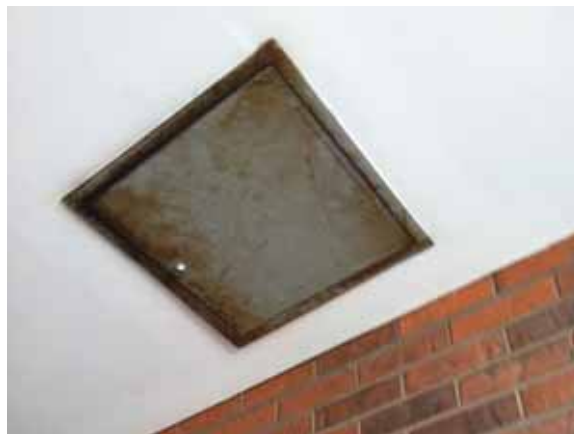
Fig. 2.1.A.23 Corroding metal cover at the canopy of the North Entrance.

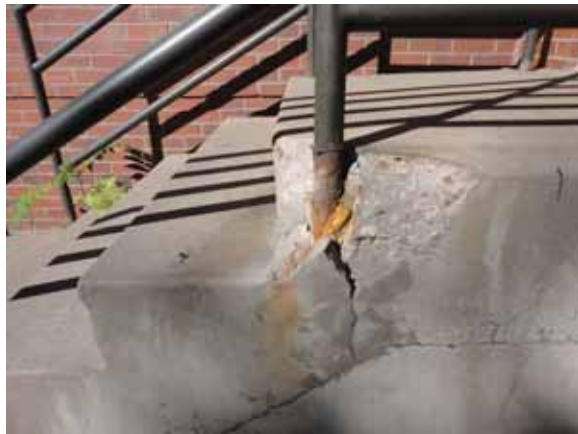
Fig. 2.1.A.24 Spalling concrete at the exterior southeast stairway.

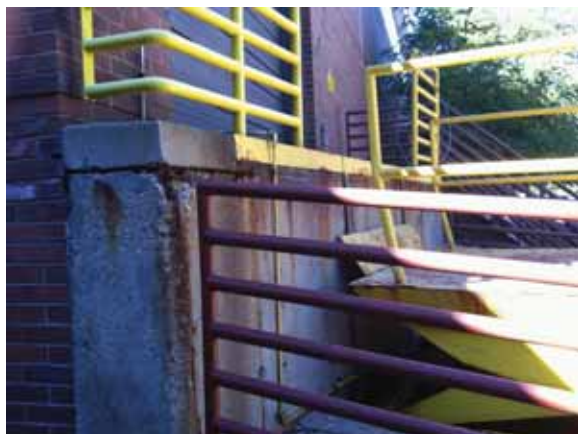
Fig. 2.1.A.25 Spalling concrete and corroding metal at the north loading dock.

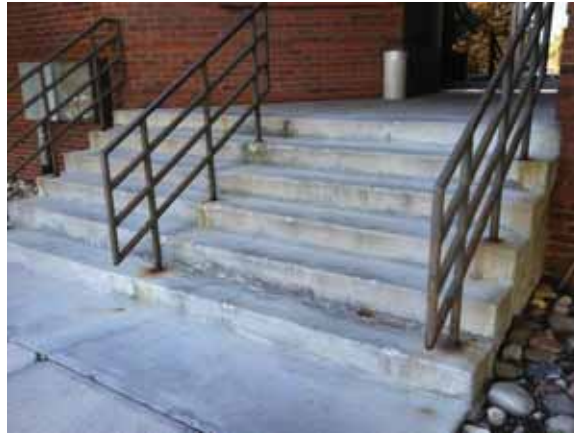
Fig. 2.1.A.26 Spalling and cracking concrete and corroding railings at the North Entrance.

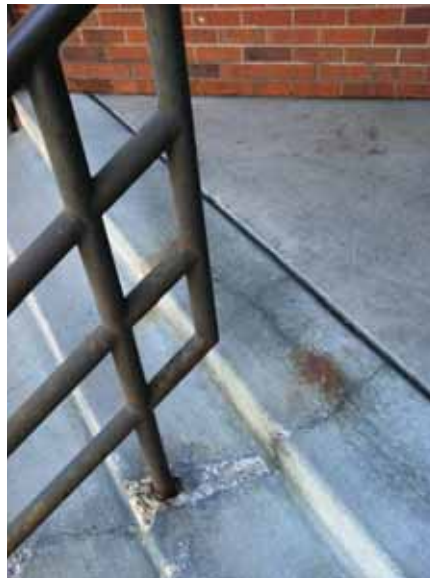
Fig. 2.1.A.27 Spalling and cracking concrete and corroding railings at the North Entrance.

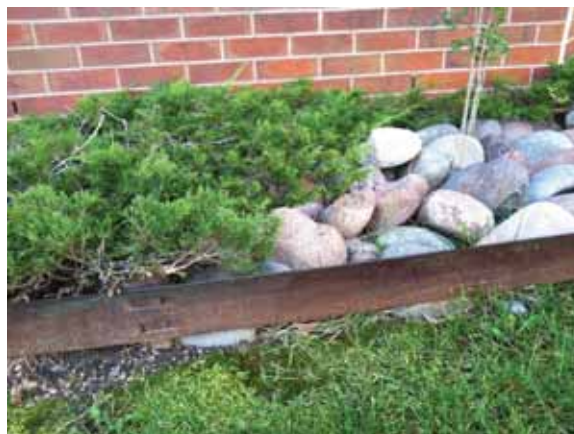
Fig. 2.1.A.28 Corroding metal lawn edging around the exterior of the building.

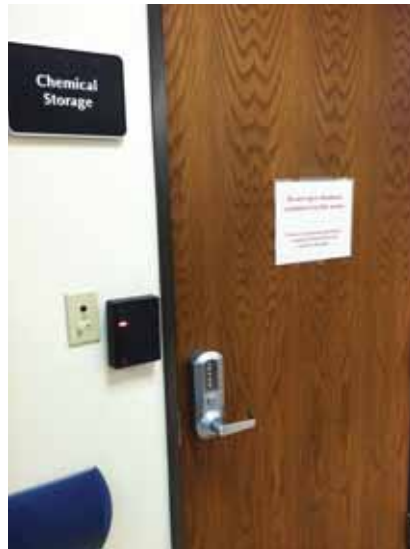
Fig. 2.1.B.2 Chemical storage and testing in the laboratories on the Fourth Floor.

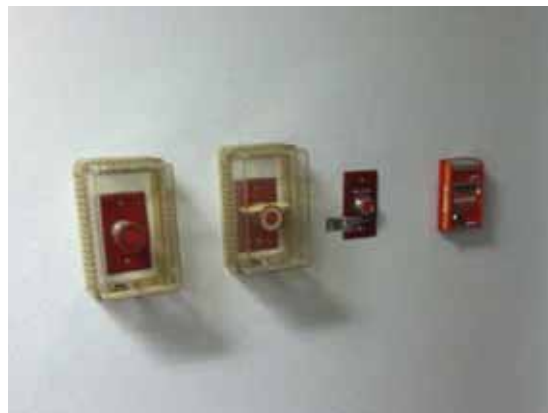
Fig. 2.1.B.8 Clean-agent fire extinguishing systems appear to be installed in the server and technology areas.

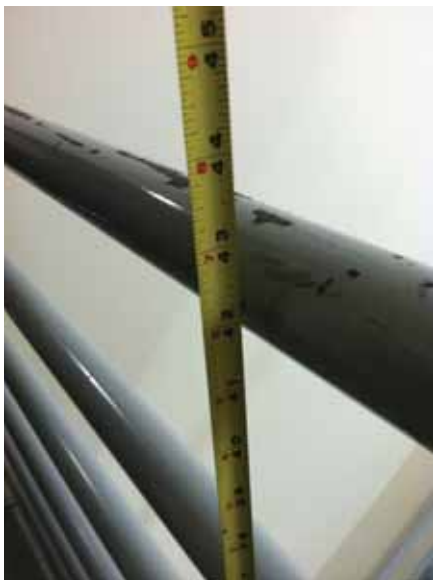
Fig. 2.1.B.9 The spacing between the railings exceeds the code-maximum of four inches.

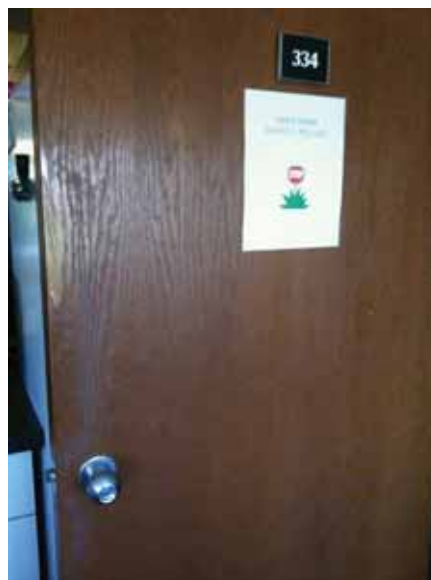
Fig. 2.1.B.10 Typical knob-style door handle found throughout the building.

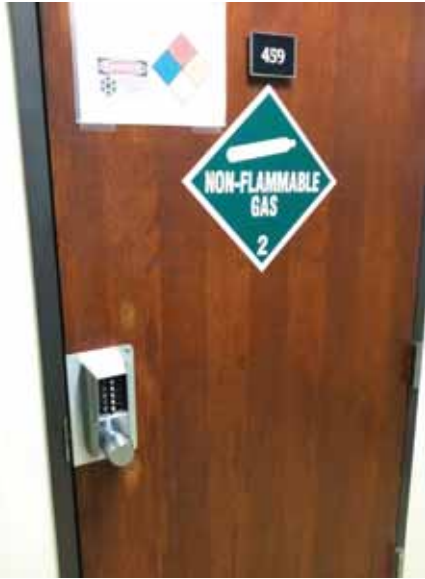
Fig. 2.1.B.11 Typical key-code system with an integrated knob-style door handle found throughout the building.

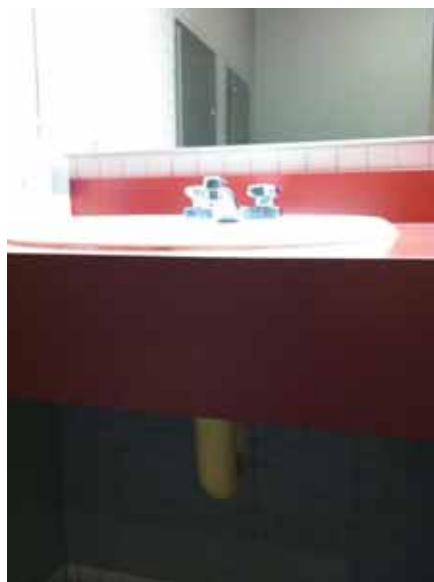
Fig. 2.1.C.1 Otherwise accessible lavatory with non-accessible knob-style faucet controls.

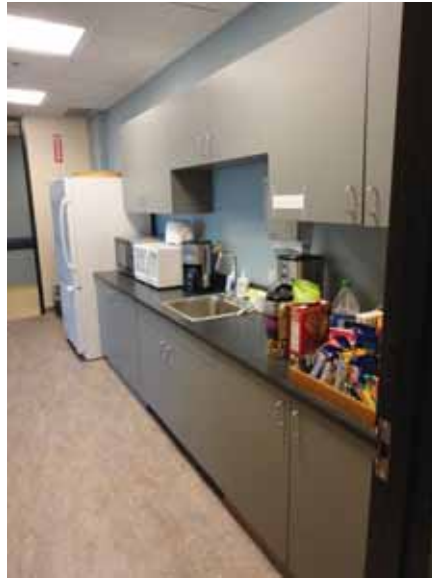
Fig. 2.1.C.4 Typical non-accessible sink found in the Break Rooms throughout.

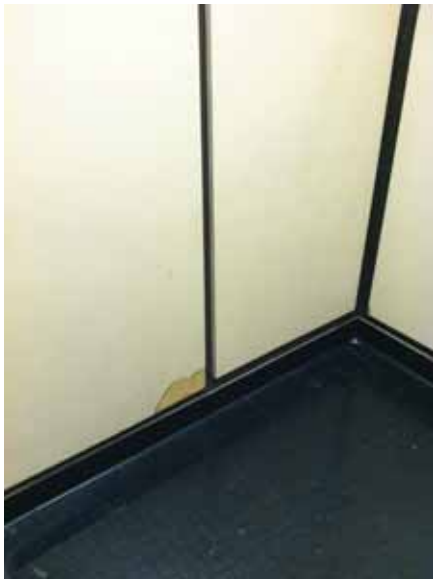
Fig. 2.1.D.1 Typical instance of damage to the panels cladding the interior walls of the elevator cabs.

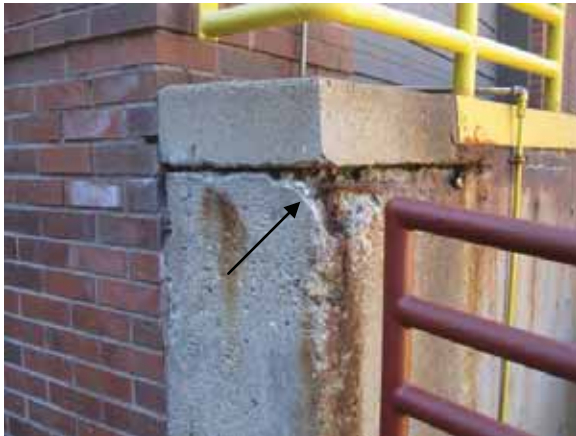
The building's exterior is in good condition with a few exceptions. Spalls and corroded reinforcing were observed at the concrete loading dock on the southeast corner (Fig. 2.2.A.1 and Fig. 2.2.A.2). The deteriorating concrete should be addressed soon to prevent additional deterioration.

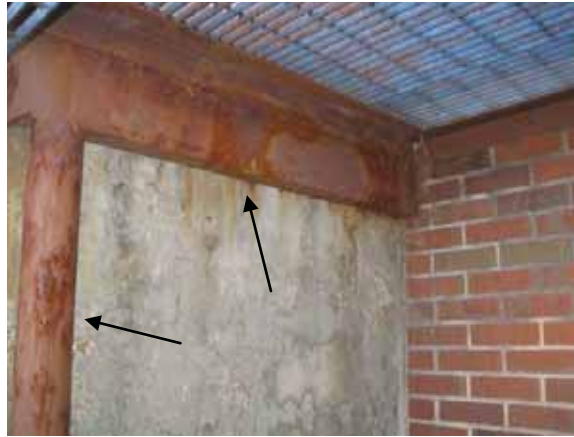
## 2.0 OVERALL BUILDING ASSESSMENT FINDINGS & RECOMMENDATIONS

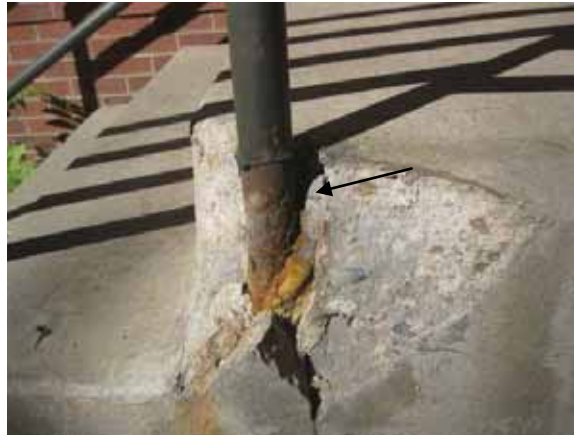
Spalls were observed on the concrete steps at the northeast exits (Fig. 2.2.A.4). The spalled concrete and corroded guardrails do not resist the code required design loading. The guardrail and concrete steps should be repaired with properly detailed connections.

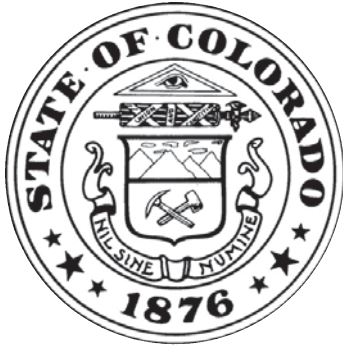
### 2.2-B BUILDING INTERIOR

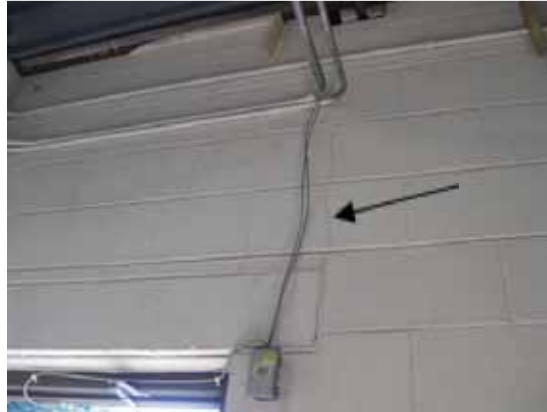
The overall condition of the structural framing that was readily observable was good. A minor crack was observed in the CMU wall at the northeast exit (Fig. 2.2.B.1). The crack should be monitored for additional movement.

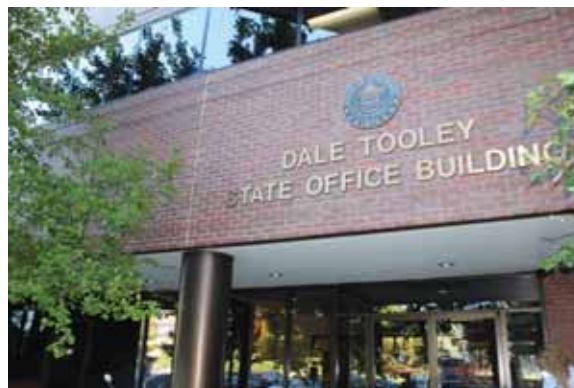
Figure 2.3.A.1 – Dale Tooley State Office Building

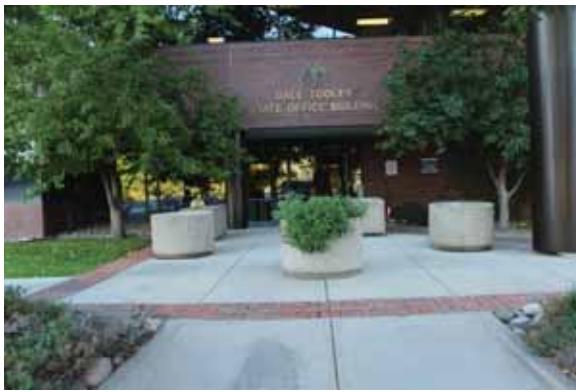
Figure 2.3.A.2 – Dale Tooley State Office Building West Entrance

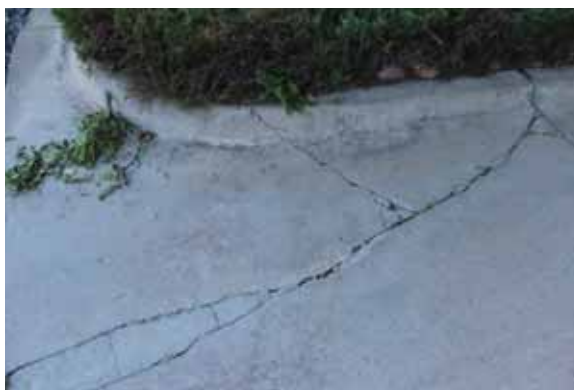
Figure 2.3.A.4 – Site Concrete Crack, Recommended for Replacement

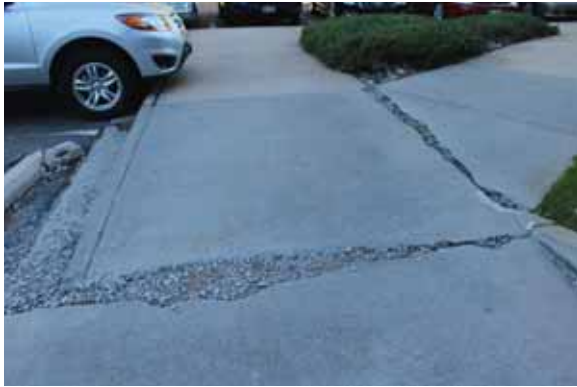
Figure 2.3.A.5 –  
Broken Site Concrete,  
Recommended for  
Replacement

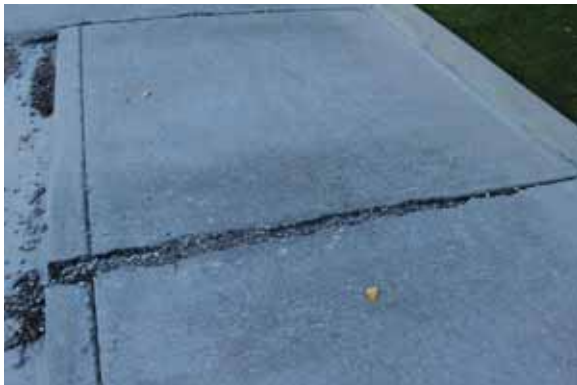
Figure 2.3.A.6 –  
Broken Site Concrete,  
Recommended for  
Replacement

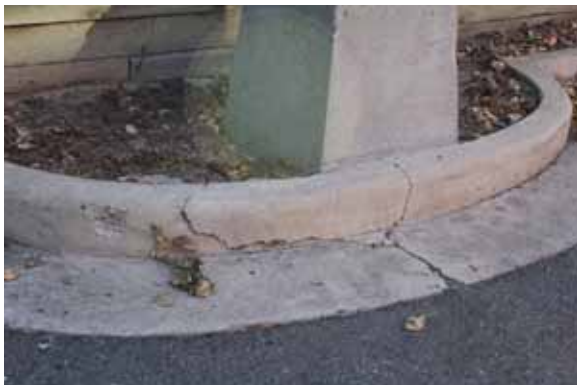
Figure 2.3.A.7 –  
Broken Site Concrete,  
Recommended for  
Replacement

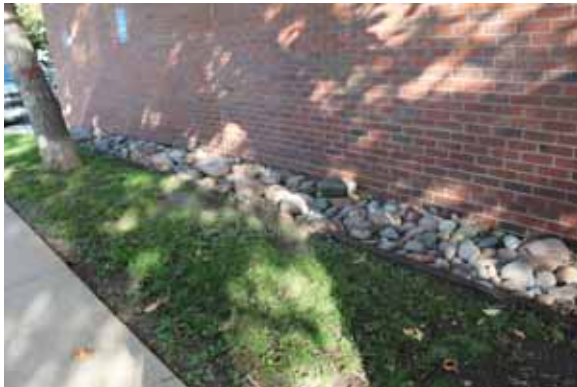
Figure 2.3.B.1– Slopes Along Building Perimeter

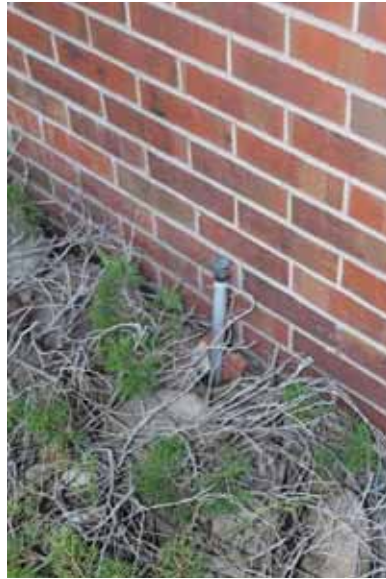
Figure 2.3.B.3 – Irrigation Near Building Foundation

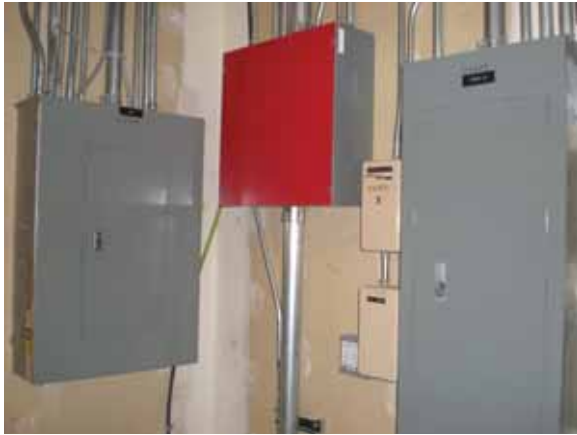
Fig 2.4.A.2 – Electrical room panelboards

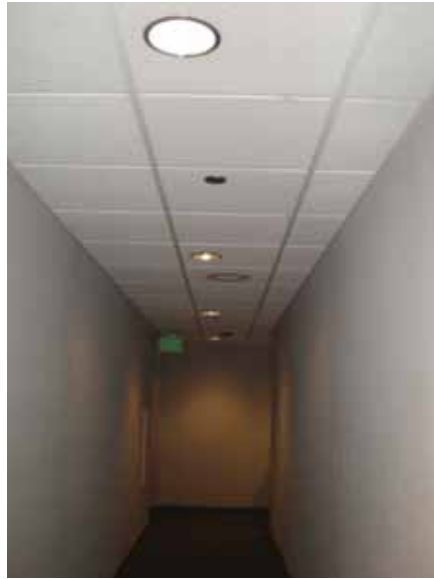
Fig 2.4.A.3 – Hallway recessed can lights

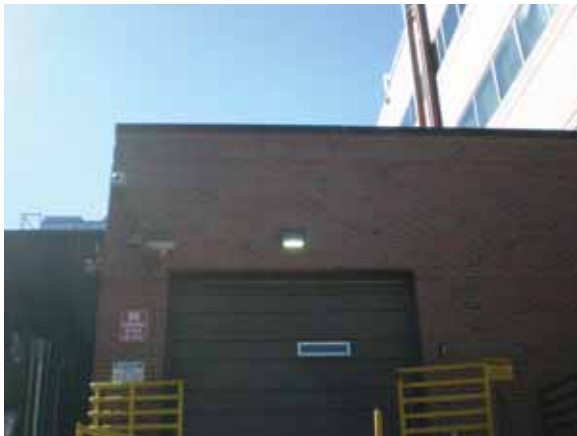
Fig 2.4.A.7 – Exterior LED light

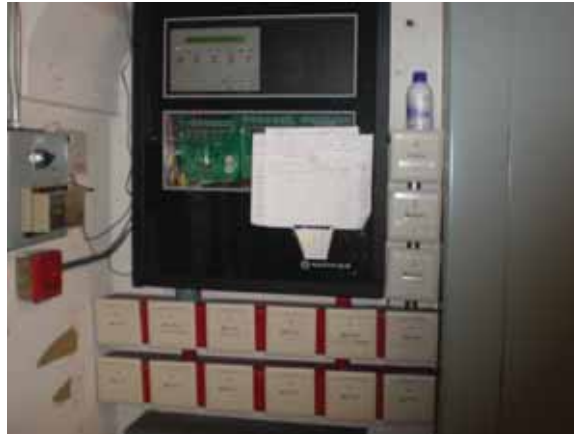
Fig 2.4.A.8 – Fire alarm control panel

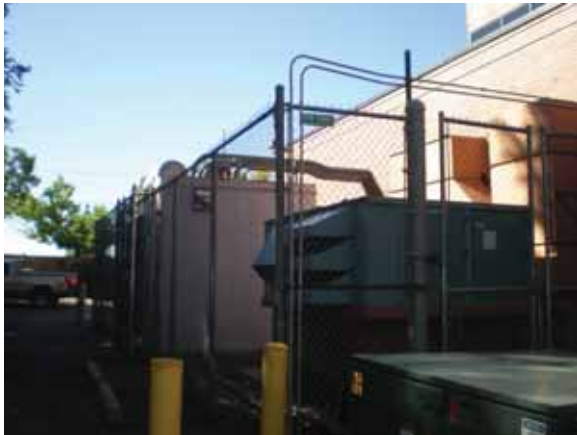
Fig 2.4.A.9 – Generator in back of the building

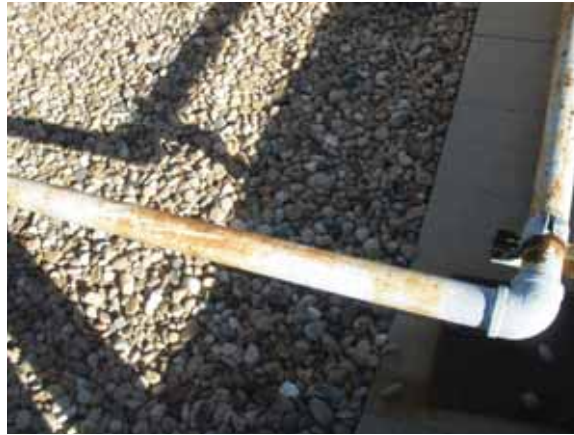
Fig 2.4.A.14 – Rusted gas piping on roof

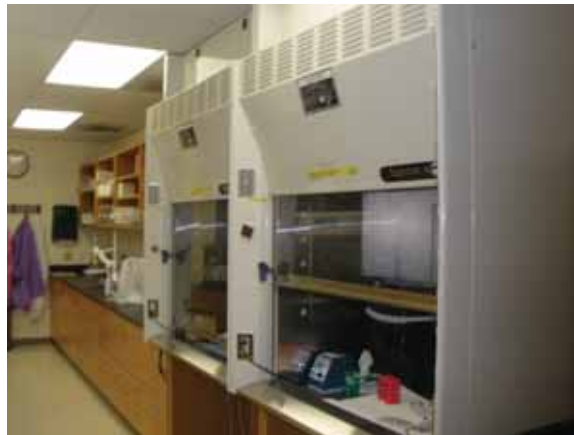
Fig 2.4.A.15 – Lab hood without controls

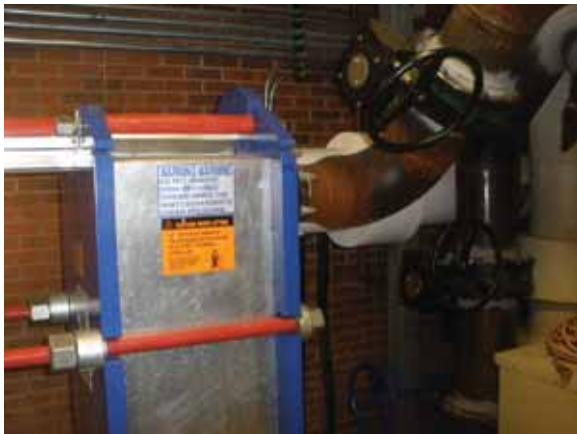
Fig 2.4.A.19 – Flat plate heat exchanger

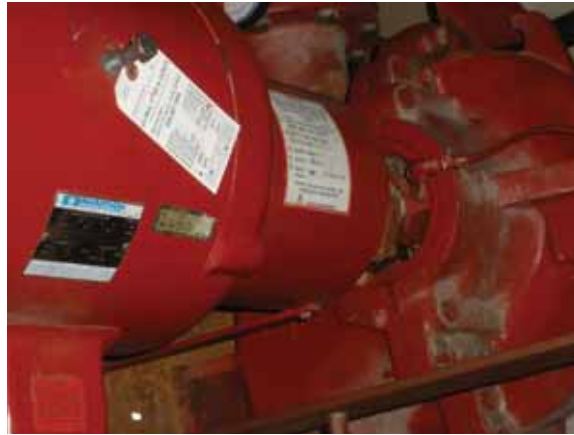
Fig 2.4.A.20 – Fire Pump Room

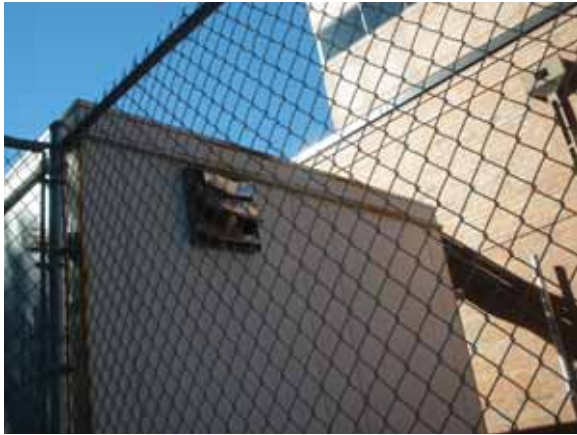
Fig 2.4.A.23 – Damaged louver

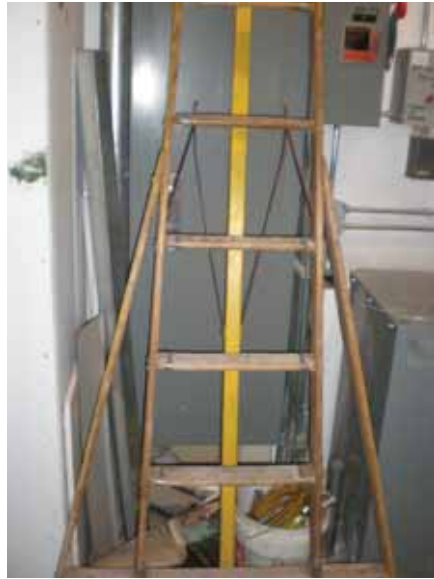
Fig 2.4.B.3 – Ladder in front of the panel board

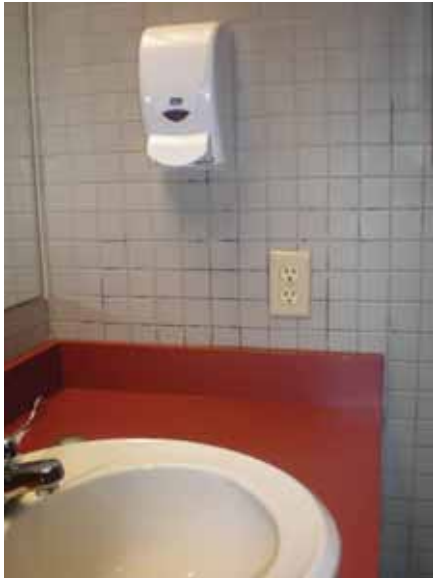
Fig 2.4.B.6 – No GFI receptacle by sink

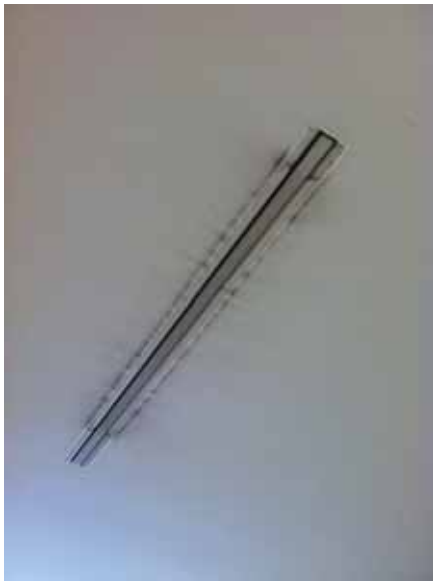
Fig. 3.0.C.1 General soiling of the gypsum board ceiling noted around the air diffusers on the First Floor.

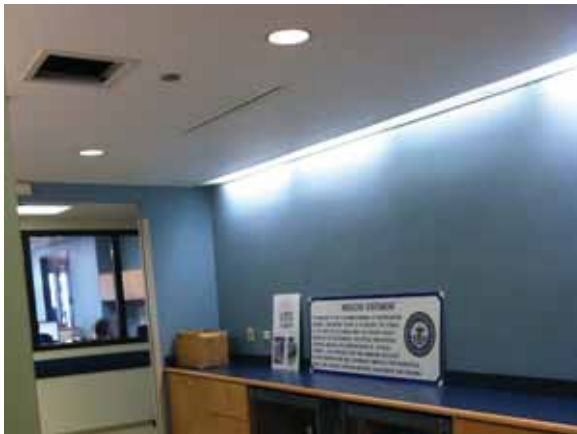
Fig. 3.0.C.2 Cover missing from a ceiling access hatch in the elevator lobby on the Fourth Floor.

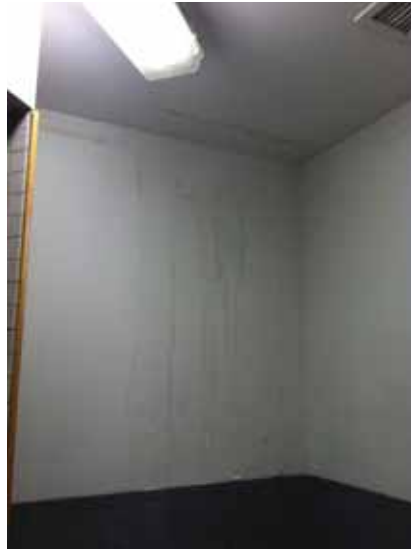
Fig. 3.0.C.3 Evidence of water damage to the ceiling and walls in the Unisex Shower Room on the First Floor.

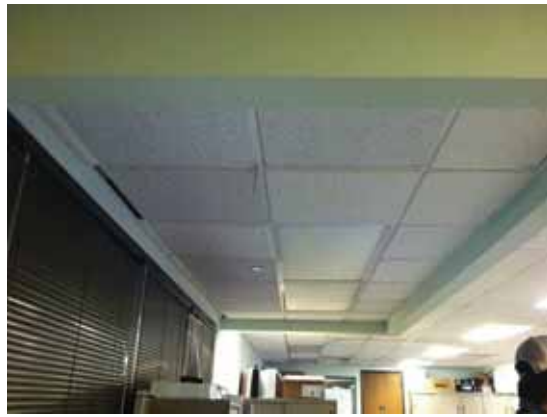
Fig. 3.0.C.4 Deteriorating and sagging 2x2 acoustic ceiling.

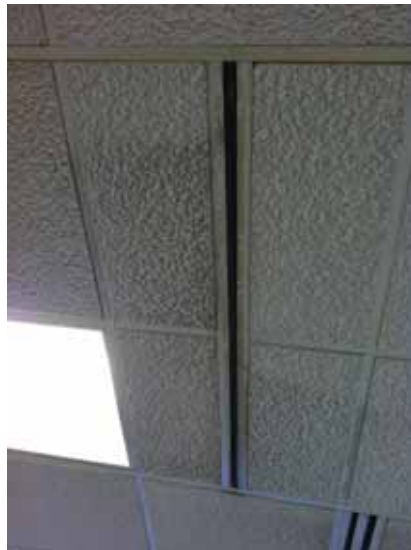
Fig. 3.0.C.5 Soiling of 2x2 acoustic ceiling tiles around air diffusers.

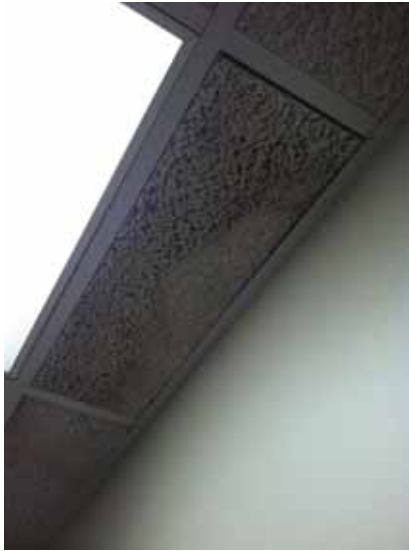
Fig. 3.0.C.6 Typical instance of water damage noted at the 2x2 acoustic ceiling on the Fourth Floor.

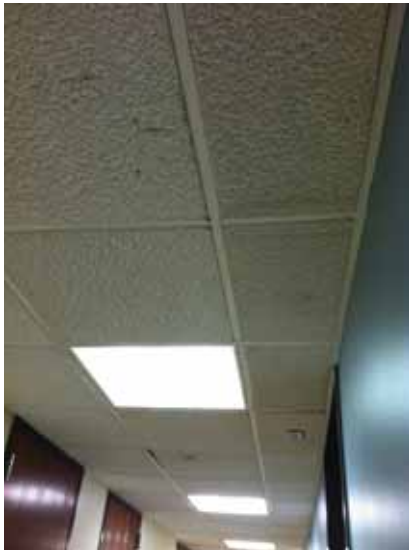
Fig. 3.0.C.7 General sagging and deterioration of the 2x2 acoustic ceiling tiles on the Fourth Floor.

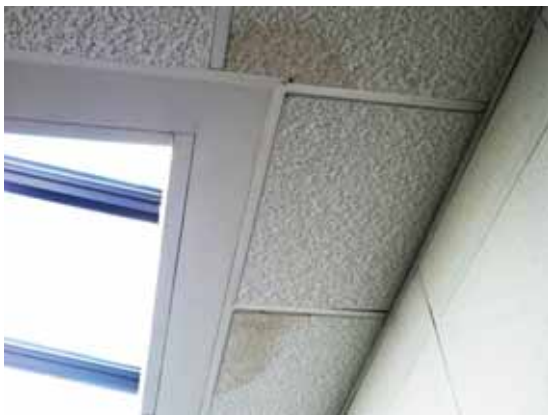
Fig. 3.0.C.8 Water damage noted to the 2x2 acoustic ceiling tiles around the skylight at the Penthouse level.

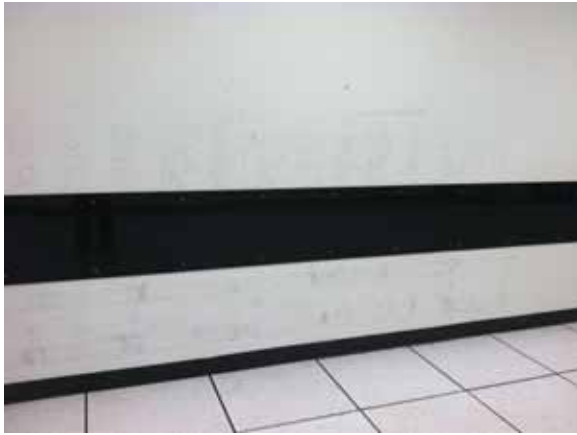
Fig. 3.0.C.9 General wear-and-tear noted to the gypsum board walls throughout the First Floor.

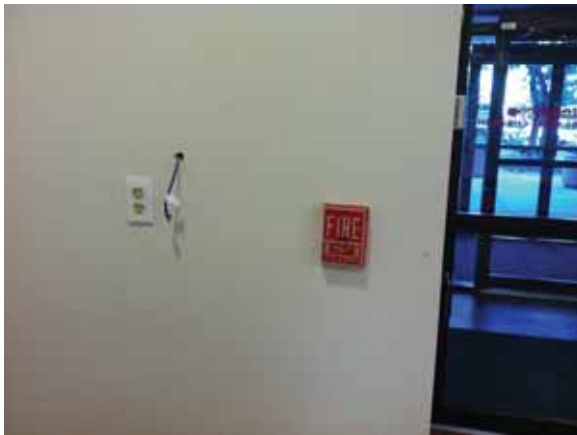
Fig. 3.0.C.10 Loose cord hanging out of a hole in the wall just to the south of the Entrance Lobby on the First Floor.

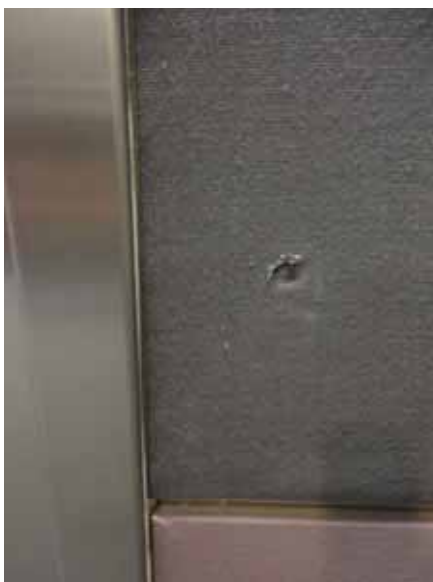
Fig. 3.0.C.11 Damage noted at a fabric wall panel in the Second Floor elevator lobby.

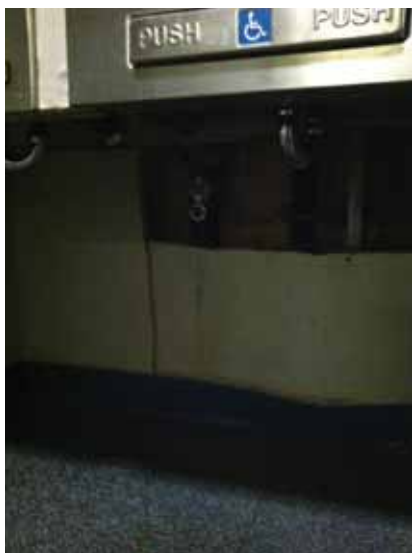
Fig. 3.0.C.12 Area of missing gypsum board and damaged gypsum board and vinyl baseboard located underneath the drinking fountains on the Third Floor.

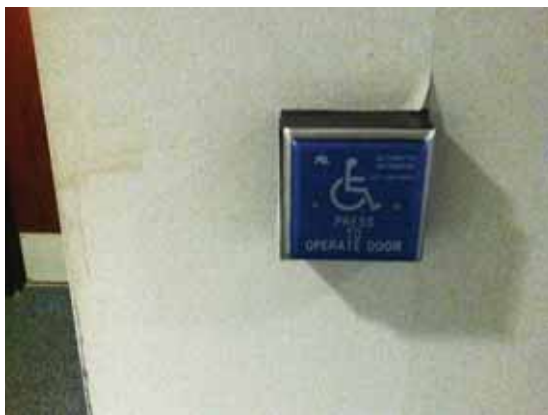
Fig. 3.0.C.13 Deteriorated and damaged wallcovering noted throughout the east corridor on the First Floor.

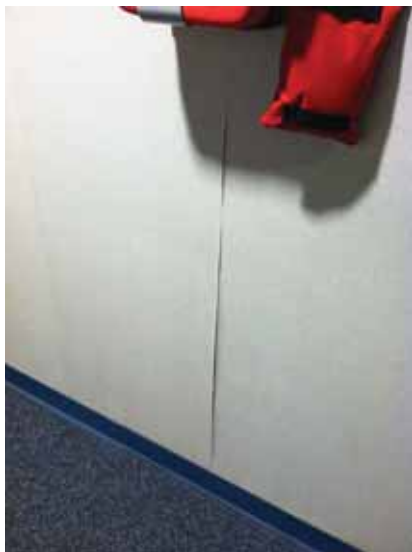
Fig. 3.0.C.14 Typical instance of deteriorating and damaged wallcovering noted throughout the Second and Third Floor corridors.

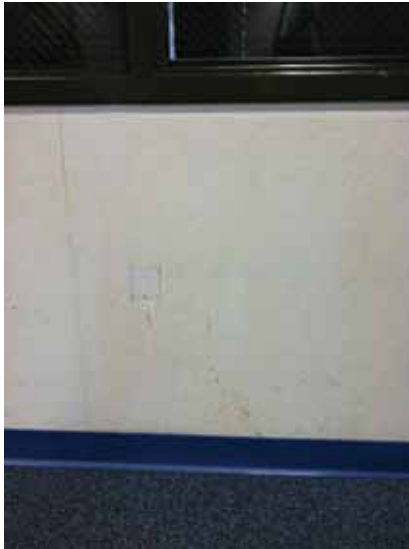
Fig. 3.0.C.15 Typical instance of damaged wallcovering noted throughout the Second and Third Floor corridors.

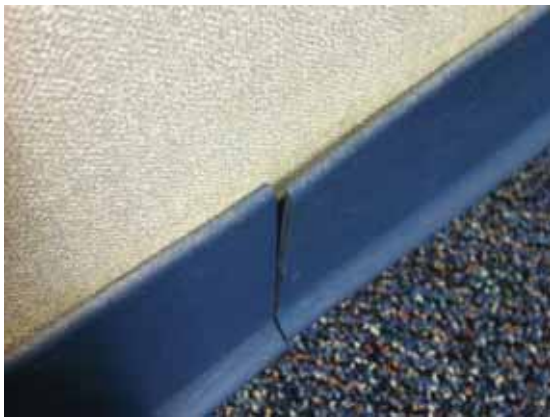
Fig. 3.0.C.16 Vinyl baseboard pulling away from the wall in spots throughout the Second and Third Floor corridors.

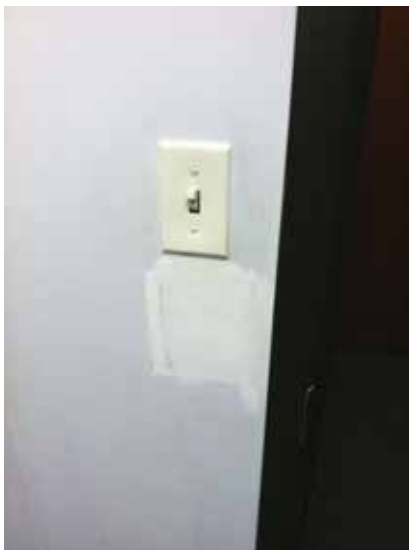
Fig. 3.0.C.17 An area of the gypsum board wall that was repaired but left unfinished in the First Floor Unisex Shower Room.

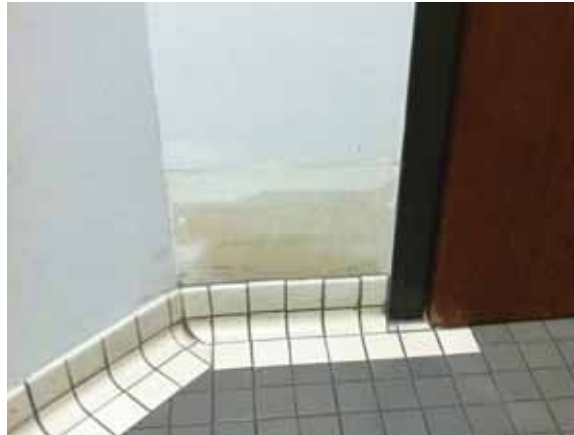
Fig. 3.0.C.18 Damaged gypsum board noted in the First Floor Women's Restroom.

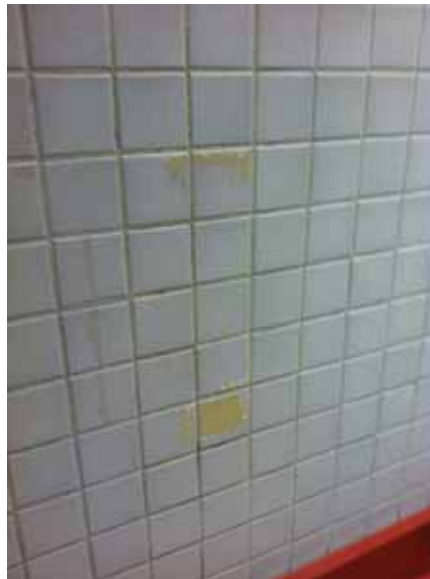
Fig. 3.0.C.19 Residue noted on the 2-inch square wall tiles in the First Floor Women's Restroom.

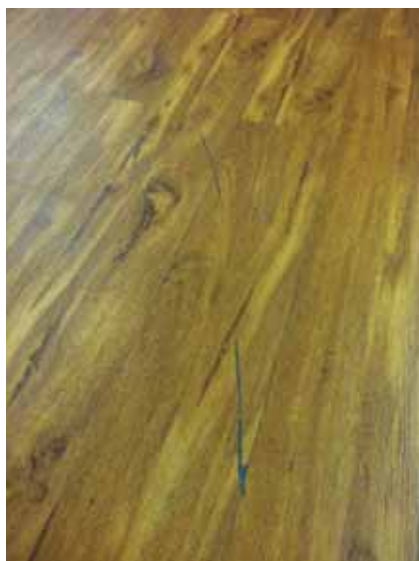
Fig. 3.0.C.20 Scuff marks noted to the vinyl flooring in the entrance and elevator lobbies on the First Floor.

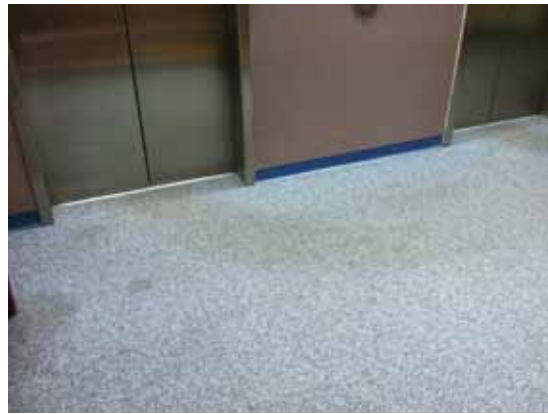
Fig. 3.0.C.21 Areas of worn and soiled carpet in the Second and Third Floor elevator lobbies.

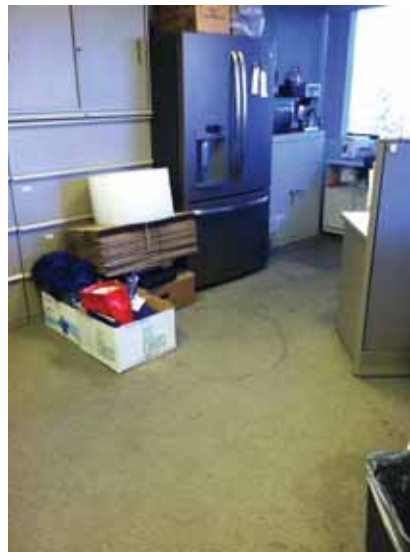
Fig. 3.0.C.22 Areas of worn and soiled carpet noted in the offices included in the site survey visit.

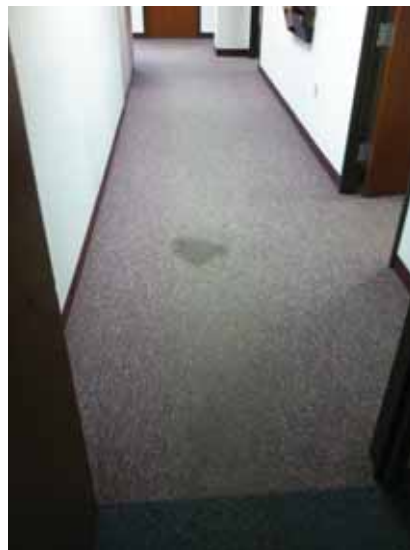
Fig. 3.0.C.23 Areas of worn and soiled carpet noted in the First through Third Floor corridors.

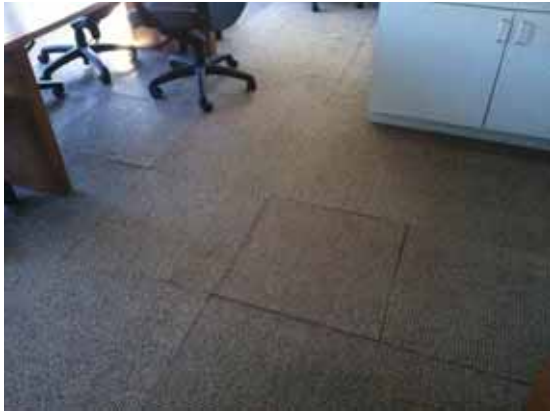
Fig. 3.0.C.24 Carpet flooring pulling loose along the seams and creating a potential tripping hazard.

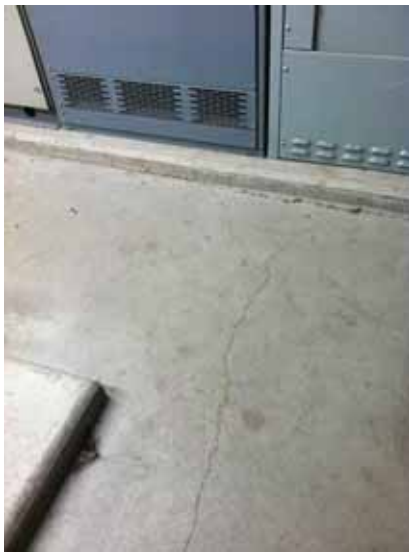
Fig. 3.0.C.25 Typical cracking noted in the concrete in the equipment rooms on the east side of the First Floor.

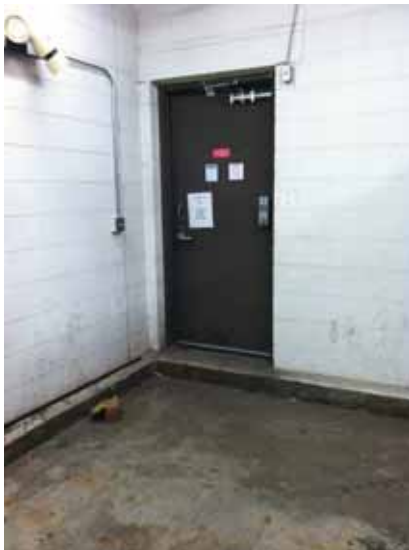
Fig. 3.0.C.26 Evidence of water damage noted at the concrete floor in the battery storage room at the southeast corner of the First Floor.
