CAPITOL COMPLEX MASTER PLAN  
FINDINGS & RECOMMENDATIONS (F & R) NEEDS ASSESSMENT  
DALE TOOLEY BUILDING, 690 KIPLING STREET (LAKEWOOD)

NOVEMBER 2014

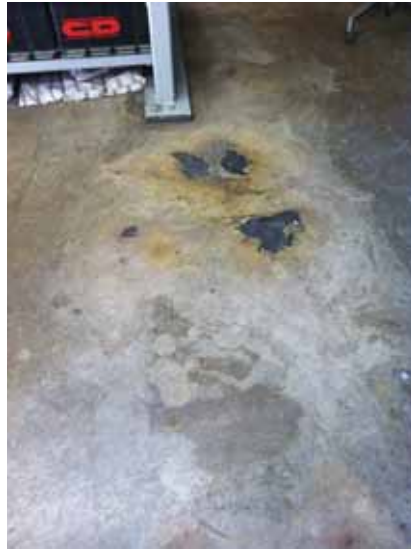
Fig. 3.0.C.27 Corrosion noted at the concrete floor in the middle of the battery storage room at the southeast corner of the First Floor.

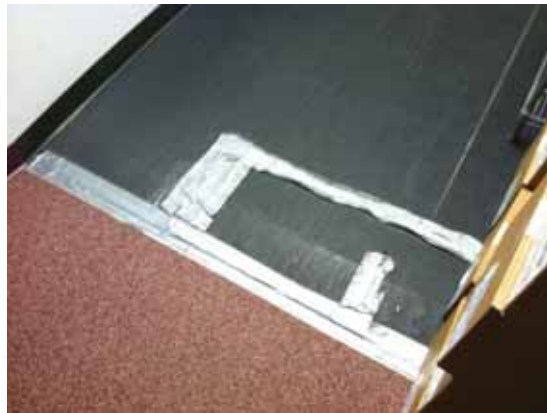
Fig. 3.0.C.28 Tape on the surface of the ramp leading up to the server and technology rooms located on the northeast side of the Third Floor is creating a tripping hazard.

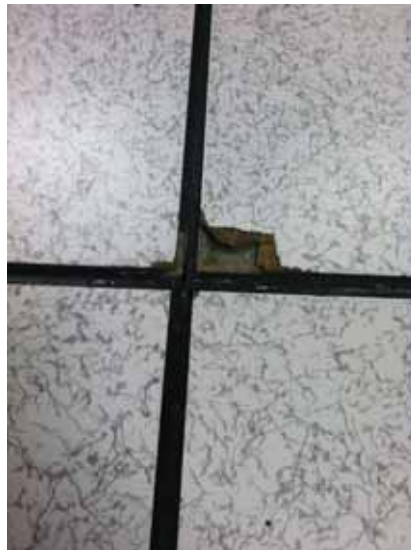
Fig. 3.0.C.29 Damaged areas of the raised floor in the Third Floor server and technology rooms is creating a potential tripping hazard.

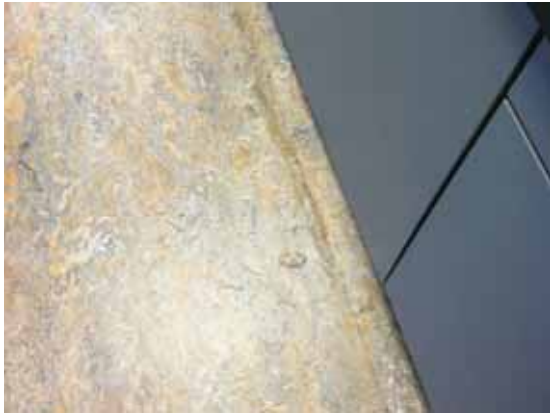
Fig. 3.0.C.30 Damage noted to the vinyl flooring in the Fourth Floor Break Room in front of the cabinets.

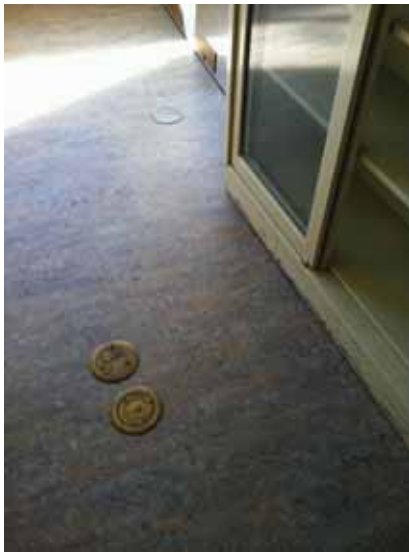
Fig. 3.0.C.31 Raised floor-mounted receptacles noted throughout the Fourth Floor Break Room.

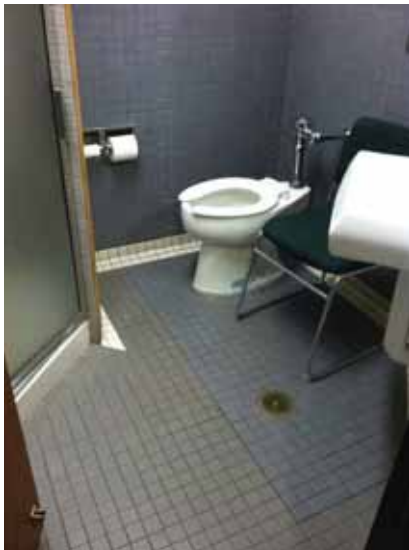
Fig. 3.0.C.32 Area of newer-looking tile noted on the floor in the First Floor Unisex Shower Room.

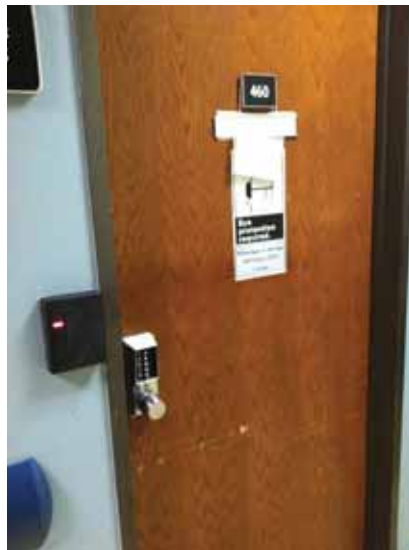
Fig. 3.0.C.33 General wear-and-tear noted at the doors throughout the building.

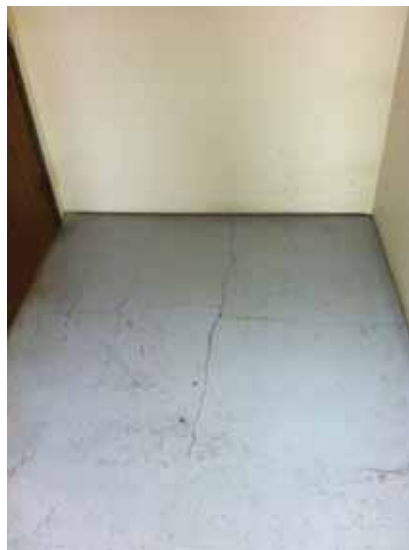
Fig. 3.0.C.34 Cracking noted throughout the north exit stairway.

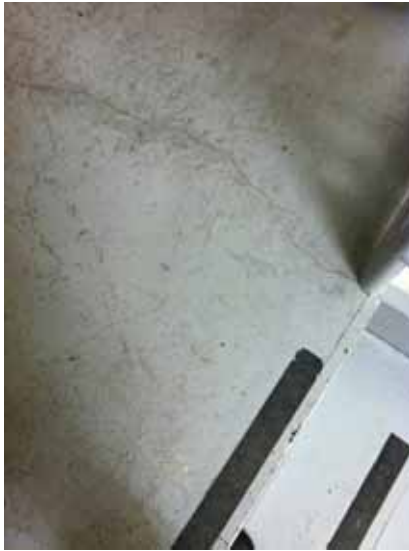
Fig. 3.0.C.35 Cracking noted throughout the north exit stairway.

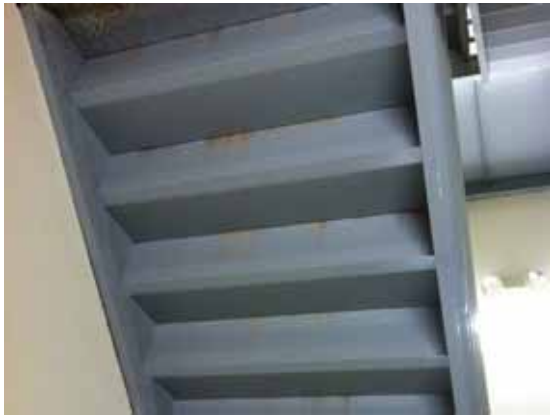
Fig. 3.0.C.36 Corrosion noted at the bottom side of the north exit stairway with roof access.

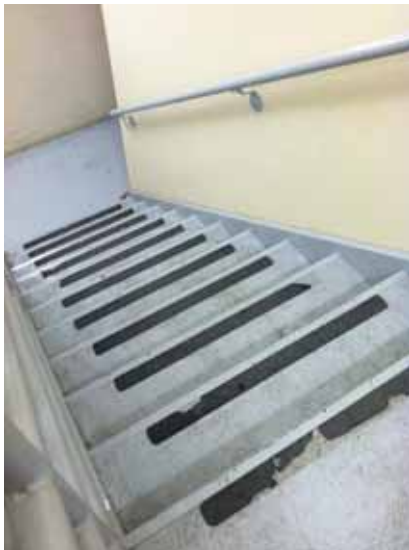
Fig. 3.0.C.37 General soiling and wear-and-tear noted throughout the north exit stairway.

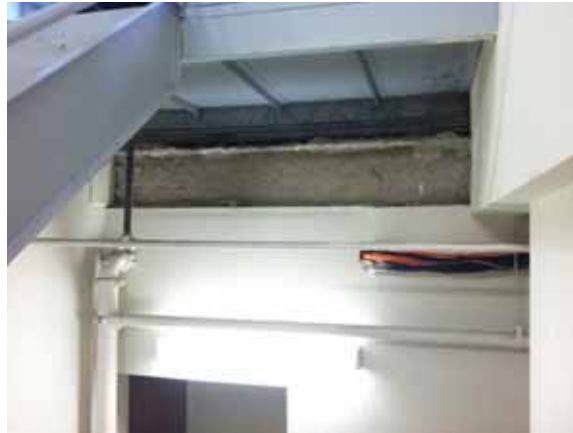
Fig. 3.0.C.38 Area of exposed floor structure under a landing in the north exit stairway.
