CAPITOL COMPLEX MASTER PLAN
FINDINGS & RECOMMENDATIONS (F & R) NEEDS ASSESSMENT
NORTH CAMPUS EAST BUILDING, 6221 NORTH DOWNING STREET (DENVER)

NOVEMBER 2014

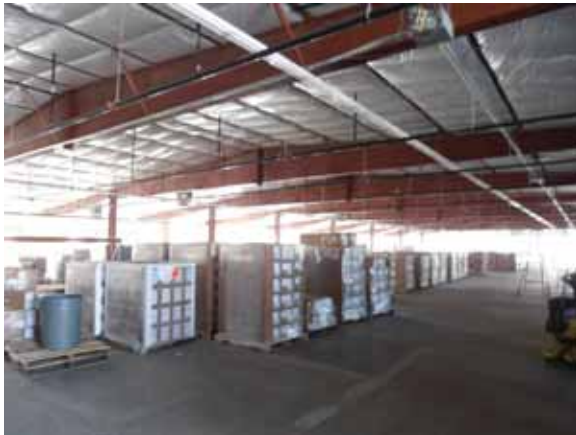
Fig. 1.0.D.1 – Open cold storage

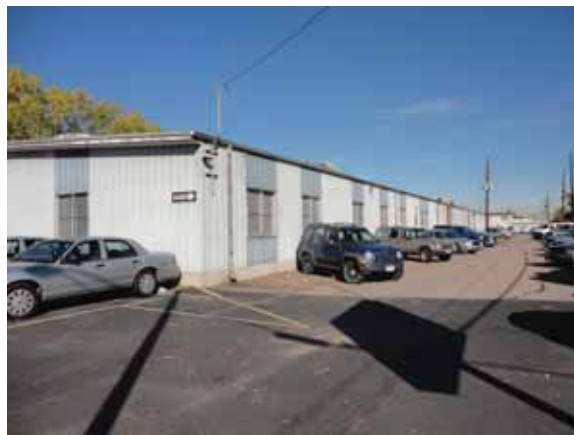
Front/East Elevation of the North Campus East Building

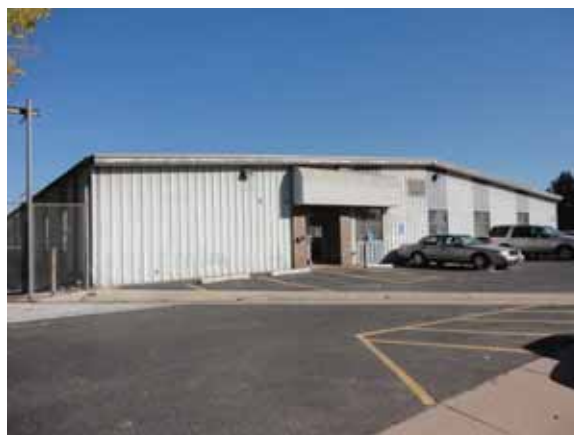
Side/South Elevation of the North Campus East Building

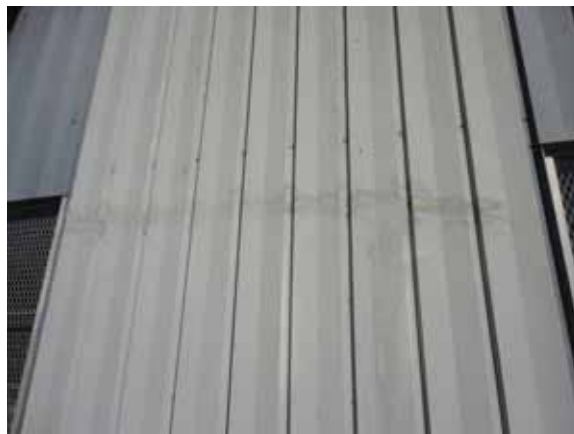
Fig. 2.1.A.1 Typical deterioration noted at the metal panels in areas around the exterior of the building.

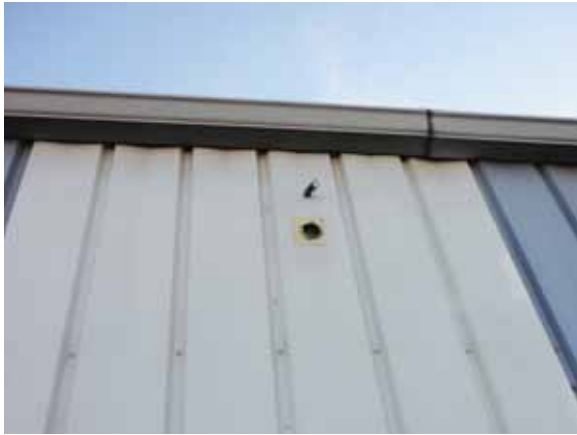
Fig. 2.1.A.2 Unrepaired holes leaving the building envelope vulnerable to water penetration observed in areas around the exterior of the building.

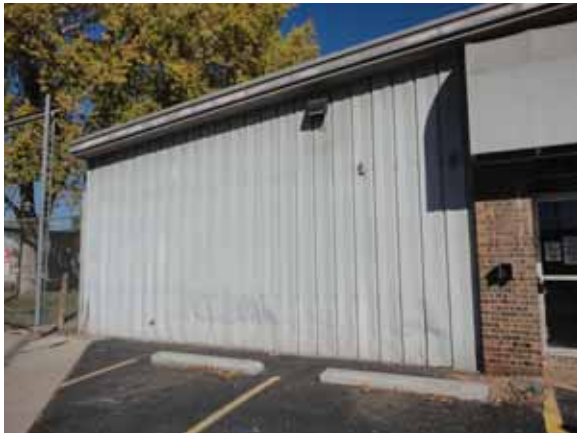
Fig. 2.1.A.3 Damaged metal panels observed along parking areas around the exterior of the building.

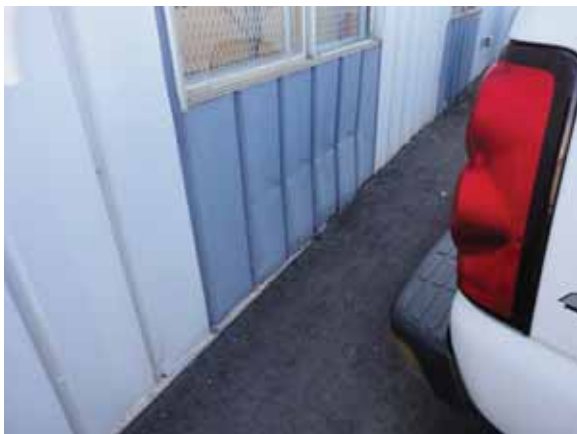
Fig. 2.1.A.4 Damaged metal panels observed along parking areas around the exterior of the building.

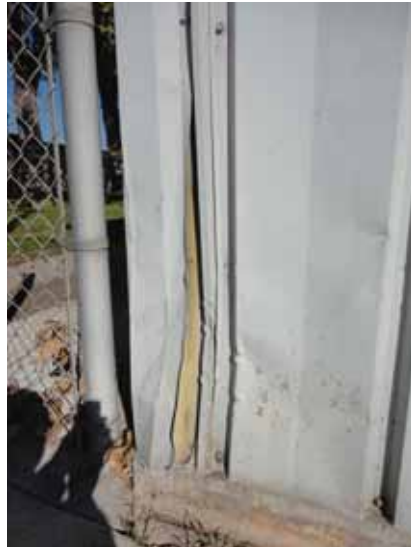
Fig. 2.1.A.5 Extensive damage to the metal panels noted during the site survey visit.

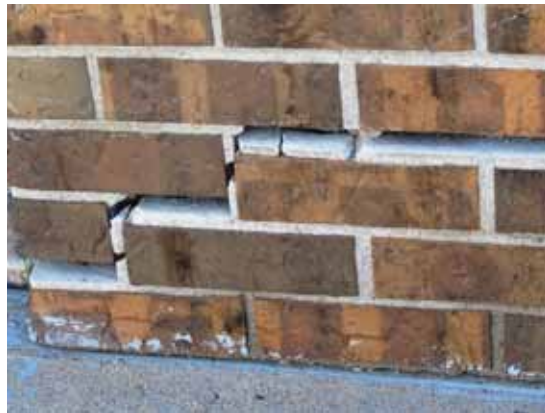
Fig. 2.1.A.6 Cracking and deterioration of a brick infill wall noted on the north side of the building.

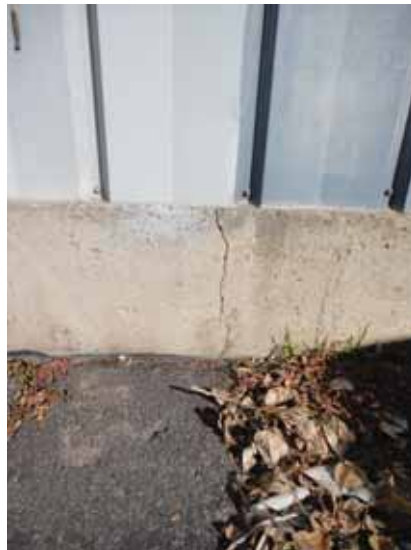
Fig. 2.1.A.7 Cracked concrete observed along the building's foundation.

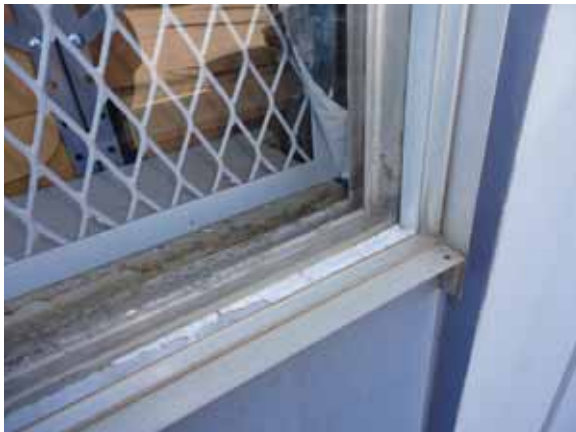
Fig. 2.1.A.8 Evidence of deterioration and water intrusion noted at the windows around the exterior of the building.

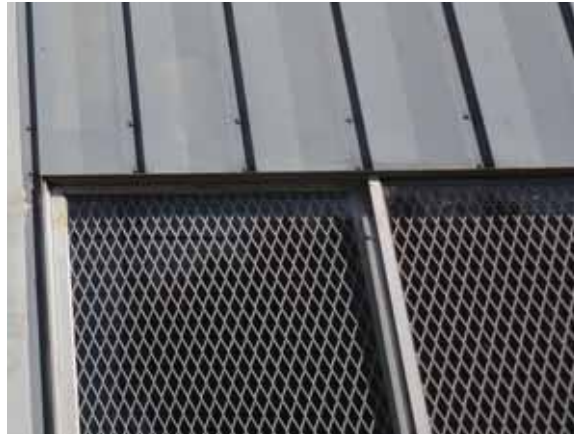
Fig. 2.1.A.9 Evidence of corrosion noted at the window frames around the exterior of the building.

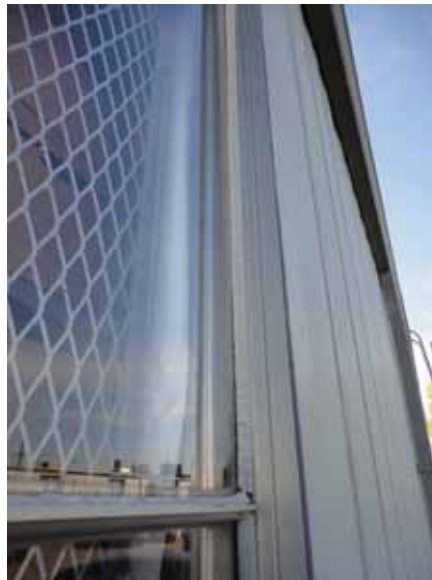
Fig. 2.1.A.10 Typical instance of deteriorating sealant observed at the windows around the exterior of the building.

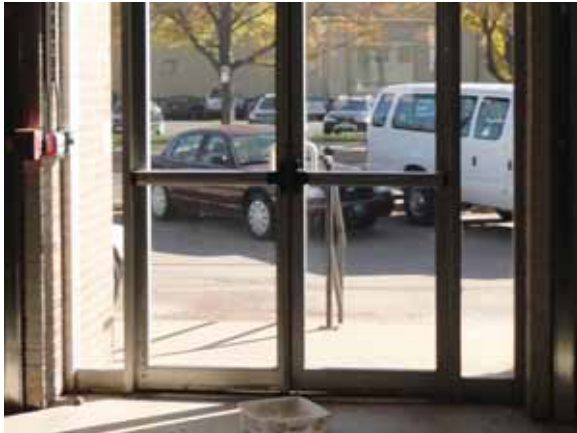
Fig. 2.1.A.11 Deterioration of the weatherstripping along the base of a door noted to be creating an air gap.

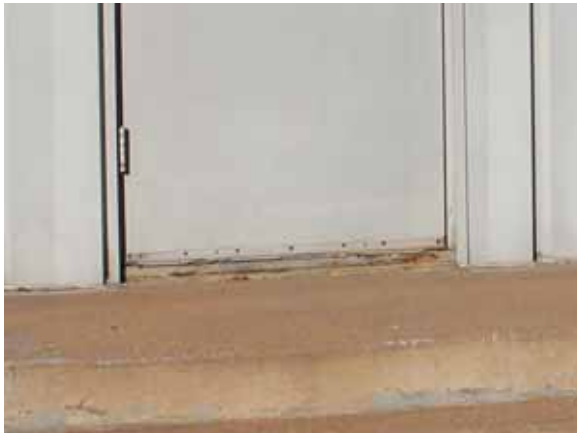
Fig. 2.1.A.12 Deterioration of the weatherstripping and corrosion of the metal observed at the base of an exterior door on the east side of the building.

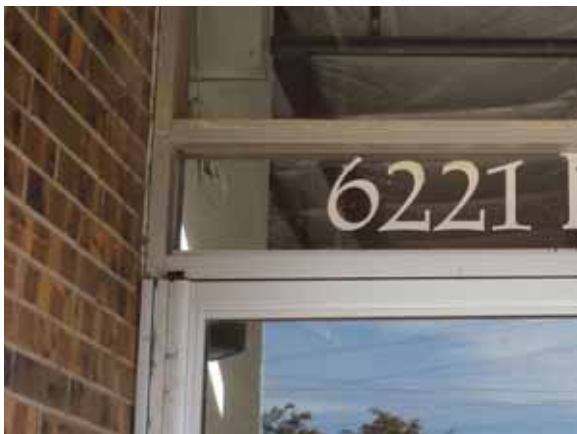
Fig. 2.1.A.13 General deterioration of the sealant noted at the doors around the exterior of the building.

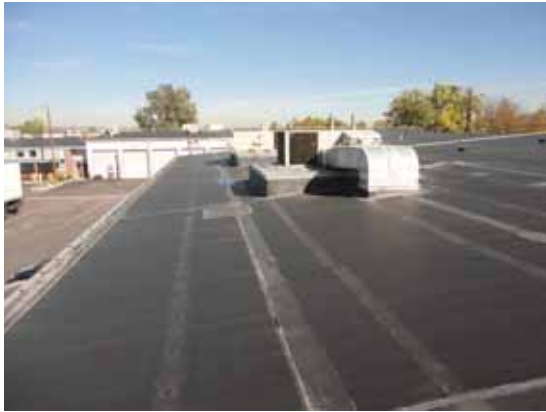
Fig. 2.1.A.14 Rubber membrane roof in fair to poor condition overall.

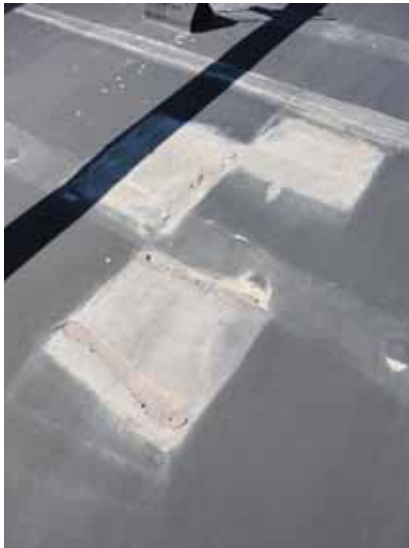
Fig. 2.1.A.15 Typical instance of deteriorating sealant at patched areas of the rubber roofing membrane.

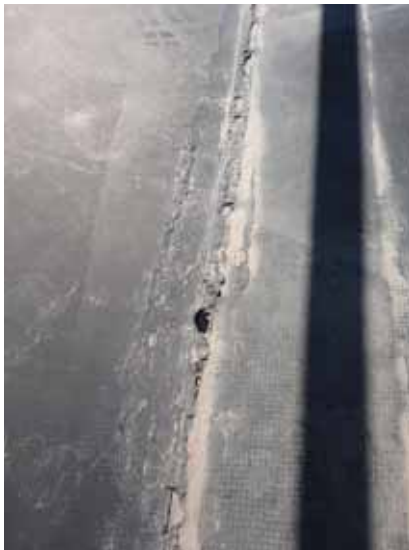
Fig. 2.1.A.16 Typical instance of deteriorating sealant along the seams of the rubber roofing membrane.

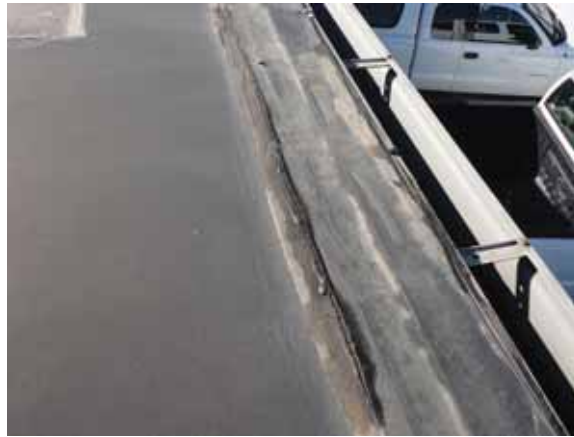
Fig. 2.1.A.17 Typical instance of sealant missing entirely along the seams of the rubber membrane and exposing the roof system to water penetration.

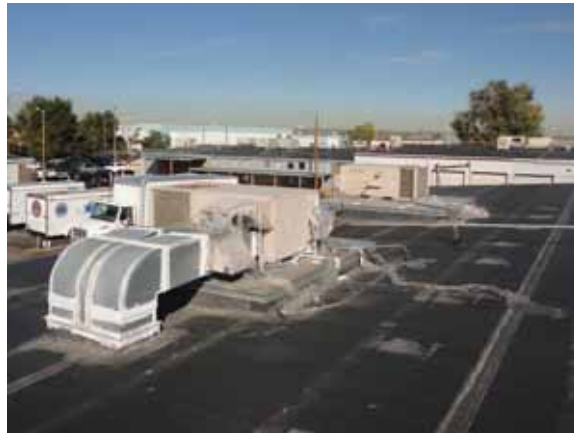
Fig. 2.1.A.18 Thin plastic sheeting wrapped around the rooftop equipment noted to be deteriorating.

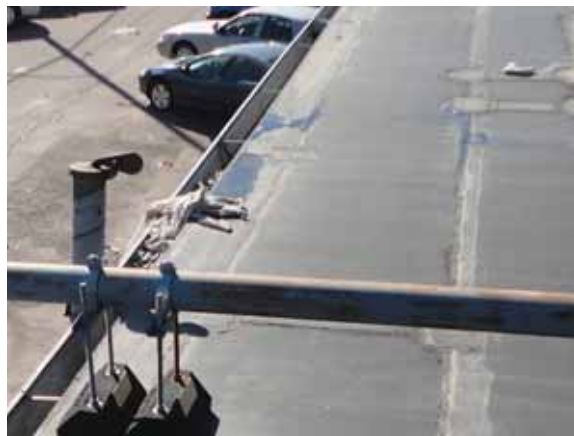
Fig. 2.1.A.19 Thin plastic sheeting from around the rooftop equipment is collecting in areas of the gutters.

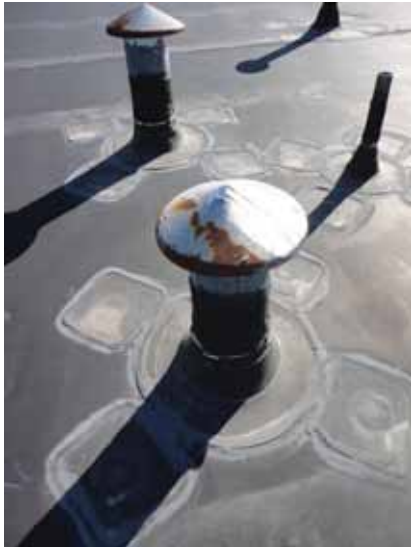
Fig. 2.1.A.20 Evidence of corrosion noted at a roof vent cover.

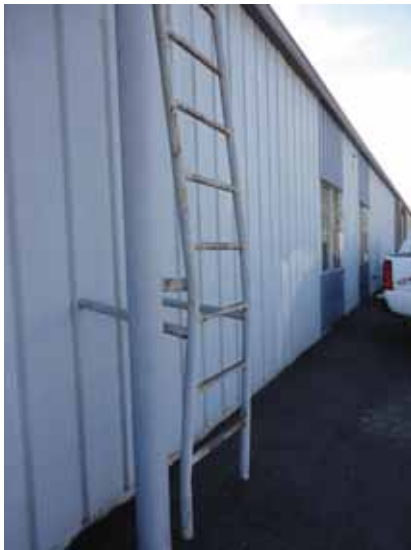
Fig. 2.1.A.21 Evidence of corrosion noted at the ladder leading up to the roof on the west side of the building.

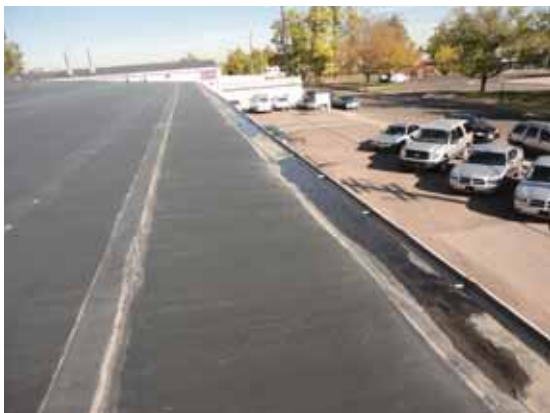
Fig. 2.1.A.22 Areas of standing water observed during the site survey visit.

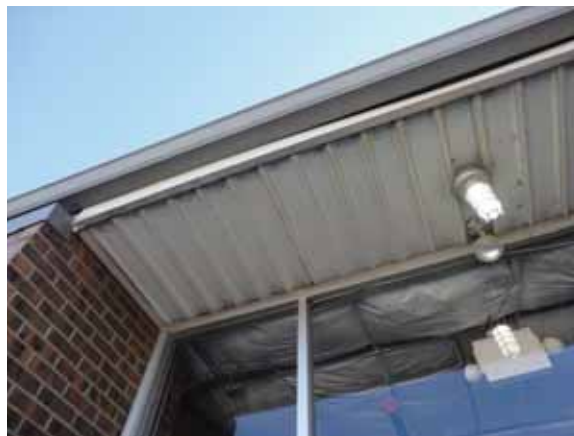
Fig. 2.1.A.23 Evidence of corrosion noted at the metal canopy at the northern entrance on the west side of the building.

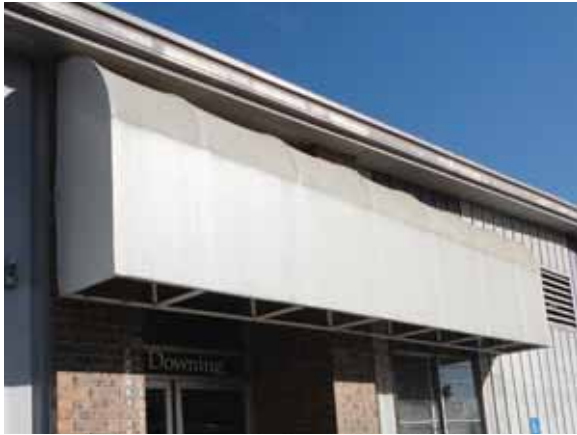
Fig. 2.1.A.24 Generally soiled canopy with a corroding metal frame observed at the entrance on the south side of the building.

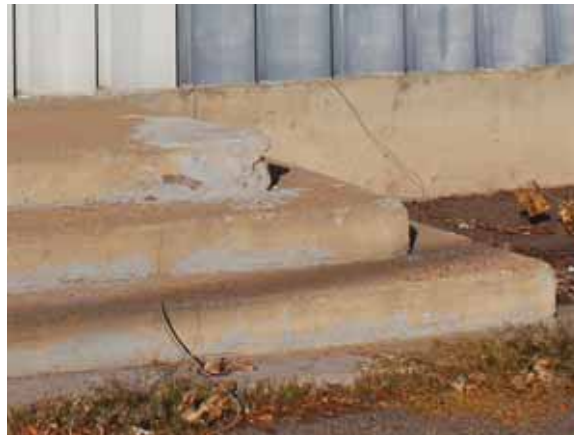
Fig. 2.1.A.25 Typical instance of deteriorating paint and spalling and cracking concrete observed at the exterior stairways and ramps on the north and east sides of the building.

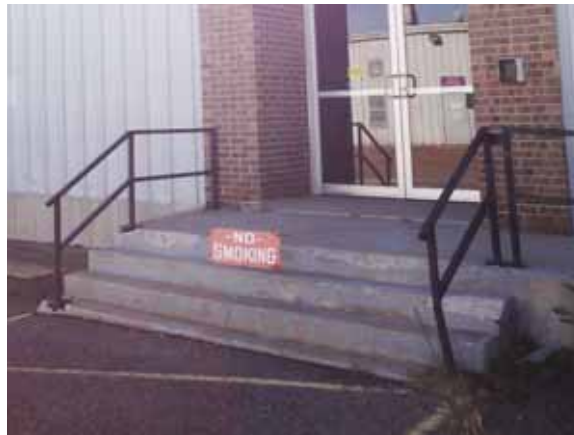
Fig. 2.1.A.26 Spalling and cracking of the concrete stairway and corroding and damaged metal railings observed at the entrance on the west end of the north side of the building.

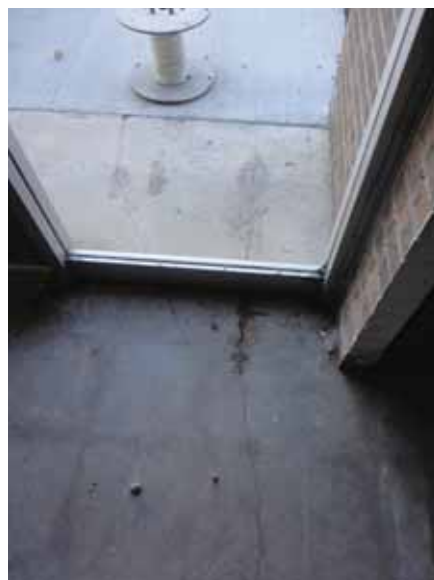
Fig. 2.1.A.27 Deterioration of the concrete slab, observed at the northernmost entrance on the west side of the building, appears to carry through to the inside of the building.

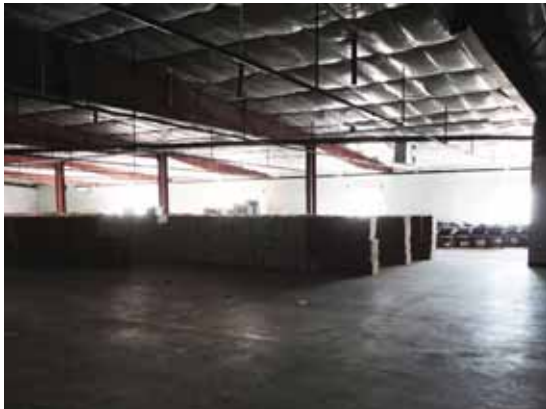
Fig. 2.1.B.1 Stacks of cardboard boxes full of documents and rows of furniture being stored on the northeast side of the building.

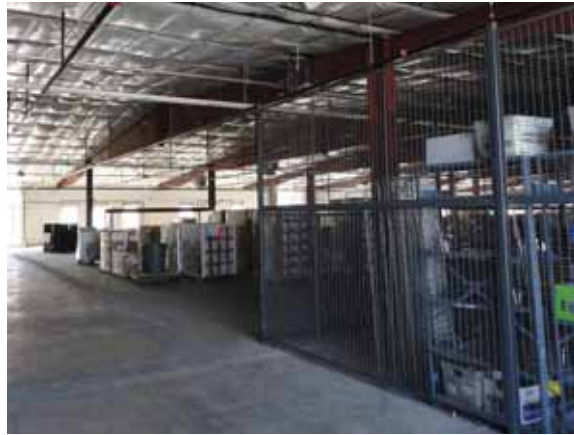
Fig. 2.1.B.3 Items stored in fenced-off areas and stacks of cardboard boxes being stored on the south side of the building.

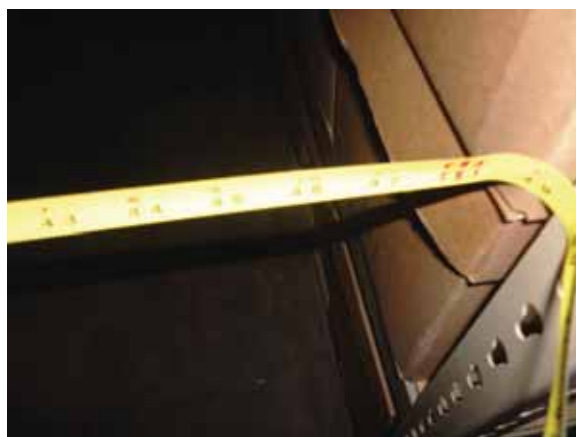
Fig. 2.1.B.5 Aisles generally observed to be 36 inches or greater in the areas included in the site survey visit.

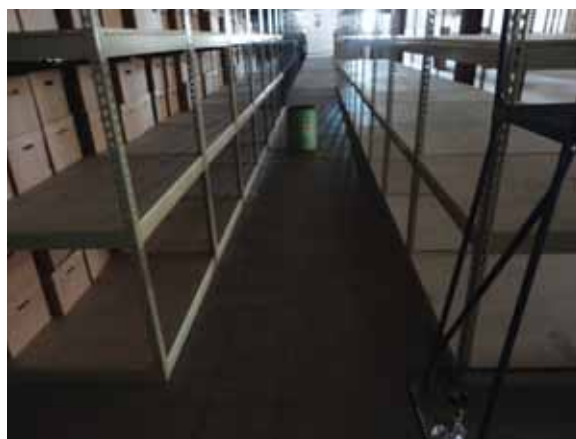
Fig. 2.1.B.6 Items observed in the middle of an aisle during the site survey visit.

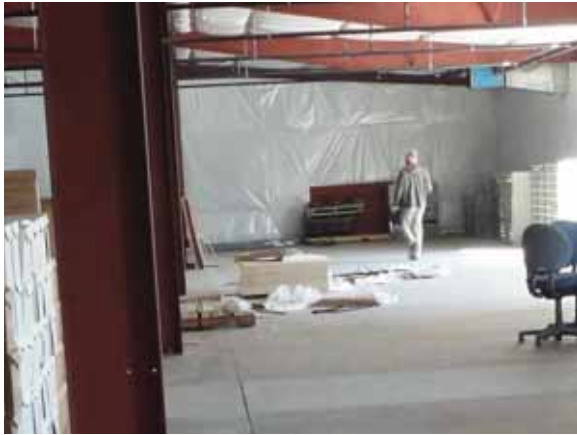
Fig. 2.1.B.7 Items observed in the middle of an aisle during the site survey visit.

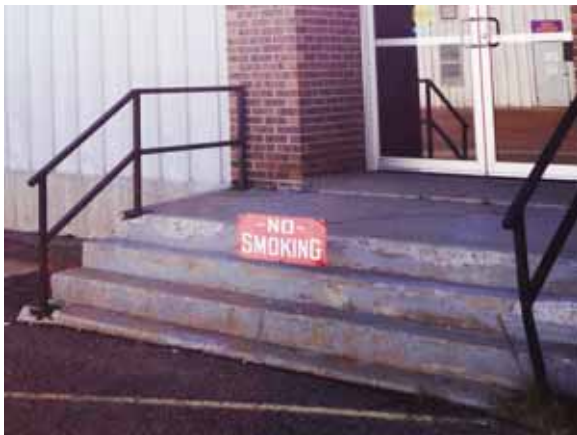
Fig. 2.1.B.8 A “No Smoking” sign strung with wire between the stairway railings and blocking the means of egress from the entrance on the west end of the north side of the building.

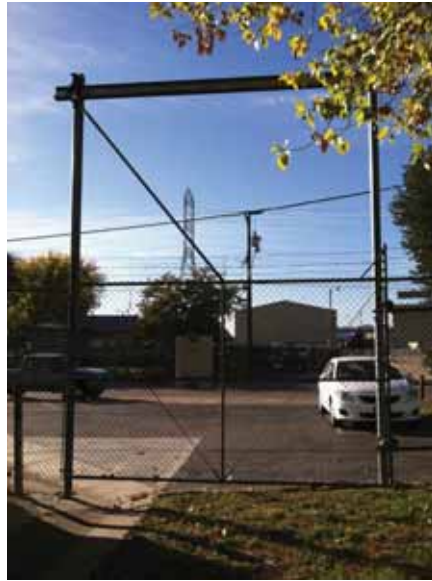
Fig. 2.1.B.10 Gate located on the south side of the west courtyard.

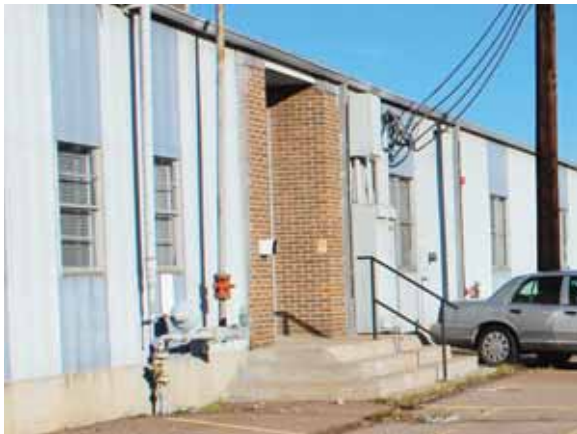
Fig. 2.1.B.11 A stairway on the east side of the building that is not equipped with handrails on both sides as required by code and with spalling and cracking concrete creating a potential tripping hazard.

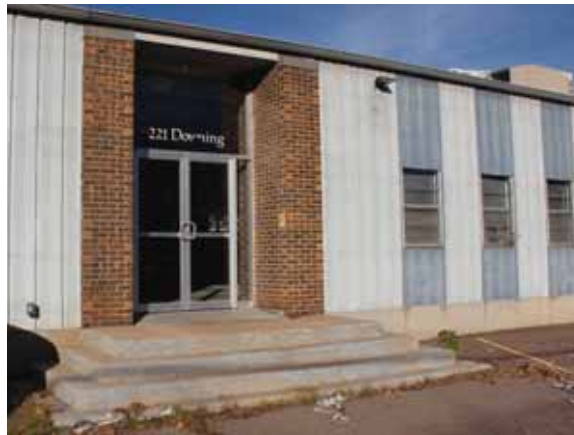
Fig. 2.1.B.12 A stairway on the east side of the building that is not equipped with handrails as required by code and with spalling and cracking concrete creating a potential tripping hazard.

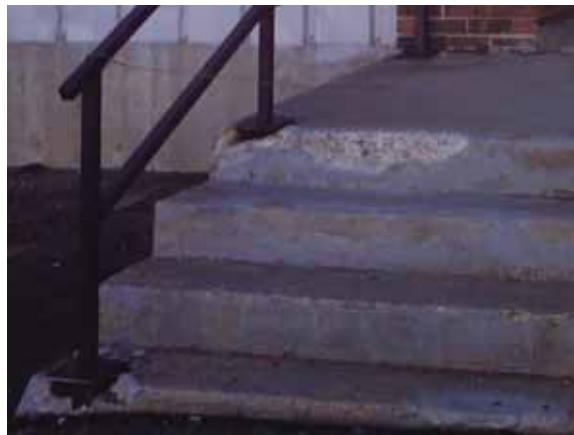
Fig. 2.1.B.13 Spalling and cracking concrete at railing posts observed at an exterior stairway on the north side of the building.

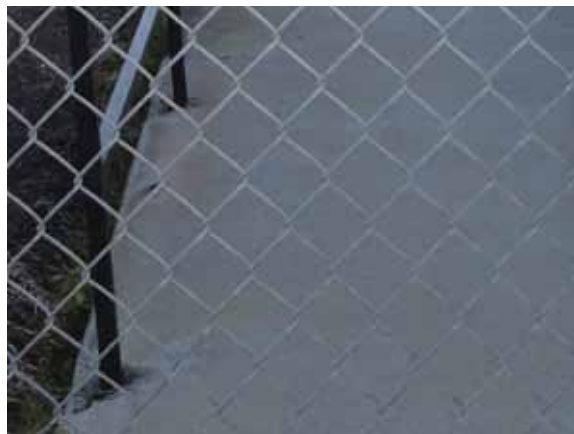
Fig. 2.1.B.14 Spalling and cracking concrete at railing posts observed at an exterior ramp on the north side of the building.

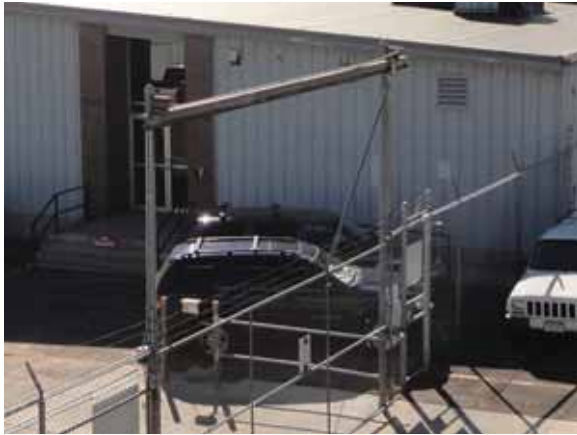
Fig. 2.1.B.15 The accessible route to and from the ramp at the entrance on the west end of the north side of the building is currently blocked by parked cars.

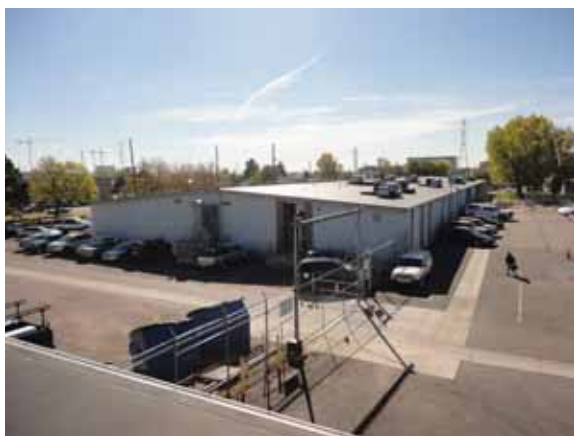
Fig. 2.1.B.16 Gated fencing controls access to the west side of the building and the majority of the North Campus site.

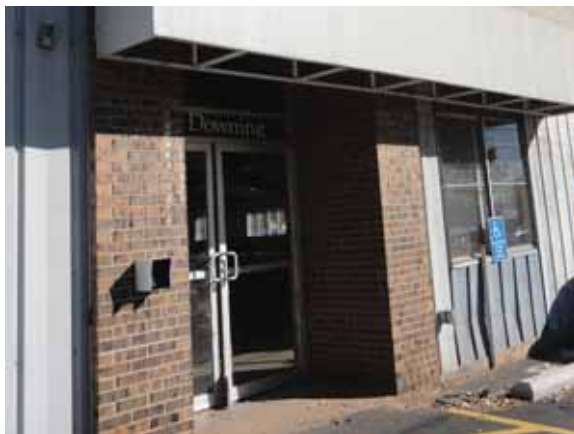
Fig. 2.1.B.17 Typical instance of a key code entry system observed at a few of the entrances along the north, east, and south sides of the building.

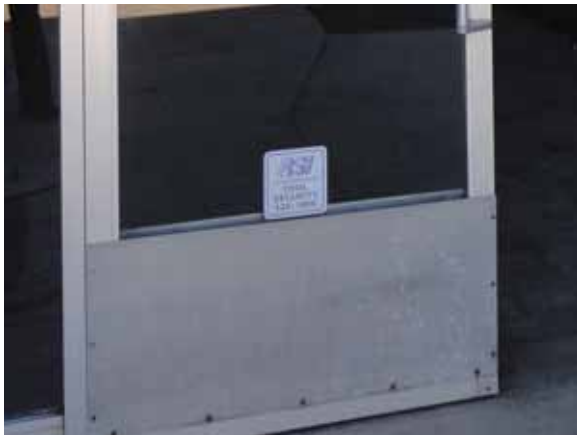
Fig. 2.1.B.18 RSI Total Security sign observed in a few locations around the exterior of the building.

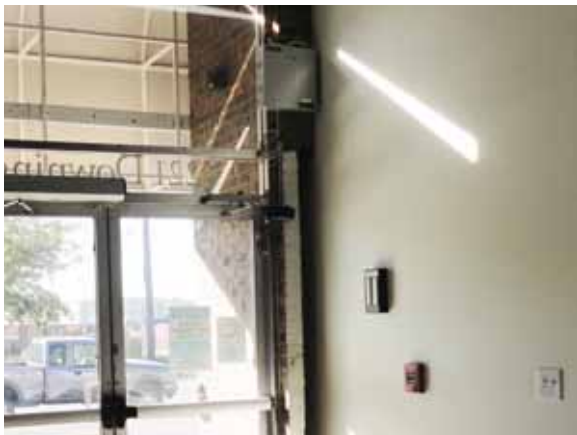
Fig. 2.1.B.19 A security device observed at the entrance on the south side of the building.

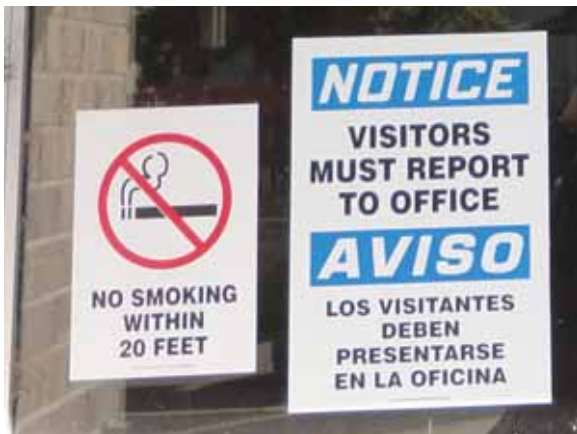
Fig. 2.1.B.20 Visitors are directed to check-in with the office in order to gain access to the building.

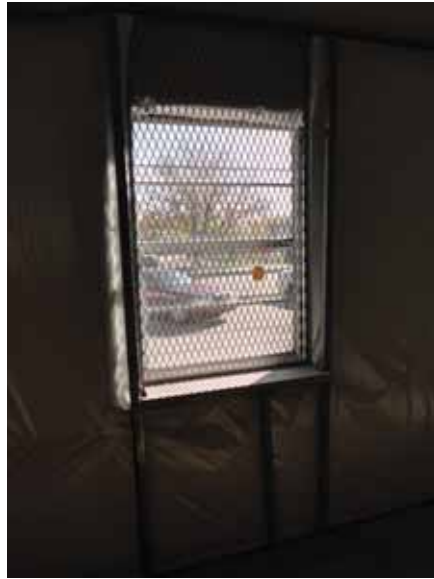
Fig. 2.1.B.21 Typical instance of a metal security grille observed at the windows around the exterior of the building.

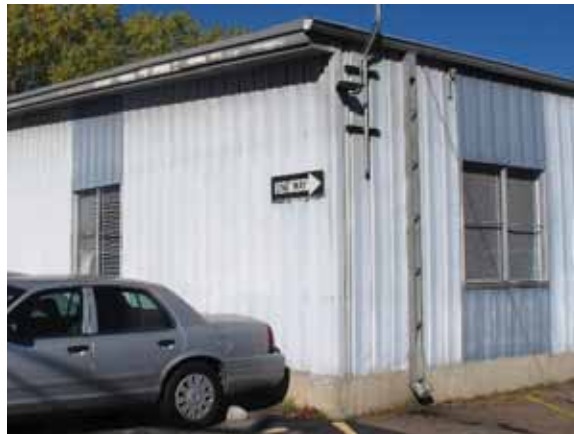
Exterior downspouts were observed to empty within 1'-0" of the building line (Fig. 2.2.A.1).

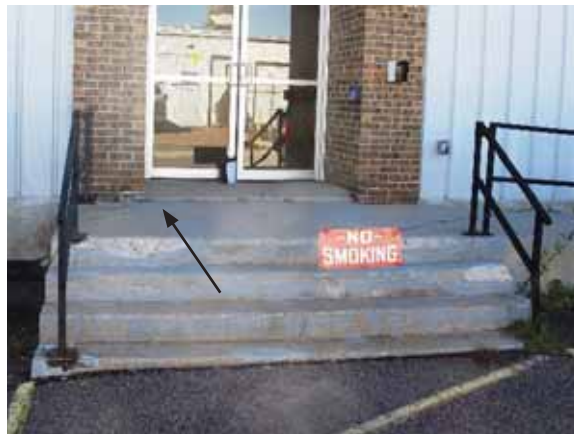
The concrete stair and ramp at the building's north exit appear to be settling away from the main building, and show signs of environmental spalling and cracking (Fig. 2.2.A.2).

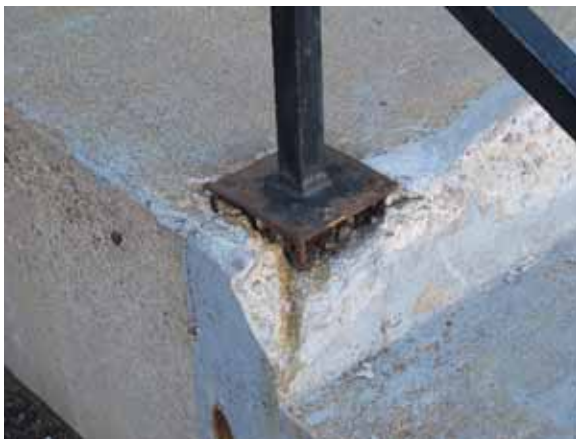
The anchorage points of the guardrail at the north exit stair and ramp have all failed (Fig. 2.2.A.4).

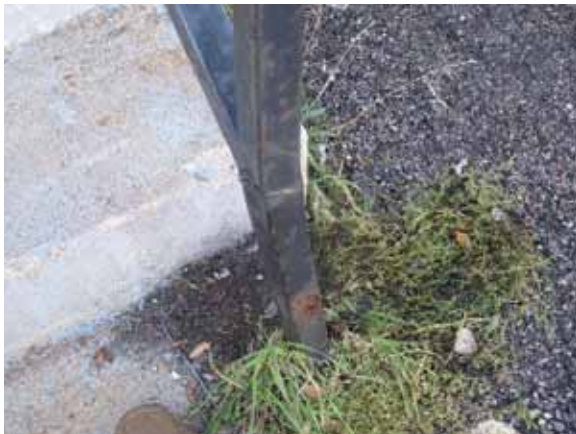
The vertical guardrail post at the bottom of the west side of the exit stairs appears to have been struck with a horizontal force, causing a buckle and fracture failure of the steel section (Fig. 2.2.A.5).

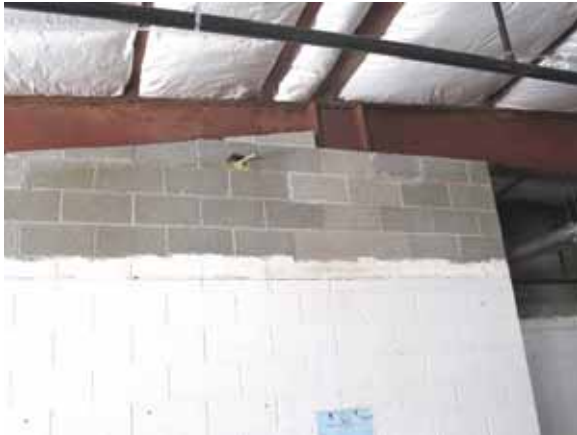
building frame's design likely did not account for support from the masonry wall, which may result in buckling or other localized failures of the steel frame. This concern is exacerbated by the Metal Building Manufacturer's Association's (MBMA's) drift and deflection limits for most engineered metal buildings; the metal building frame is likely to deflect vertically and horizontally more than the masonry wall below.

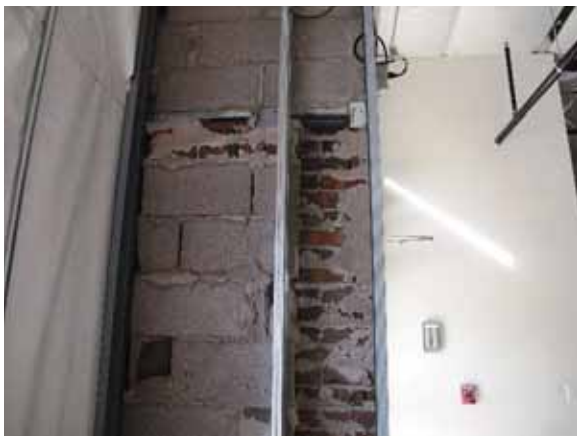
The infill masonry at building entrances and exits in exterior walls was exposed on the back side. It is unknown at this time if the masonry was designed to span without structural backing, but a backing system did exist at the time the walls were constructed as evidenced by the “flat” areas of mortar observed in Fig. 2.2.B.2.

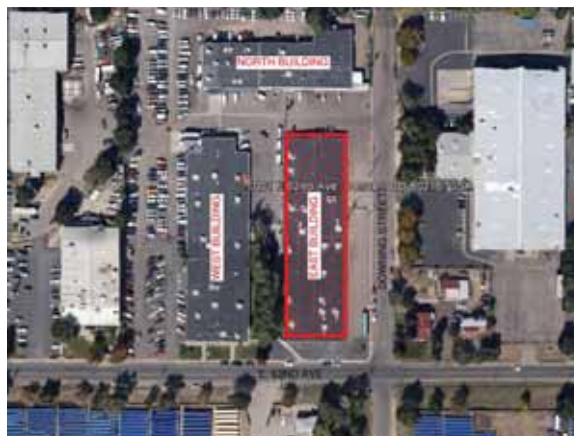
Figure 2.3.A.1 – East Building of North Campus Vicinity Map

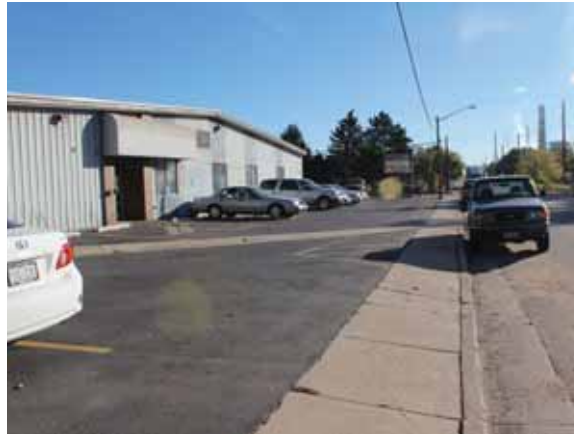
Figure 2.3.A.3 – South Entrance

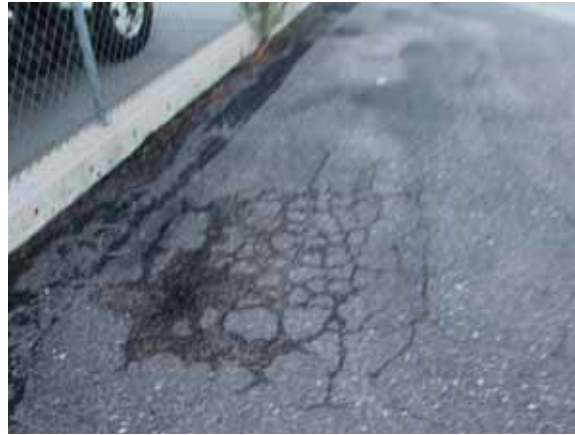
Figure 2.3.A.6 – Poor Site Asphalt Condition

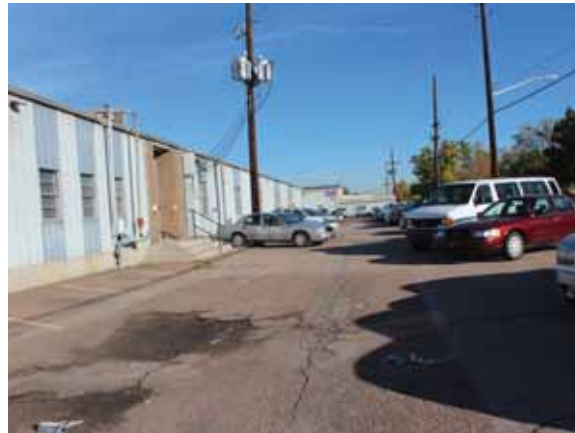
Figure 2.3.A.7 – Poor Site Asphalt Condition

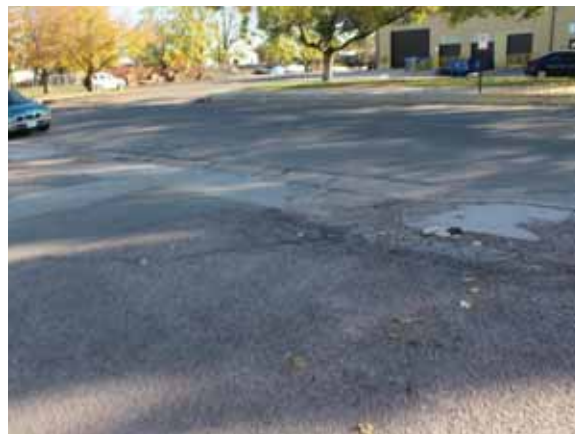
Figure 2.3.A.8 – Poor Site Asphalt Condition

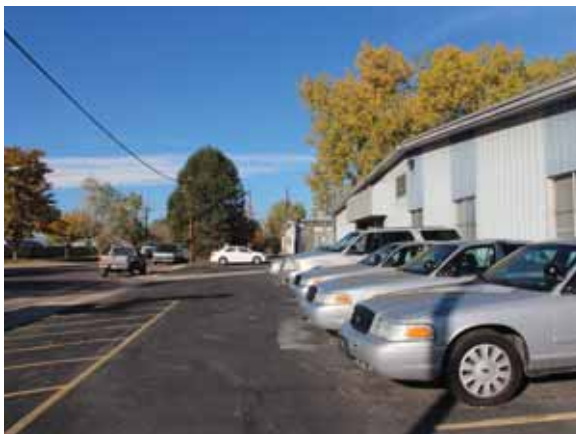
Figure 2.3.B.1 – Building Perimeter Slope

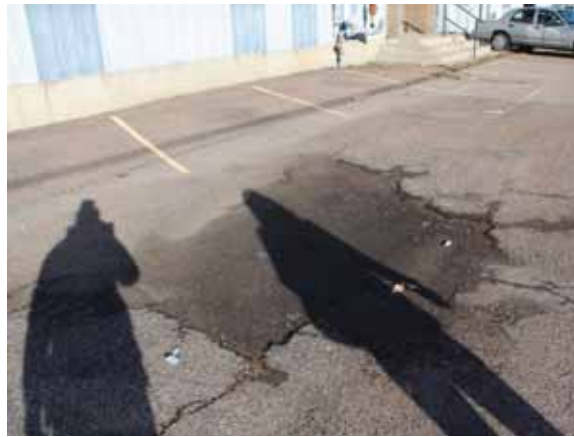
Figure 2.3.B.2 – Broken Asphalt at a location of depressed grade

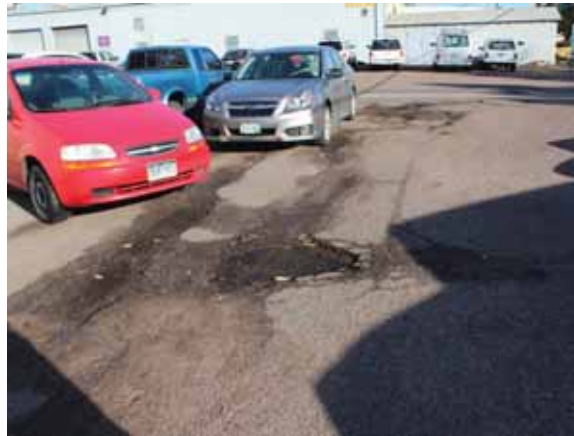
Figure 2.3.B.3 – Broken, Depressed Asphalt

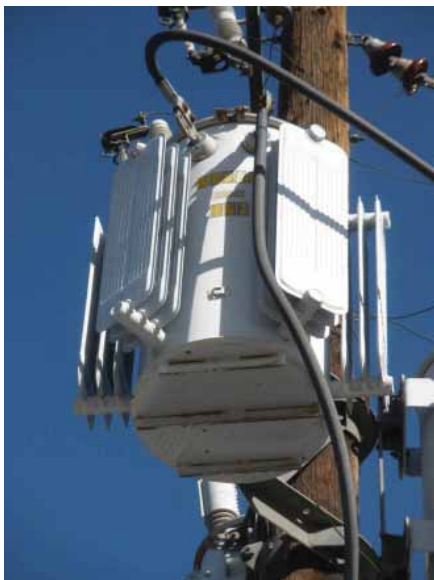
Fig. 2.4.A.2 – Utility transformer

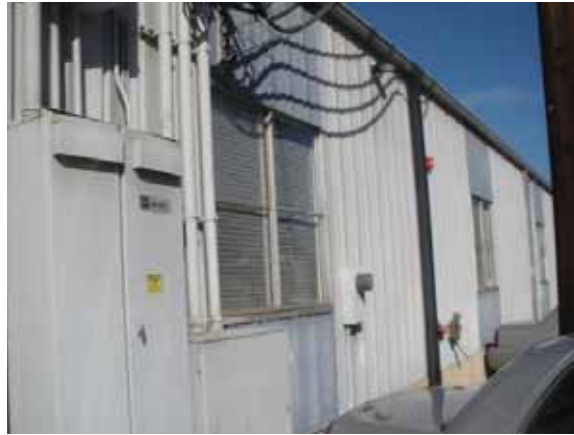
Fig. 2.4.A.3 – Electrical Service Entrance

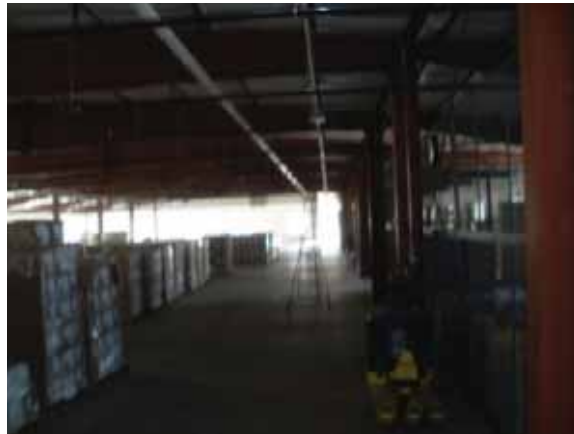
Fig. 2.4.A.4 – Linear fluorescent luminaires

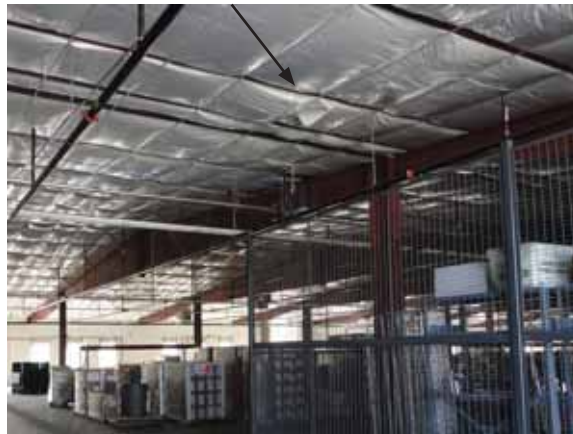
Fig. 3.0.C.1 Insulation observed hanging loose during the site survey visit..

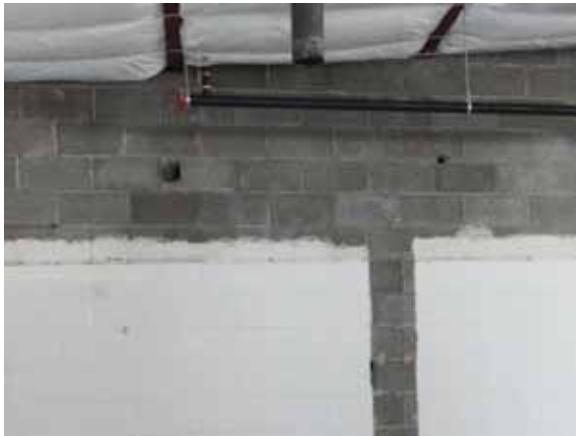
Fig. 3.0.C.2 Holes observed in the masonry block wall separating the building in half.

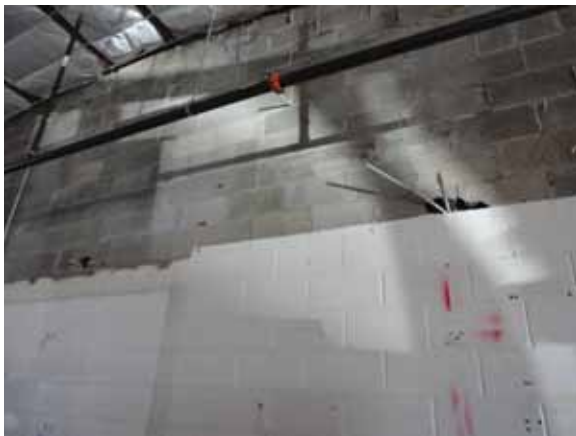
Fig. 3.0.C.3 Pieces of pipes or tubes sticking out of a few of the holes observed in the masonry block wall separating the building in half.

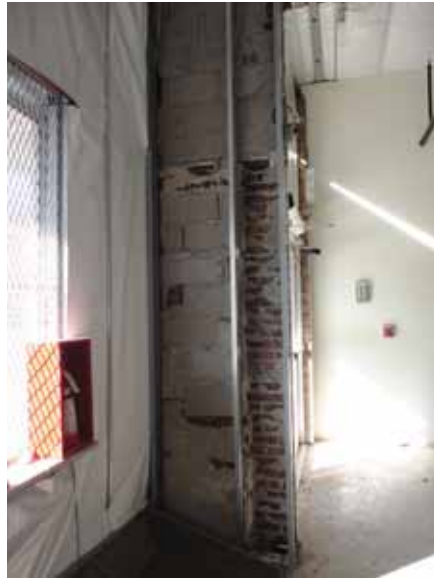
Fig. 3.0.C.4 Areas of unfinished walls observed during the site survey visit.

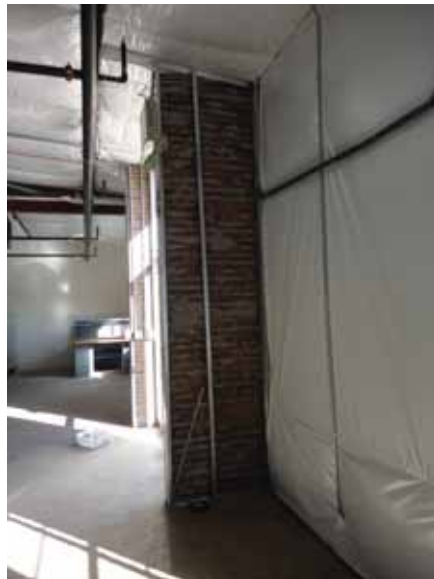
Fig. 3.0.C.5 Areas of unfinished walls observed during the site survey visit.

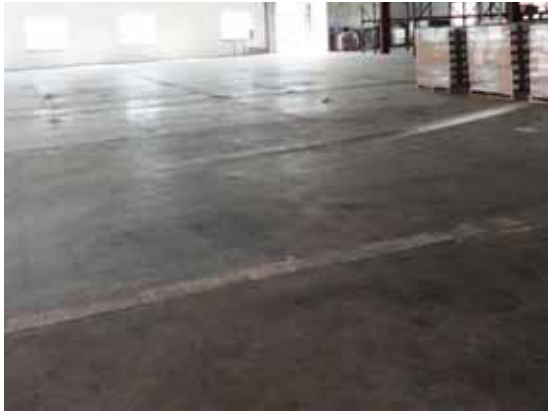
Fig. 3.0.C.6 General deterioration of the concrete flooring observed during the site survey visit.

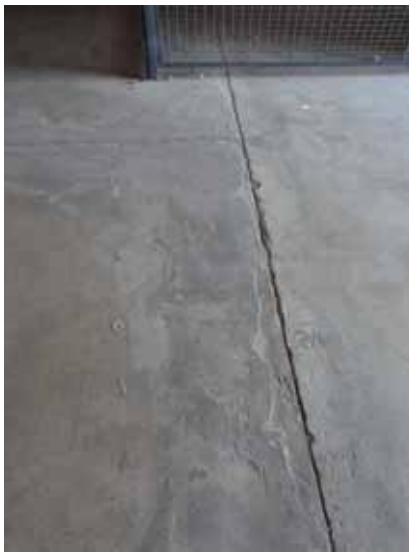
Fig. 3.0.C.7 Deterioration and spalling of the concrete flooring observed throughout the building.

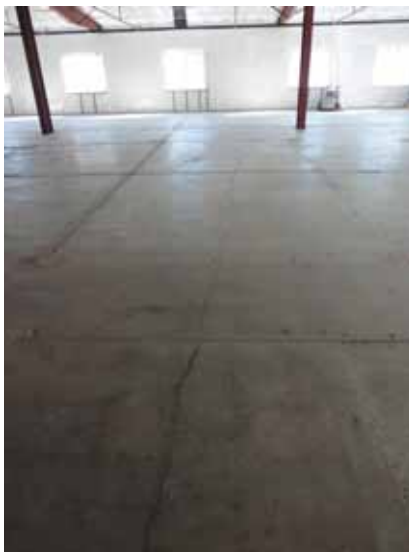
Fig. 3.0.C.8 Cracking areas of the concrete flooring observed throughout the building.

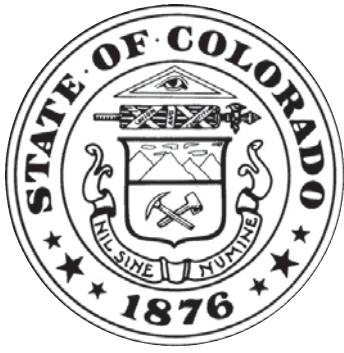
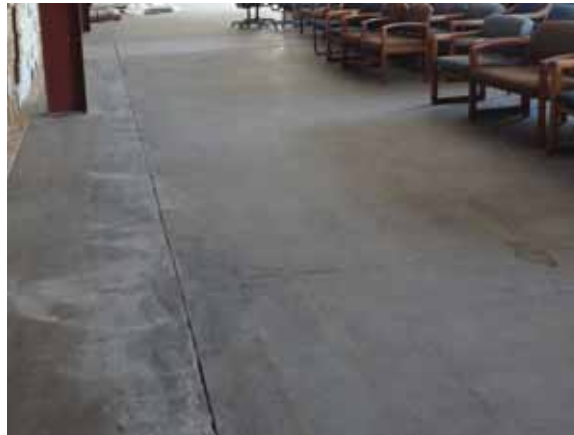
Fig. 3.0.C.9 An area of potential water damage observed at the concrete flooring on the north side of the building.

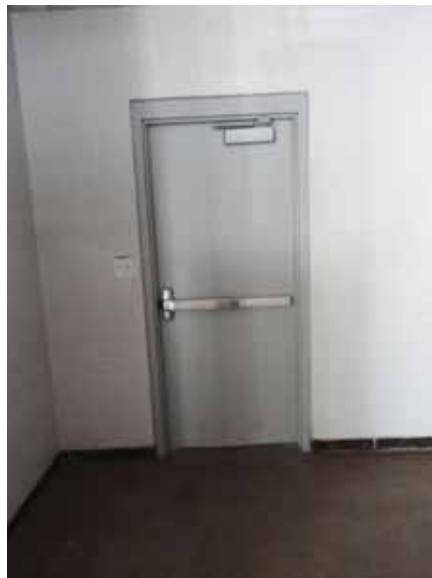
Fig. 3.0.C.10 Minor wear-and-tear and soiling observed at a few of the interior doors.

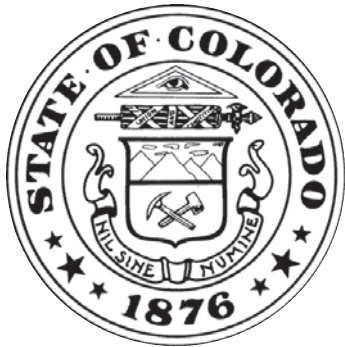
3.0-F SECURITY SYSTEMS
