CAPITOL COMPLEX MASTER PLAN  
FINDINGS & RECOMMENDATIONS (F & R) NEEDS ASSESSMENT  
EXECUTIVE RESIDENCE & CARRIAGE HOUSE, 400 EAST 8TH AVENUE (DENVER)

NOVEMBER 2014

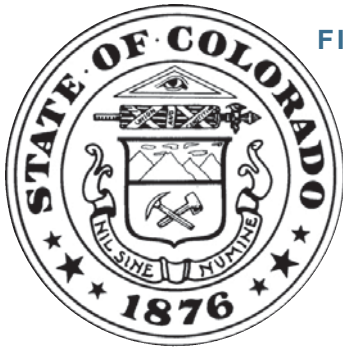
**FINDINGS & RECOMMENDATIONS (F&R) NEEDS ASSESSMENT  
EXECUTIVE RESIDENCE & CARRIAGE HOUSE  
400 EAST 8TH AVENUE (DENVER)**

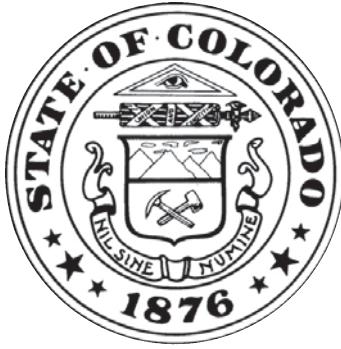
## EXECUTIVE SUMMARY

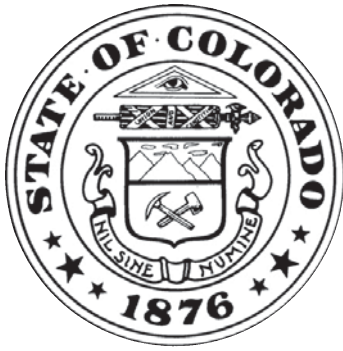
### 1.0-C CIVIL OVERVIEW

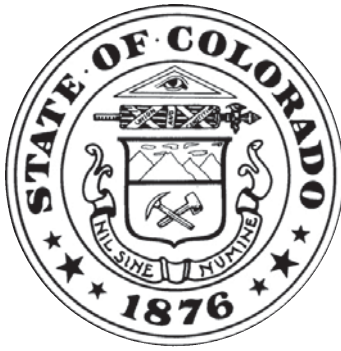
### 1.0-E VOICE AND DATA OVERVIEW

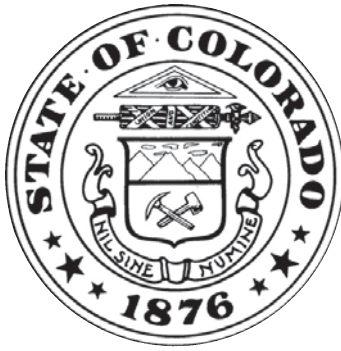
### 1.0-F SECURITY SYSTEMS OVERVIEW

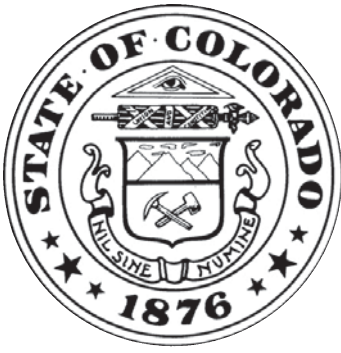
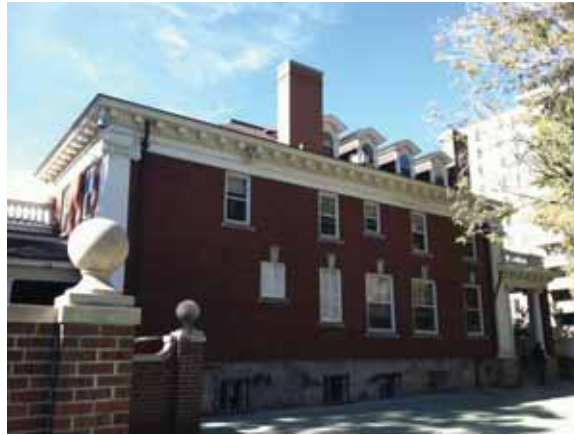
Side/East Elevation of the Executive Residence

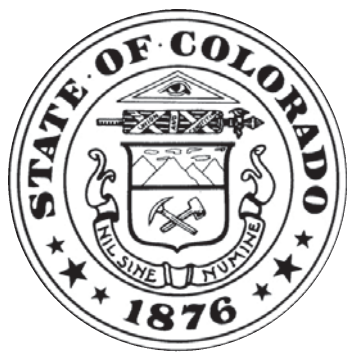
Fig. 2.1.A.4, and Fig. 2.1.A.5). Some of the soiling of the foundation appears to be due to irrigation that is saturating the building, especially along the south side of the building (see Fig. 2.1.A.6 and Fig. 2.1.A.7). The mortar in the joints between the foundation blocks was noted to be deteriorating in areas around the building and leaving the building envelope vulnerable to water penetration (see Fig. 2.1.A.8 and Fig. 2.1.A.9). The repaired areas of the spalling foundation blocks appear to be temporary fixes with general deterioration of the repairs noted (see Fig. 2.1.A.10 and Fig. 2.1.A.11). The window ledges around the building appear to be concrete or stone and were noted to be generally soiled with some cracking that was readily observable from the ground (see Fig. 2.1.A.12).

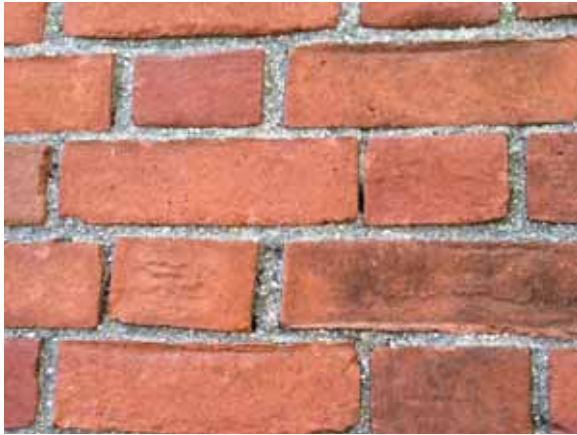
Fig. 2.1.A.1 Areas of deteriorating or missing mortar noted in a few areas of the brick walls around the exterior of the building.

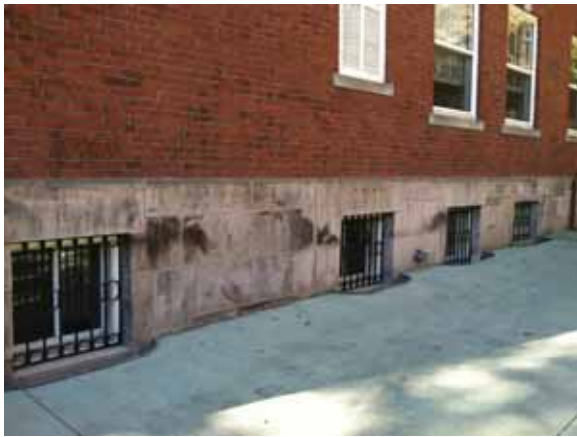
Fig. 2.1.A.2 Areas of widespread soiling of the foundation noted around the exterior of the building.

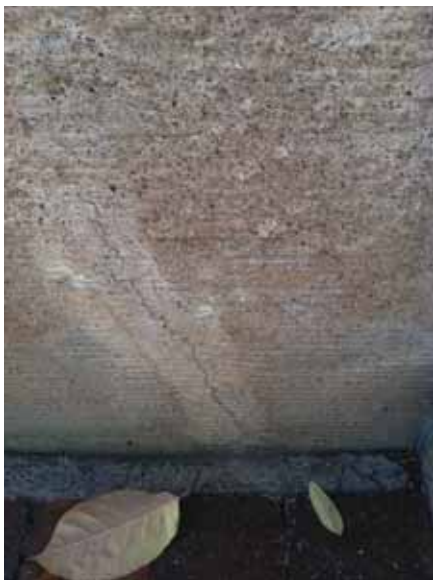
Fig. 2.1.A.3 Cracking of the foundation.

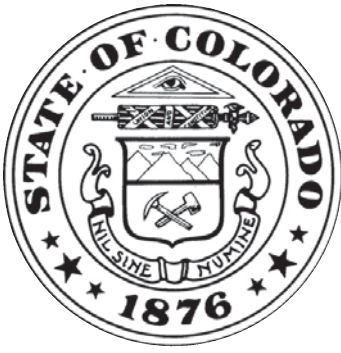
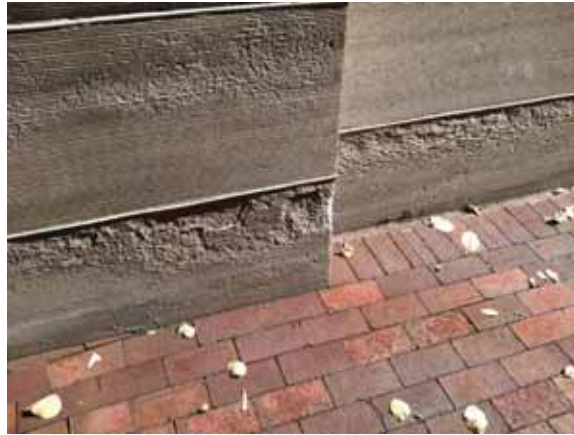
Fig. 2.1.A.4 Spalling of the foundation blocks.

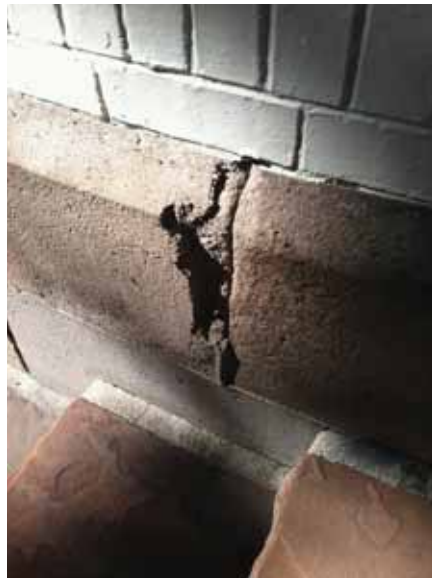
Fig. 2.1.A.5 Cracking and spalling noted at the foundation.

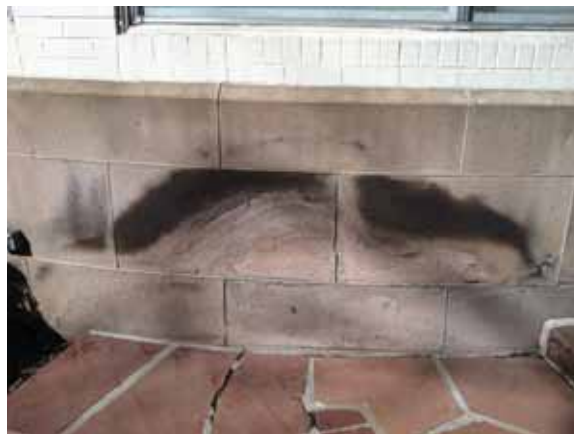
Fig. 2.1.A.6 Soiling and damage that is likely due to irrigation.

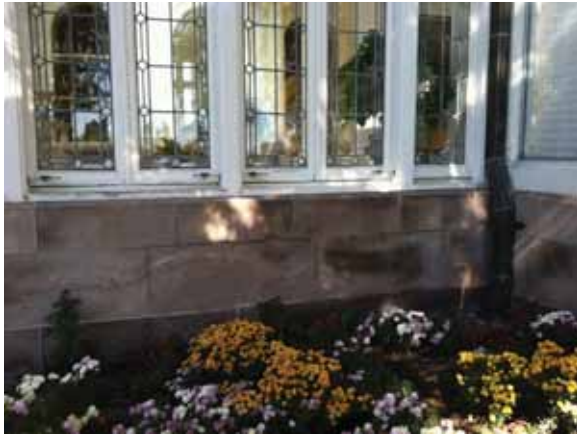
Fig. 2.1.A.7 Soiling and damage that is likely due to irrigation.

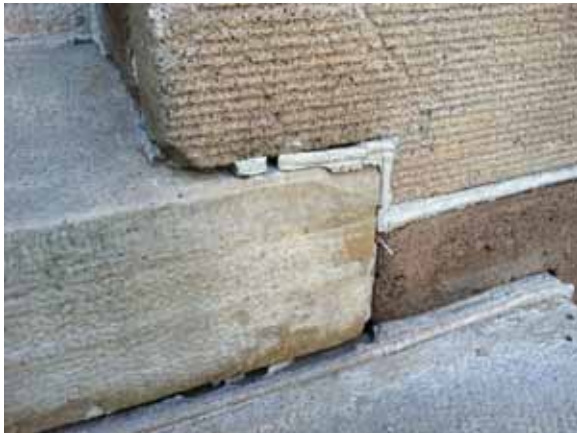
Fig. 2.1.A.8 Deterioration of the mortar noted at the foundation.

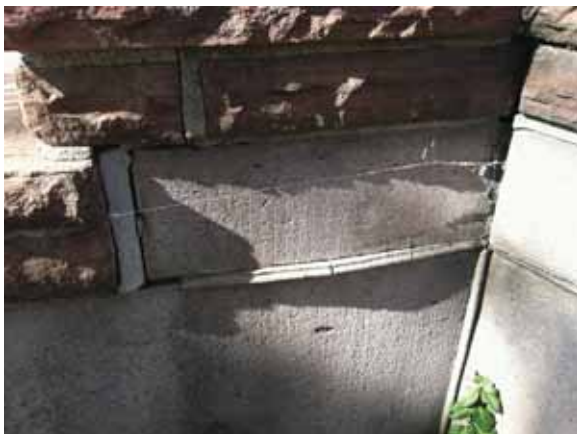
Fig. 2.1.A.9 Deterioration of the mortar noted at the brick and at the foundation.

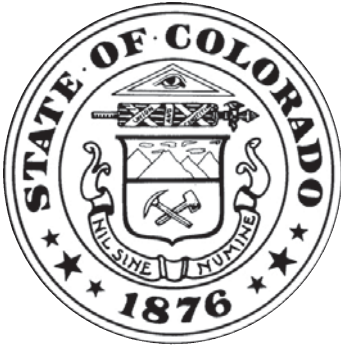
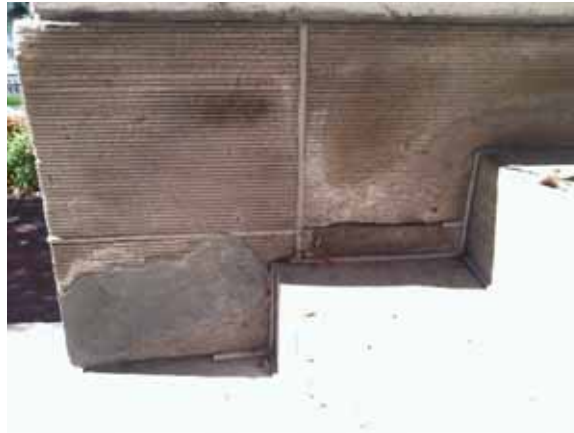
Fig. 2.1.A.10 Areas of poor repairs of the foundation are beginning to deteriorate.

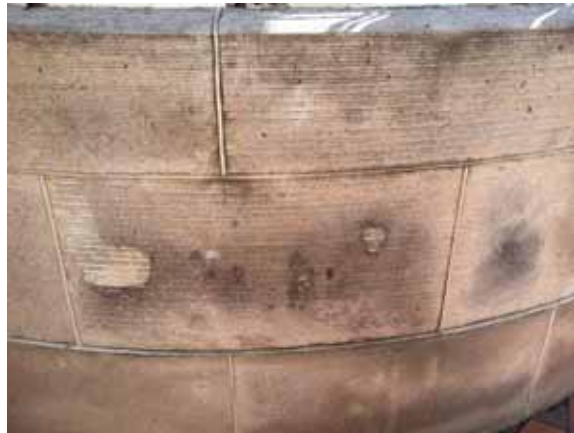
Fig. 2.1.A.11 Areas of poor repairs of the foundation are beginning to deteriorate.

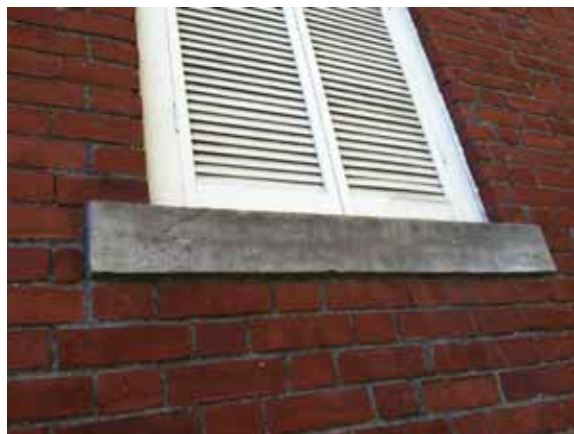
Fig. 2.1.A.12 Generally soiled window ledges with some cracking readily observable from the ground.

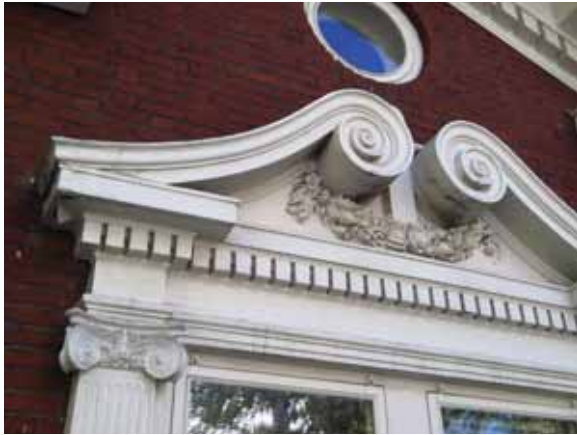
Fig. 2.1.A.13 Generally soiled decorative trim with cracking and peeling paint.

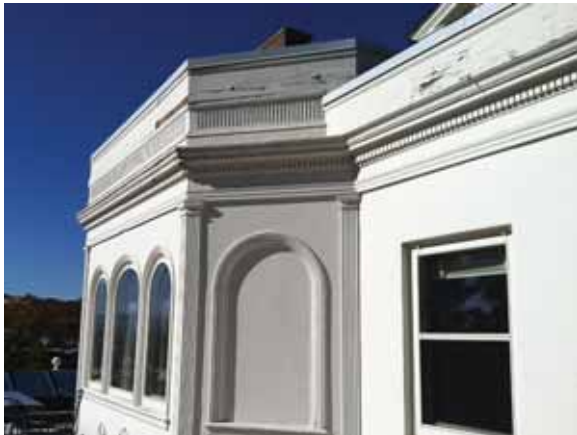
Fig. 2.1.A.14 Widespread peeling and cracking paint noted at the wood trim around the exterior of the building.

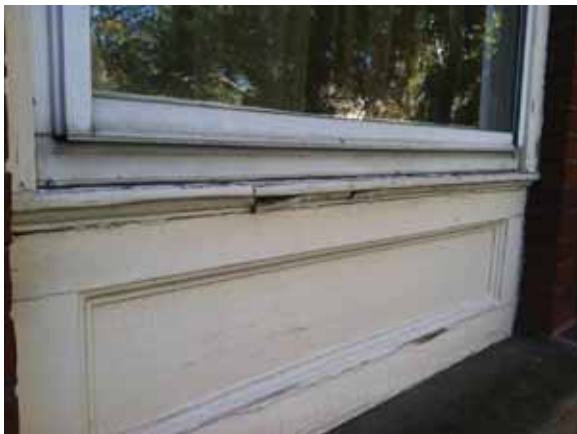
Fig. 2.1.A.15 Widespread peeling and cracking paint noted at the wood trim around the exterior of the building.

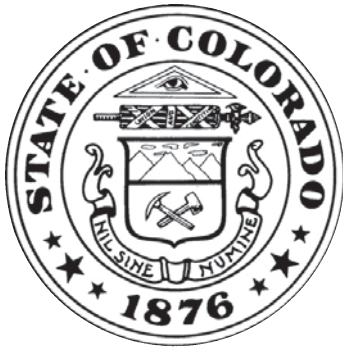
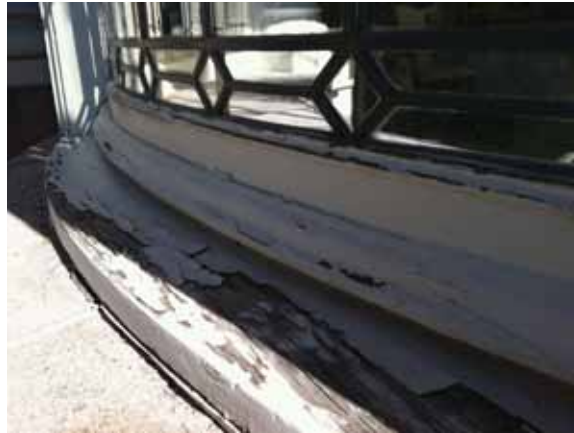
Fig. 2.1.A.16 Widespread peeling and cracking paint noted at the wood trim around the exterior of the building.

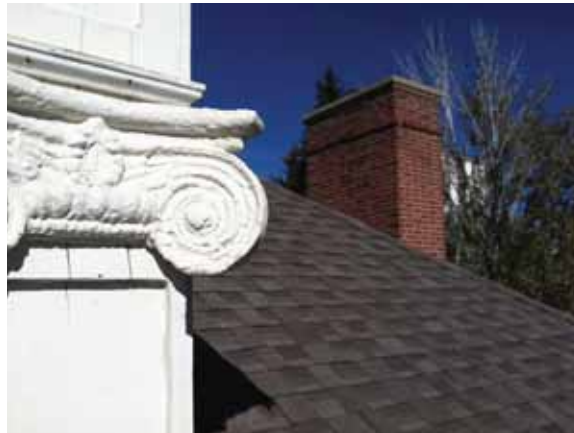
Fig. 2.1.A.17 Decorative wood trim with multiple layers of paint observed to be cracking.

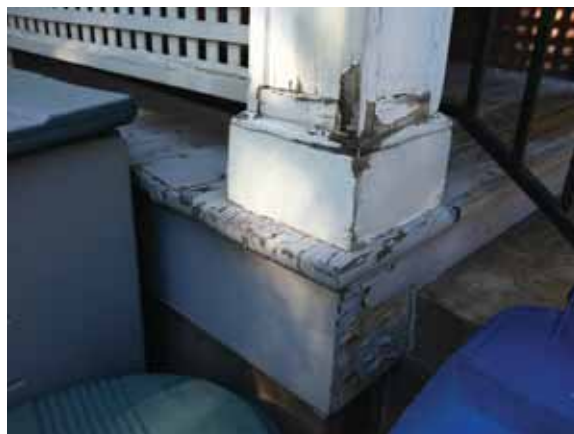
Fig. 2.1.A.18 Widespread deterioration of the paint at the southeast porch is exposing the wood to the elements.

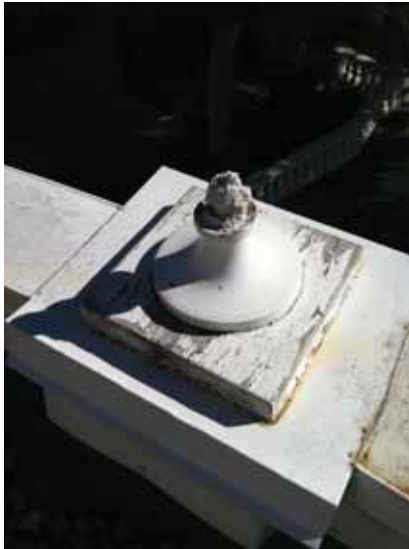
Fig. 2.1.A.19 Extensive deterioration noted at the decorative elements along the roof deck railings.

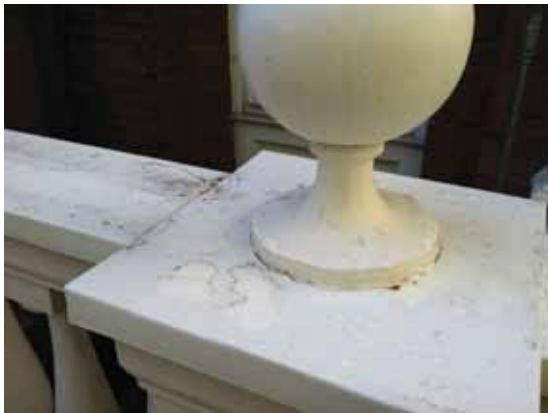
Fig. 2.1.A.20 The top surface of the roof deck railings appears to be generally flat, allowing water to stand and cause damage.

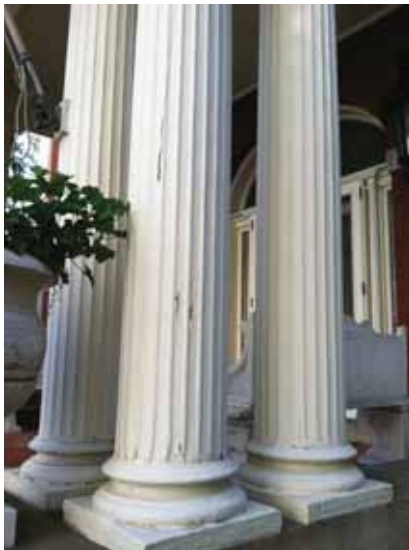
Fig. 2.1.A.21 Cracking and peeling paint observed at the columns.

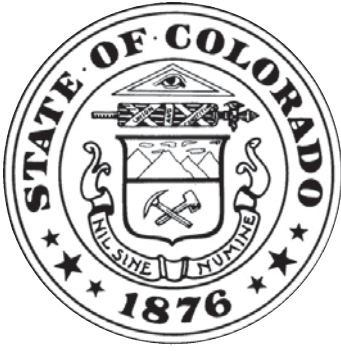
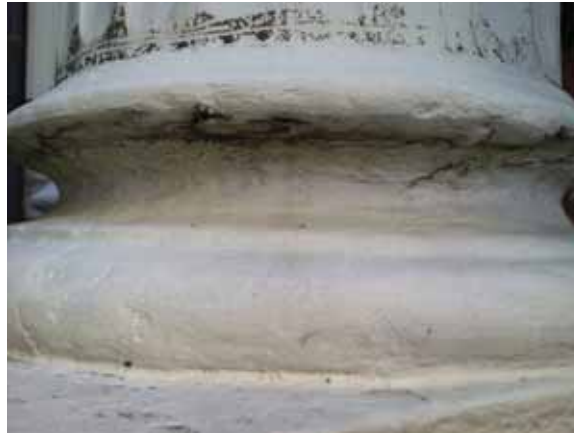
Fig. 2.1.A.22 Cracking and peeling paint exposing the column's substrate material underneath to the elements.

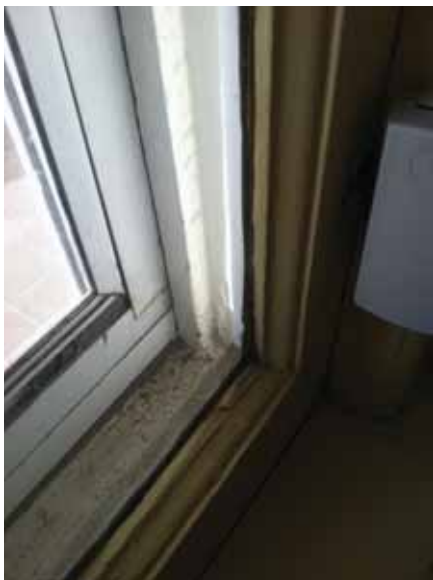
Fig. 2.1.A.23 Damage noted on the interior side of a few of the First through Third Floor windows.

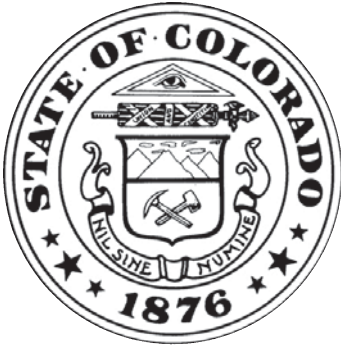
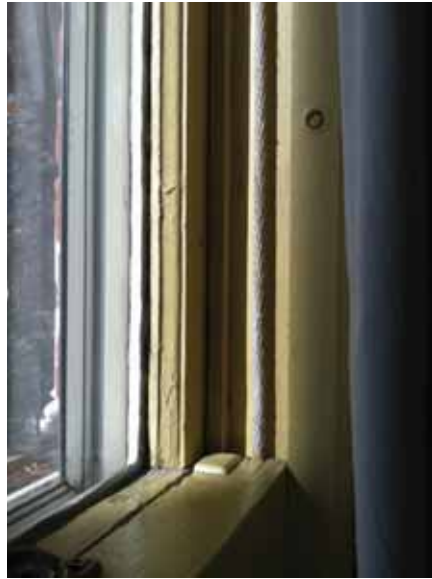
Fig. 2.1.A.24 Damage noted on the interior side of a few of the First through Third Floor windows.

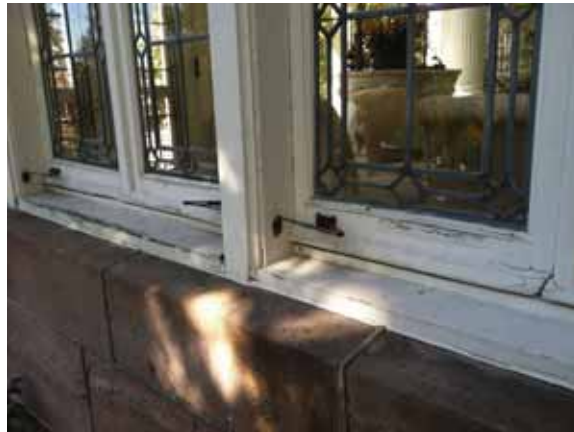
Fig. 2.1.A.25 First Floor windows noted to have peeling and cracking paint at the wood frames.

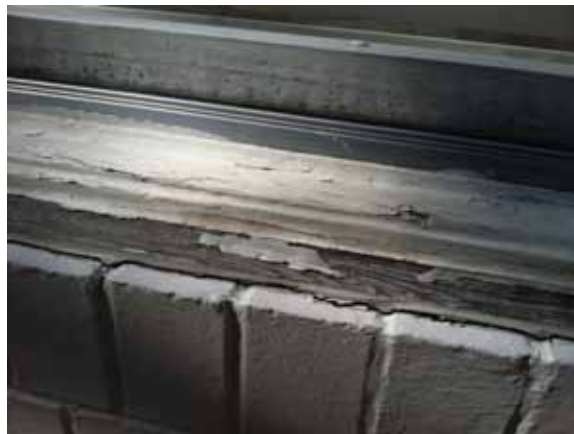
Fig. 2.1.A.26 First Floor windows noted to have peeling and cracking paint and deterioration of the wood frames.

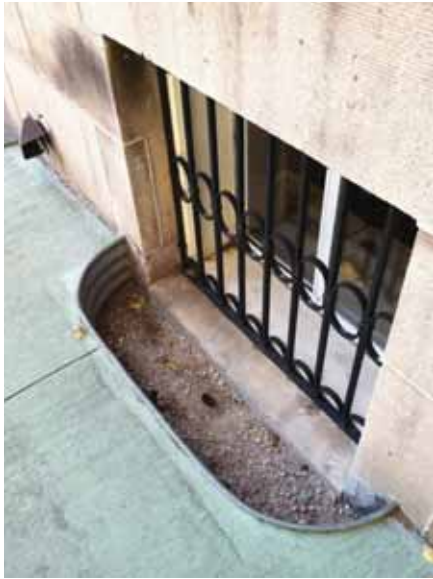
Fig. 2.1.A.27 Window well on the east side of the building observed to have evidence of water saturation.

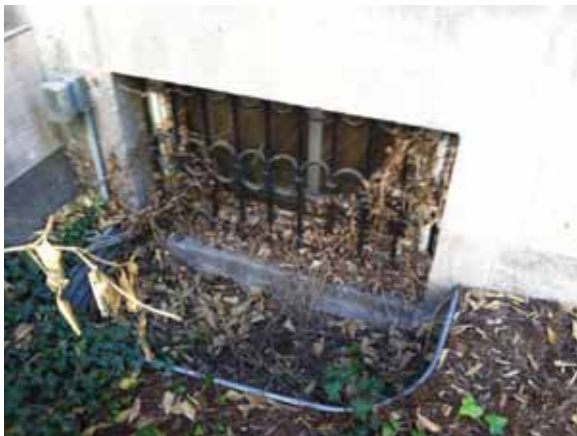
Fig. 2.1.A.28 Debris observed in a few of the window wells around the building.

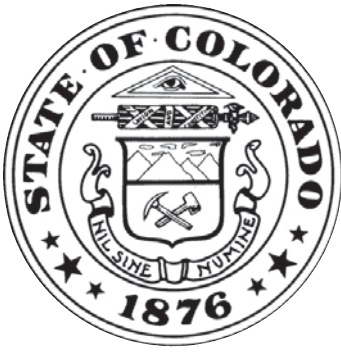
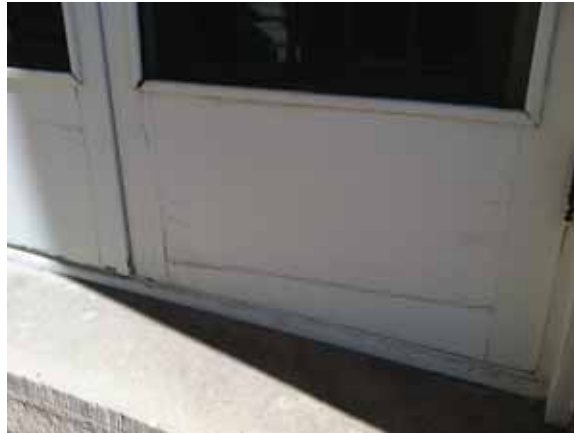
Fig. 2.1.A.29 Doors with peeling and cracking paint and general deterioration at the covered porch on the west side of the building.

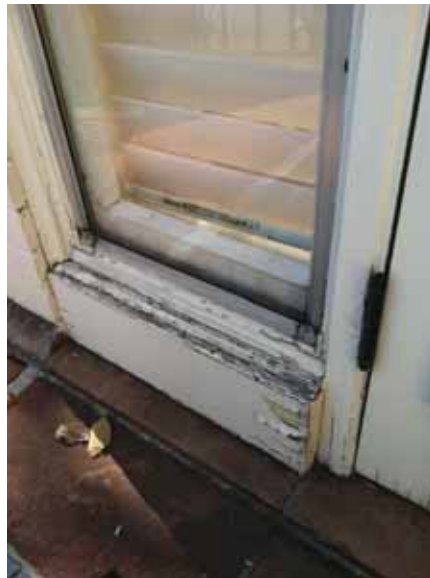
Fig. 2.1.A.30 Cracking and peeling paint noted at the side-lites on either side of the patio doors on the east end of the south side of the First Floor Palm Room.

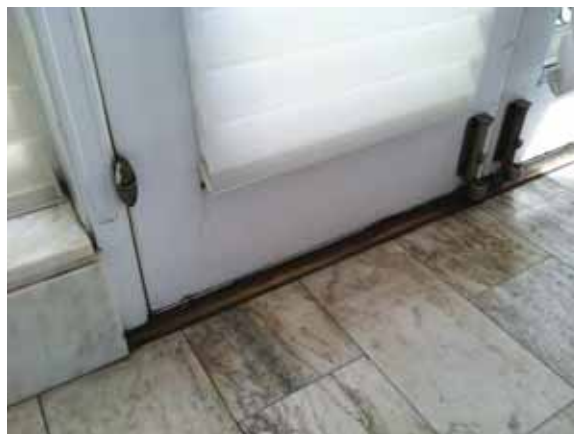
Fig. 2.1.A.31 Evidence of water intrusion observed on the interior side of the First Floor Palm Room patio doors on the east end of the south side of the building.

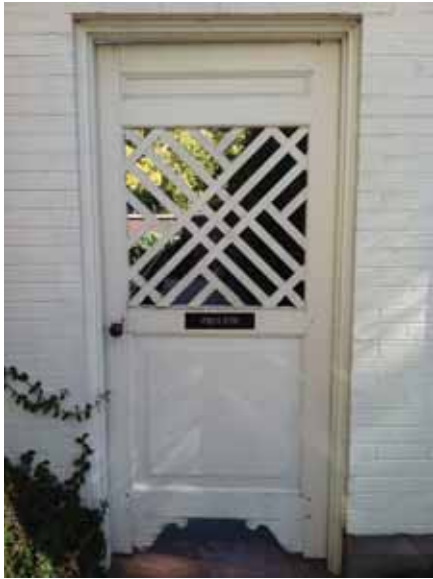
Fig. 2.1.A.32 Wood door in the east brick perimeter wall observed to have cracking wood and peeling paint.

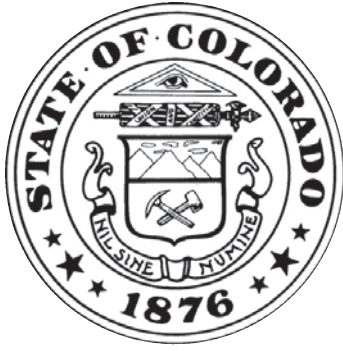
side of the First Floor Palm Room patio doors on the east end of the south side of the building and repair as necessary. Clean and repair or replace any damaged or soiled areas of the doors, side-lites, and interior finishes.

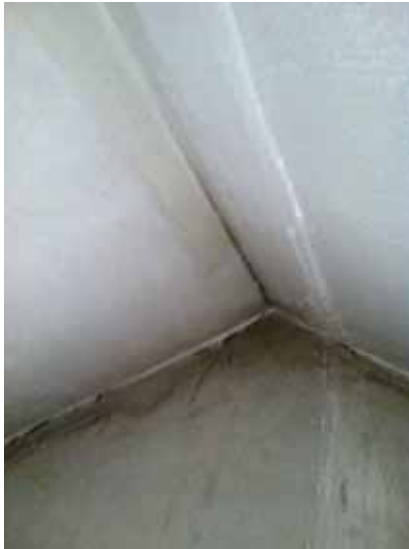
Fig. 2.1.A.33 Evidence of widespread water intrusion and damage noted throughout the attic.

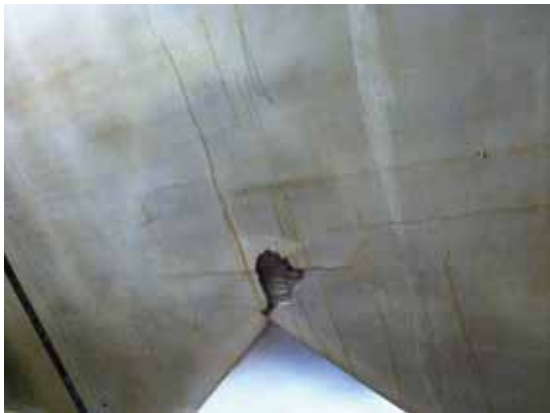
Fig. 2.1.A.34 Evidence of widespread water intrusion and damage noted throughout the attic.

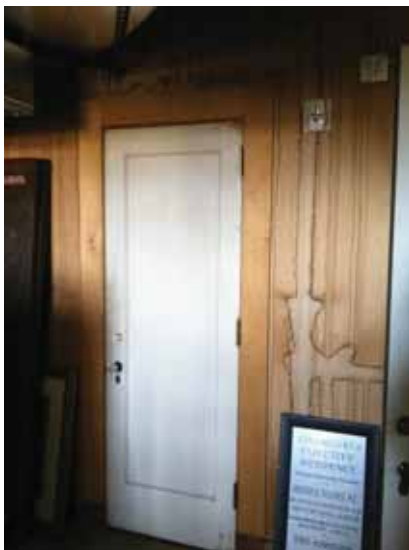
Fig. 2.1.A.35 Evidence of widespread water intrusion and damage noted throughout the attic.

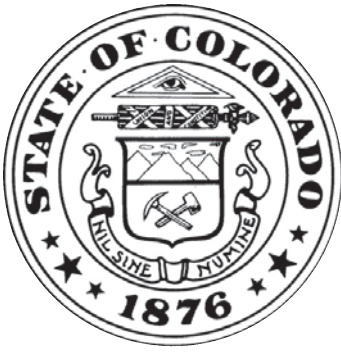
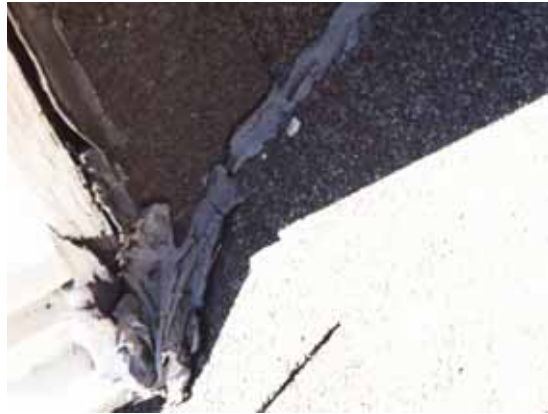
Fig. 2.1.A.36 Areas of deteriorating flashing and sealant observed on the roof.

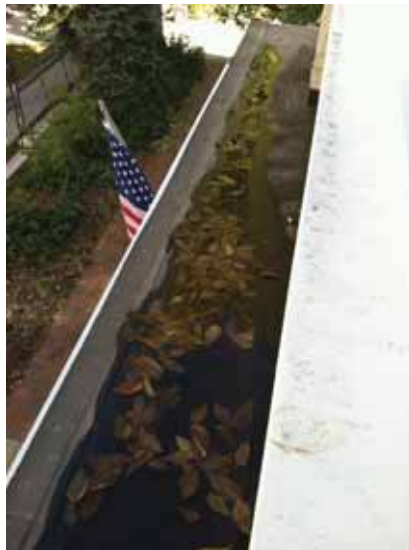
Fig. 2.1.A.37 Corrosion and deteriorating sealant noted at the readily observable roof vents.

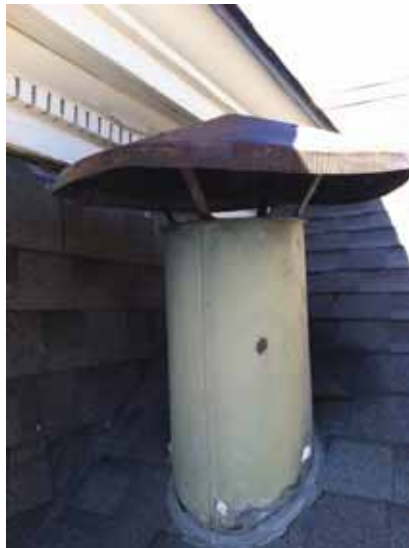
Fig. 2.1.A.38 The generally flat area around the perimeter of the main roof is covered with an EPDM roofing membrane that has been patched, is collecting soil, and appears to be deteriorating with age.

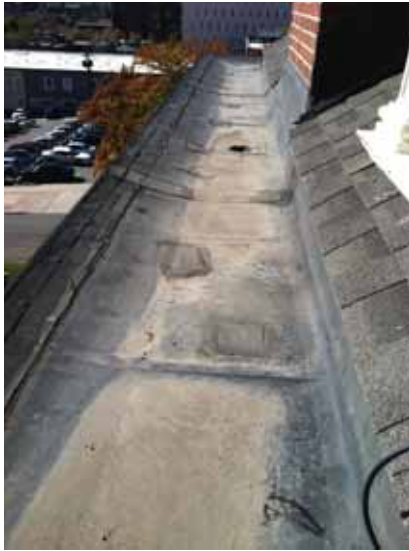
Fig. 2.1.A.39 Leaves and debris collecting at the roof over the front porch on the north side of the building.

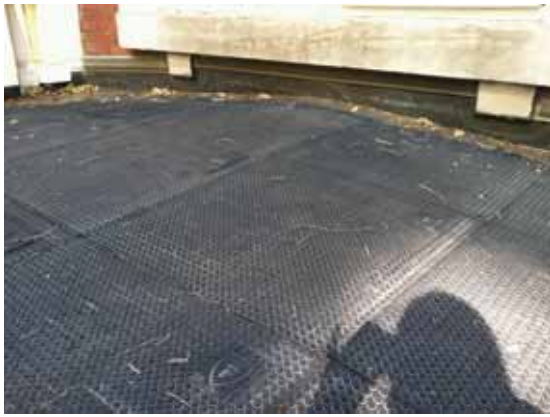
Fig. 2.1.A.40 Leaves and standing water observed along the front edge of the roof over the front porch on the north side of the building.

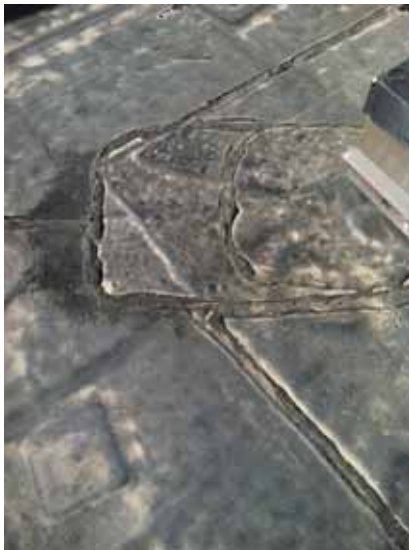
Fig. 2.1.A.41 General deterioration of the EPDM membrane, former patchwork, and sealant noted at the flat roof deck areas.

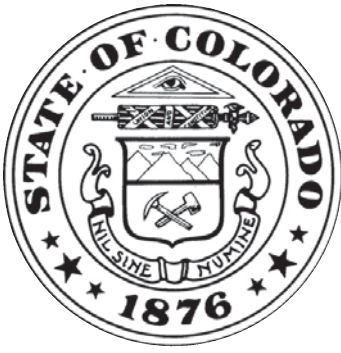
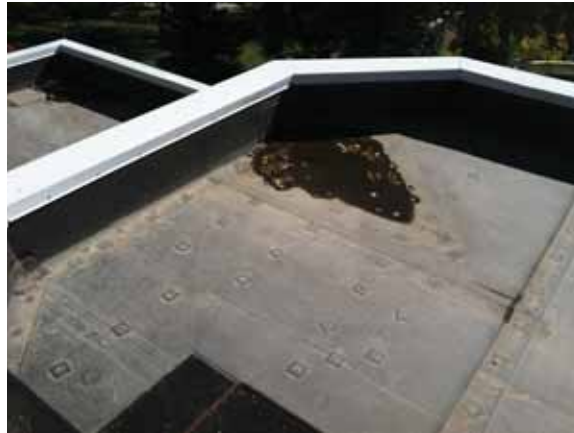
Fig. 2.1.A.42 Areas of standing water observed at the flat roof decks covered with an EPDM membrane.

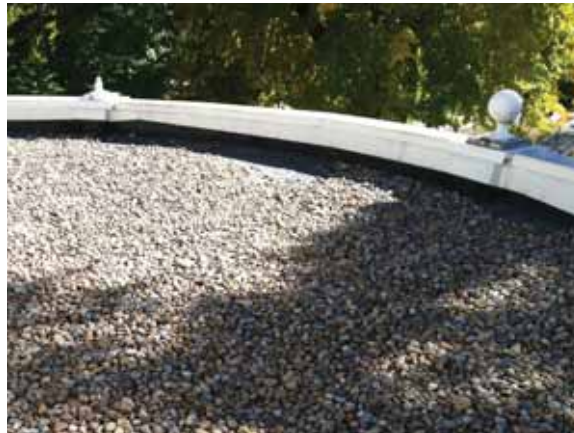
Fig. 2.1.A.43 Areas with thin or no ballast along the perimeter edges of the flat roof decks.

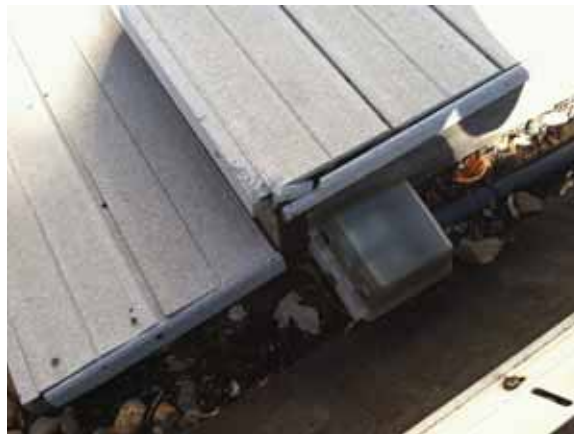
Fig. 2.1.A.44 Minor damage noted at the composite roof deck walkway on the south side of the building.

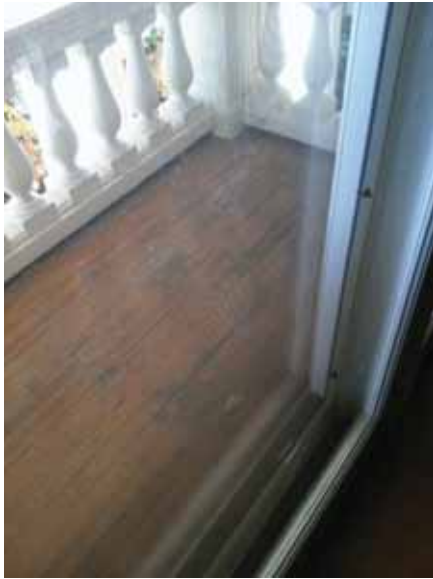
Fig. 2.1.A.45 Deterioration of the wood decking noted at the porch outside of the Second Floor office on the west side of the building.

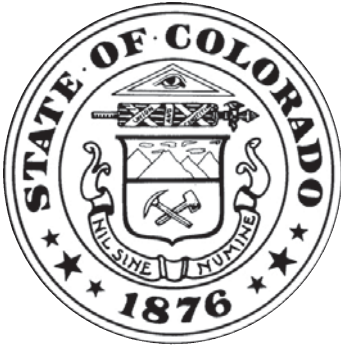
## 2.0 OVERALL BUILDING ASSESSMENT FINDINGS & RECOMMENDATIONS

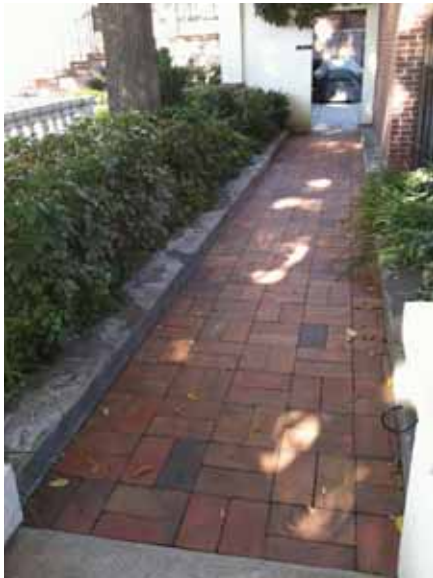
Fig. 2.1.A.46 Deterioration and spalling noted at areas of the concrete edging.

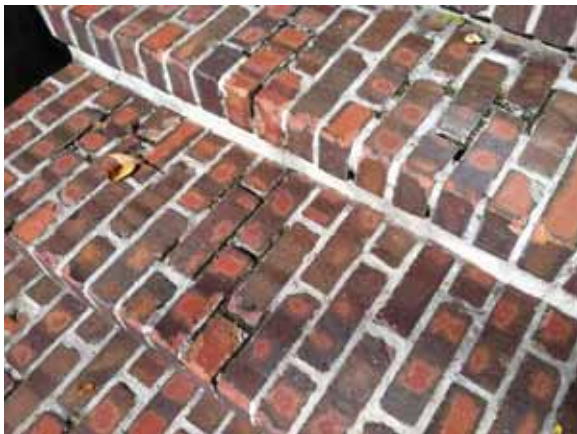
Fig. 2.1.A.47 Deteriorating mortar noted at areas of the brick pavers and stairways throughout the site.

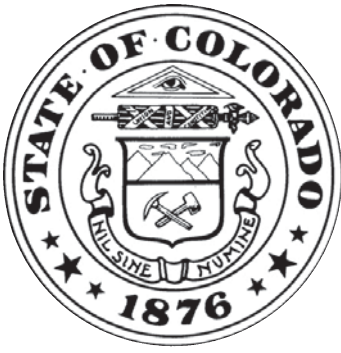
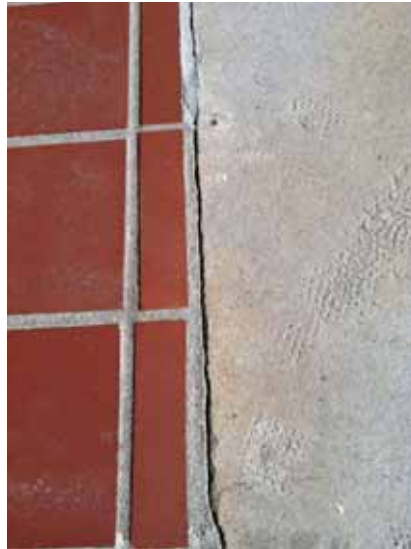
Fig. 2.1.A.48 Deteriorating mortar noted between the stone stairway and tile paving at the porch on the west side of the building.

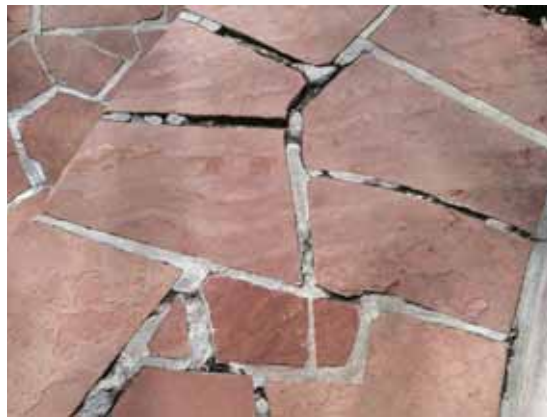
Fig. 2.1.A.49 Deteriorating mortar noted between areas of the stone pavers throughout the site.

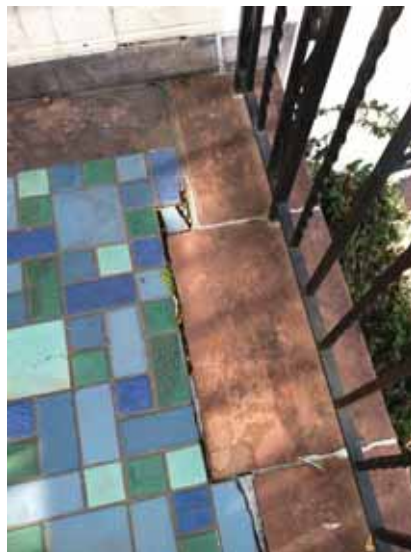
Fig. 2.1.A.50 Deteriorating mortar noted between areas of the tile pavers throughout the site.

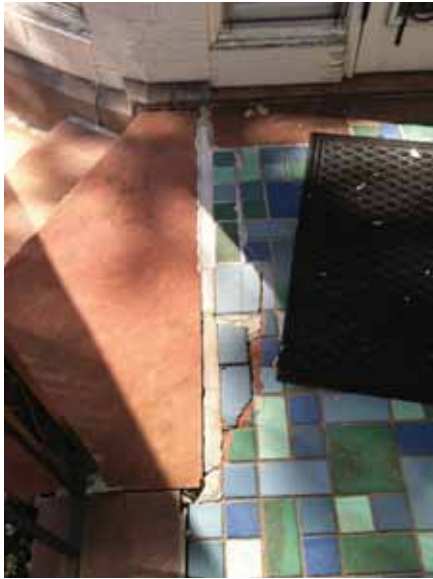
Fig. 2.1.A.51 An area of damaged tile pavers creating a potential tripping hazard noted at the patio on the southeast side of the First Floor Palm Room.

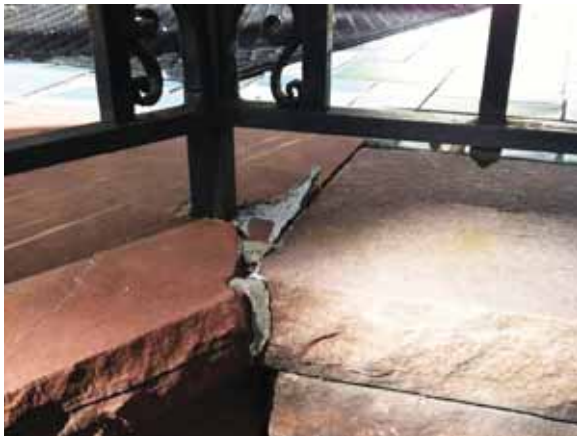
Fig. 2.1.A.52 Cracked paving noted at the guardrail posts along the edge of the patio on the southeast side of the First Floor Palm Room.

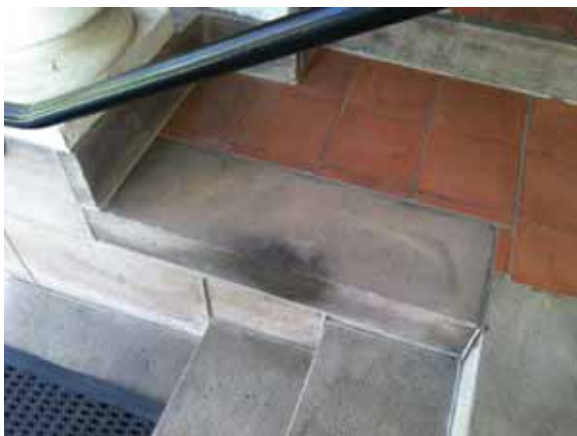
Fig. 2.1.A.53 Soiling noted to the paving at the covered porch on the west side of the building.

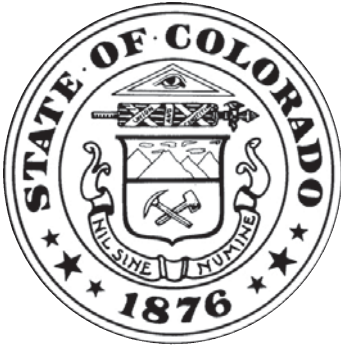
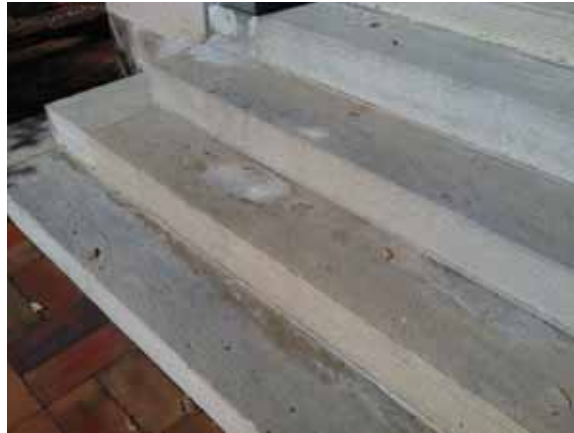
Fig. 2.1.A.54 Areas of spalling and damage observed at the exterior stairways around the building.

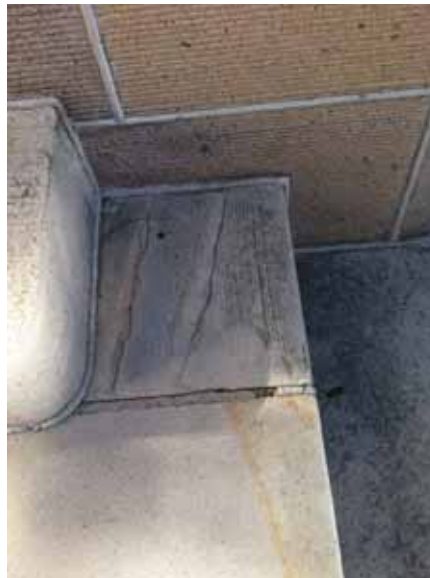
Fig. 2.1.A.55 Areas of spalling and soiling observed at the exterior stairways around the building.

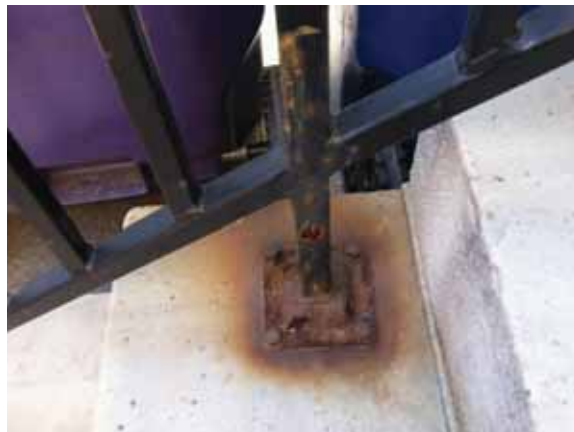
Fig. 2.1.A.56 Corroding railing posts observed at the southeast service entrance.

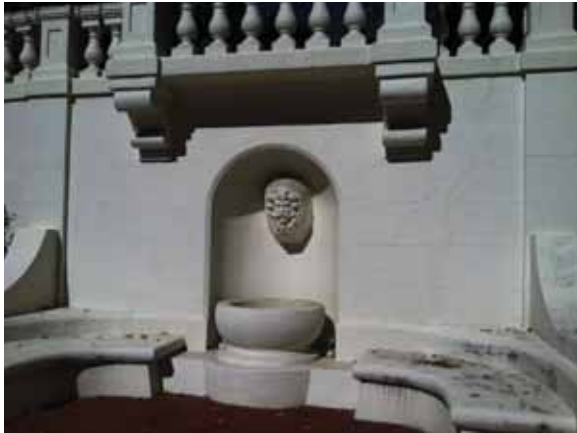
Fig. 2.1.A.57 Widespread cracking observed at the curved white retaining wall and soiling of the seating and flat surfaces.

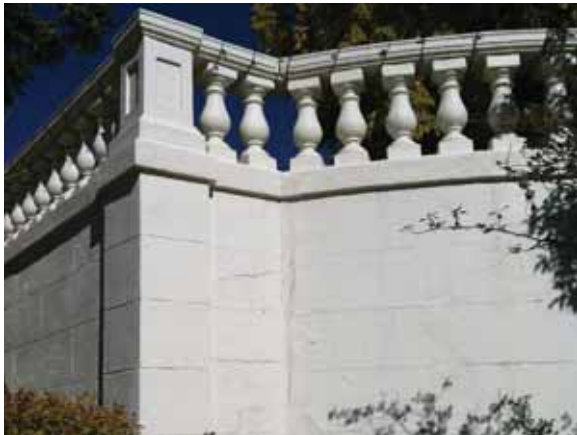
Fig. 2.1.A.58 Widespread cracking observed at the curved white retaining wall.

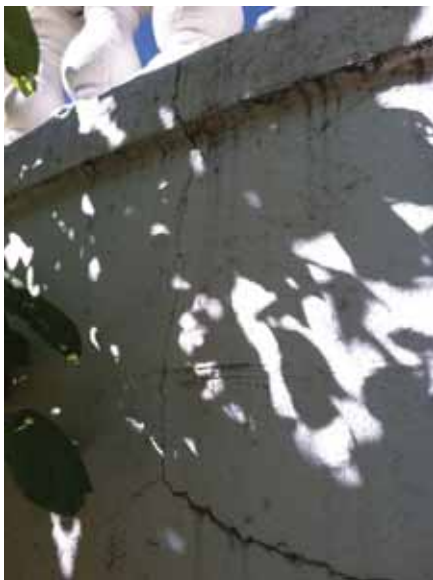
Fig. 2.1.A.59 Widespread cracking observed at the curved white retaining wall with soiling noted along the landscaped areas.

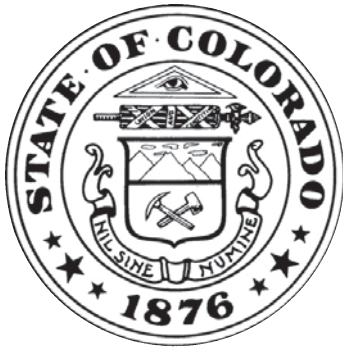
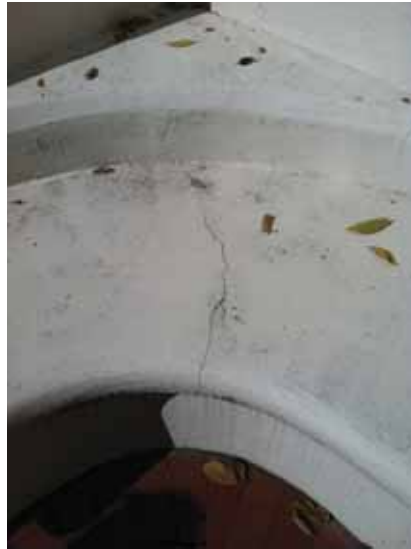
Fig. 2.1.A.60 Cracking observed at the seating and flat surfaces at the curved white retaining wall.

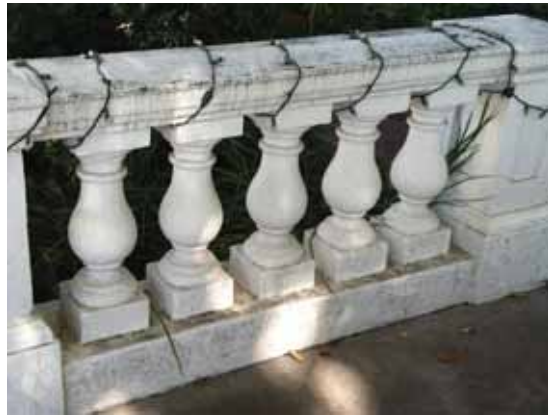
Fig. 2.1.A.61 Soiling noted at the railings along the curved white retaining wall.

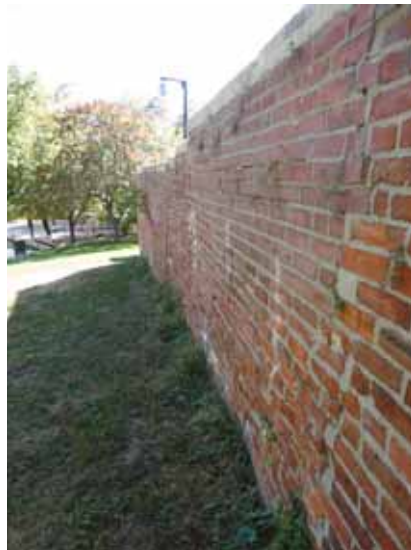
Fig. 2.1.A.62 Portion of the brick perimeter wall noted to be failing structurally along the eastern and southern portions of the terraced grounds, near the Tebo Visitor's Center.

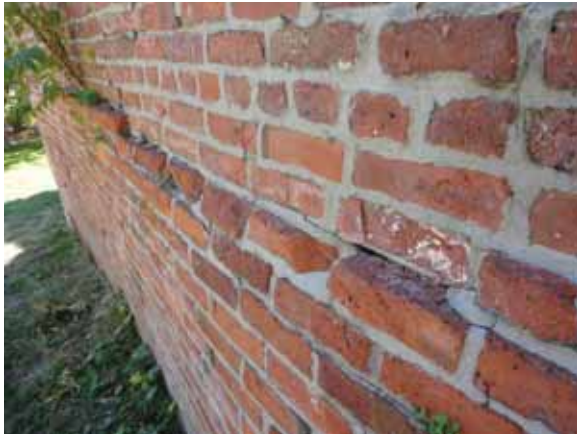
Fig. 2.1.A.63 Portion of the brick perimeter wall noted to be failing structurally along the eastern and southern portions of the terraced grounds, near the Tebo Visitor's Center.

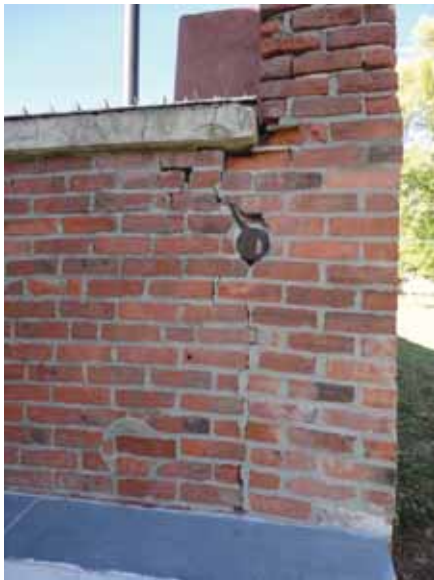
Fig. 2.1.A.64 Portion of the brick perimeter wall noted to be failing structurally along the eastern and southern portions of the terraced grounds, near the Tebo Visitor's Center.

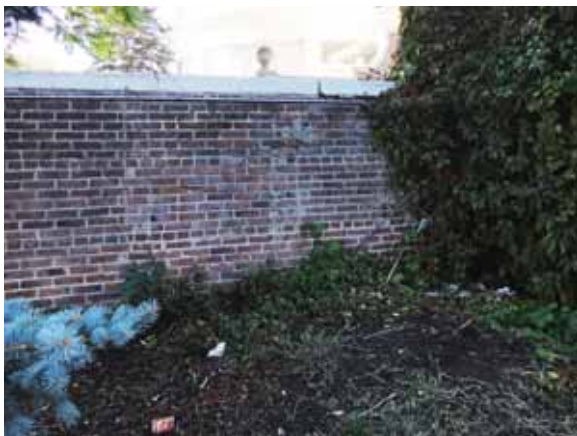
Fig. 2.1.A.65 General deterioration of the brick perimeter walls noted during the site survey visit.

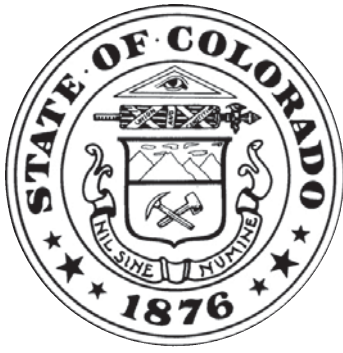
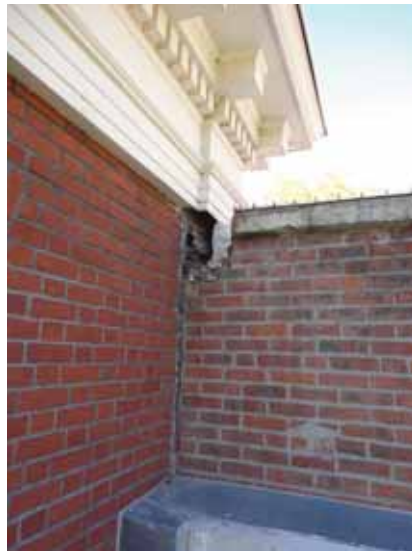
Fig. 2.1.A.66 General deterioration and damage noted at the brick perimeter walls during the site survey visit.

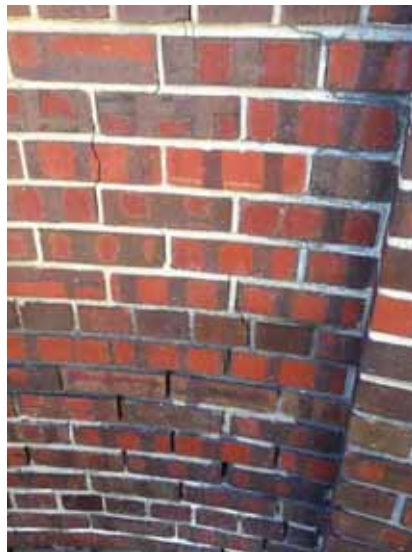
Fig. 2.1.A.67 Cracking of the brick perimeter walls with deteriorating and missing mortar noted during the site survey visit.

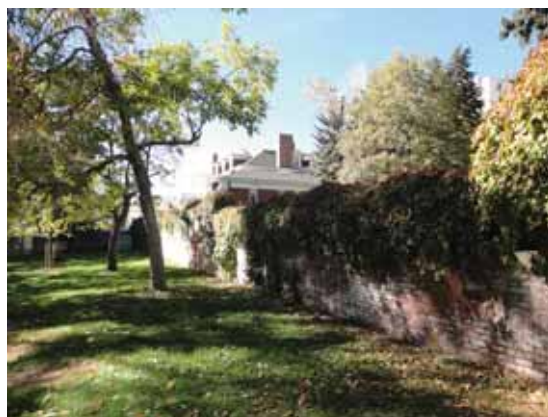
Fig. 2.1.A.68 Paint observed to be in an advanced state of deterioration at the brick perimeter wall between the east lawn of the Executive Residence and the Governor's park.

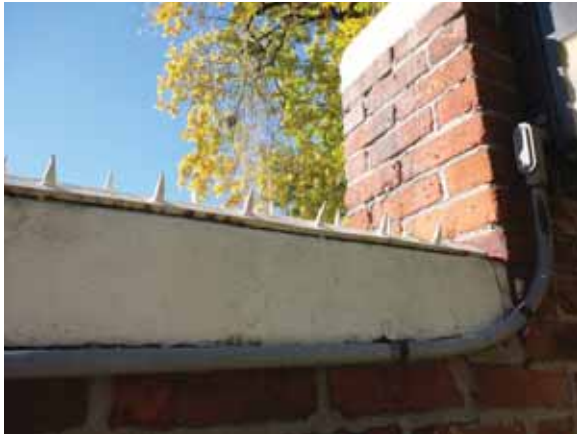
Fig. 2.1.A.69 Corrosion of the metal spikes observed along the top of the brick perimeter wall.

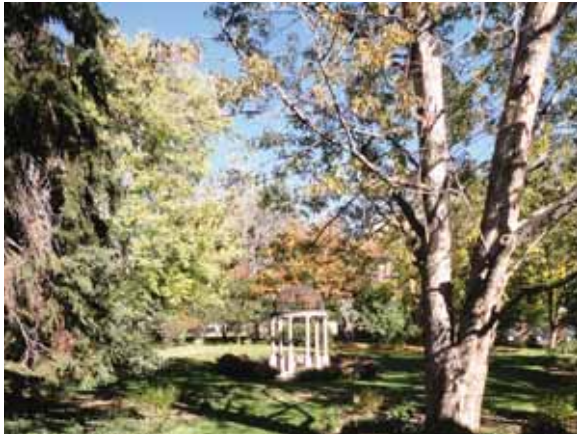
Fig. 2.1.A.70 The historic pergola on the northeast lawn is showing evidence of wear-and-tear.

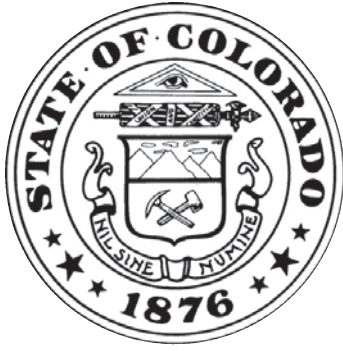
- Clean the soiled/stained areas of the paving and stairways throughout using an approved method. Move or readjust any irrigation lines that are currently saturating the site's walkways and stairways with water.

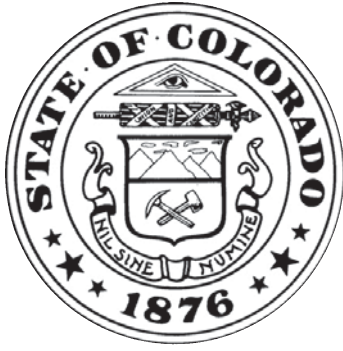
The 2003 edition of ICC/ANSI A117.1, Accessible and Usable Buildings and Facilities

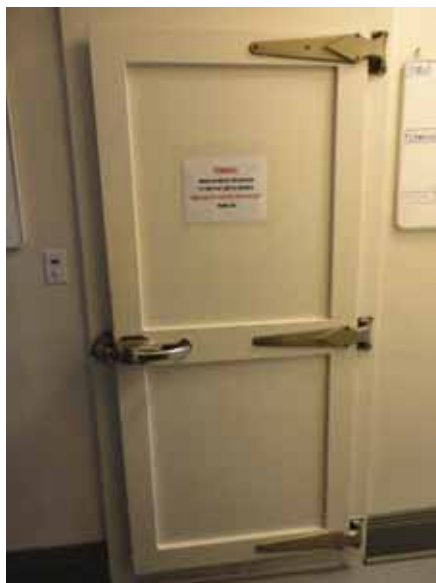
Fig. 2.1.B.1 Latching hardware observed on the historic walk-in refrigerator located south of the Kitchen on the east side of the First Floor.

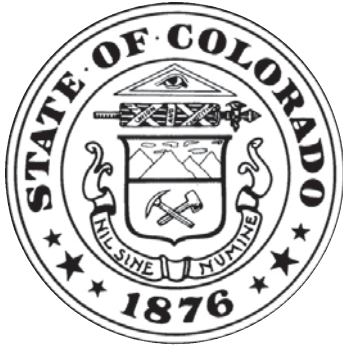
### **Fire Suppression Systems**
