CAPITOL COMPLEX MASTER PLAN  
FINDINGS & RECOMMENDATIONS (F & R) NEEDS ASSESSMENT  
EXECUTIVE RESIDENCE & CARRIAGE HOUSE, 400 EAST 8TH AVENUE (DENVER)

NOVEMBER 2014

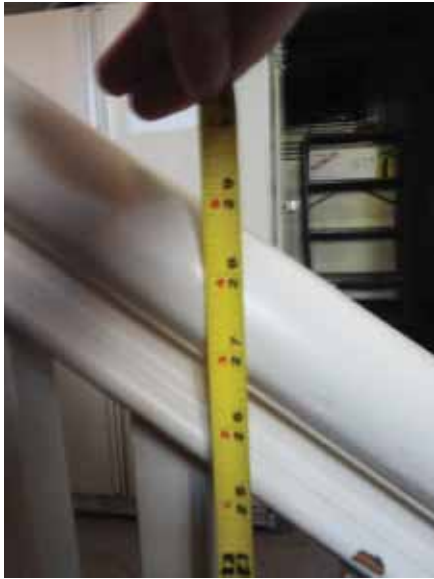
Fig. 2.1.B.2 The height to the top of the handrail measured above the stair tread nosing in the southeast interior exit stairway.

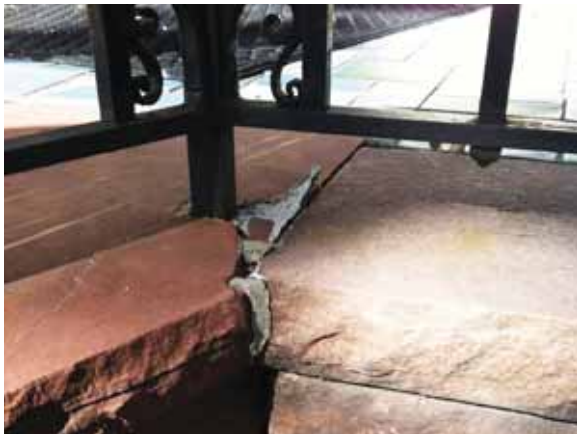
Fig. 2.1.B.3 Spalling and cracking paving at the patio on the southeast side of the First Floor Palm Room.

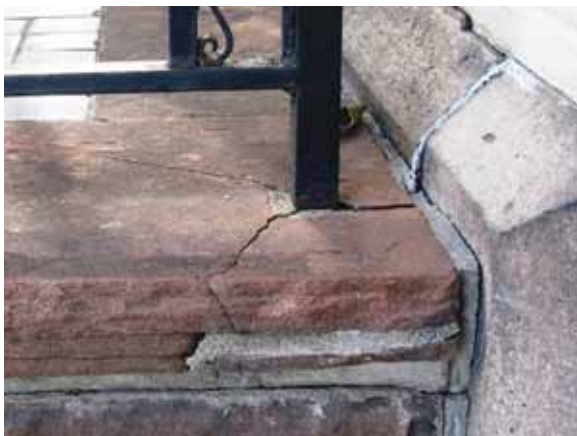
Fig. 2.1.B.4 Spalling and cracking paving at the patio on the southeast side of the First Floor Palm Room.

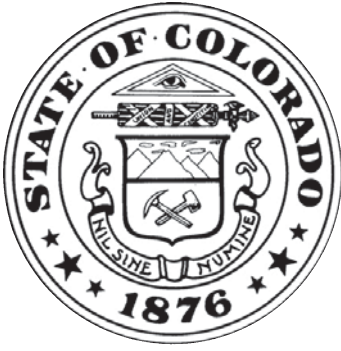
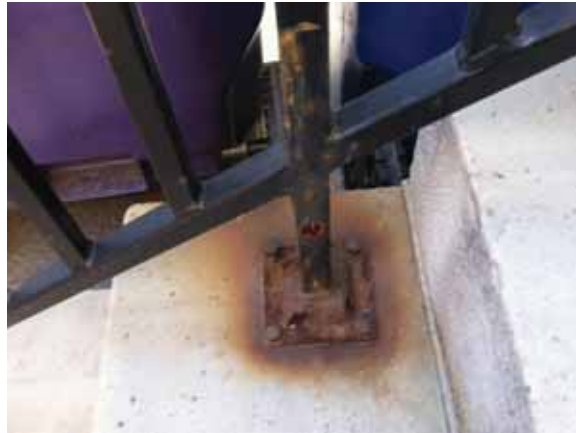
Fig. 2.1.B.5 Corroding railing posts at the exterior stairway of the southeast service entrance.

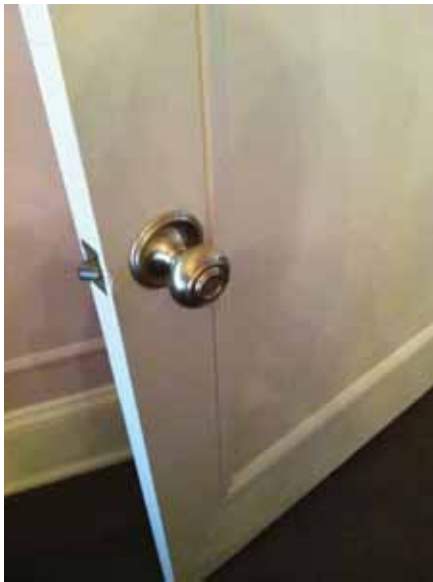
Fig. 2.1.B.6 Typical metal knob-style door handle found throughout the building.

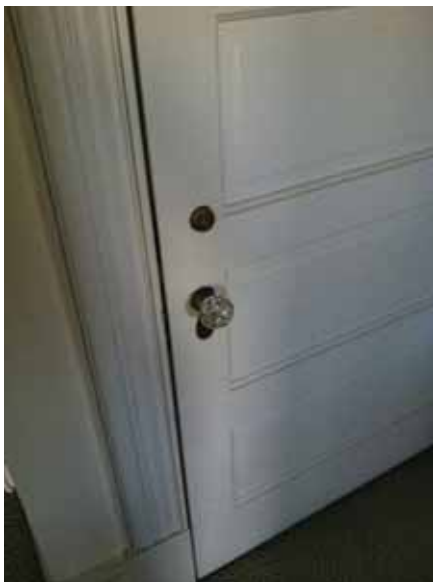
Fig. 2.1.B.7 Typical glass knob-style door handle found throughout the building.

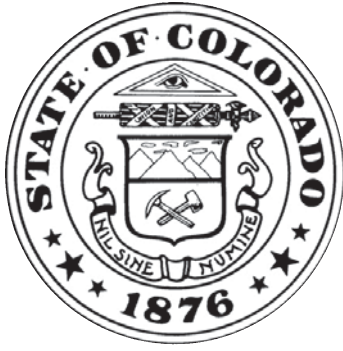
### **Recommendations:**

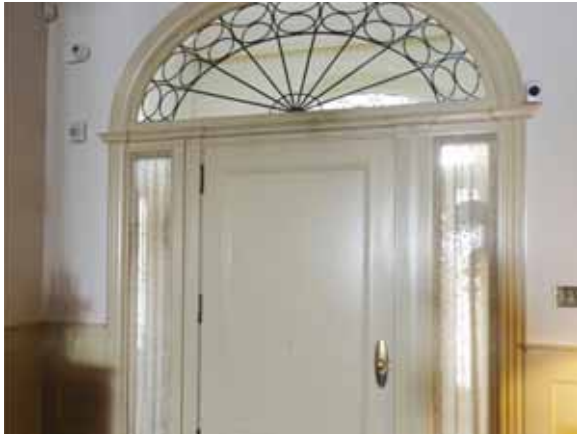
Fig. 2.1.B.8 Security alarms and detection devices observed on either side of the Front Door on the north side of the building at the First Floor.

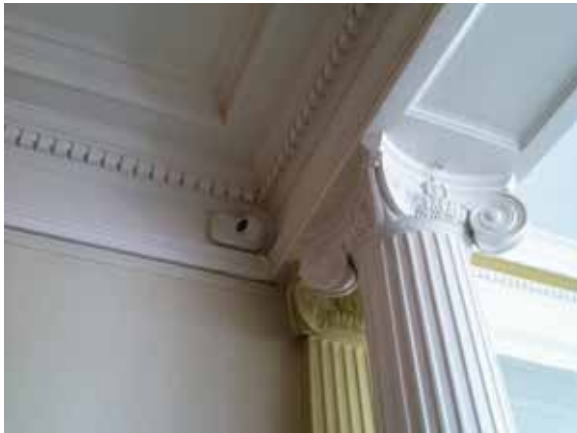
Fig. 2.1.B.9 A security camera observed in the Grand Hallway on the First Floor.

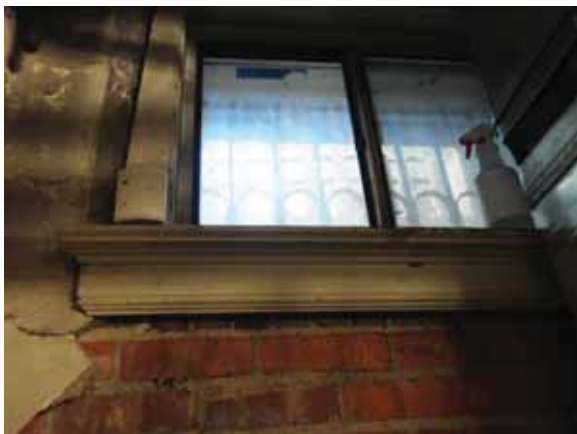
Fig. 2.1.B.10 A security device observed at a window along the east side of the Basement Floor.

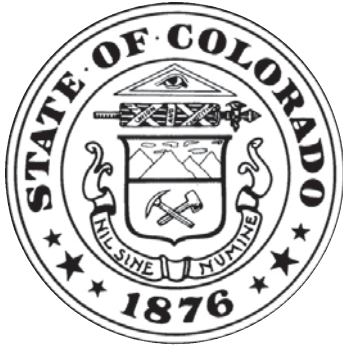
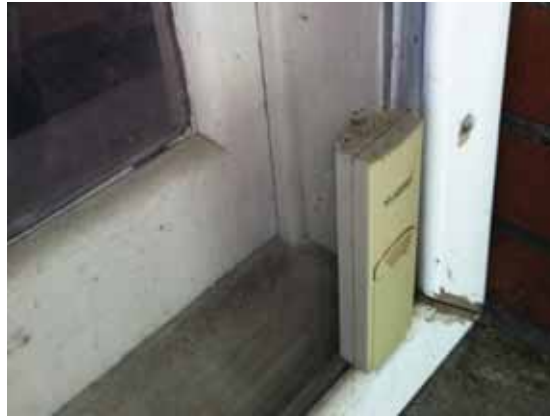
Fig. 2.1.B.11 A security device observed on the exterior side of a window.

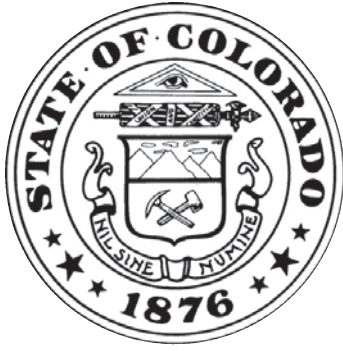
planned for the Executive Residence.

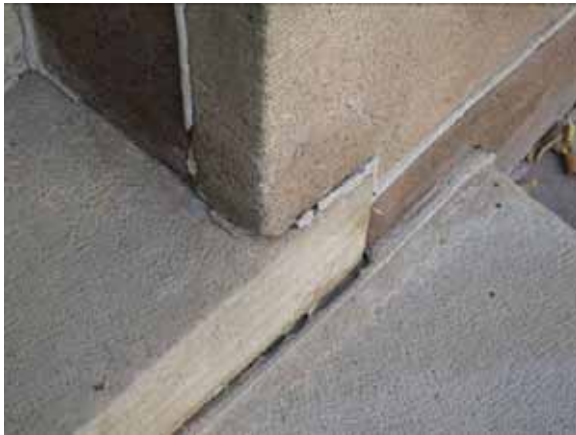
Mortar joints at the north side's main entry's stone blocks were failing (Fig. 2.2.A.1). Also, the western side of the stairs at the north entry appear to be settling away from the stone blocks (Fig. 2.2.A.1).

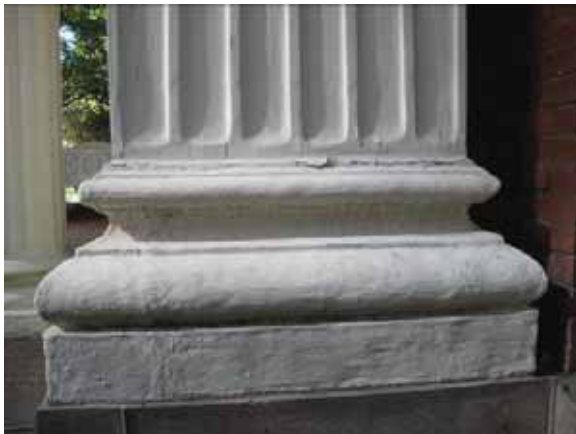
Although it is unknown if the exterior columns at the north side's main entry are entirely structural, or merely architectural wraps, there is some weathering and peeling of the coatings at the column bases (Fig. 2.2.A.2). These finishes are allowing water to penetrate into the substrate, and may be causing deterioration of the structure beyond.

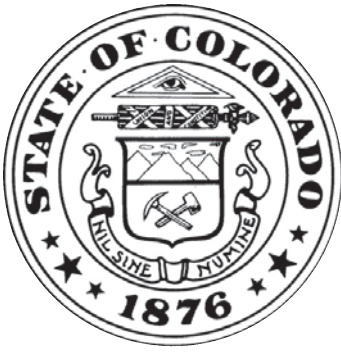
Portions of concrete at the building's western patio area appear to be failing, either by poor mix design, possible poor patching in the past, or freeze and thaw cycling (Fig. 2.2.A.3 and Fig. 2.2.A.4). At least one area was able to be powdered by finger-pressure abrading.

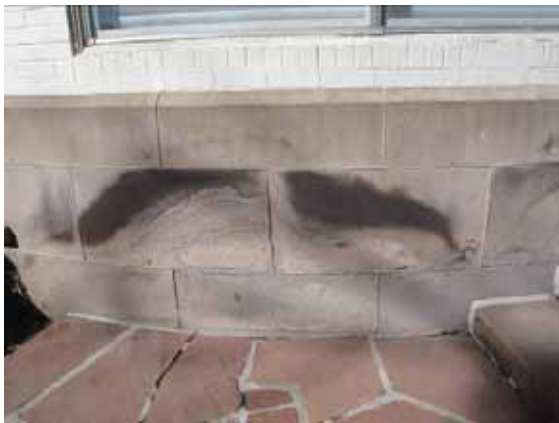
There was evidence of past water saturation of some concrete elements at the building's southern side, likely from an old irrigation system (Fig. 2.2.A.6). The concrete surface appeared brittle at the discolored region.

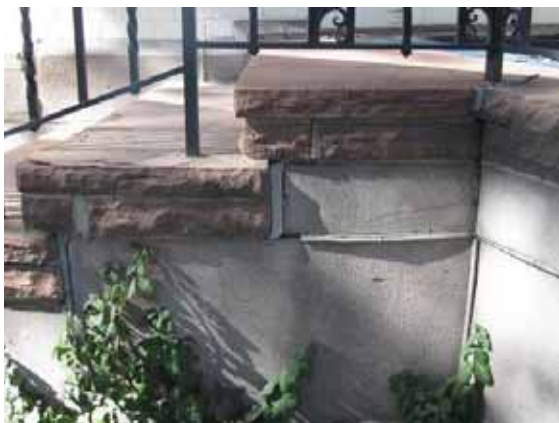
The concrete and pavers at the southeast patio area show evidence of possible soil movement and/or water damage from freeze and thaw cycling, particularly at mortar joints (Fig. 2.2.A.7 and Fig. 2.2.A.8).

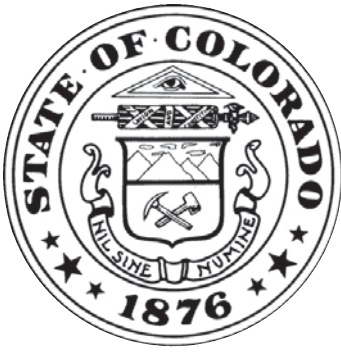
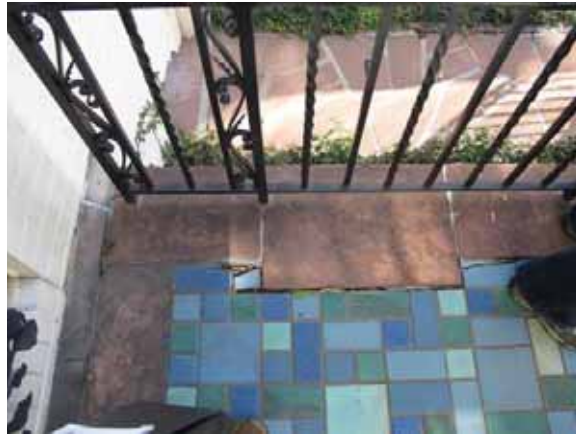
## 2.0 OVERALL BUILDING ASSESSMENT FINDINGS & RECOMMENDATIONS

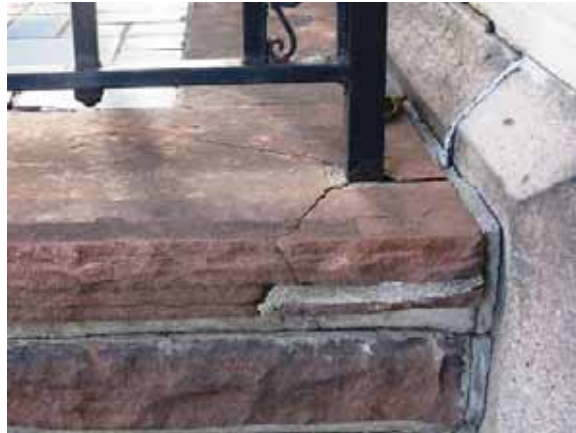
The guardrail anchorage at the southeast patio is also showing evidence of distress (Fig. 2.2.A.9).

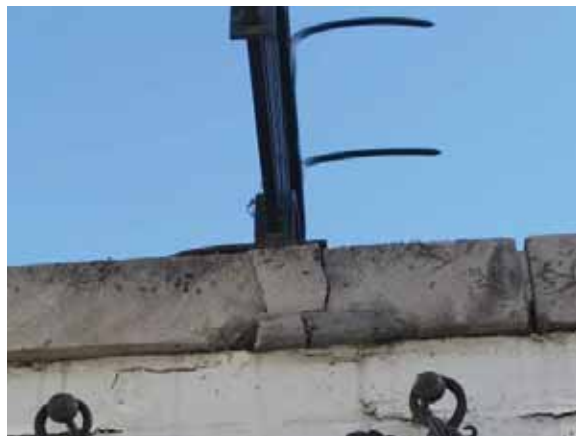
Anchorage of a steel security grill at a concrete block at the southeast patio corner appears to have failed (Fig. 2.2.A.10).

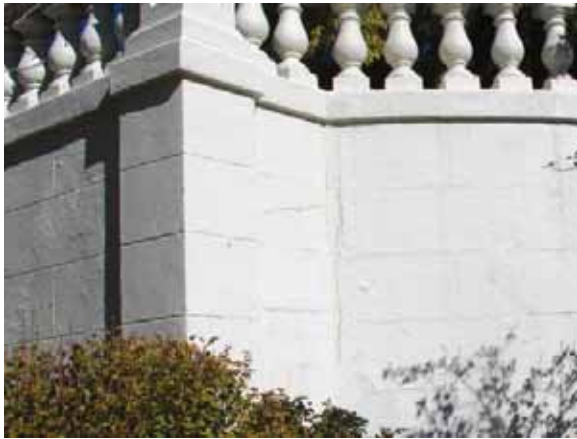
The radial concrete site retaining wall at the building's southern lawn has multiple cracks at its exterior face (Fig. 2.2.A.11 and Fig. 2.2.A.12). The cracks may be related to insufficient reinforcing quantity or spacing in the concrete, or unanticipated loading behind the wall due to surcharge loadings (such as water retention).

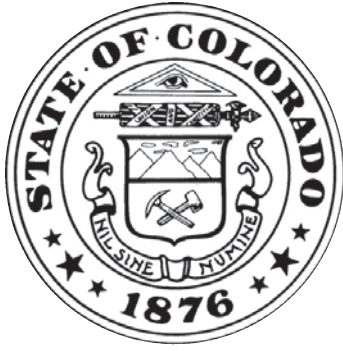
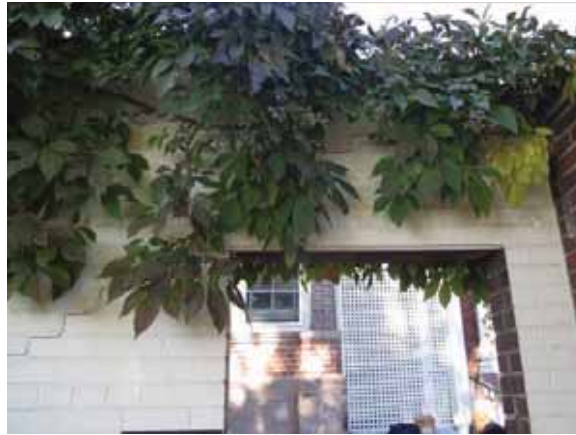
## 2.0 OVERALL BUILDING ASSESSMENT FINDINGS & RECOMMENDATIONS

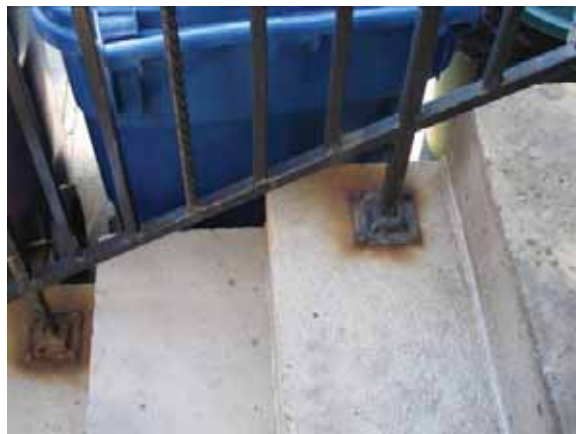
Anchorage of a guardrail at the building's eastern side is corroding (Fig. 2.2.A.15).

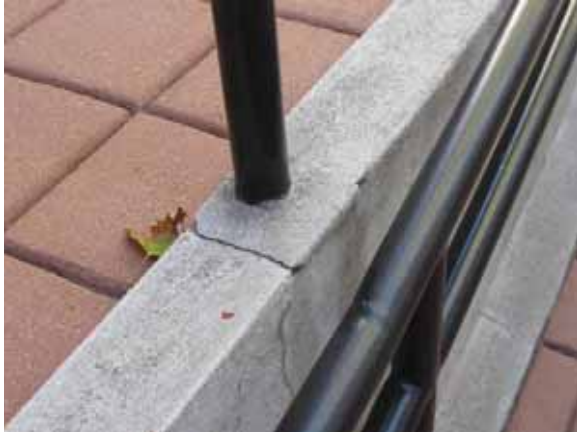
The guardrail anchorage at the entry ramp at the building's eastern side appear to utilize a embedded steel plate with minimal concrete cover. The concrete covering these anchorage points is spalling and falling away, providing a potential catch point for water (Fig. 2.2.A.16).

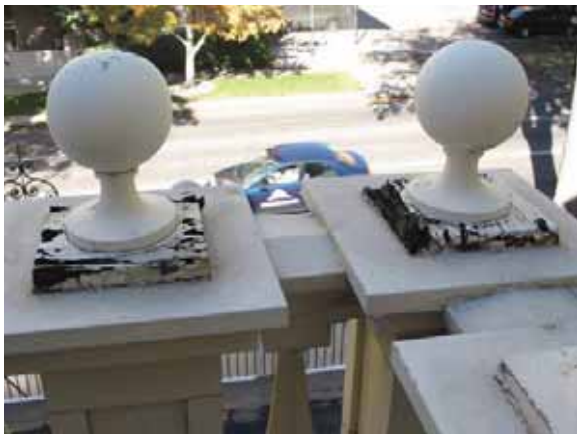
Decorative wooden rail elements at the northern awning, accessible from the second floor, are deteriorating, likely from water penetration (Fig. 2.2.A.17).

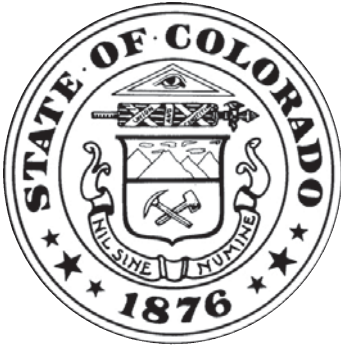
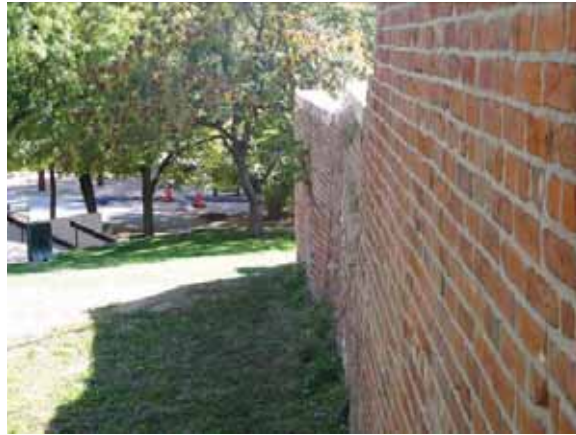
## 2.0 OVERALL BUILDING ASSESSMENT FINDINGS & RECOMMENDATIONS

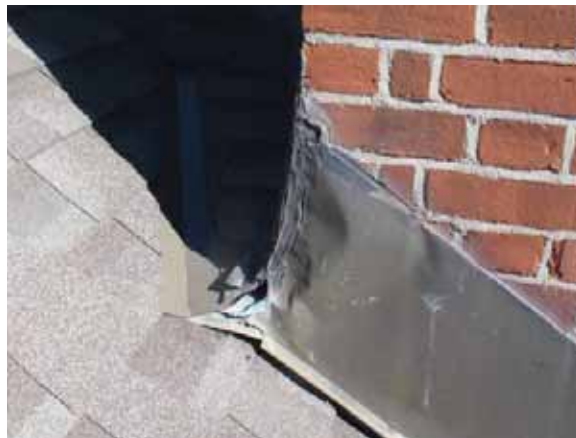
Some flashing and sealant failures were observed at the roof (Fig. 2.2.A.20).

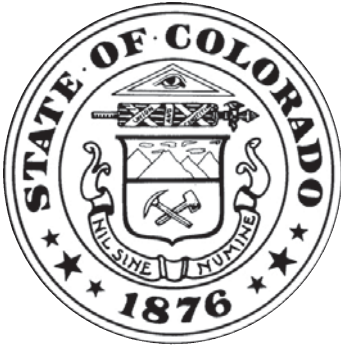
### 2.2-B BUILDING INTERIOR

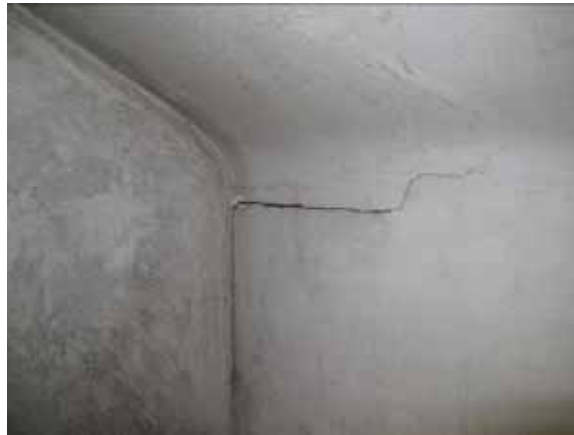
The upper floor has some cracking of plaster and lath finishes, typically at reentrant corners of dormer windows and roof hip lines (Fig. 2.2.B.1).

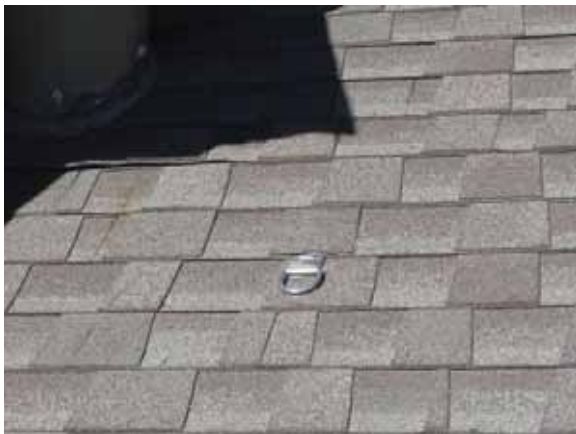
The main roof has some permanent fall protection anchorage installed (Fig. 2.2.C.1), however, it appeared there were not sufficient anchorage points to access the entire roof. No anchorage points were observable at the uppermost flat roof portion.

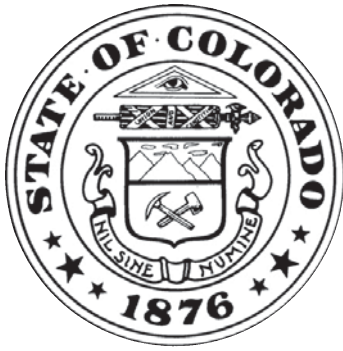
protection anchors already installed on the upper roof, but an access plan should be prepared and provided to any personnel accessing these roofs. Alternatively, parapets should be at least 42 inches tall for access near the exposed edges to meet current safety codes.

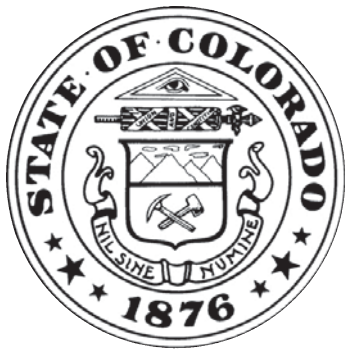
## 2.0 OVERALL BUILDING ASSESSMENT FINDINGS & RECOMMENDATIONS

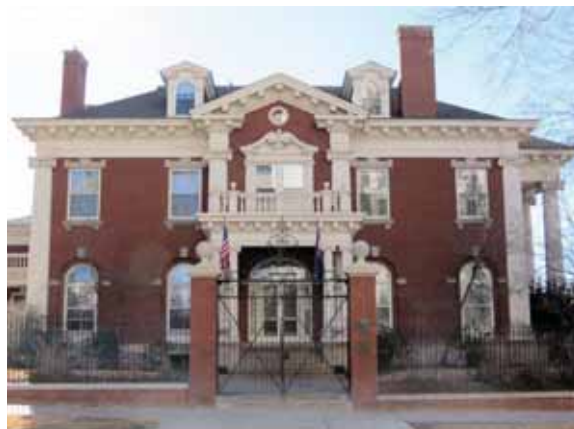
Figure 2.3.A.1 – Colorado Executive Building North Entrance

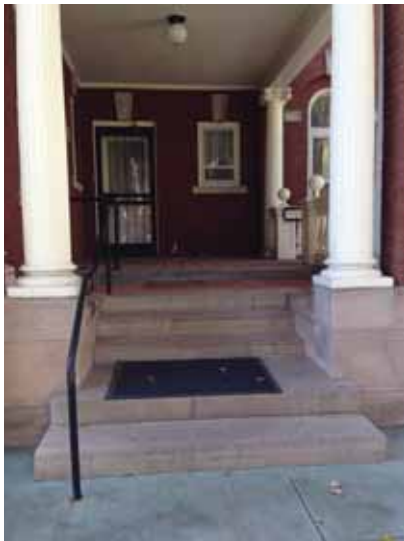
Figure 2.3.A.2 – Building East Entrance

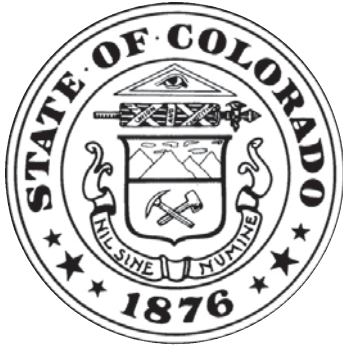
The site is located in the Denver Storm Drainage Master Plan Basin 4600-02 (Cherry Creek Mall). This basin consists of 4.58 square miles and conveys the 2, 5, and 100-year storm event via both storm sewer and roadway conveyance. Runoff from the major basin is conveyed westerly to Cherry Creek, ultimately discharging to the South Platte River. Within this basin, storm sewer facilities typically are designed to convey the 5-year rainfall event at a minimum and it is assumed the same for this area of the city.

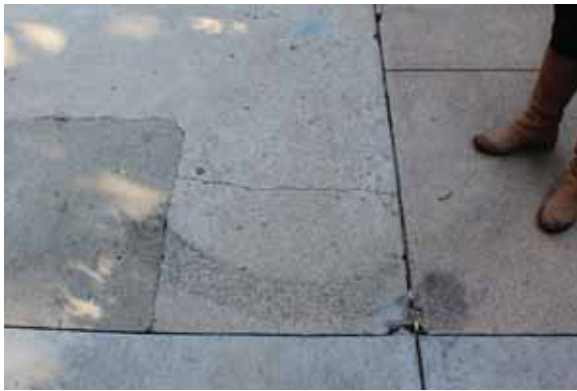
Figure 2.3.A.4 – Site Concrete Crack

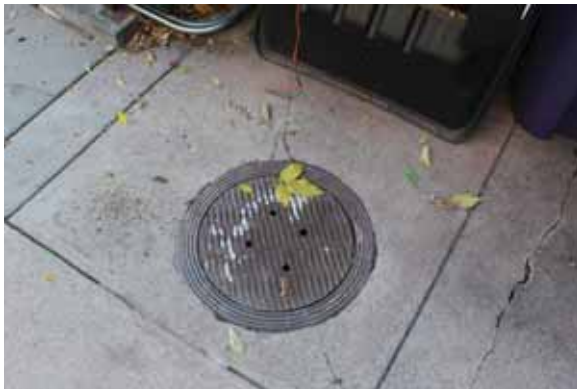
Figure 2.3.A.5 – Site Concrete Crack

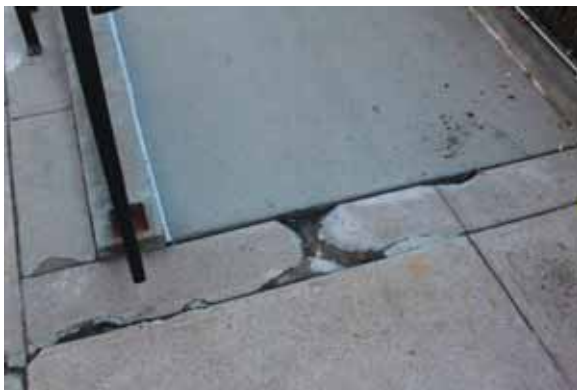
Figure 2.3.A.6 – Broken Site Concrete, Recommended for Replacement

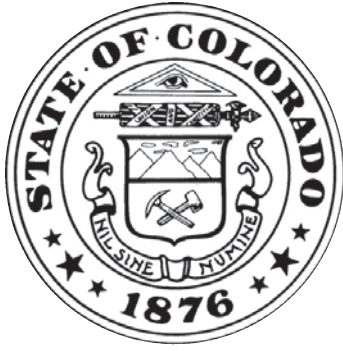
### Recommendations:

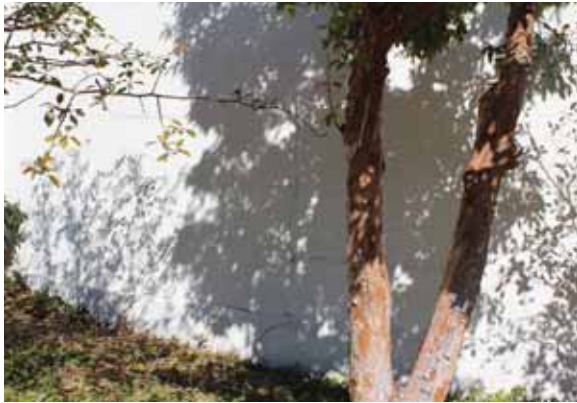
Figure 2.3.B.1 – Retaining Wall Cracking

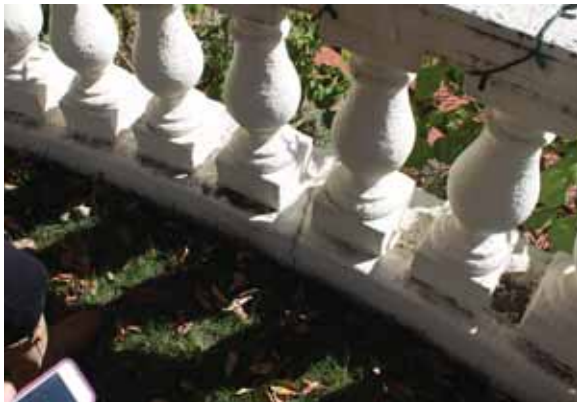
Figure 2.3.B.2 – Retaining Wall Cracking

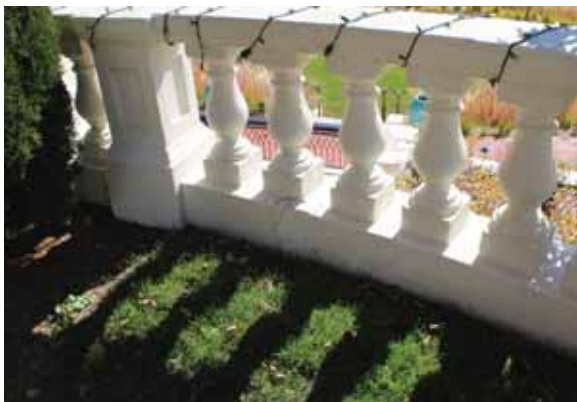
Figure 2.3.B.3 – Retaining Wall Cracking

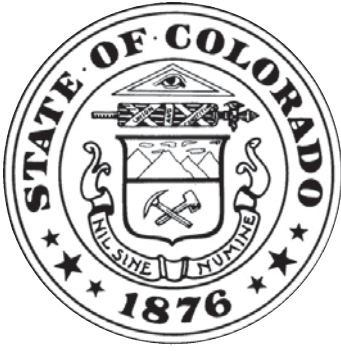
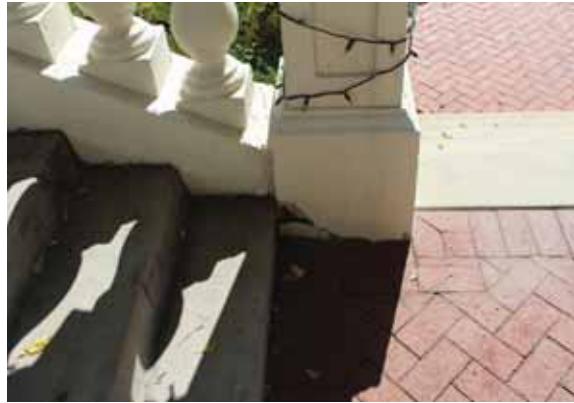
Figure 2.3.B.4 – Broken  
Pillar Base

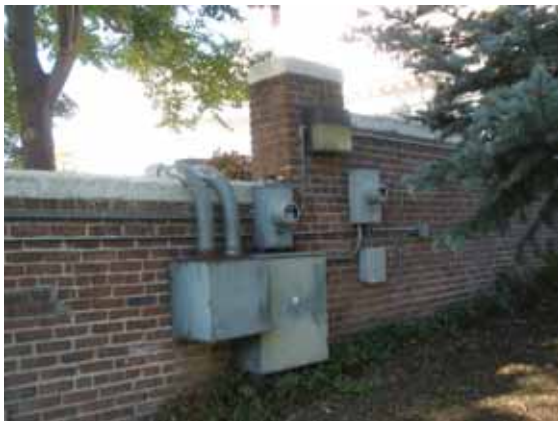
Fig. 2.4.A.2 – Utility meters

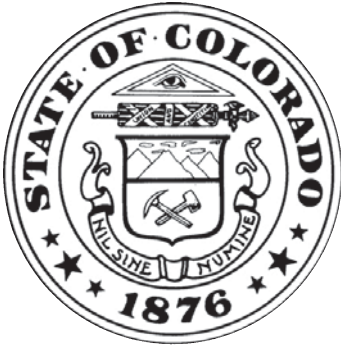
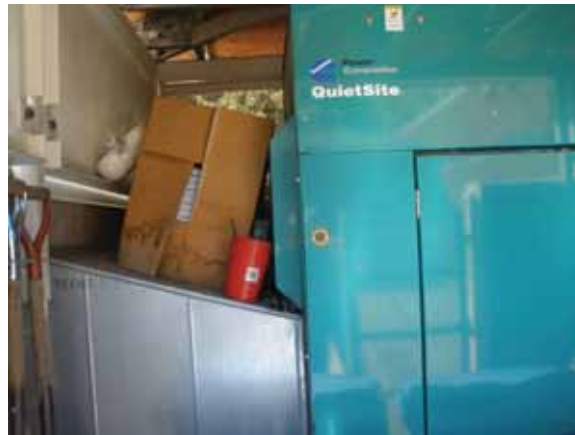
Fig. 2.4.A.3 – Emergency generator

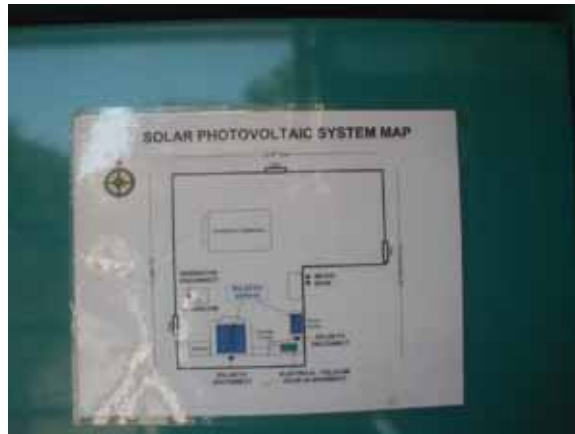
Fig. 2.4.A.4 – Photovoltaic system map

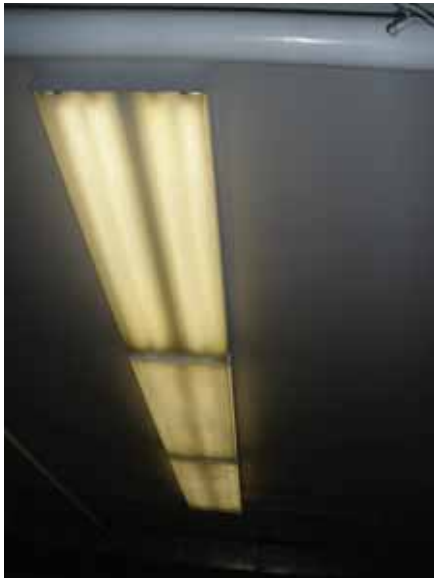
Fig. 2.4.A.5 – Linear fluorescent luminaire

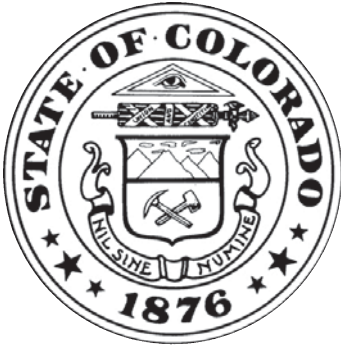
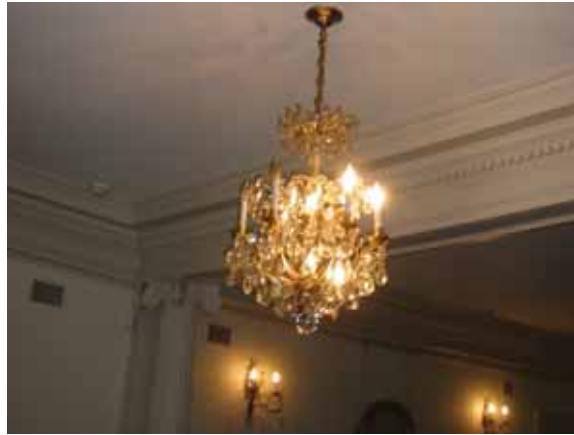
Fig. 2.4.A.7 – Historic chandelier

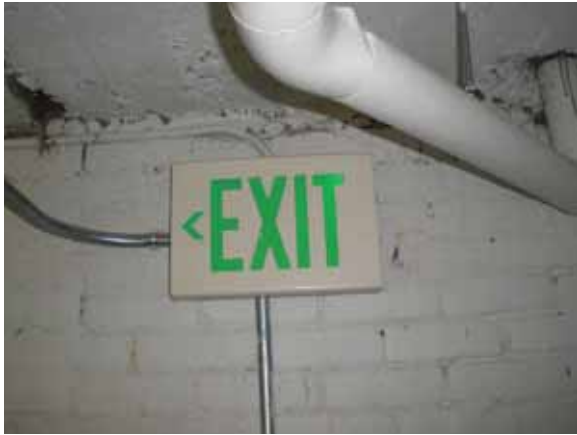
Fig. 2.4.A.10 – Exit sign

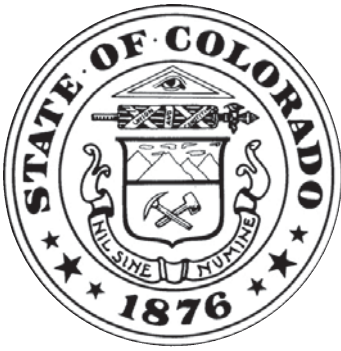
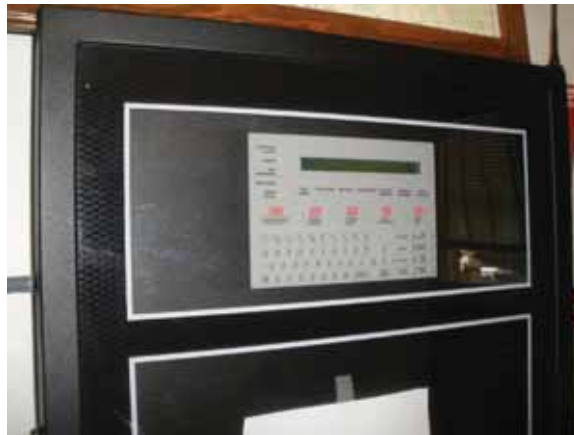
Fig. 2.4.A.12 – Fire alarm control panel

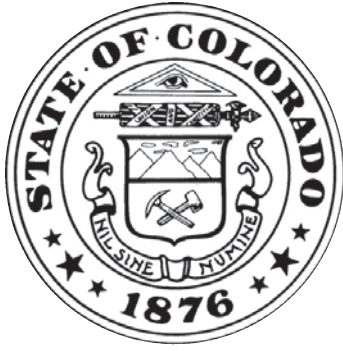
Perimeter zones of the building are provided with hot water baseboard for heating (see Fig. 2.4.A.25). The condition of the baseboard heaters appeared to be satisfactory. A small kitchenette is provided on the second floor which has a residential cooking stove; dishwasher and refrigerator (see Fig. 2.4.A.26). No hood is provided for the cooking stove.

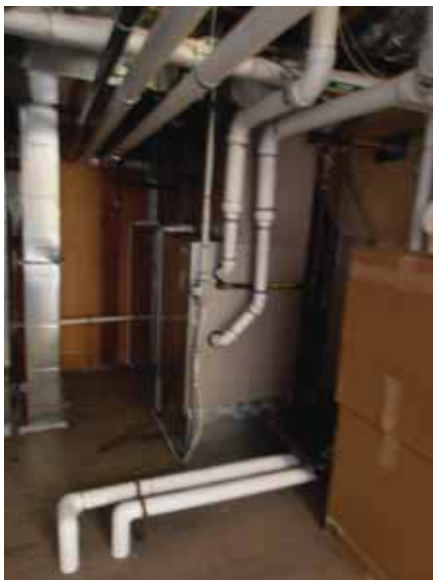
Fig. 2.4.A.19 – Furnace in attic

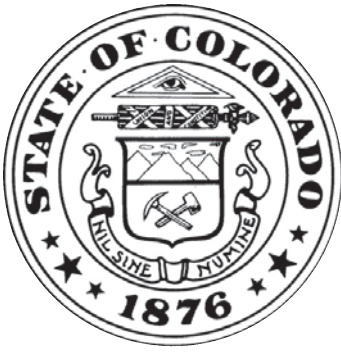
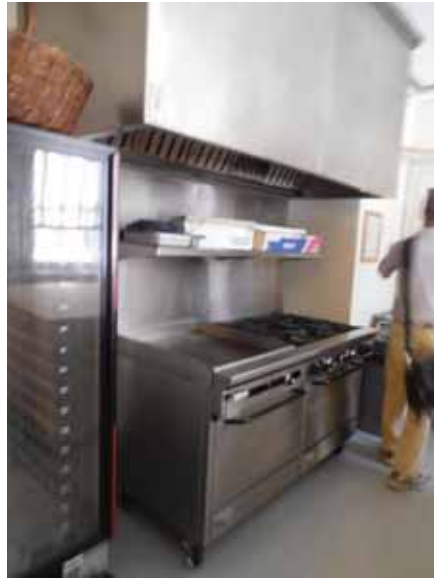
Fig. 2.4.A.20 – Kitchen exhaust hood

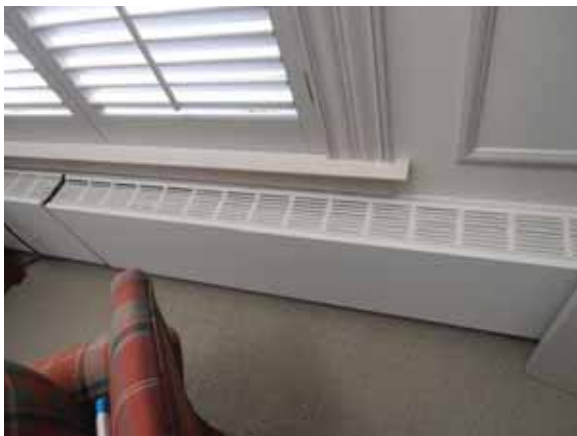
Fig. 2.4.A.25 – Baseboard radiation

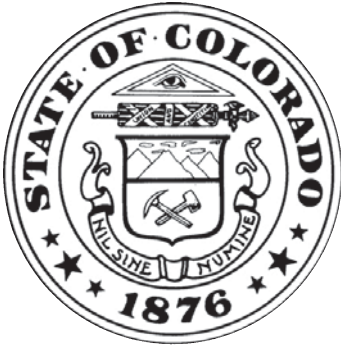
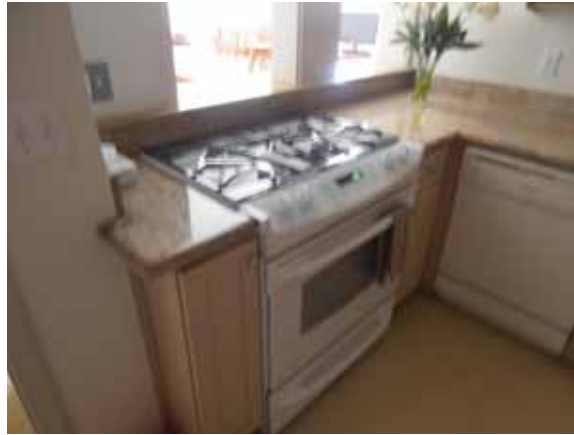
Fig. 2.4.A.26 – Residential stove and dishwasher

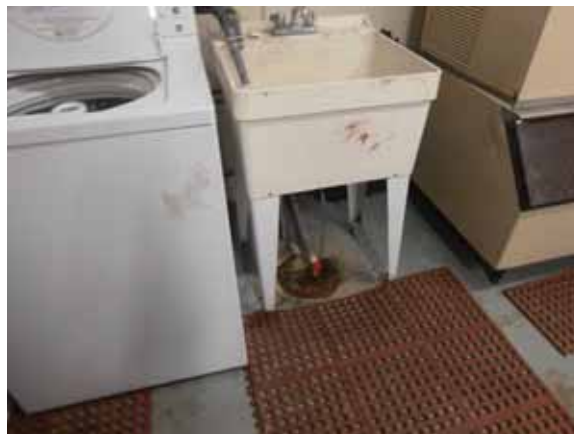
Fig. 2.4.A.28 – Floor drain cover rusted

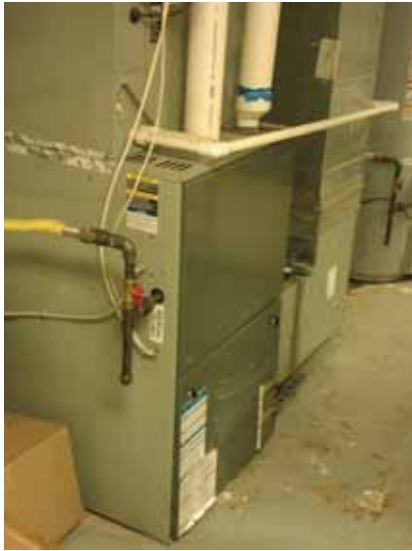
Fig. 2.4.A.29 – Furnace

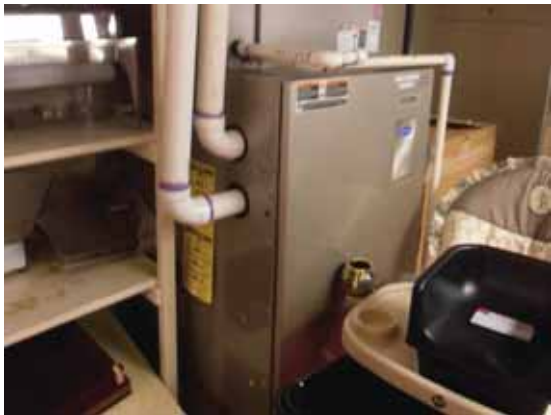
Fig. 2.4.A.31 – Equipment storage around furnace

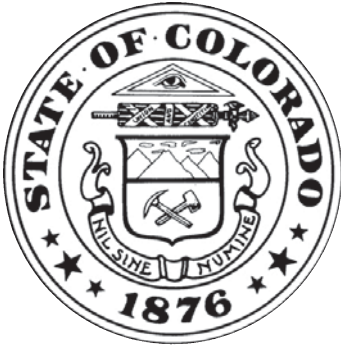
### Recommendations:

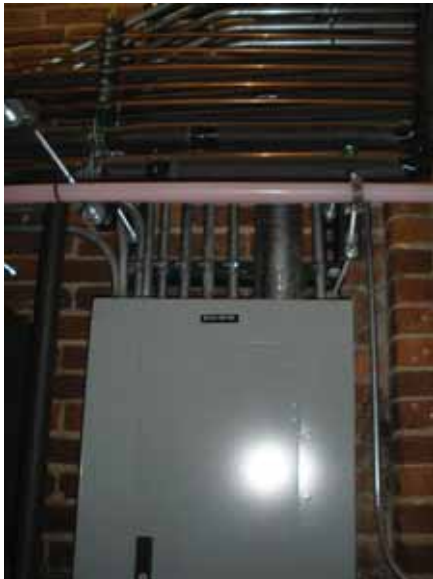
Fig. 2.4.B.3 – Water and coolant lines above panel

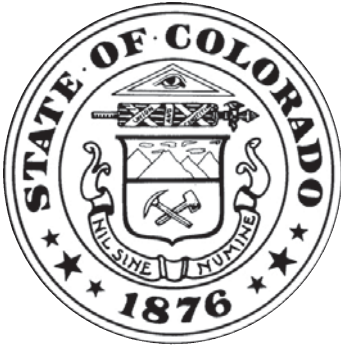
### 2.4-C PLANNED AND ON-GOING PROJECTS

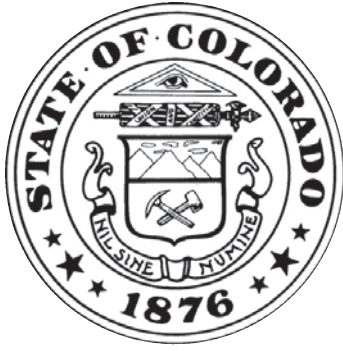
installed on each floor and should be vertically stacked floor-to-floor, if possible. Facilities with larger floor plates may require a 2nd IDF closet per floor.

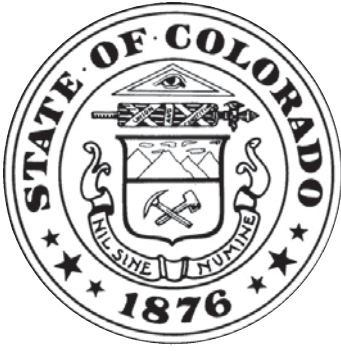
### 2.5-B CODE ISSUES

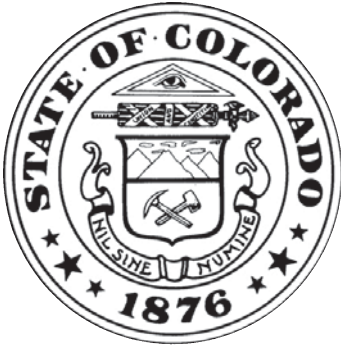
as a specification, but rather as an outline to provide information on recommended security systems technology and design criteria.

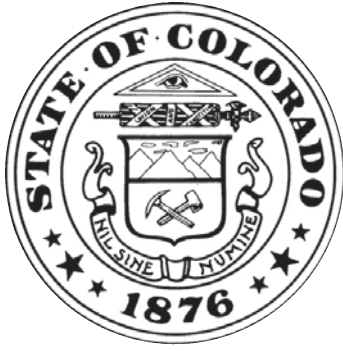
Electronic security systems provided for the Executive Residence and Carriage House shall be an extension of existing State facility security system infrastructure, as appropriate. It is generally recommended that the facilities be provided with electronic security applications and equipment as listed below:

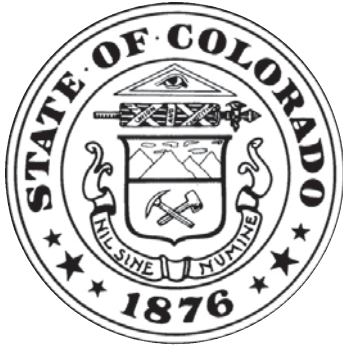
### 2.6-B CODE ISSUES

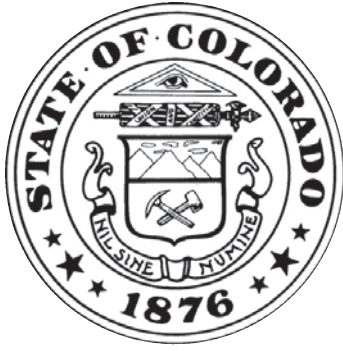
### 3.0 FLOOR-BY-FLOOR ASSESSMENT FINDINGS AND RECOMENDATIONS

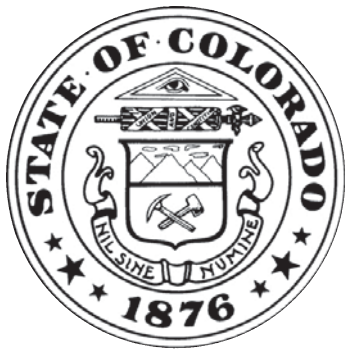
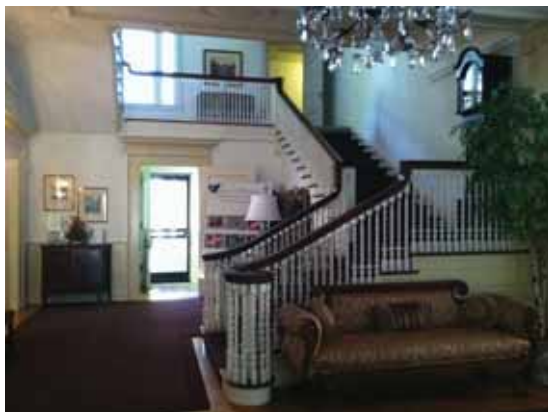
View of the Grand Stairway

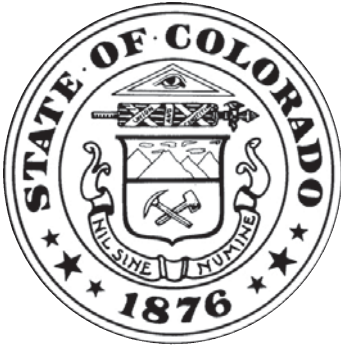
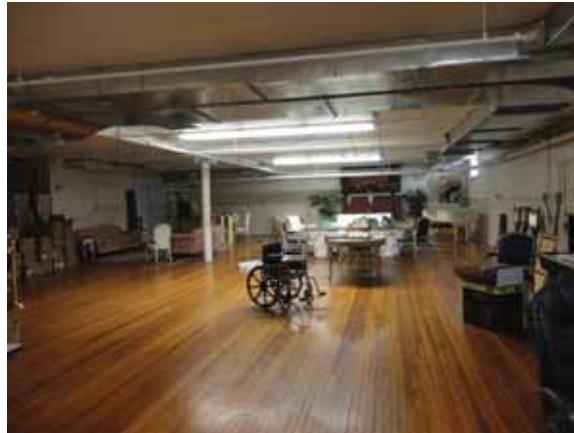
View of the Ballroom in the basement

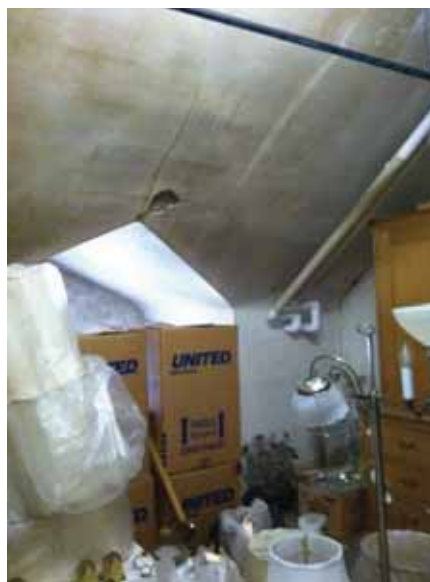
Fig. 3.0.C.1 Water damage and spalling observed at the ceilings throughout the attic storage space on the Third Floor.

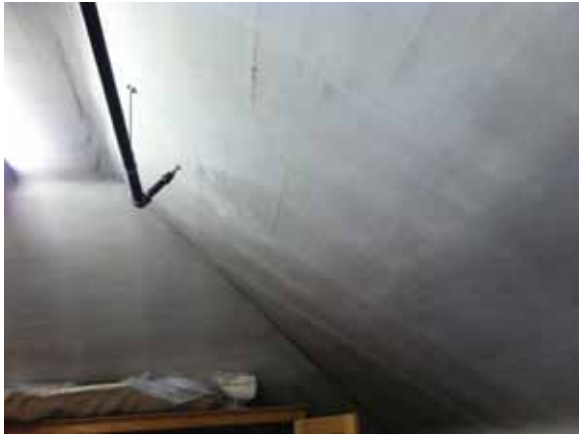
Fig. 3.0.C.2 Water damage and cracking observed at the ceilings throughout the attic storage space on the Third Floor.

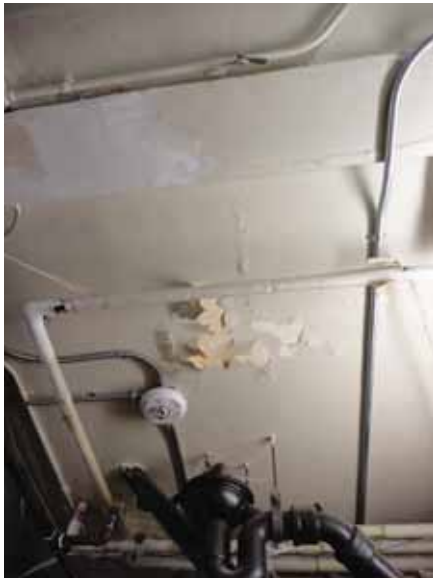
Fig. 3.0.C.3 Peeling paint observed at the ceiling on the Basement Floor.

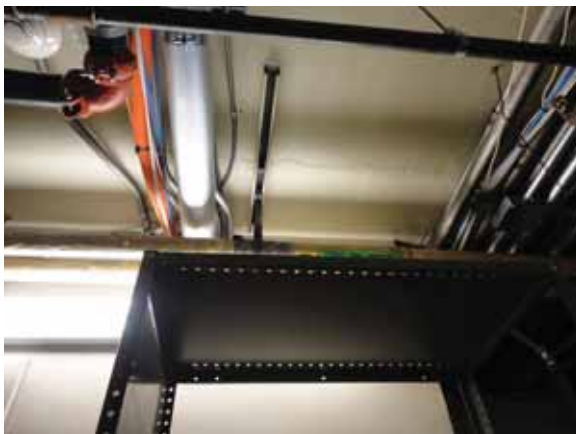
Fig. 3.0.C.4 Cracking observed at the ceiling on the Basement Floor.

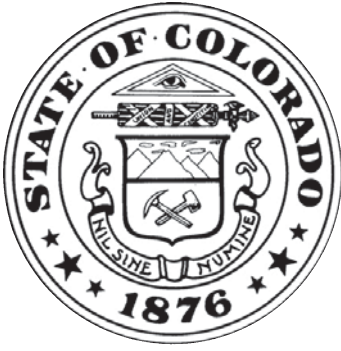
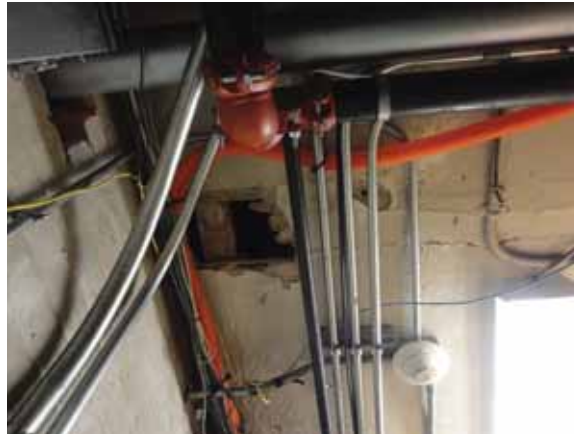
Fig. 3.0.C.5 Damage observed at areas of the plaster and wood lath ceiling on the Basement Floor.

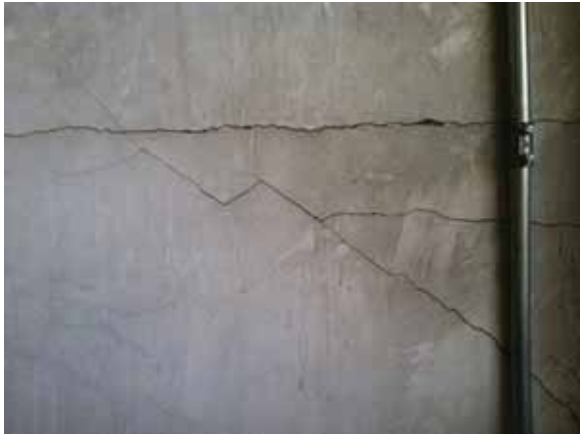
Fig. 3.0.C.6 Widespread areas of water damage, cracking, and spalling observed at the walls throughout the attic storage space on the Third Floor.

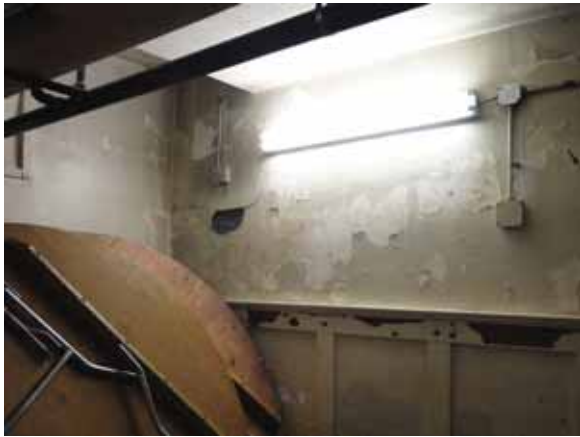
Fig. 3.0.C.7 Peeling paint and cracking noted at a wall of the storage space located on the north side of the Basement Floor.

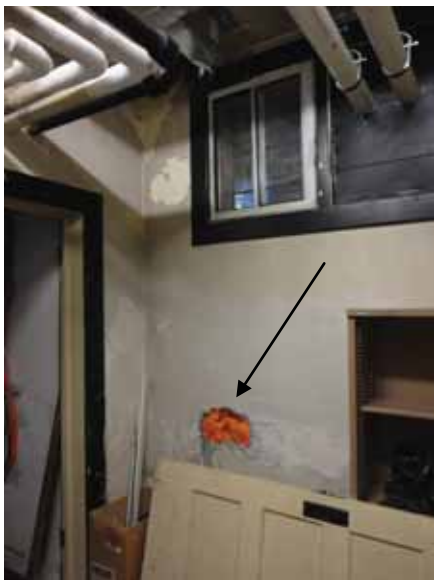
Fig. 3.0.C.8 Damage noted along the south wall of the building in the Mechanical Room on the east end of the south side of the Basement Floor.

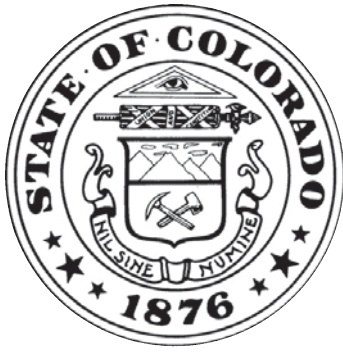
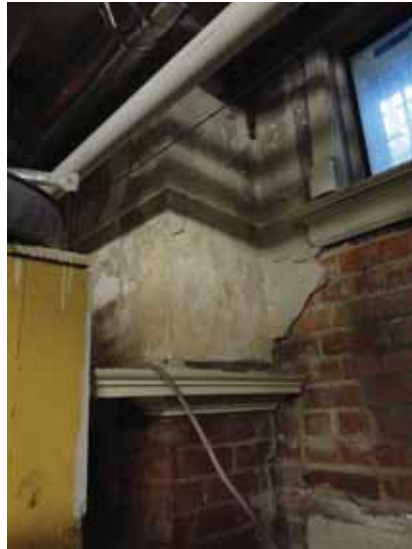
Fig. 3.0.C.9 Wall coating observed to be cracking off of the east wall under a window in the Furnace Room at the northeast corner of the Basement Floor.

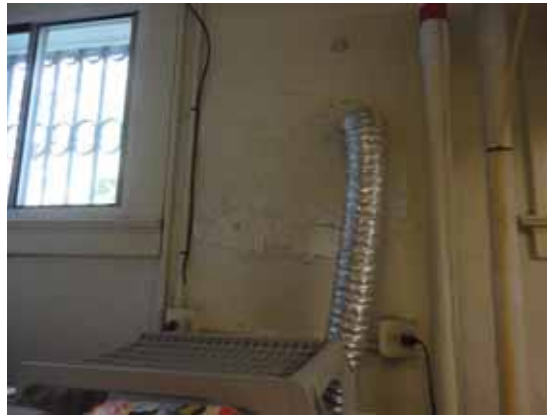
Fig. 3.0.C.10 Damage observed at the east wall and south of the window in the Basement Floor Laundry Room.

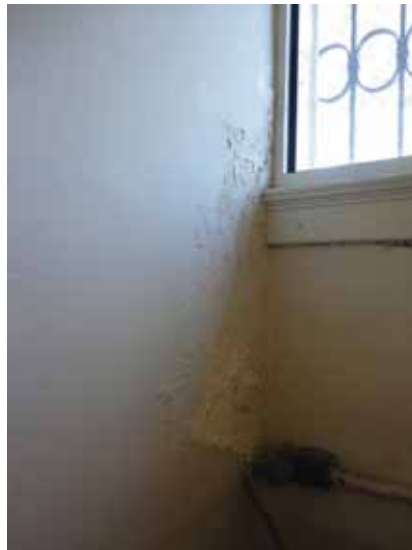
Fig. 3.0.C.11 Damage observed at the east wall and north of the window in the Basement Floor Laundry Room.

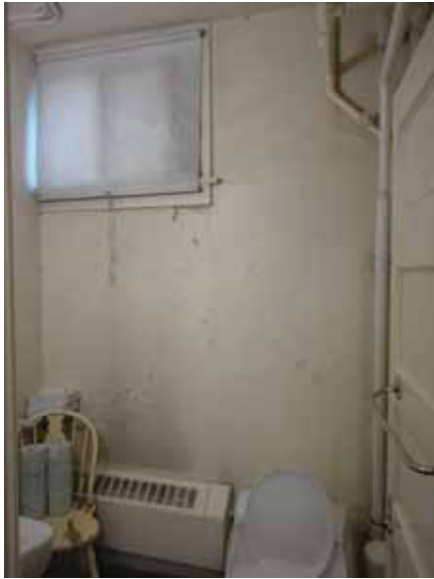
Fig. 3.0.C.12 Damage observed at the east wall of the window in the restroom located north of the Laundry Room on the Basement Floor.

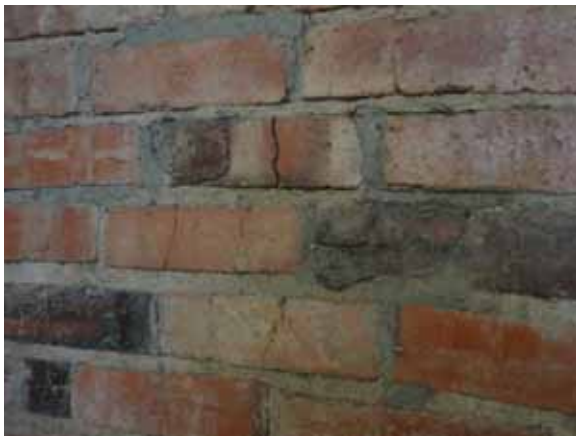
Fig. 3.0.C.13 Deterioration and cracking noted at the brick wall in the southeast stairway at the Basement Floor.

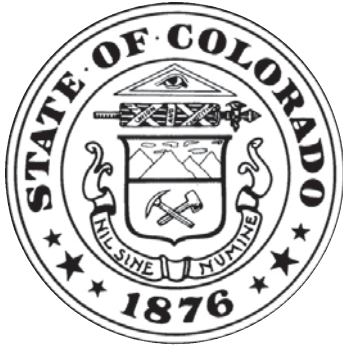
Office, and Governor's Spouse's Home Office were observed to be in fair condition overall with general wear-and-tear and areas of deterioration and warping noted (see Fig. 3.0.C.18, Fig. 3.0.C.19, and Fig. 3.0.C.20).

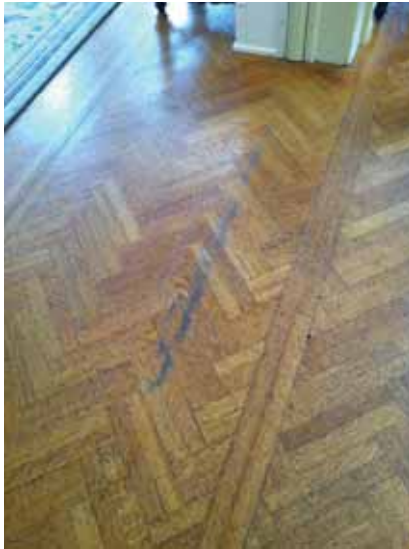
Fig. 3.0.C.14 Worn and soiled wood floors observed throughout the First Floor.

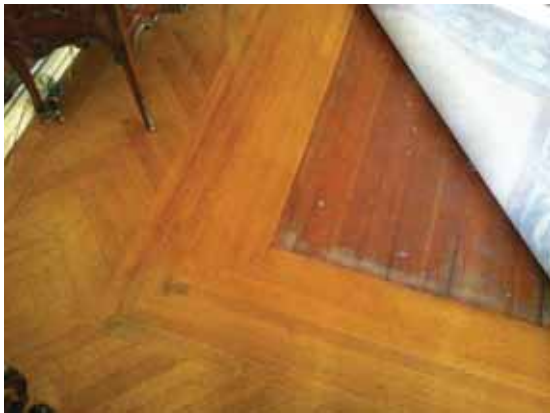
Fig. 3.0.C.15 Scuffed and soiled wood floors observed on the First Floor with areas of the flooring finish worn down to the bare wood.

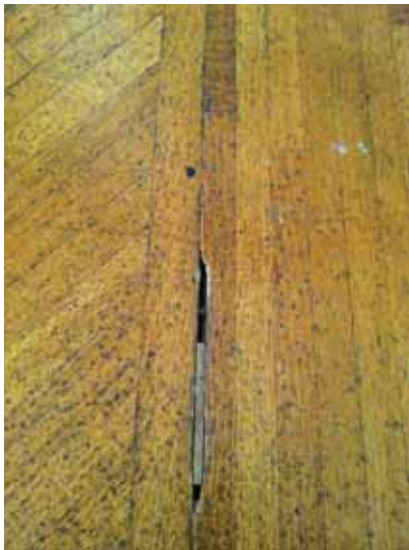
Fig. 3.0.C.16 Damaged sections of the wood floors observed throughout the First Floor.
