CAPITOL COMPLEX MASTER PLAN  
FINDINGS & RECOMMENDATIONS (F & R) NEEDS ASSESSMENT  
EXECUTIVE RESIDENCE & CARRIAGE HOUSE, 400 EAST 8TH AVENUE (DENVER)

NOVEMBER 2014

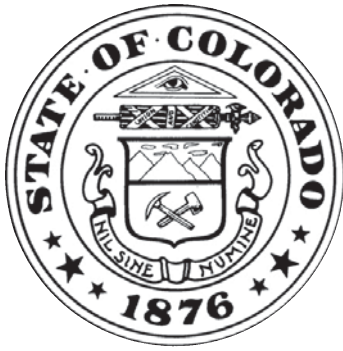
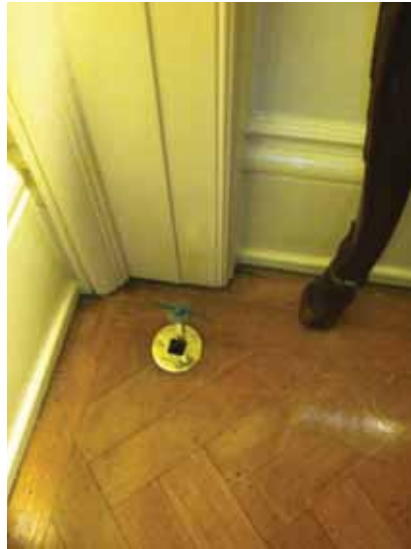
Fig. 3.0.C.17 A metal valve, or control, noted to be projecting above the floor of the Family Game Room/Bar in the northeast corner of the First Floor and creating a potential tripping hazard.

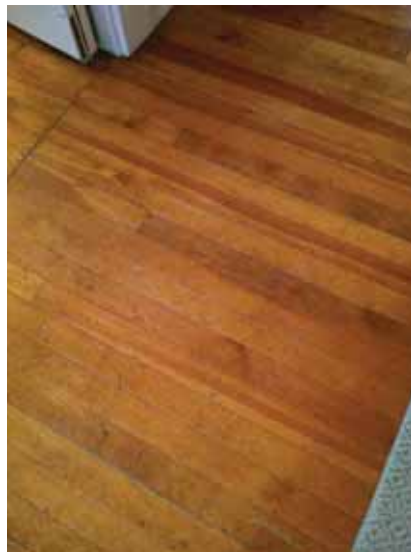
Fig. 3.0.C.18 General wear-and-tear noted at the wood floors in the Living Room on the Second Floor.

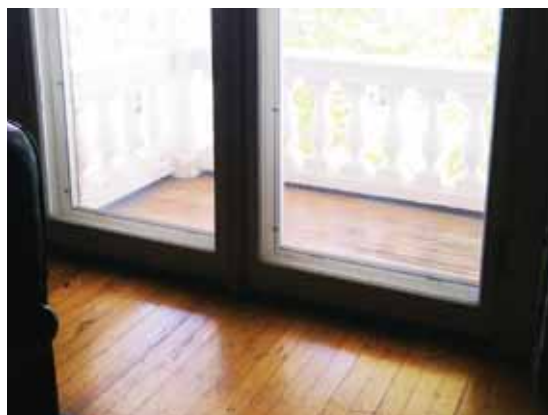
Fig. 3.0.C.19 Wood floors observed to be generally worn and warping in the Governor's Home Office on the Second Floor.

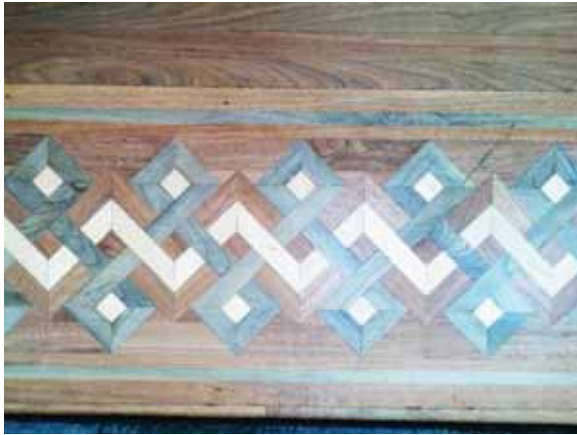
Fig. 3.0.C.20 General wear-and-tear observed at the wood floors in the Governor's Spouse's Home Office on the Second Floor.

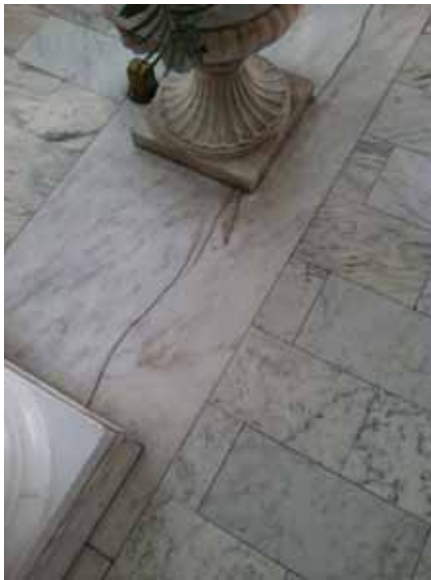
Fig. 3.0.C.21 Areas of cracked and deteriorating marble flooring observed in the Palm Room on the south side of the First Floor.

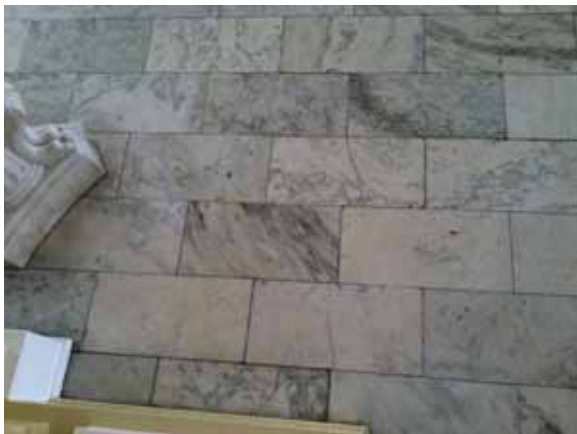
Fig. 3.0.C.22 Areas of cracked, deteriorating, and soiled marble flooring observed in the Palm Room on the south side of the First Floor.

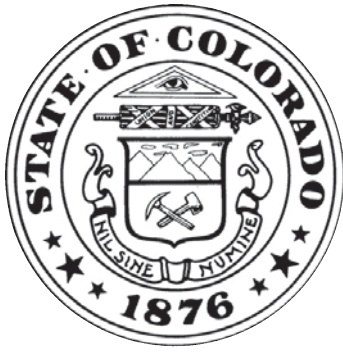
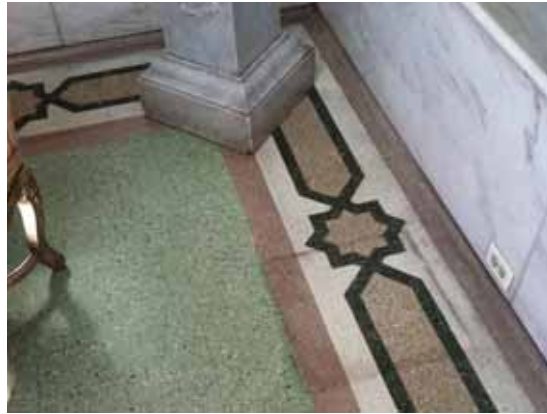
Fig. 3.0.C.23 Area of soiled terrazzo flooring observed in the Well Room at the southwest corner of the First Floor.

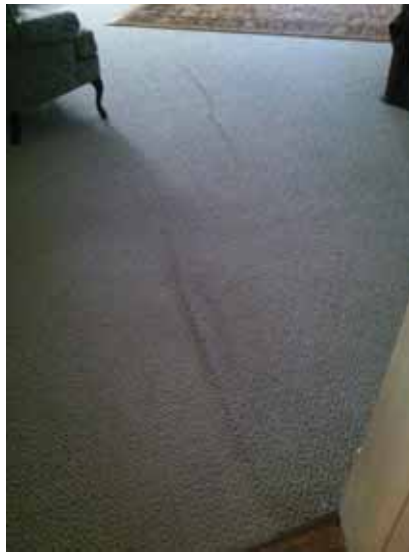
Fig. 3.0.C.24 Typical instance of carpet observed to be pulling loose and bunching, creating a potential tripping hazard, throughout the personal living quarters.

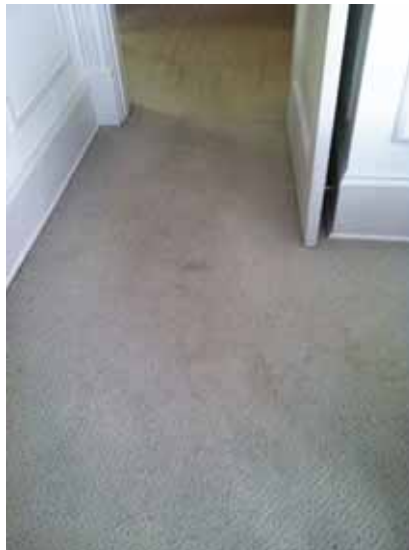
Fig. 3.0.C.25 Typical instance of soiled and worn carpet observed throughout the personal living quarters.

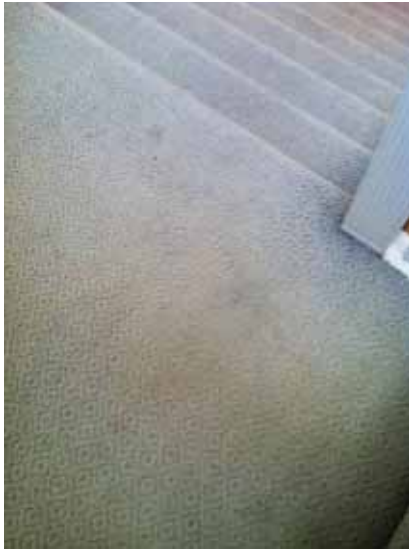
Fig. 3.0.C.26 Typical instance of soiled and worn carpet observed on the Grand Stairway.

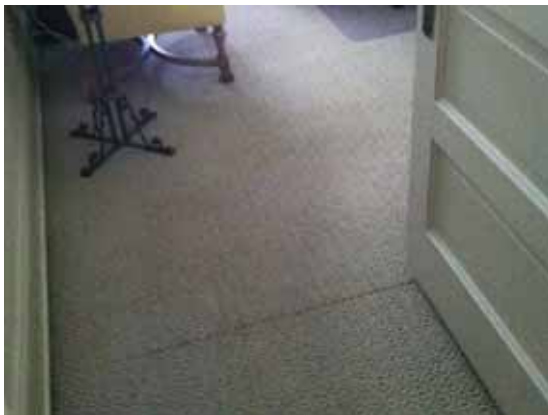
Fig. 3.0.C.27 Typical instance of deteriorating carpet pulling loose at the seams observed throughout the personnel office spaces on the east side of the building between the First and Second Floors.

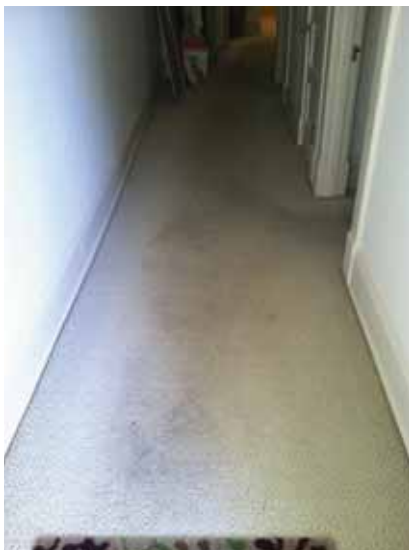
Fig. 3.0.C.28 Typical instance of soiled and worn carpet observed throughout the personnel office spaces on the east side of the building between the First and Second Floors.

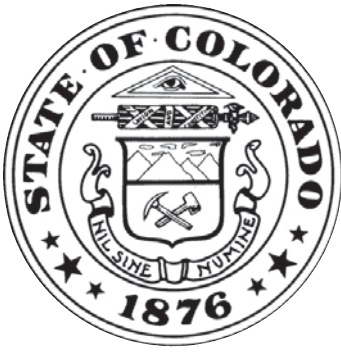
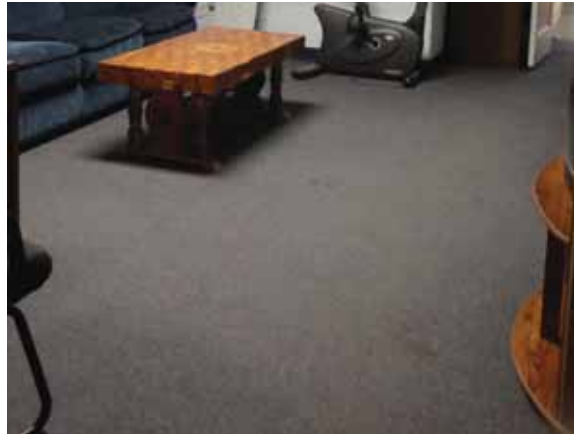
Fig. 3.0.C.29 Soiled and worn carpet observed in the Trooper Down Room on the Basement Floor.

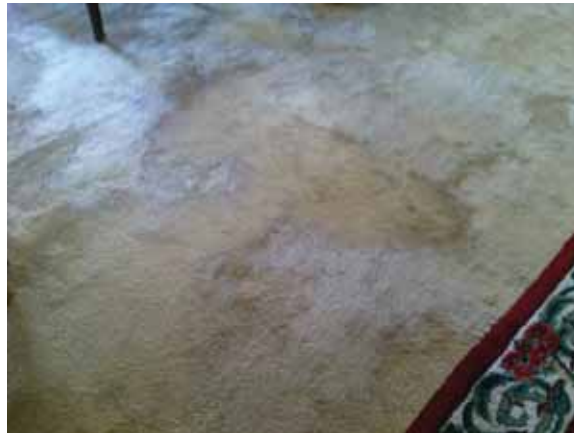
Fig. 3.0.C.30 The area rug in the Drawing Room at the northwest corner of the First Floor was noted to be worn and soiled.

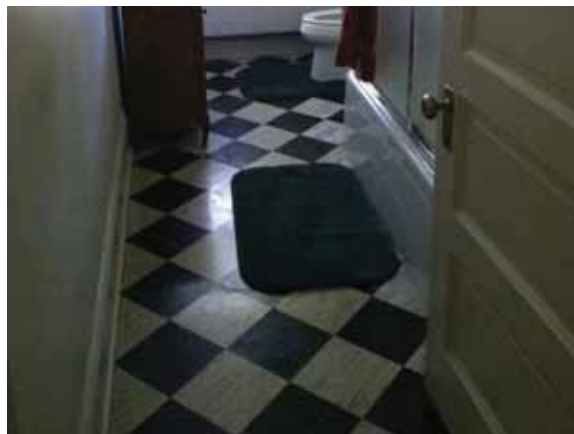
Fig. 3.0.C.31 Worn linoleum, or vinyl, tile flooring in the restroom serving the personnel offices on the east side of the building between the First and Second Floors.

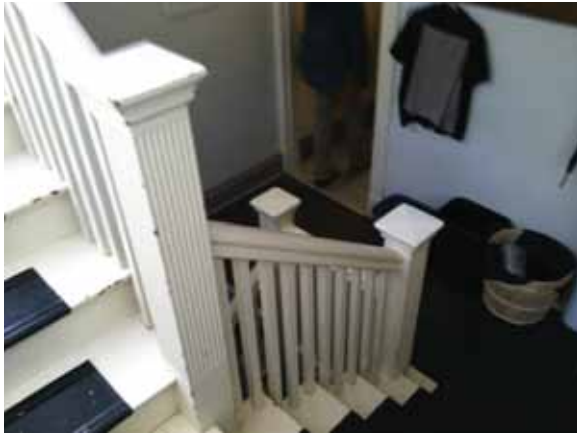
Fig. 3.0.C.32 Areas of worn pain noted throughout the southeast stairway.

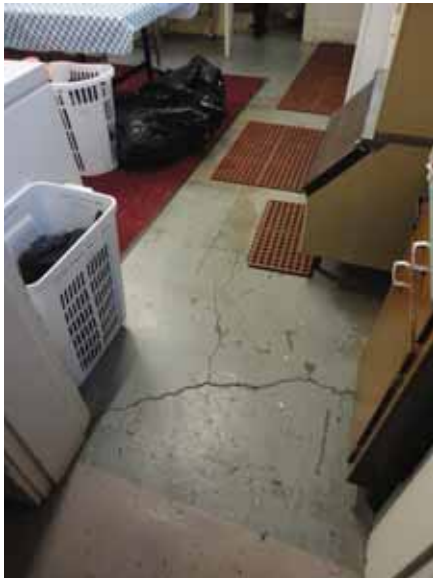
Fig. 3.0.C.33 Cracked concrete flooring observed in areas throughout the Basement Floor.

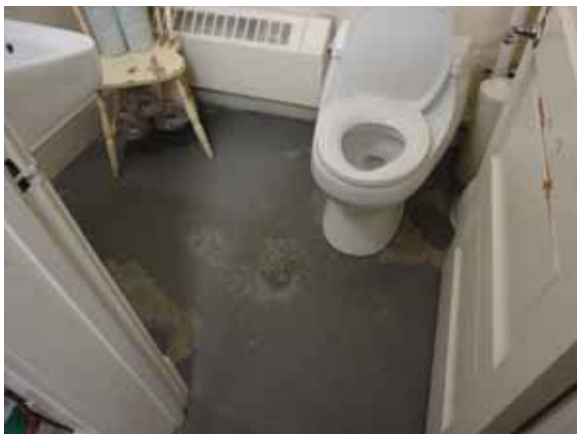
Fig. 3.0.C.34 Worn paint observed at the concrete flooring in areas throughout the Basement Floor.

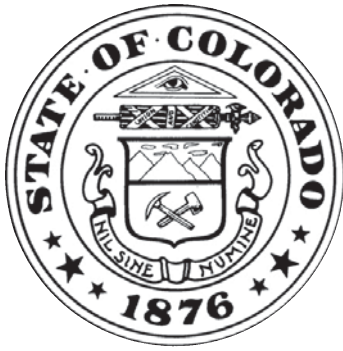
### 3.0 FLOOR-BY-FLOOR ASSESSMENT FINDINGS & RECOMMENDATIONS

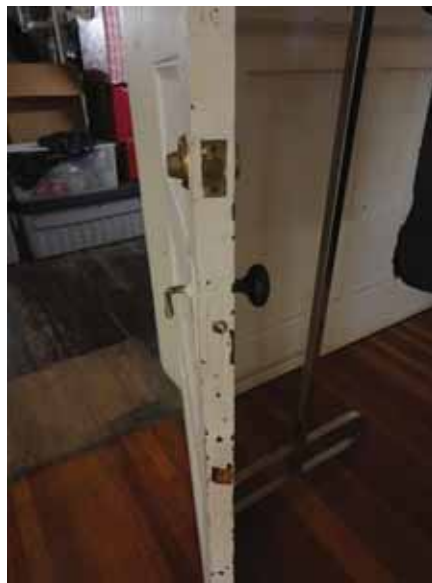
Fig. 3.0.C.35 Wear-and-tear observed at the doors throughout the Basement Floor.

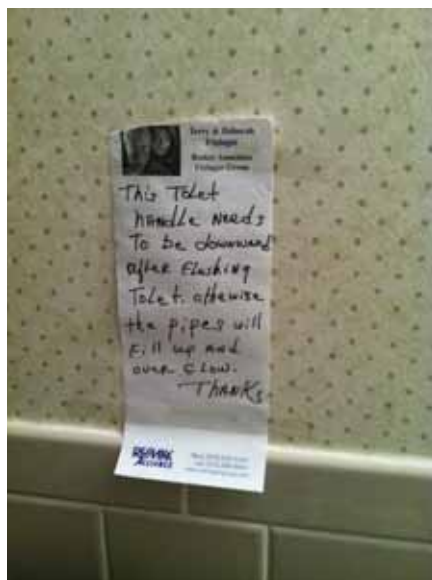
Fig. 3.0.C.36 An improperly functioning toilet observed in a private restroom on the Second Floor.

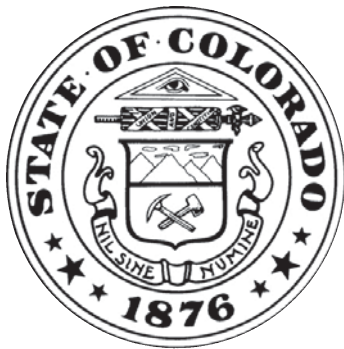
- Replace all carpet throughout the Second and Third Floor private living quarters, the personnel office area on the east side of the building between the First and Second Floors, the Trooper Down Room on the Basement Floor, and on the Grand Stairway.

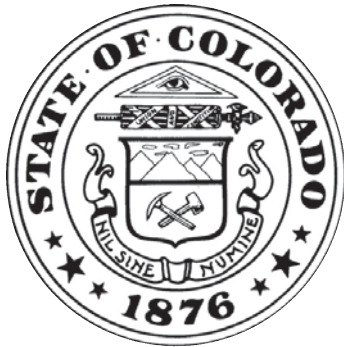
4.0 LEVELS OF RENOVATION NEEDED
