CAPITOL COMPLEX MASTER PLAN

FINDINGS & RECOMMENDATIONS (F & R) NEEDS ASSESSMENT

GRAND JUNCTION STATE SERVICES BUILDING, 222 SOUTH 6TH STREET
(GRAND JUNCTION)

NOVEMBER 2014

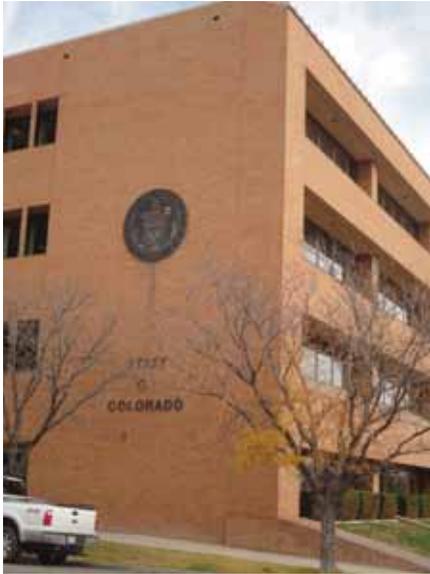
The brick cladding the building appears to be in good to fair condition overall. Soiling was observed in a few locations around the building, especially under the Colorado State Seal on the west side of the building and along control joints (see Fig. 2.1.A.1). A small portion of brick was observed to be crumbling and the sealant was noted to be deteriorating along the base of the building, potentially exposing the system to water penetration (see Fig. 2.1.A.2). The waterproofing along the base of the building on the south side was noted to be deteriorating and potentially exposing the building to water penetration as well (see Fig. 2.1.A.3). There is a metal header that is exposed and corroding above an air intake grille at the Penthouse (see Fig. 2.1.A.4). There are pipe penetrations through an area of the brick wall at the Penthouse that have not been sealed, leaving the building envelope vulnerable to water penetration (see Fig. 2.1.A.5).

Fig. 2.1.A.1 Typical soiling of the brick observed around the perimeter of the building.

- Clean soiled/stained brick veneer around the exterior of the building.
- Repair or replace any deteriorating or otherwise damaged brick around the exterior of the building.

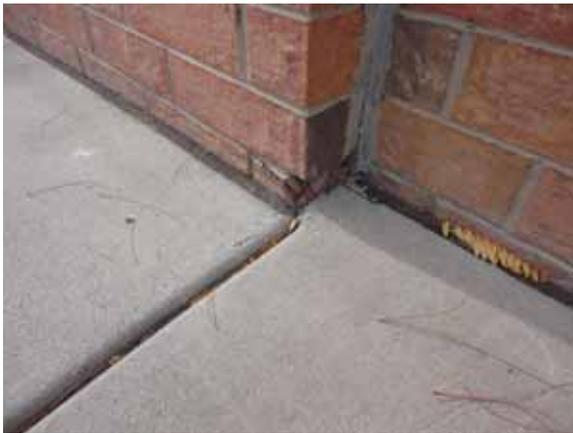
Fig. 2.1.A.2 Crumbling brick and deteriorating sealant observed along the base of the building.

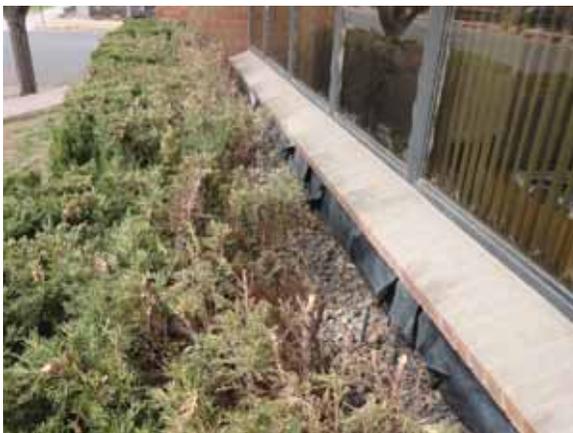
Fig. 2.1.A.3 Deterioration of the waterproofing observed on the south side of the building.

- Replace the deteriorating waterproofing along the base of the building on the south side with a new waterproofing system.
- Seal the openings around the pipe penetrations through the brick walls at the Penthouse to prevent water from penetrating the building envelope.

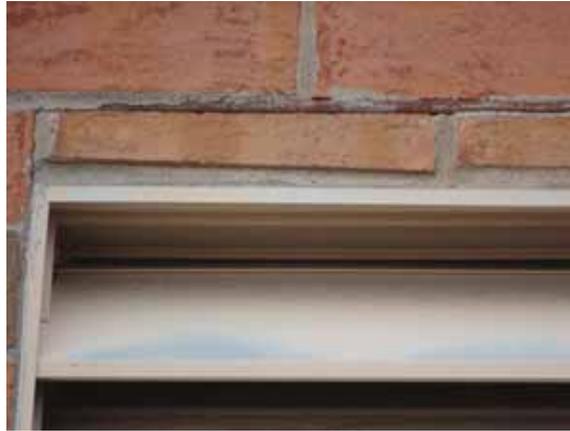
Fig. 2.1.A.4 An exposed metal header with evidence of corrosion observed at an air intake grille at the Penthouse.

- Remove the corrosion from the metal lintels around the exterior of the building and provide a protective coating to prevent future corrosion.
- Clean the stucco soffits around the exterior of the building.

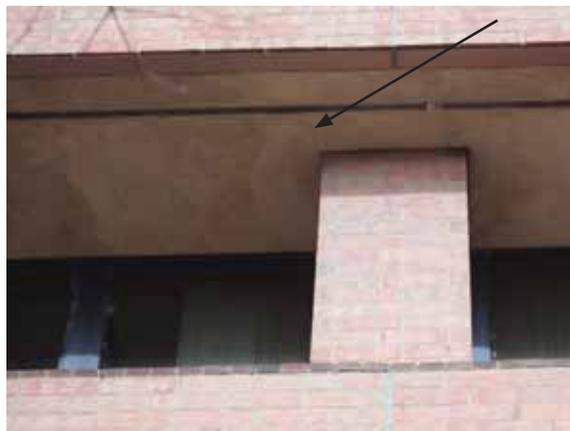
The stucco soffits around the exterior of the building are in generally fair condition overall with soiling and spots of readily observable cracking noted during the site survey visit (see Fig. 2.1.A.6). The metal lintels, supporting the brick above, along the front edge of the soffits were observed to be corroding and to have deteriorating sealant along the edge of the stucco (see Fig. 2.1.A.7).

Fig. 2.1.A.6 Typical instance of soiled and cracking stucco soffits noted during the site survey visit.

- Repair or replace any areas of deteriorating or otherwise damaged stucco at the soffits around the exterior of the building.
- Remove existing sealant where deteriorating around the exterior of the building, including at the Penthouse, and replace with new sealant. Sealant, backup materials, and preformed joint fillers should be nonstaining.

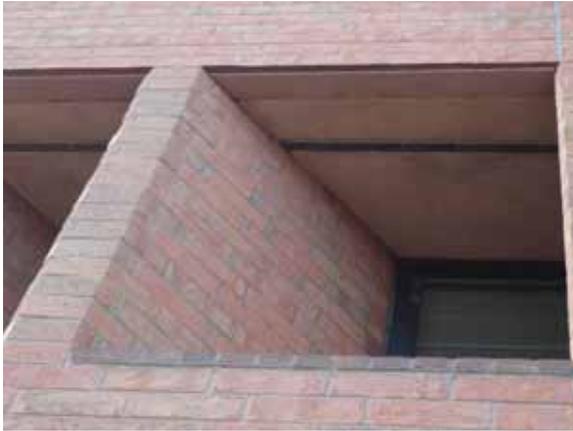
Fig. 2.1.A.7 Evidence of corrosion and deteriorating sealant observed at the metal headers along the front edge of the soffits.

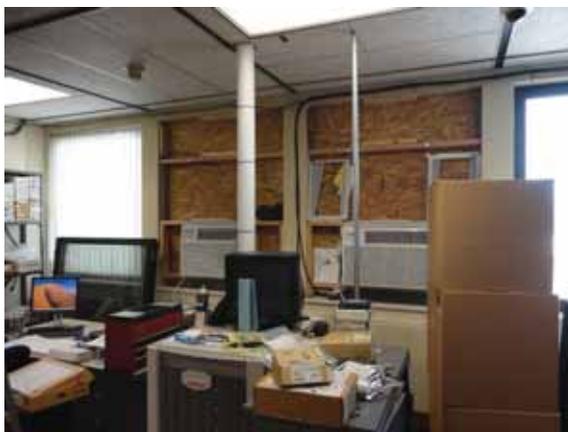
to deteriorate due to age around the building. Two of the windows have been removed on the north side of the building along the Fourth Floor due to the installation of two air conditioning window units. The window openings have been filled in with a sheet of engineered wood particle board and do not appear to have been properly waterproofed on the exterior side or insulated on the interior side (see Fig. 2.1.A.8 and Fig. 2.1.A.9).

Fig. 2.1.A.9 View of the windows removed from the north side along the Fourth Floor from the interior of the building.

- Provide waterproofing and insulation at the two windows openings on the north side of the building along the Fourth Floor with engineered wood particle board and air conditioning units.
- Remove existing sealant where deteriorating and replace with new sealant. Sealant, backup materials, and preformed joint fillers should be nonstaining.
- Repair or replace the weatherstripping at the exterior doors around the building to prevent air leakage.
- Refurbish the doors and door frames around the exterior of the building.
- Repair or replace the corroding and damaged door at the Penthouse.

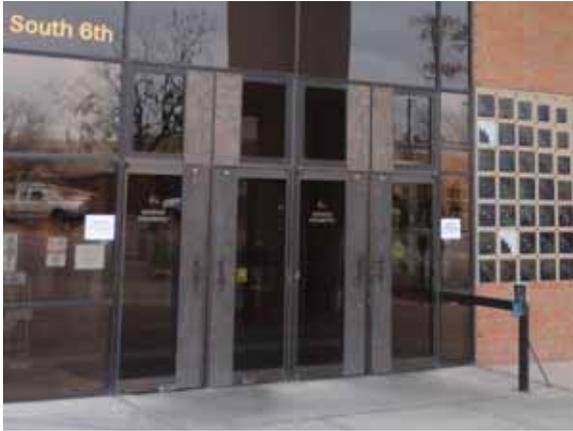
Fig. 2.1.A.10 General wear-and-tear and aging of the doors noted around the exterior of the building.

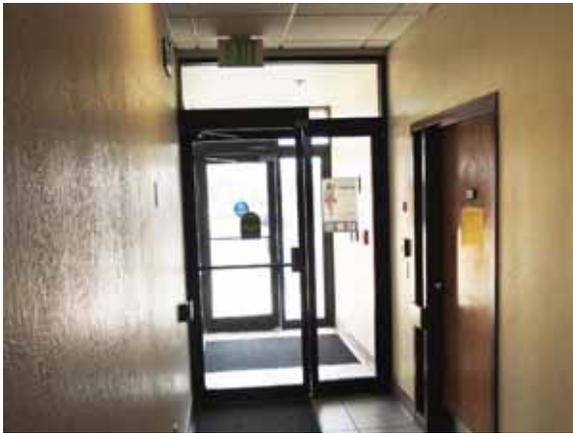
Fig. 2.1.A.11 Air gaps and deterioration of the weatherstripping noted at the doors around the exterior of the building.

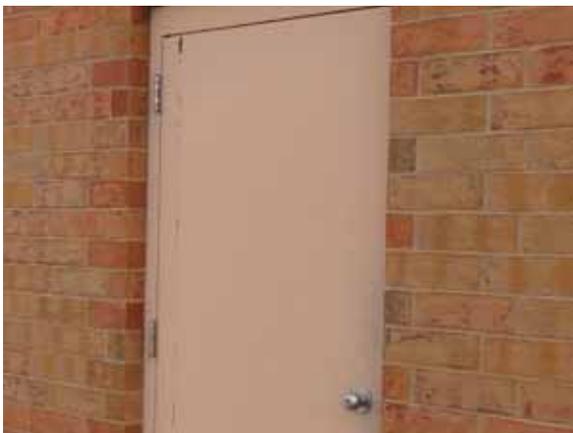
Fig. 2.1.A.12 Penthouse door with damage and minor corrosion noted during the site survey visit.

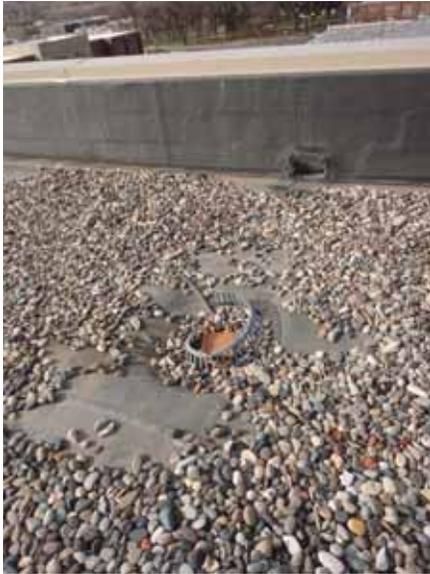
The roof appears to be in fair to poor condition overall. The roof is ballasted and the ballast is thin or missing in spots, exposing the roof membrane (see Fig. 2.1.A.13). The membrane along the inside face of the parapet is noted to be deteriorating and pulling away from the wall in areas (see Fig. 2.1.A.14). Some of the roof drain covers are in good condition and some are damaged and no longer functioning properly (see Fig. 2.1.A.13). The metal coping along the parapet is beginning to deteriorate with the seam covers noted to be coming loose in a few areas (see Fig. 2.1.A.15). Some of the concrete pavers around the roof are in good condition and some are in fair to poor condition with cracking and deterioration noted, creating a potential tripping hazard (see Fig. 2.1.A.16).

Fig. 2.1.A.13 Typical areas of thin ballast exposing the roof membrane, general deterioration of the membrane along the inside face of the parapet, and a damaged roof drain cover that is no longer functioning properly.

- Replace the existing roof with a new roofing system, including, but not limited to, a new membrane, ballast, roof drains, flashing and parapet coping material.

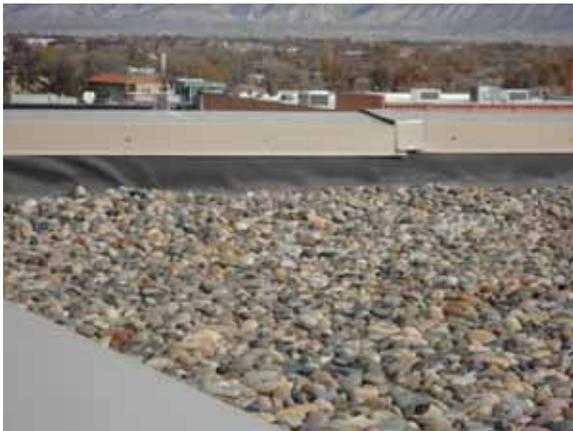
Fig. 2.1.A.14 Areas of the membrane noted to be pulling away from the inside face of the parapet.

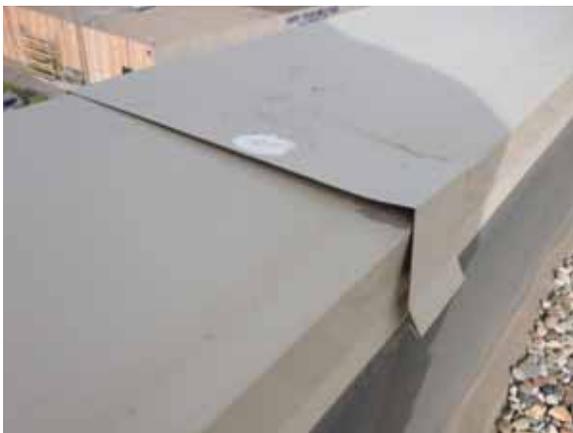
Fig. 2.1.A.15 Seam covers noted to be coming loose along the metal coping around the parapet.

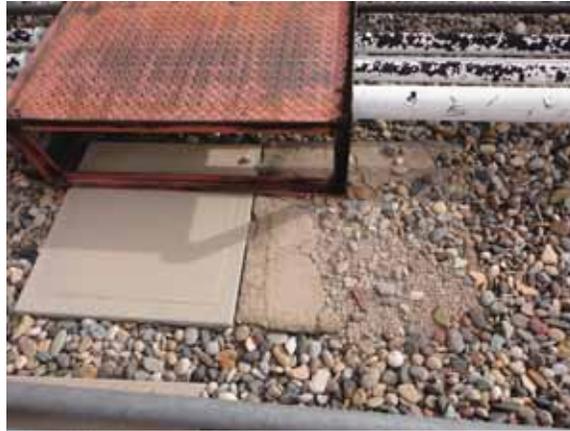
Fig. 2.1.A.16 A concrete paver in good condition and a concrete paver in poor condition observed during the site survey visit.

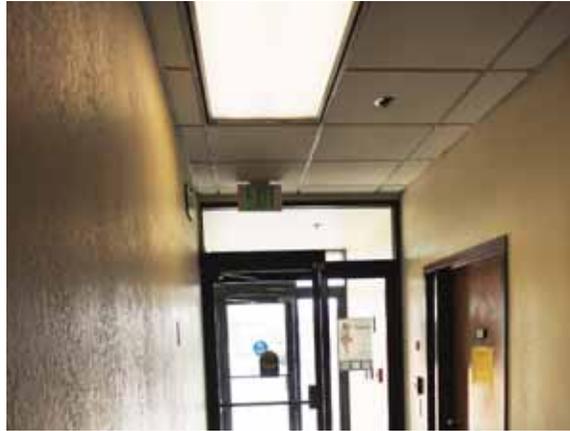
Fig. 2.1.B.1 Typical instance of an inadequately illuminated exit sign.

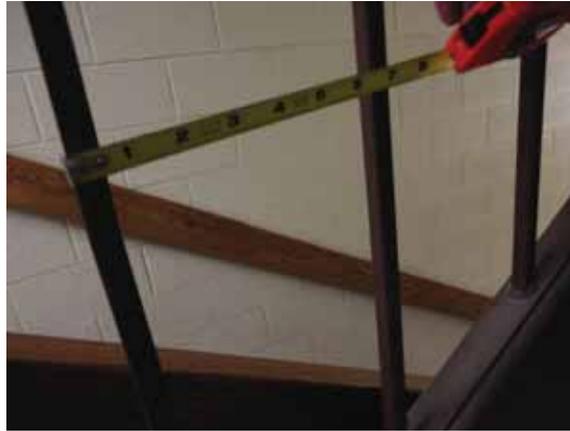
Fig. 2.1.B.4 The distance between the guardrail openings exceeds 4 inches in diameter.

- Replace the existing stairway railing system with a new railing system that complies with the code requirements.

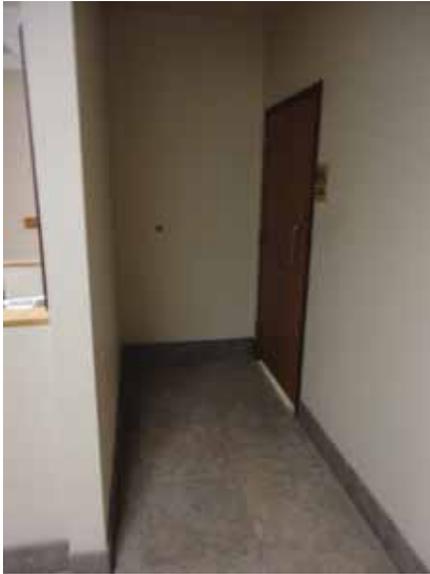
Fig. 2.1.C.3 The maneuvering clearances of the approach to the restroom doors is approximately 40 inches wide.

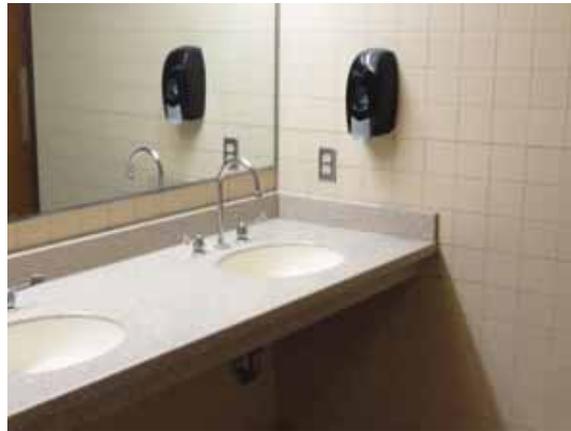
Fig. 2.1.C.6 Typical instance of an electrical receptacle, located within 6 feet of the edge of a sink, that does not appear to be equipped with ground-fault circuit interrupter protection.

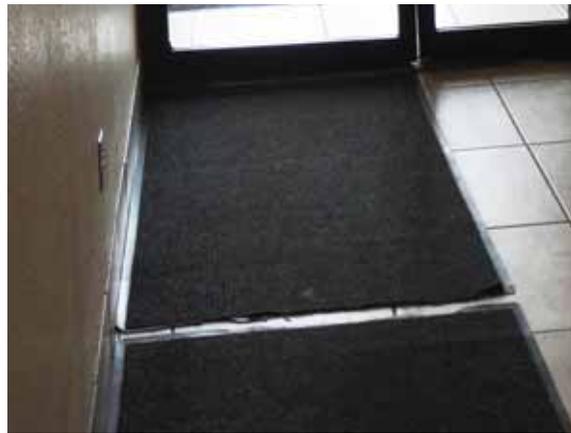
Fig. 2.1.C.7 Deteriorating floor mats creating a potential tripping hazard leading to the entrance vestibule on the north end of the east side of the building.

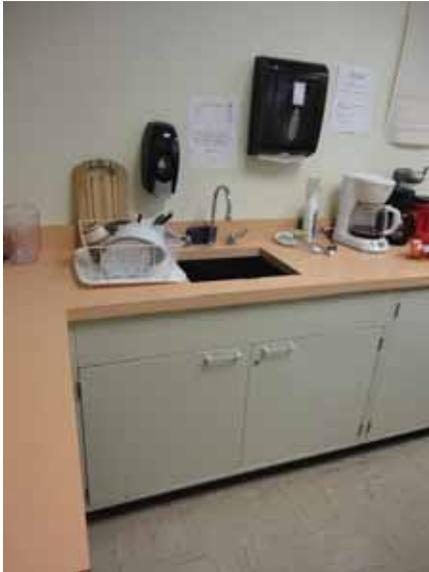
Fig. 2.1.C.8 Typical non-accessible sink found in the Break Rooms included in the site survey visit.

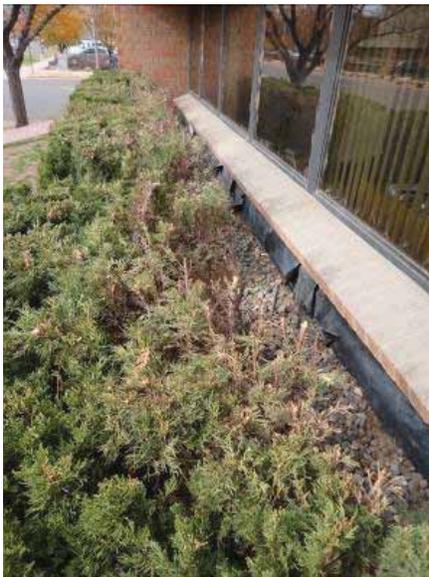
Fig. 2.2.A.1

The building's exterior is in good condition with a few exceptions. A deteriorated water proofing membrane was observed on the south side of the building at grade level (Fig. 2.2.A.1). The deteriorating concrete should be addressed soon to prevent additional deterioration.

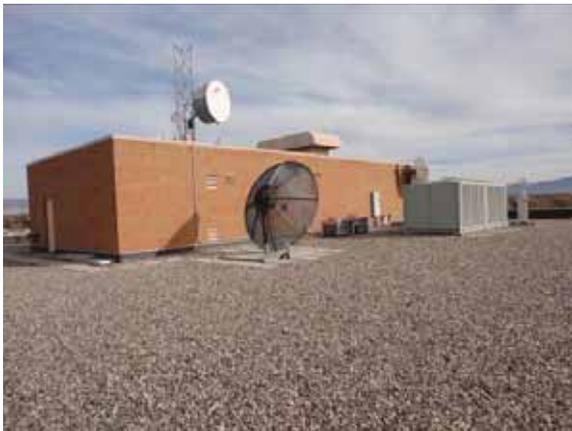
Fig. 2.2.A.2

RF antennas were observed on the roof with no warning signs (Fig. 2.2.A.2). RF antennas can expose people to harmful radiation and cause serious damage. The owner of the antennas should provide signage and safe distance requirements prior to people stepping out on the roof.

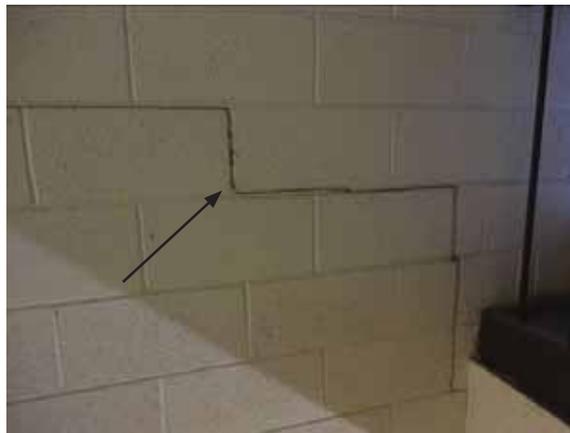
Fig. 2.2.B.1

The overall condition of the structural framing that was readily observable was good. A crack was observed in the CMU wall in a stairwell (Fig. 2.2.B.1). The crack should be monitored for additional movement.

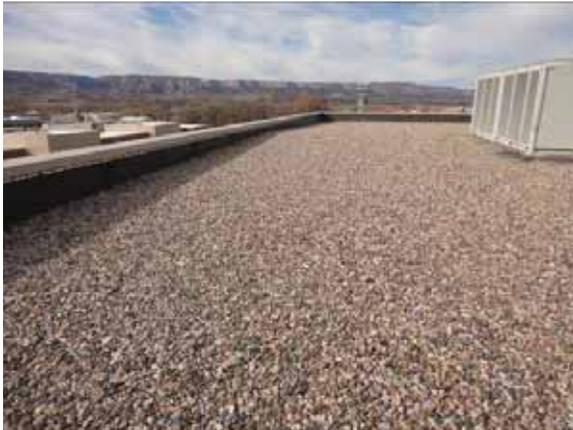
Fig. 2.2.C.1

Inadequate parapet heights were observed at the roof level (Fig. 2.2.C.1). The maximum parapet height along the entire roof edge was measured to be approximately 30 inches tall. Parapets should be at least 42 inches tall or fall protection provided for access near the exposed edges to meet current safety codes. No tie-back anchors or horizontal lifelines were observed.

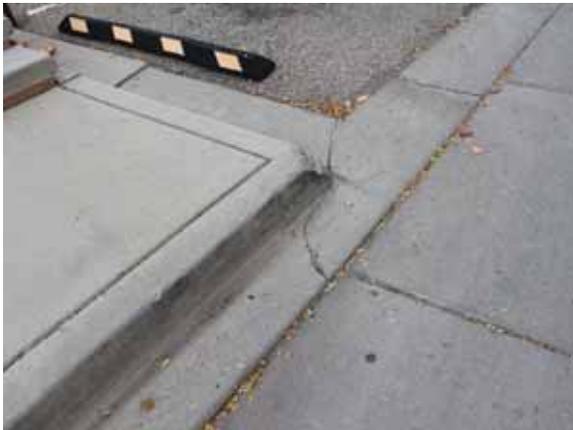
Figure 2.3.A.5 – Broken Site Concrete, Recommended for Replacement

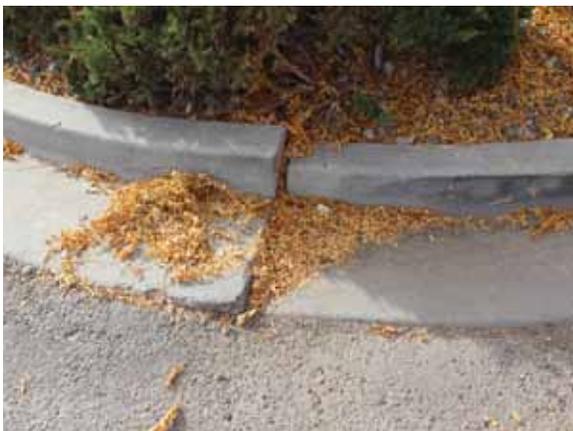
Figure 2.3.A.6 – Settlement of Curb and Gutter in Landscaped Island

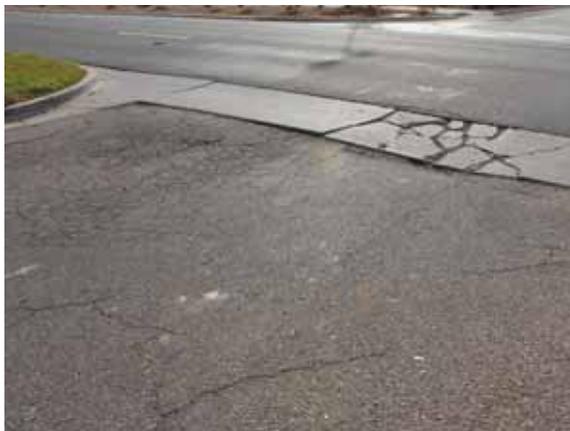
The site asphalt was noted to be in poor condition (Fig. 2.3.A.7 through Fig. 2.3.A.10). Numerous locations of depressions and cracking were observed especially in the parking lot to the east. It is recommended that the asphalt be repaired or the site be re-paved to improve the surface drainage and maintain the site posterity.

Figure 2.3.A.7 – Poor Site Asphalt Condition

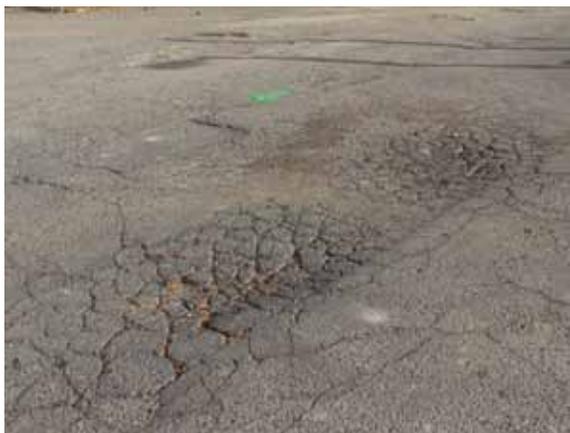
Figure 2.3.A.8 – Asphalt Deterioration

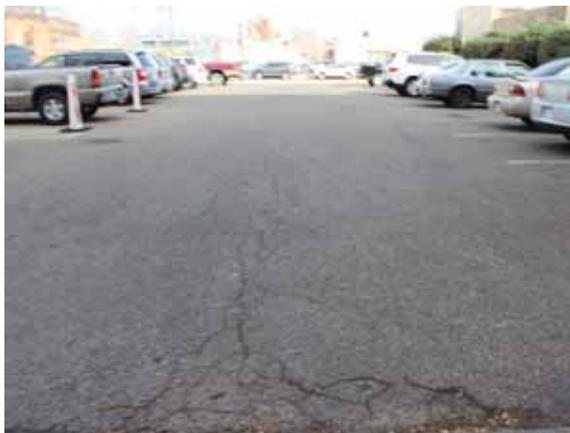
Figure 2.3.A.9 – Poor Site Asphalt Condition

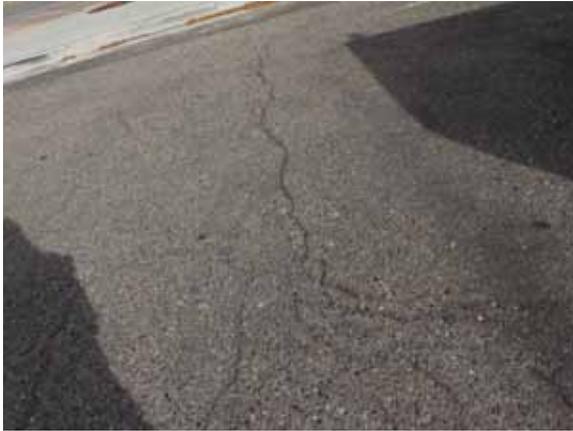
Figure 2.3.A.10 – Asphalt Cracking

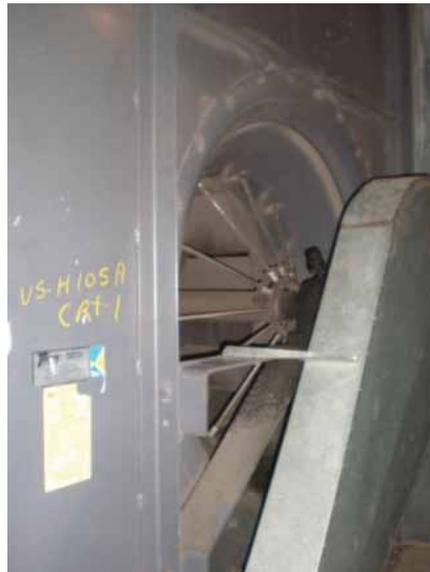
Fig. 2.4.A.25 – Fan inlet guide vanes and grease leakage

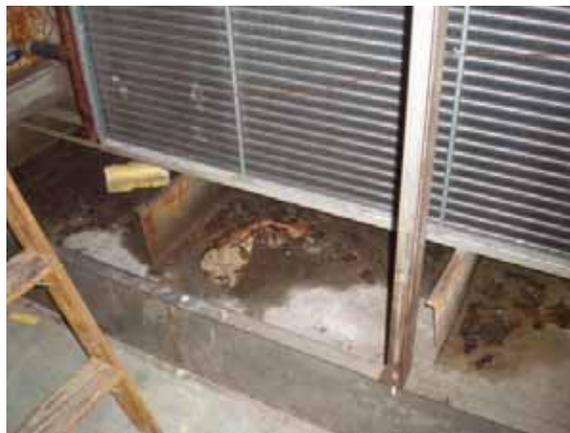
Fig. 2.4.A.26 – Rusted condensate drain pan

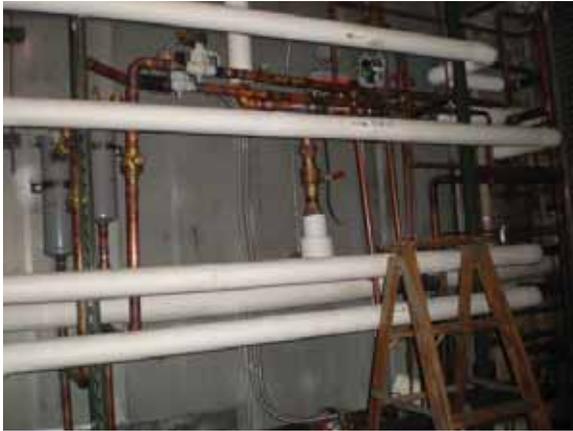
Fig. 2.4.A.27 – Portion of pipes not insulated

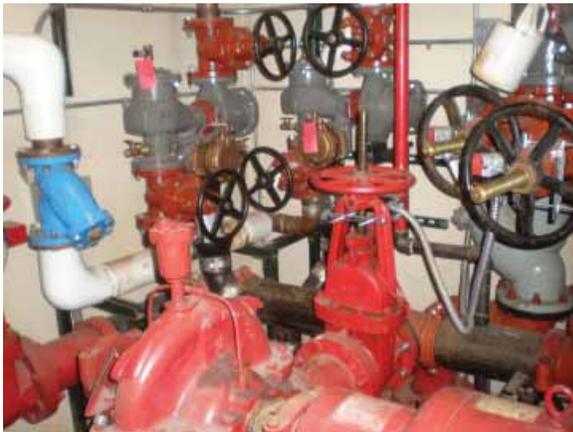
The fire pump room layout does not meet current code requirements. Some of the deficiencies notices are: (1) Section 4.12.1.1.6 (1) clearance between components for installation and maintenance; (2) clearance between components and the wall for installation and maintenance; (2) Section 4.12.2 Equipment Access; (3) Jockey pump is installed directly on the floor without any housekeeping pad. The pipes connected to jockey pump are not supported from wall. Discuss these with AHJ and follow their directive.

Fig. 2.4.B.1 – Fire pump room

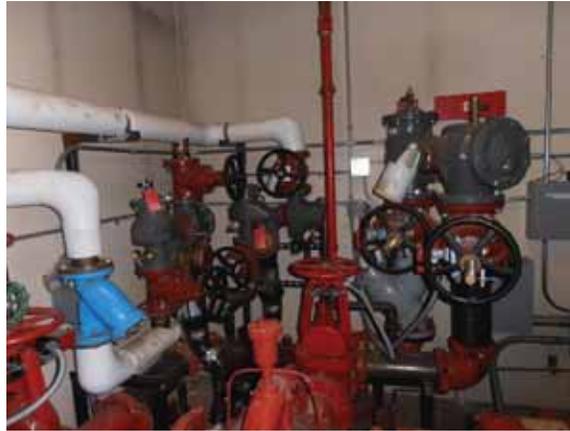
Fig. 2.4.B.2 – Fire pump room – no maintenance space

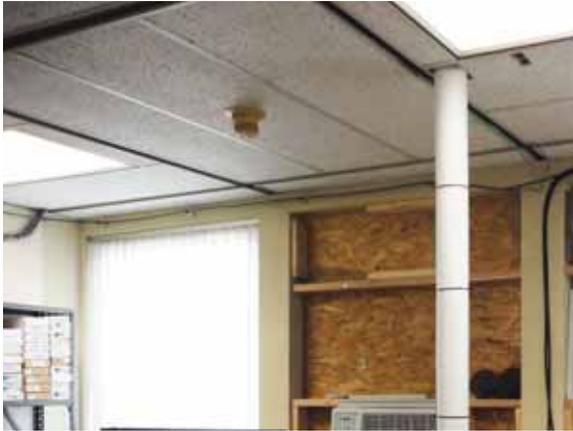
Fig. 3.0.C.1 General deterioration due to aging noted at the acoustic ceilings during the site survey visit.

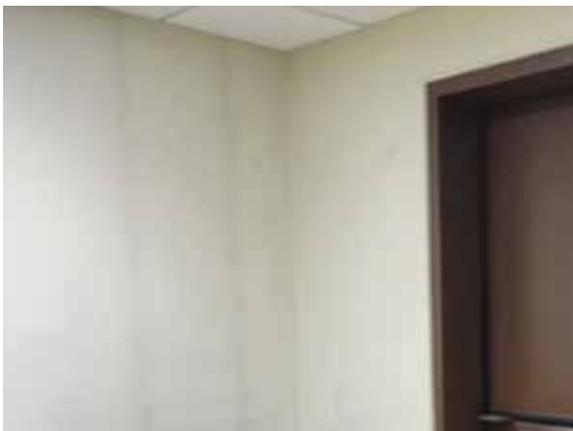
Fig. 3.0.C.2 Areas of soiled gypsum board walls observed during the site survey visit.

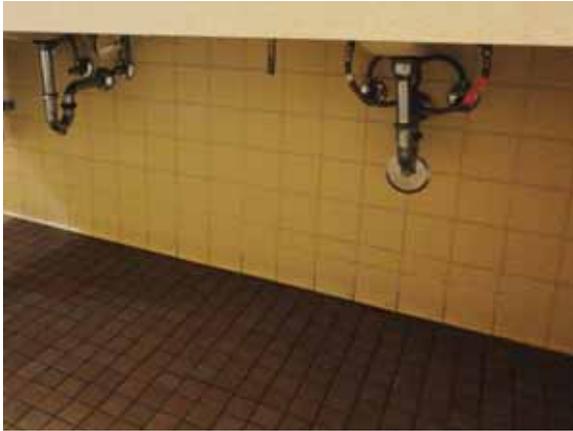
Fig. 3.0.C.6 An area of soiled four-inch square wall tiles observed in a restroom during the site survey visit.

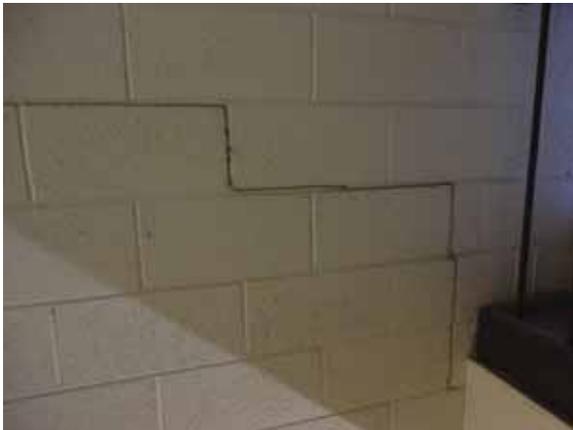
An area of the concrete block wall was observed to be cracked in a portion of an interior exit stairway included in the site survey visit (see Fig. 3.0.C.7). There is a pipe penetration through an area of the concrete block wall in the interior exit stairway which has not been sealed and is in violation of fire code regulations (see Fig. 3.0.C.8).

Fig. 3.0.C.7 Cracking of the concrete block wall observed in a portion of an interior exit stairway included in the site survey visit.

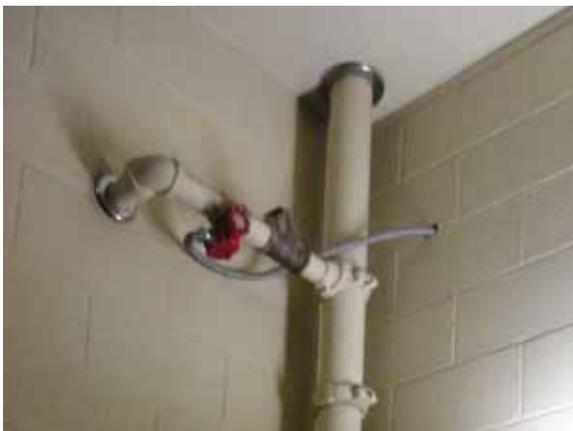
Fig. 3.0.C.8 An unsealed opening observed at a pipe penetration through the concrete block wall in a portion of an interior exit stairway included in the site survey visit.

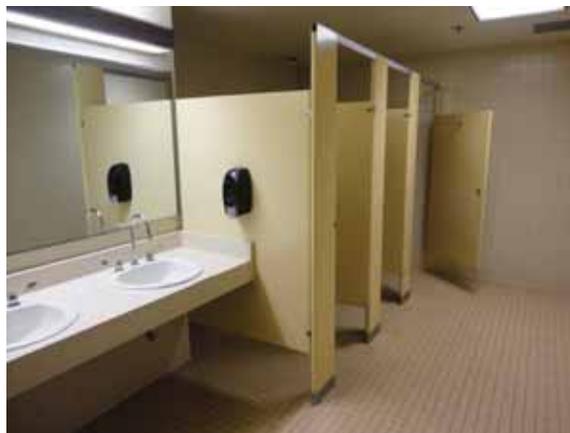
Fig. 3.0.C.9 Generally soiled two-inch square tile flooring noted in the restrooms throughout.

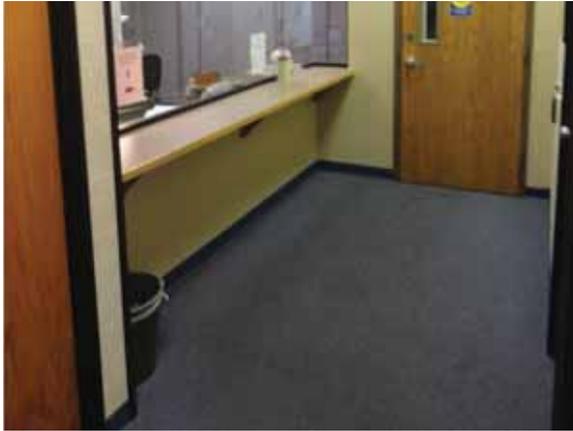
Fig. 3.0.C.10 Areas of worn and soiled carpet observed during the site survey visit.

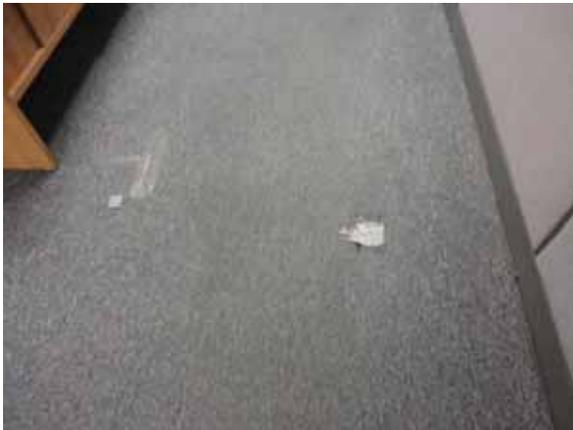
Fig. 3.0.C.11 Tape observed at an area of the carpet flooring and creating a potential tripping hazard.

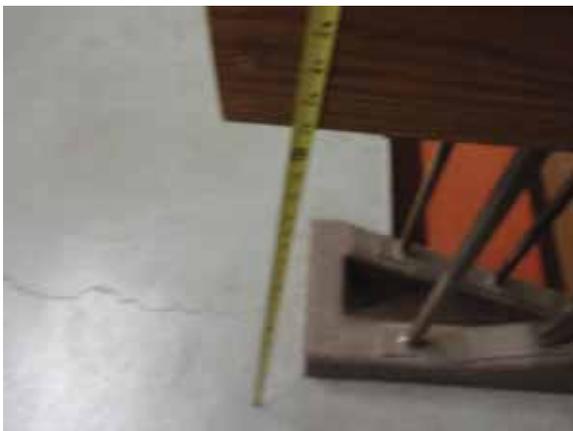
Cracking of the concrete flooring was noted at an interior exit stairway landing included in the site survey visit (see Fig. 3.0.C.12). Worn paint was observed at the concrete flooring in the employee entrance and freight elevator lobby on the east end of the north side of the First Floor (see Fig. 3.0.C.13). A portion of the rubber flooring on the stairs was observed to have been taped down and is creating a potential tripping hazard (see Fig. 3.0.C.14).

Fig. 3.0.C.12 Cracking noted at the concrete flooring at an interior exit stairway landing included in the site survey visit.

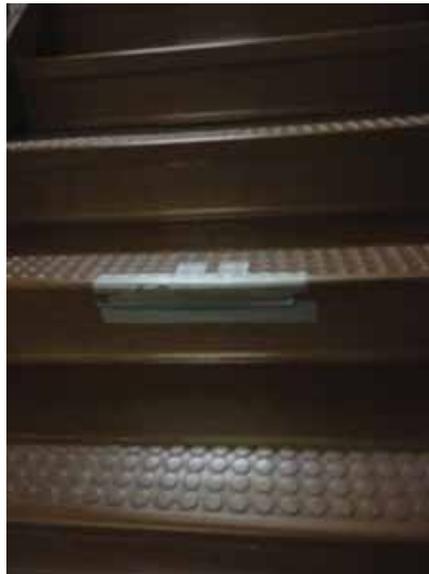
Fig. 3.0.C.14 Tape observed at the rubber flooring on the stairs is creating a potential tripping hazard.

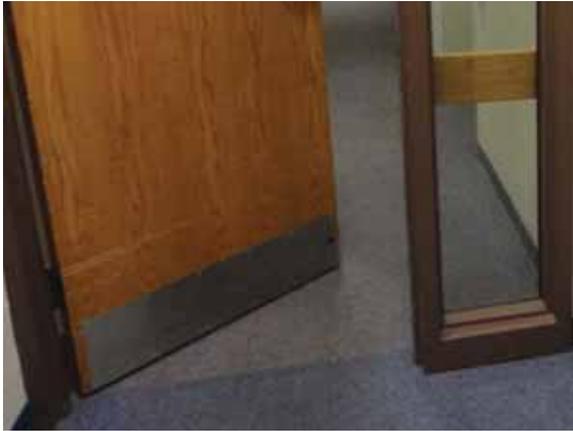
Fig. 3.0.C.15 General wear-and-tear noted at the wood doors throughout the building.

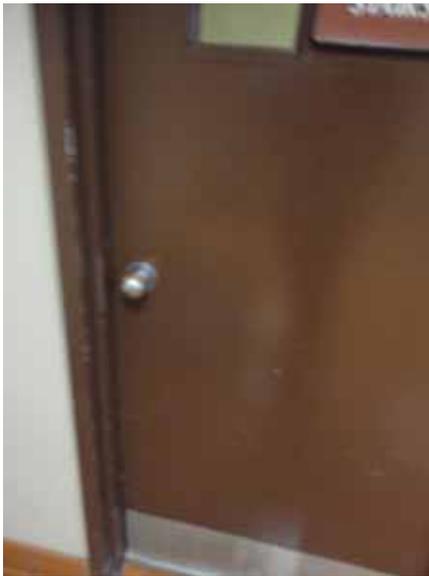
Fig. 3.0.C.16 General wear-and-tear noted at the metal doors throughout the building.

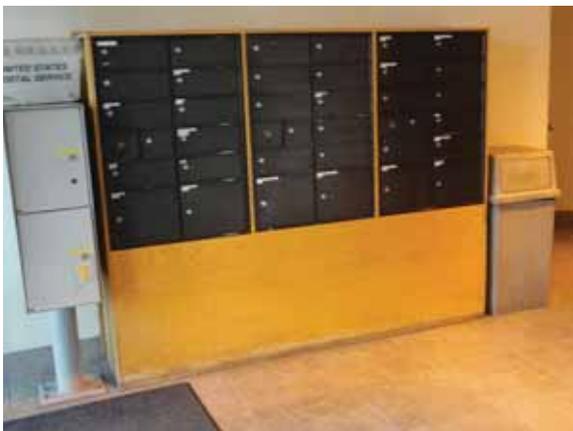
Fig. 3.0.C.17 General wear-and-tear noted at the wood cabinetry housing the mailboxes in the lobby of the main entrance.

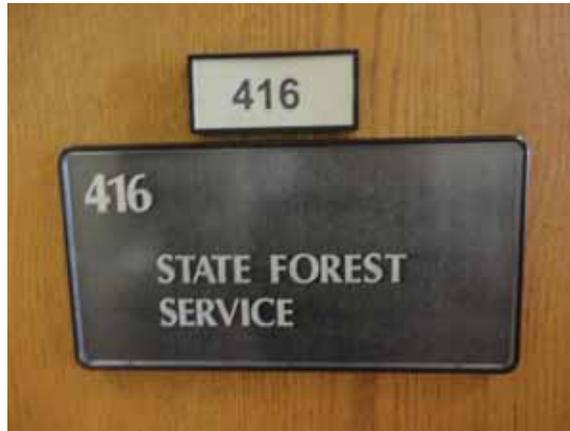
Fig. 3.0.C.18 General deterioration and wear-and-tear noted at the interior signage throughout.
