CAPITOL COMPLEX  
MASTERPLAN

DENVER,  
COLORADO

Facility Assessments

## 4.2 - FACILITY ASSESSMENT & PRIORITIES SUMMARY

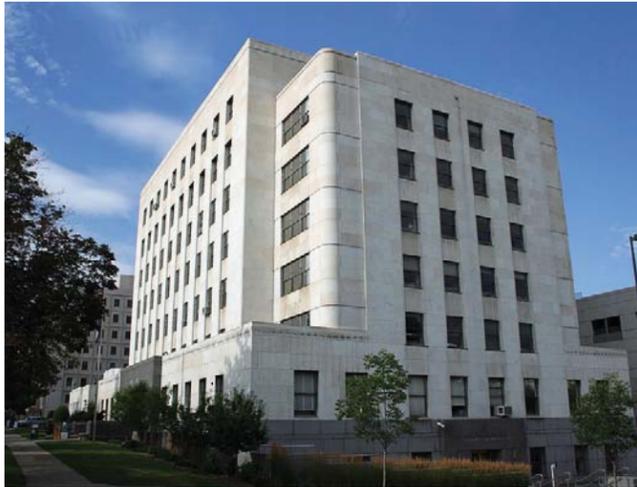
### 4.3.1 CAPITOL ANNEX BUILDING

1. Total gut and renovation of the building back to the core shell, with the exception of the historically-protected areas outlined in the facility assessment, including, but not limited to, the replacement of all windows and converting steam heat to hot water. This would provide an effective approach for abating all asbestos, replacing all of the aged electrical systems, replacing all of the old plumbing piping, and providing a more efficient layout. These recommendations encompass life safety, loss of use/reliability, finishes, and overall energy efficiency issues. Cost Estimate: \$22,321,671.

2. Asbestos abatement. This recommendation encompasses life safety and loss of use/reliability issues. Cost estimate: \$710,767.
3. Replace all electrical. This recommendation encompasses life safety and loss of use/reliability issues and is due to electrical code issues including an inadequate service load capacity. Cost estimate: \$3,202,081

4. Convert steam heat to hot water. This recommendation encompasses loss of use/reliability and overall energy efficiency issues and is due to the inability to maintain a consistent comfortable working temperature within the building. Cost estimate: \$5,434,187.

5. Replace all plumbing piping. This recommendation encompasses life safety and loss of use/reliability issues and is due to plumbing code issues as well as ongoing maintenance efforts. Cost estimate: \$2,899,510.

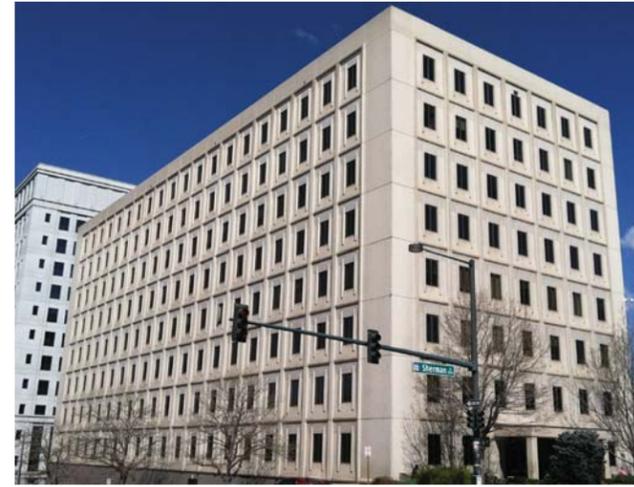
### 4.3.2 CENTENNIAL BUILDING

1. Total gut and renovation back to core shell, including, but not limited to, replacing the roof, replacing the windows, replacing the aged fire alarm system and HVAC systems, adding stair pressurization for life safety, installing energy saving lighting, adding insulation to the exterior walls, and providing a more efficient layout. These recommendations encompass life safety, loss of use/reliability, finishes, and overall energy efficiency issues. Cost estimate: \$34,212,015.

2. Replace fire alarm. This recommendation encompasses life safety issues and is due to fire protection code issues and the age of the system. Cost estimate: \$291,541.

3. Replace all HVAC, add stair pressurization. This recommendation encompasses life safety issues and overall energy efficiency issues and is due to the age of the HVAC systems and to fire protection code issues. Cost estimate: \$9,839,947.

4. Replace roof. This recommendation encompasses loss of use/reliability issues and is due to the age of the roof. Cost estimate: \$301,539.
5. Replace all plumbing piping. This recommendation encompasses life safety and loss of use/reliability issues. Cost estimate: \$2,722,582.

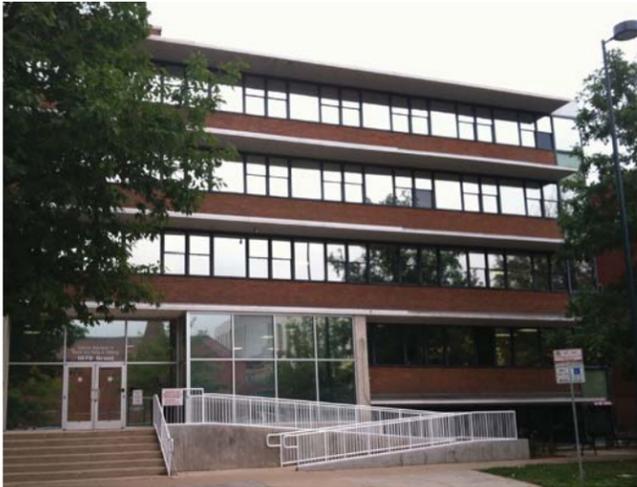
### 4.3.3 1570 GRANT BUILDING

1. Modernize elevators. This recommendation encompasses life safety issues and is due to the age of the elevator systems. Cost estimate: \$71,420.
2. Replace windows. This recommendation encompasses loss of use/reliability issues and overall energy efficiency issues and is due to the age and condition of the windows. Cost estimate: \$1,133,406.

3. Modify fire sprinkler system. This recommendation encompasses life safety issues and is due to egress issues from the building and fire protection code issues. Cost estimate: \$545,534.

4. Replace HVAC. This recommendation encompasses loss of use/reliability issues and overall energy efficiency issues and is due to the age of the HVAC systems. Cost estimate: \$1,900,098.

5. Replace AHU system in basement. This recommendation encompasses loss of use/reliability issues and overall energy efficiency issues and is due to the age of the system. Cost estimate: \$294,642.

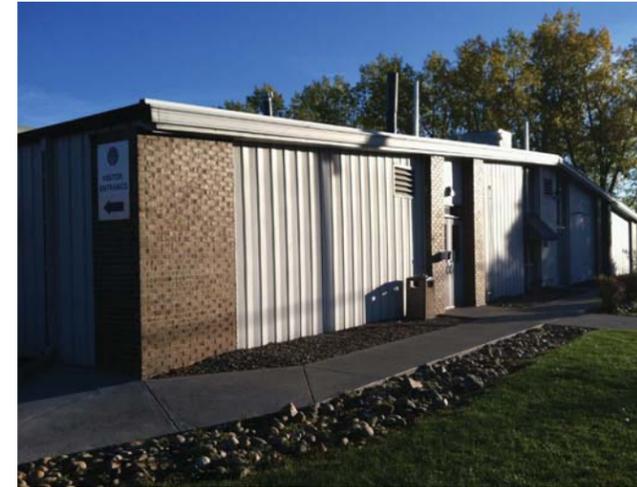
### 4.3.4 NORTH CAMPUS WEST BUILDING

1. Correct fuel testing room code issues. This recommendation encompasses life safety issues and is related to the hazardous materials stored and tested in the room and fire protection code and National Electrical Code issues. Cost estimate: \$189,661.

2. Correct print shop code issues. This recommendation encompasses life safety issues and is due to the levels of paper dust accumulation throughout and fire protection code and National Electrical Code issues. Cost estimate: \$202,396.

3. Replace fire alarm/install fire sprinkler system. This recommendation encompasses life safety issues and is due to the age of the fire alarm system and fire protection code issues related to the fuel testing room and print shop code issues. Cost estimate: \$289,938.

4. Replace roof and add fall protection. This recommendation encompasses life safety and loss of use/reliability issues and is due to the age and condition of the roof and the fact that no fall protection is provided. Cost estimate: \$565,523.

5. Replace HVAC. This recommendation encompasses loss of use/reliability issues and overall energy efficiency issues and is due to the age and condition of the HVAC system and the inability to maintain a consistent comfortable working temperature within the building. Also provide air distribution, as part of the overall project, in the main entrance and lobby spaces which currently use portable heaters to provide heat. Cost estimate: \$687,552.

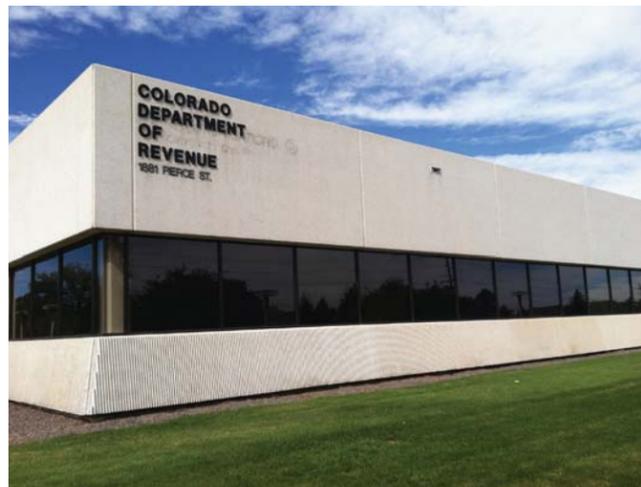
### 4.3.5 1881 PIERCE BUILDING

1. Install fire sprinkler system throughout the first floor. This recommendation encompasses life safety issues and is due to egress and fire protection code issues. Cost estimate: \$949,488.

2. Accessibility upgrades. This recommendation encompasses life safety issues and is due to a number of non-accessible drinking fountains and other non-accessible features found throughout the restrooms and break rooms. Cost estimate: \$328,957.

3. Repair/replace site paving. This recommendation encompasses life safety issues and loss of use/reliability issues and is due to the overall deterioration of the site pavement which is creating a potential tripping hazard. Cost estimate: \$2,830,816.

4. Asbestos assessment and abatement. This recommendation encompasses life safety issues. Cost estimate: \$634,199.
5. Replace HVAC system. This recommendation encompasses loss of use/reliability issues and overall energy efficiency issues and is due to the age and condition of the HVAC system and the inability to maintain a consistent comfortable working temperature within the building. Cost estimate: \$542,650.

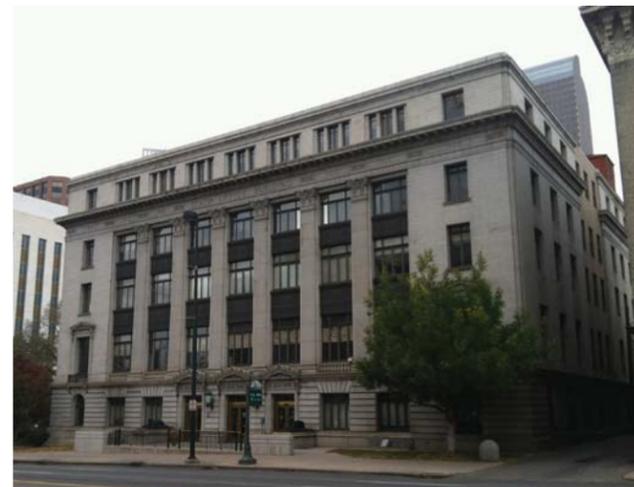
### 4.3.6 STATE OFFICE BUILDING

1. Replace fire sprinkler piping. This recommendation encompasses life safety issues and is due to the age of the fire sprinkler piping and fire protection code issues. Cost estimate: \$782,031.

2. Provide fall protection at roof. This recommendation encompasses life safety issues and is due to code issues and the fact that inadequate fall protection is provided at the roof. Cost estimate: \$26,857.

3. Replace north chiller. This recommendation encompasses loss of use/reliability and overall energy efficiency issues and is due to the current system's inability to meet the building load. Cost estimate: \$613,487.

4. Replace windows. This recommendation encompasses loss of use/reliability issues and overall energy efficiency issues and is due to the age and condition of the windows. Cost estimate: \$1,076,998.

5. Replace/repair exterior sealant and grout. This recommendation encompasses loss of use/reliability issues and is due to the overall deterioration of the sealant and grout which is creating access points by which water can penetrate the building envelope. Cost estimate: \$80,342.

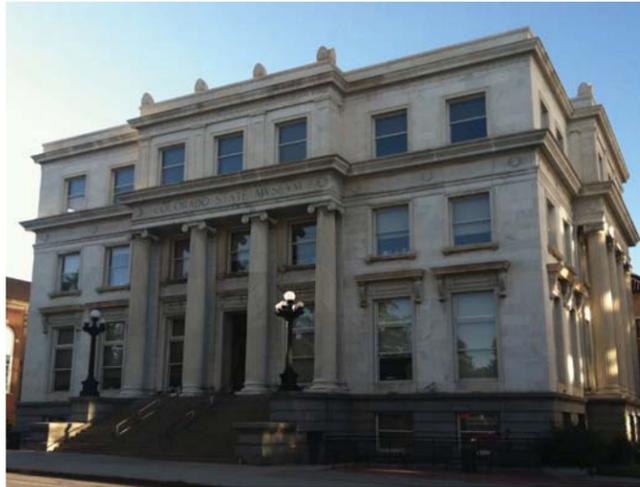
### 4.3.7 LEGISLATIVE SERVICES BUILDING

1. Add panic devices on alley gates to allow exit to public way. This recommendation encompasses life safety issues and is due to egress issues from the building. Cost estimate: \$51,056.

2. Upgrade fire alarm. This recommendation encompasses life safety issues and is due to the age of the system and fire protection code issues. Cost estimate: \$33,881.

3. Floor 3, Hearing Room: need fire rated wall and change door swing. This recommendation encompasses life safety issues and is due to fire protection code issues related to assembly occupancies. Cost estimate: \$98,727.

4. Replace windows and exterior doors. This recommendation encompasses loss of use/reliability issues and overall energy efficiency issues and is due to the age and condition of the windows and exterior doors. Cost estimate: \$332,038.

5. Replace electric panel boards. This recommendation encompasses loss of use/reliability issues and overall energy efficiency issues and is due to the age of the panel boards. Cost estimate: \$602,620.

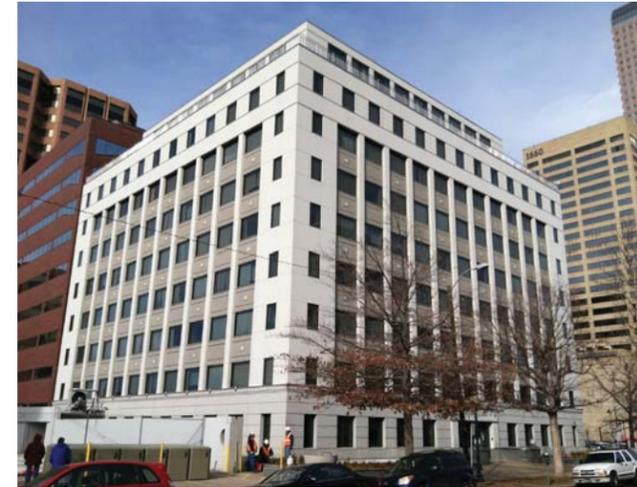
### 4.3.8 HUMAN SERVICES BUILDING

1. Replace engine generator. This recommendation encompasses life safety issues due to the age of the generator which is used for emergency power. Cost estimate: \$438,599.

2. Replace electrical panels and receptacles. This recommendation encompasses life safety, loss of use/reliability, and overall energy efficiency issues and is due to the age of the panels and receptacles. Cost estimate: \$3,848,536.

3. Accessibility upgrades. This recommendation encompasses life safety issues and is due to non-accessible features found throughout the restrooms and break rooms. Cost estimate: \$136,051.

4. Replace roof. This recommendation encompasses loss of use/reliability issues and is due to the age and condition of the roof. Cost estimate: \$609,958.

5. Light fixture and controls upgrade. This recommendation encompasses loss of use/reliability issues and overall energy efficiency issues and is due to the age of the T8 fluorescent fixtures and controls. Cost estimate: \$1,012,390.

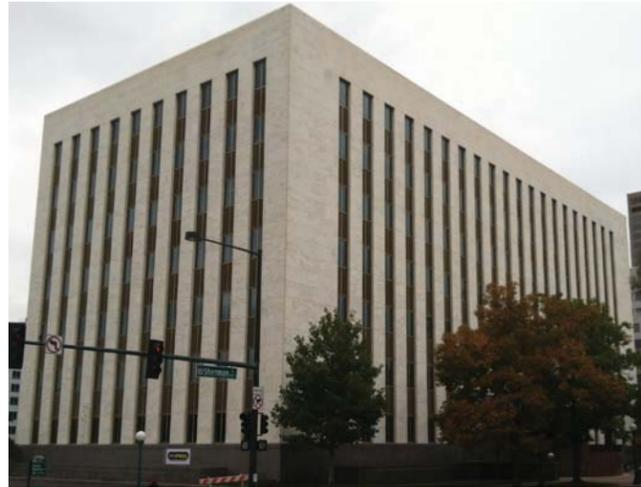
### 4.3.9 STATE SERVICES BUILDING

1. Replace fire alarm. This recommendation encompasses life safety issues and is due to fire protection code issues and the age of the system. Cost estimate: \$643,728.
2. Replace engine generator. This recommendation encompasses life safety issues. Cost estimate: \$161,301.
3. Insulate exterior walls. This recommendation encompasses loss of use/reliability and energy. Cost estimate: \$1,188,172.
4. Replace roof. This recommendation encompasses loss of use/reliability issues and is due to the age and condition of the roof. Cost estimate: \$638,206.
5. Repair/replace exterior sealant. This recommendation encompasses loss of use/reliability issues and is due to the overall deterioration of the sealant which is creating access points by which water can penetrate the building envelope. Cost estimate: \$569,715.

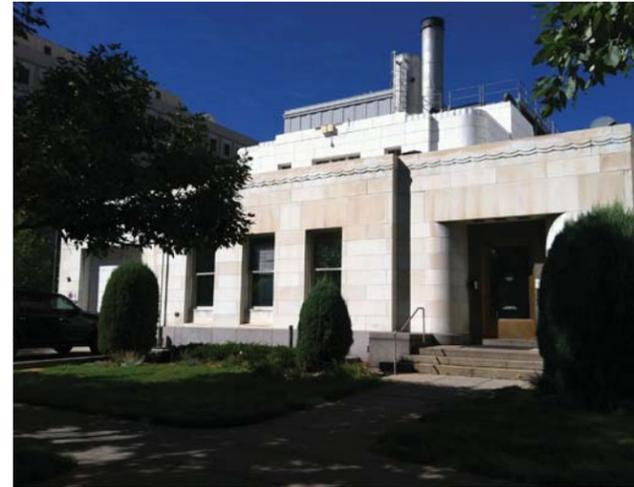
### 4.3.10 POWER PLANT BUILDING

1. Install a full fire alarm and detection system throughout. This recommendation encompasses life safety issues and is due to the lack of a full detection fire alarm system. Cost estimate: \$32,101.

2. Provide fall protection at roof. This recommendation encompasses life safety issues and is due to code issues and the fact that inadequate fall protection is provided at the roof. Cost estimate: \$20,269.

3. Replace all electrical panels and receptacles that are past their useful life. This recommendation encompasses life safety, loss of use/reliability, and overall energy efficiency issues and is due to the age of the panels and receptacles. Cost estimate: \$898,703.

4. Repair exterior walls and window leaks. This recommendation encompasses loss of use/reliability issues and is due to the age and condition of the windows and the cladding on the building and the overall deterioration of the mortar and sealant. Cost estimate: \$665,694.

5. Replace lighting. This recommendation encompasses loss of use/reliability issues and is due to the age and condition of the fixtures. Cost estimate: \$187,710.

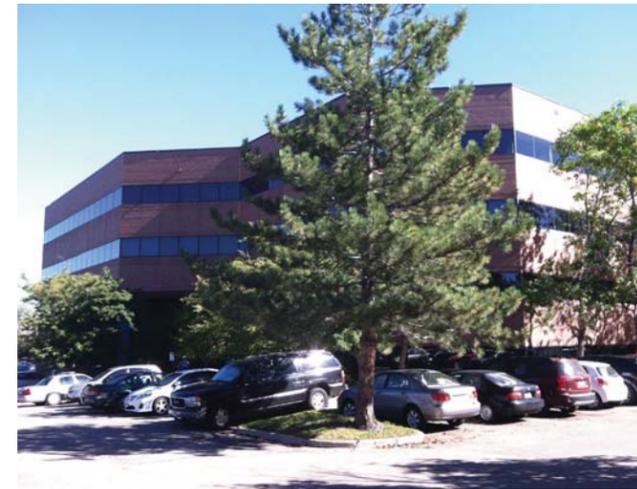
**4.3.12 700 KIPLING BUILDING**

1. Upgrade fire alarm. This recommendation encompasses life safety issues and is due to fire protection code issues and the age of the system. Cost estimate: \$111,882.
