CAPITOL COMPLEX MASTER PLAN
FINDINGS & RECOMMENDATIONS (F & R) NEEDS ASSESSMENT
CAMP GEORGE WEST, 15000 SOUTH GOLDEN ROAD (PLEASANT VIEW)

NOVEMBER 2014

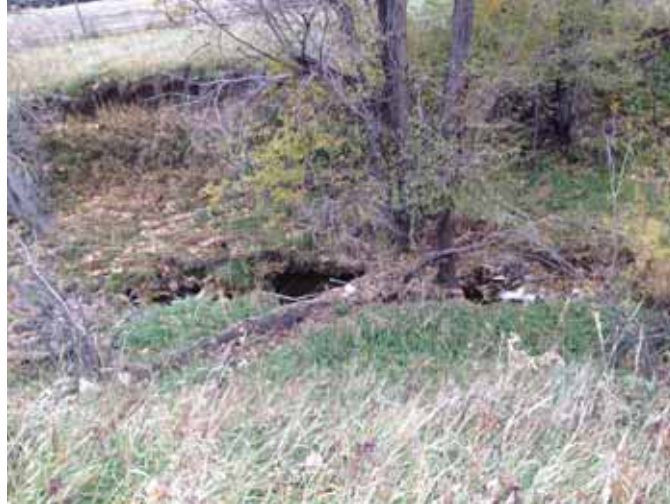
Figure 2.1.A.5 –
Lena Gulch, East
Reach

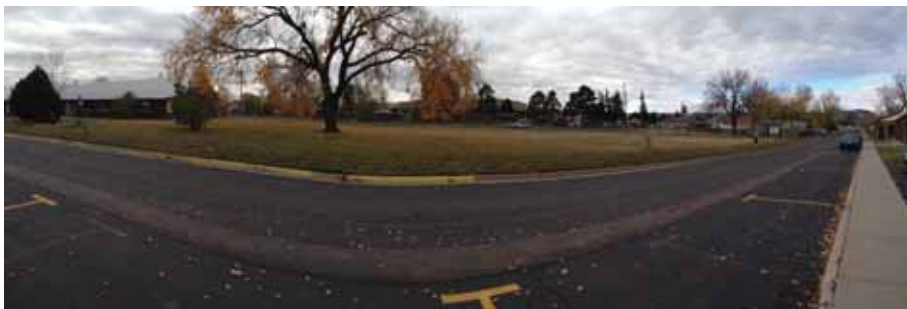
Figure 2.1.A.6 – Site Asphalt Roadways

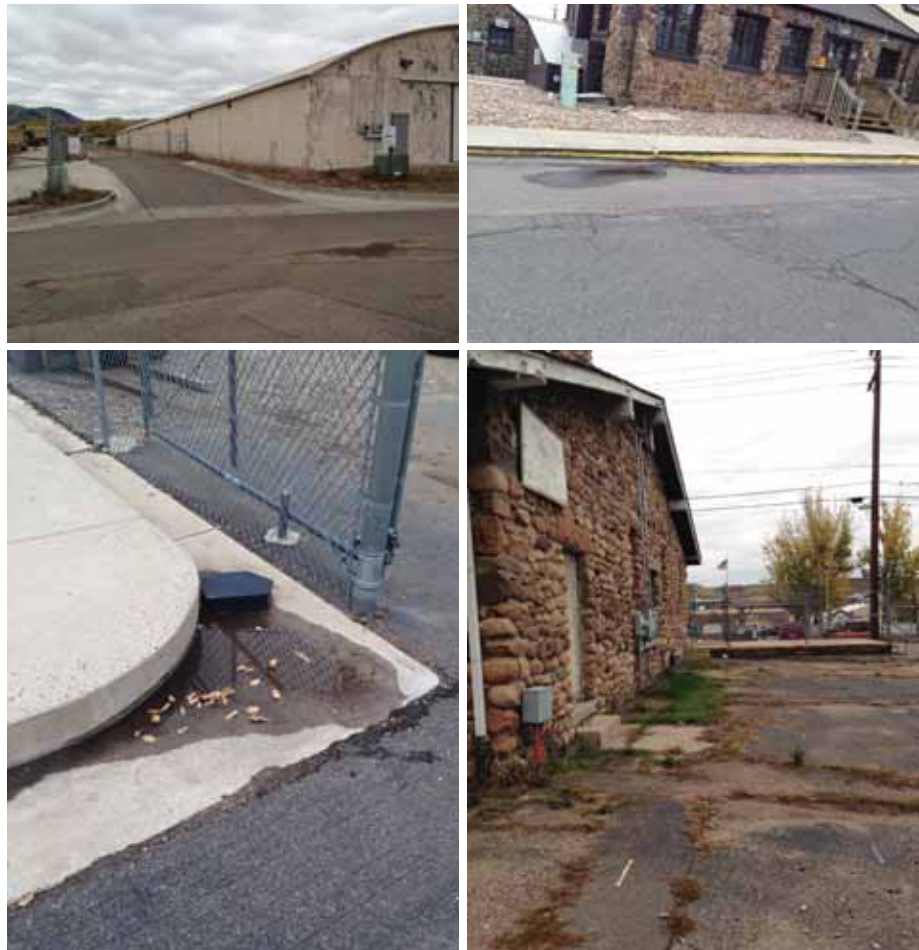
Figure 2.1.A.7 – Evidence of Local Ponding

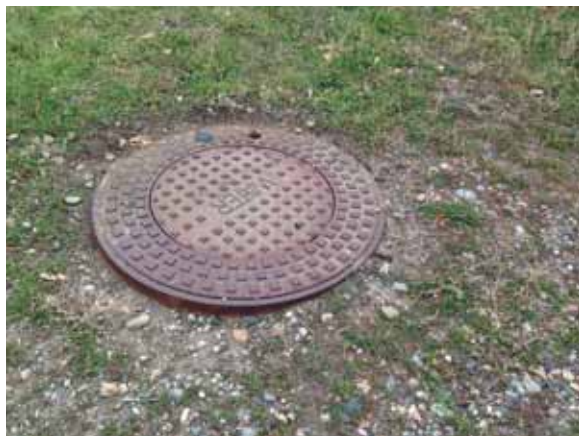
Figure 2.1.A.8 – Water Manhole

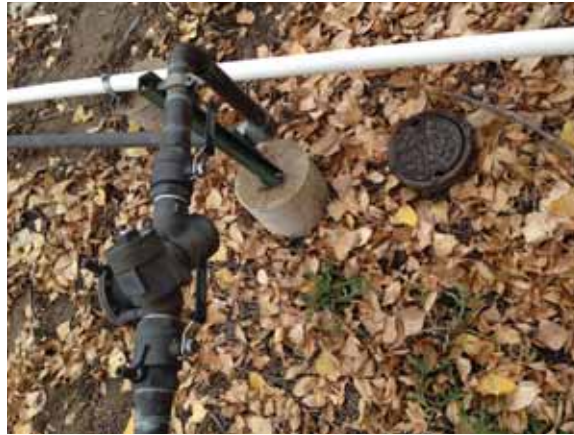
Figure 2.1.A.9 – Water Meter

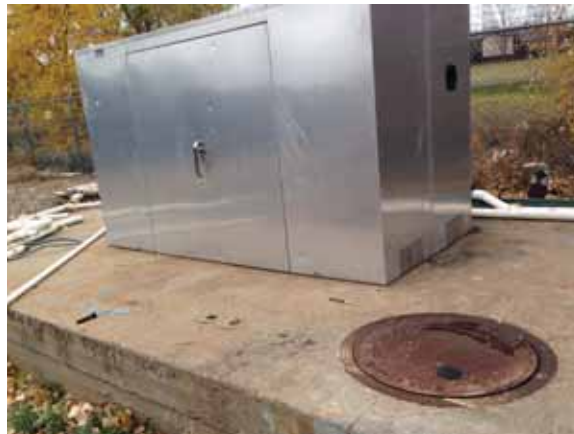
Figure 2.1.A.10 – Water Vault

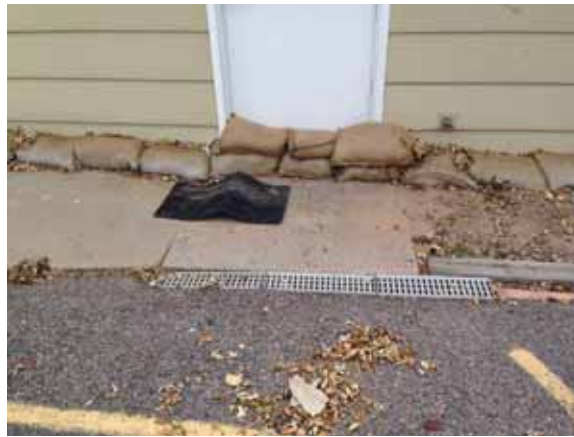
Figure 2.1.A.13 – Trench Drain and Sandbags at Building #97

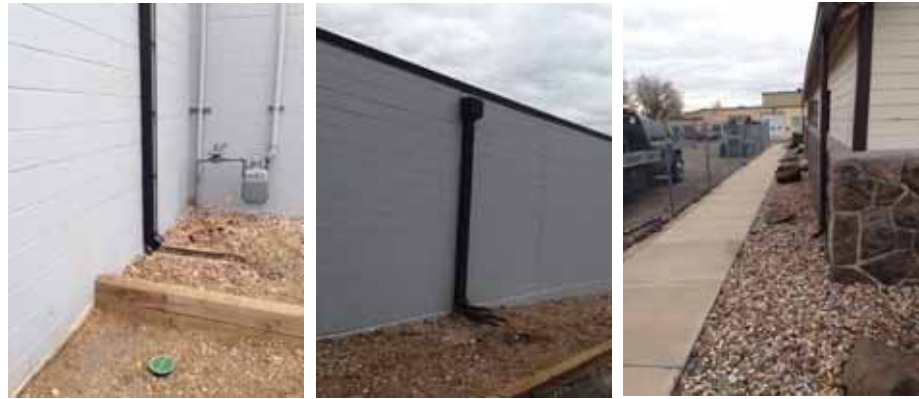
Figure 2.1.A.19 – Roof Drains

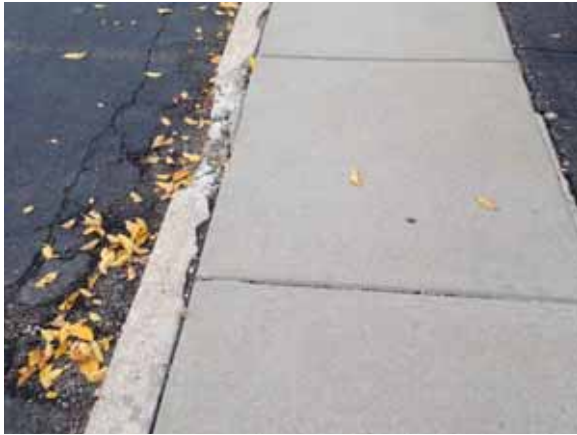
Figure 2.1.A.20 – Broken Curb

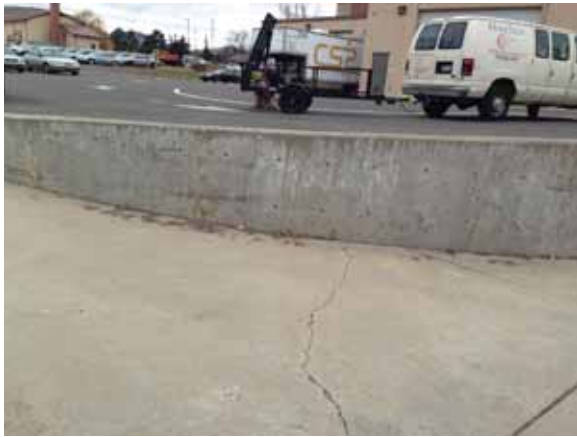
Figure 2.1.A.21 – Site Concrete Crack

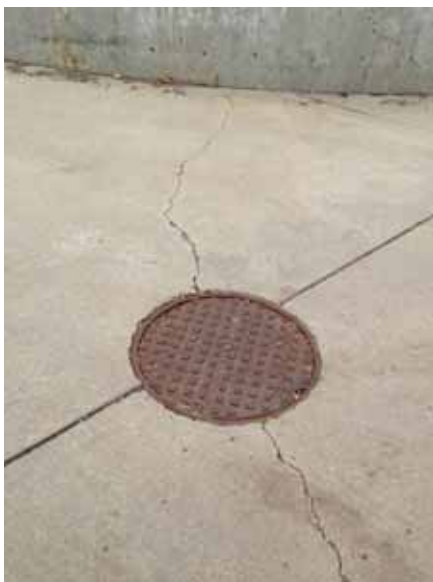
Figure 2.1.A.22 – Site Concrete Crack

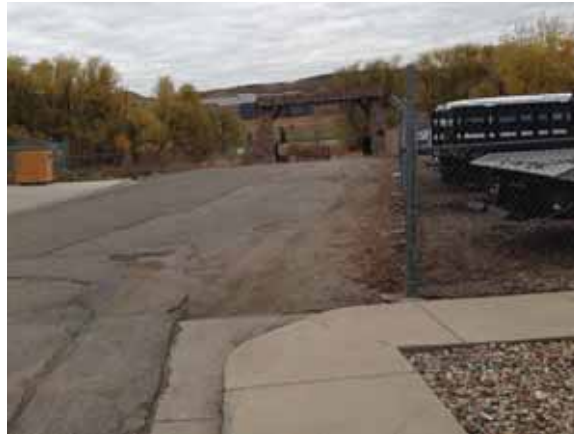
Figure 2.1.A.23 – Sidewalk Cracking

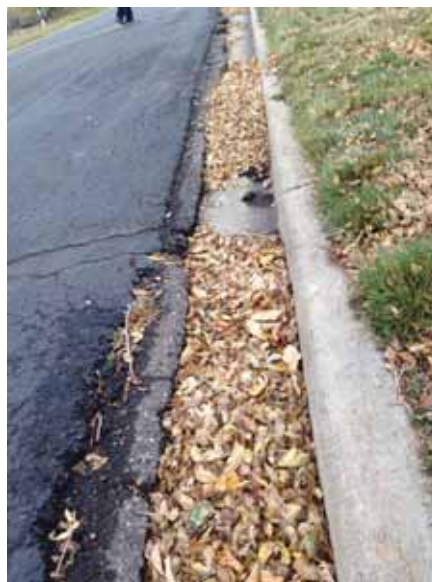
Figure 2.1.A.24 – Asphalt Thickness above Gutter

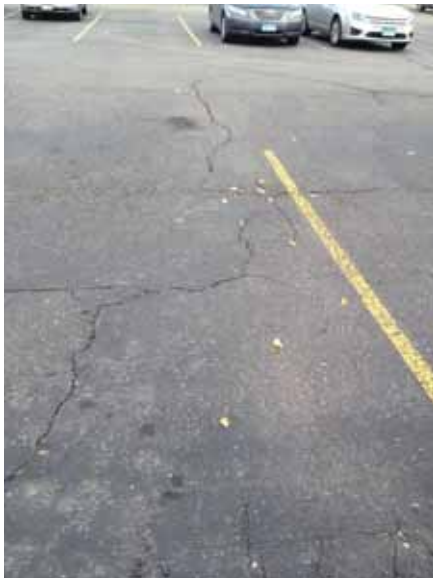
Figure 2.1.A.26 – Asphalt Cracking near Building #120

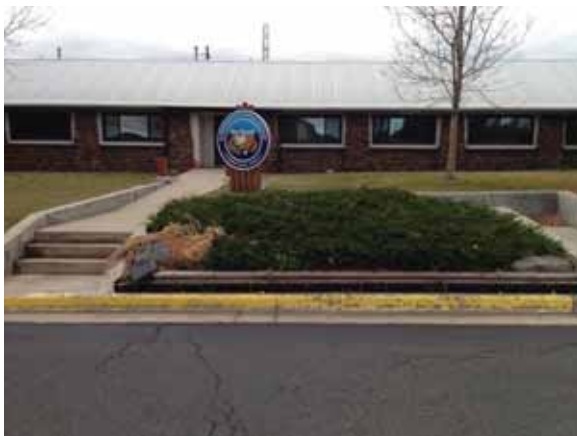
Figure 2.1.A.27 – Asphalt Cracking near Building #120

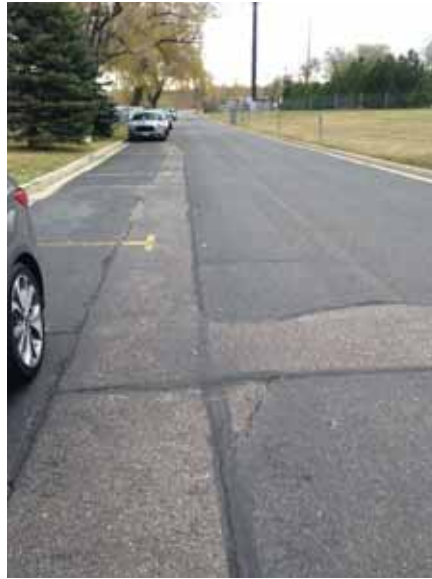
Figure 2.1.A.28 – Uneven Asphalt and Sealed Cracks

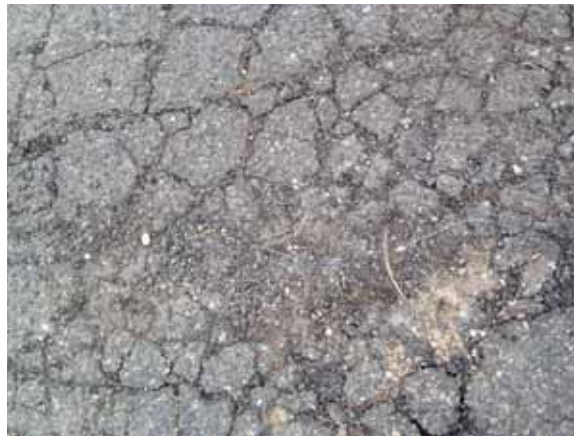
Figure 2.1.A.29 – Broken Asphalt in Poor Condition

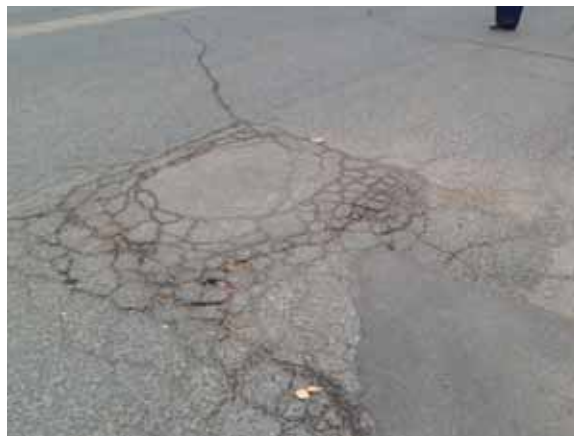
Figure 2.1.A.30 – Poor Asphalt Condition in Drive Isles

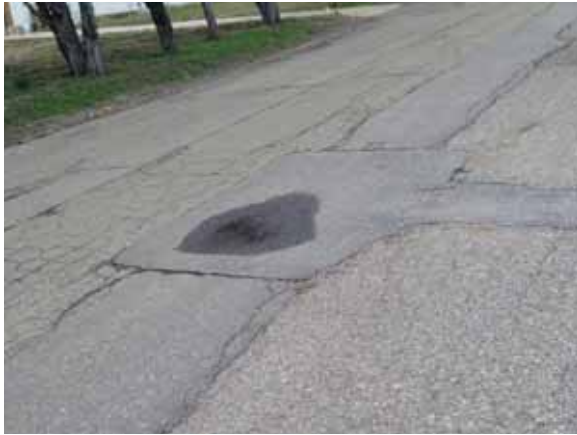
Figure 2.1.A.31 – Uneven,
Patched Asphalt

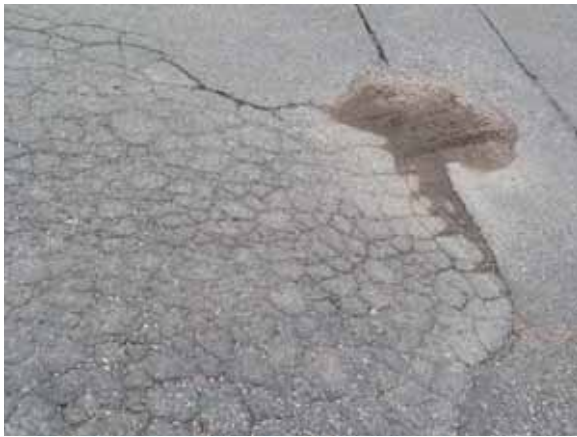
Figure 2.1.A.32 – Poor
Asphalt Condition in
Parking Area

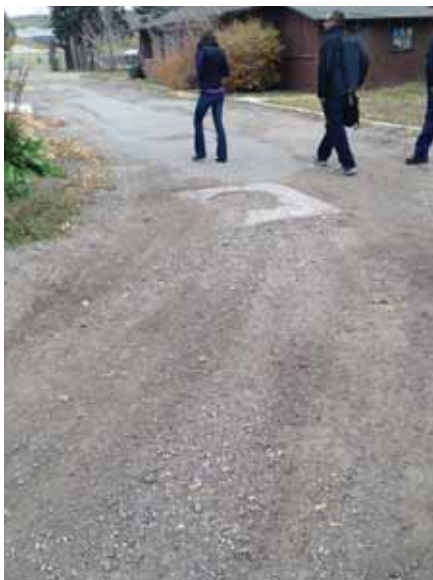
Figure 2.1.A.33 – Poor Asphalt
Condition in Drive Aisle

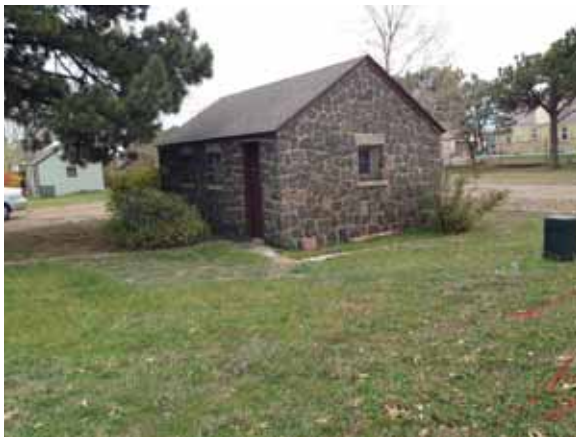
Figure 2.1.B.1 – Flat Grades Away From Building

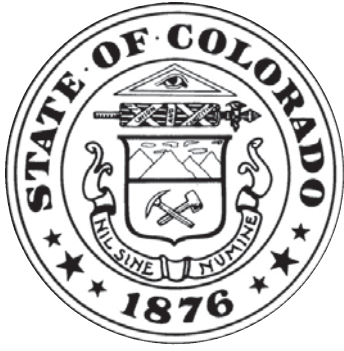
2.0 OVERALL SITE ASSESSMENT FINDINGS & RECOMMENDATIONS

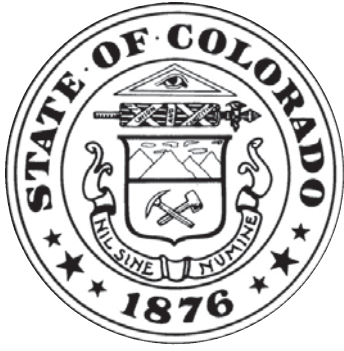
2.0 OVERALL SITE ASSESSMENT FINDINGS & RECOMMENDATIONS
