**OFFICE OF THE
STATE ARCHITECT**

**VACANT
FACILITIES
REPORT**

Revision: December 2020

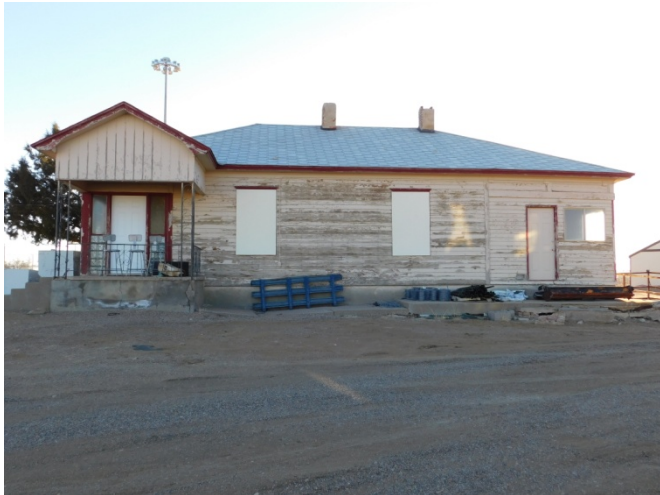
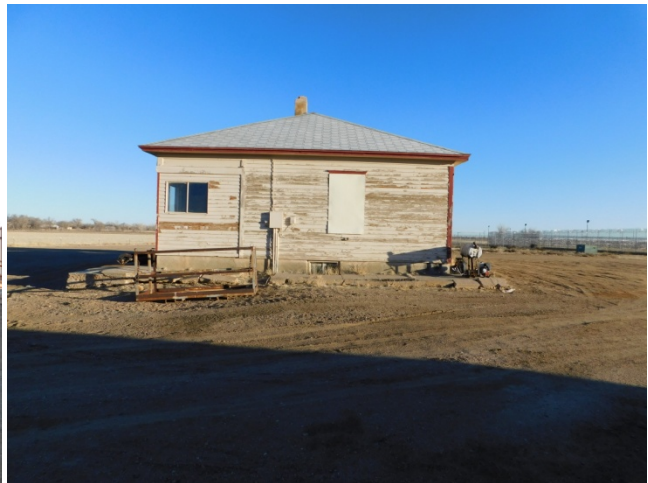
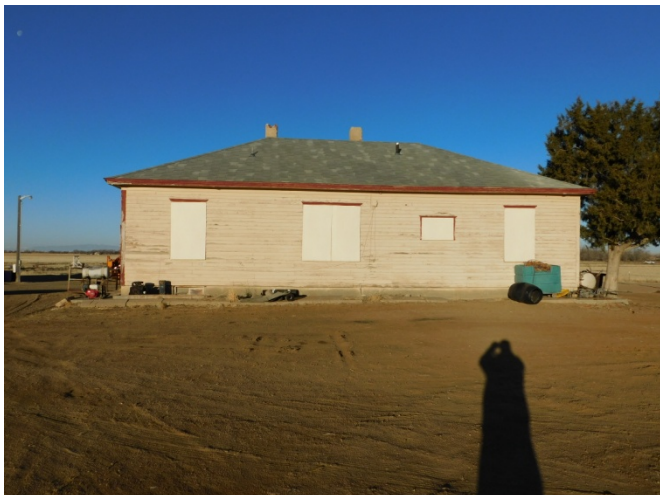
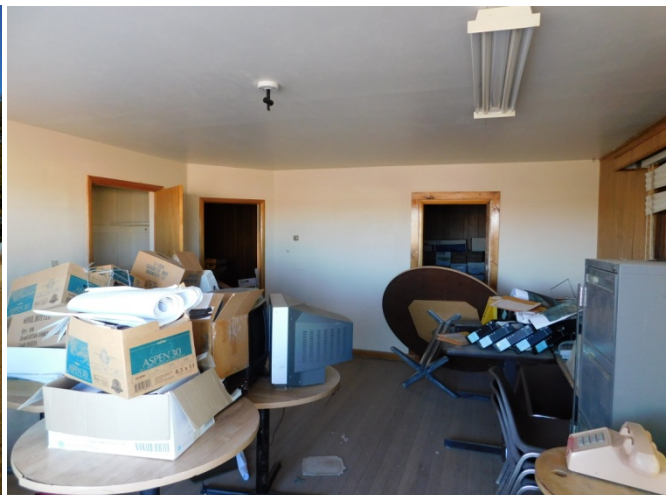
The building is at the end of its lifecycle and has a completely depreciated value. Refurbishing the building would require a capital investment to remediate hazardous materials and refurbish the interior and exterior. Access to the property is over state land through a secured area, so there does not appear to be any repurposing potential.

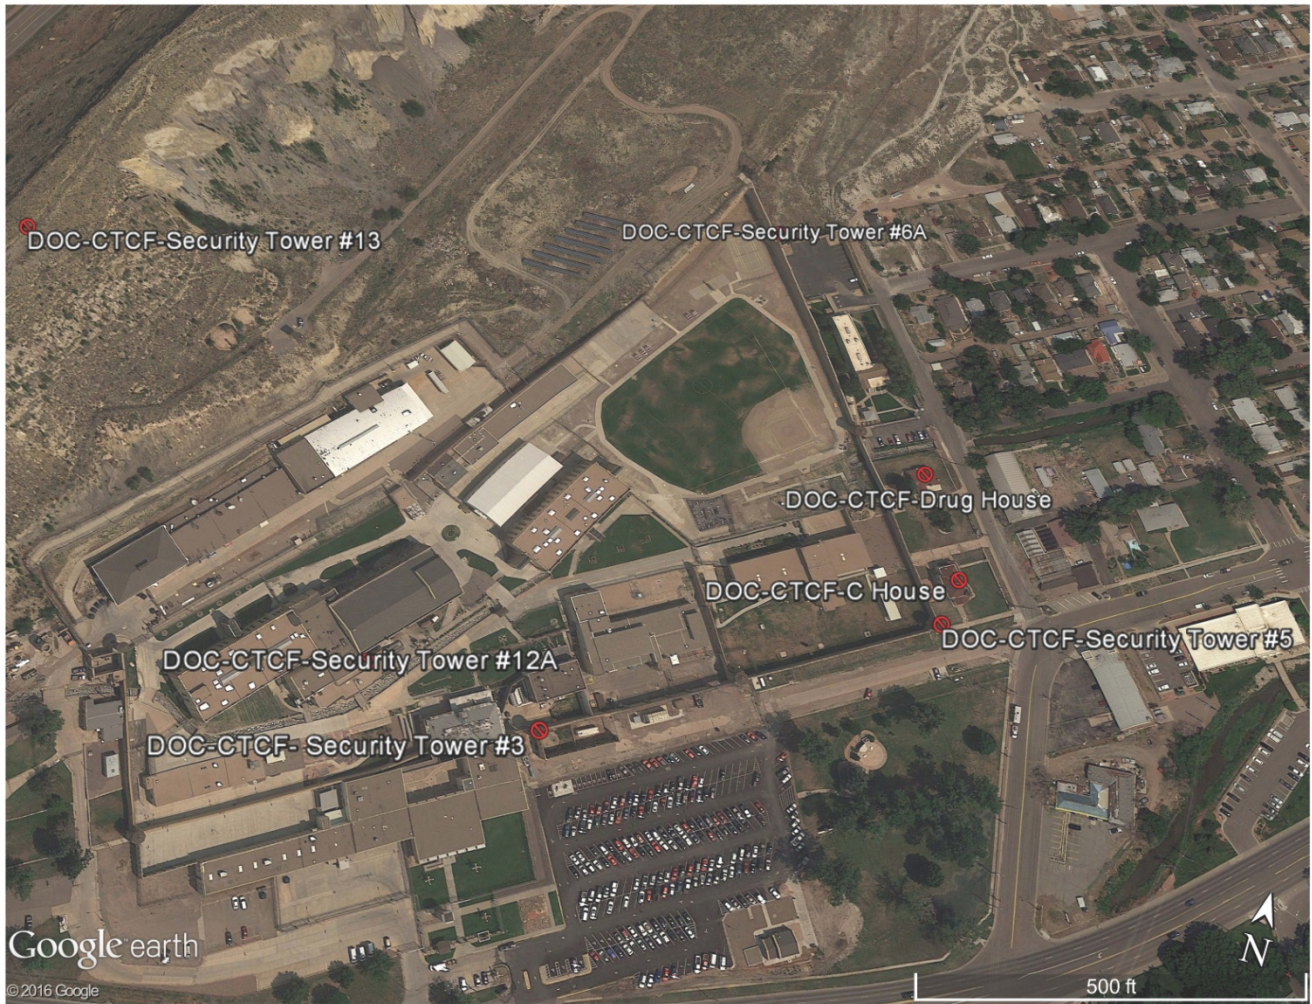
The building is currently dry-closed with no current use by the agency. The agency has indicated it would demolish the asset should funds become available. The interior has been remediated due to a water leak in 2010.

The building is at the end of its lifecycle and has a completely depreciated value. Refurbishing the building would require a capital investment to remediate hazardous materials and refurbish the interior and exterior. Access to the property is over state land, so there does not appear to be any repurposing potential.

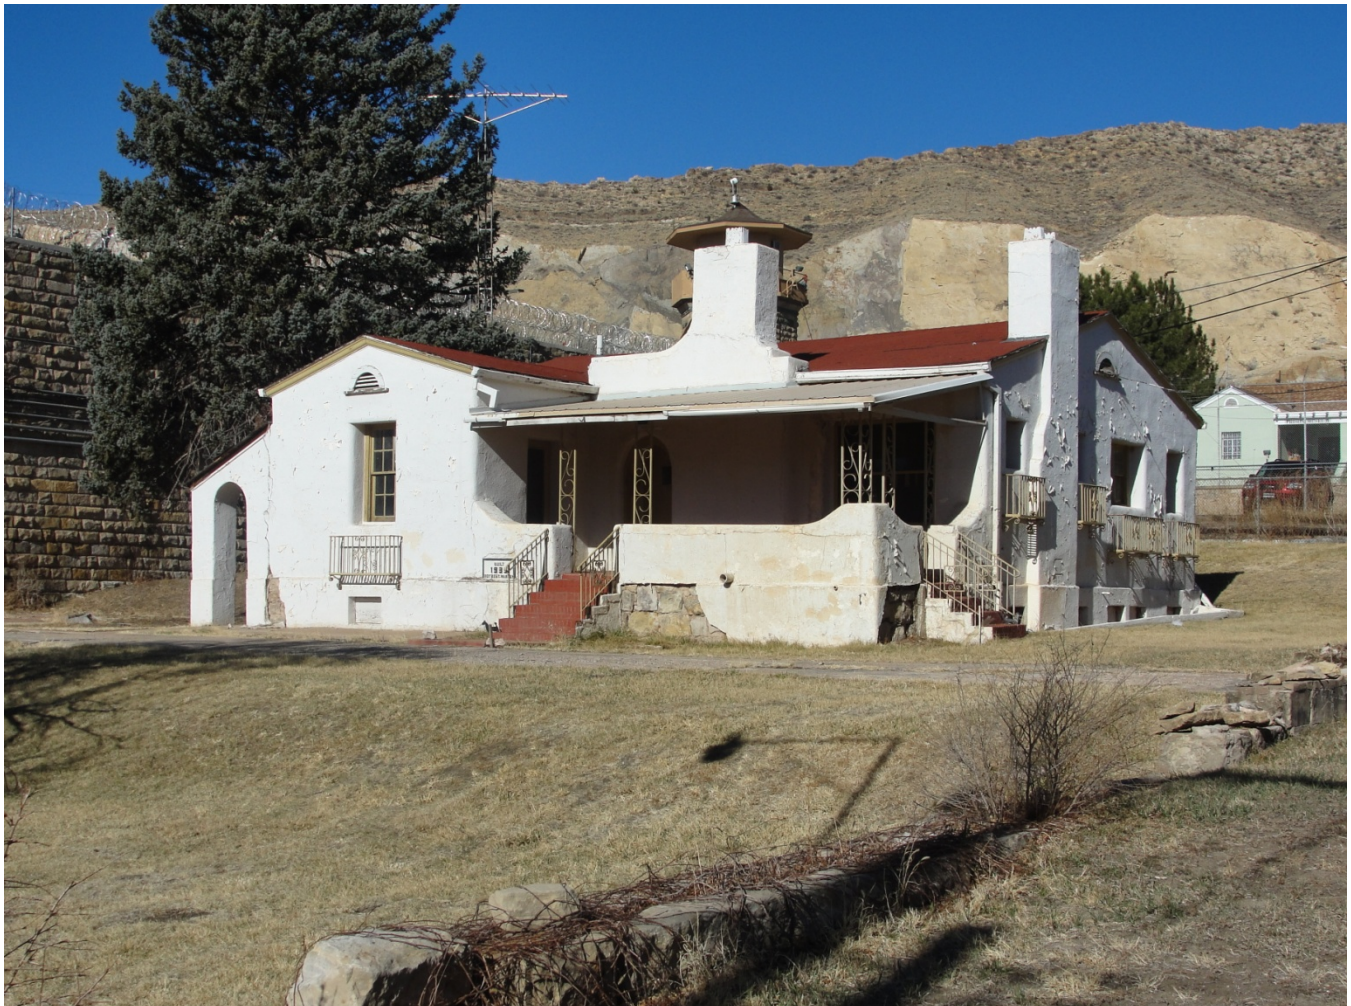
The building is at the end of its lifecycle and has a completely depreciated value. Refurbishing the building would require a capital investment to remediate hazardous materials and refurbish the interior and exterior. Access to the property is over state land through a secured area, so there does not appear to be any repurposing potential. However, due to the historic nature of the asset, the agency has marked this to be refurbished and used for other agency purposes.

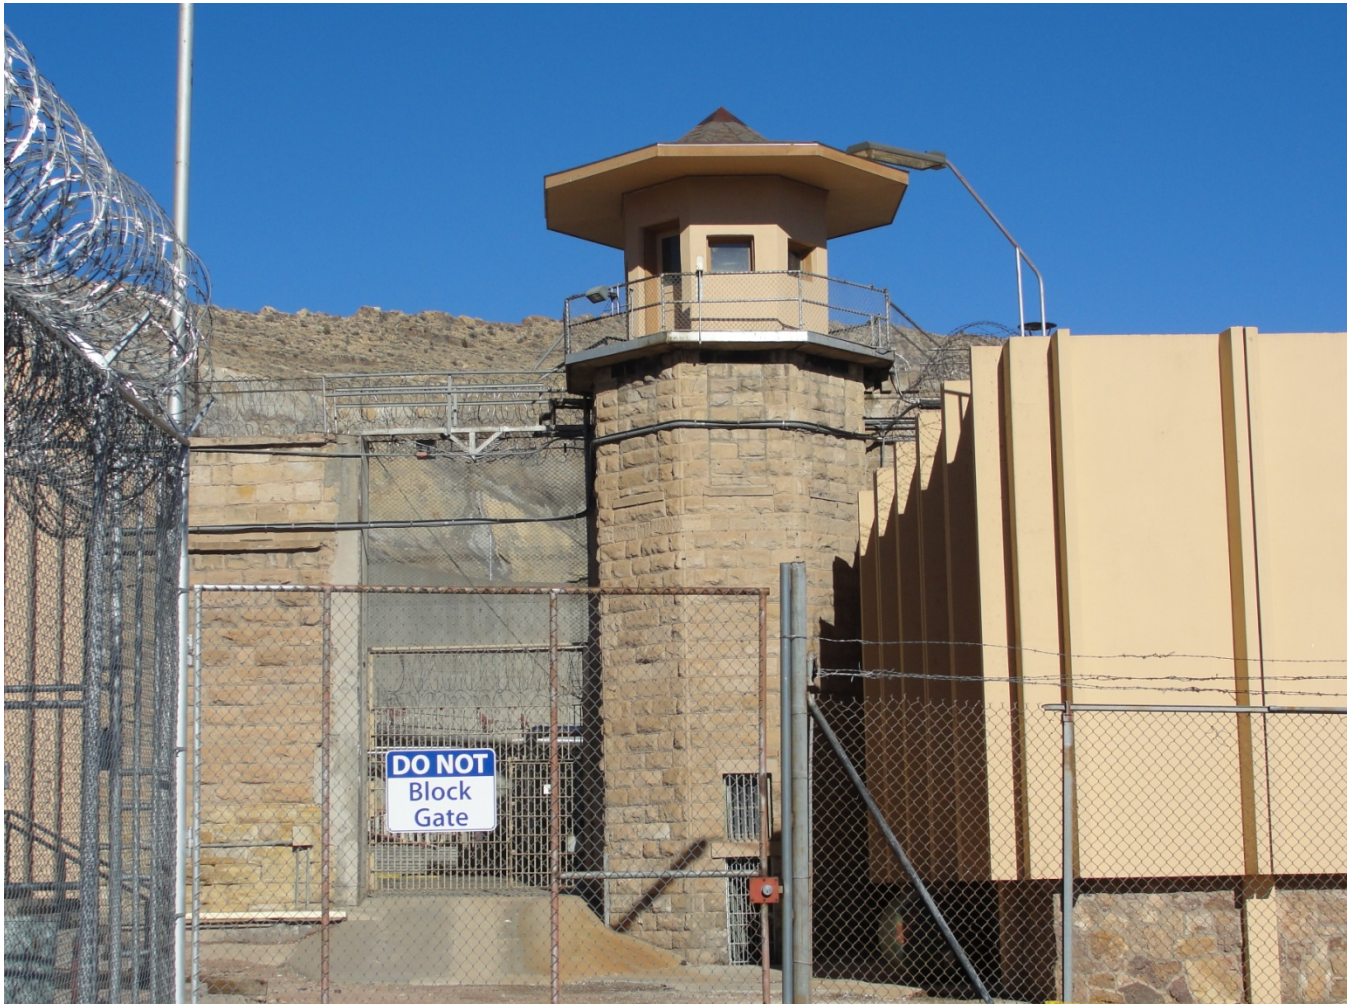
This asset is part of a security wall and has no potential for private use. The asset, if refurbished, might be used by the agency for other purposes. This asset will not be made active due to staffing needs.

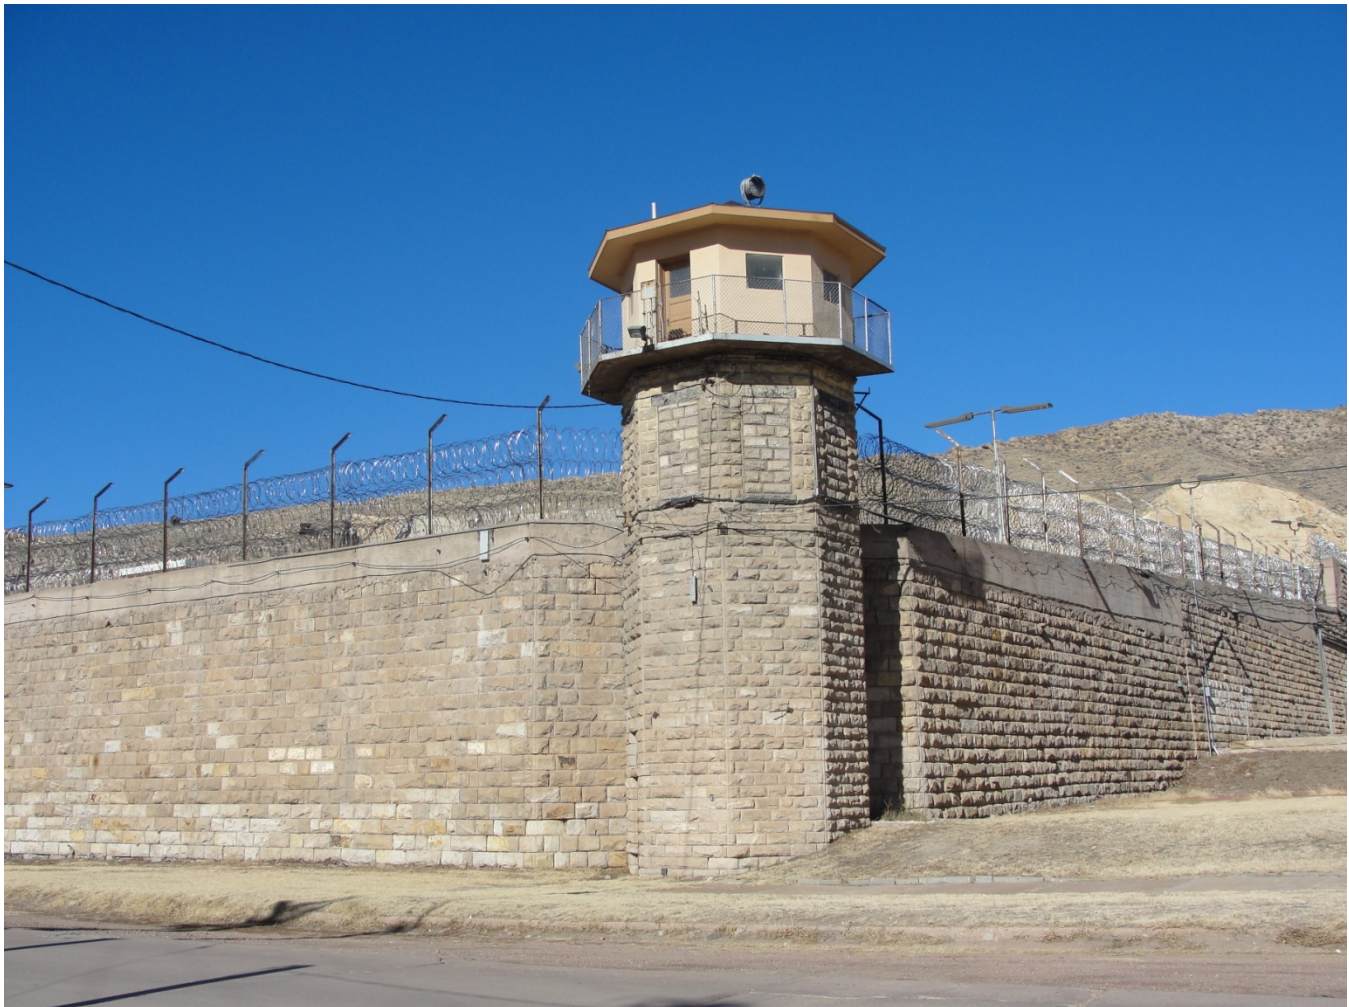
This asset is part of a security wall and has no potential for private use. The asset, if refurbished, might be used by the agency for other purposes. This asset will not be made active due to staffing needs.

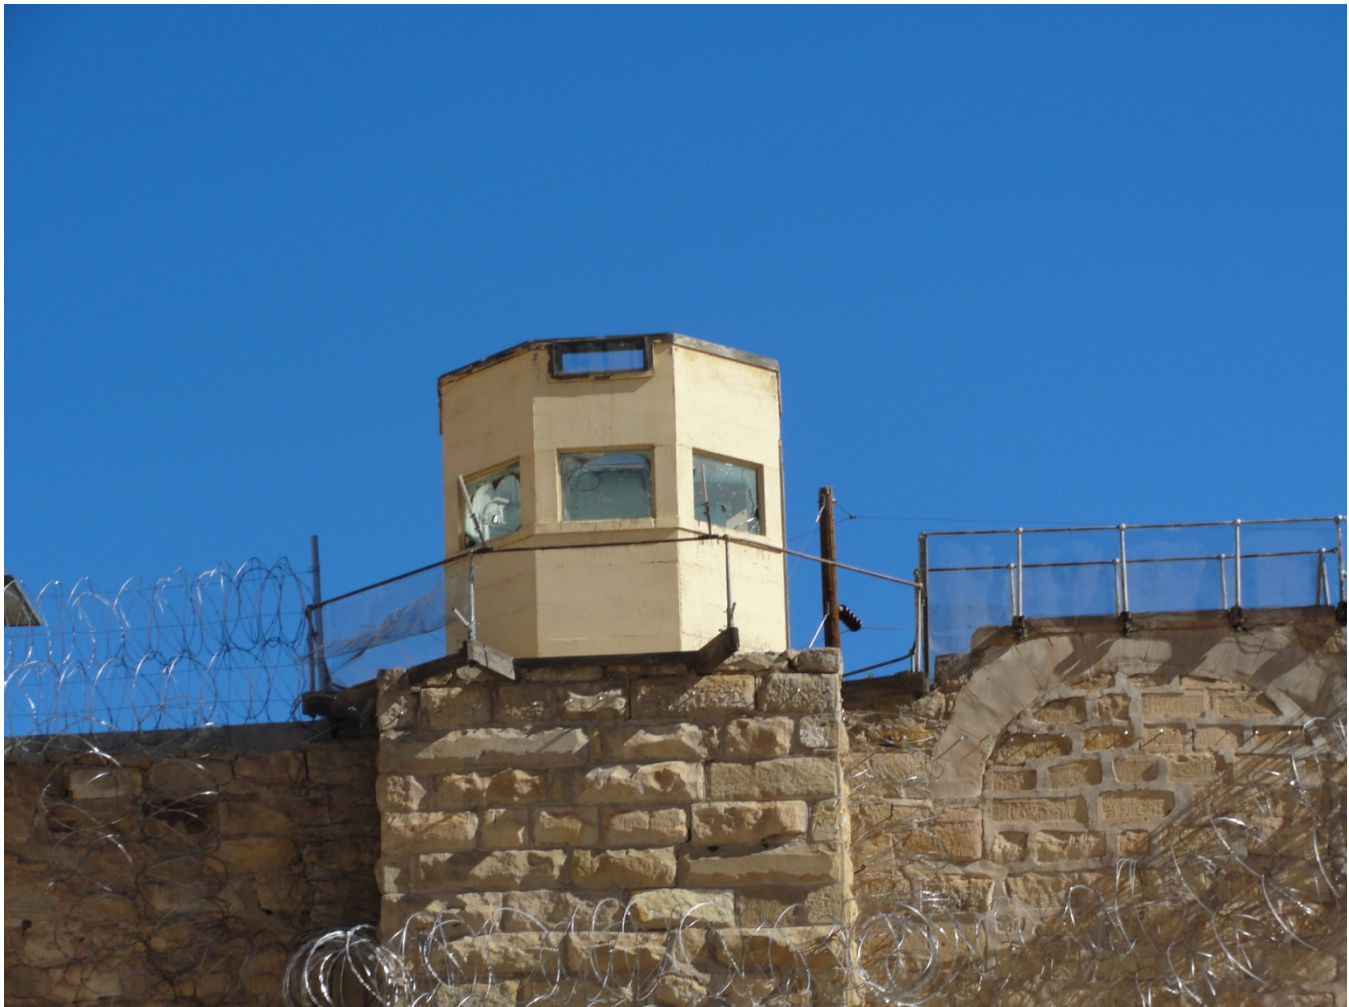
This asset is on a sloping, rocky site with no road or heavy equipment access. Demolition would require strategic disassembly. There is a high risk of rock slides with risk of damage to existing perimeter security fencing.

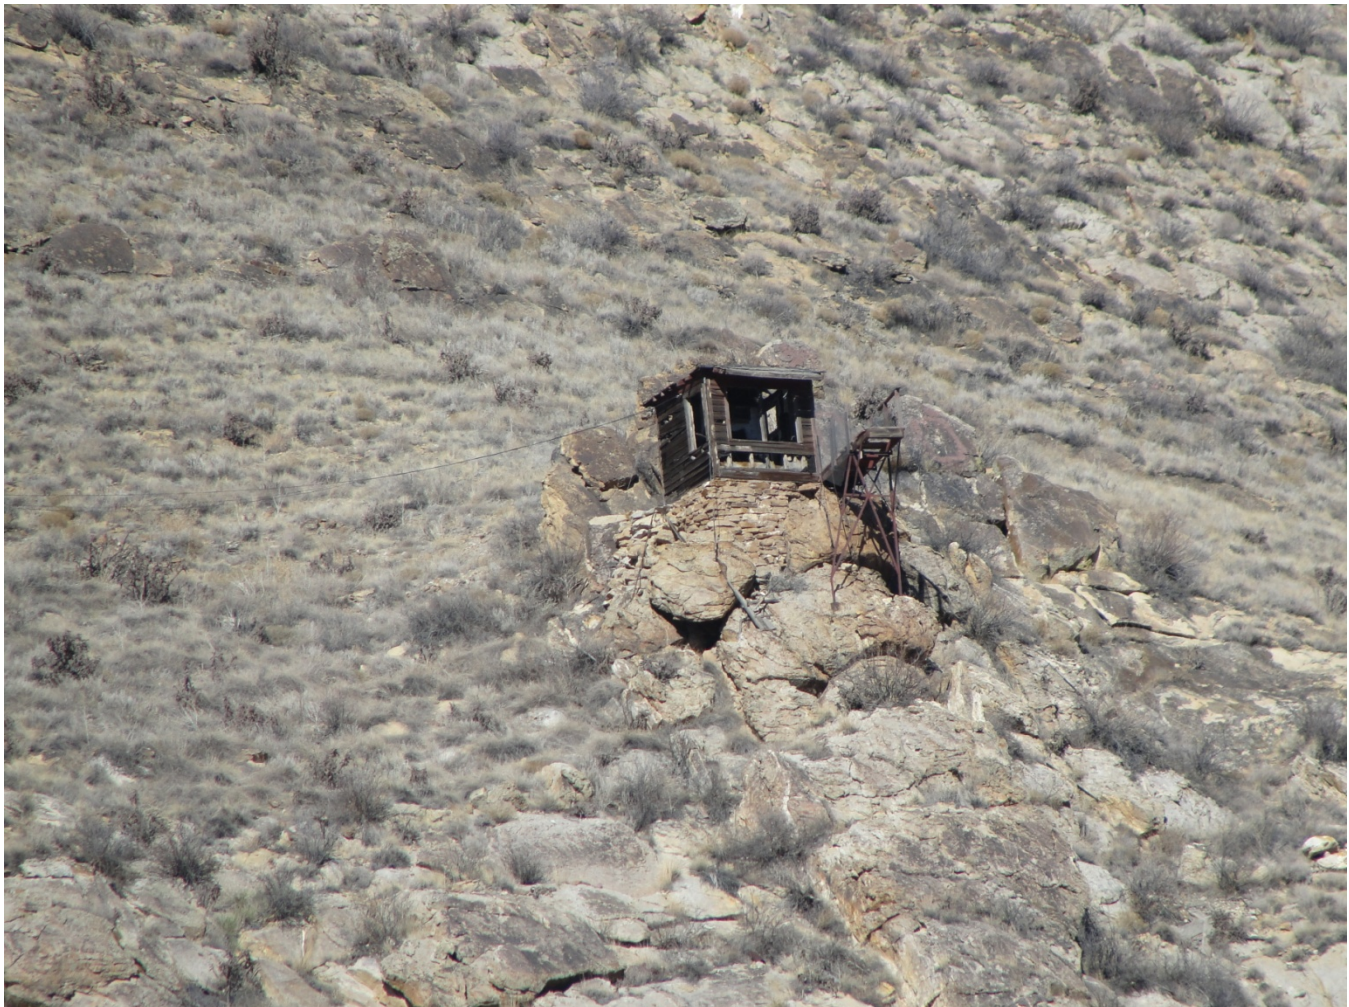
This asset is on a sloping rocky site with no road or heavy equipment access and demolition would require strategic disassembly. There is a high risk of rock slides with risk of damage to existing perimeter security fencing from falling debris.

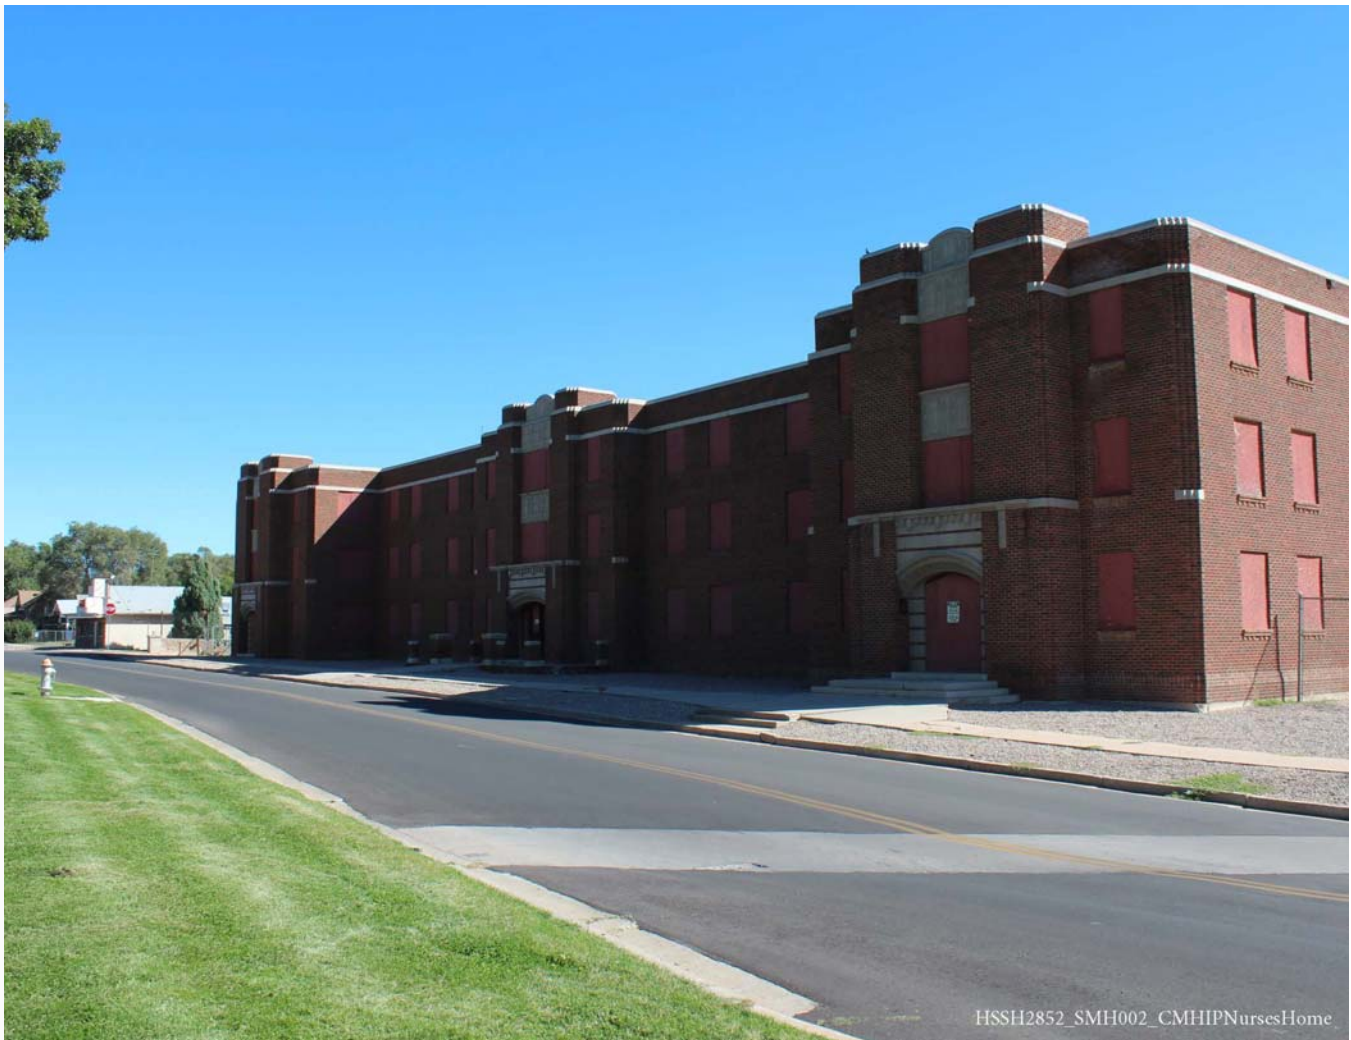
HSSH2852_SMH002_CMHIPNursesHome

The building has been vacant since 2009. It is in wet-closed condition, so it is conditioned in the winter. There are no current agency demolition plans for this facility.

The building was a maximum security prison, so repurposing this facility would be difficult if not impossible for a different use. Previous work on the building severed a post-tensioned cable in slab assembly so some repair would be required if the building were to be used again. The structural defect has not deemed the building unsafe but has resulted in some warped slabs.

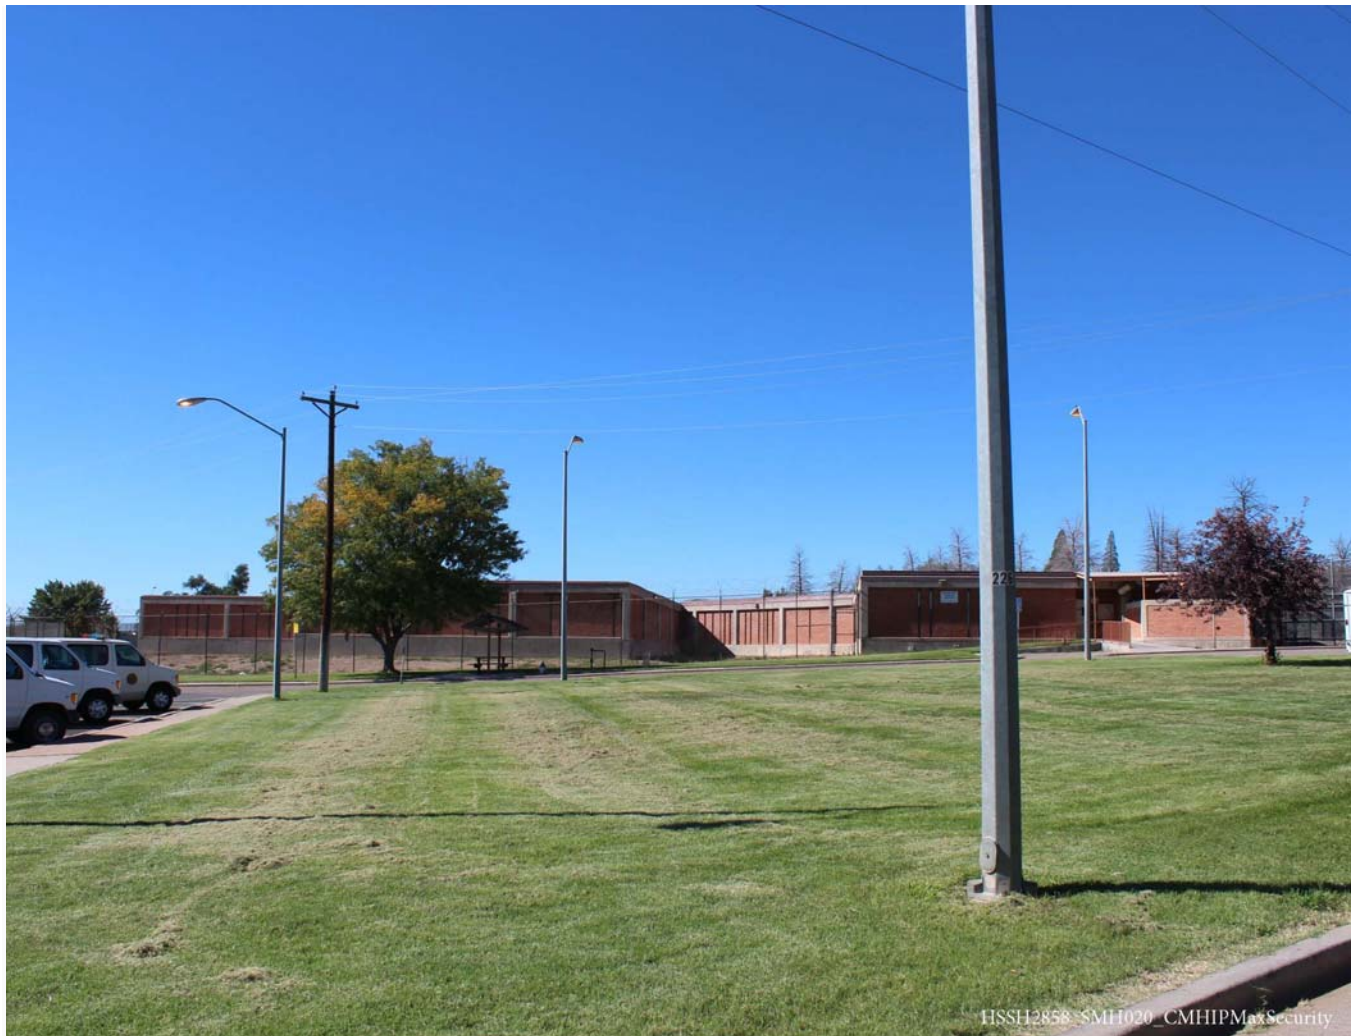
HSSH2858 SMH020_CMHIPMaxSecurity

The building has been vacant since 2009. It is in dry-closed condition with minimal holding costs. It is slated for demolition by the agency.

The building was part of the maximum security prison, so repurposing this building would likely be tied to the reuse of the maximum security building. Otherwise, it would be difficult to separately parcel the land for this building and due to its size, of low value for either lease or sale.

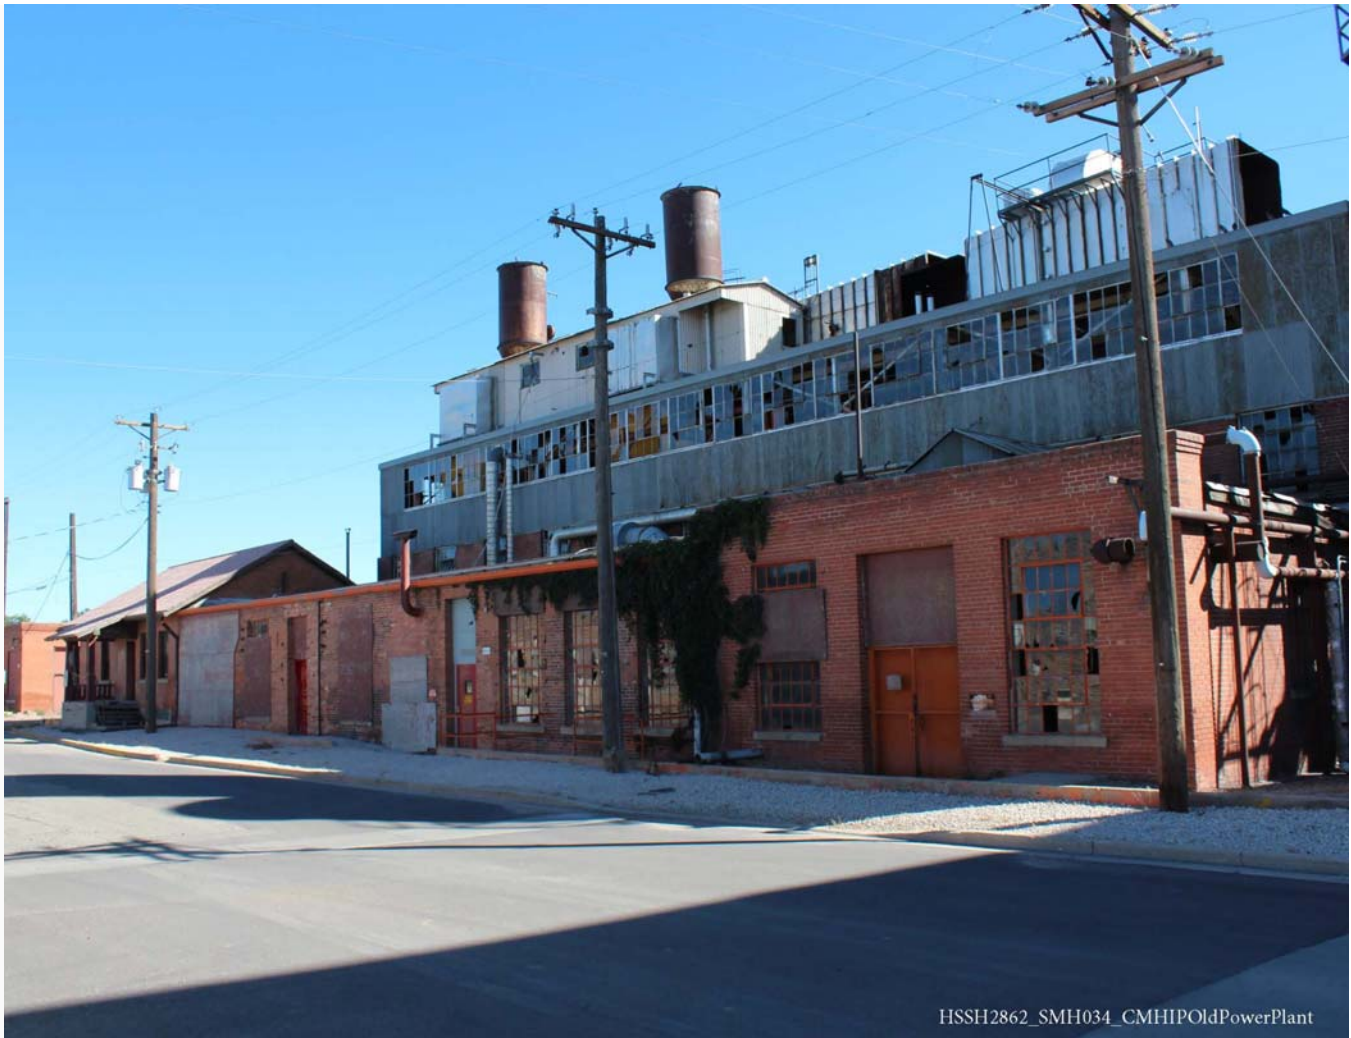
HSSH2862_SMH034_CMHIPOldPowerPlant

The building has been vacant for at least three decades. It is in dry-closed condition with minimal holding costs. It is slated for demolition by the agency.

The building has an interior that would require a substantial cost to remodel. Extensive code and environmental hazards exist. Since the building is situated in the center of campus, a sale would be difficult or impossible. Prior to any lease, the building would require a large scale interior remodel.

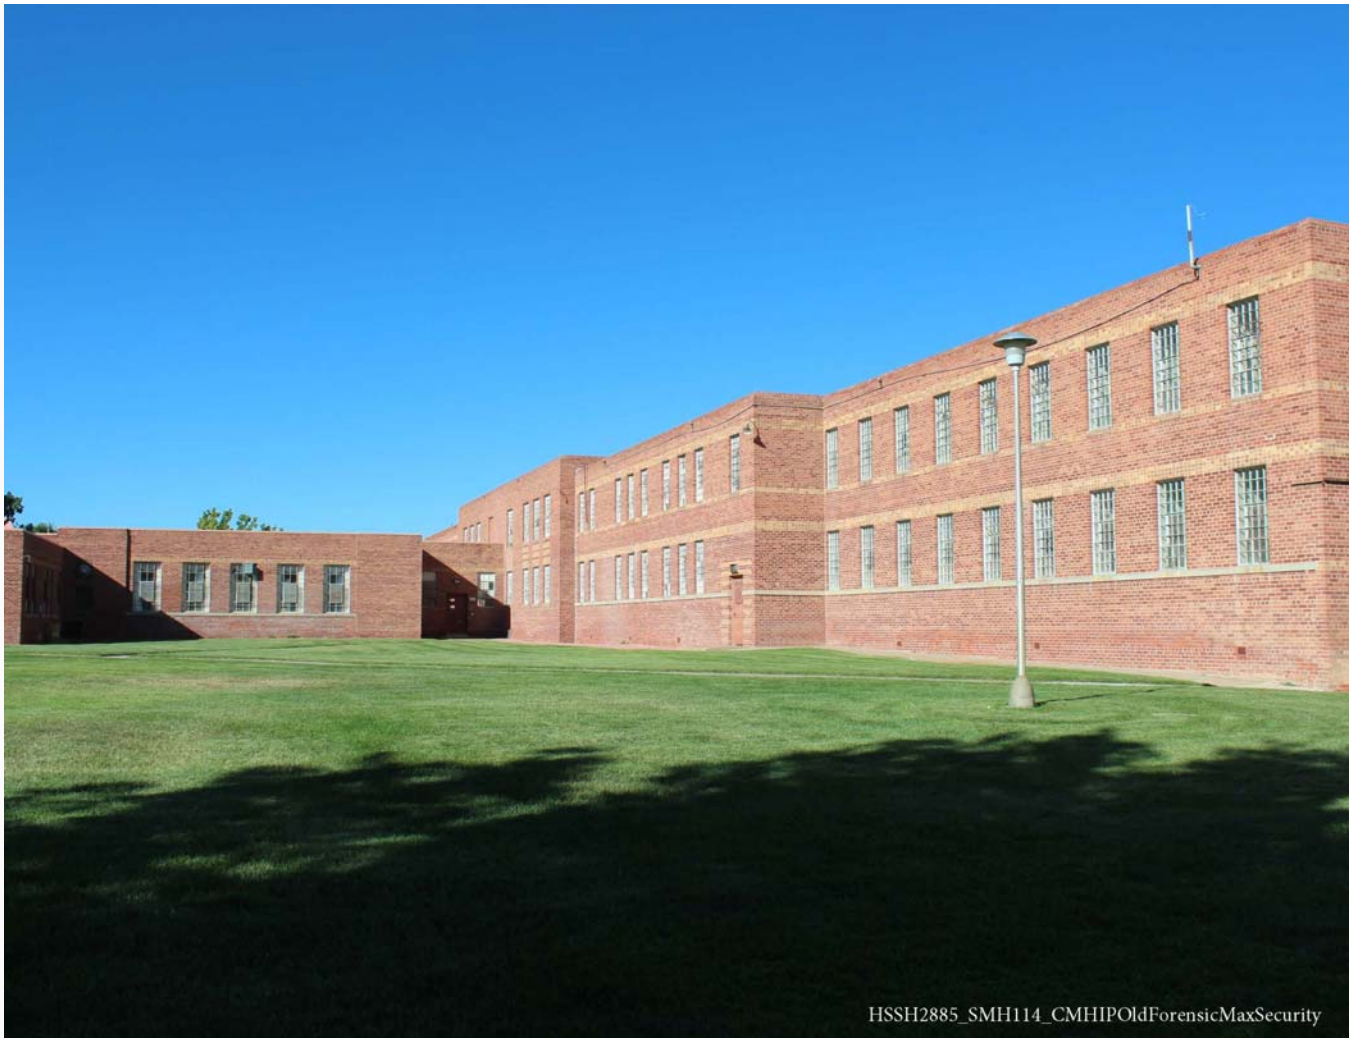
HSSH2885_SMH114_CMHIPOldForensicMaxSecurity

The building has been vacant for at least three decades. It is in dry-closed condition with minimal holding costs. It is slated for demolition by the agency.

The location of this building makes repurposing to use by the private sector challenging. The location next to the old power plant, max security facility and the existing rail lines without dedicated parking limits available markets. The building is at the end of its depreciation cycle so refurbishment would be high compared to the buildings value. It likely contains environmental hazards.

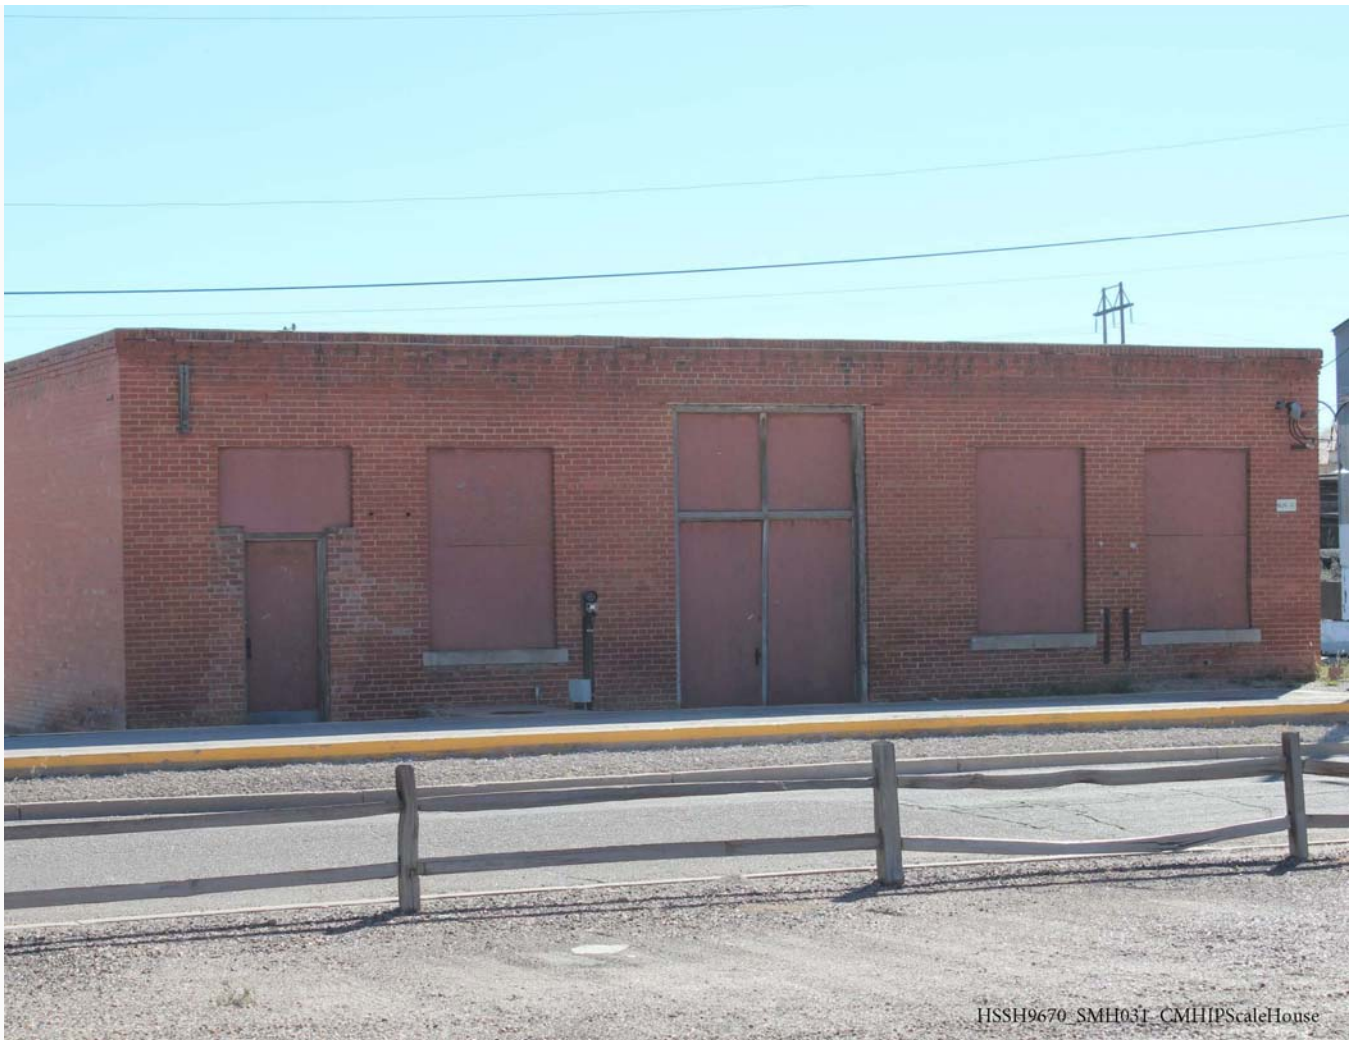
HSSH9670 SMH031 CMHIPScaleHouse

The building has been vacant for at least three decades. It is in dry-closed condition with minimal holding costs. It is slated for demolition by the agency.

The location of this building makes repurposing to use by the private sector challenging. The location next to the old power plant, max security facility and the existing rail lines without dedicated parking limits available markets. The building is at the end of its depreciation cycle so refurbishment would be high compared to the buildings value. It likely contains environmental hazards and has portions of the exterior in a state of collapse.

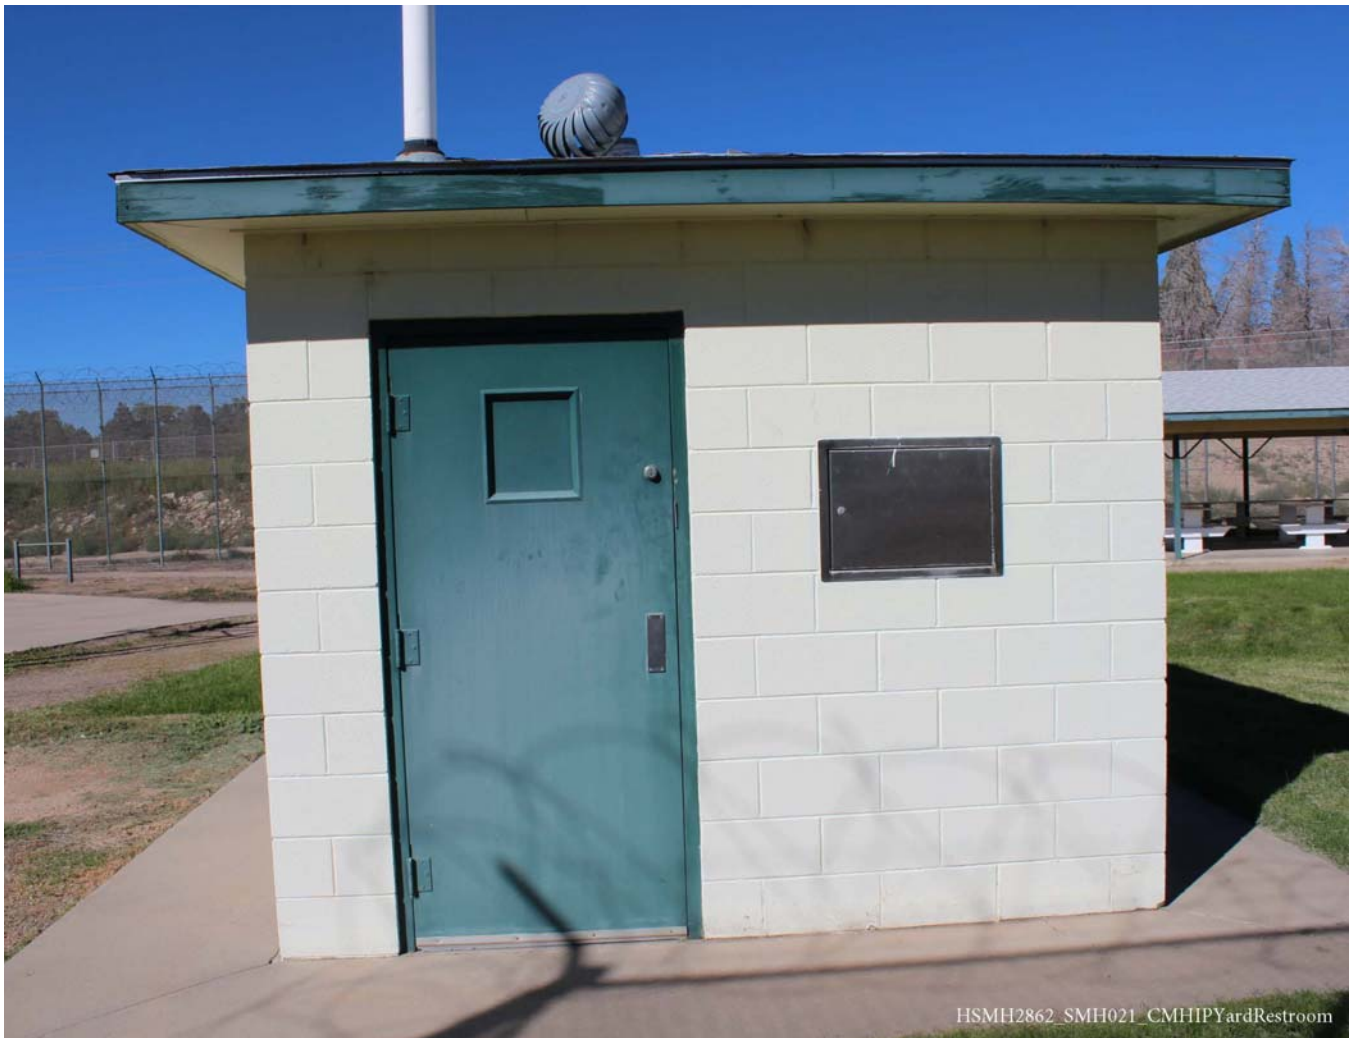
HSMH2862 SMH021 CMHIPYardRestroom

The size and type of building makes the chance of repurposing very low.

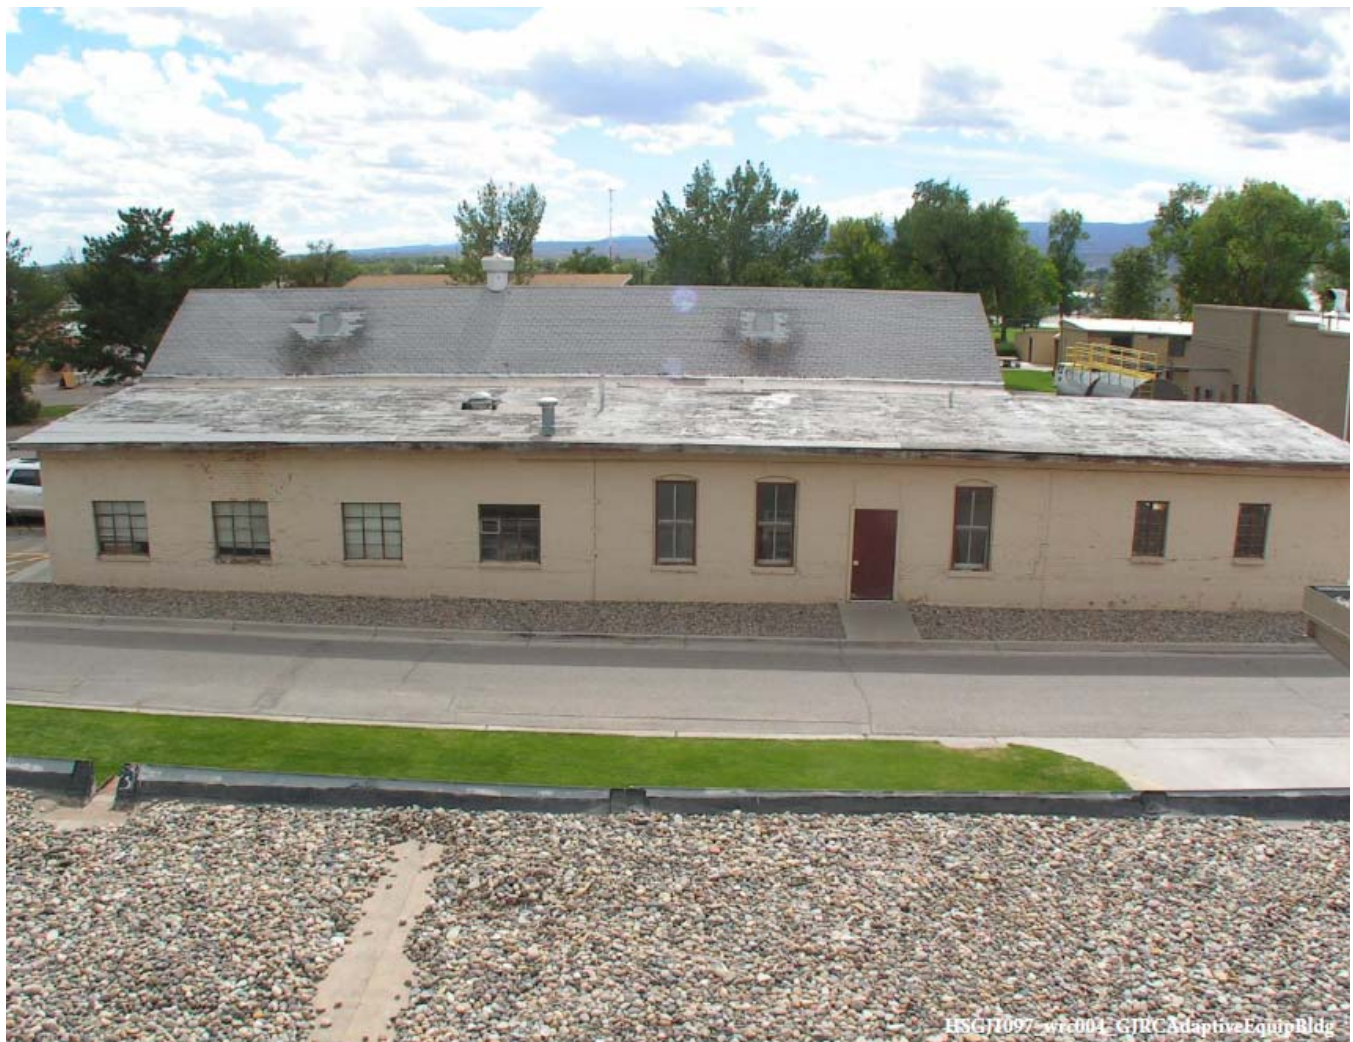
HSGJ1097 - w/c004 GJRC Adaptive Equip Bldg

The building is at the end of its lifecycle and a completely depreciated value. Refurbishing the building would require a capital investment to remediate hazardous materials and refurbish the interior and exterior. This asset along with the others on the 46 acre campus is in the process of having the programs relocated and the land and buildings sold.

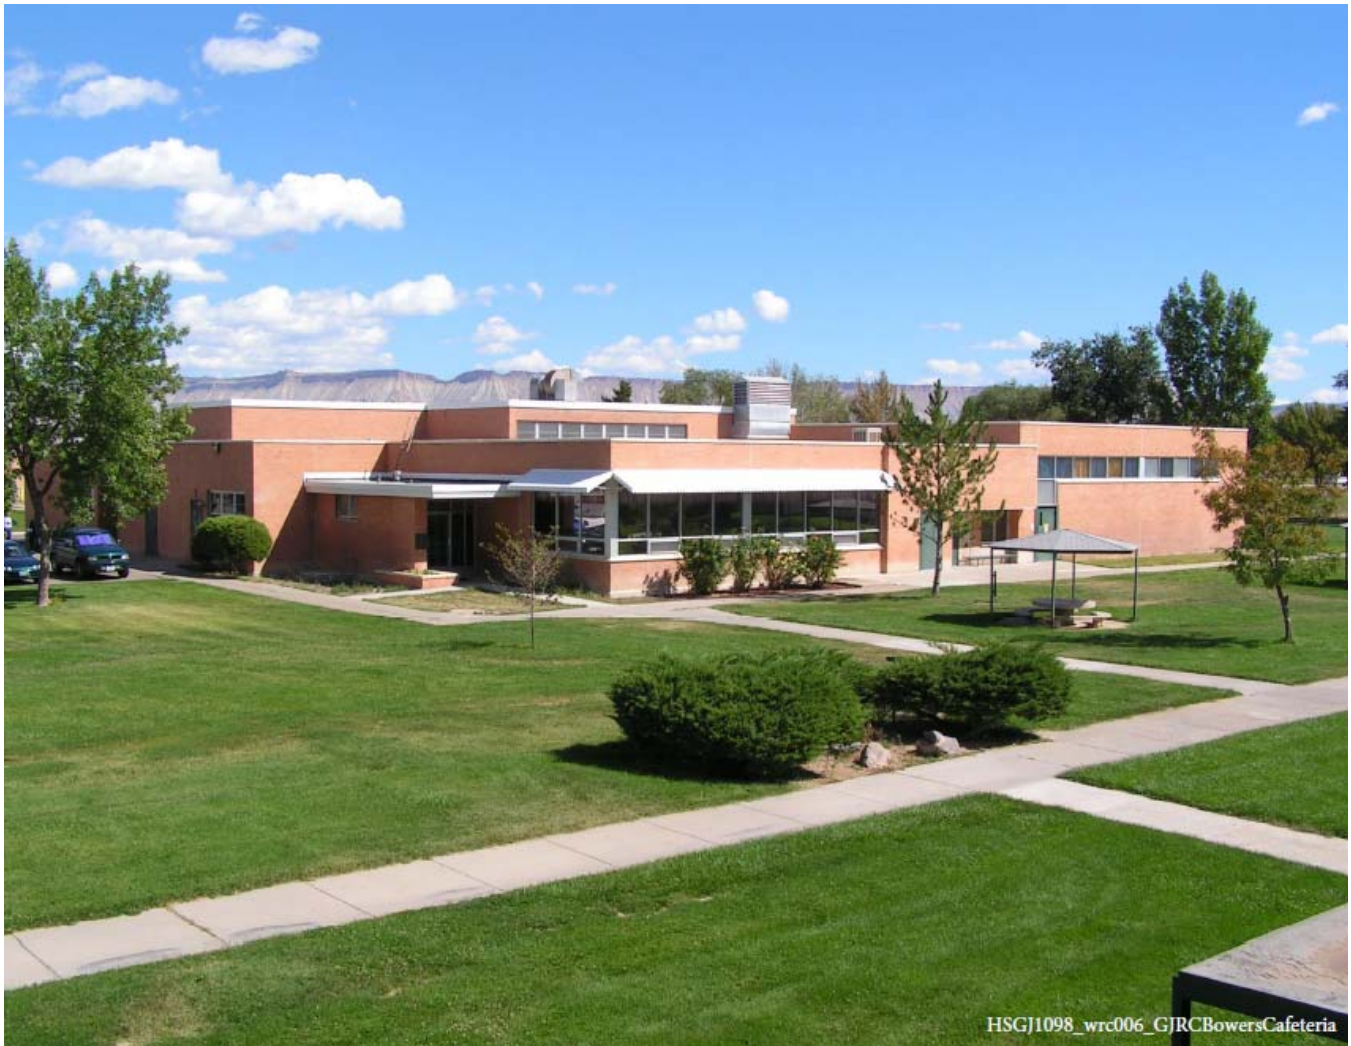
HSGJ1098_wrc006_GJRCBowersCafeteria

The building is at the end of its lifecycle and a completely depreciated value. Refurbishing the building would require a capital investment to remediate hazardous materials and refurbish the interior and exterior. This asset along with the others on the 46 acre campus is in the process of having the programs relocated and the land and buildings sold.
