**OFFICE OF THE
STATE ARCHITECT**

**VACANT
FACILITIES
REPORT**

Revision: December 2020

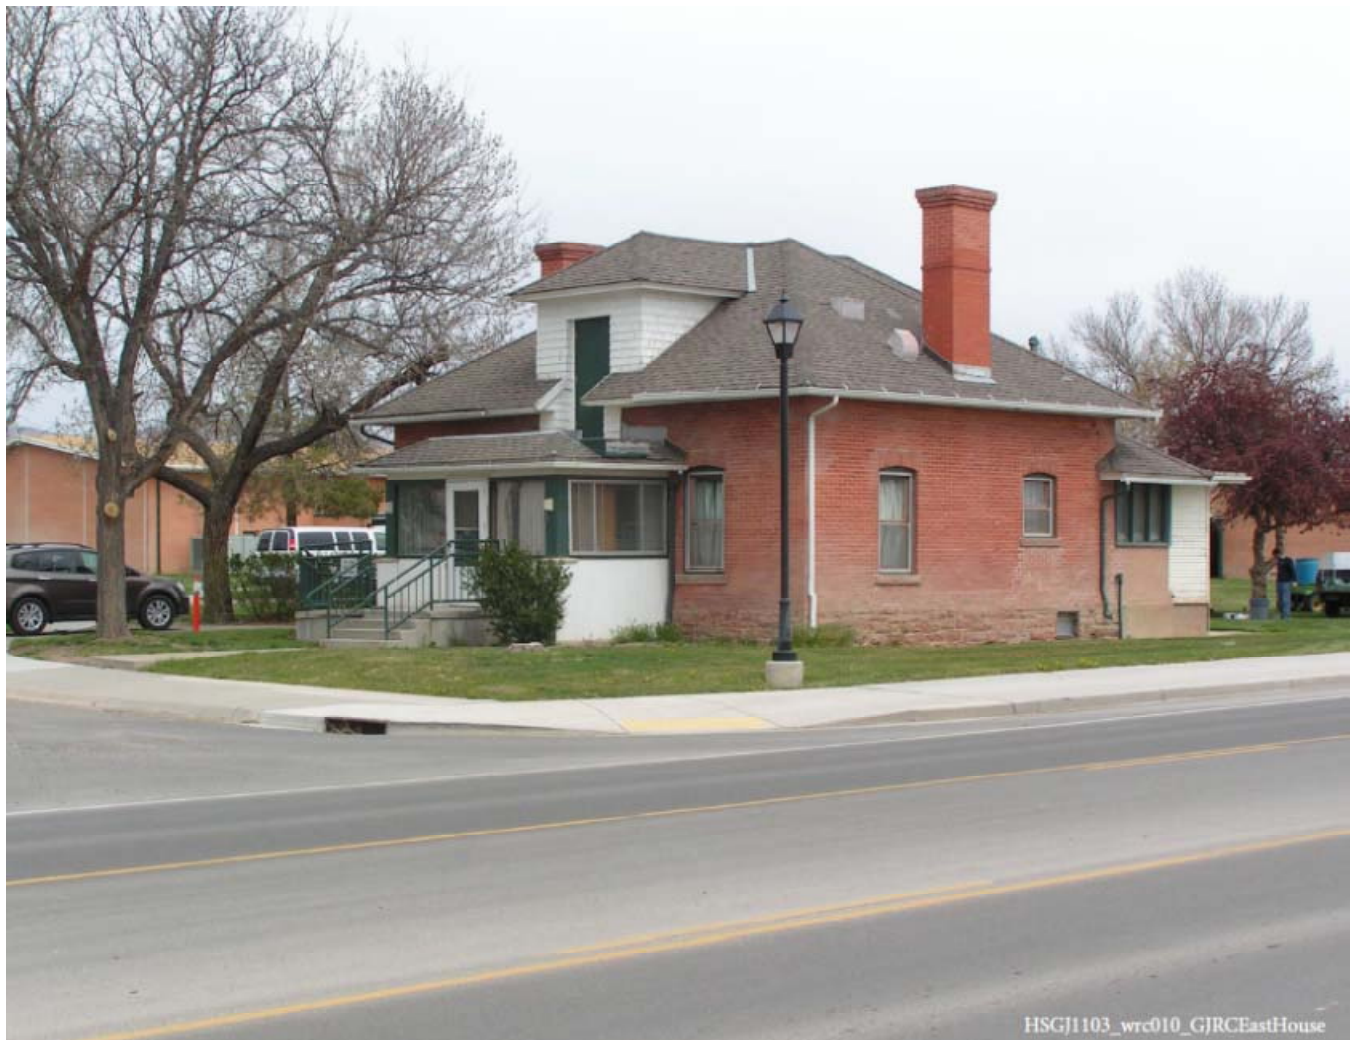
HSGJ1103_wrc010_GJRCEastHouse

The building is at the end of its lifecycle and a completely depreciated value. Refurbishing the building would require a capital investment to remediate hazardous materials and refurbish the interior and exterior. This asset along with the others on the 46 acre campus is in the process of having the programs relocated and the land and buildings sold.

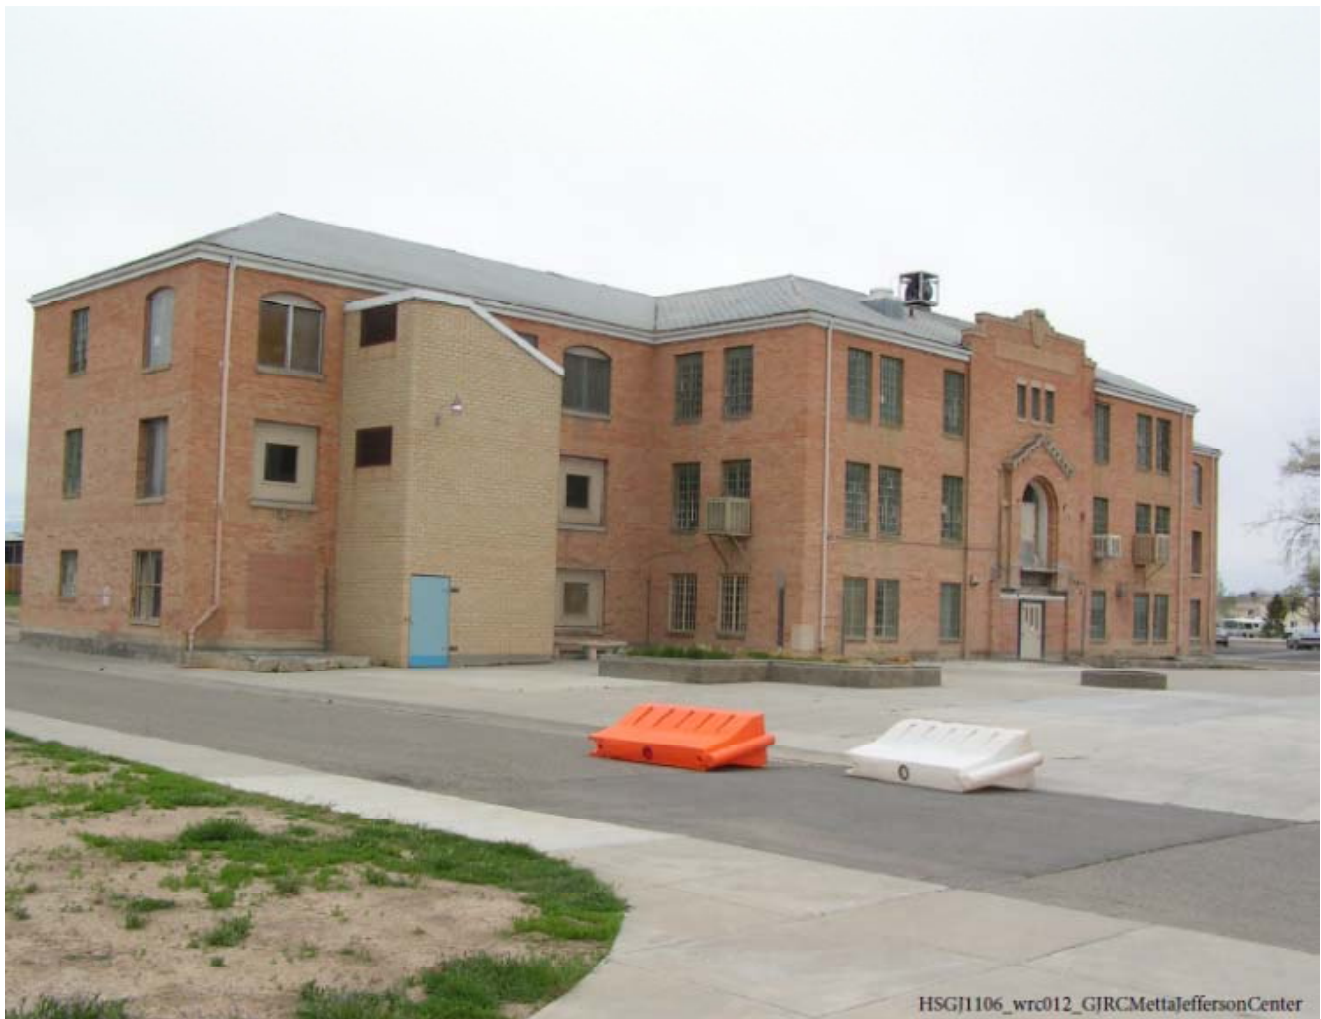
HSGJ1106_wrc012_GJRCMettaJeffersonCenter

The building is at the end of its lifecycle and a completely depreciated value. Refurbishing the building would require a capital investment to remediate hazardous materials and refurbish the interior and exterior. This asset along with the others on the 46 acre campus is in the process of having the programs relocated and the land and buildings sold.

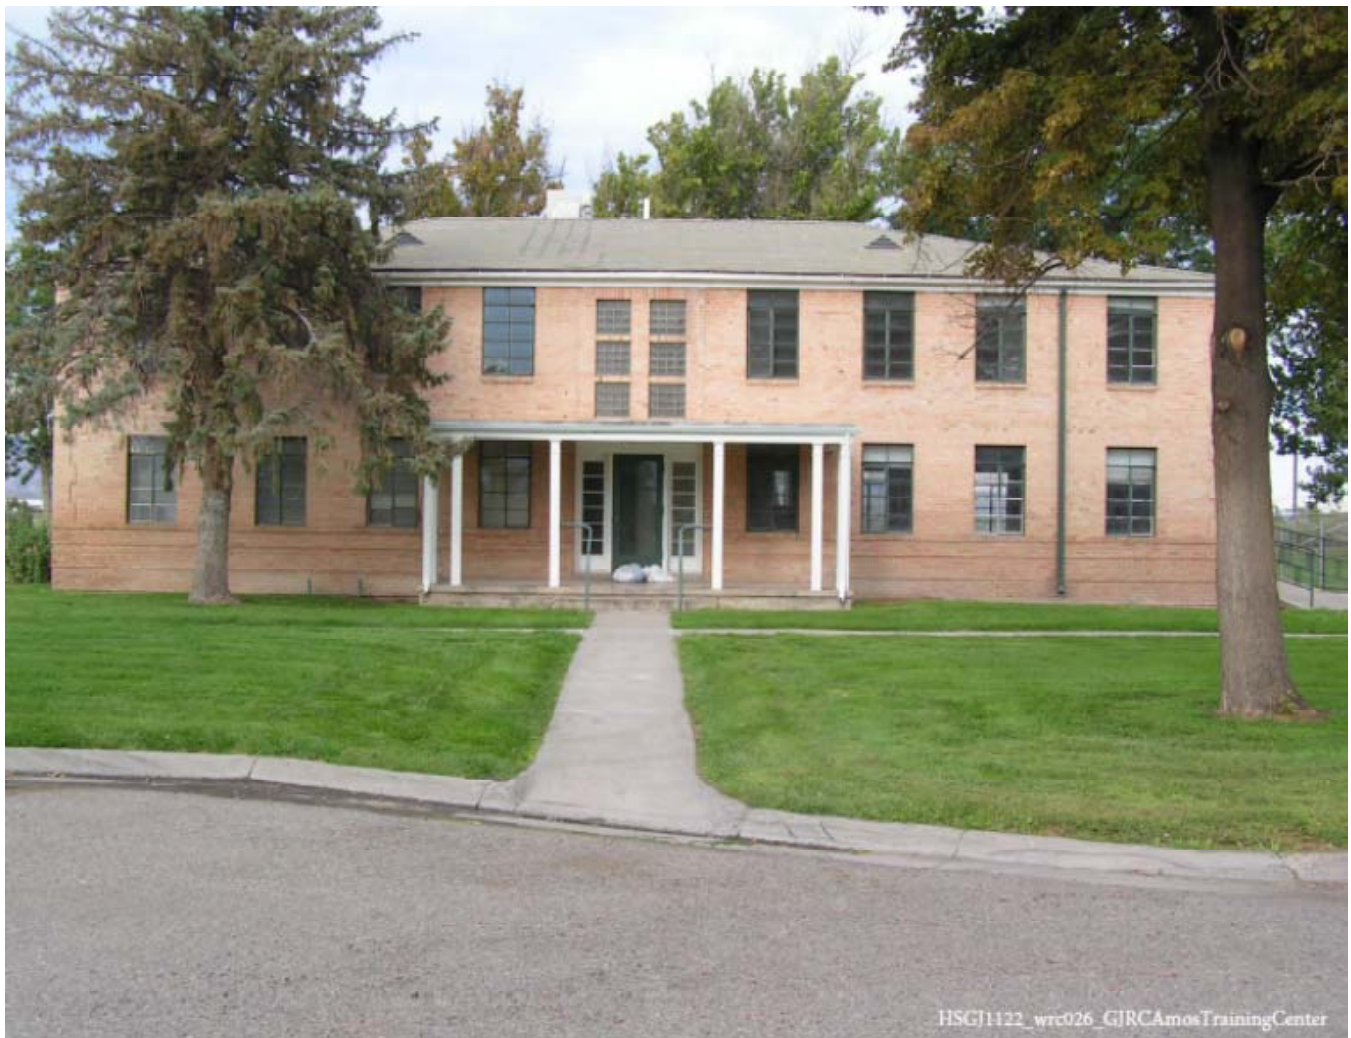
HSGJ1122_wrc026_GJRCAmosTrainingCenter

The building is at the end of its lifecycle and a completely depreciated value. Refurbishing the building would require a capital investment to remediate hazardous materials and refurbish the interior and exterior. This asset along with the others on the 46 acre campus is in the process of having the programs relocated and the land and buildings sold.

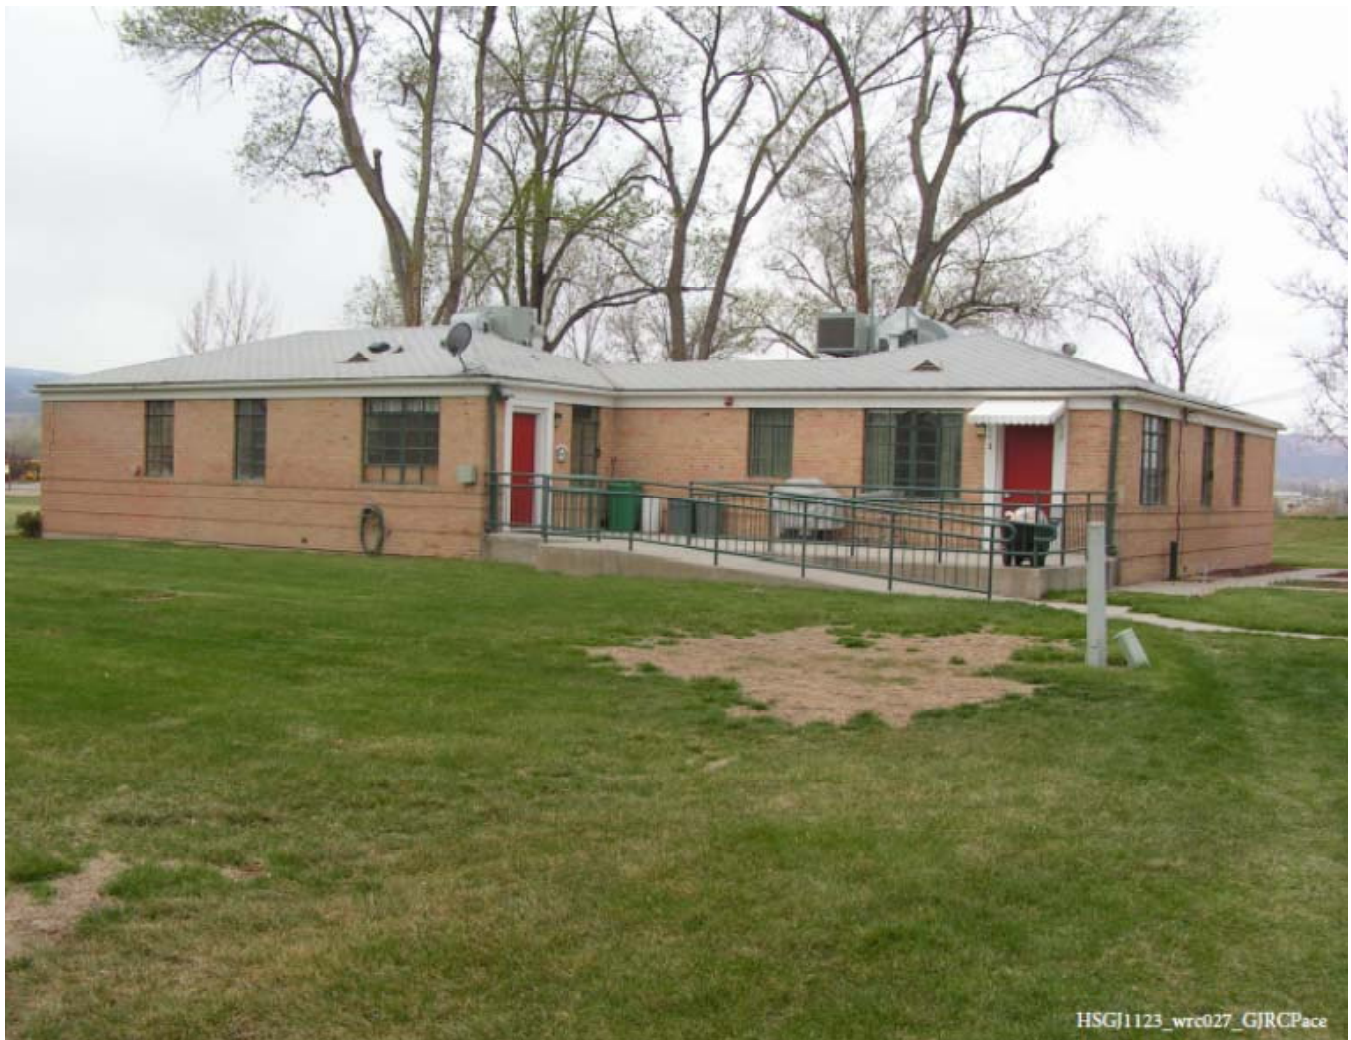
HSGJ1123_wrc027_GJRCPace

The building is at the end of its lifecycle and a completely depreciated value. Refurbishing the building would require a capital investment to remediate hazardous materials and refurbish the interior and exterior. This asset along with the others on the 46 acre campus is in the process of having the programs relocated and the land and buildings sold.

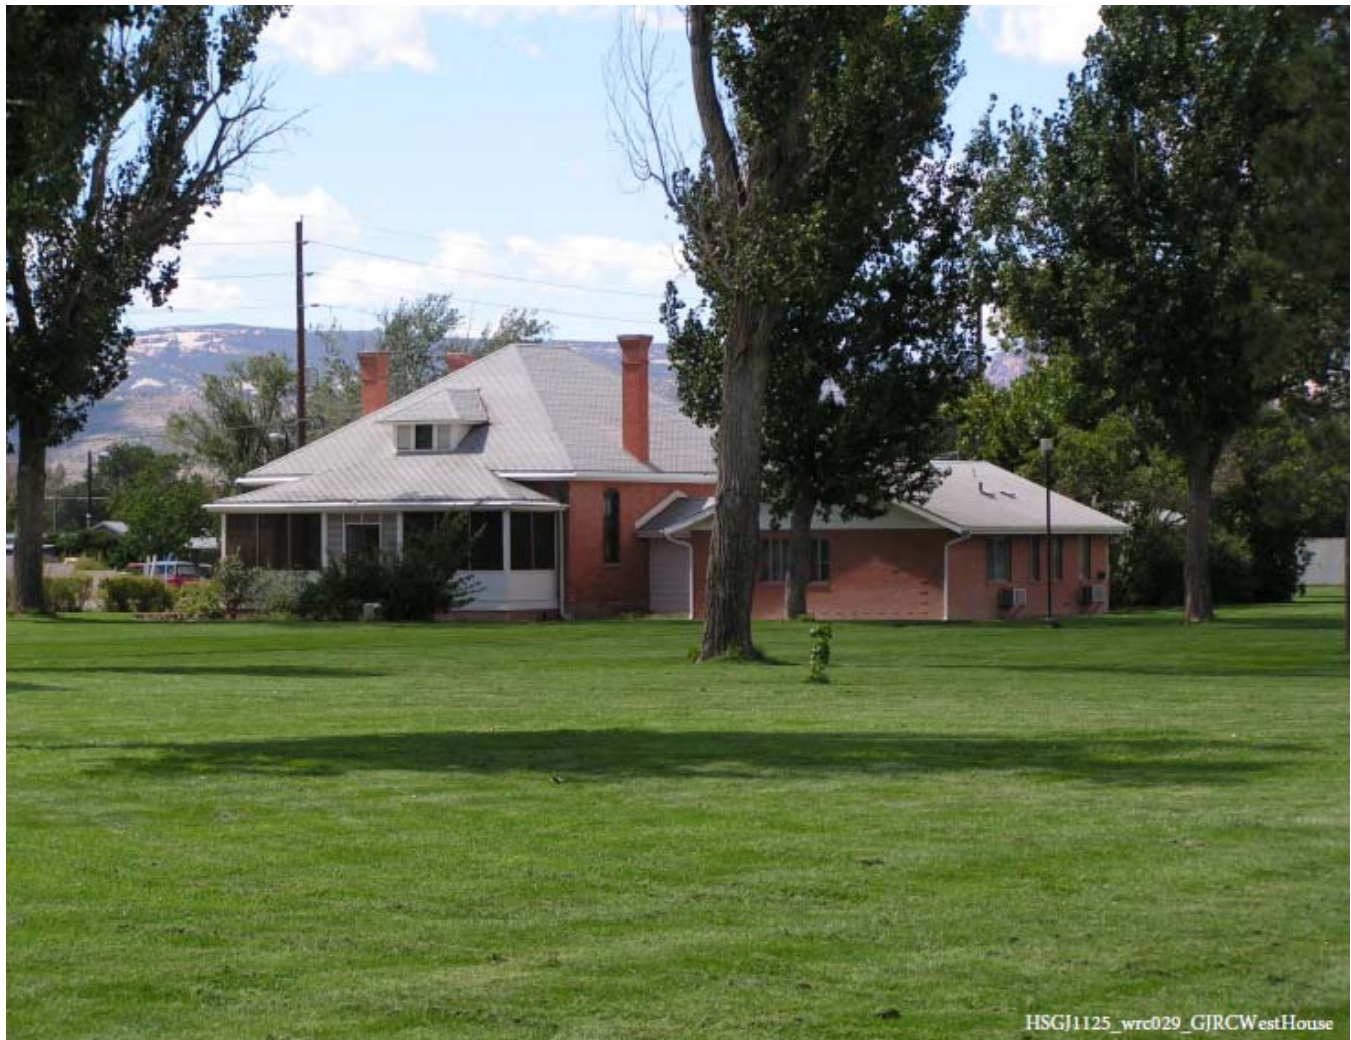
The building is at the end of its lifecycle and a completely depreciated value. Refurbishing the building would require a capital investment to remediate hazardous materials and refurbish the interior and exterior. This asset along with the others on the 46 acre campus is in the process of having the programs relocated and the land and buildings sold.

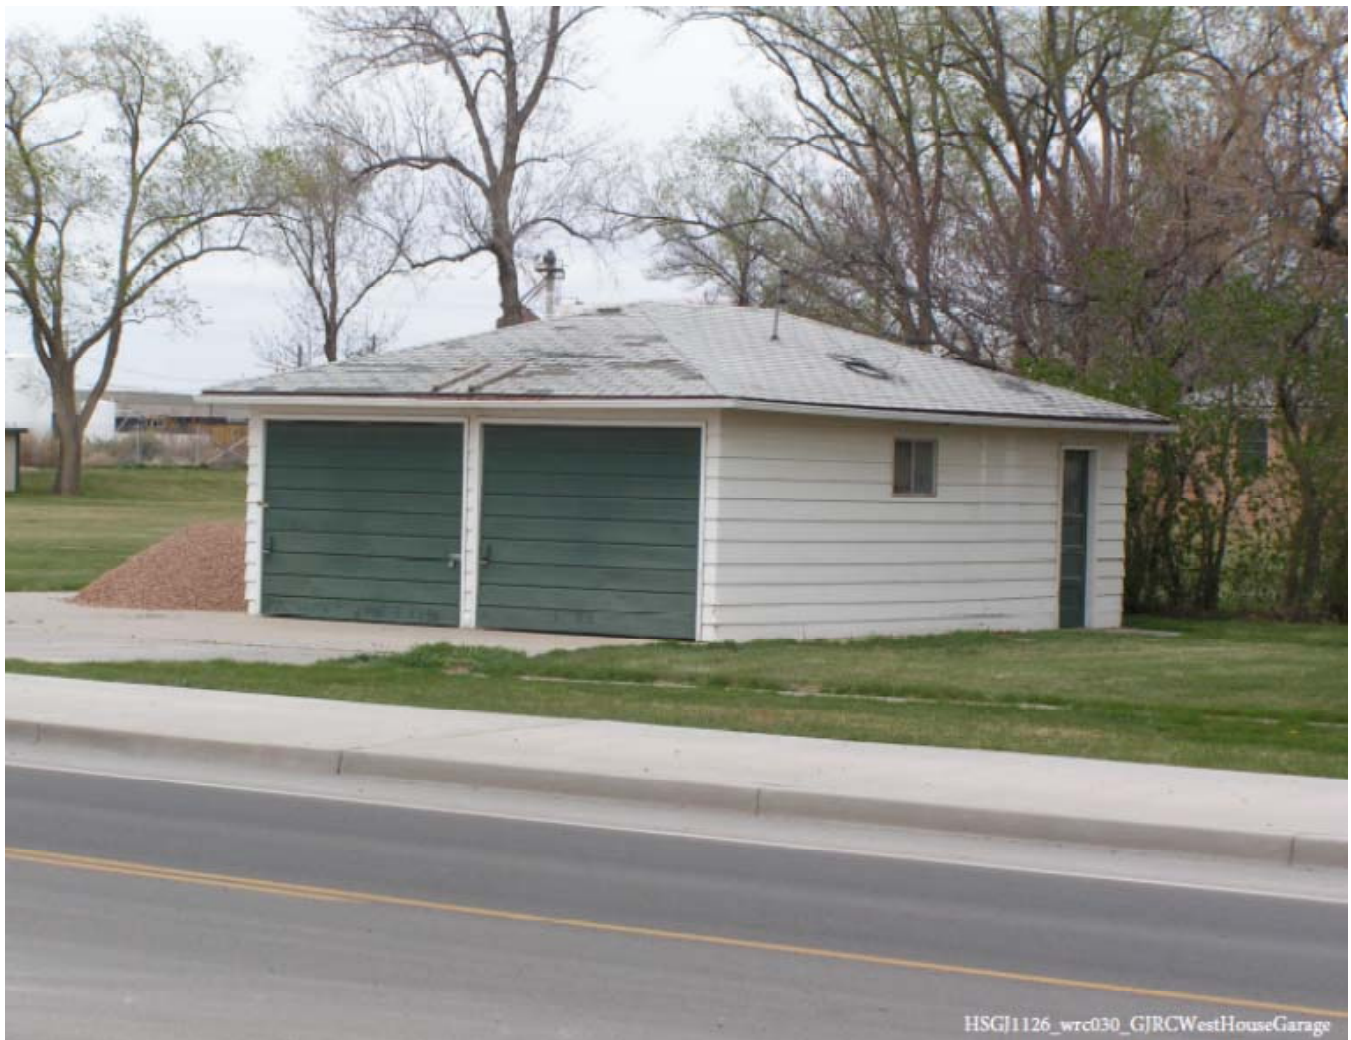
HSGJ1126_wrc030_GJRCWestHouseGarage

The building is at the end of its lifecycle and a completely depreciated value. Refurbishing the building would require a capital investment to remediate hazardous materials and refurbish the interior and exterior. This asset along with the others on the 46 acre campus is in the process of having the programs relocated and the land and buildings sold.

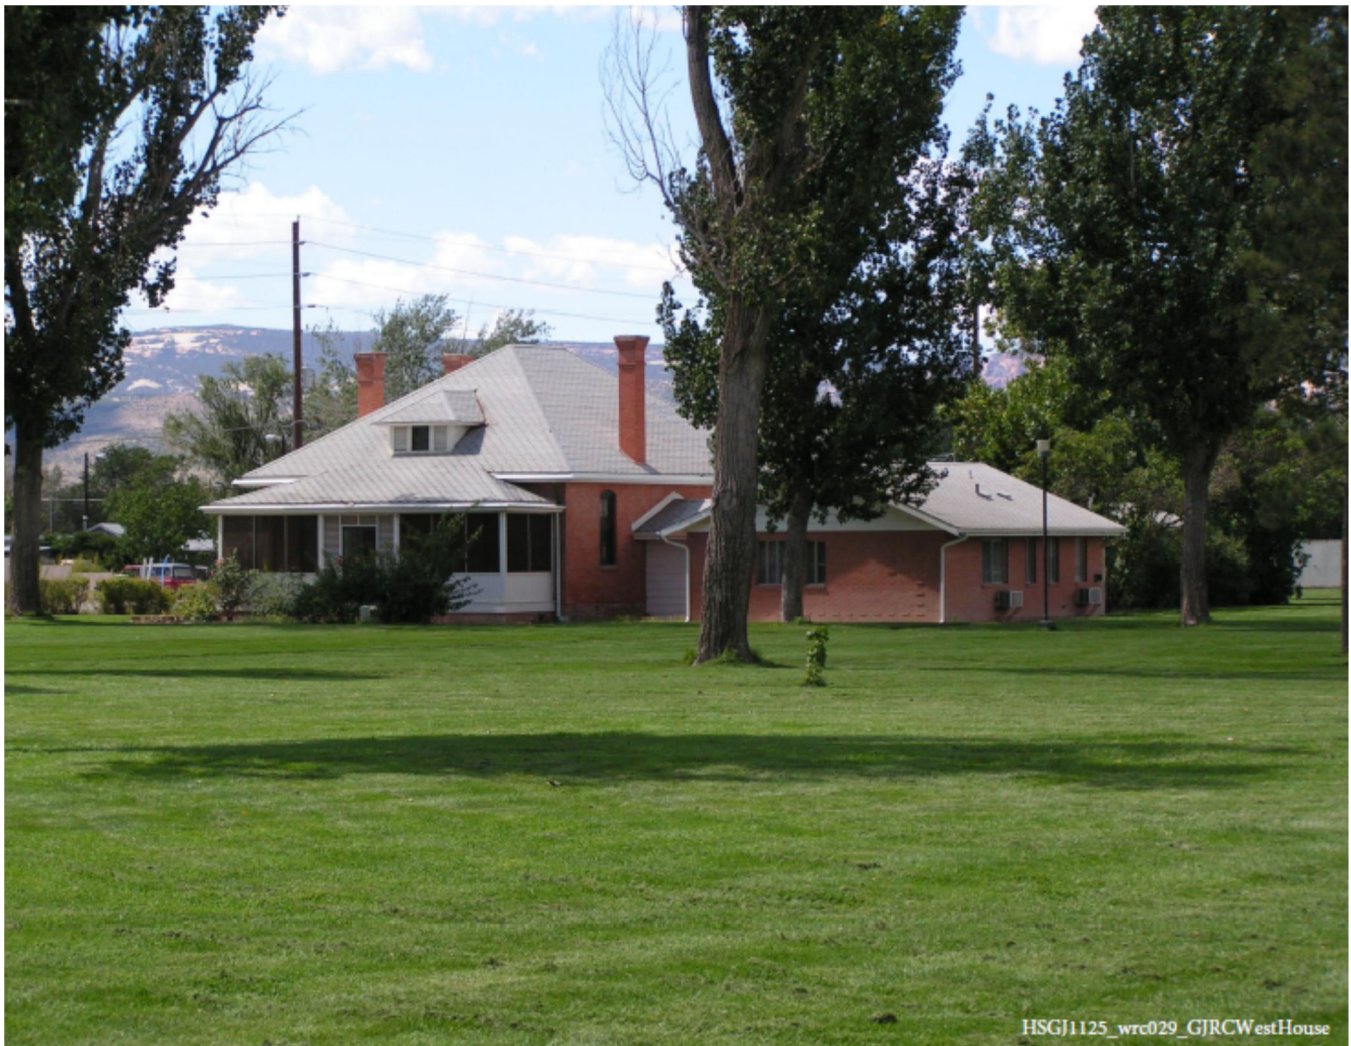
The building is at the end of its lifecycle and a completely depreciated value. Refurbishing the building would require a capital investment to remediate hazardous materials and refurbish the interior and exterior. This asset along with the others on the 46 acre campus is in the process of having the programs relocated and the land and buildings sold.

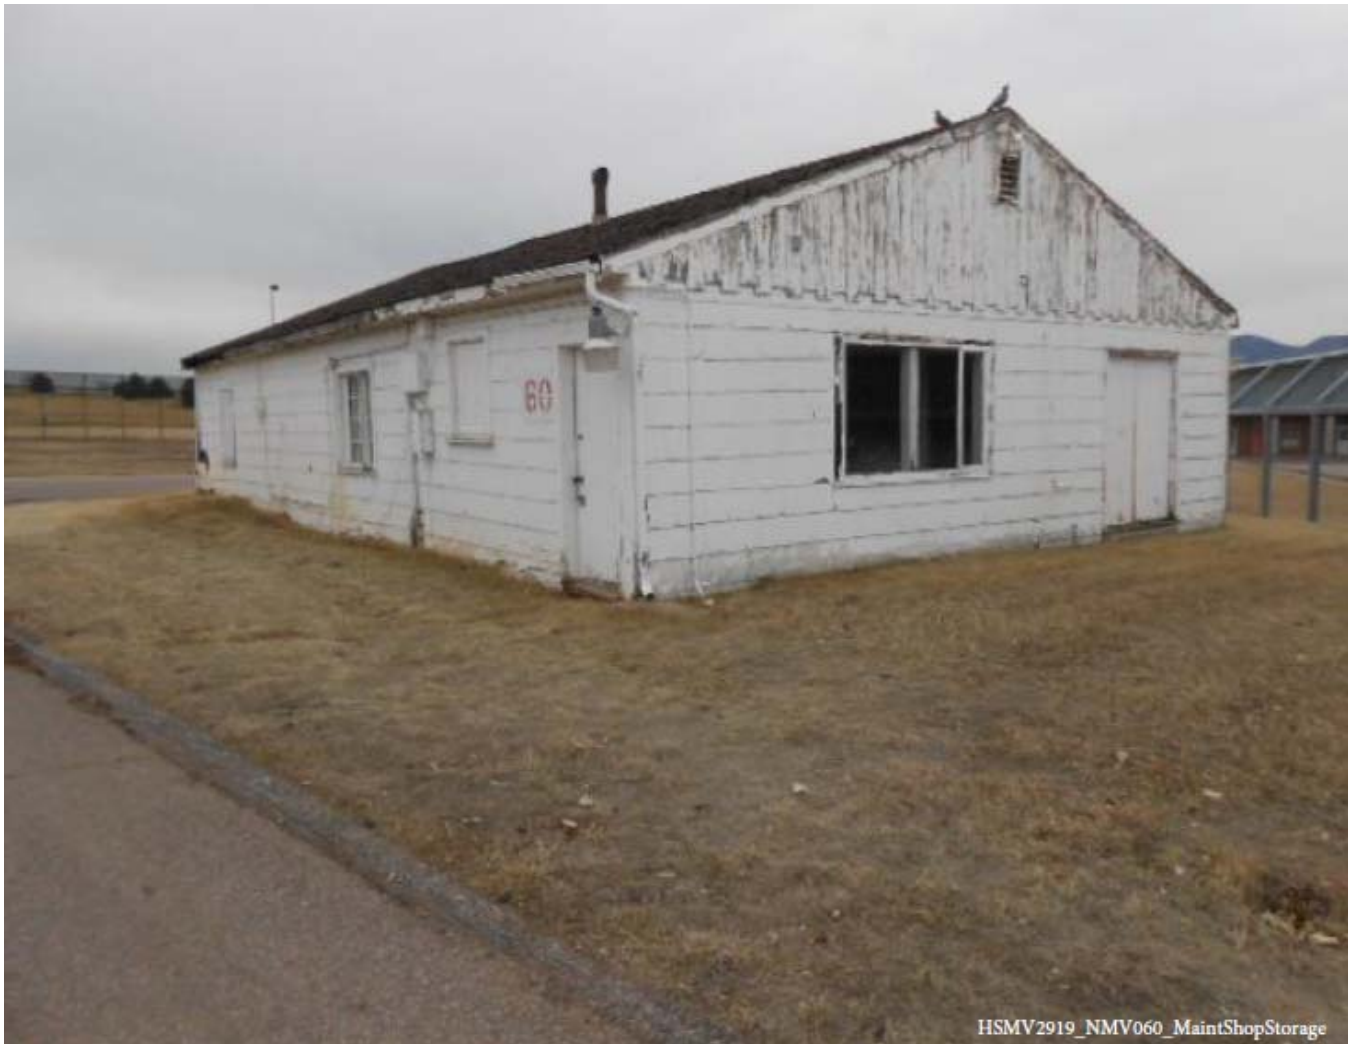
The building is at the end of its lifecycle and a completely depreciated value. Refurbishing the building would require a capital investment to remediate hazardous materials and refurbish the interior and exterior. This asset is within a security perimeter that has no potential for use outside of the agency.

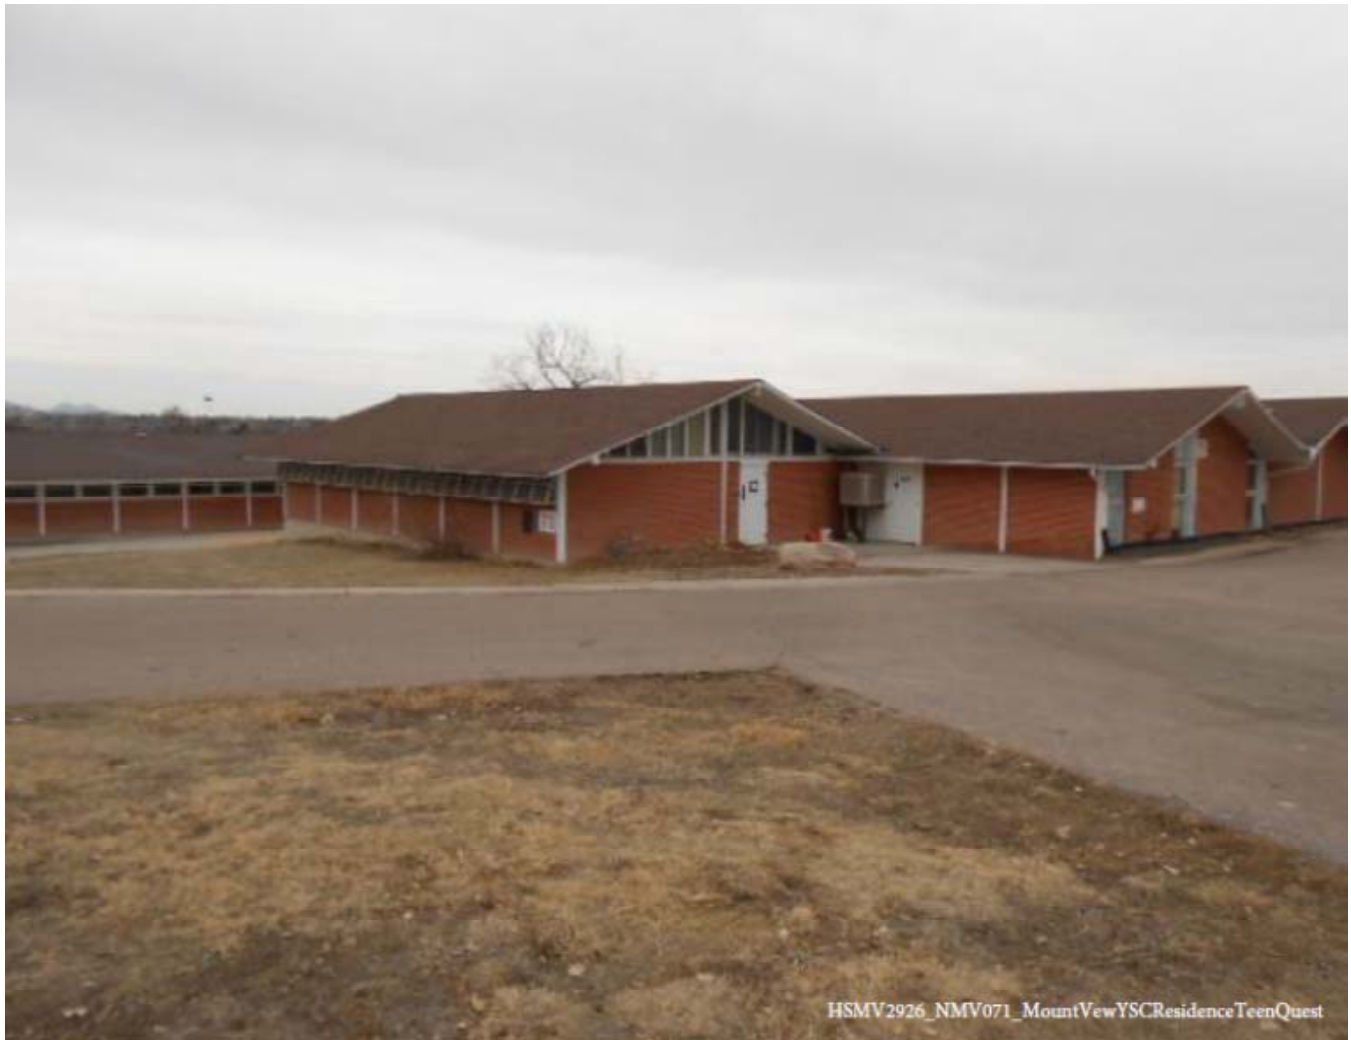
HSMV2926_NMV071_MountVewYSCResidenceTeenQuest

The building is at the end of its lifecycle and has a mostly depreciated value. Refurbishing the building would require a capital investment to remediate hazardous materials and refurbish the interior and exterior. This asset is within a security perimeter that has no potential for use outside of the agency.

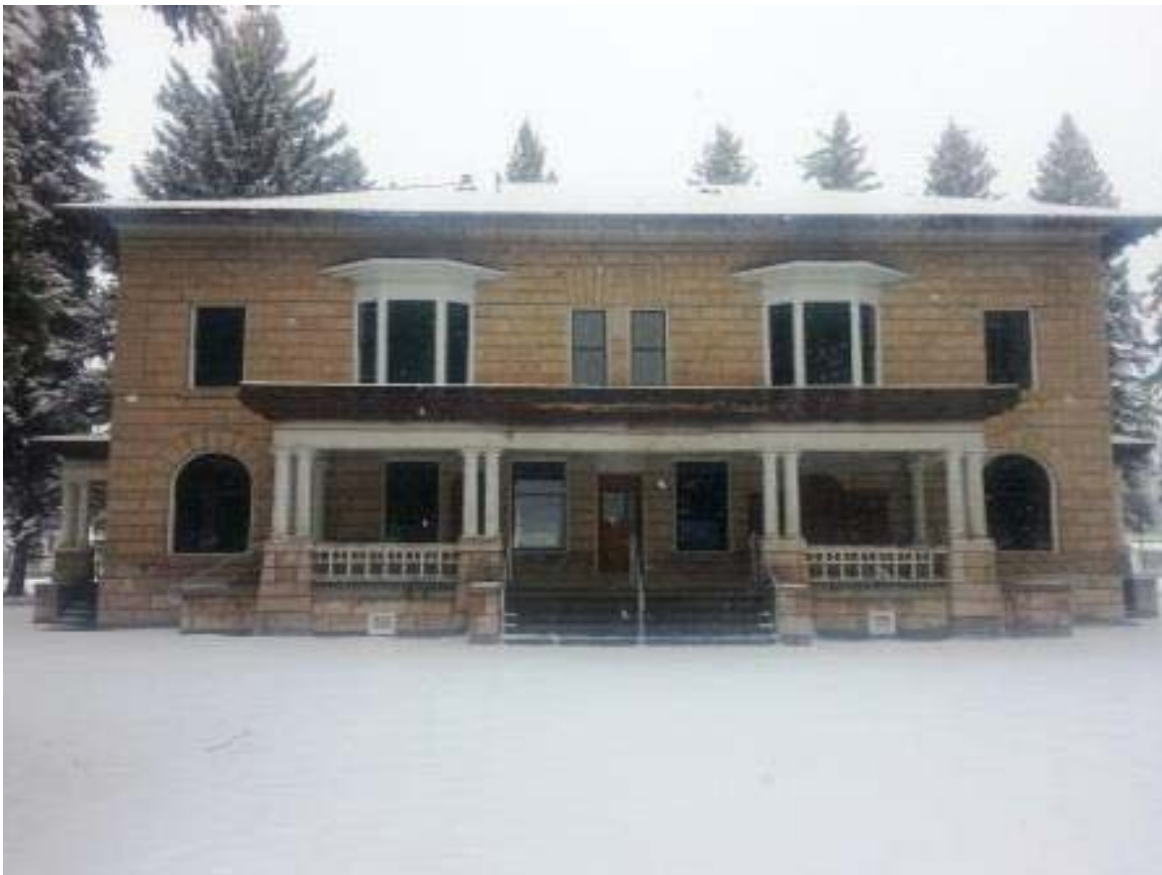
The building is over 100 years old and at the end of its lifecycle and a completely depreciated value. Refurbishing the building would require a capital investment to remediate hazardous materials and refurbish the interior and exterior.

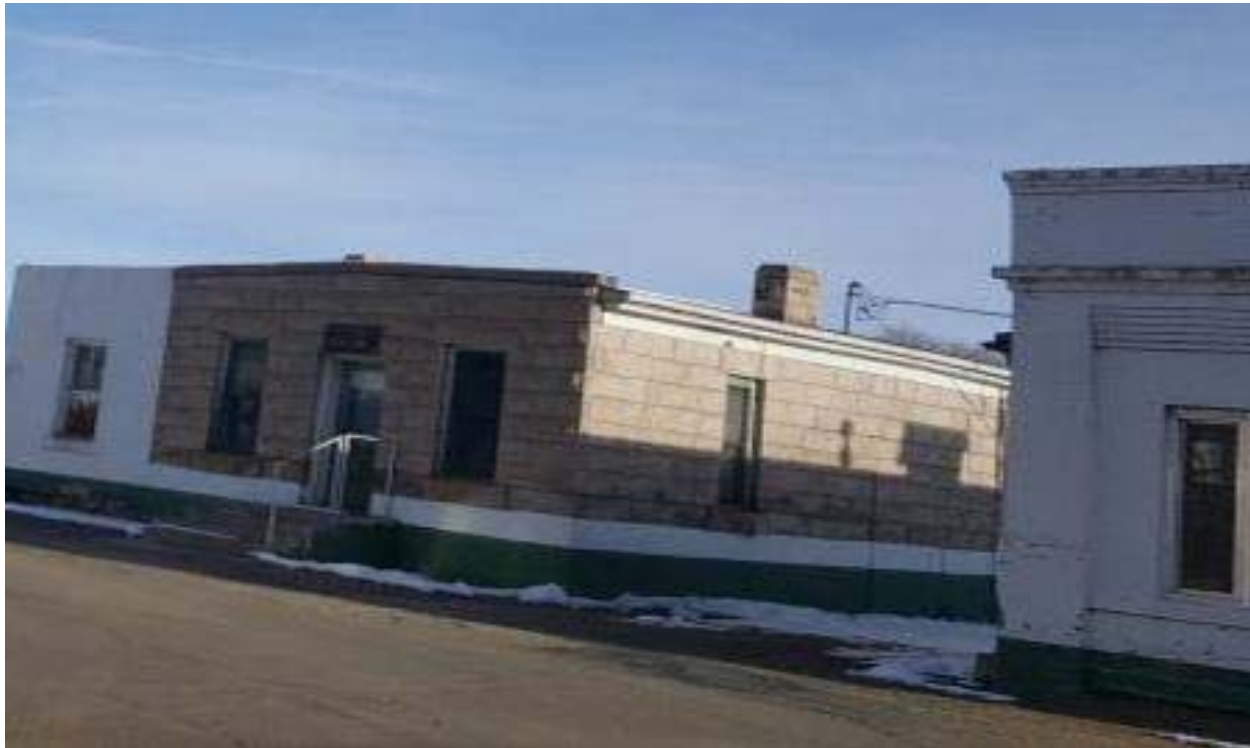
The building is over 100 years old and at the end of its lifecycle and a completely depreciated value. Refurbishing the building would require a capital investment to remediate hazardous materials and refurbish the interior and exterior.

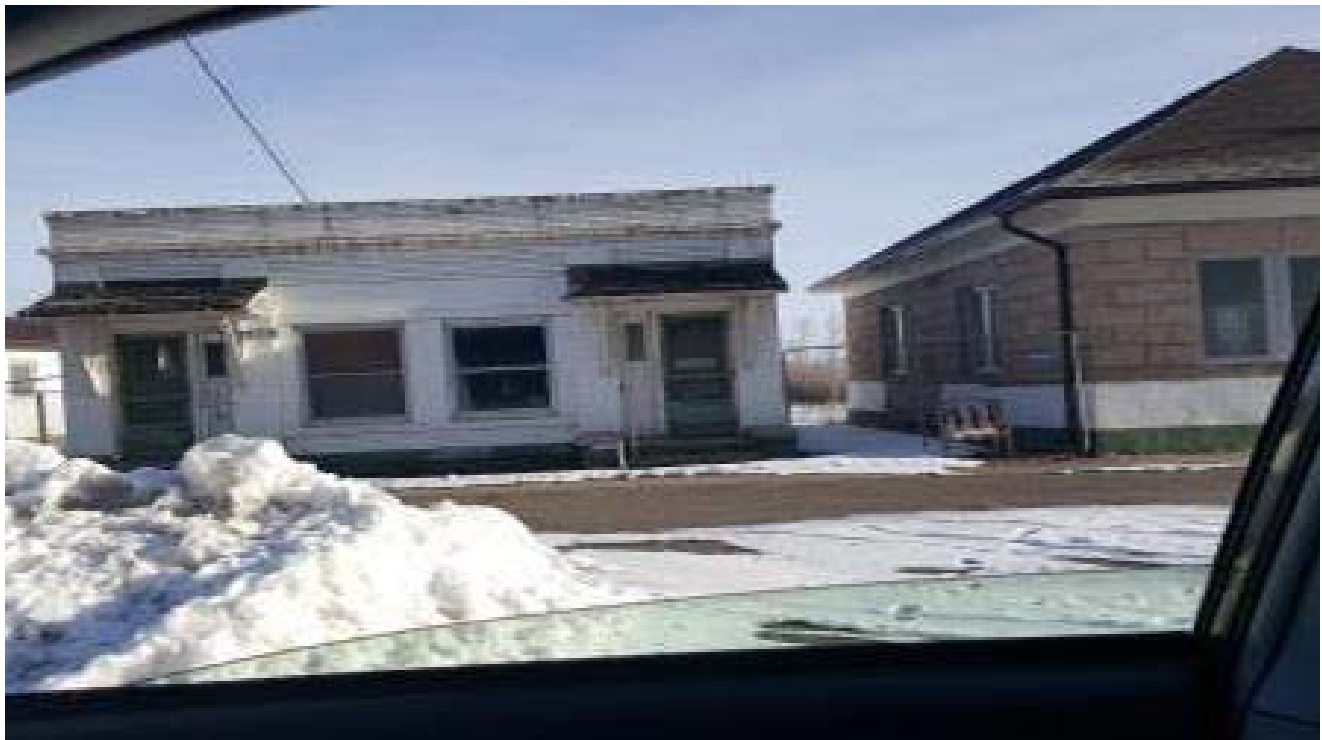
The building is over 100 years old and at the end of its lifecycle and a completely depreciated value. Refurbishing the building would require a capital investment to remediate hazardous materials and refurbish the interior and exterior.

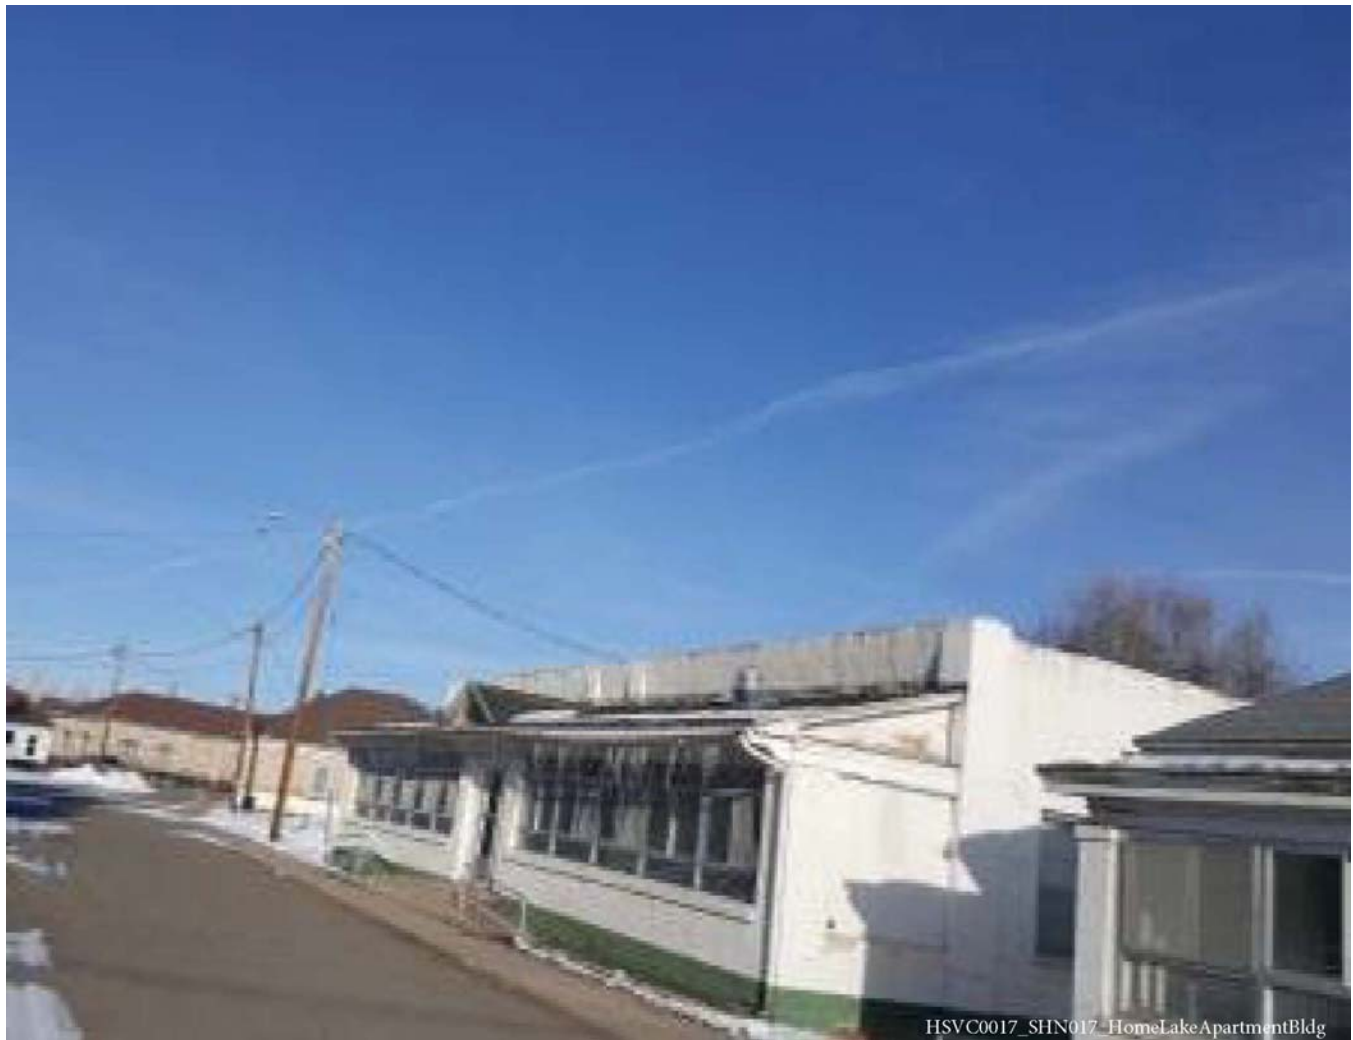
The building is over 100 years old and at the end of its lifecycle and a completely depreciated value. Refurbishing the building would require a capital investment to remediate hazardous materials and refurbish the interior and exterior.

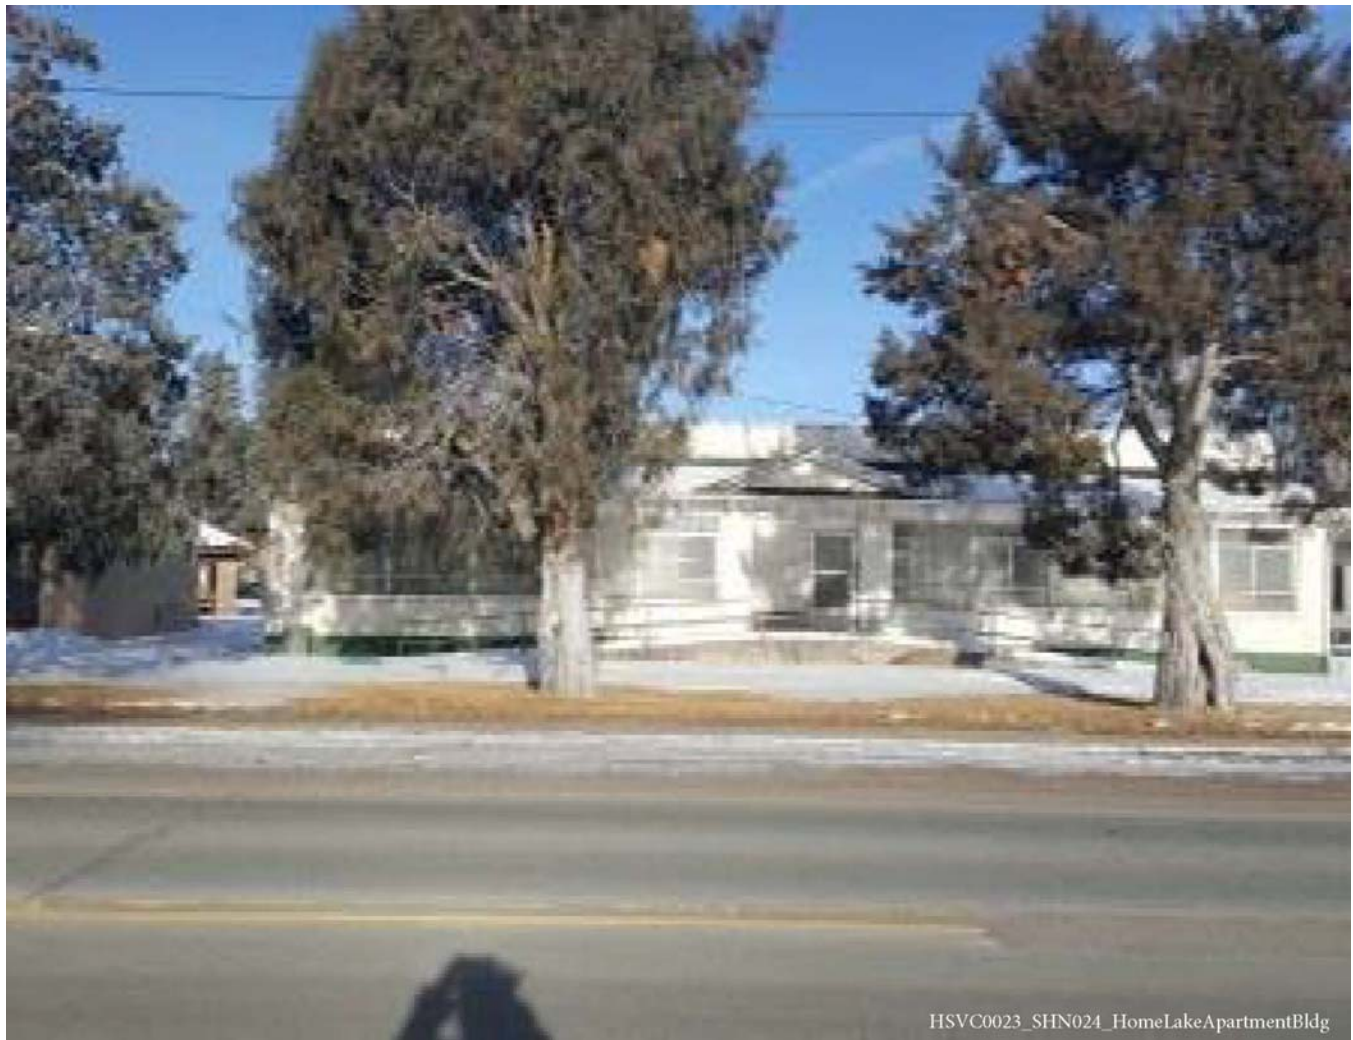
HSVC0023_SHN024_HomeLakeApartmentBldg

The building is over 100 years old and at the end of its lifecycle and a completely depreciated value. Refurbishing the building would require a capital investment to remediate hazardous materials and refurbish the interior and exterior.

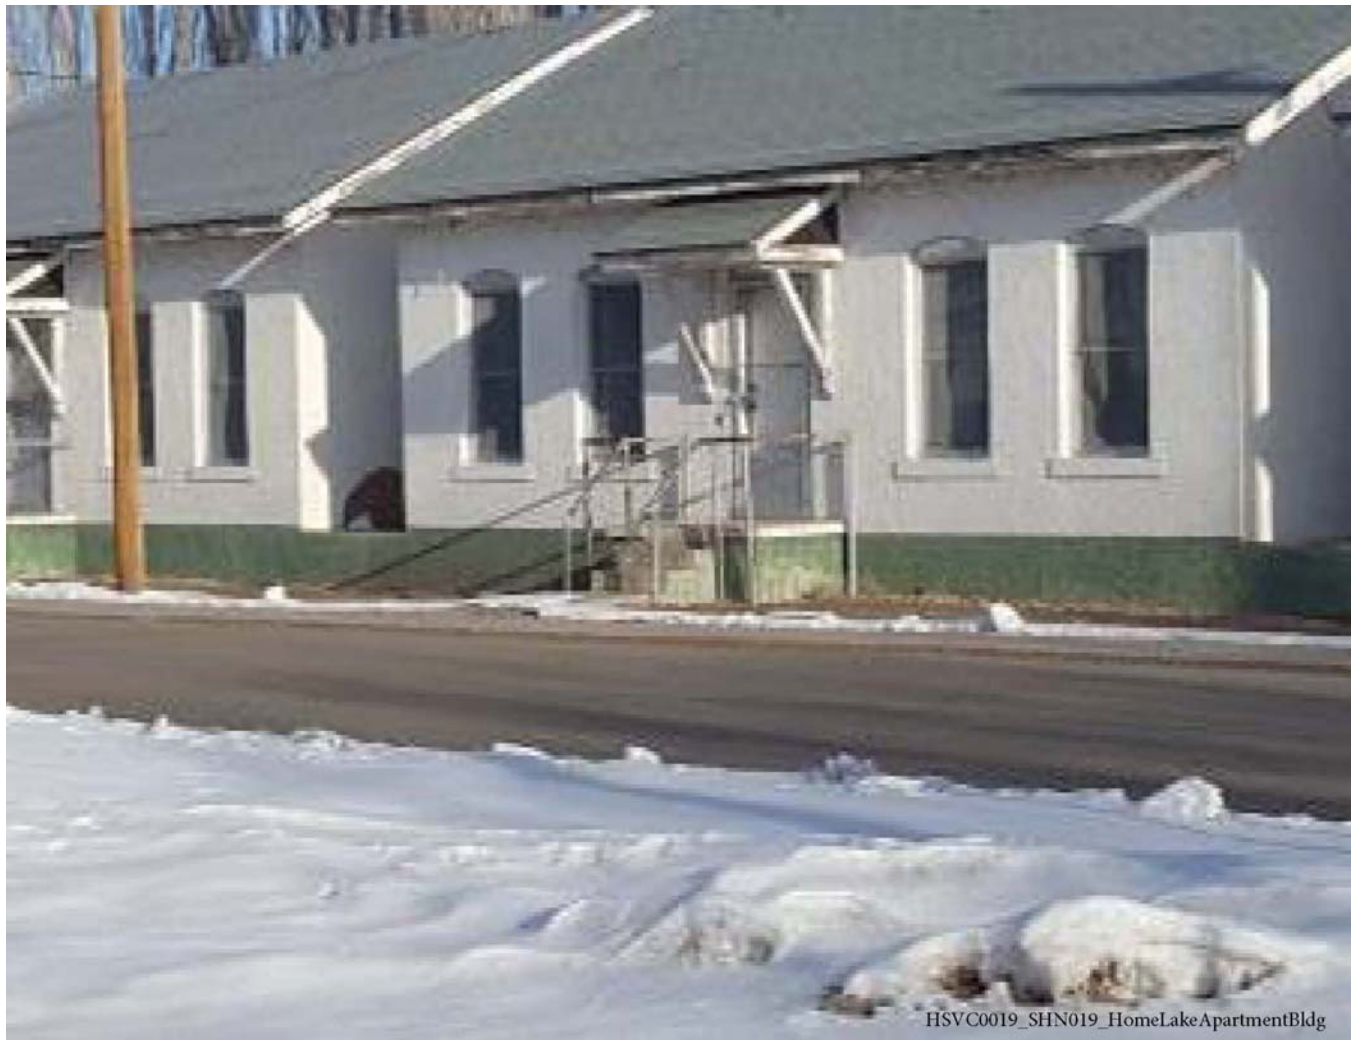
HSVC0019_SHN019_HomeLakeApartmentBldg

The building is over 100 years old and at the end of its lifecycle and a completely depreciated value. Refurbishing the building would require a capital investment to remediate hazardous materials and refurbish the interior and exterior.

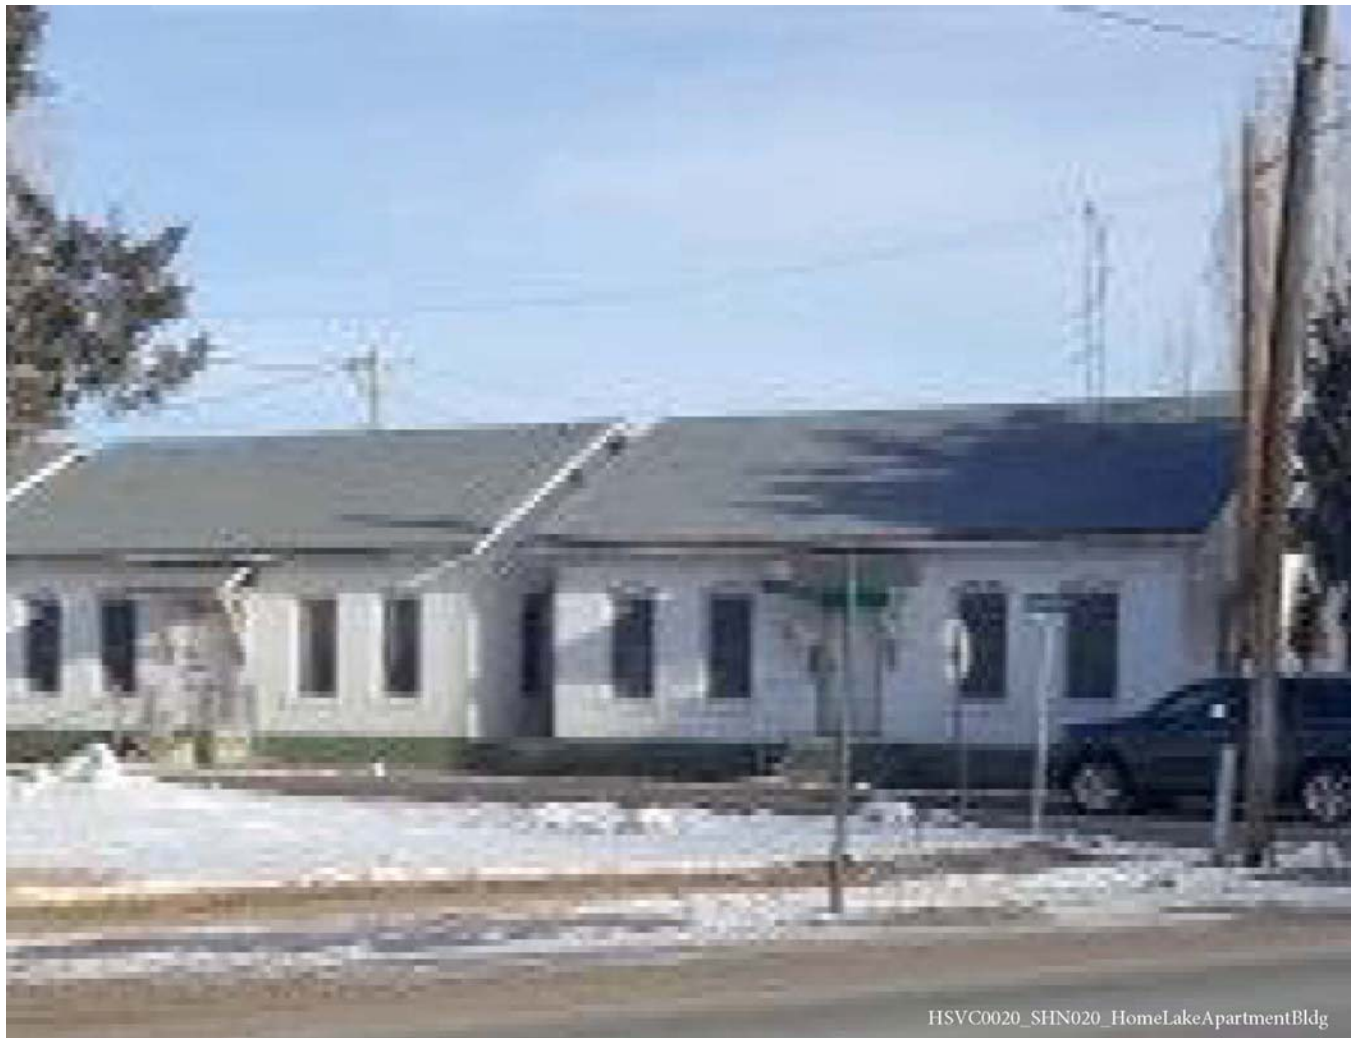
HSVC0020_SHN020_HomeLakeApartmentBldg

The building is over 100 years old and at the end of its lifecycle and a completely depreciated value. Refurbishing the building would require a capital investment to remediate hazardous materials and refurbish the interior and exterior.
