**OFFICE OF THE
STATE ARCHITECT**

**VACANT
FACILITIES
REPORT**

Revision: December 2020

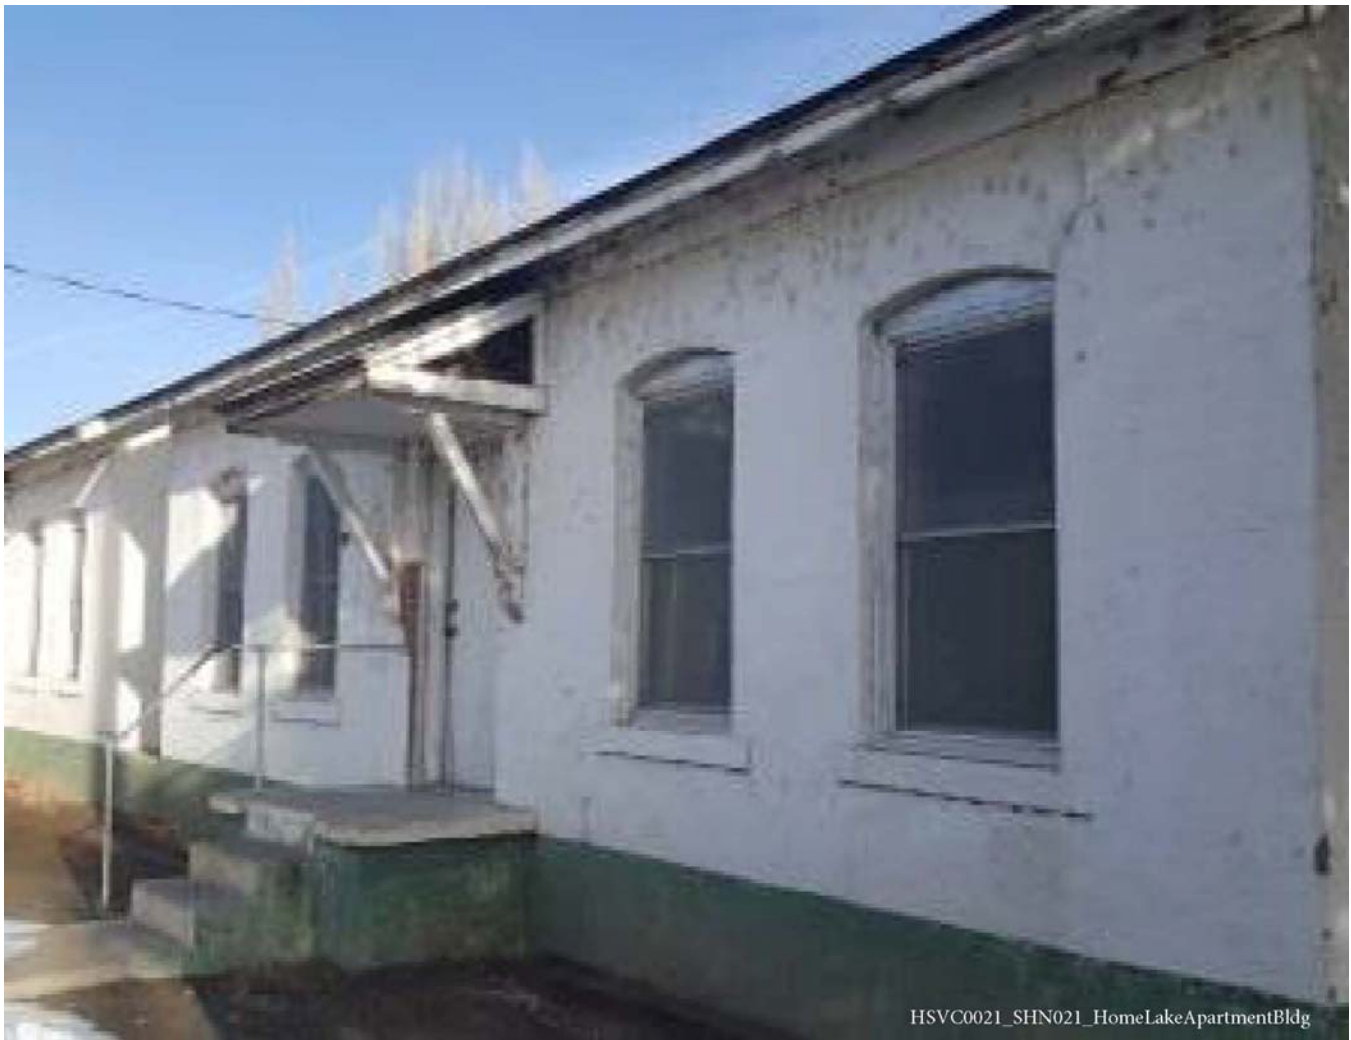
The building is over 100 years old and at the end of its lifecycle and a completely depreciated value. Refurbishing the building would require a capital investment to remediate hazardous materials and refurbish the interior and exterior.

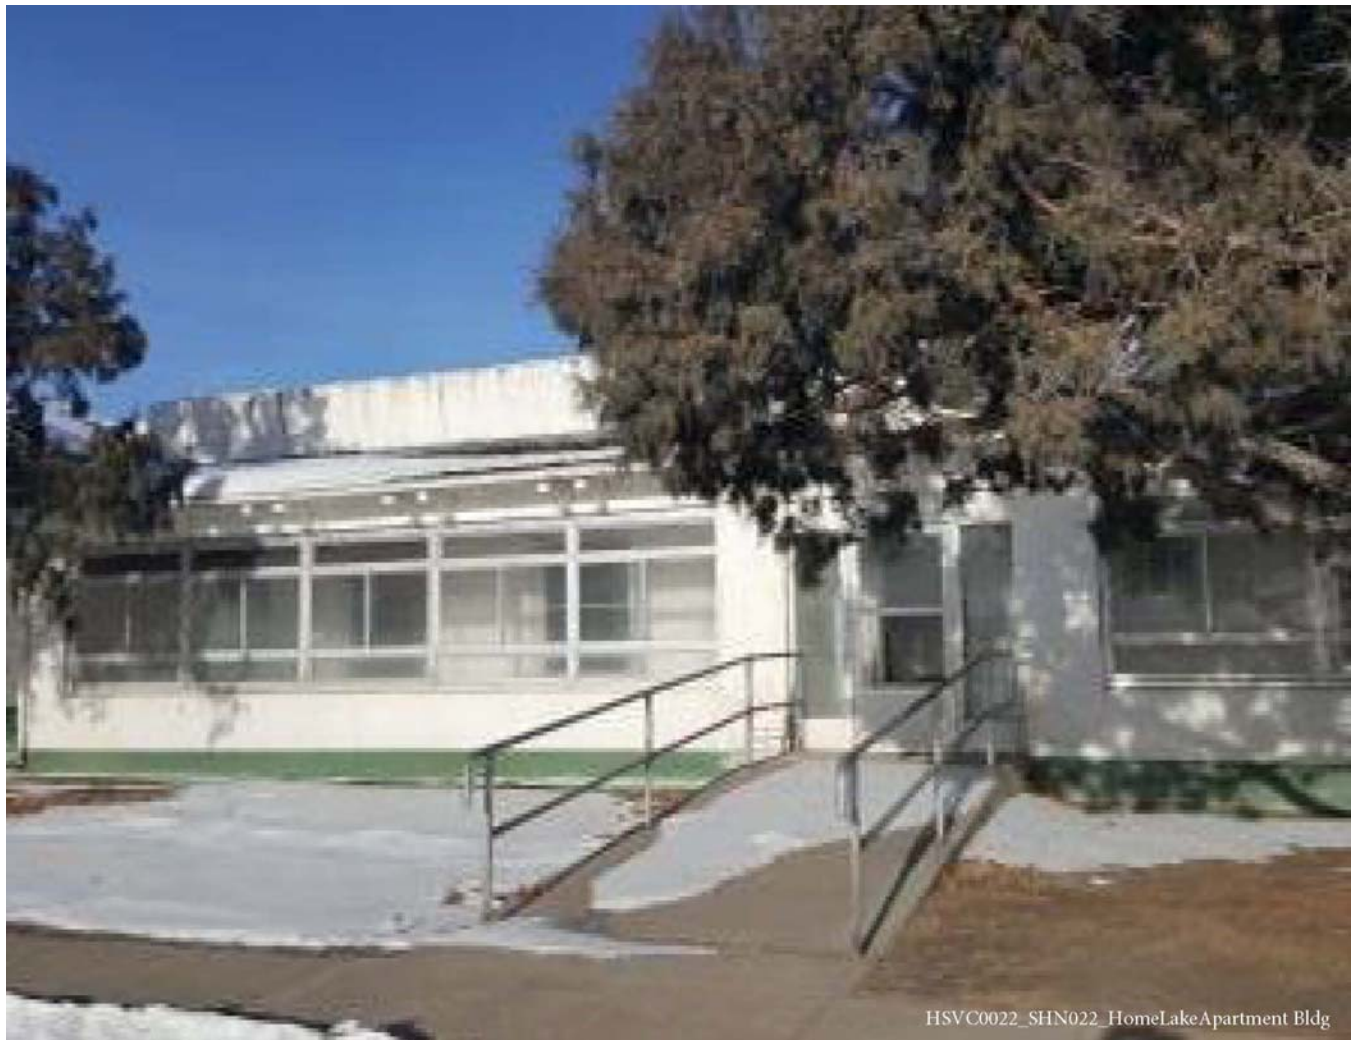
The building is over 100 years old and at the end of its lifecycle and a completely depreciated value. Refurbishing the building would require a capital investment to remediate hazardous materials and refurbish the interior and exterior.

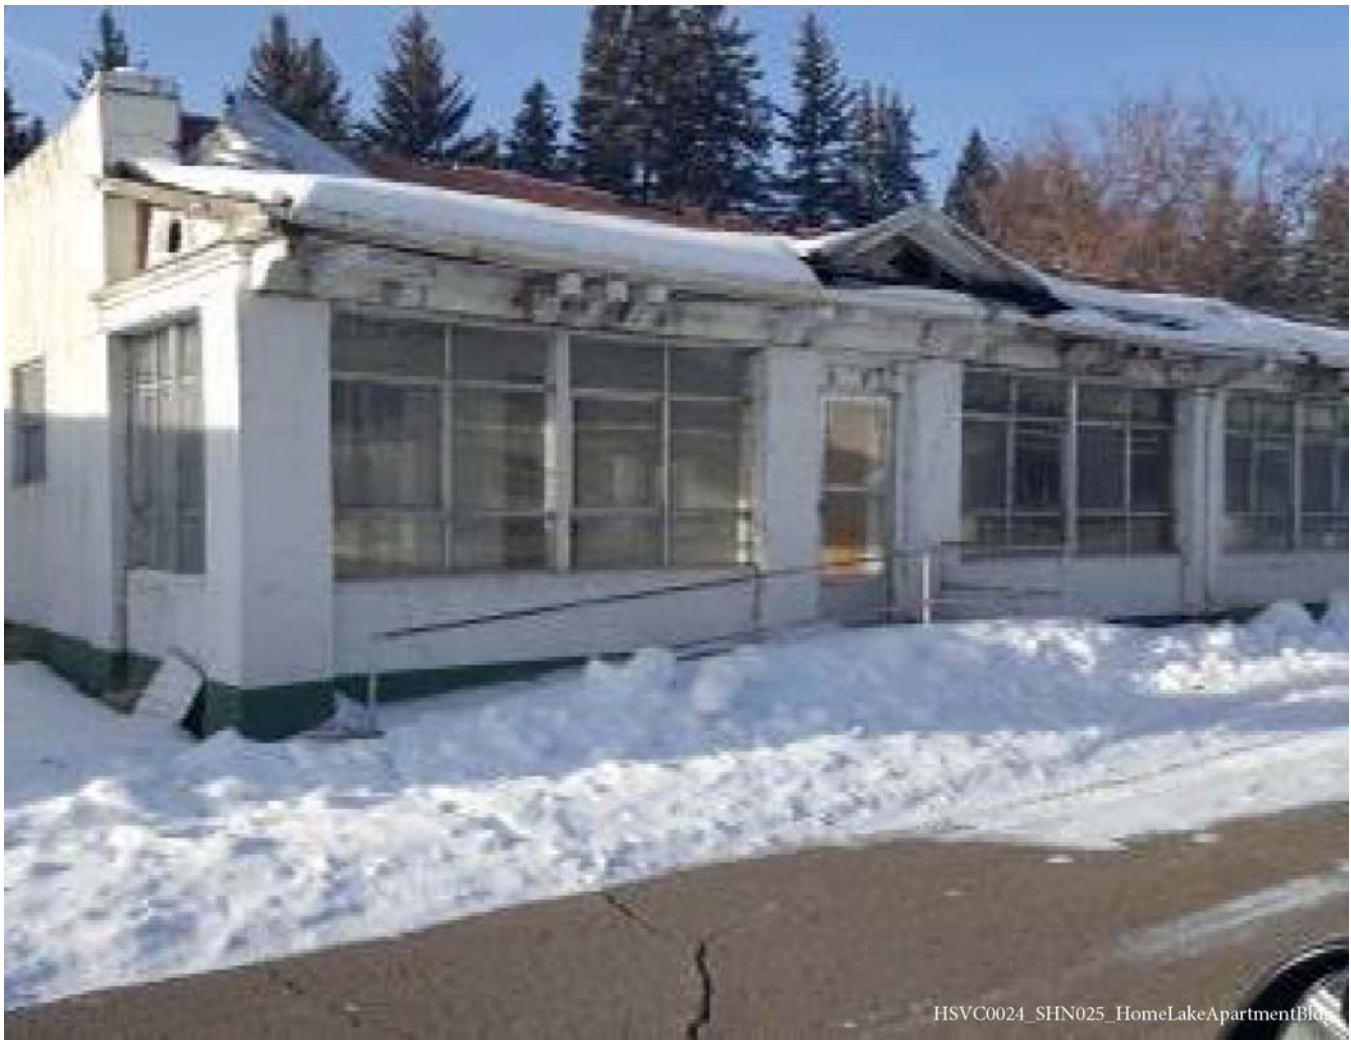
HSVC0024_SHN025_HomeLakeApartmentBldg

The building is over 100 years old and at the end of its lifecycle and a completely depreciated value. Refurbishing the building would require a capital investment to remediate hazardous materials and refurbish the interior and exterior.

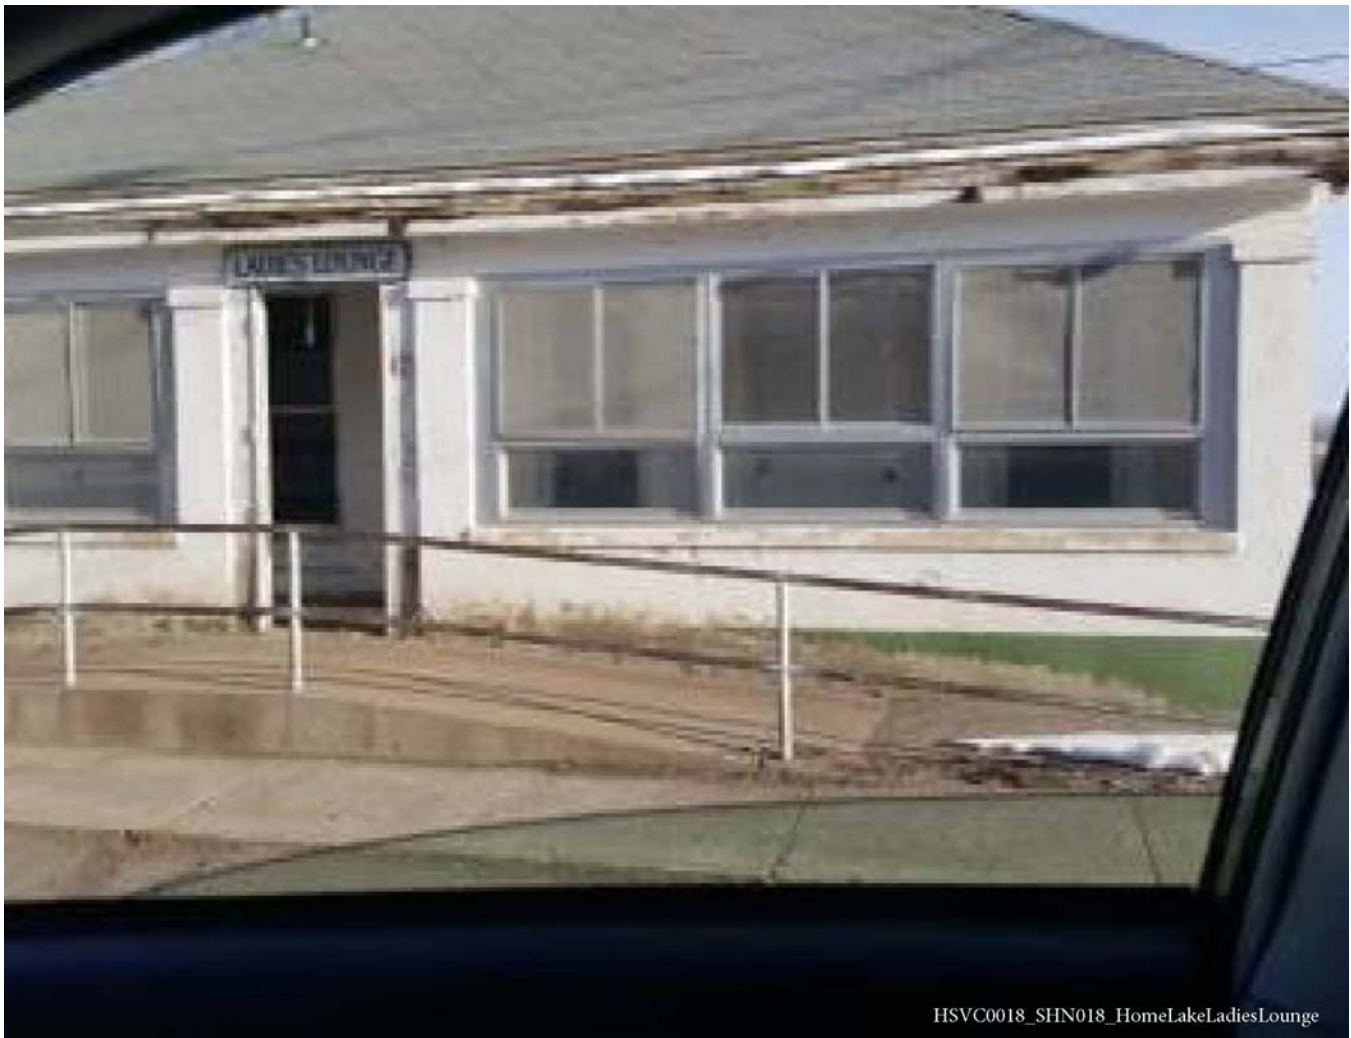
HSVC0018_SHN018_HomeLakeLadiesLounge

The building is over 100 years old and at the end of its lifecycle and a completely depreciated value. Refurbishing the building would require a capital investment to remediate hazardous materials and refurbish the interior and exterior.

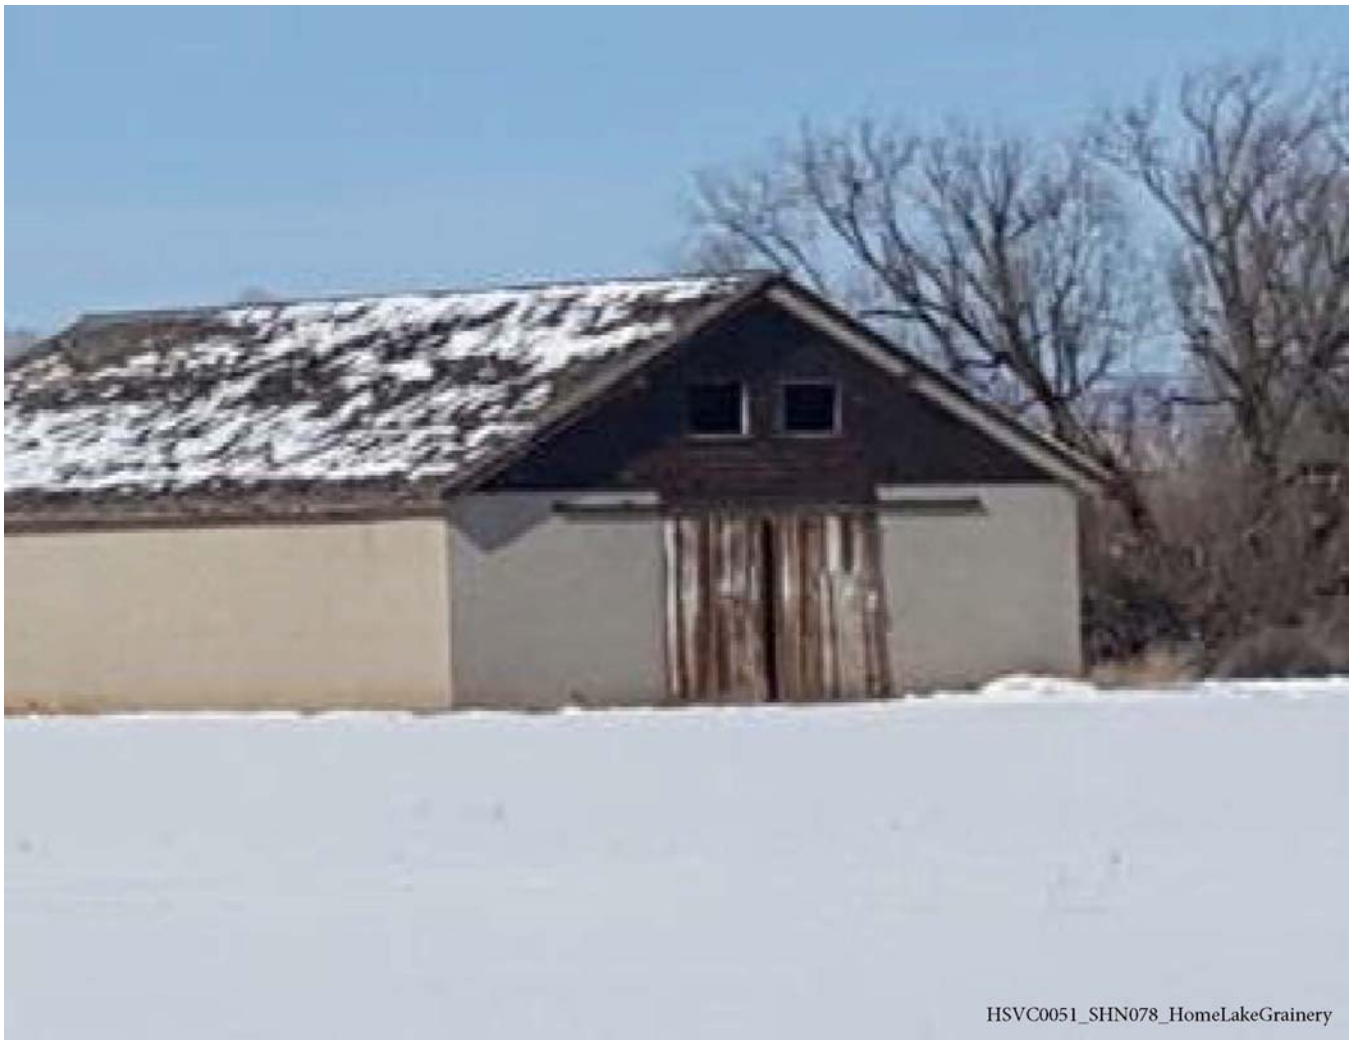
HSVC0051_SHN078_HomeLakeGrainery

The building is over 100 years old and at the end of its lifecycle and a completely depreciated value. Refurbishing the building would require a capital investment to remediate hazardous materials and refurbish the interior and exterior.

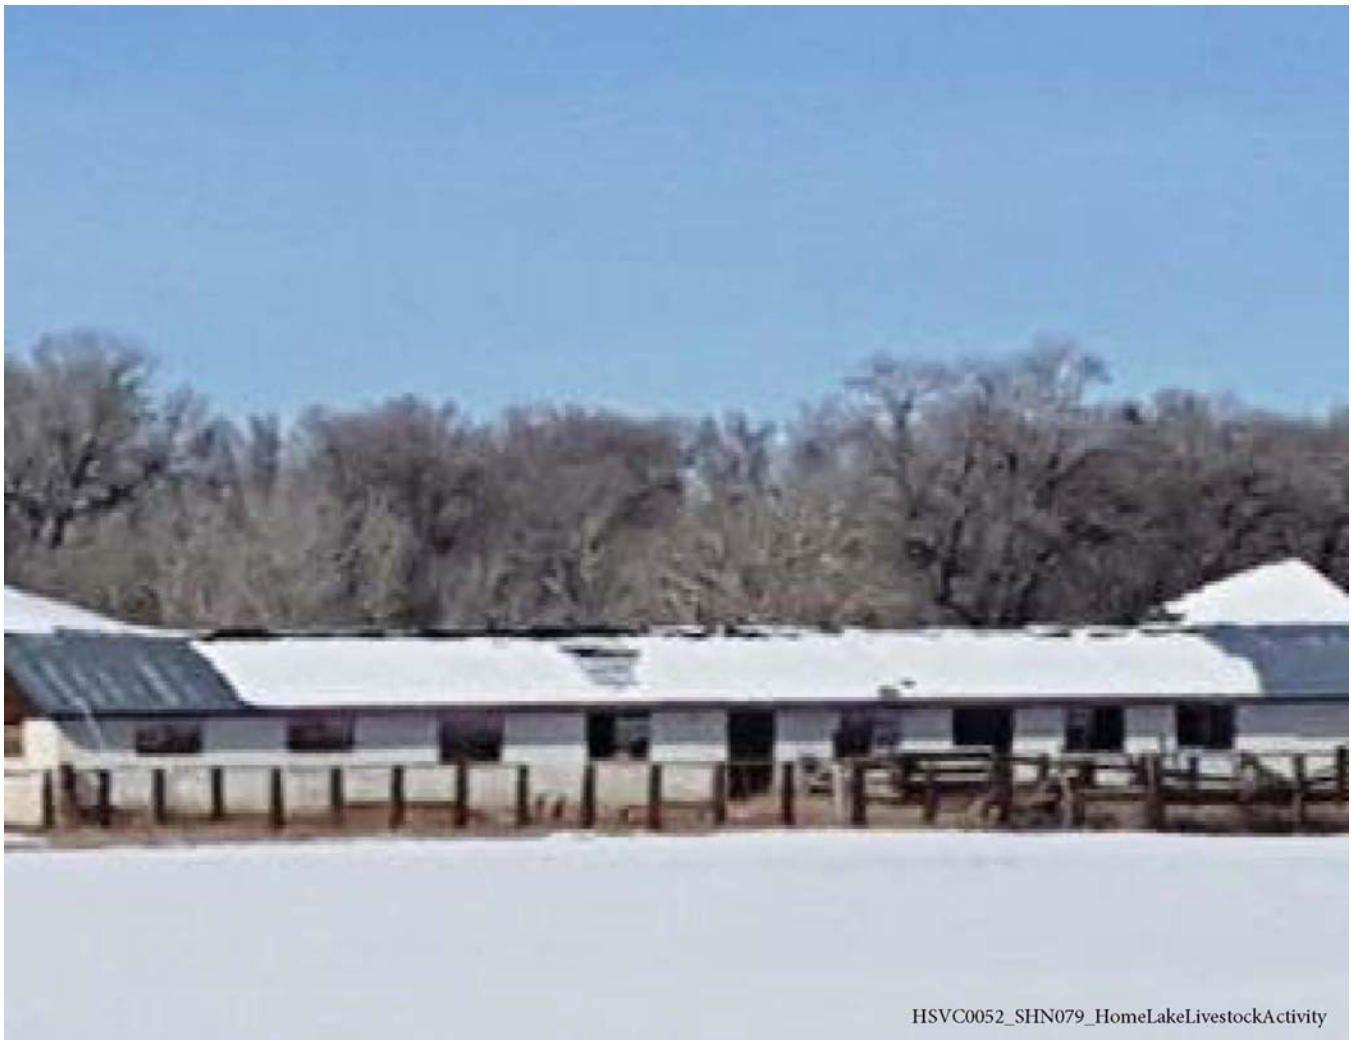
HSVC0052_SHN079_HomeLakeLivestockActivity

The building is over 100 years old and at the end of its lifecycle and a completely depreciated value. Refurbishing the building would require a capital investment to remediate hazardous materials and refurbish the interior and exterior.

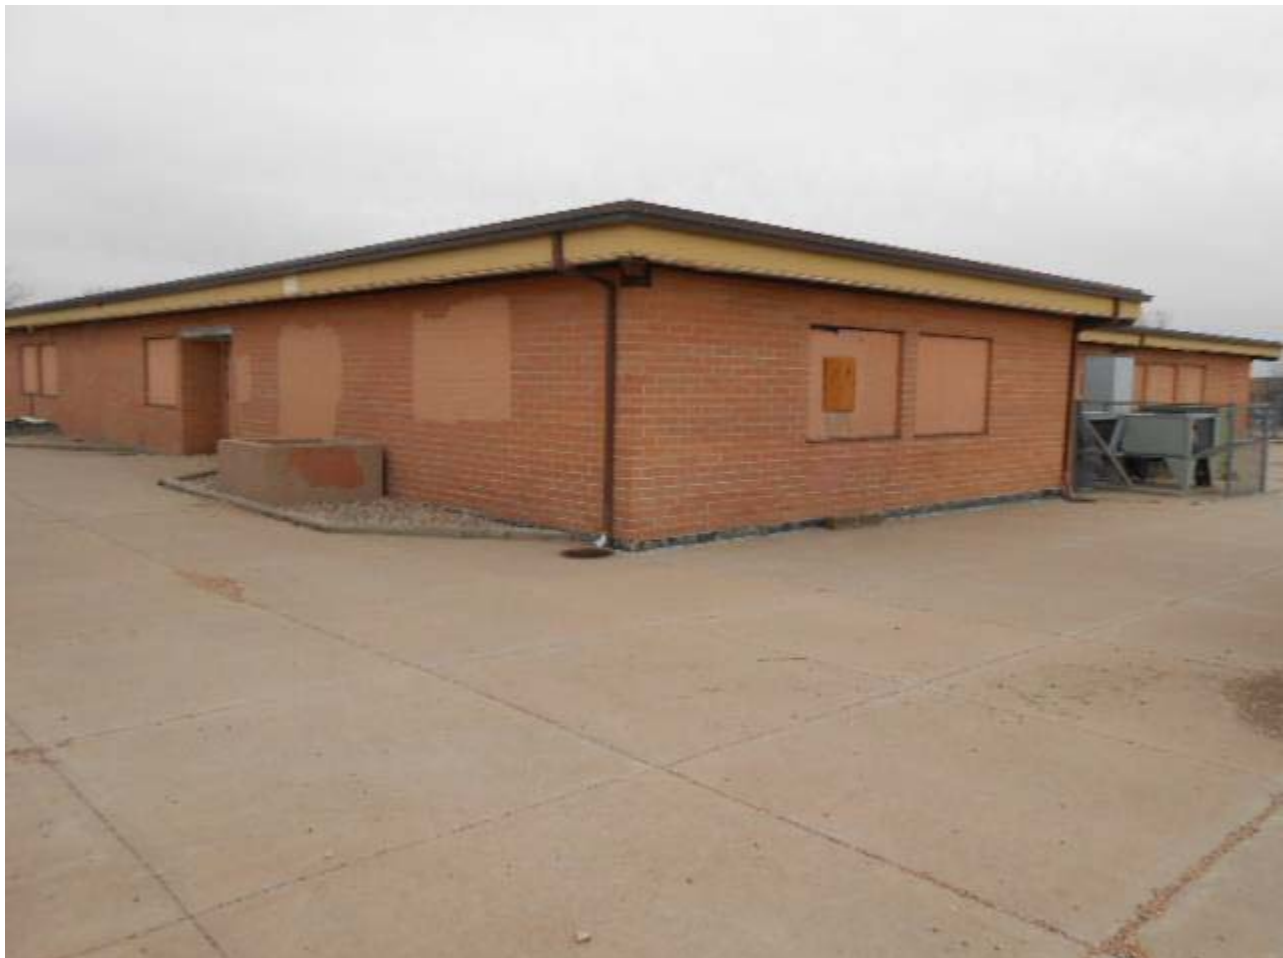
The building is at the end of its lifecycle and a completely depreciated value. Refurbishing the building would require a capital investment to remediate hazardous materials and refurbish the interior and exterior. While the exterior is in good condition, the interior cannot be used without extensive material clean up and remodeling. The land has marketable value and the agency is in the process of negotiating a sale or lease to the county.

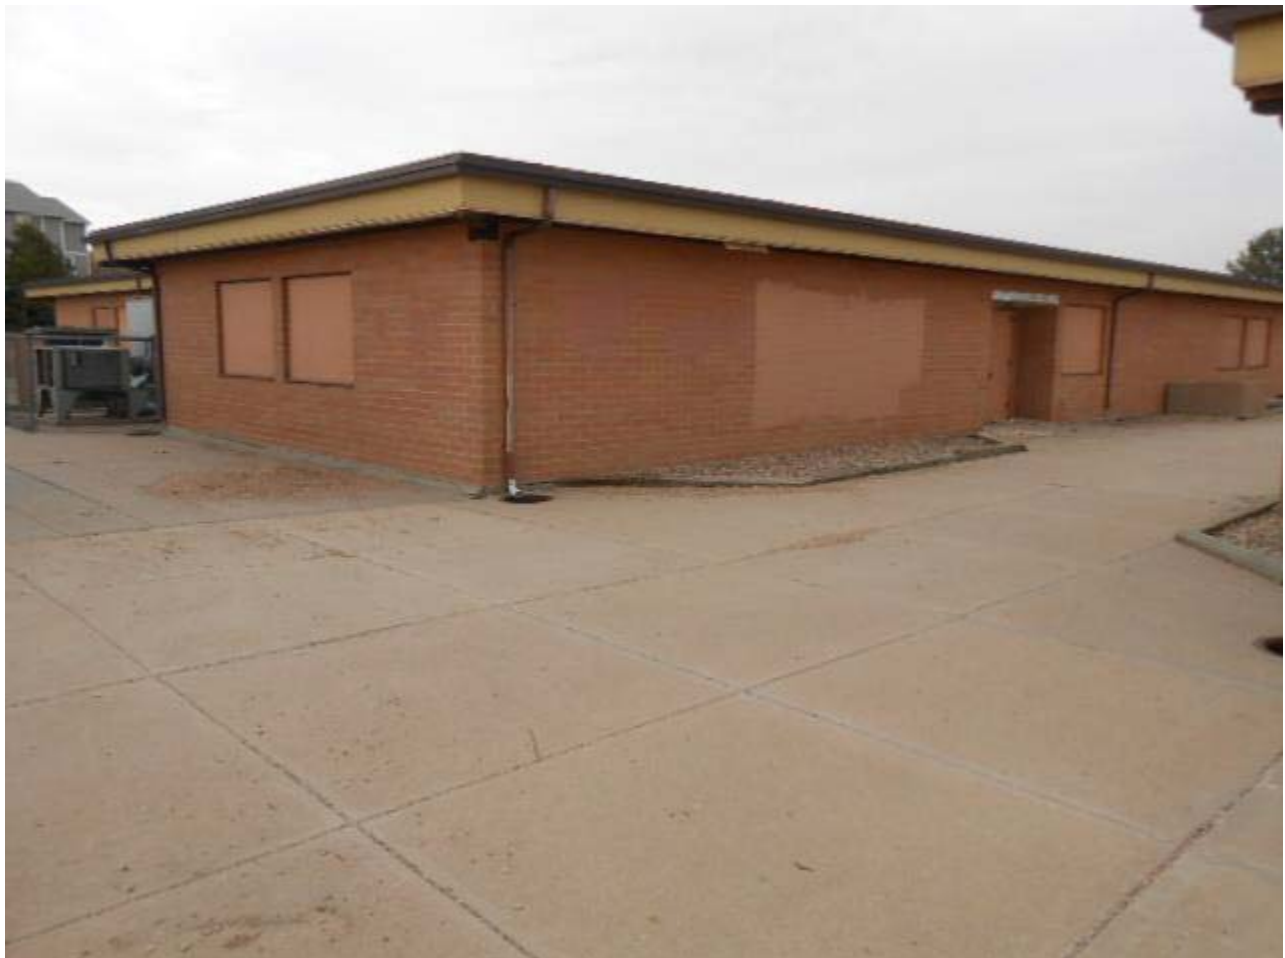
The building is at the end of its lifecycle and a completely depreciated value. Refurbishing the building would require a capital investment to remediate hazardous materials and refurbish the interior and exterior. While the exterior is in good condition, the interior cannot be used without extensive material clean up and remodeling. The land has marketable value and the agency is in the process of negotiating a sale or lease to the county.

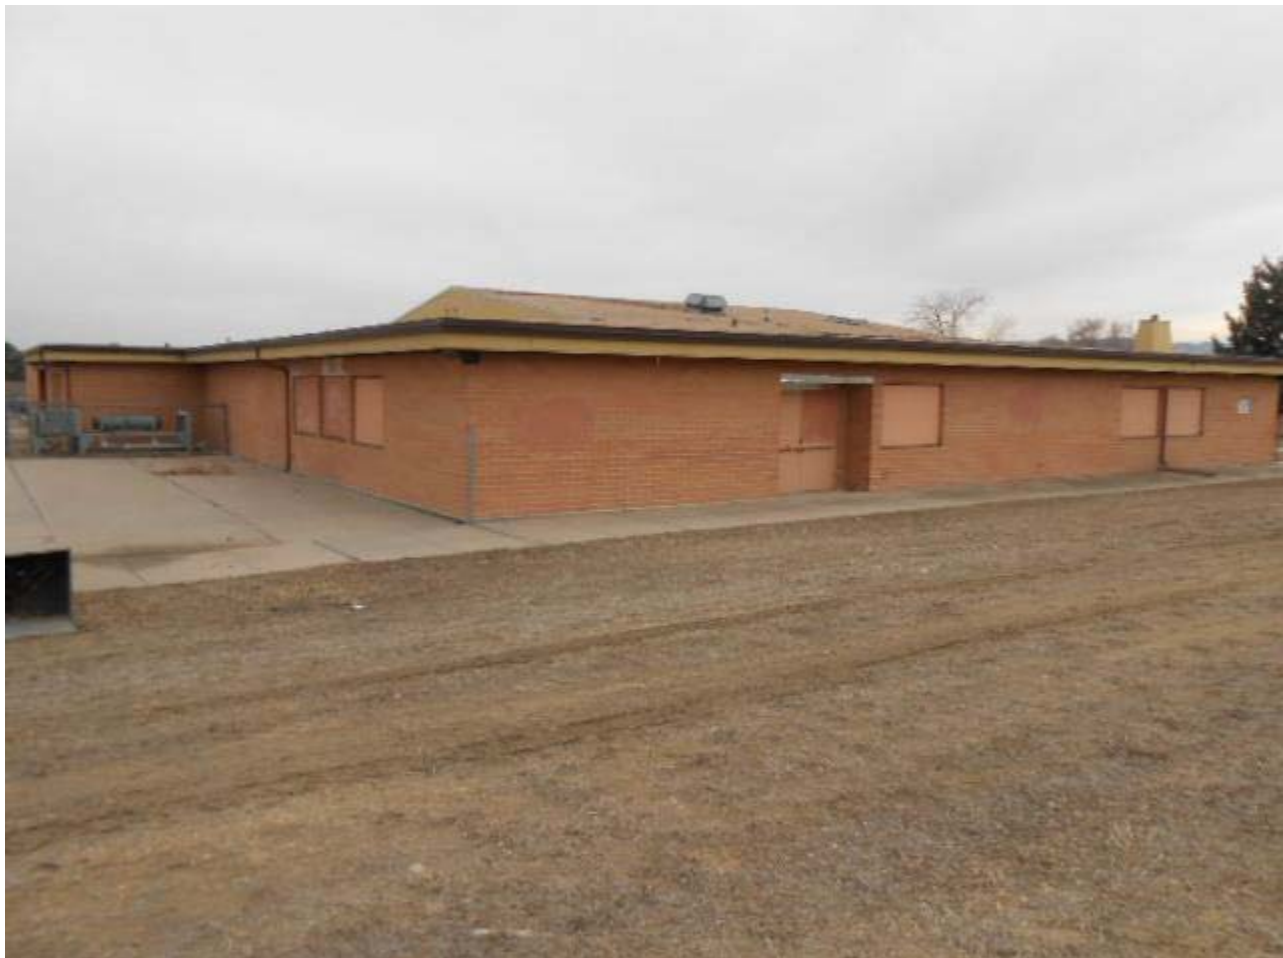
The building is at the end of its lifecycle and a completely depreciated value. Refurbishing the building would require a capital investment to remediate hazardous materials and refurbish the interior and exterior. While the exterior is in good condition, the interior cannot be used without extensive material clean up and remodeling. The land has marketable value and the agency is in the process of negotiating a sale or lease to the county.

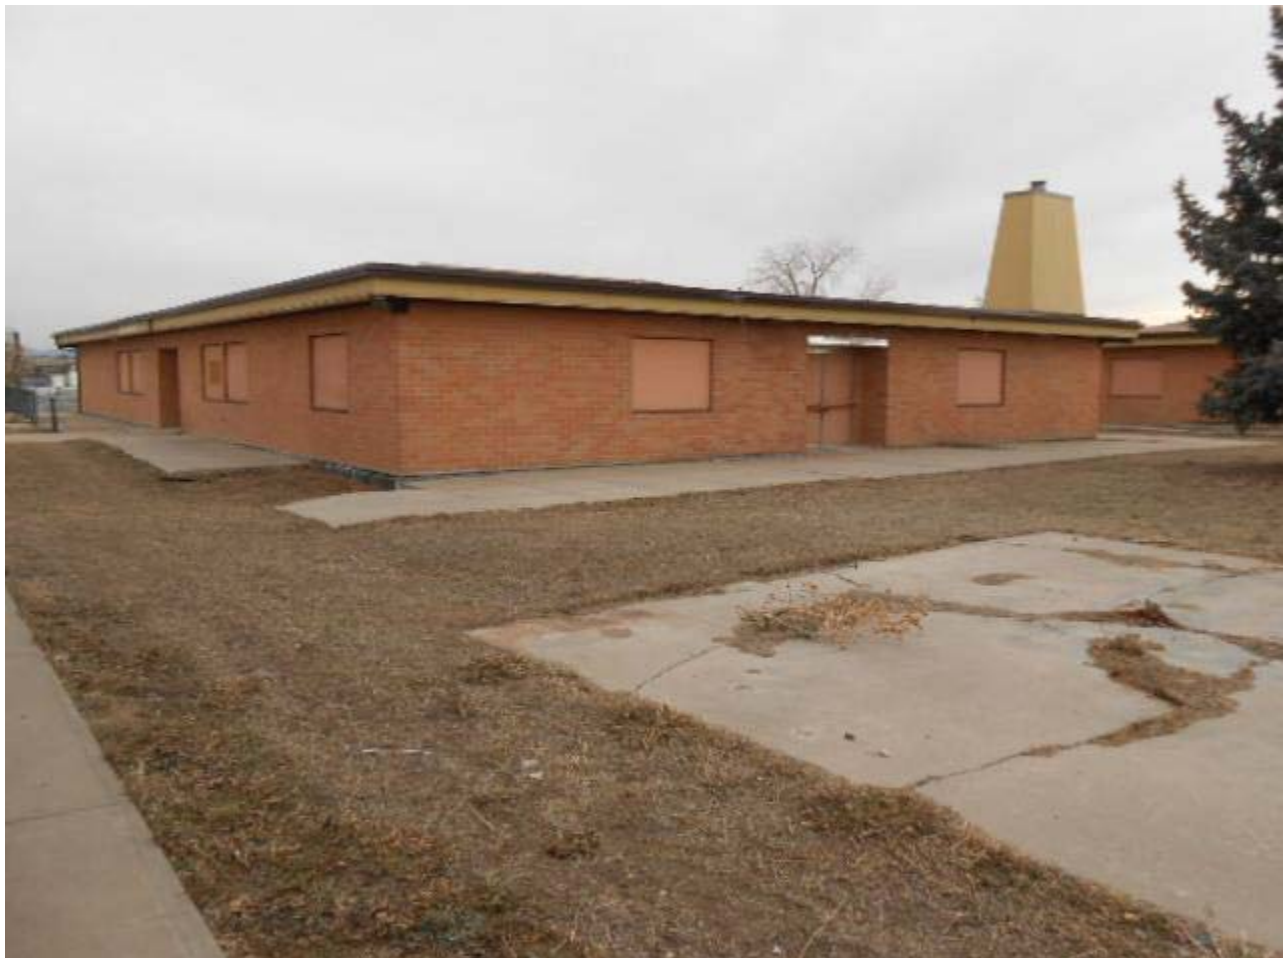
The building is at the end of its lifecycle and a completely depreciated value. Refurbishing the building would require a capital investment to remediate hazardous materials and refurbish the interior and exterior. While the exterior is in good condition, the interior cannot be used without extensive material clean up and remodeling. The land has marketable value and the agency is in the process of negotiating a sale or lease to the county.

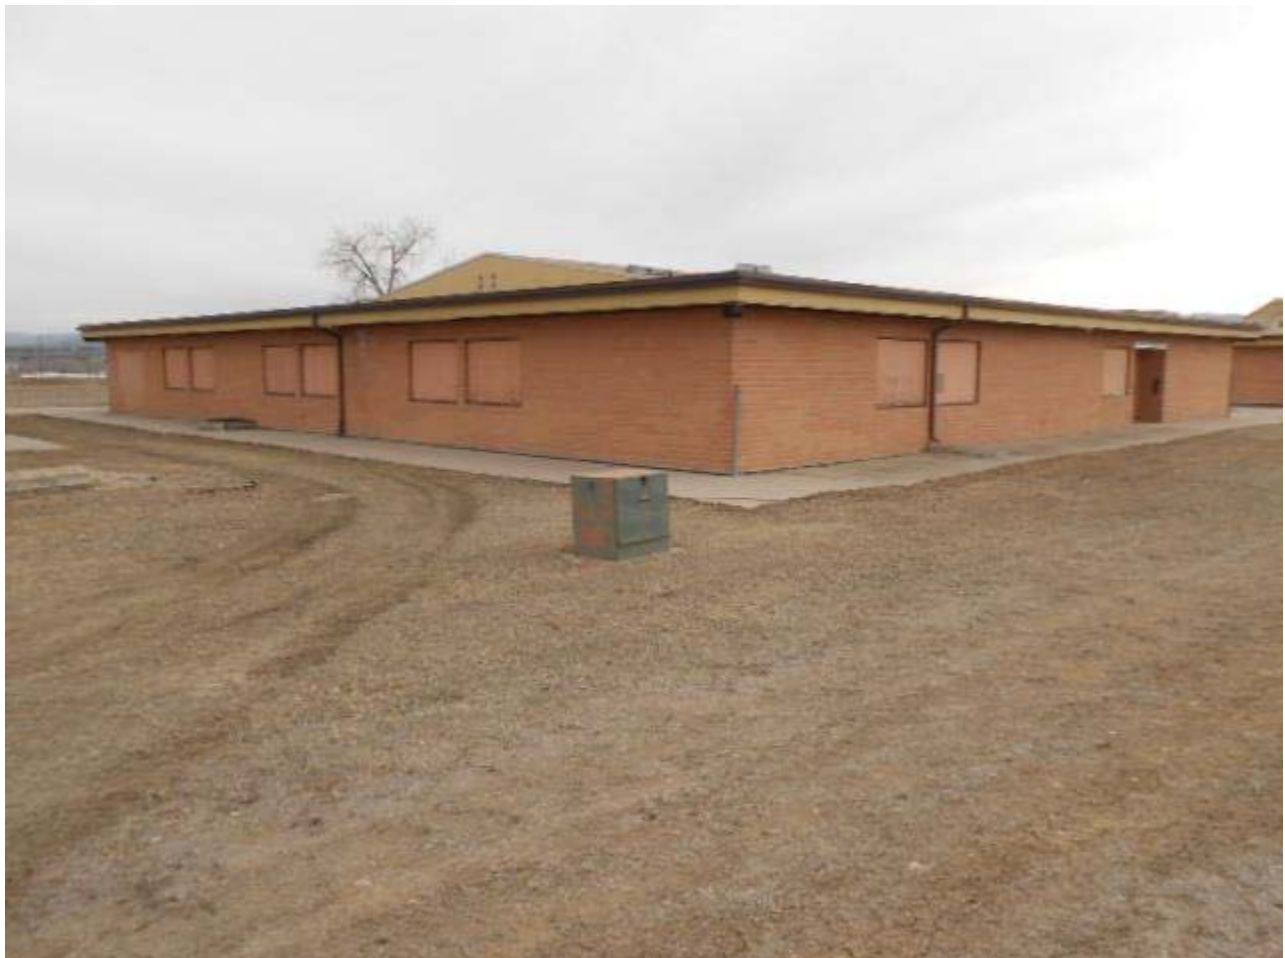
The building is at the end of its lifecycle and a completely depreciated value. Refurbishing the building would require a capital investment to remediate hazardous materials and refurbish the interior and exterior. While the exterior is in good condition, the interior cannot be used without extensive material clean up and remodeling. The land has marketable value and the agency is in the process of negotiating a sale or lease to the county.

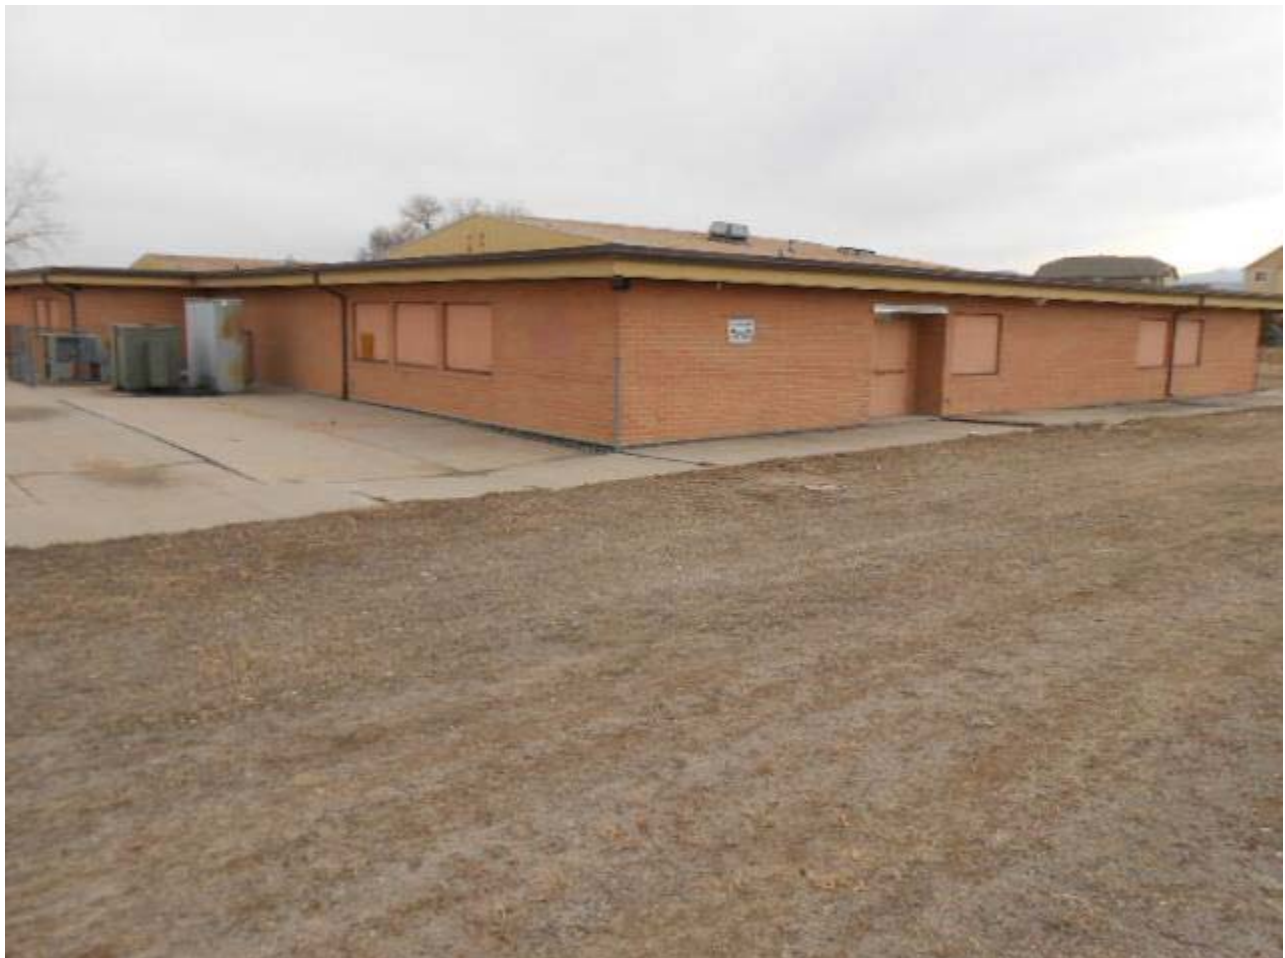
The building is at the end of its lifecycle and a completely depreciated value. Refurbishing the building would require a capital investment to remediate hazardous materials and refurbish the interior and exterior. While the exterior is in good condition, the interior cannot be used without extensive material clean up and remodeling. The land has marketable value and the agency is in the process of negotiating a sale or lease to the county.

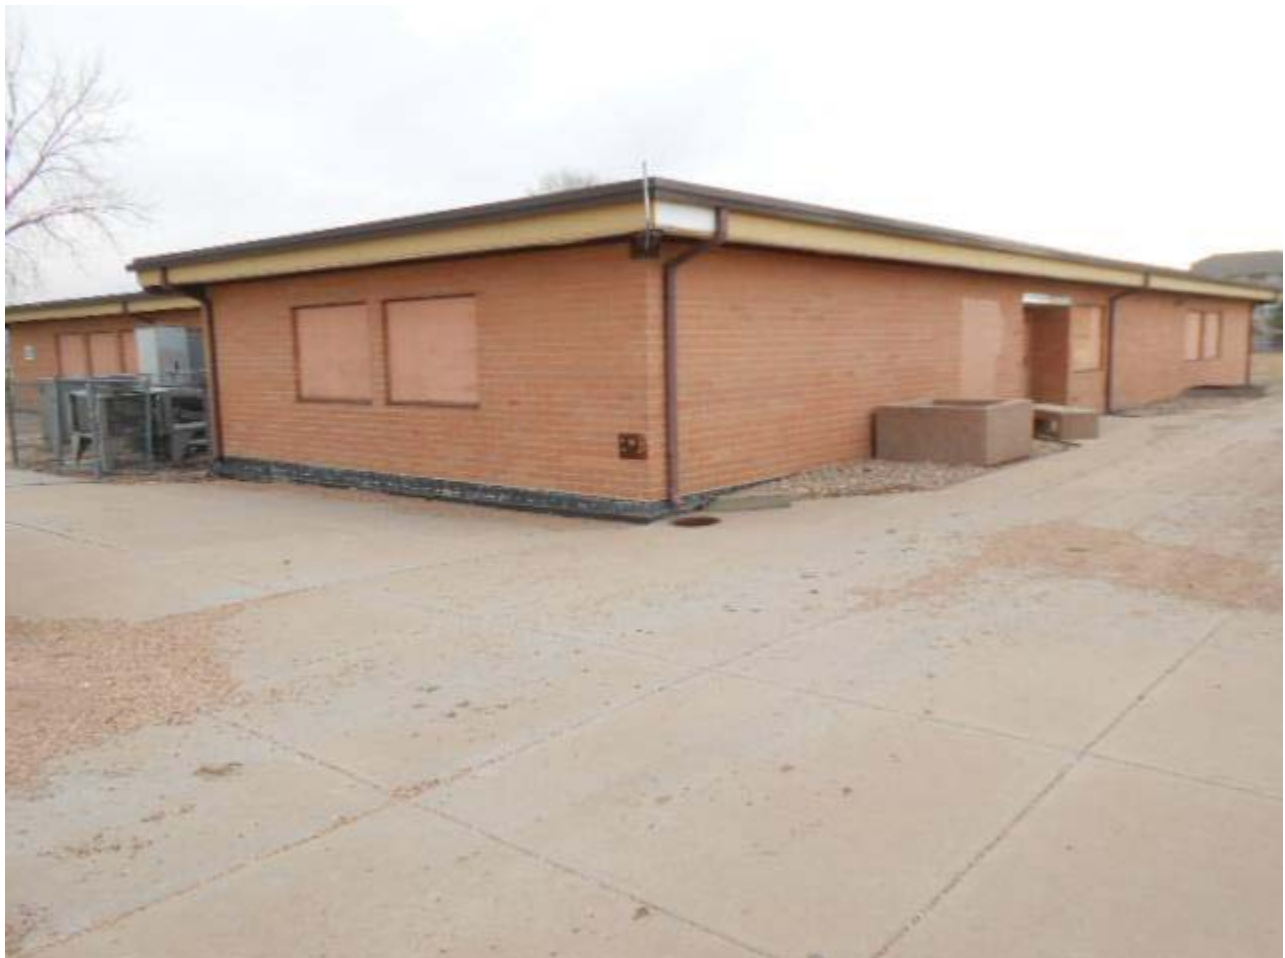
The building is at the end of its lifecycle and a completely depreciated value. Refurbishing the building would require a capital investment to remediate hazardous materials and refurbish the interior and exterior. While the exterior is in good condition, the interior cannot be used without extensive material clean up and remodeling. The land has marketable value and the agency is in the process of negotiating a sale or lease to the county.

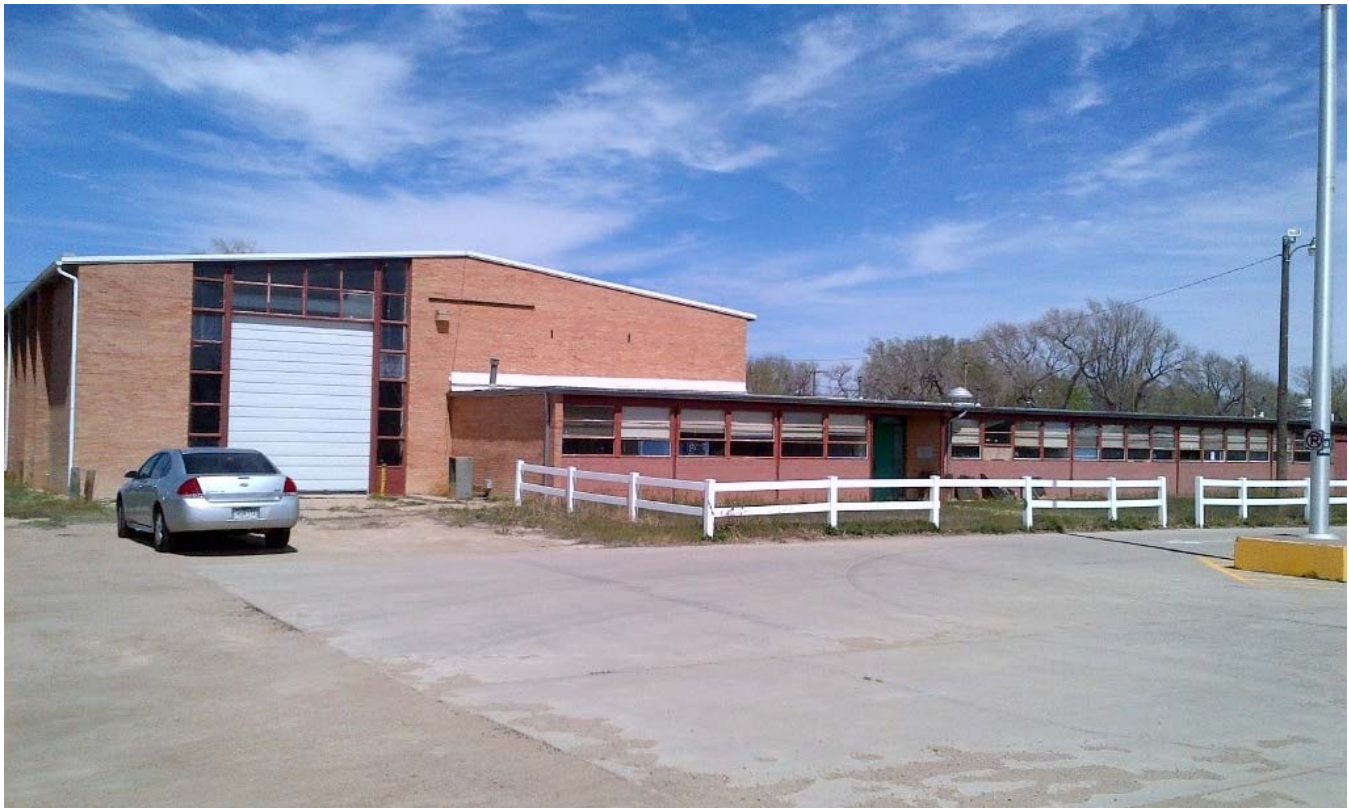
The building is at the end of its lifecycle and requires a complete interior refurbishment. This asset has repurposing potential.

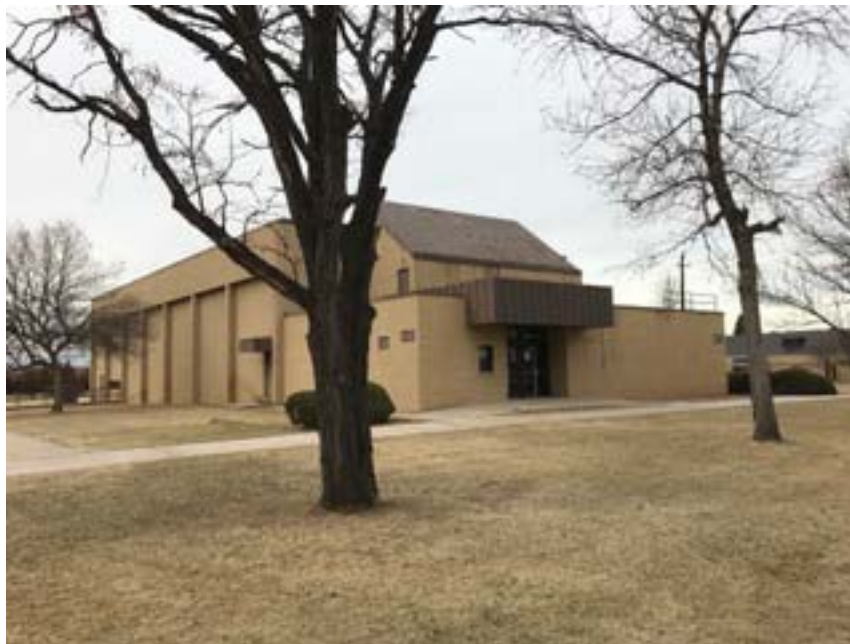
This building is on a campus that is deed restricted, so a sale to an outside party may not be possible.

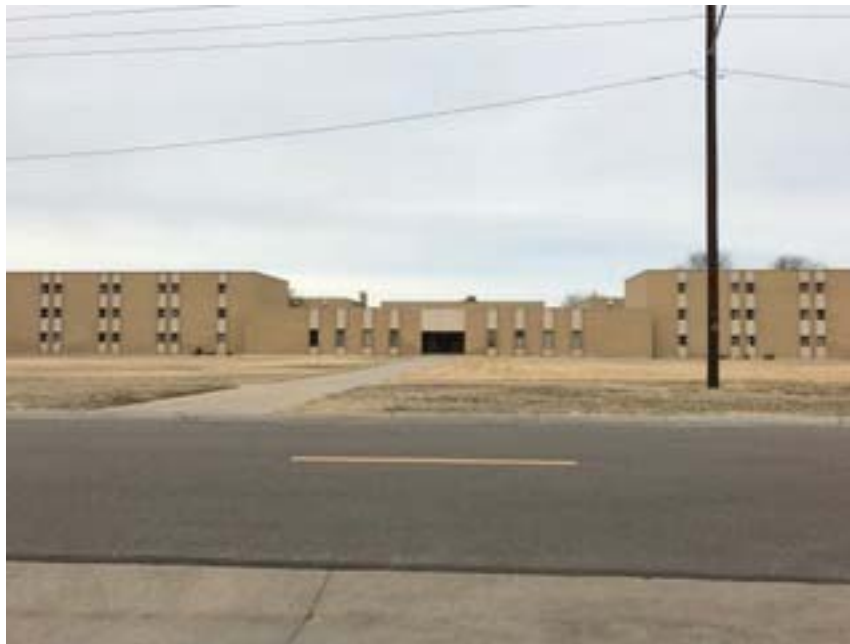
This building is on a campus that is deed restricted, so a sale to an outside party may not be possible.

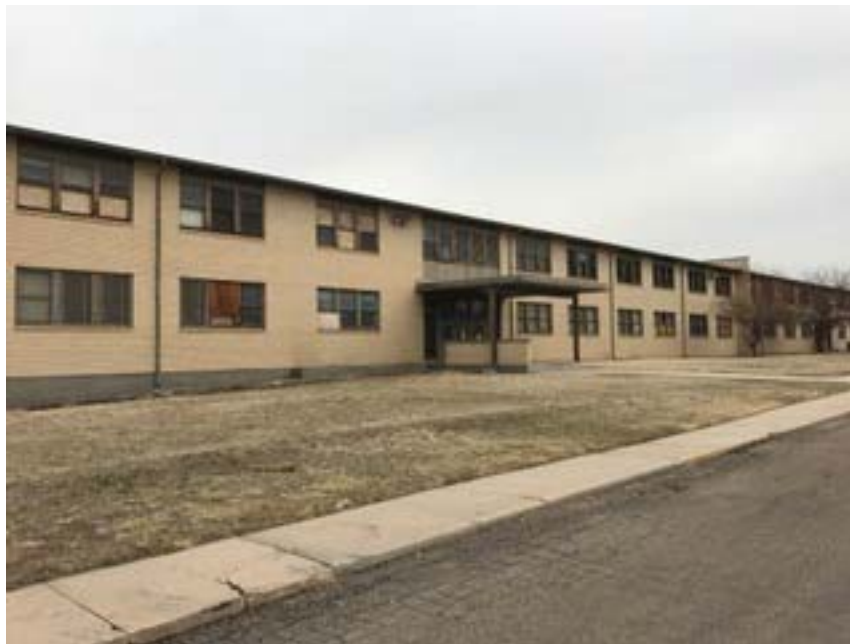
This building is on a campus that is deed restricted, so a sale to an outside party may not be possible.

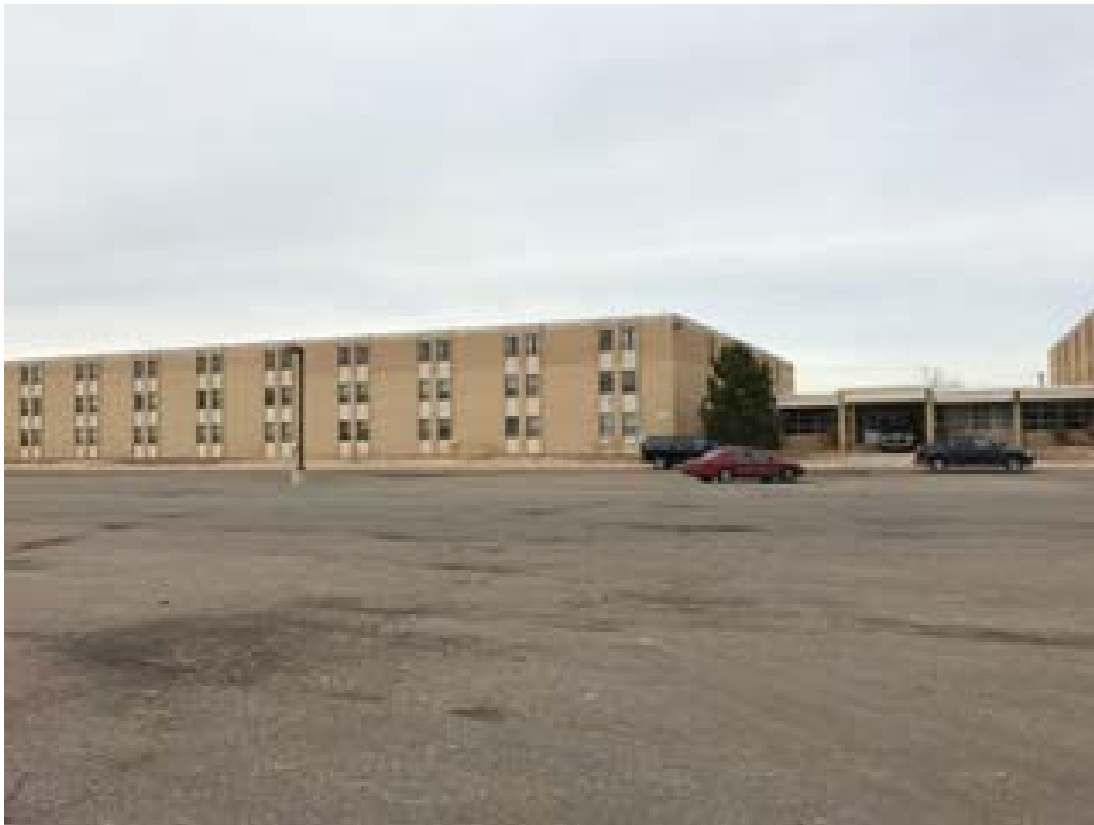
This building is on a campus that is deed restricted, so a sale to an outside party may not be possible.

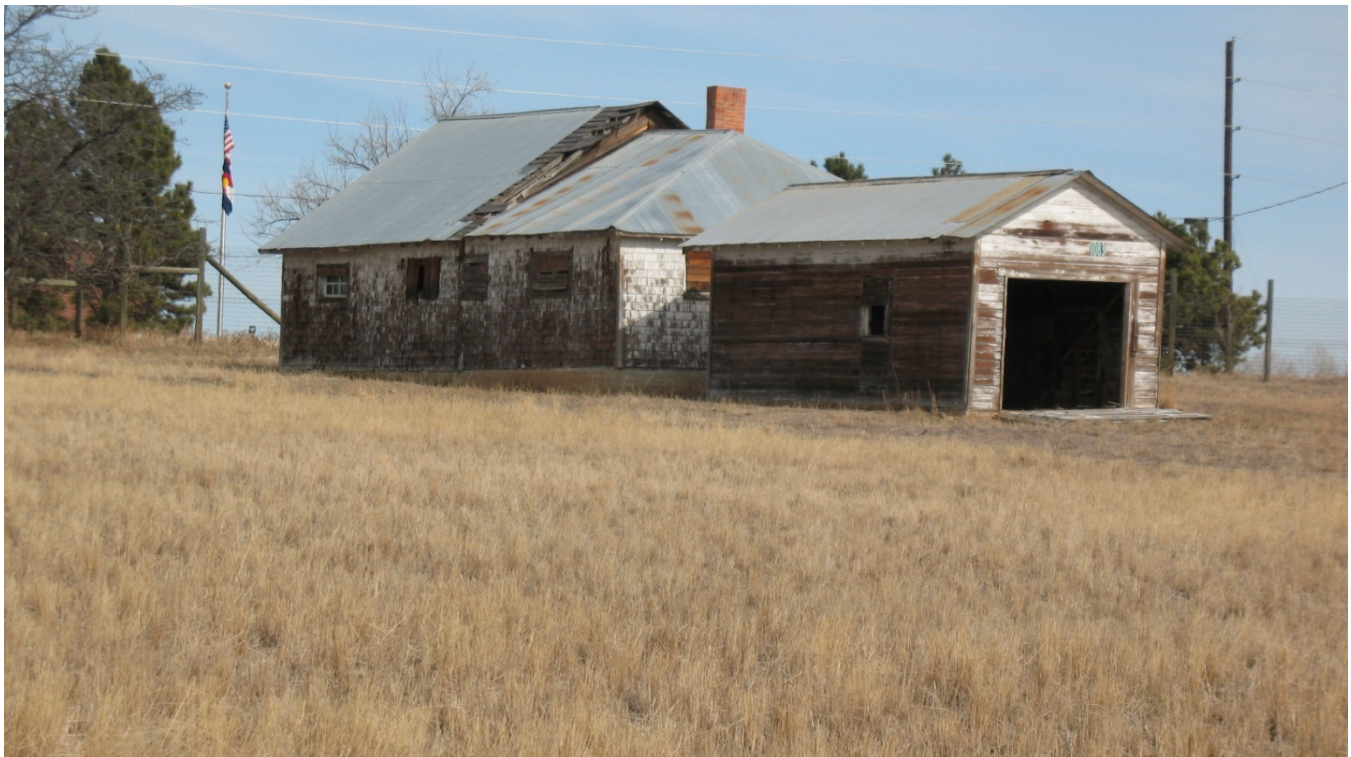
Due to age, the asset may have some historical values, but refurbishing it would be costly. The parcel may have market value.
