**OFFICE OF THE
STATE ARCHITECT**

**VACANT
FACILITIES
REPORT**

Revision: December 2020

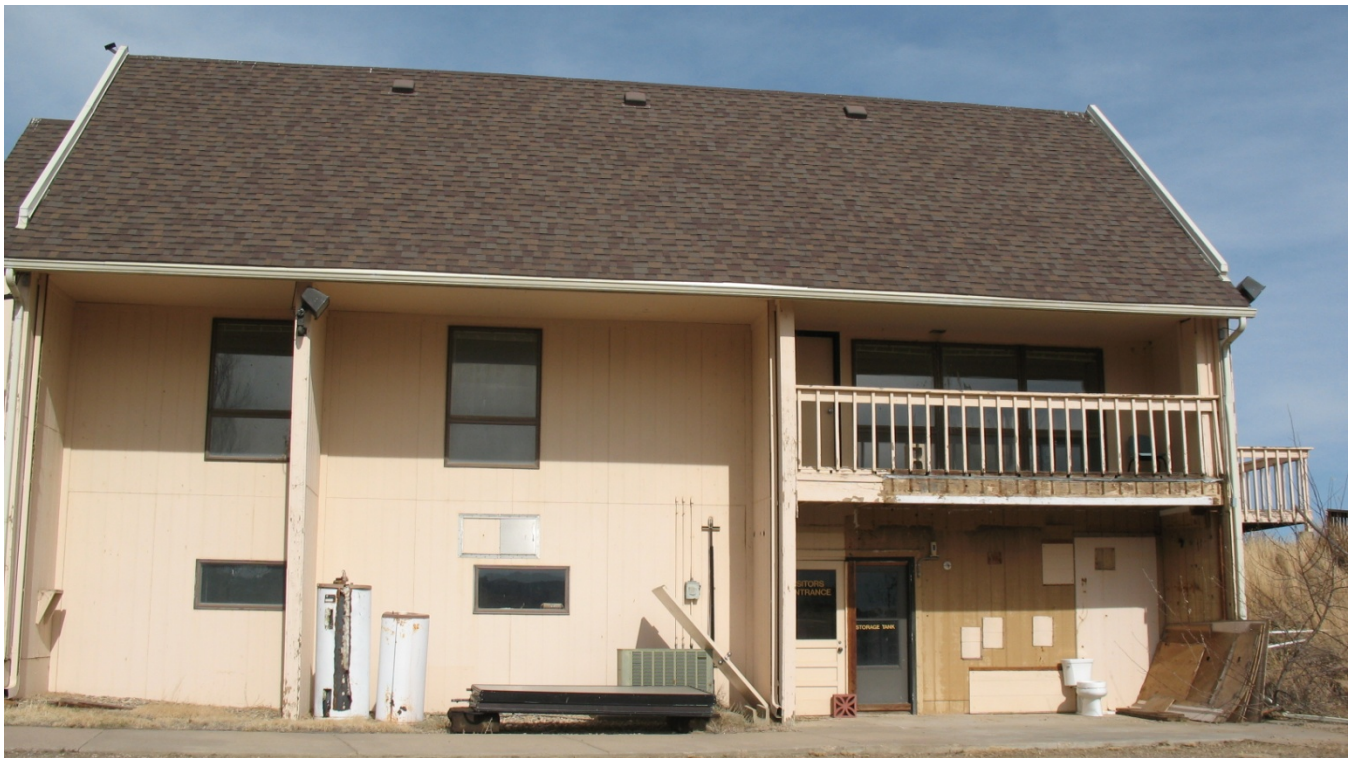
As part of a campus, selling the asset may be difficult or impossible and require funds to refurbish.

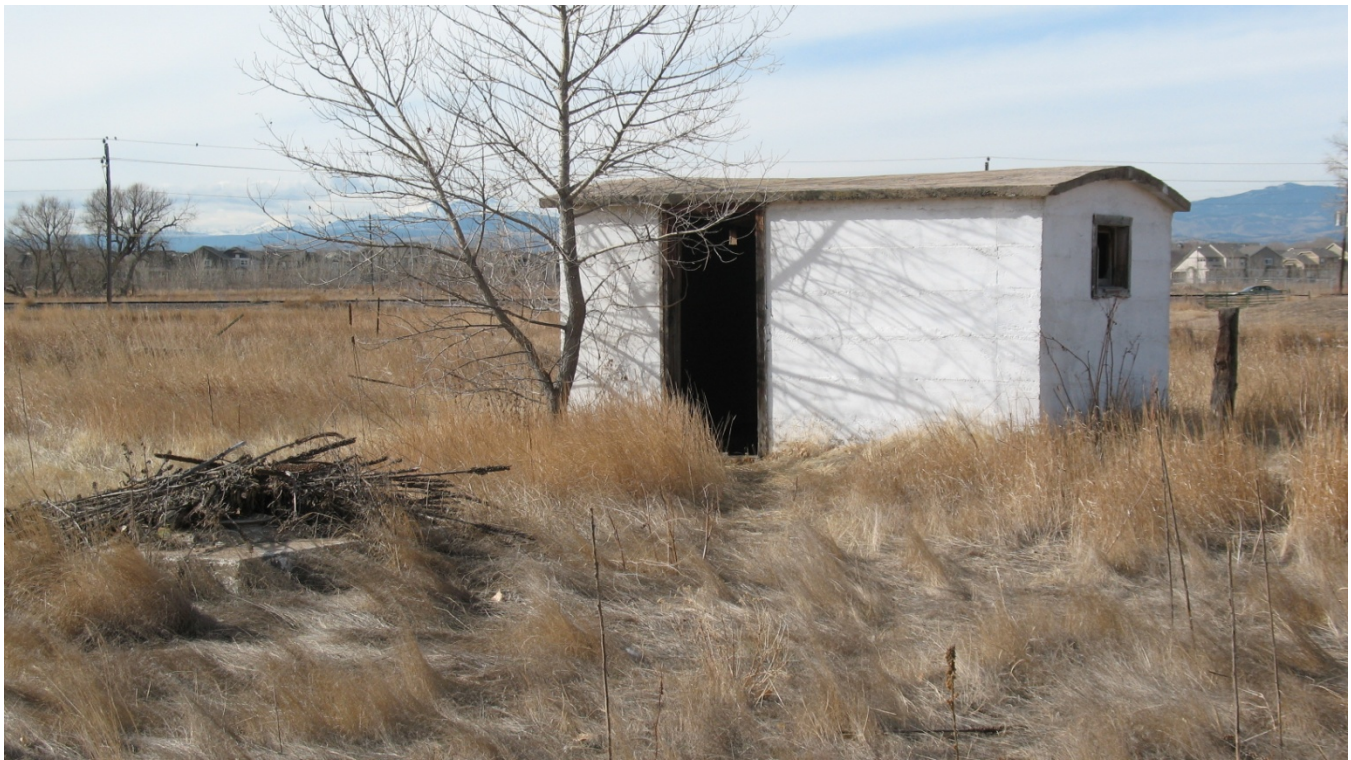
The land may have value, but the asset has no potential for re-use.

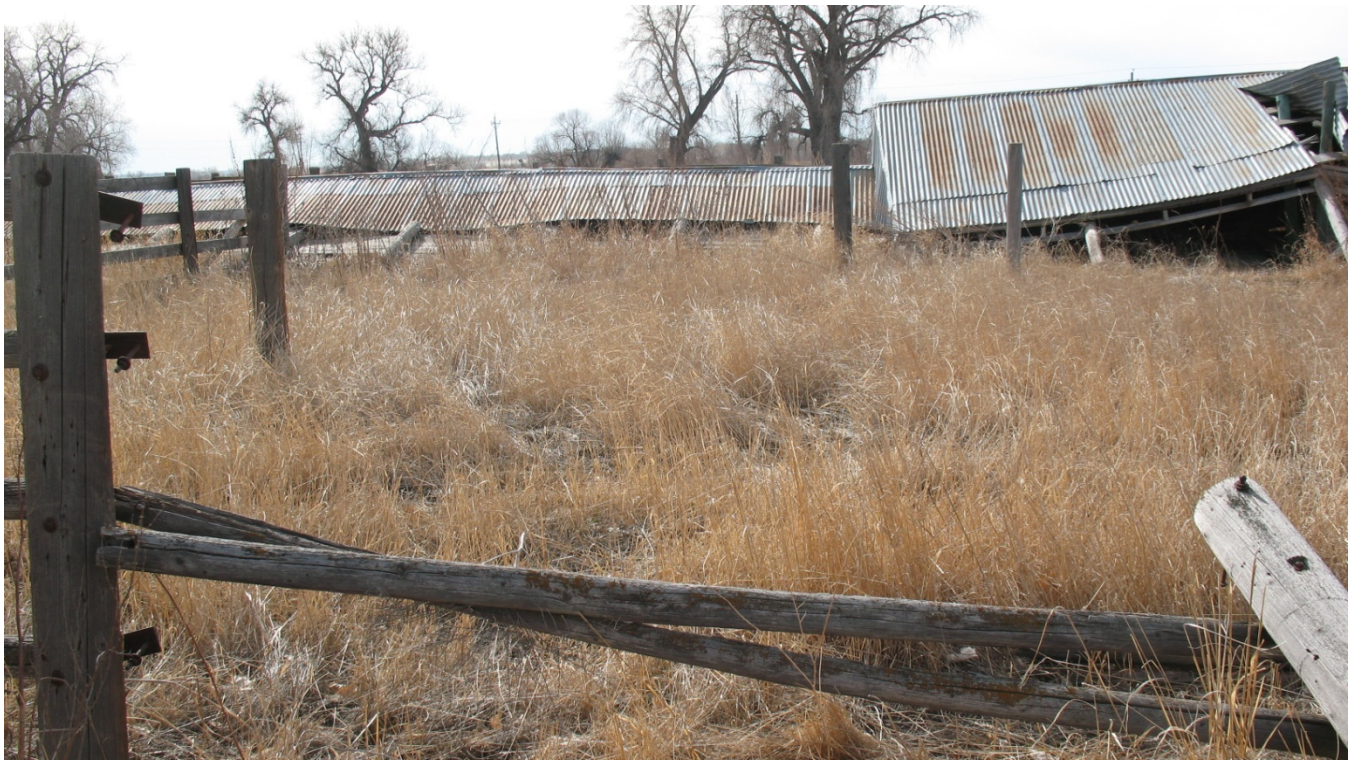
The land may have value, but the asset has no potential for re-use.

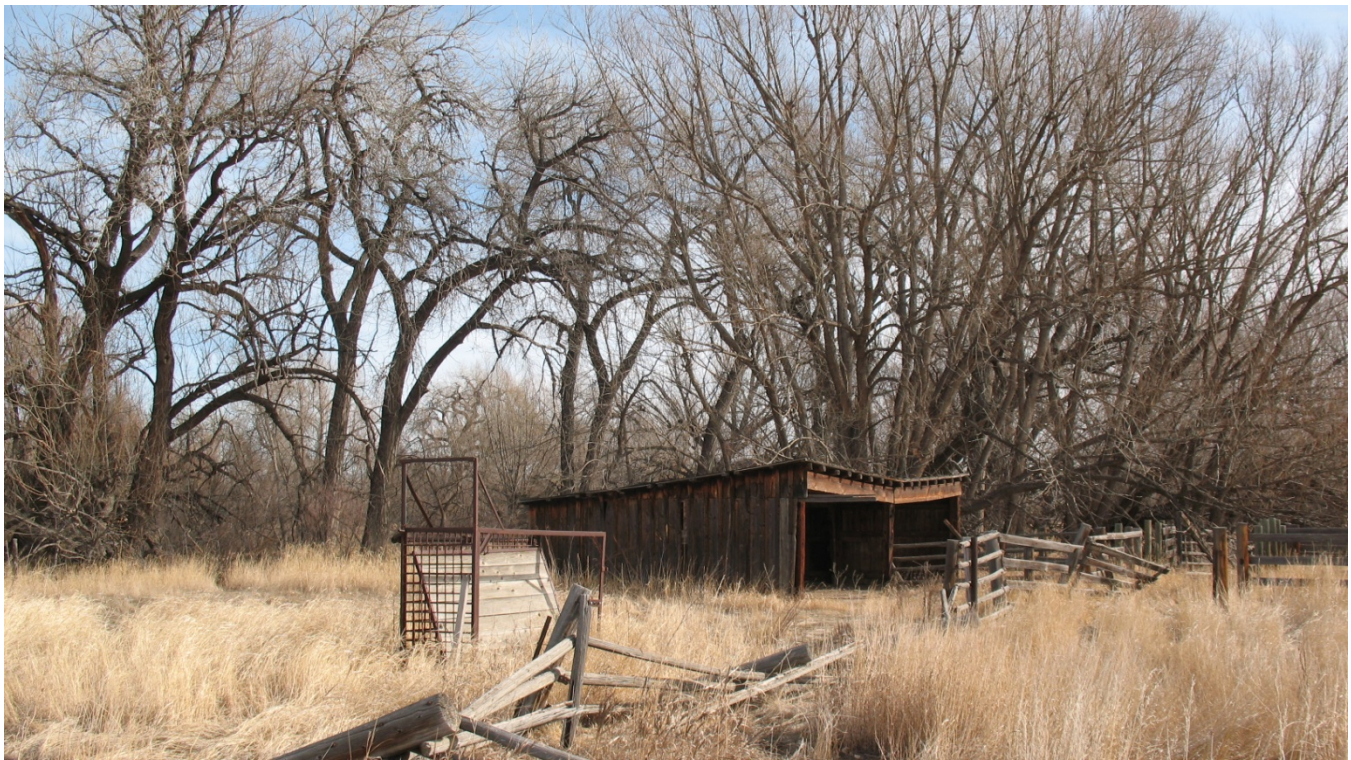
The land may have value, but the asset has no potential for re-use.

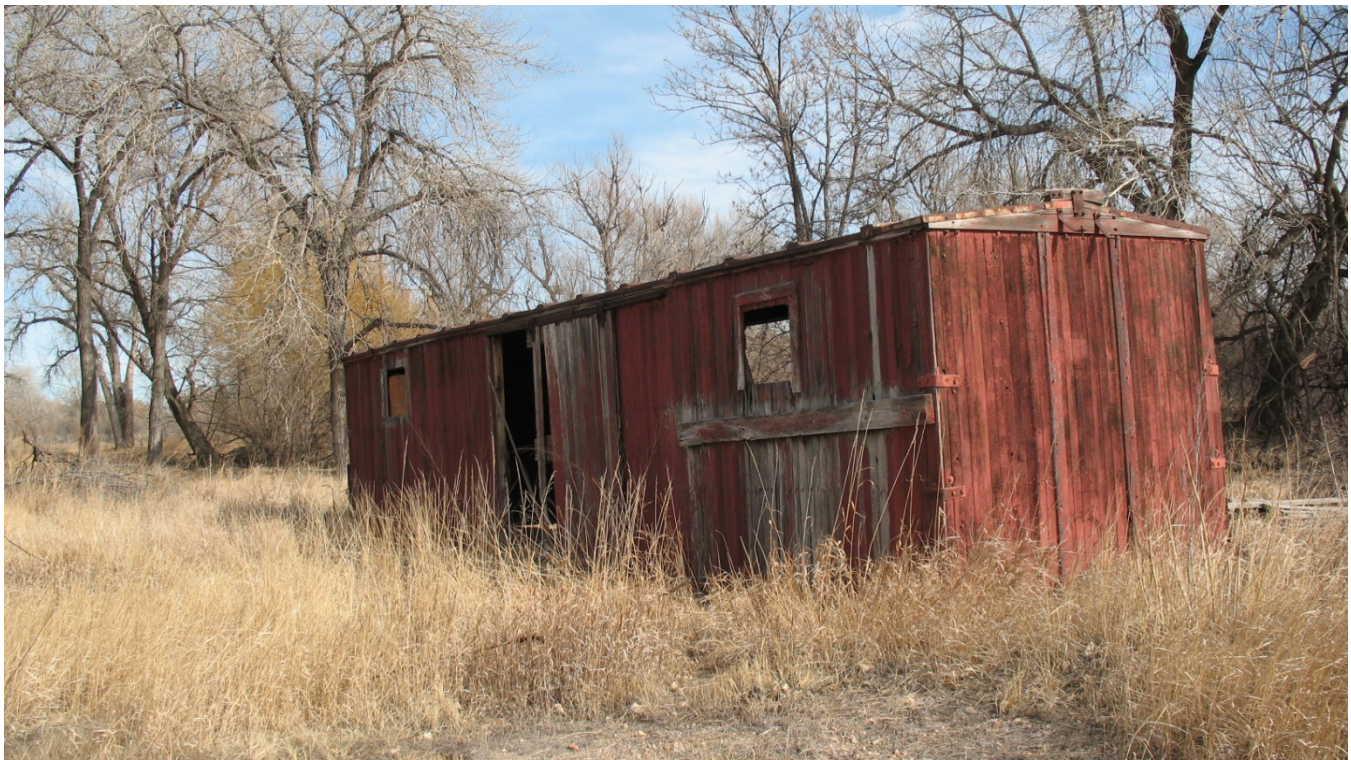
The land may have value, but the asset has no potential for re-use.

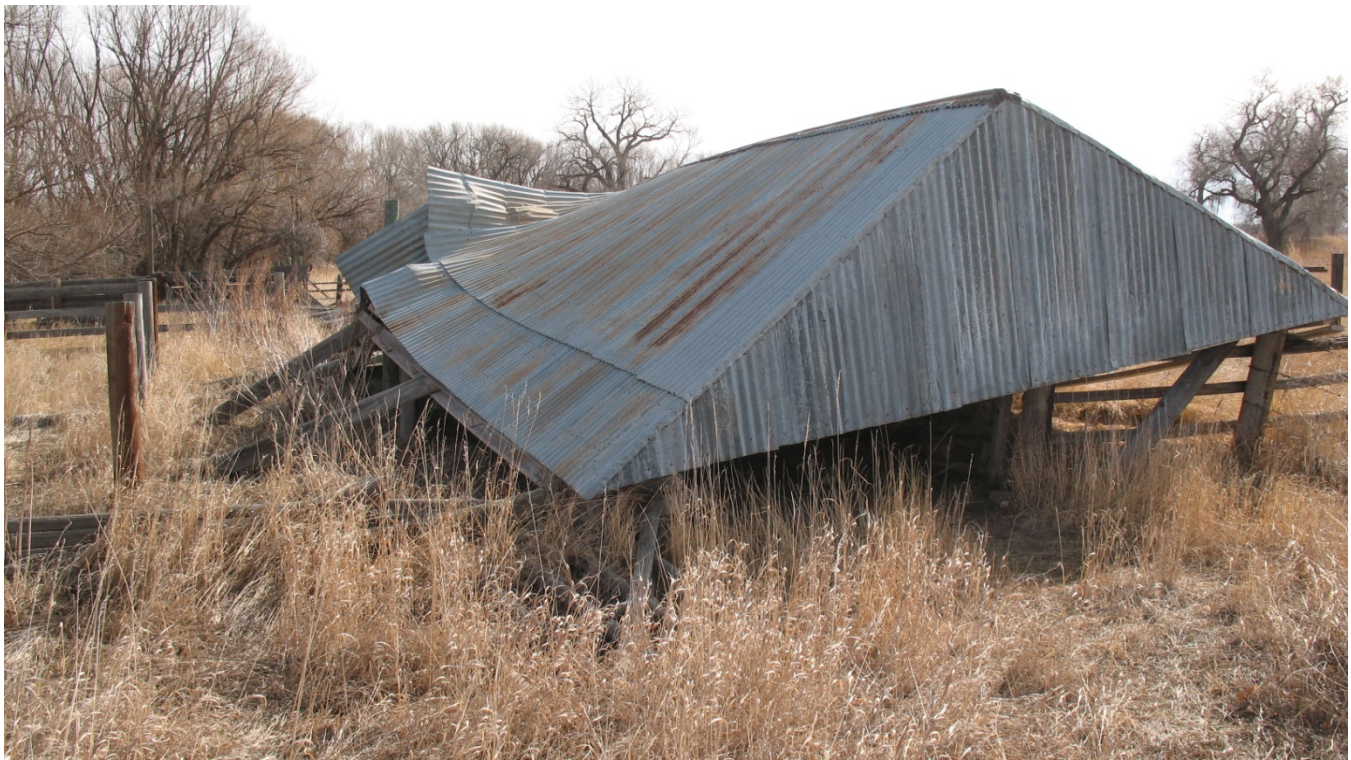
The land may have value, but the asset has no potential for re-use.

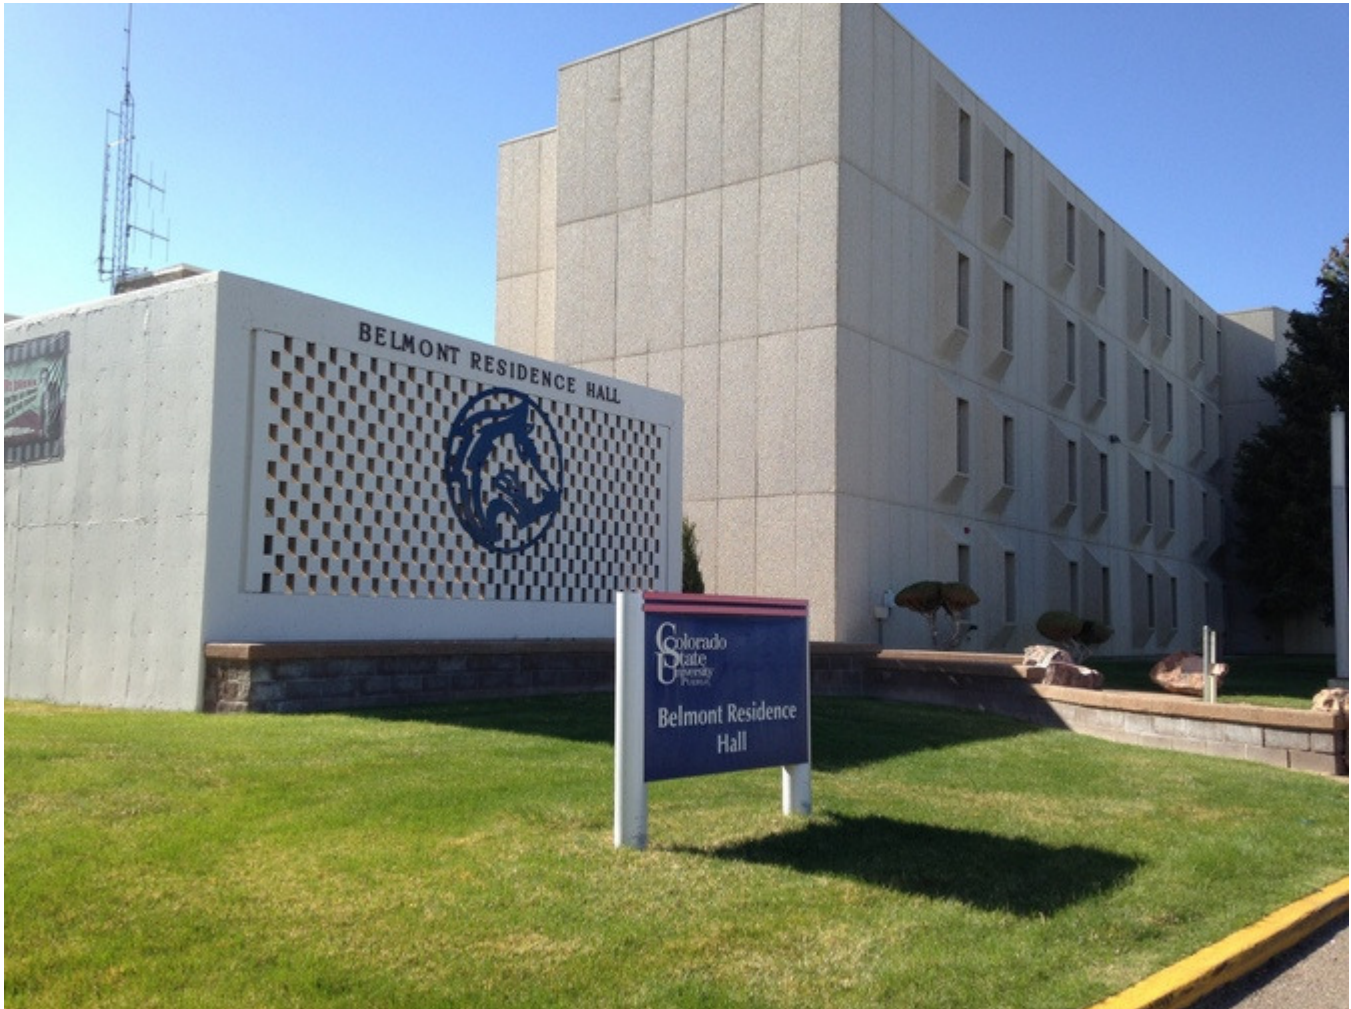
As part of a campus, selling the asset would be difficult. The institution is evaluating options for re-use.

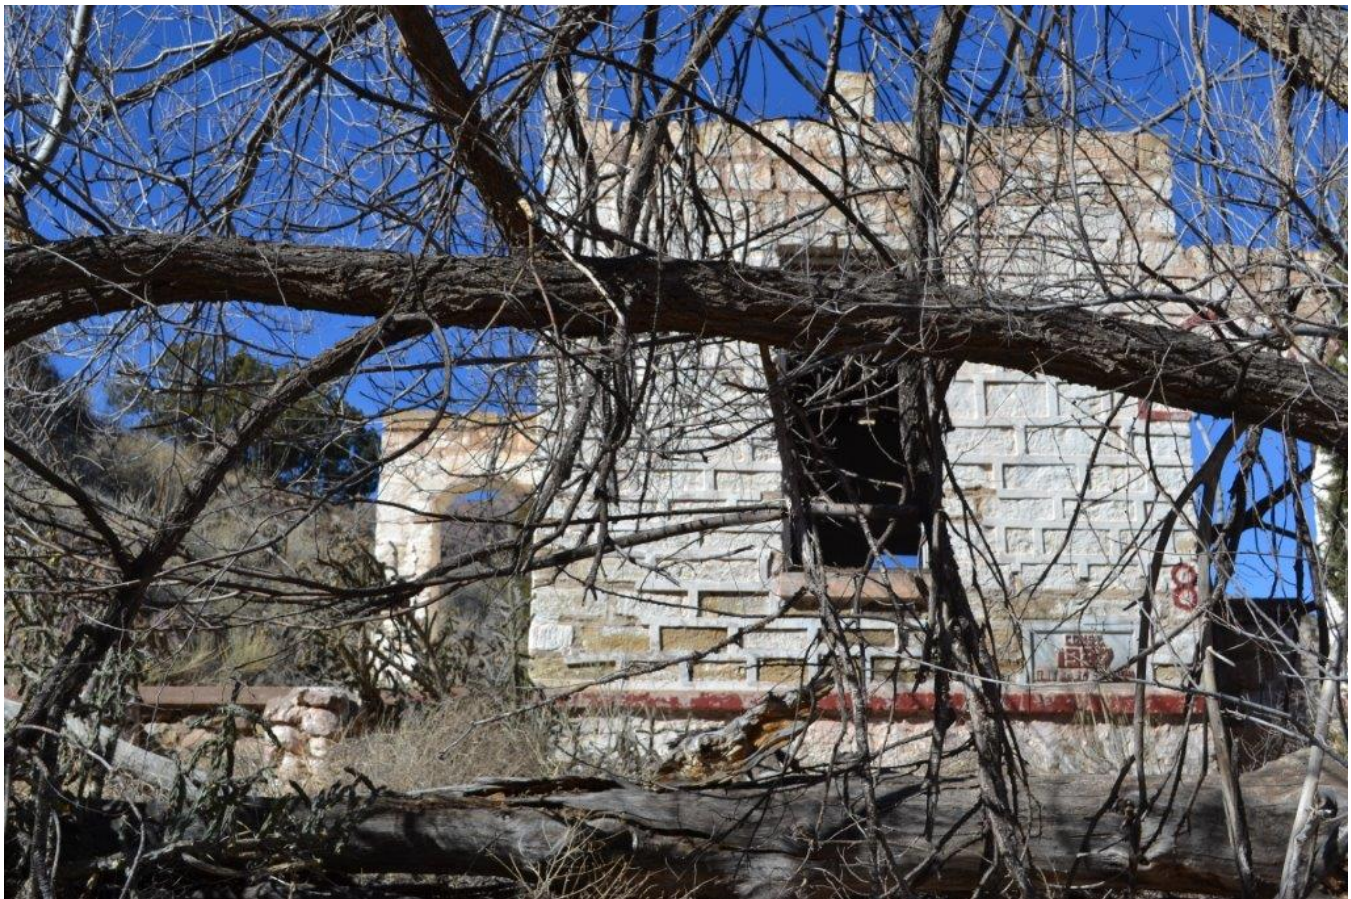
This building is completely depreciated and has no potential for reuse without a major remodel or rebuild.

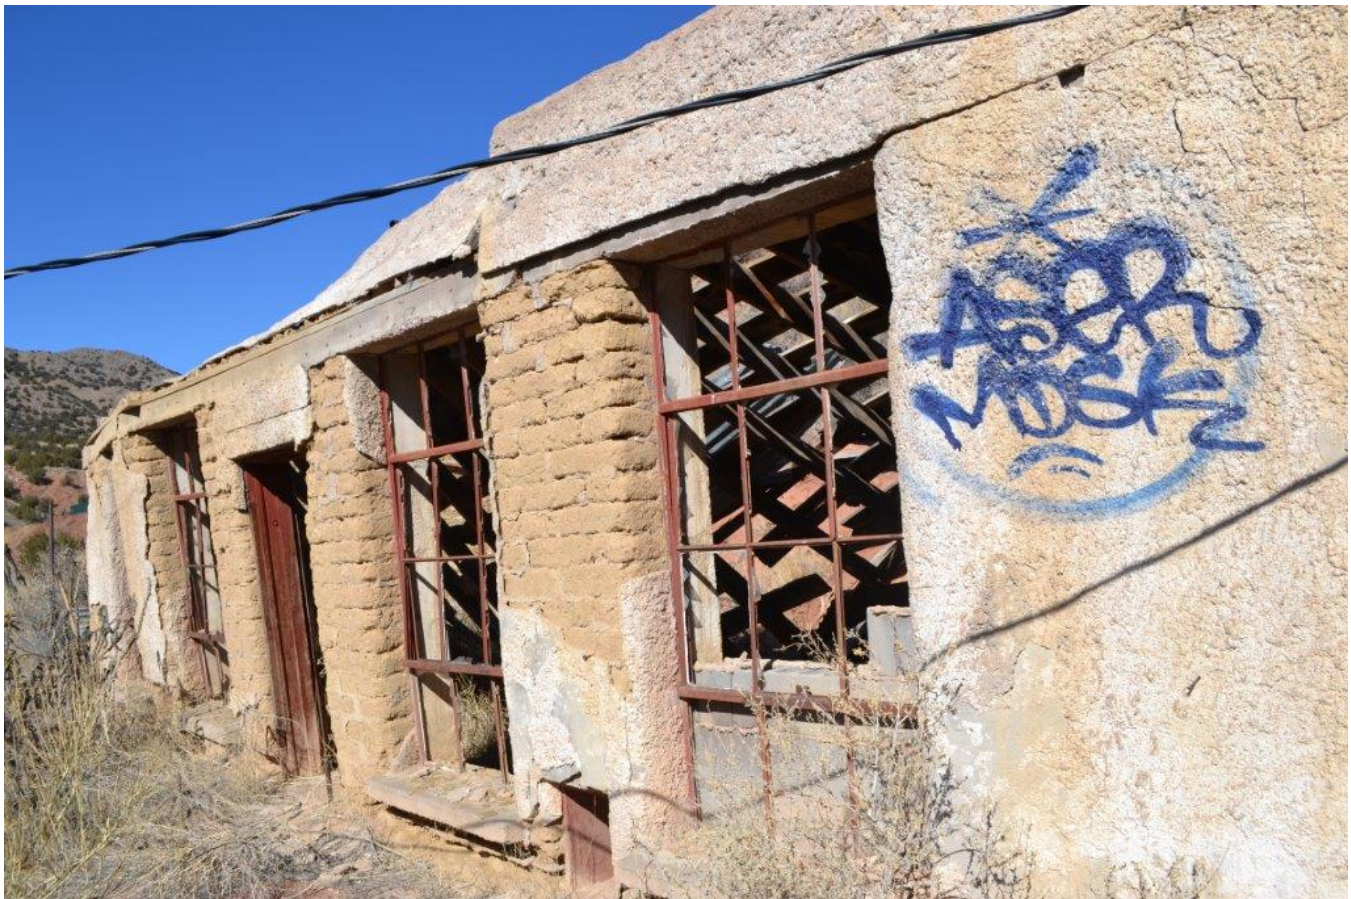
This building is completely depreciated and has no potential for reuse without a major remodel or rebuild.

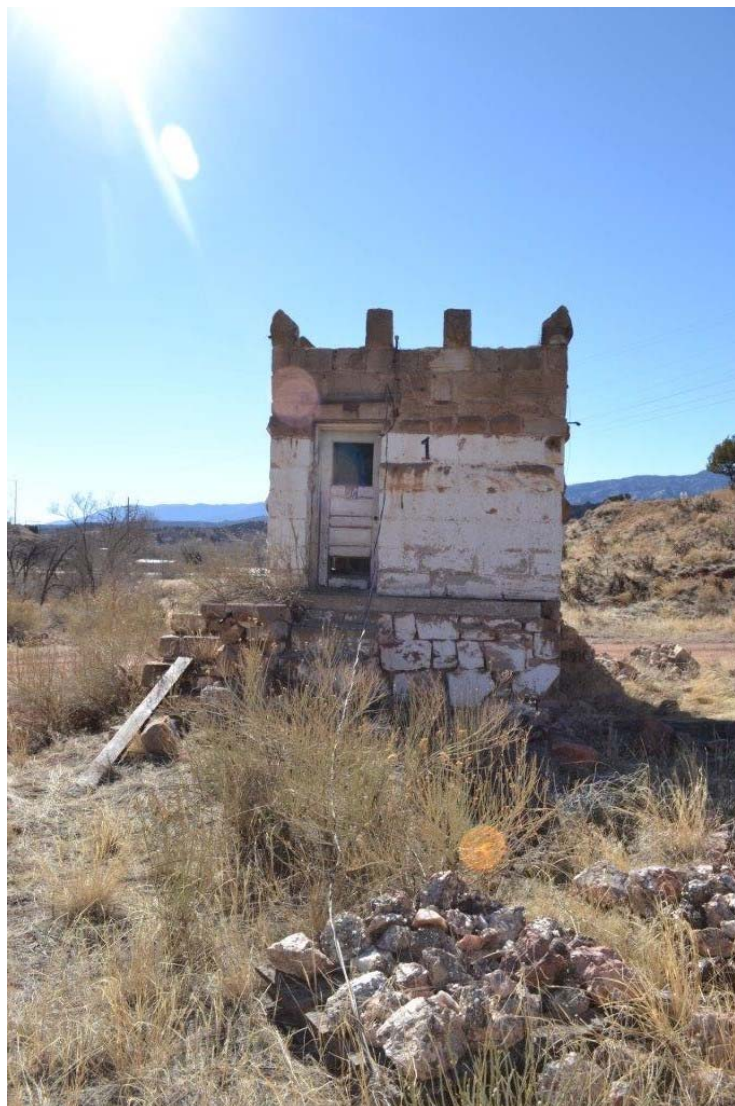
This building is completely depreciated and has no potential for reuse without a major remodel or rebuild.

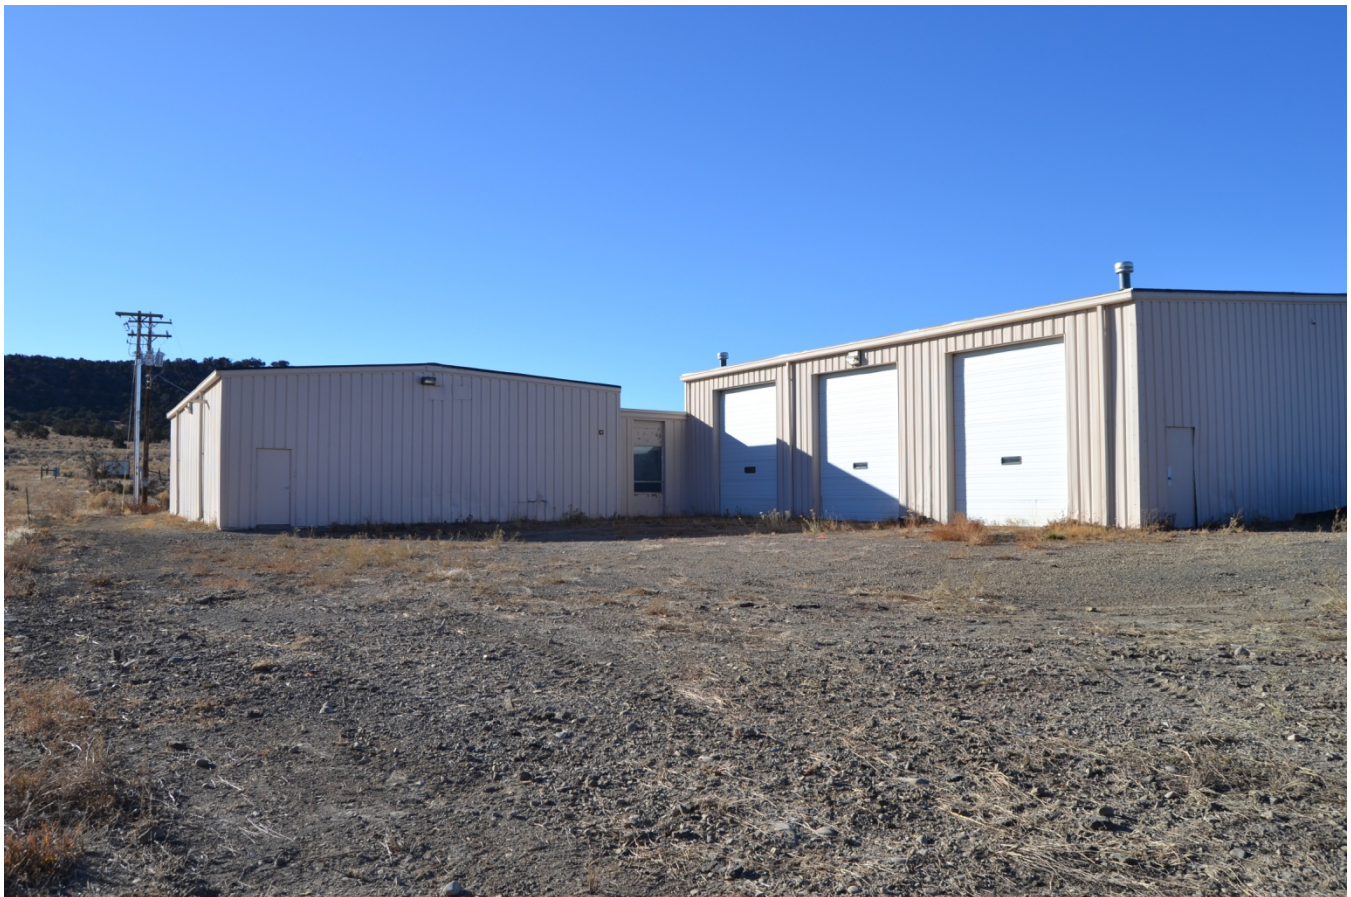
This building can be reused with some refurbishment funds.

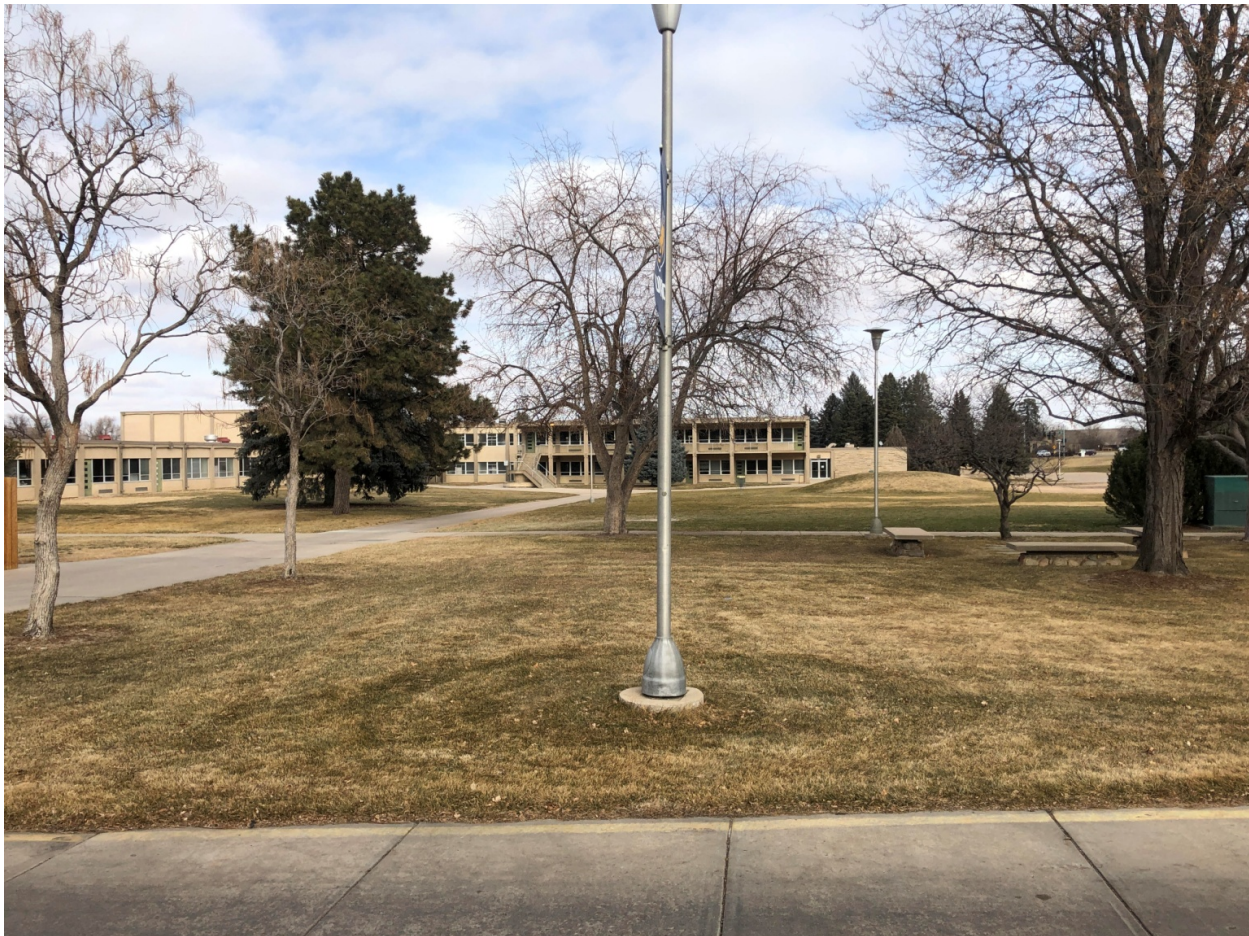
Some abatement has occurred, but it is unknown if all materials have been removed. The building can be used for classroom and office use with minimal renovation. If the interior were to be completely renovated, the building could be repurposed into many other uses.
