CAPITOL COMPLEX MASTER PLAN

FINDINGS & RECOMMENDATIONS (F & R) NEEDS ASSESSMENT

NORTH CAMPUS NORTH BUILDING, 6321 NORTH DOWNING STREET (DENVER)

NOVEMBER 2014

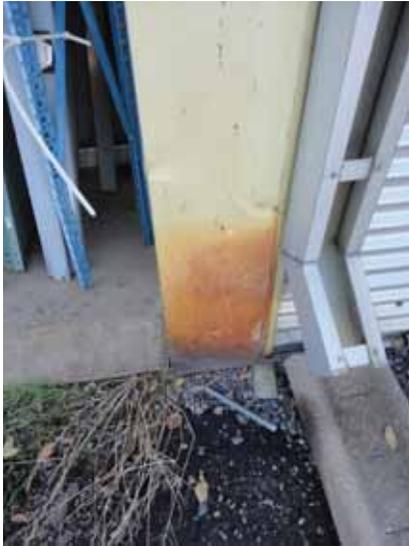
The metal panels on the exterior walls of the original engineered metal building are in poor condition overall. Areas of peeling paint and areas with evidence of corrosion were observed around the exterior of the original building (see Fig. 2.1.A.1, Fig. 2.1.A.2, and Fig. 2.1.A.3). There were holes and gaps readily observable in the metal panels from the inside of the building (see Fig. 2.1.A.4). Other damaged areas of the metal panels were observed around the building (see Fig. 2.1.A.5 and Fig. 2.1.A.6). The damage is likely from vehicles running into the building. It was noted that there are no concrete guard posts/bollards placed around the original building to protect the structure from vehicle damage in and around the loading dock doors and parking areas. There was dirt and debris observed to be collecting along the north side of the building (see Fig. 2.1.A.7).

Fig. 2.1.A.2 Corrosion observed at the metal panels around the exterior of the original building.

- Remove the building skin around the exterior of the original building and replace with a new building skin, including new insulation.
- Install concrete guard posts/bollards along parking areas and around overhead rolling doors around the exterior of the original building to protect the structure from future vehicular damage.

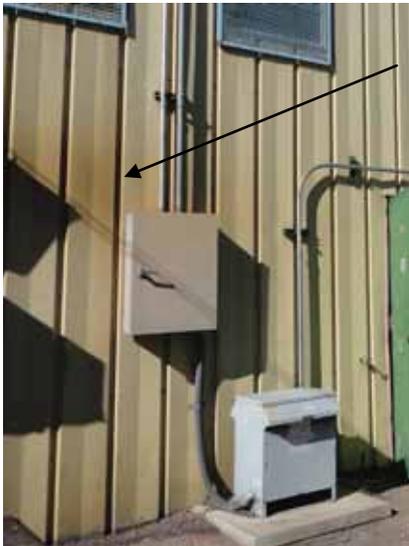
Fig. 2.1.A.3 Corrosion observed at the metal panels around the exterior of the original building.

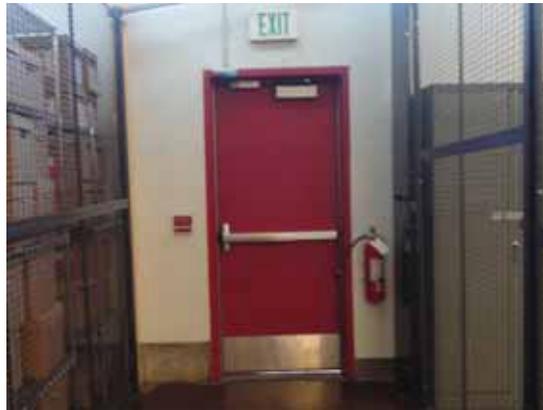
The double entrance doors on the south side of the west addition have evidence of extensive wear-and-tear along the bottom halves of the doors with the paint scraped off and exposing the metal (see Fig. 2.1.A.8). Deteriorating weatherstripping was noted at the door on the north side of the west addition with air gaps observed along the base of the door (see Fig. 2.1.A.9).

Fig. 2.1.A.9 Deteriorating weatherstripping with air gaps observed along the base of the entrance on the north side of the west addition.

- Refurbish or replace the entrance doors on the south side of the west addition. Add bumpers to the base of both doors as necessary to protect them from future damage.
- Replace the weatherstripping around the entrance doors on the north and south sides of the west addition as necessary to prevent air leakage from the building.

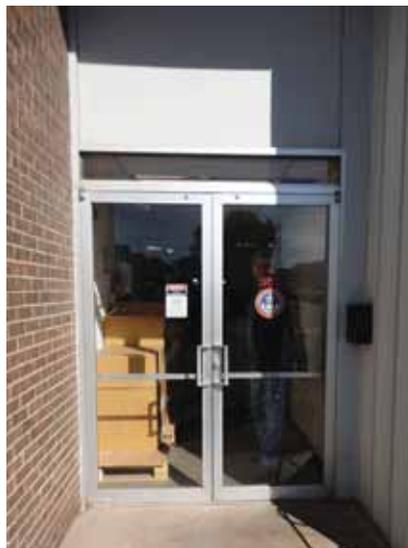
Deteriorating weatherstripping and wear-and-tear was noted in general at the doors around the exterior of the original building (see Fig. 2.1.A.10, Fig. 2.1.A.11, and Fig. 2.1.A.12). The overhead rolling doors around the exterior of the original building are in generally fair to poor condition with wear-and-tear and damaged noted throughout (see Fig. 2.1.A.13 and Fig. 2.1.A.14).

Fig. 2.1.A.10 Deteriorating weatherstripping observed at the exterior doors on the north and south side of the corridor between the original building and the west addition.

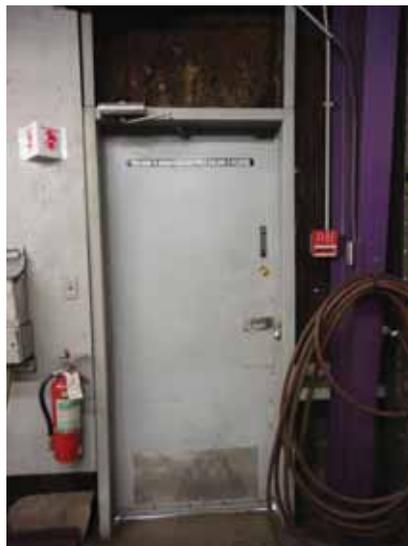
Fig. 2.1.A.11 Typical air gaps observed along the base of the doors around the exterior of the original building.

- Replace existing windows around the exterior of the original building with new energy efficient windows and frames.
- Replace entrance doors and overhead rolling doors around the exterior of the original building with new doors and frames and new lever-style door handles.

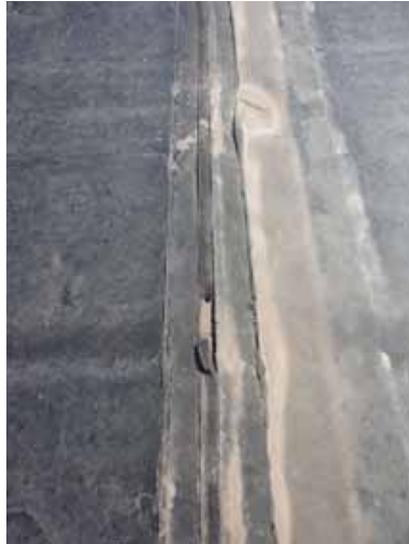
Fig. 2.1.A.18 Typical instance of deteriorating sealant observed at the roof.

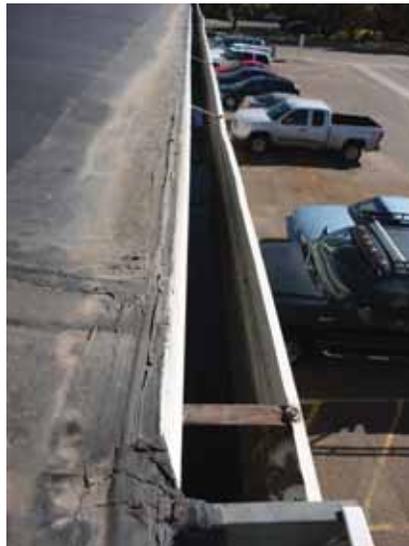
Fig. 2.1.A.20 Typical instance of deterioration along the edge of the roof.

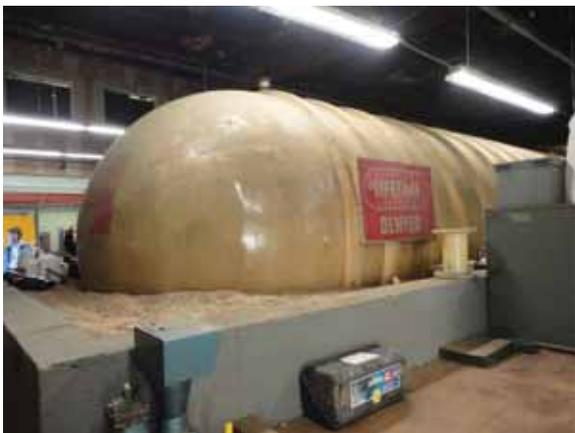
Fig. 2.1.B.3 An above-ground 10,000 gallon fuel storage tank observed in the northeast corner of the original building.

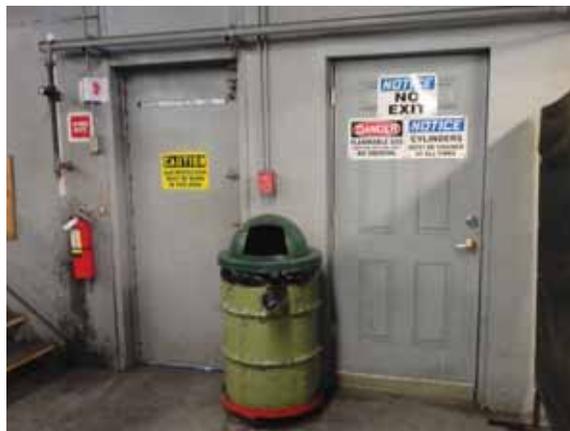
Fig. 2.1.B.6 A room with hazardous materials stored by the Community College of Denver observed on the southeast side of the original building.

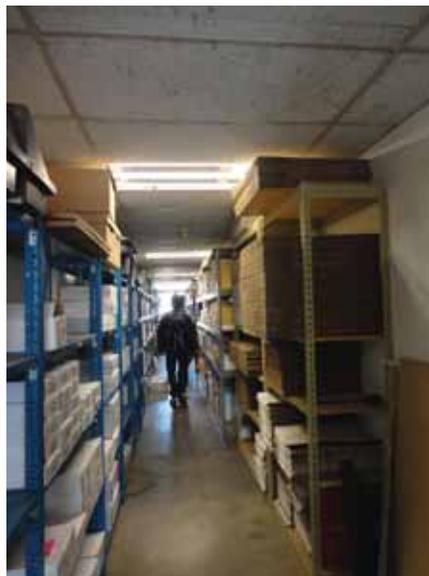
The north-south corridor on the west side of the original building is currently being used as storage space (see Fig. 2.1.B.7). The storage on either side of the corridor has reduced the width of the corridor. Materials are also being stored just outside of the pair of doors on the north side of the corridor, blocking the west side of the doors (see Fig. 2.1.B.8). The corridor width appears to be wide enough for the current egress requirements of the IDS Shipping & Receiving storage and warehouse spaces on the southwest corner of the original building. If the building occupancies change, the items being stored within the corridor and blocking the north exit may need to be removed per egress code requirements.

Fig. 2.1.B.7 The north-south corridor along the west side of the original building is currently used for storage.

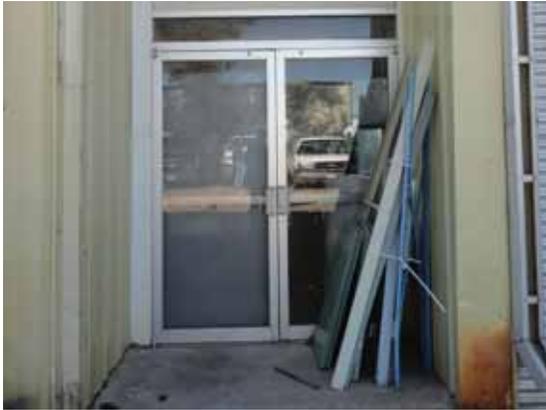
Fig. 2.1.B.8 Materials being stored outside of the pair of doors on the north side of the north-south corridor located along the west side of the original building.

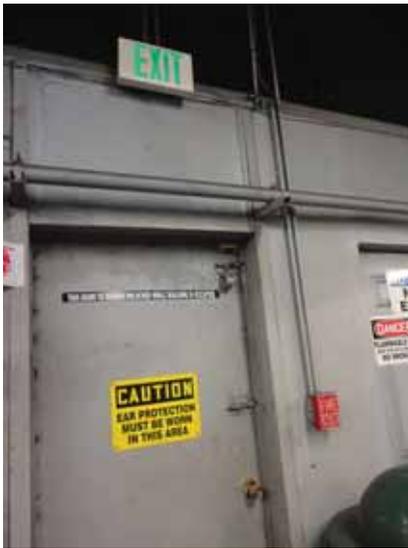
It was noted that the egress doors throughout the areas occupied by the Community College of Denver are equipped with bolt-style locks (see Fig. 2.1.B.9 and Fig. 2.1.B.10). The egress door on the west end of the south side of the welding shop was observed to have a latch-style locking device used in conjunction with a padlock (see Fig. 2.1.B.11). According to Section 1008.1.9.4 of the IBC (2012), manually operated flush bolts or surface bolts are not permitted. Panic hardware or fire exit hardware should be provided on these doors per egress code requirements to allow egress even when the doors are locked and the space is not open to the general public.

Fig. 2.1.B.9 Bolt-style locks observed on the egress doors throughout the areas occupied by the Community College of Denver.

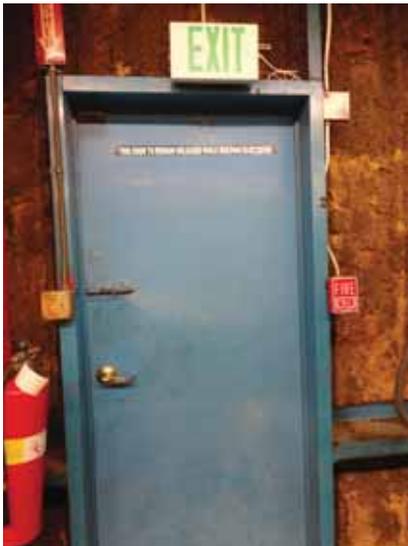
Fig. 2.1.B.10 Bolt-style locks observed on the egress doors throughout the areas occupied by the Community College of Denver.

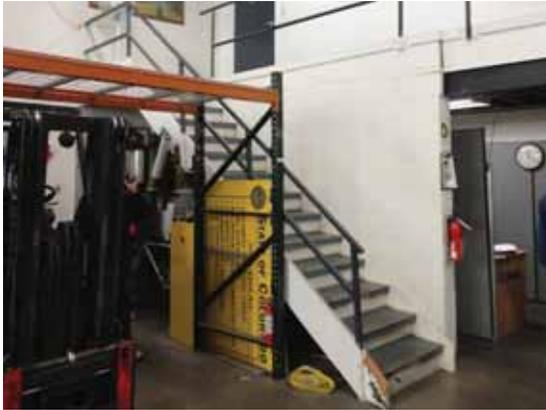
Fig. 2.1.B.12 Typical instance of handrails that exist on only one side of the stairs throughout the original building.

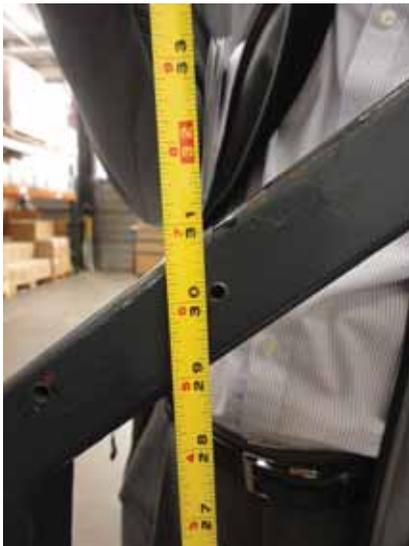
Fig. 2.1.B.14 The height to the top of the railing measured above the stair tread nosing at the stairway leading to the mezzanine in the IDS Shipping & Receiving space on the southwest side of the original building.

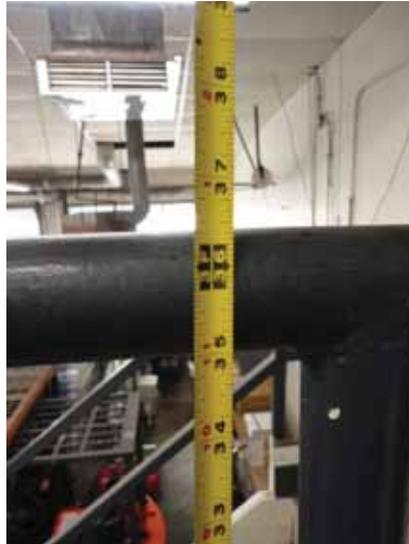
Fig. 2.1.B.15 The height to the top of the guardrail along the edge of the mezzanine in the IDS Shipping & Receiving space on the southwest side of the original building.

- Replace the existing stairway and mezzanine railing systems with new railing systems that comply with the code requirements.
- Install a new handrail system along the wall-side of each stair, where not provided, in order to comply with the code requirement that handrails shall be provided on both sides of stairs and ramps.

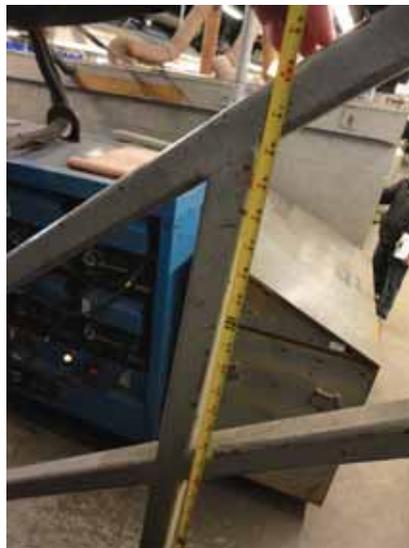
Fig. 2.1.B.16 The height to the top of the railing measured above the stair tread nosing of the stairway on the east side of the Community College of Denver's welding shop.

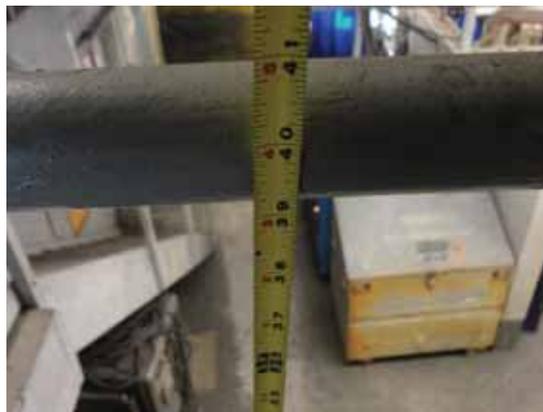
Fig. 2.1.B.17 The height to the top of the guardrail along the edge of the mezzanine at the northeast corner of the Community College of Denver's welding shop.

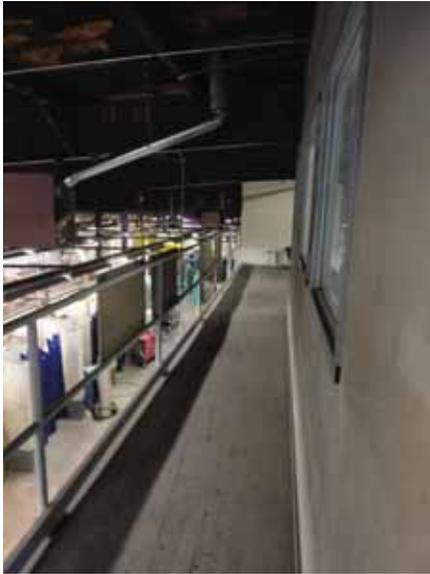
Fig. 2.1.B.18 The distance between the guardrail openings exceeds 4 inches in diameter along the edge of the stairway and mezzanine at the northeast corner of the Community College of Denver's welding shop.

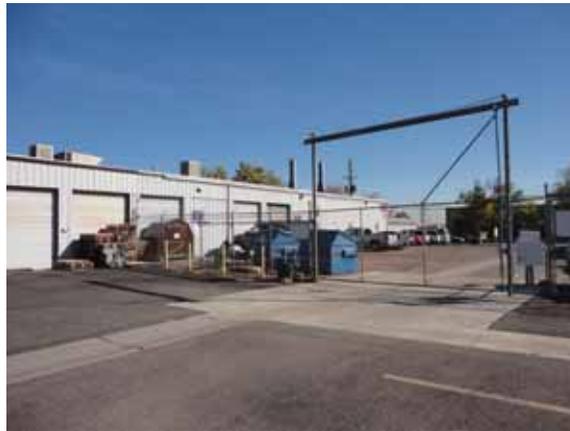
There is a fence on the south side of the building to the west of the area used by the Community College of Denver (see Fig. 2.1.B.22) and a fence surrounding the property which controls access to the portions of the North Campus North Building serving the State of Colorado. A security camera was observed on a light pole on the east end of the south side of the west addition (see Fig. 2.1.B.23). Electronic door entry systems were observed outside of the main entrances to the west addition and to the IDS Shipping & Receiving area (see Fig. 2.1.B.24). A security camera was observed within the secure storage area on the northwest side of the west addition (see Fig. 2.1.B.25). It was reported that more site security is needed.

Fig. 2.1.B.22 Exterior fence controlling access to the North Campus site to the west of the space occupied by the Community College of Denver in the North Building.

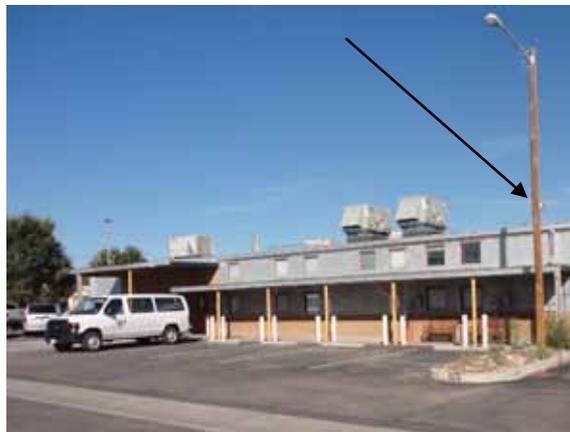
Fig. 2.1.B.23 Security camera observed on a light pole on the east end of the south side of the west addition.

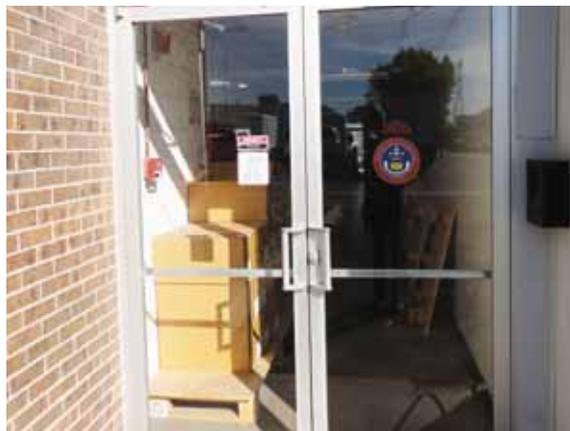
Fig. 2.1.B.24 Signage for a security system and an electronic door entry system observed at the entrance to the IDS Shipping & Receiving area.

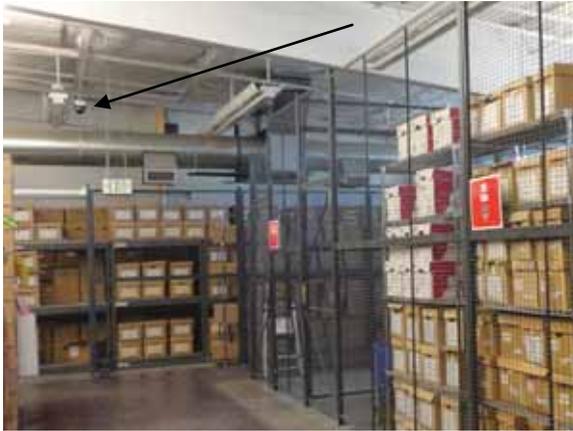
Fig. 2.1.B.25 Security camera observed in the secure storage area on the northwest side of the west addition.

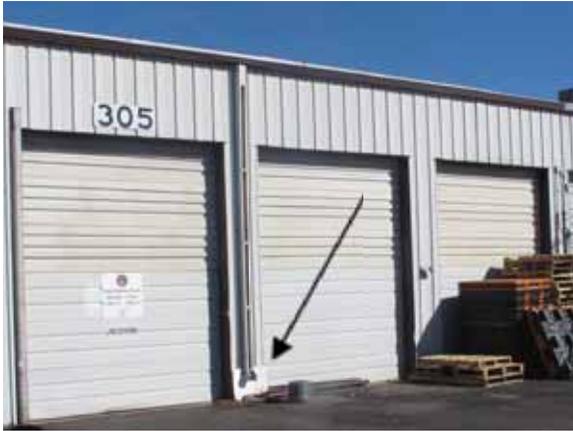
Fig. 2.2.A.3

Exterior downspouts were observed to empty within 1'-0 of the building line (Fig. 2.2.A.3).

- Locations with corroded steel should be cleaned of all corrosion and painted with an exterior-grade coating.
- Increase the length of downspouts such that they empty at least 3'-0 from the building line, or add splashblocks of equivalent length.
- Replace damaged metal panels.

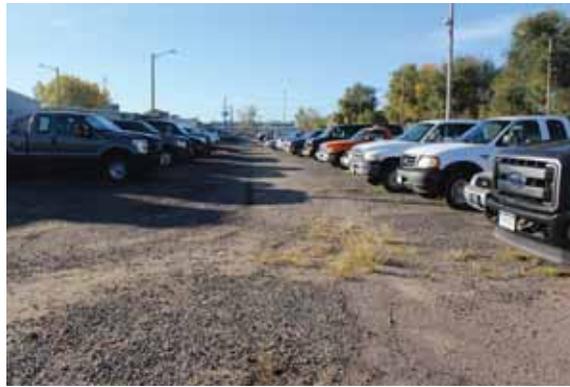
The site asphalt was noted to be in very poor condition (Fig. 2.3.A.8 and Fig. 2.3.A.9). Numerous locations of depressions and cracking were observed. It is recommended that the entire site be re-paved to improve the surface drainage and maintain the site posterity.

Figure 2.3.A.8 – Poor Site Asphalt Condition

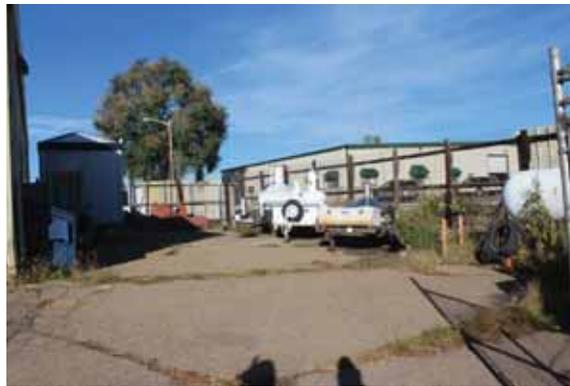
Figure 2.3.A.9 – Poor Site Asphalt Condition

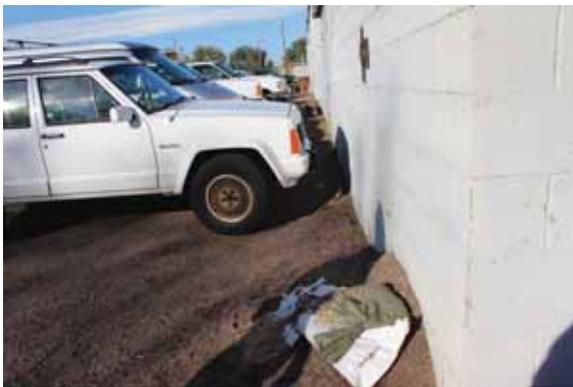
Site slopes were analyzed by visual inspection and topography was evaluated using Google Earth. Current geotechnical recommendations and standard practice for slopes away from the building are 10:1 for 10 feet and 2% in hardscape areas. Since the site is all hardscape, the site generally meets these slopes (Fig. 2.3.B.1). Ponding was observed at one location to the west of the building in the parking lot (Fig 2.3.B.2). Ponding at this location is a minor concern but causes a safety hazard. Stagnant water provides an opportunity for mold and mildew growth, which is slippery in a walking path. In the winter, the water will freeze and become ice. Ponding of water will also create more opportunity for asphalt cracking and deterioration. It is recommended that this area be re-graded and re-paved to provide positive drainage.

Figure 2.3.B.1 – Building Perimeter

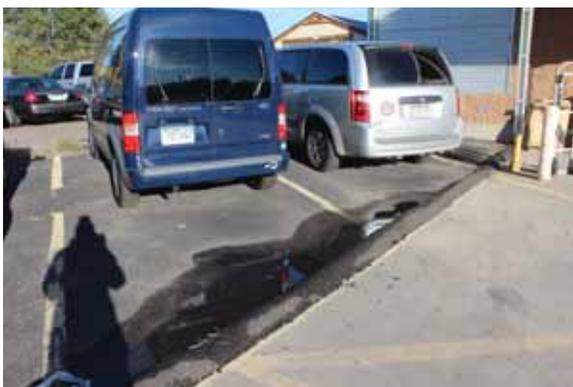
Figure 2.3.B.2 – Standing Water

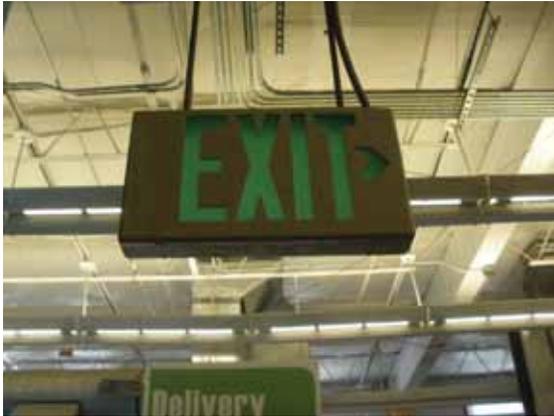
The exit signs appear to be in good condition. Emergency egress lighting is provided by twin-head wall packs located throughout the building (see Fig. 2.4.A.10). One of the exit signs observed had an open cover and was missing its battery (see Fig. 2.4.A.11). This unit should be repaired or replaced with new.

Fig. 2.4.A.11 – Exit sign

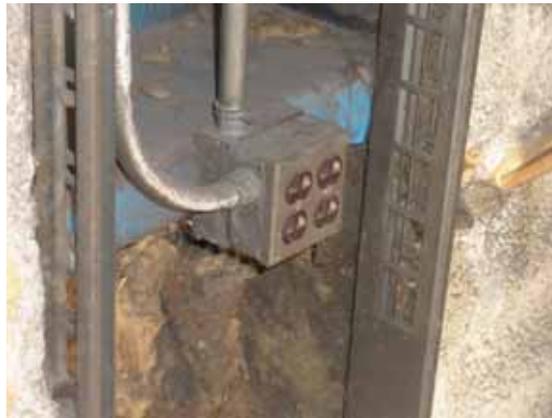
Most receptacles appear to be in good working condition; however, some of the spaces have receptacles that are in bad condition.

Fig. 2.4.A.15 – Receptacle located in the weld shop

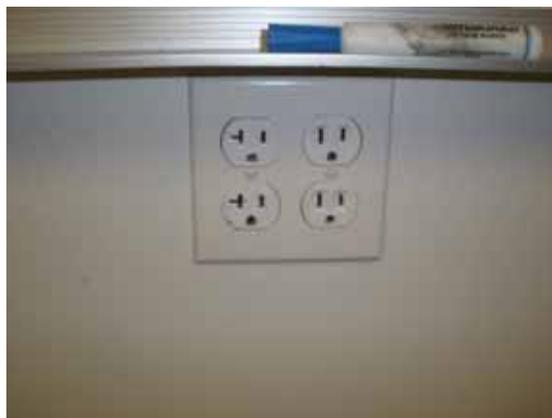
Fig. 2.4.A.16 – Receptacle located in the student classroom

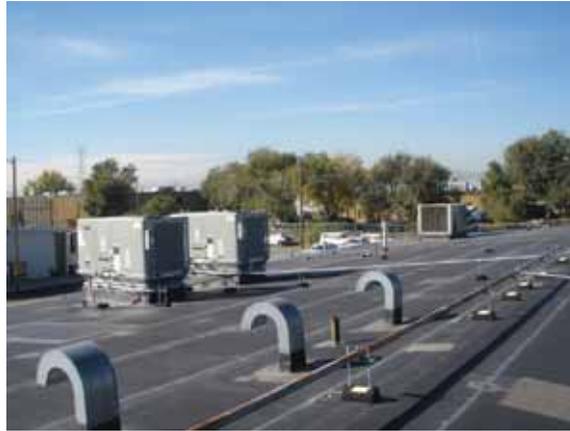
Fig. 2.4.A.20 – Rooftop units

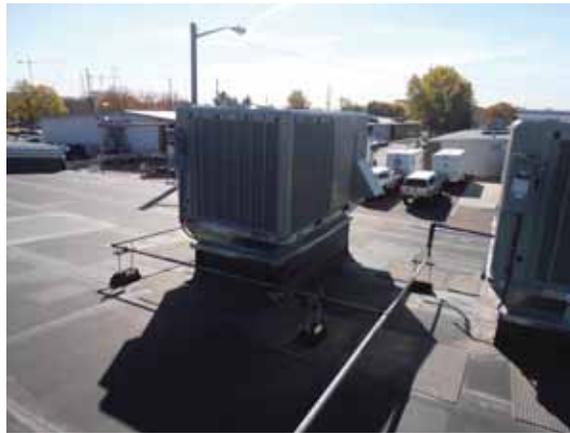
Fig. 2.4.A.21 – New RTU installation

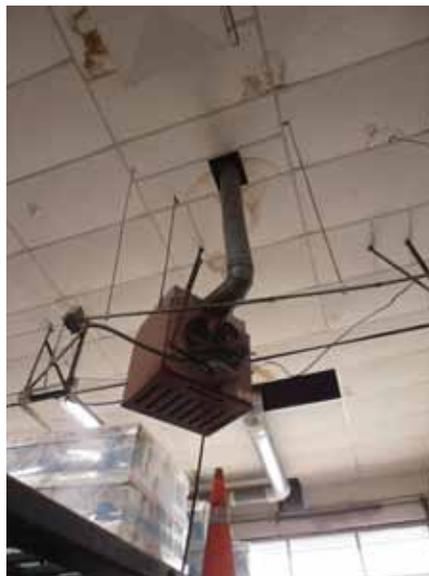
Fig. 2.4.A.22 – Gas fired unit heater

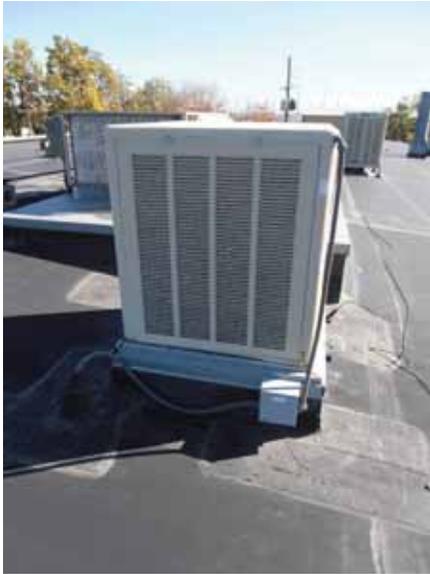
Fig. 2.4.A.23 – Evaporative cooler

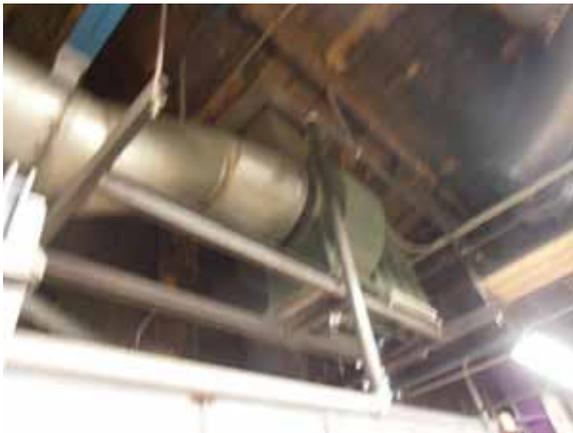
Fig. 2.4.A.24 – Welding shop exhaust fan

We recommend a good routine of housekeeping for the the Welding and Machine Shop to ensure that combustible dust does not accumulate on the electrical gear. This will help increase the safety in the building. However, any issues may be resolved if the community college relocates and the space is used for something else.

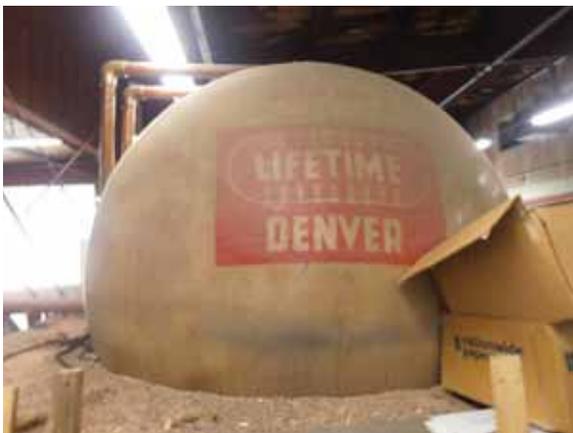
Fig. 2.4.A.25 – Waste gasoline storage tank

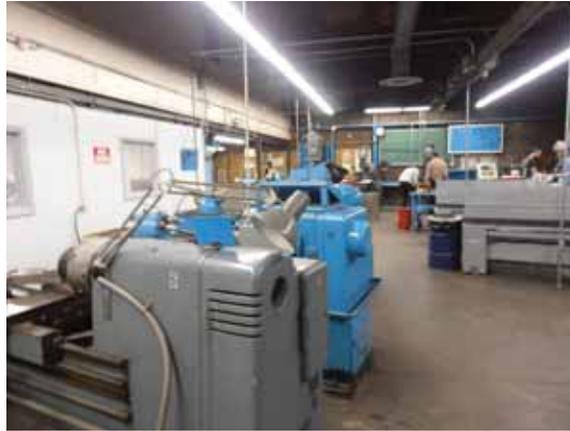
Fig. 2.4.A.26 – Machine shop layout

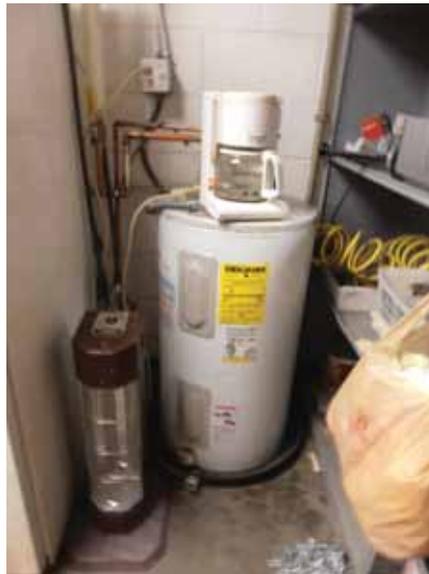
Fig. 2.4.A.27 – Electric hot water heater

- Consider providing sprinklers for fire suppression in the storage areas.
- Since the building has a gas supply, replace the existing electric domestic water heater with a gas fired heater (see Fig 2.4.A.27). This will result in energy cost savings.

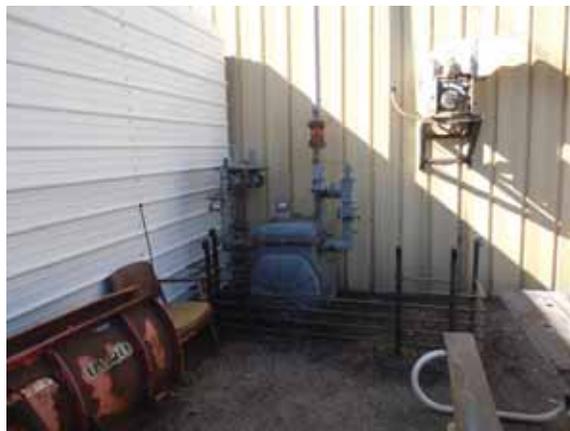
Fig. 2.4.A.28 – Gas entry/meter

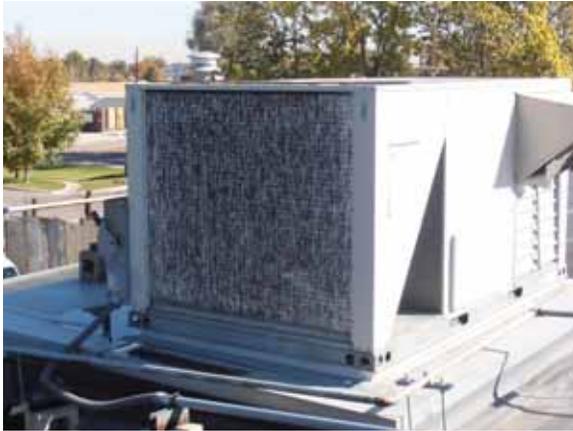
Fig. 2.4.A.29 – Existing RTU

- The condenser fins for the original RTUs are damaged. The units appear to be at the end of their useful life. Plan for replacement of old RTUs with new efficient units, which will result in energy cost savings.
- Xcel Energy rebates may be available for RTU replacement.
- Provide local exhaust for grinding/machine shop.
- The outside air intake filters for the RTU is falling apart and needs replaced. Provide a new filter.
- The gas piping on the roof is rusted. Clean and paint the piping to minimize weather effect on piping. Also provide piping identification tags.
- A RTU condensate drain trap is missing. Provide trap to meet RTU requirements.

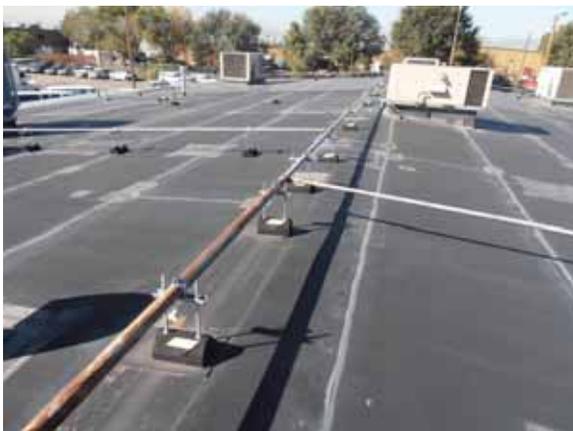
Fig. 2.4.A.31 – Gas piping on roof

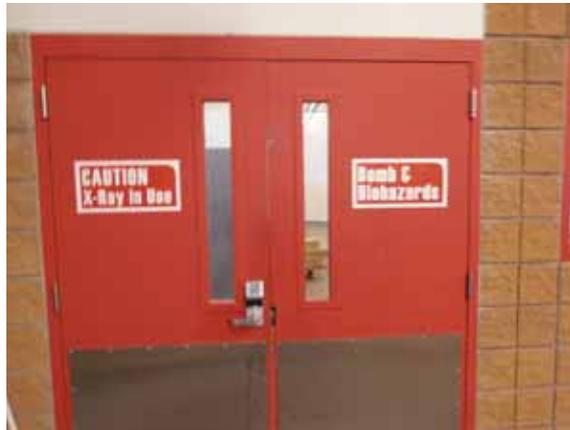
Fig. 2.4.A.33 – Mail sorting room

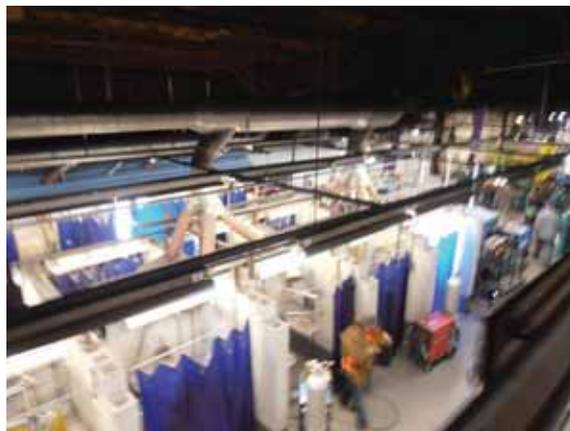
Fig. 2.4.A.34 – Welding shop layout

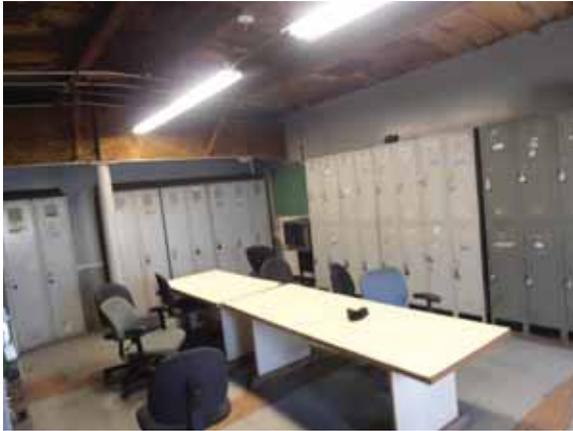
Fig. 2.4.A.35 – Mezzanine locker room

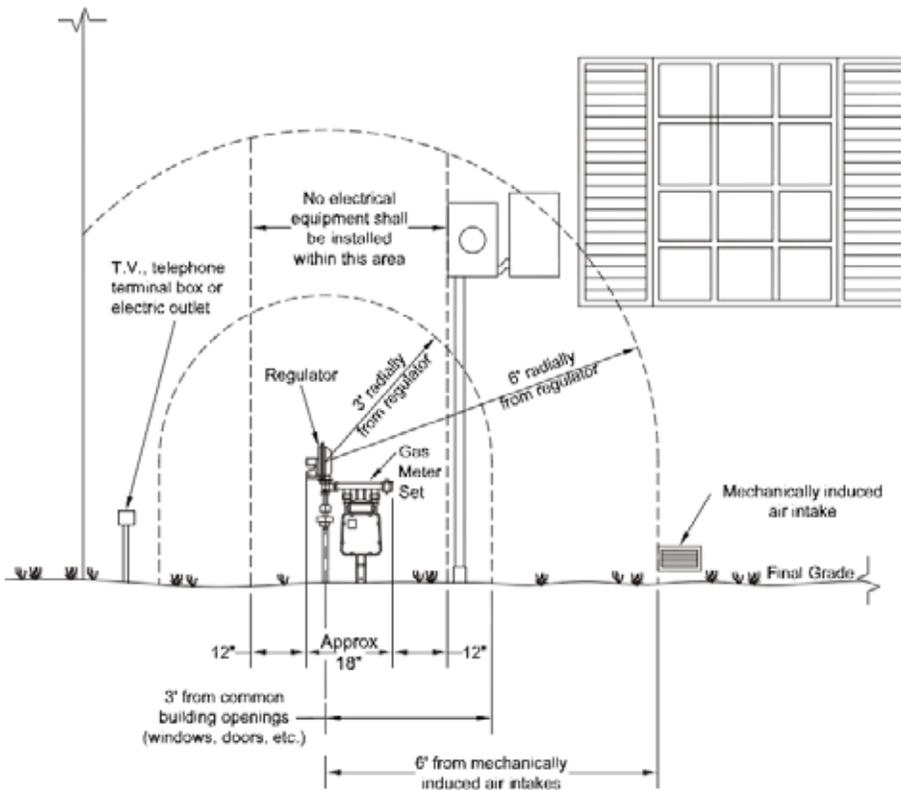
Fig. 2.4.A.36 – Xcel energy requirements

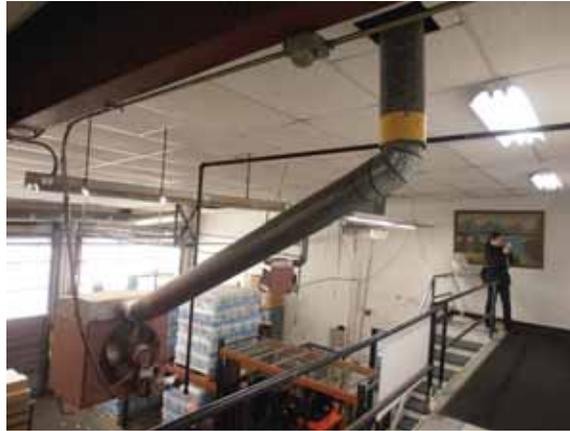
Fig. 2.4.A.37 – First level storage

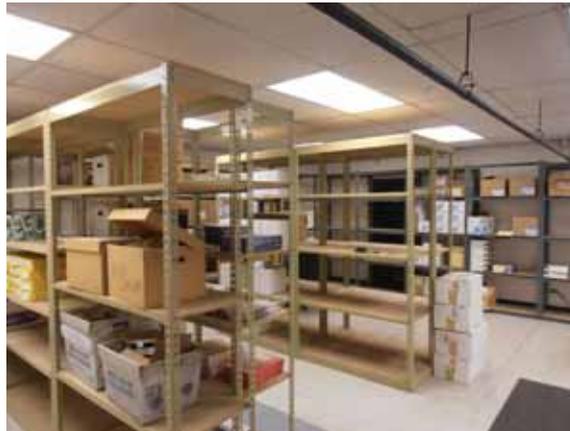
Fig. 2.4.A.38 – Mezzanine level storage

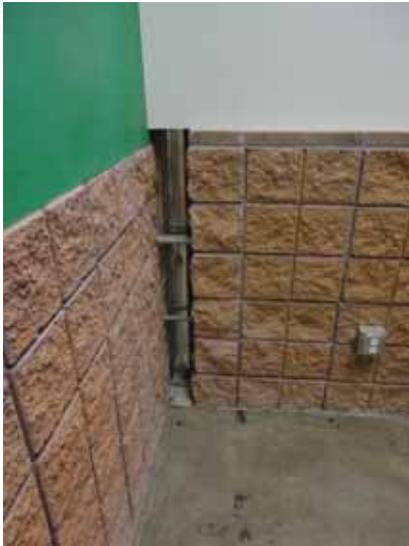
Fig. 3.0.C.5 An unfinished section of wall observed at the masonry block wainscoting in the west addition.

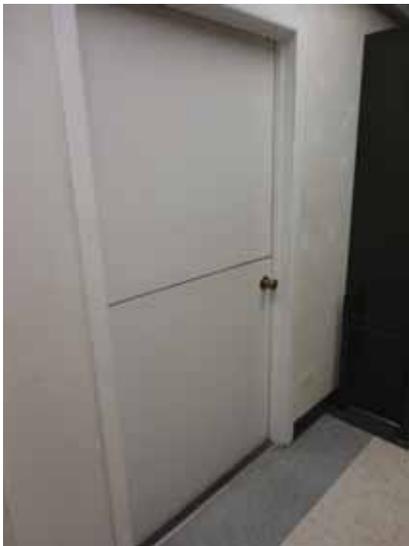
Fig. 3.0.C.6 An area of patched but unfinished gypsum board observed in the IDS Shipping & Receiving area located in the southwest corner of the original building.

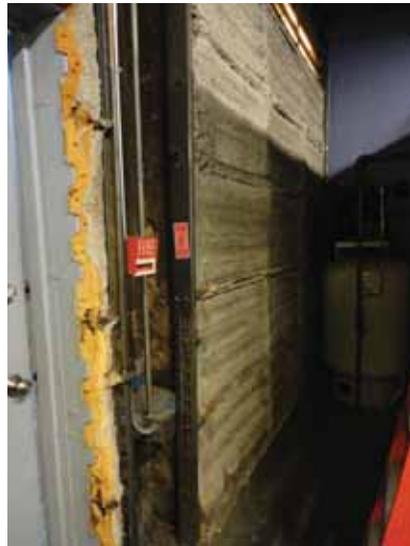
The areas of the original building currently occupied by the Community College of Denver have metal panels and overhead rolling doors with deteriorating insulation in poor condition along the exterior walls (see Fig. 3.0.C.8 and Fig. 3.0.C.9) and gypsum board, wood paneling, and concrete block walls throughout the interior spaces. The gypsum board walls are in fair condition throughout with areas of wear-and-tear noted (see Fig. 3.0.C.10). The concrete block walls are in fair condition throughout with areas of wear-and-tear and cracking along the joints between the blocks noted (see Fig. 3.0.C.11).

Fig. 3.0.C.8 Deteriorating insulation covering the metal panels and overhead rolling doors at the exterior walls throughout the areas of the original building occupied by the Community College of Denver.

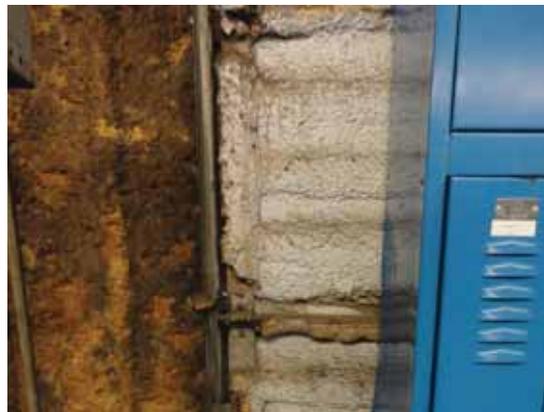
Fig. 3.0.C.9 Deteriorating insulation at the exterior walls and other areas of the original building occupied by the Community College of Denver.

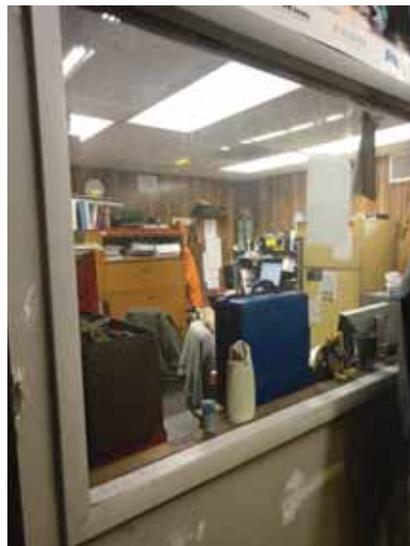
Fig. 3.0.C.10 Wear-and-tear noted at the gypsum board walls throughout the spaces occupied by the Community College of Denver.

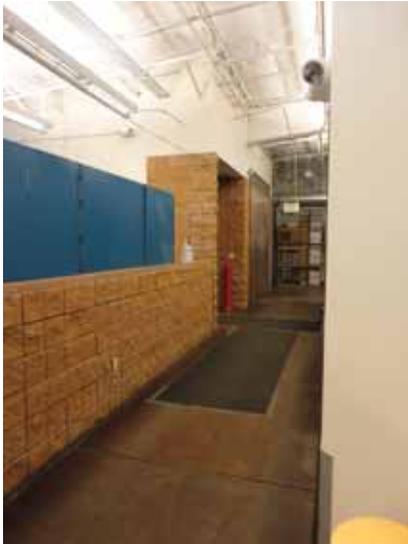
Fig. 3.0.C.14 Floor rugs taped to the concrete flooring and creating a potential tripping hazard in areas of the west addition.

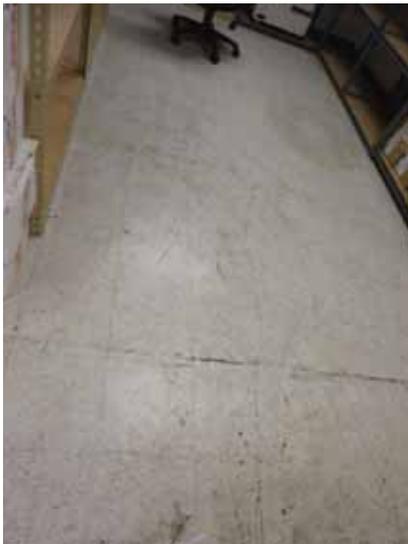
Fig. 3.0.C.16 Soiled, deteriorating, and damaged linoleum flooring observed throughout the IDS Shipping & Receiving mezzanine office and storage areas.

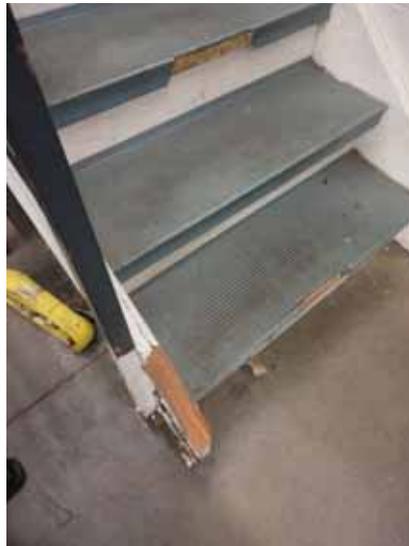
Fig. 3.0.C.17 Soiled and damaged rubber flooring on the stairway leading up to the IDS Shipping & Receiving mezzanine office and storage areas.

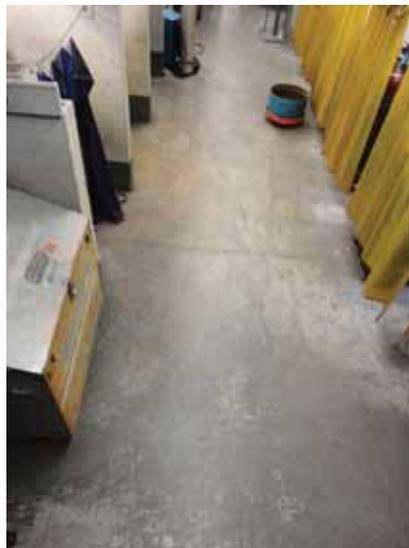
Fig. 3.0.C.18 Typical instance of cracking concrete flooring observed throughout the original building.

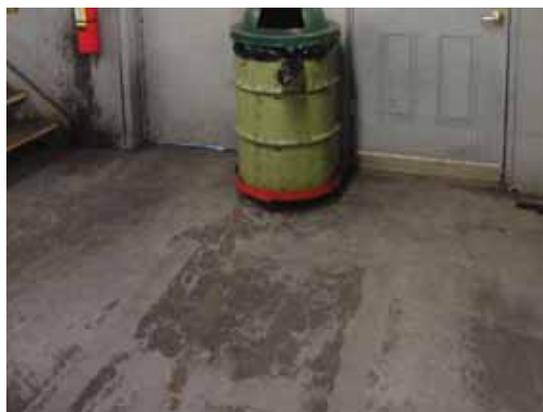
Fig. 3.0.C.19 General deterioration of the protective coating at the concrete floors observed throughout the original building.

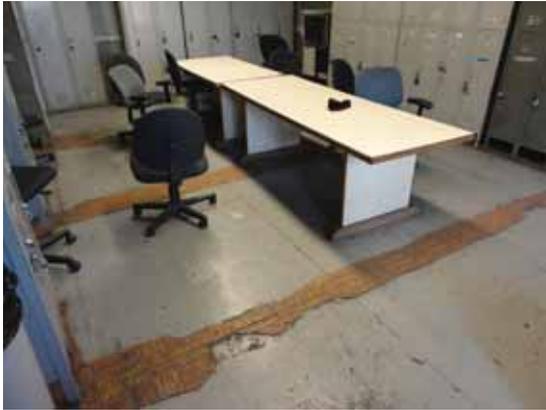
Fig. 3.0.C.20 Deteriorating linoleum or vinyl flooring observed in the mezzanine locker room, currently used by Denver Community College, is creating a potential tripping hazard.

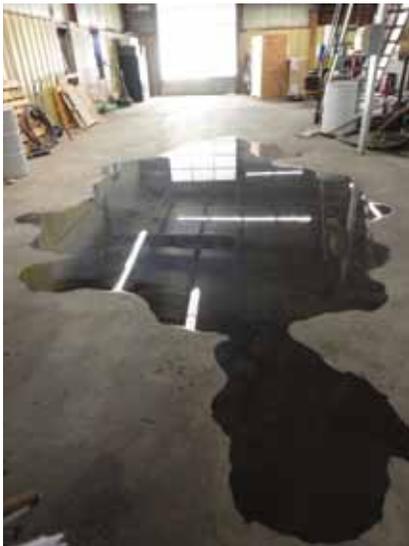
Fig. 3.0.C.22 Standing water observed at the concrete flooring in the northeast corner of the original building.
