CAPITOL COMPLEX MASTER PLAN
FINDINGS & RECOMMENDATIONS (F & R) NEEDS ASSESSMENT
1570 GRANT BUILDING, 1570 GRANT STREET (DENVER)

NOVEMBER 2014

FINDINGS & RECOMMENDATIONS (F&R) NEEDS ASSESSMENT

1570 GRANT BUILDING
1570 GRANT STREET (DENVER)

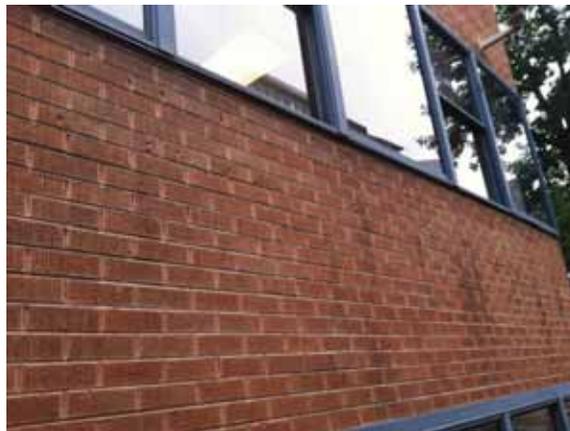
The brick cladding the majority of the building is in fair condition overall. A number of holes in the brick were noted at the north side of the building under the First Floor windows at the west end (see Fig. 2.1.A.1 and Fig. 2.1.A.2). Cracking along the joints between the brick was also noted at the north side of the east building entrance (see Fig. 2.1.A.3) and at the south side of the building just above grade level (see Fig. 2.1.A.4). Minor spalling was noted at the south side of the building, on the east end (see Fig. 2.1.A.5).

Fig. 2.1.A.2 Holes in the brick at the north side of the building under the First Floor windows.

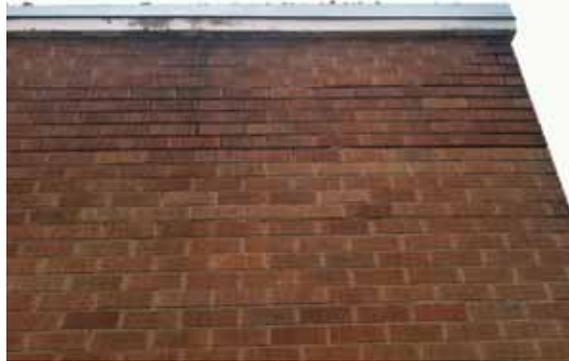
The mortar between the bricks exhibited a minor amount of deterioration in general (see Fig. 2.1.A.8). Specific deterioration was noted at the south side of the building just above grade level (see Fig. 2.1.A.9 and Fig. 2.1.A.10) and at the Penthouse walls on the roof (see Fig. 2.1.A.11 and Fig. 2.1.A.12).

Fig. 2.1.A.11 Deterioration of the mortar and soiling of the brick at the Penthouse walls.

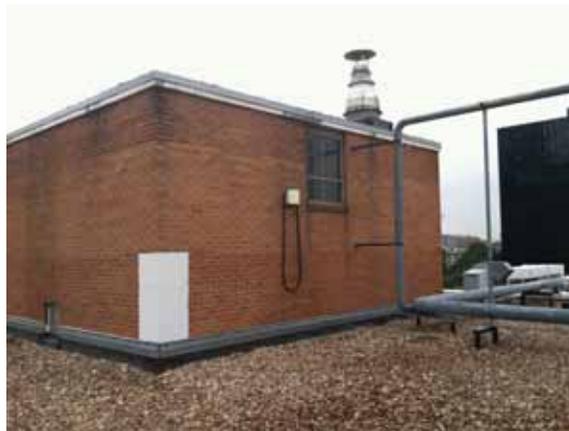
Fig. 2.1.A.12 Deterioration of the mortar and soiling of the brick at the Penthouse walls.

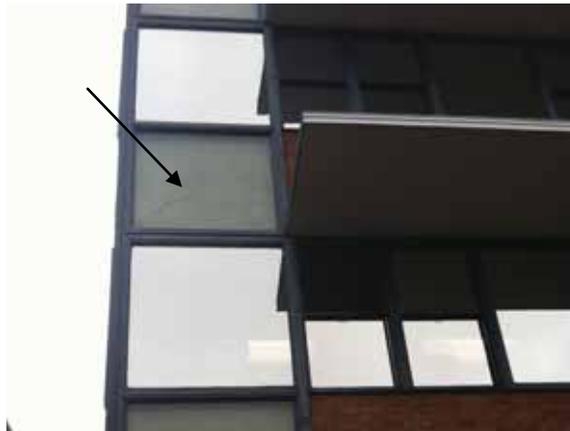
Fig. 2.1.A.16 Cracked concrete panel at the southeast corner.

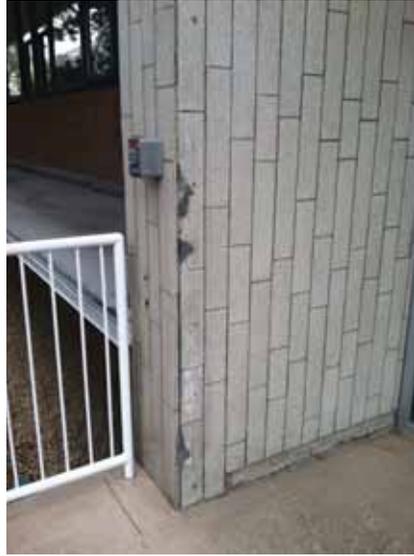
The masonry veneer outside of the main Grant Street Entrance is damaged and missing in spots (see Fig. 2.1.A.21).

Fig. 2.1.A.21 Damaged and missing masonry veneer at the Grant Street Entrance.

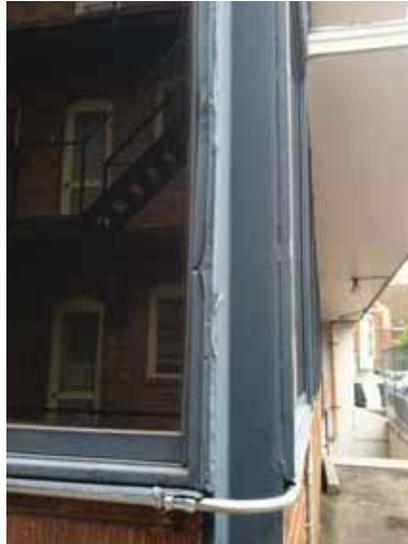
Fig. 2.1.A.24 Damaged window frame with peeling paint.

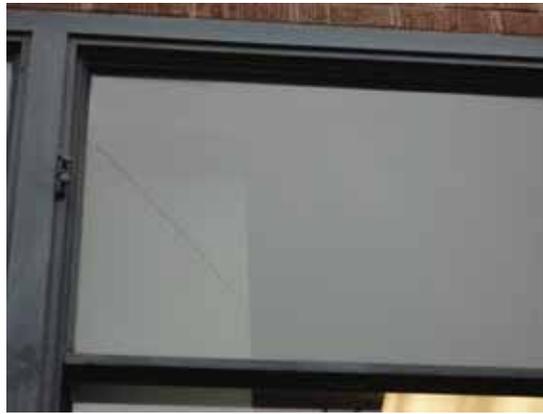
Fig. 2.1.A.25 Broken window at the north side.

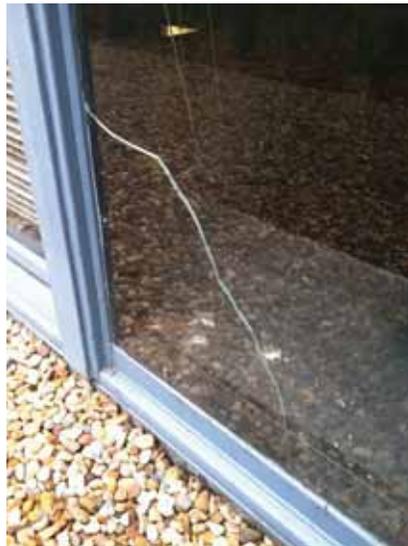
Fig. 2.1.A.26 Broken window at the north side.

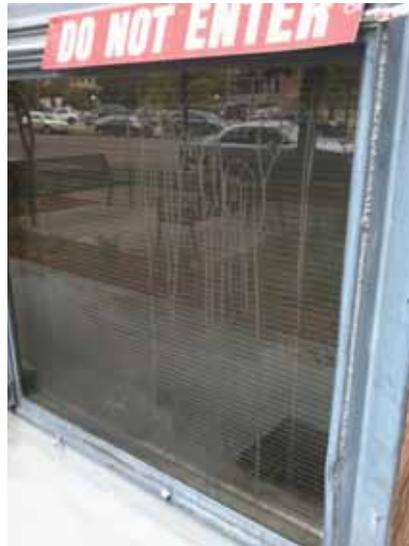
Fig. 2.1.A.30 Bent window frame at the southwest corner with corrosion at the base.

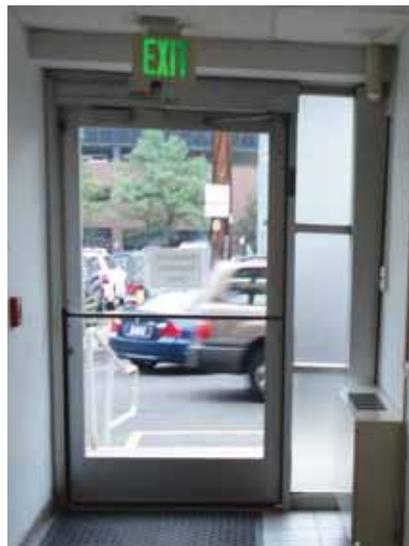
The entrance doors at the east side of the building were noted to have spots of deteriorated or missing weather stripping, allowing air leakage from the building (see Fig. 2.1.A.31). The frame around the exterior door at the north end of the east entrance is soiled and damaged (see Fig. 2.1.A.32 and Fig. 2.1.A.33).

Fig. 2.1.A.31 Exterior door with areas of deteriorated or missing weather stripping at the east side.

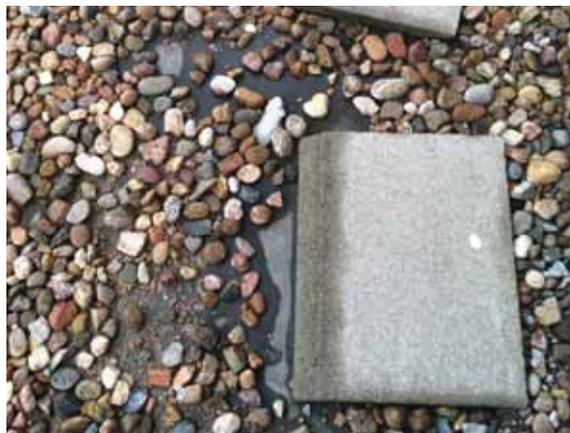
Fig. 2.1.A.35 Area of thin ballast leaving the roof membrane exposed on the roof.

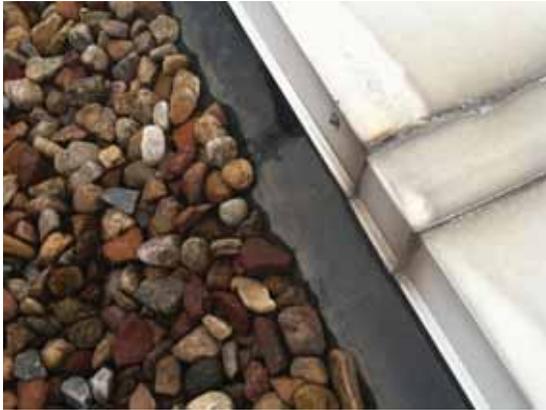
Fig. 2.1.A.40 Typical deteriorating sealant found along the joints of the parapet coping.

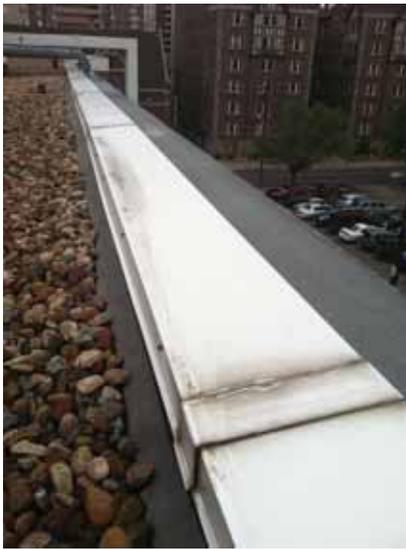
Fig. 2.1.A.41 Typical parapet coping with deteriorating sealant along the joints and with evidence of standing water.

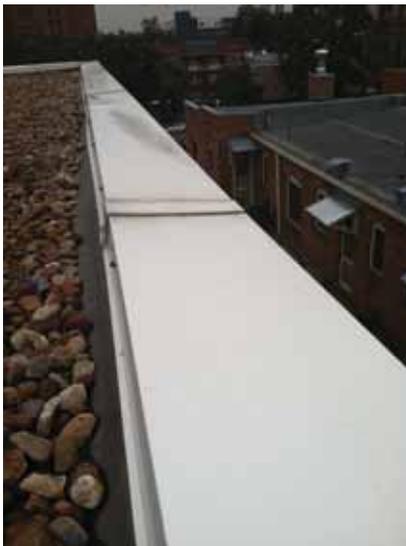
Fig. 2.1.A.42 Warping parapet coping.

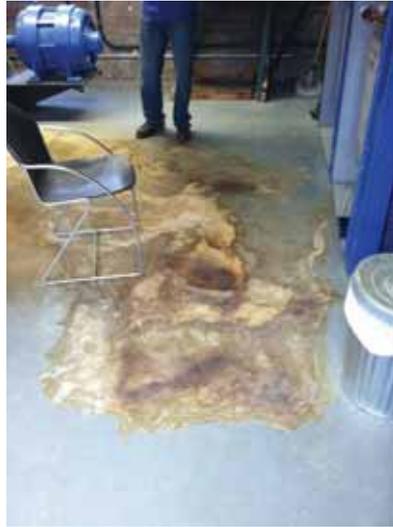
The Penthouse Roof shows signs of water damage at the floor (see Fig. 2.1.A.43 and Fig. 2.1.A.44) and at the ceiling (see Fig. 2.1.A.45).

Fig. 2.1.A.43 Signs of water damage on the floor of the Penthouse.

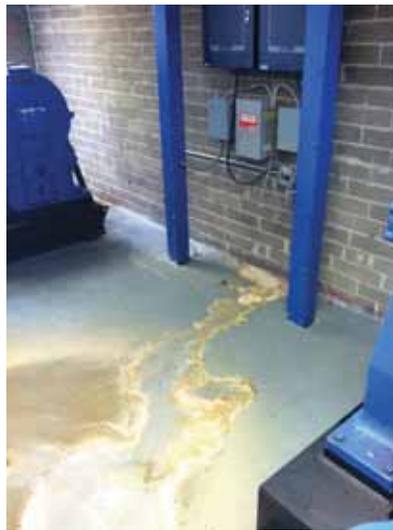
Fig. 2.1.A.44 Signs of water damage on the floor of the Penthouse.

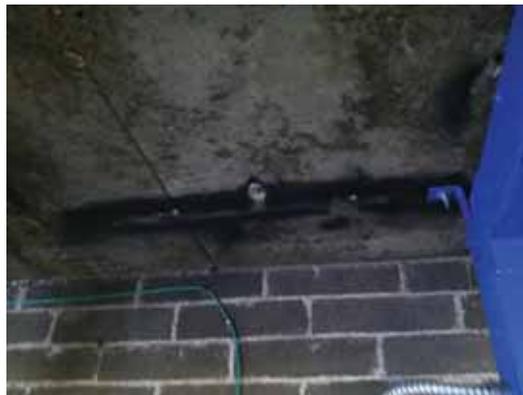
Fig. 2.1.A.45 Signs of water damage at the ceiling of the Penthouse.

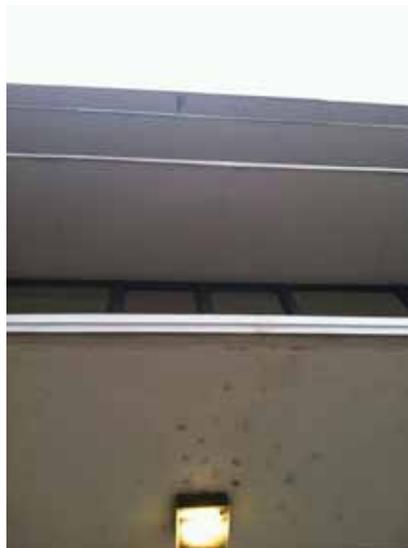
Fig. 2.1.A.46 Water damage observed underneath the Grant Street Entrance canopy.

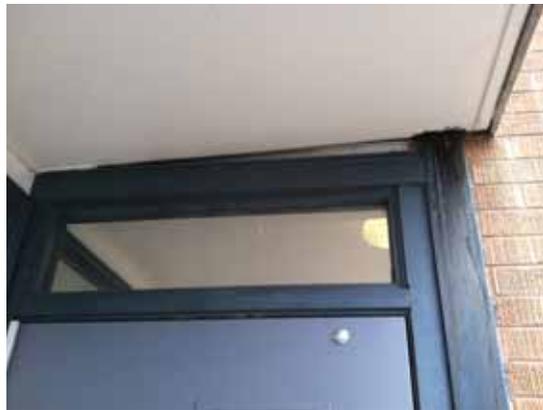
Fig. 2.1.A.47 Canopy leaking at the north end of the East Entrance.

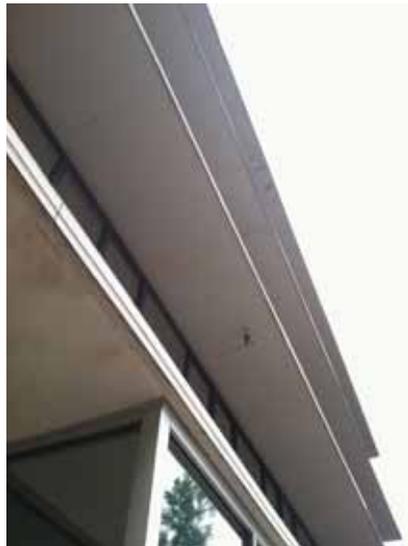
Fig. 2.1.A.48 Canopies over windows on the west side of the building with peeling paint, cracking, and spalling.

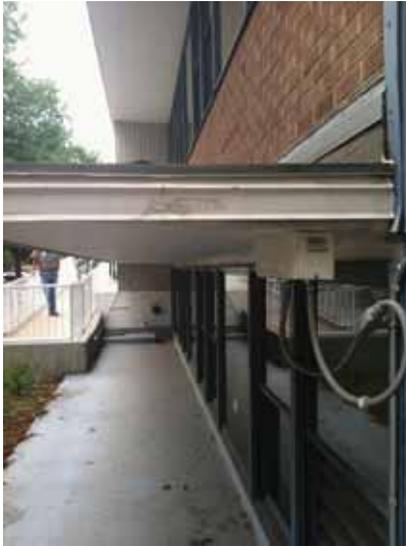
Fig. 2.1.A.49 Canopy over the Basement windows at the south end of the west side of the building.

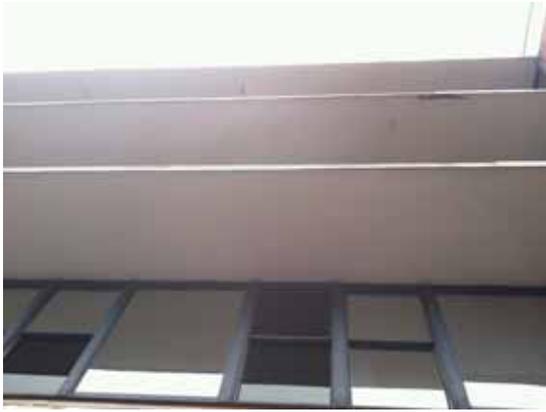
Fig. 2.1.A.50 Canopies over windows on the east side of the building with peeling paint, cracking, and spalling.

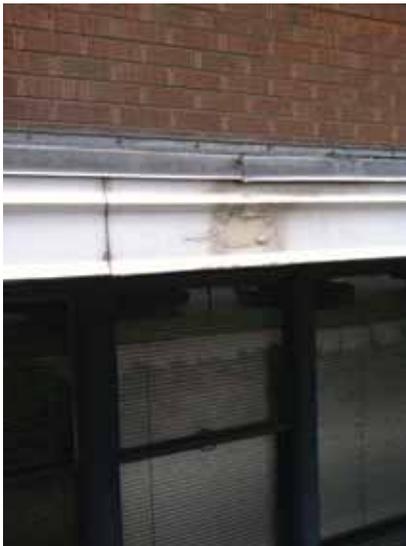
Fig. 2.1.A.51 Flashing with peeling paint at a west window canopy.

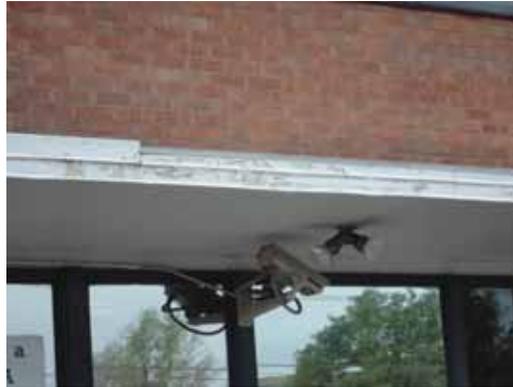
Fig. 2.1.A.52 Flashing with peeling paint at the east entrance canopy.

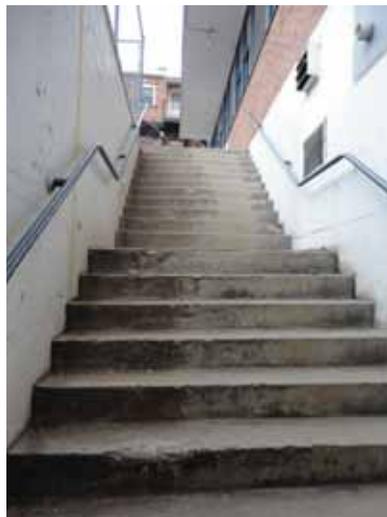
The exterior concrete stairway at the south end of the east side of the building, leading from the Basement up to grade level at the parking lot, was observed to have widespread damage including cracking and spalling (see Fig. 2.1.A.53 and Fig. 2.1.A.54).

Fig. 2.1.A.53 Exterior concrete stairway on the east side of the building with cracking and spalling.

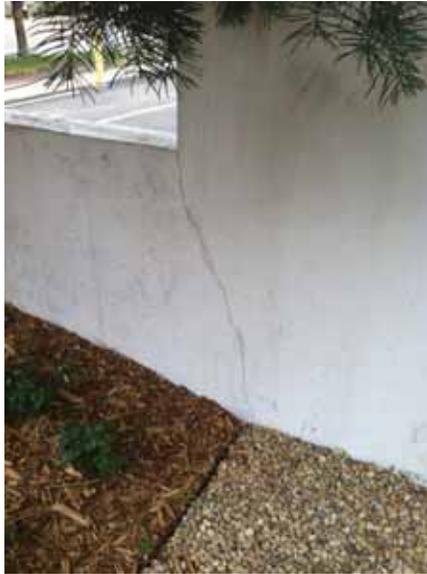
Fig. 2.1.A.56 Crack in the northeast retaining wall.

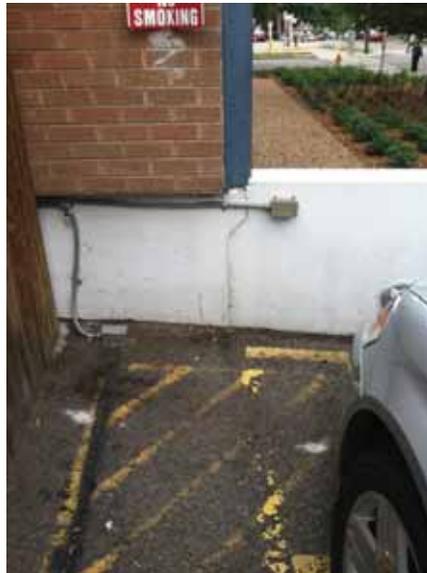
Fig. 2.1.A.57 Crack in the northeast retaining wall.

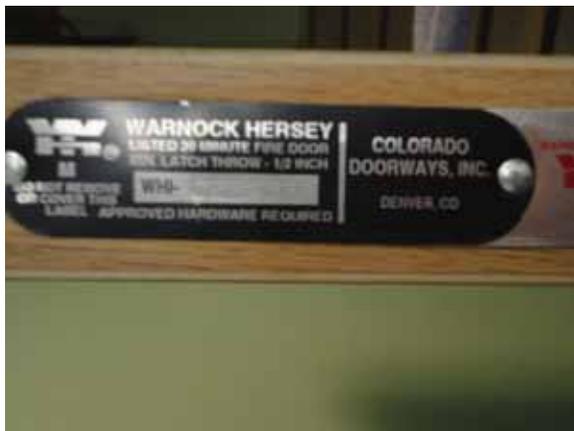
According to Section 1015.2.1 of the IBC (2012), where two exits or exit access doorways are required from any portion of the exit access, the exit doors or exit access doorways shall be placed a distance apart equal to not less than one-half of the length of the maximum overall diagonal dimension of the building or area to be served (1570 Grant Building's diagonal dimension of the building = 162'-8-3/4" divided by 2 = 81'-4-3/8") measured in a straight line between exit doors or exit access doorways. (The straight line distance between the two doors of the interior exit stairways is 59'-6-1/4" which is less than the 81'-4-3/8" required.

Fig. 2.1.B.1 Fire rating label on interior exit stairway door.

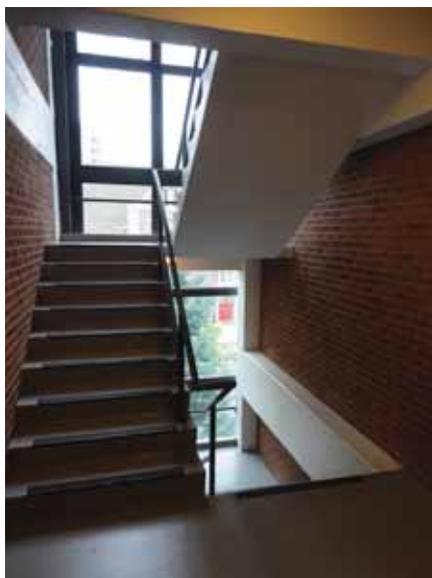
The stair dimensions and details observed during the site visit generally comply with the code requirements for existing stairs with the exception of the railing systems. The stairways currently have railing systems on only one side of the stairs (see Fig. 2.1.B.2). According to Section 1009.15 of the IBC (2012) and Section 505.2 of ICC/ANSI A117.1 (2003), handrails shall be provided on both sides of stairs and ramps. The top of the railings are too low in height. The top of the horizontal handrail above finish floor at the Roof Level landing is approximately 31-3/4 inches (see Fig. 2.1.B.3). According to Section 1013.3 of the IBC (2012), required guards located along the open-side of walking surfaces shall not be less than 42 inches high, measured vertically from the adjacent walking surfaces and from the line connecting the leading edges of the tread nosings on stairs. The top of

Fig. 2.1.B.2 Handrails currently exist on only one side of the stairs.

- Replace the existing stairway railing system with a new railing system that complies with the code requirement for handrail height and of a maximum of 4 inches of space between guardrails.
- Install a new handrail system along the wall-side of each stair in order to comply with the code requirement that handrails shall be provided on both sides of stairs and ramps.
- Repair the spalling concrete stair tread at the south exterior stair of the East Entrance and reattach the railing post to provide a secure handrail per code requirements.
- Verify the cause of apparent water accumulation at the East Entrance ramp and repair or replace damaged building components as necessary to prevent future occurrences.

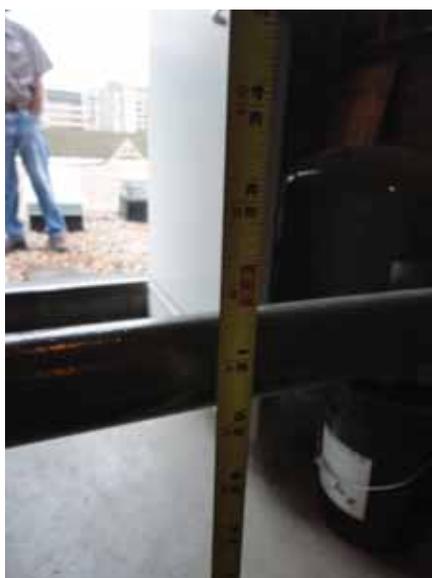
the handrail above the stair nosing is approximately 29-1/2 inches (see Fig. 2.1.B.4). According to Section 1012.2 of the IBC (2012) and Section 505.4 of ICC/ANSI A117.1 (2003), handrail height, measured above stair tread nosing, or finish surface of ramp slope, shall be uniform, not less than 34 inches and not more than 38 inches. The current handrail system exceeds guardrail opening limitations, easily allowing passage of a sphere 4 inches in diameter (see Fig. 2.1.B.5). According to Section 1013.4 of the IBC (2012), required guardrails shall not have openings which allow passage of a sphere 4 inches in diameter.

Fig. 2.1.B.3 Measurement to top of railing above finish floor at the Roof Level landing is approximately 31-3/4 inches.

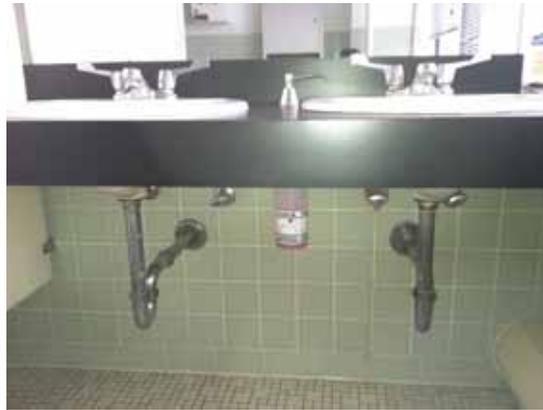
Fig. 2.1.C.2 Accessible lavatory pipes without protective insulation.

- Reconfigure non-accessible restrooms on the Third Floor to include required wheelchair maneuvering clearances and a minimum of one accessible toilet stall per restroom where possible.
- Install a minimum of one accessible lavatory with accessible fixtures per restroom on the Third Floor where not provided and wrap the lavatory pipes with insulation.
- Install accessible sinks in the break rooms throughout where possible.
- Replace existing floor mats in the Locker Rooms on the Basement Floor with floor mats in compliance with ICC/ANSI A117.1-2003.

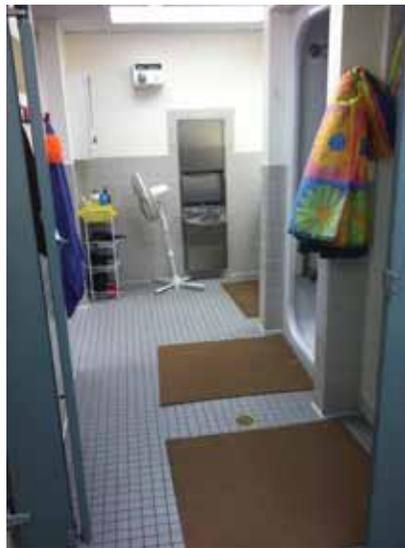
The Basement Floor has two sets of bathrooms. There are non-accessible bathrooms as well as Locker Rooms with accessible toilets, lavatories, and shower facilities. The accessible toilet stalls and lavatories in the Locker Rooms have floor mats which appear to create a potential tripping hazard and issues with safe access (see Fig. 2.1.C.3 and Fig. 2.1.C.4). According to Section 302.2 of ICC/ANSI A117.1-2003, carpet or carpet tile shall be securely attached and shall have a firm cushion, pad, or backing or no cushion or pad. Carpet or carpet tile shall have a level loop, textured loop, level cut pile, or level cut/uncut pile texture. The pile shall be 1/2 inch maximum in height and exposed edges shall be fastened to the floor and shall have trim along the entire length of the exposed edge. The edge trim must comply with Section 303.3 which states that changes in level greater than 1/4 inch in height shall be beveled with a slope not steeper than 1:2. The floor mats currently in the locker rooms have vertical sides, appear to be greater than 1/4 inch in height, and do not appear to be securely attached to the floor.

Fig. 2.1.C.3 Mats on the floor outside of the showers provide issues with approaching the accessible toilet compartment.

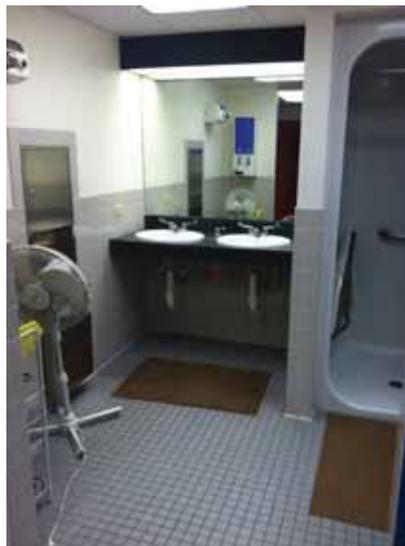
Fig. 2.1.C.4 Mats on the floor provide issues with approaching the accessible lavatory.

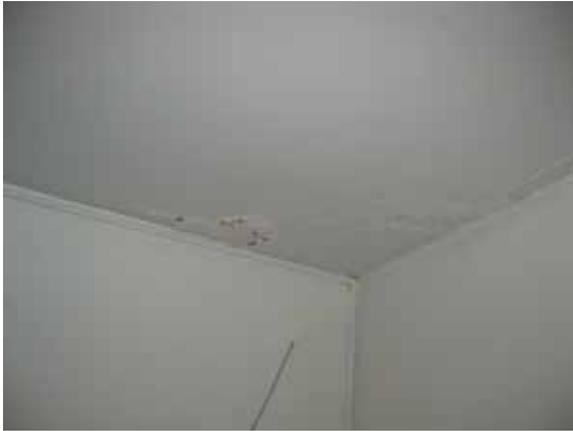
Fig. 2.2.B.1

Cracks and signs of water intrusion were observed in the basement at the south west corner (Fig. 2.2.B.1). The cracks are minor, but should be repaired to prevent water from entering the concrete and causing further deterioration.

- Inject the cracks in the basement ceiling at the southwest corner with urethane grout to prevent water intrusion and further deterioration.
- Remove the concrete overlay in the mechanical room and slope concrete surface to the floor drains.

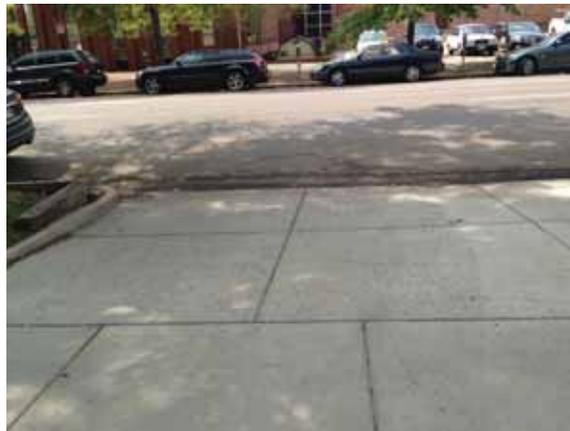
Numerous locations of broken concrete and concrete cracking was observed. Repair or replace broken or cracked concrete.

Fig. 2.3.A.6 Site Concrete Crack

- Concrete cracks approximately 1/8 inch wide or smaller showing no differential movement can be sealed using an approved joint sealant. Cracks should be routed and cleaned per an approved industry method prior to sealing.
- Concrete panels showing numerous excessive cracking and/or differential movement should be replaced.
- Replacement of concrete shall be completed in full stone segments, i.e. to the nearest joint location. Repair the subgrade materials and place new curb & gutter or sidewalk. Replace backfill materials and repair/replace any landscaping/paving disturbed during repair operations.

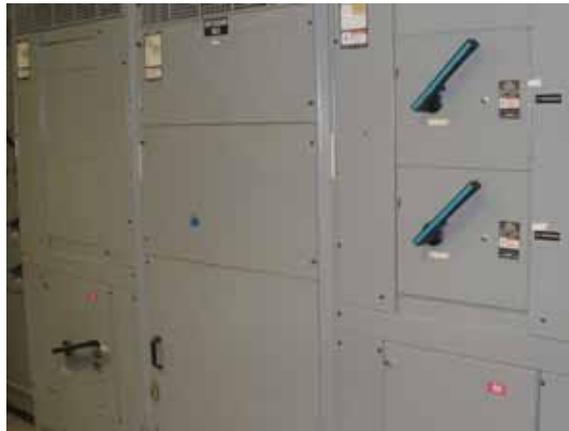
The Department of Health Care & Financing building appears to have been built sometime between 1940 and 1950 and purchased by the state about 10 years ago. Feeding the building is a 30+ year old 300kVA, 208/120V utility transformer from Xcel. Since this building was purchased after the tunnels were complete, the transformer does not connect to the utilities feeding most of the other buildings in the complex. The utility transformer feeds a 1200amp, 208/120V switchboard in the main basement electrical room (see Fig. 2.4.A.1). Each floor (one to four) has at least three electrical panels; one in the women's room door, one in the janitor closet and one by the stair door. The panelboard by the stair door on each floor appears to be 30+ years old.

Fig. 2.4.A.1 – Main Switchgear

- All panelboards past their useful life should be replaced. At minimum, all the panelboards by the stairs need to be replaced with new ones. In addition, replace the conductors feeding the panels and their loads.

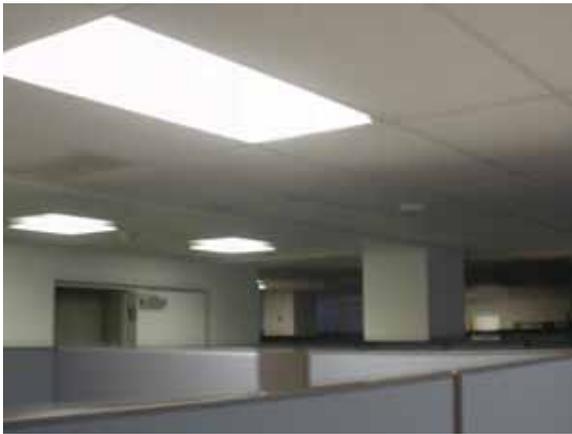
The lighting fixtures appear to be less than 10 years old and are T8 fluorescent type (see Fig. 2.4.A.2). It was reported that this building is a candidate for an LED lighting upgrade. The building is on a building management system that controls the times the lights are on in the open office spaces. There is an override button located by the entry way of every space (see Fig. 2.4.A.3).

Fig. 2.4.A.2 – Open Office Lighting

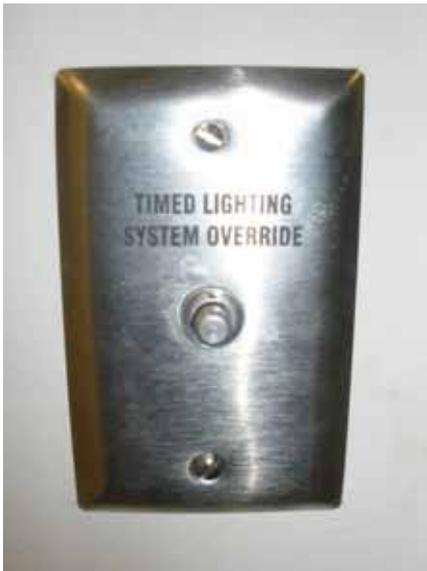
Fig. 2.4.A.3 – Lighting override switch

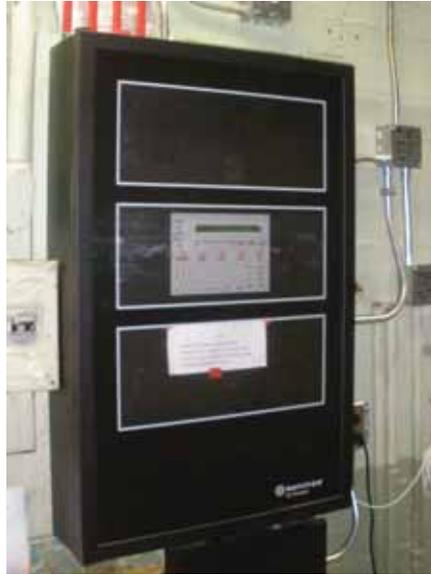
The fire alarm system appears to be less than five years old and has full detection in the building with elevator recall. The fire alarm system appears to be up to code.

Fig. 2.4.A.4 – Fire alarm control panel

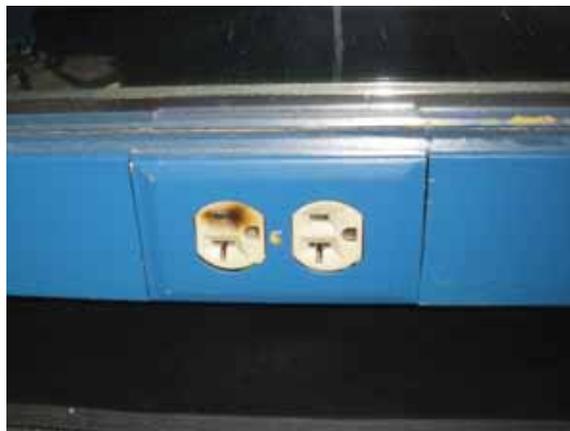
Receptacles in the office spaces appear to be less than 10 years old. The receptacles in the mechanical and basement spaces are in bad condition and past useful life (see Fig. 2.4.A.5).

Fig. 2.4.A.5 – Burned out receptacle

- Replace all of the 30+ year old receptacles and wire from associated panelboards.

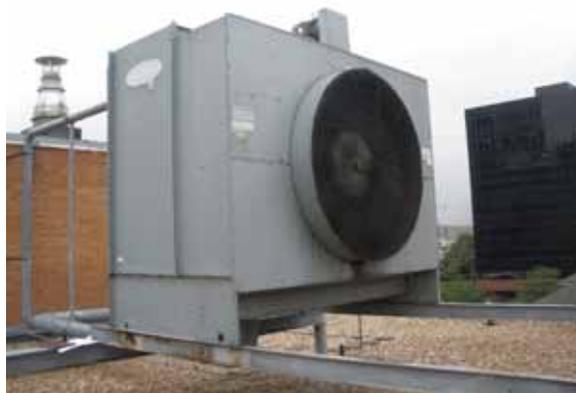
The HVAC system for the building consists of two water cooled “Trane” screw chillers located in the basement mechanical room, one cooling tower located on the roof (see Fig. 2.4.A.8) with remote sump in the basement and two “Aerco” condensing boilers located in the basement boiler room. The hydronic distribution is variable primary for both the chilled water and hot water system. The cooling capacity of each chiller is approximately 80 tons and the input heating capacity of each boiler is approximately two million Btu/hr. The hydronic distribution system is a two-pipe variable flow system. Aqua-stats have been installed on main supply and return water piping for automatic heating and cooling changeover. Chilled water distribution consists of one pump while the hot water distribution has two pumps operating on lead/lag basis. Condenser water circulation is via one pump located in the basement near the tower sump. Controls in the building are Siemens Direct Digital Controls.

Fig. 2.4.A.8 - Cooling Tower

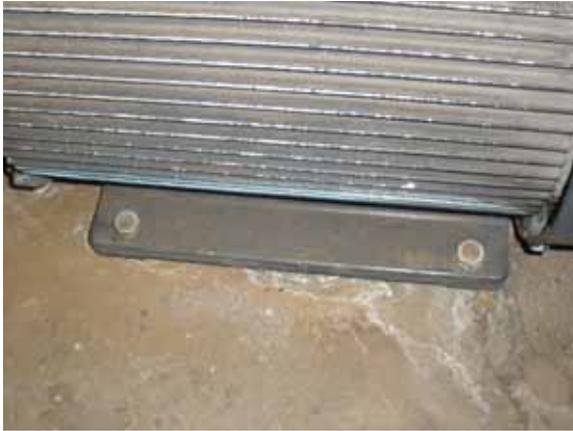
Fig. 2.4.A.12 - Condenser water pump motor installed directly on floor

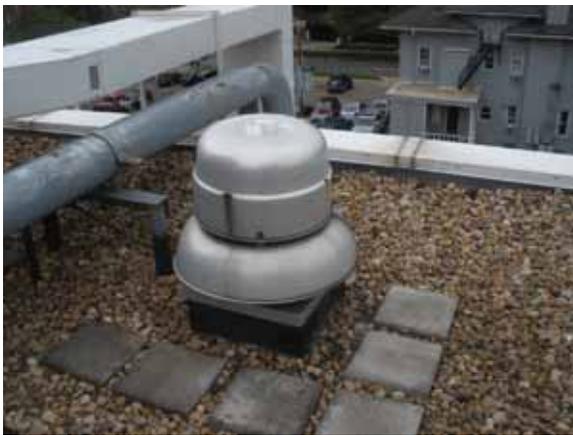
Fig. 2.4.A.13 - Toilet Exhaust Fan

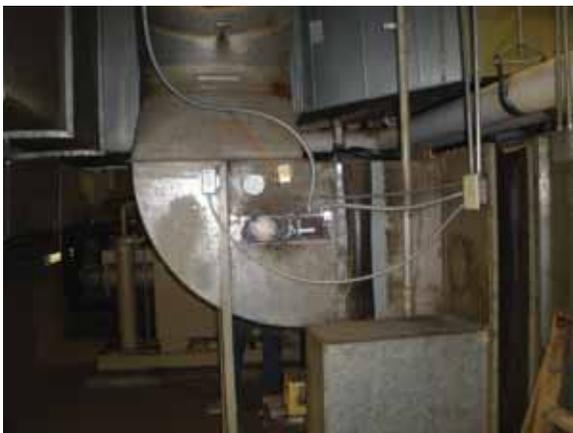
Fig. 2.4.A.14 - SA duct from AHU

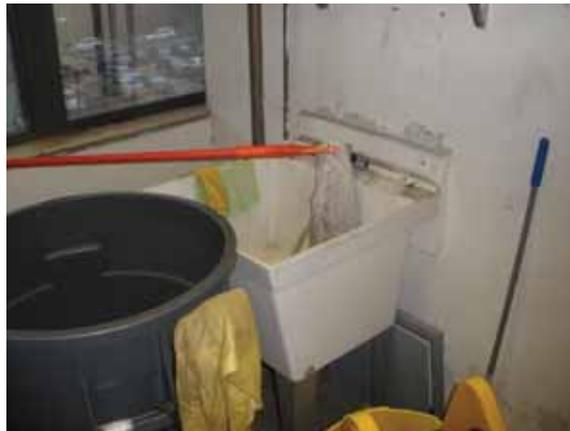
Fig. 2.4.A.16 - Janitor closet

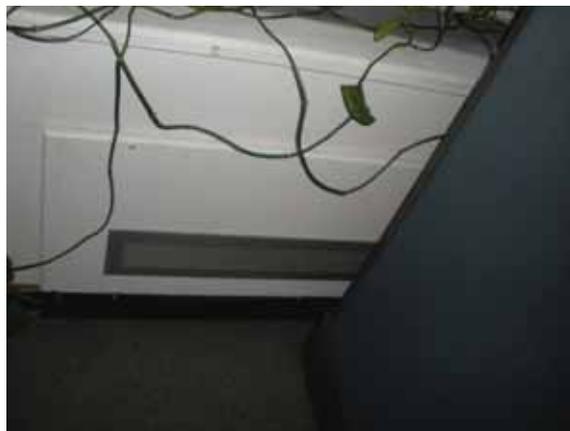
Fig. 2.4.A.17 - Induction Unit blocked

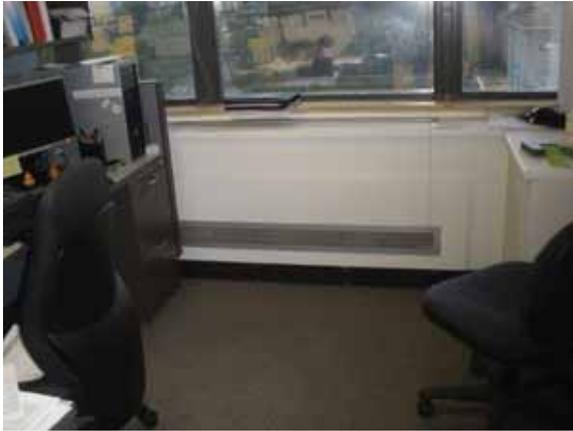
Fig. 2.4.A.18 - Perimeter units blocked by office partitions

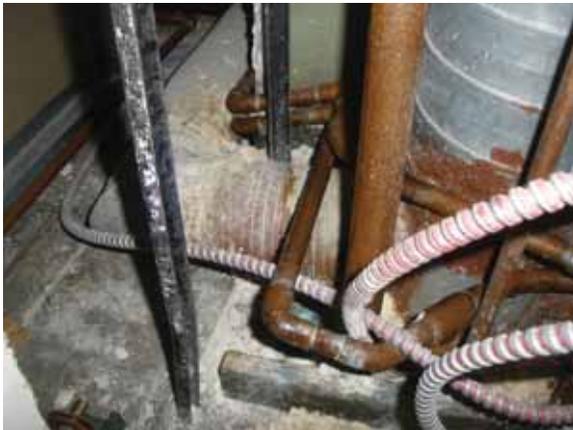
Fig. 2.4.A.19 - Un-insulated piping in the riser

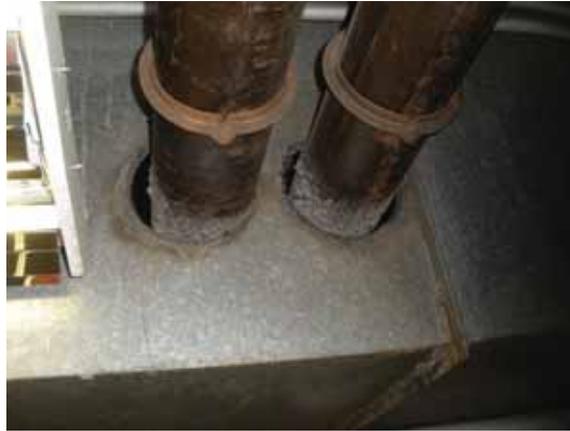
Fig. 2.4.A.21 – Pipe penetration through ductwork/no sealing around pipes

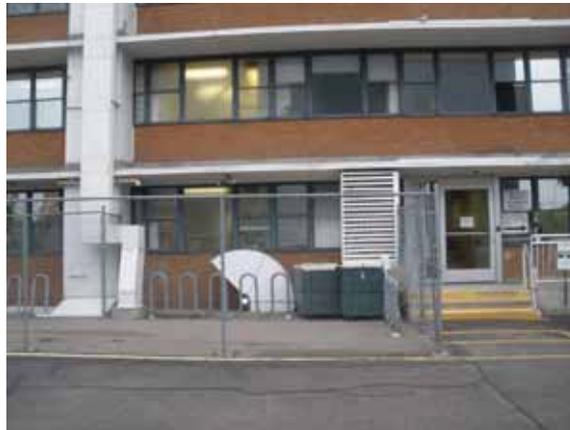
Fig. 2.4.A.22 – Outside air intake at ground level

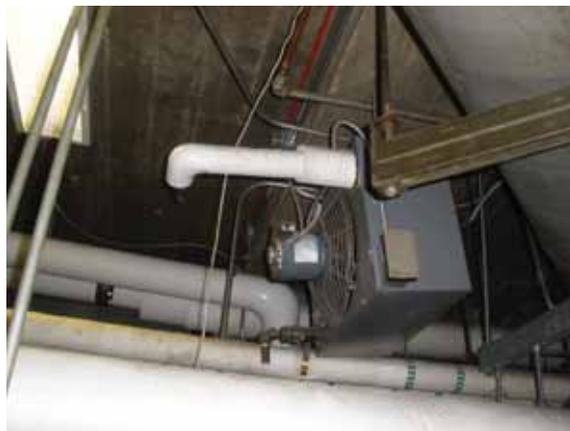
Old out of service equipment is abandoned at place. Abandoned equipment takes space away from existing equipment and future equipment see (Fig. 2.4.A.23).

Fig. 2.4.A.23 – Abandoned heater

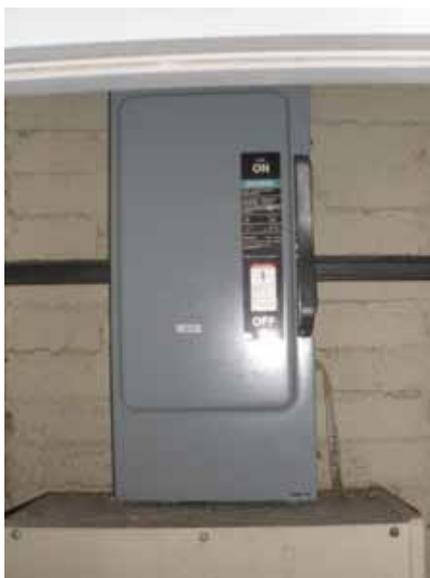
Fig. 2.4.B.1 – Disconnect switch without proper working space

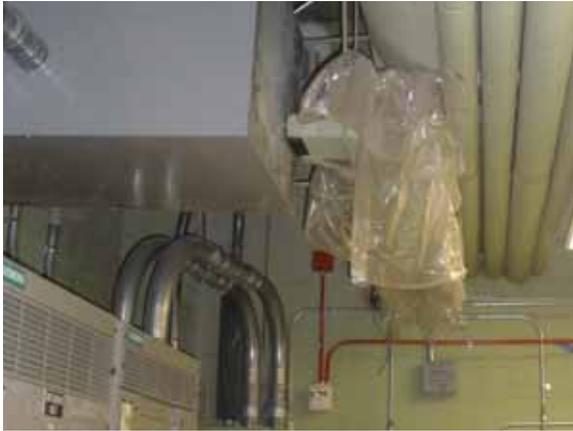
Fig. 2.4.B.2 – Plastic keeping water from electrical gear

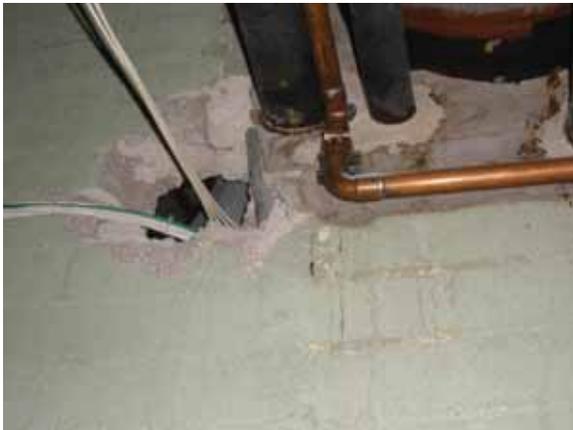
Fig. 2.4.B.3 – Penetrations not fire sealed

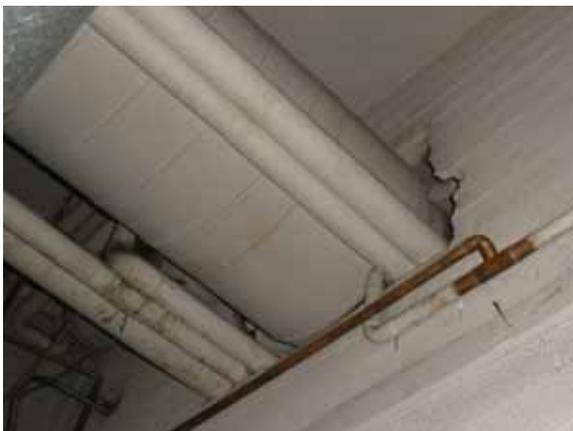
Fig. 2.4.B.4 - Penetrations not fire sealed

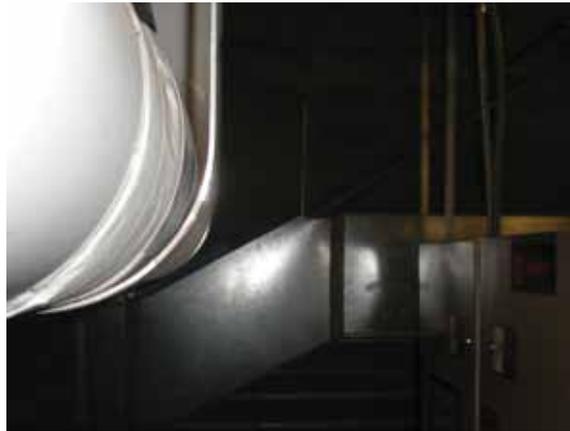
In the basement mechanical room, Chiller #2 control cabinet does not have the proper clearance to open the door completely to work on the equipment in a safe manner (see Fig. 2.4.B.6).

Fig. 2.4.B.6 – Ductwork in front of chiller control panel

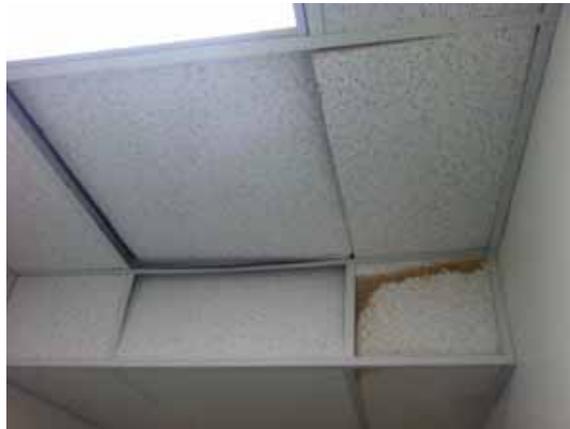
Fig. 3.0.C.3 Damaged 2x4 acoustic ceiling tiles.

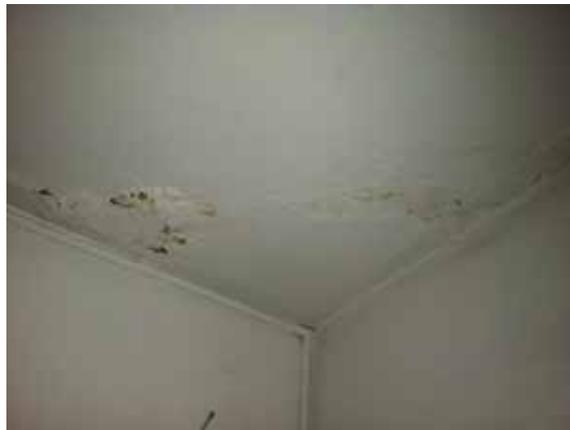
Fig. 3.0.C.4 Water damage to the ceiling along the west side of Room 026

- Repair or replace any damaged gypsum board walls and ceilings throughout, including the damaged gypsum board ceiling on the west side of Room 026.
- Paint the gypsum board walls and ceilings throughout.

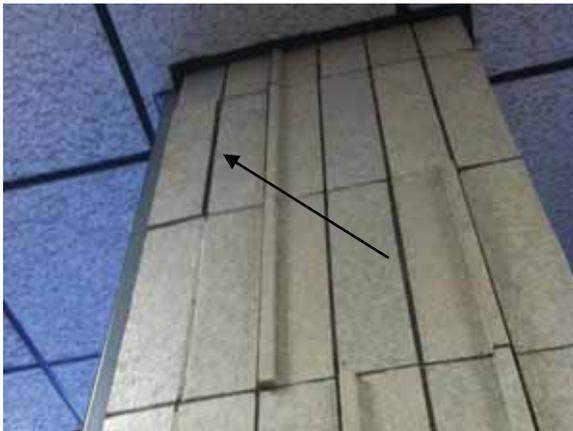
The main Grant Street Entrance consists of both painted gypsum board in fair condition and masonry veneer cladding the walls in fair to poor condition. The masonry veneer is dirty and pulling away from the wall in some locations (see Fig. 3.0.C.5 and Fig. 3.0.C.6). The gypsum board walls throughout the remaining spaces included in the site visit are in generally fair condition with typical areas of scuffed paint noted (see Fig. 3.0.C.7). There is an area of unpatched gypsum board at a previously removed wall outlet noted on the Third Floor (see Fig. 3.0.C.8). There is also an area of gypsum board near the drinking fountain outside of the Women's Restroom on the Fourth Floor with obvious water damage (see Fig. 3.0.C.9). The 4x4 inch tile wainscoting and gypsum board walls in the restrooms are in generally fair condition.

Fig. 3.0.C.6 Masonry veneer pulling away from the walls of the Grant Street Entrance lobby.

- Clean the masonry veneer cladding the walls in the Grant Street Entrance lobby and repair or replace any veneer with damage or pulling away from the wall.

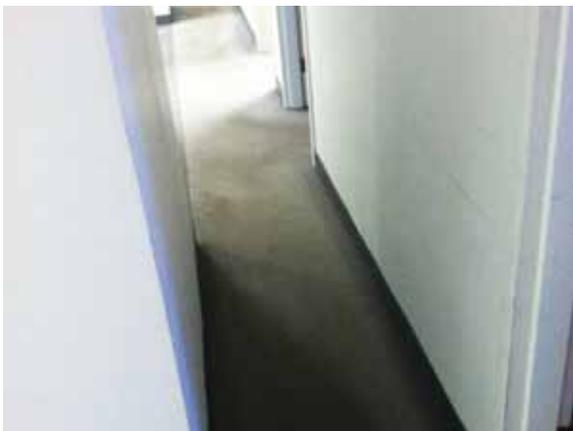
Fig. 3.0.C.7 Areas of scuffed paint on the painted gypsum board walls.

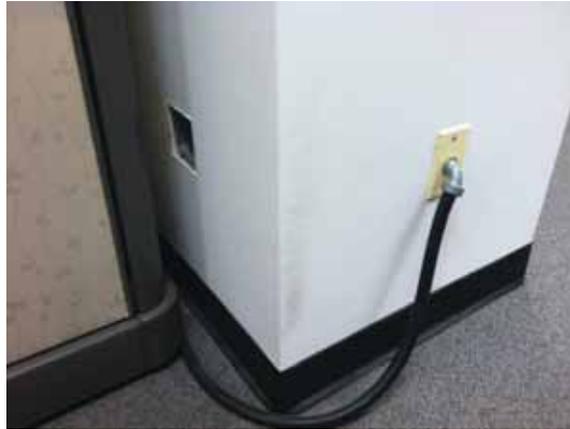
Fig. 3.0.C.8 Unpatched gypsum board at a previously removed wall outlet on the Third Floor.

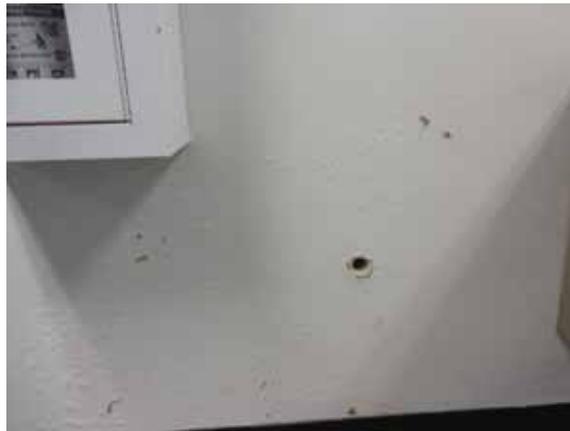
Fig. 3.0.C.9 Water damage at wall near the drinking fountain outside of the Women's Restroom on the Fourth Floor.
