CAPITOL COMPLEX MASTER PLAN

FINDINGS & RECOMMENDATIONS (F & R) NEEDS ASSESSMENT

GRAND JUNCTION STATE SERVICES BUILDING, 222 SOUTH 6TH STREET
(GRAND JUNCTION)

NOVEMBER 2014

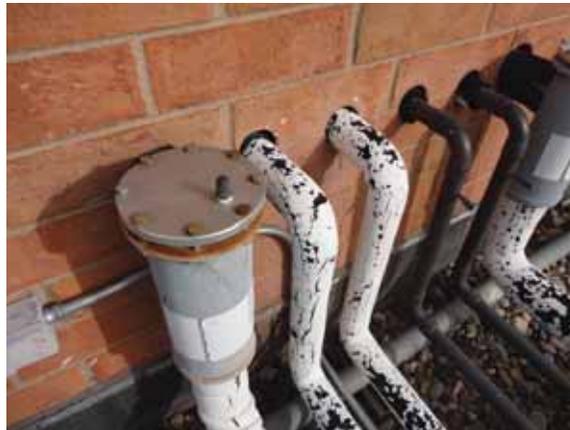
The brick cladding the building appears to be in good to fair condition overall. Soiling was observed in a few locations around the building, especially under the Colorado State Seal on the west side of the building and along control joints (see Fig. 2.1.A.1). A small portion of brick was observed to be crumbling and the sealant was noted to be deteriorating along the base of the building, potentially exposing the system to water penetration (see Fig. 2.1.A.2). The waterproofing along the base of the building on the south side was noted to be deteriorating and potentially exposing the building to water penetration as well (see Fig. 2.1.A.3). There is a metal header that is exposed and corroding above an air intake grille at the Penthouse (see Fig. 2.1.A.4). There are pipe penetrations through an area of the brick wall at the Penthouse that have not been sealed, leaving the building envelope vulnerable to water penetration (see Fig. 2.1.A.5).

Fig. 2.1.A.5 Unsealed openings around pipe penetrations at a portion of the brick walls at the Penthouse are exposing the building envelope to water penetration.

- Replace the deteriorating waterproofing along the base of the building on the south side with a new waterproofing system.
- Seal the openings around the pipe penetrations through the brick walls at the Penthouse to prevent water from penetrating the building envelope.

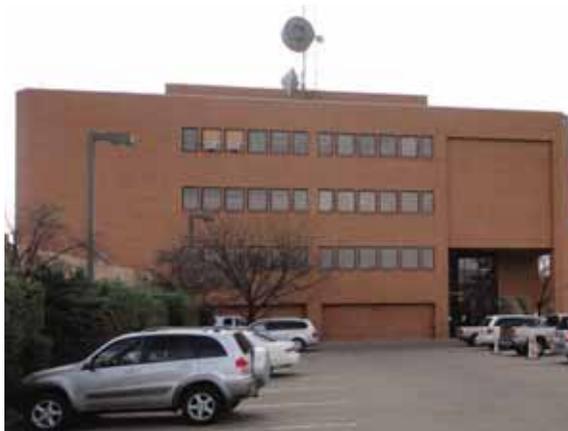
to deteriorate due to age around the building. Two of the windows have been removed on the north side of the building along the Fourth Floor due to the installation of two air conditioning window units. The window openings have been filled in with a sheet of engineered wood particle board and do not appear to have been properly waterproofed on the exterior side or insulated on the interior side (see Fig. 2.1.A.8 and Fig. 2.1.A.9).

Fig. 2.1.A.8 Two windows observed to have been removed on the north side of the building along the Fourth Floor.

- Provide waterproofing and insulation at the two windows openings on the north side of the building along the Fourth Floor with engineered wood particle board and air conditioning units.
- Remove existing sealant where deteriorating and replace with new sealant. Sealant, backup materials, and preformed joint fillers should be nonstaining.
- Repair or replace the weatherstripping at the exterior doors around the building to prevent air leakage.
- Refurbish the doors and door frames around the exterior of the building.
- Repair or replace the corroding and damaged door at the Penthouse.

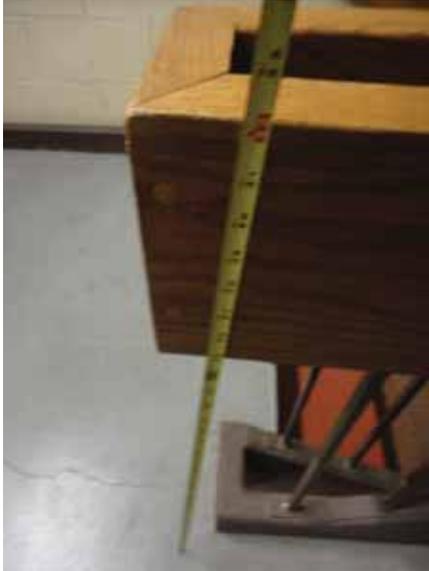
Fig. 2.1.B.2 The height to the top of the handrail measured above the stair tread nosing.

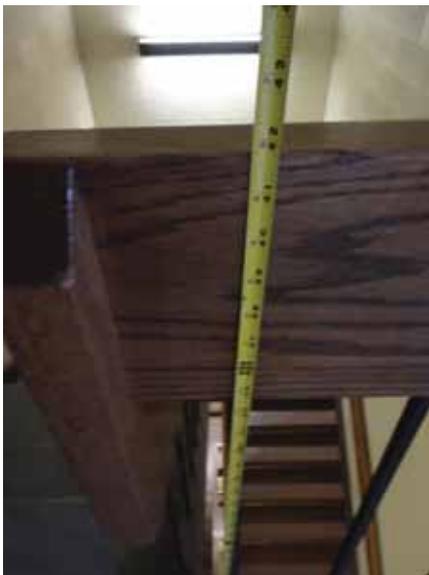
Fig. 2.1.B.3 The height to the top of the guardrail within the interior exit stairways.

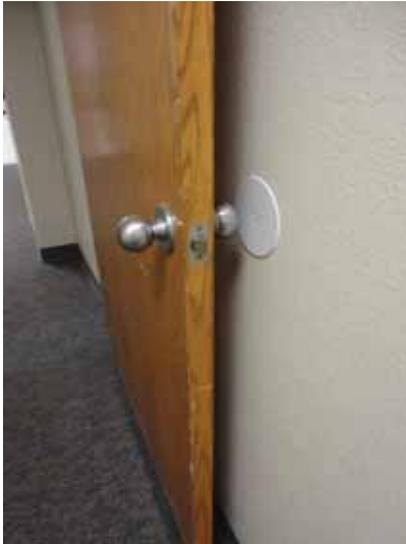
The majority of the interior doors throughout the building, including the doors to the interior exit stairways, are equipped with knob-style door handles (see Fig. 2.1.B.5). According to Section 309.4 of the 2003 edition of ICC/ANSI A117.1, the knob-style handles do not meet the requirement that: operating mechanisms shall be operable with one hand and shall not require tight grasping, pinching, or twisting of the wrist. Section 309.4 further states that the force required to activate operable parts shall be 5.0 pounds (22.2 N) maximum. A few lever-style handles were noted during the site survey visit. A few automatic door openers were noted during the site survey visit (see Fig. 2.1.B.6). It was noted that the restroom doors are generally equipped with pull-style door handles with push plates on the interior side (see Fig. 2.1.B.7).

Fig. 2.1.B.5 Typical knob-style door handle found throughout the building.

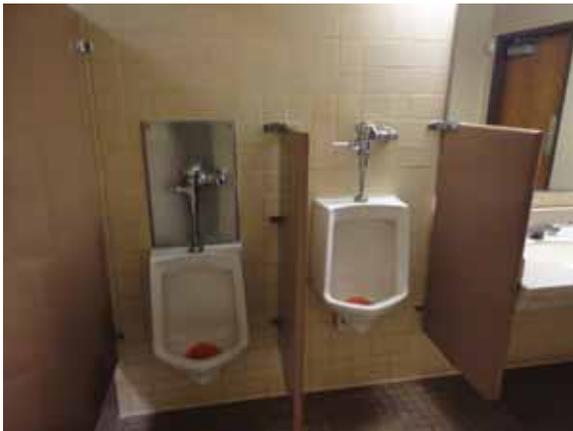
Fig. 2.1.C.4 The width of the urinal alcove is too narrow per accessibility standards.

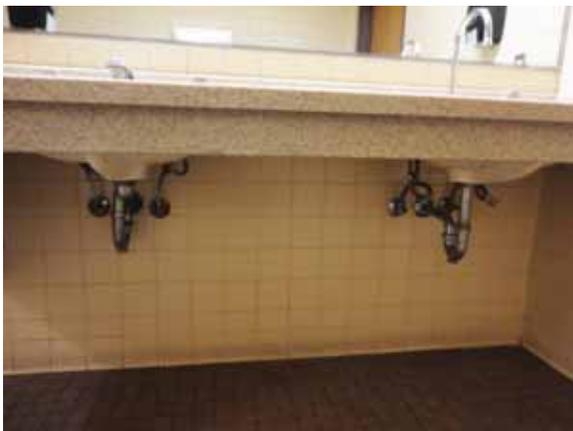
Fig. 2.1.C.5 Typical instance of an otherwise accessible lavatory without insulation wrapped around the pipes.

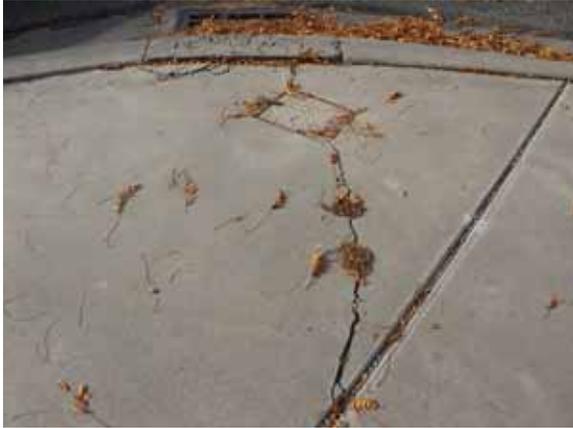
The site concrete appears to be in fair condition. Locations of broken concrete, concrete settling and concrete cracking were observed. Repair or replace broken or cracked concrete.

Figure 2.3.A.4 – Site Concrete Crack, Recommended for Replacement

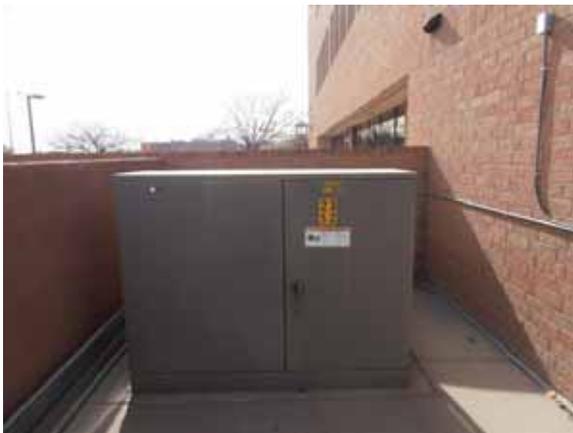
Fig. 2.4.A.1 – Utility transformer

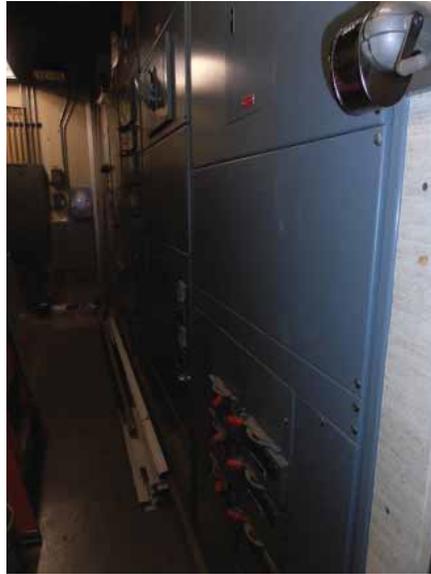
The main electrical room is located in the northeast corner of the building. It contains the 1200 amp main switchboard and other panelboards and transformers (see Fig. 2.4.A.2 and Fig. 2.4.A.3).

Fig. 2.4.A.2 – Main switchboard

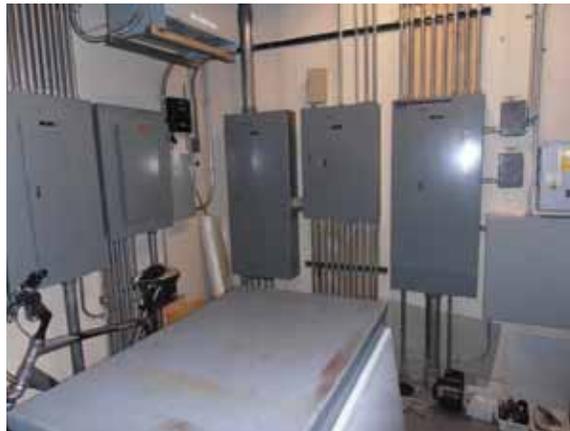
Fig. 2.4.A.3 – Panels and transformers

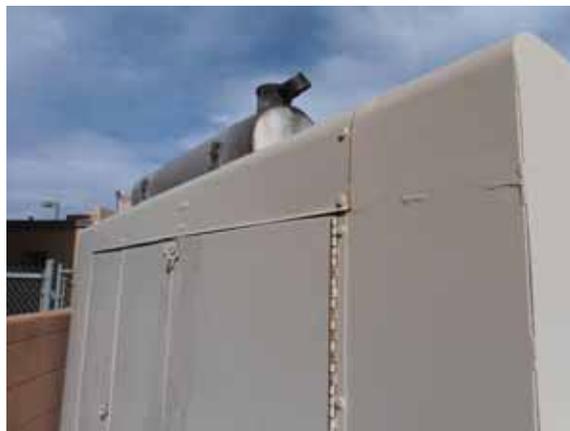
There are two generators serving this building (see Fig. 2.4.A.4 and Fig. 2.4.A.5). The diesel emergency generator is located on the northeast corner of the building. It provides emergency power to the lighting, fire alarm system, fire pump, and all other life safety loads. The other generator is a natural gas generator located on the roof and provides backup power to the server room on the fourth floor. To maintain power while the generator gets up to speed, there is an Uninterrupted Power Supply (UPS) system to power the servers for a few seconds and then the load is switched over to the generator.

Fig. 2.4.A.4 – Diesel generator

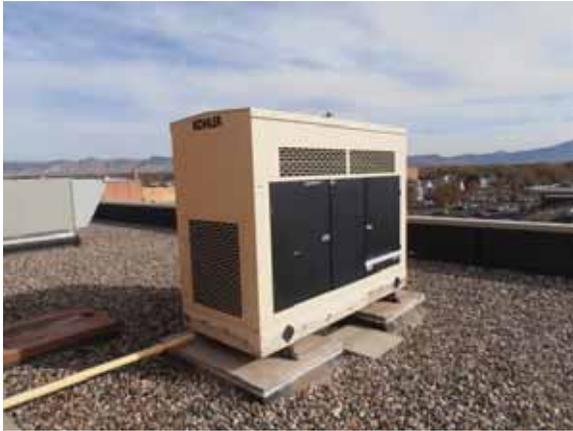
Fig. 2.4.A.5 – Natural gas generator

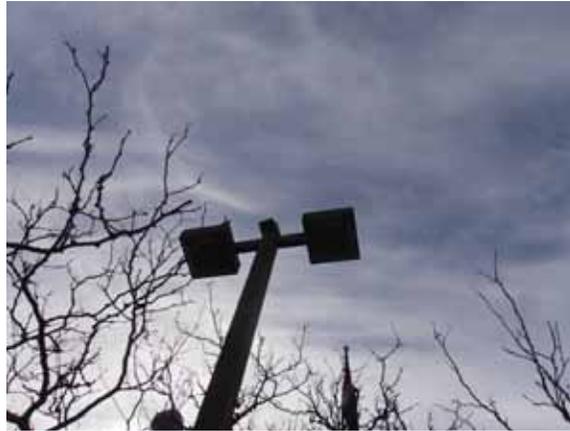
The parking lot and exterior luminaires are older metal halide (see Fig. 2.4.A.7). Some of the building luminaires have been upgraded to LED fixtures.

Fig. 2.4.A.7 – Site Luminaire

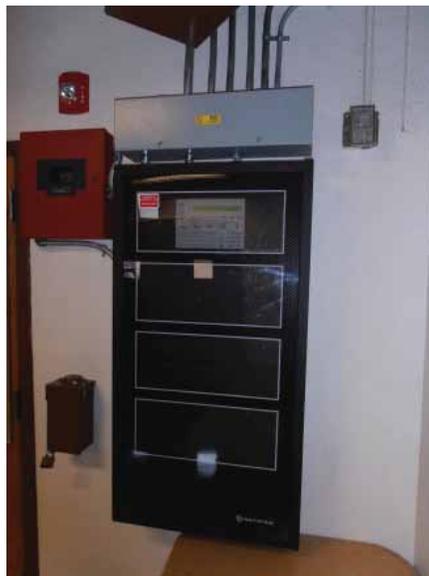
The fire alarm system is a Notifier system with full detection and pull stations that was installed within the last three years (see Fig. 2.4.A.8 and Fig. 2.4.A.9).

Fig. 2.4.A.8 – Fire alarm control panel

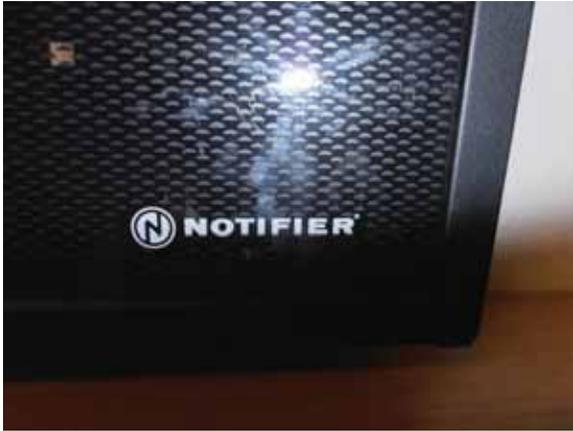
Fig. 2.4.A.9 – Notifier system

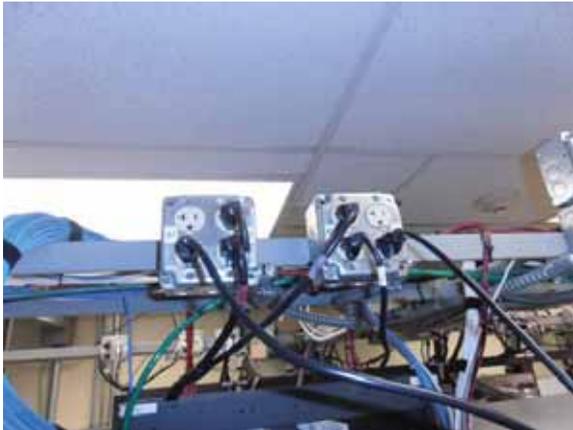
The building's receptacles appear to be in good working condition (see Fig. 2.4.A.10 and Fig. 2.4.A.11).

Fig. 2.4.A.10 – Server room receptacles

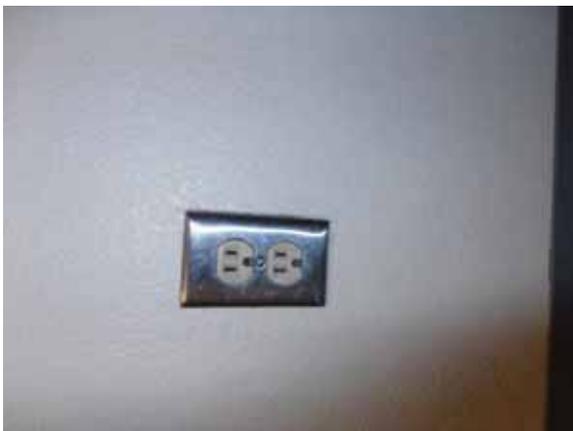
Fig. 2.4.A.11 – General purpose receptacle

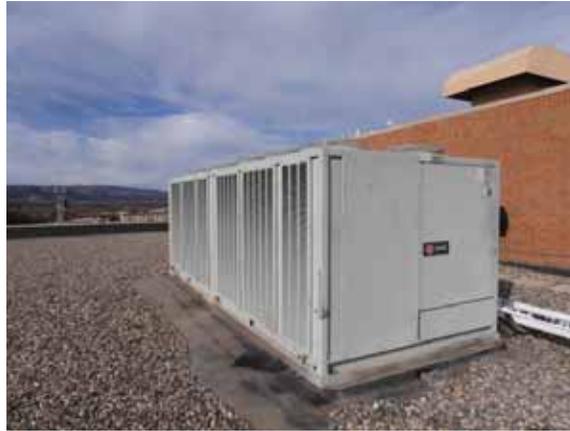
Fig. 2.4.A.12 – Rooftop unit

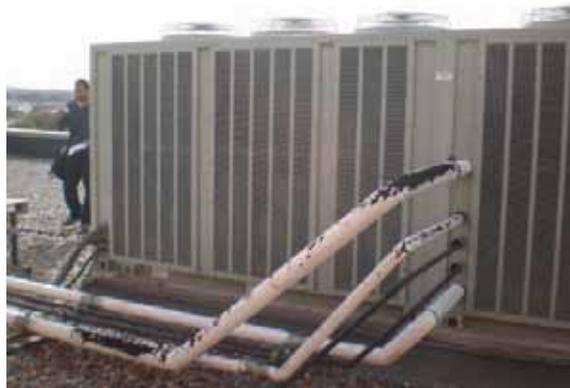
The main Trane DX condensing unit serving the built-up AHU appears to be at the end of its useful working life and needs replacement. It was indicated that replacing the unit is under discussion with the state officials. The condition of supply and return air fans appear to be satisfactory. The other DX units serving telecommunication and microwave server room are maintained by the building tenants.

Fig. 2.4.A.13 – Trane DX condensing Unit

- Replace Trane condensing unit with new, more efficient unit. It was noted that approval for replacement will be obtained from state.
- Clean and overhaul central supply and return fan. It appears there is some grease leakage which needs cleaning.

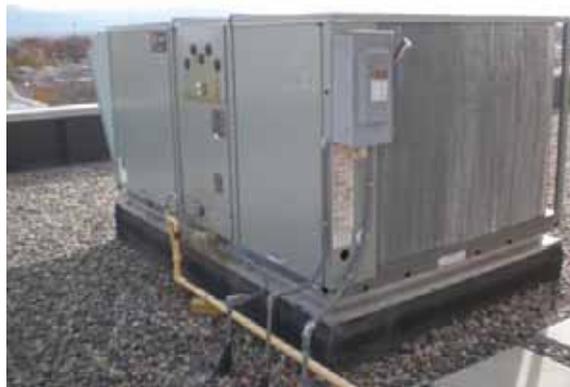
Fig. 2.4.A.14 – Trane RTU serving microwave server room

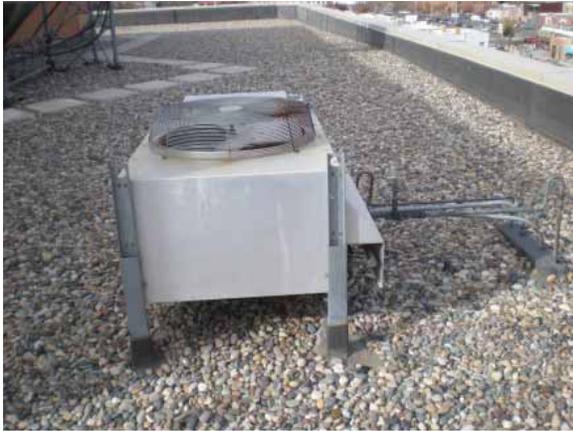
Fig. 2.4.A.15 – Condensing unit serving telecom room

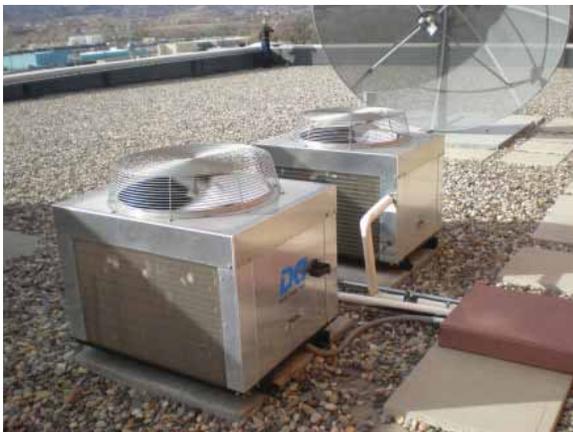
Window air conditioners (see Fig. 2.4.A.30) are provided for telecom server room since the ac unit serving telecom room is not working (see Fig. 2.4.A.16). The old non-functioning unit which serves the telecom server room should be replaced with new unit to condition the space. Redundant backup unit may be provided.

Fig. 2.4.A.16 – Data Air condensing units

- Window air conditioners are being provided for the telecom server room since the main ac unit is not working. Replace the old Data Air unit with new unit and if required provide redundant unit as backup to keep the room at design conditions.

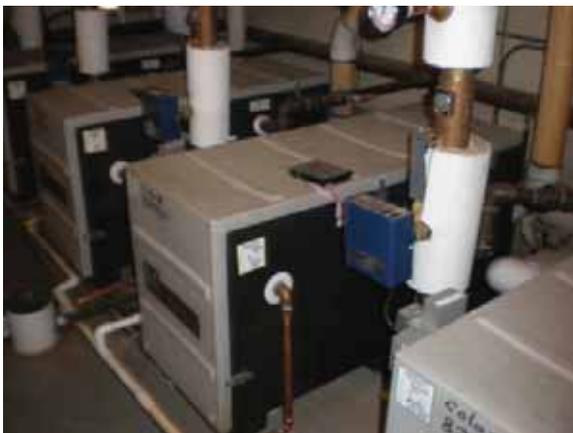
Fig. 2.4.A.17 – Hot Water Boilers

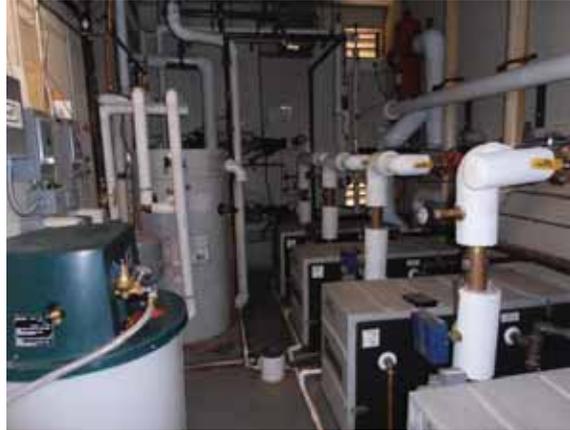
Fig. 2.4.A.18 – Boiler room

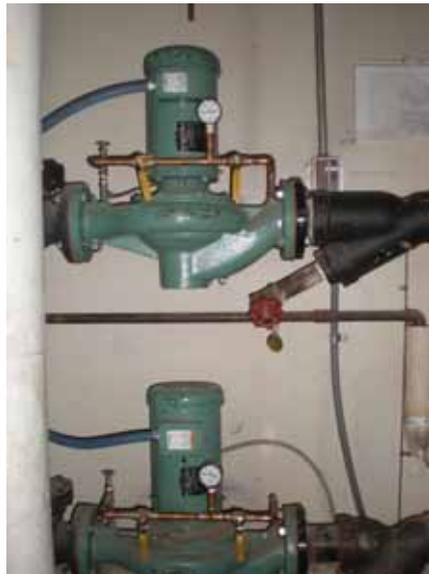
Fig. 2.4.A.19 – Hot water distribution pumps

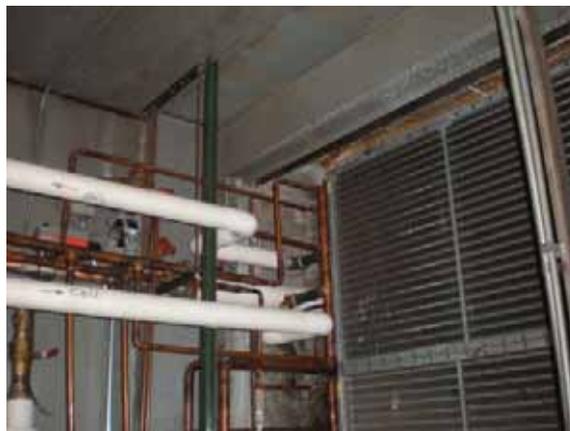
The built-up AHU consists of supply and return air fans, a DX cooling coil and a HW heating coil (see Fig. 2.4.A.20). Both fans have Variable Frequency Drive (VFD) to vary airflow in the space as per load conditions. The unit has been modified over the years. The supply and return fan motors are not premium efficiency (Fig. 2.4.A.28). The evaporative cooling section which was part of original built-up AHU has been removed by the maintenance personnel since it was not performing as intended. The built-up AHU supply fan has inlet guide vanes (see Fig. 2.4.A.25) which are not in

Fig. 2.4.A.20 – Built-up AHU hot water heating coil

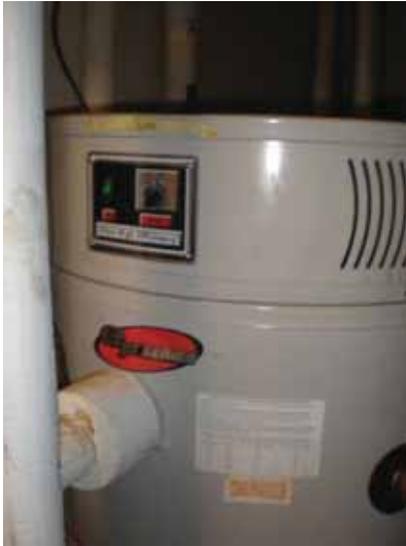
Fig. 2.4.A.21 – Domestic hot water heater

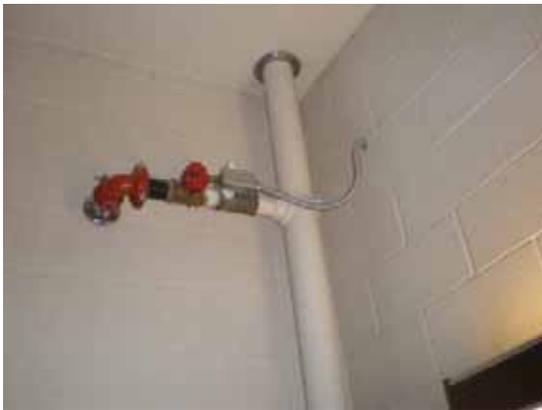
Fig. 2.4.A.22 – Stairwell stand pipe

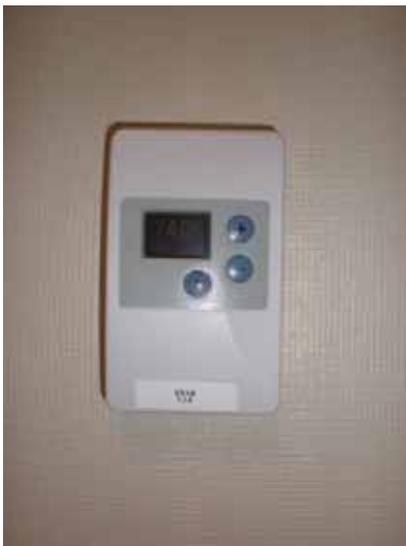
Fig. 2.4.A.23 – Digital space temperature sensor

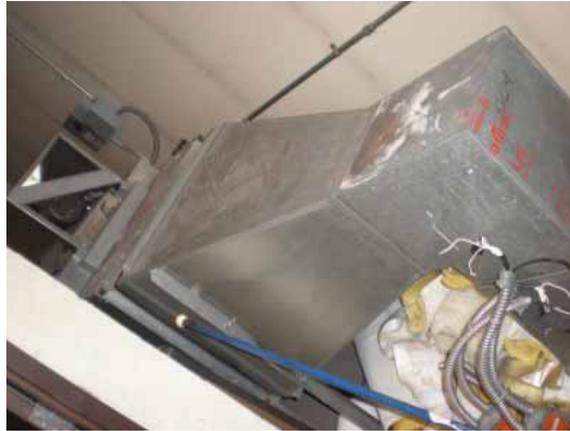
Fig. 2.4.A.24 – In-line toilet exhaust fan

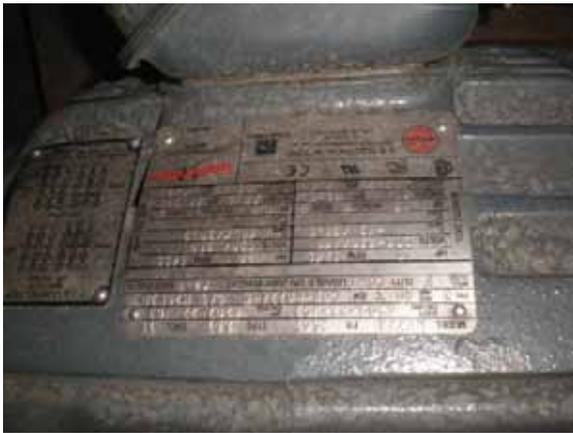
Fig. 2.4.A.28 – Supply fan motor name plate

- Provide missing insulation on hot water and refrigerant pipes connected to central hot water and DX coils.
- Provide premium efficiency motors for main supply and return air fans. This will reduce fan energy consumption which will result in energy cost savings.

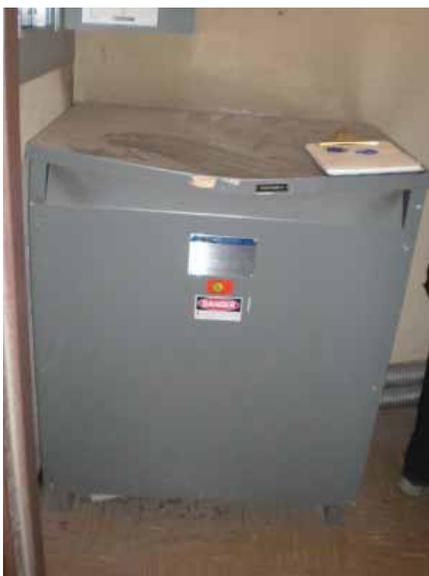
The ventilation for electrical rooms is via central AHU system. The ventilation for the third floor electrical room is inadequate as room temperature appeared to be high (see Fig. 2.4.A.29). It is recommended to verify the electric room load and provide ventilation as per the load.

Fig. 2.4.A.29 – Transformer in third floor electrical room

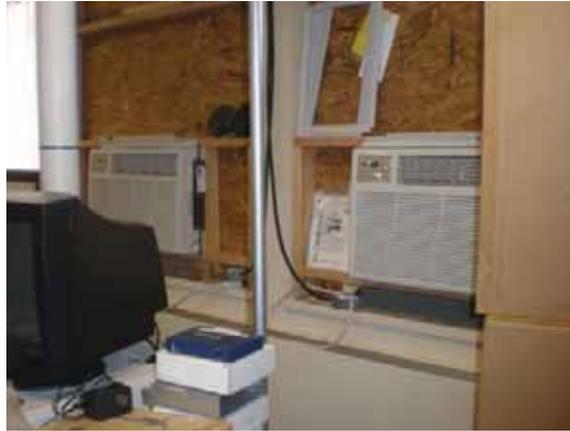
Fig. 2.4.A.30 – Window air-conditioners for telecom room

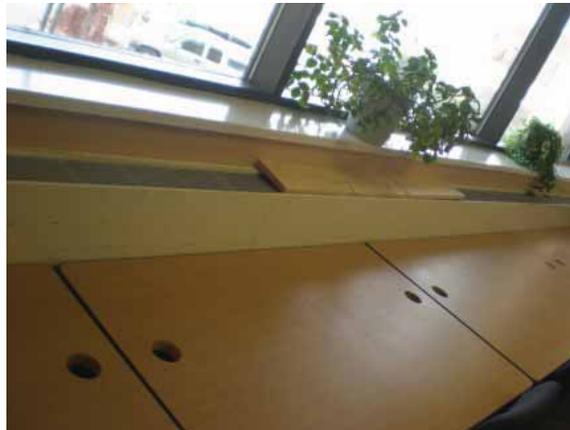
Fig. 2.4.A.31 – Baseboard outlet blocked with wood

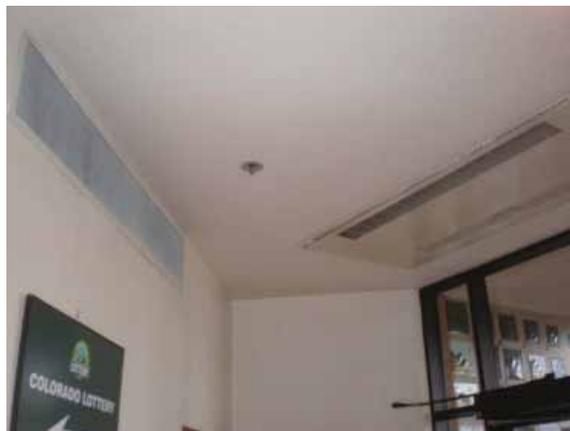
Fig. 2.4.A.32 – Sprinkler head close to cabinet heater

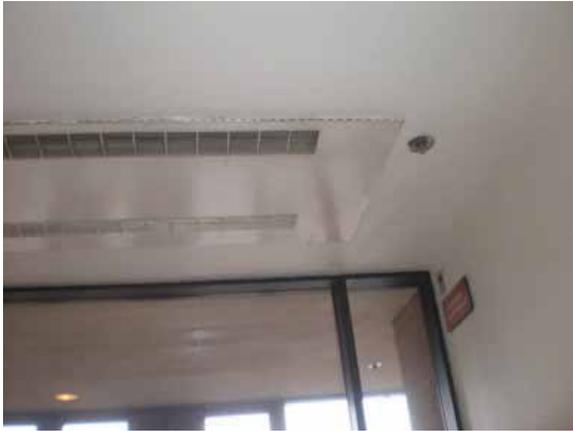
Fig. 2.4.A.33 – Sprinkler head too close to cabinet heater

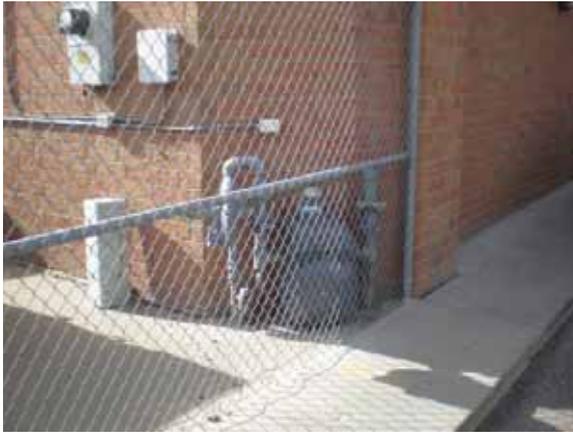
Fig. 2.4.A.34 – Electrical meter close to gas meter

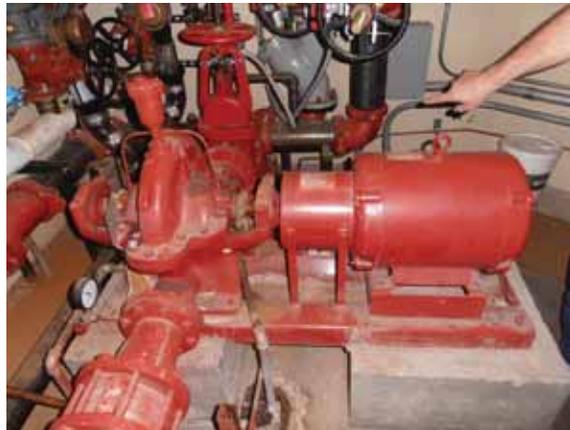
The fire pump room layout does not meet current code requirements. Some of the deficiencies notices are: (1) Section 4.12.1.1.6 (1) clearance between components for installation and maintenance; (2) clearance between components and the wall for installation and maintenance; (2) Section 4.12.2 Equipment Access; (3) Jockey pump is installed directly on the floor without any housekeeping pad. The pipes connected to jockey pump are not supported from wall. Discuss these with AHJ and follow their directive.

Fig. 2.4.B.3 – Fire pump room

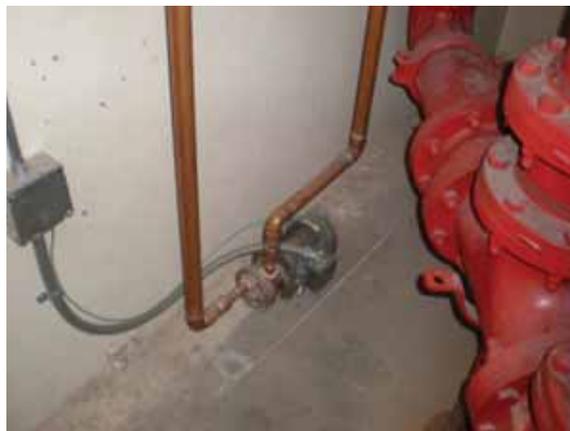
Fig. 2.4.B.4 – Fire pump room – Jockey pump

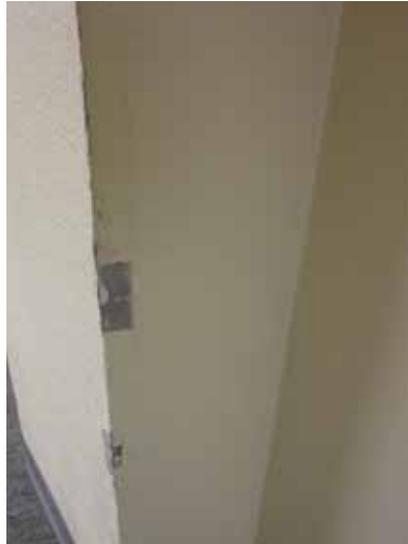
Fig. 3.0.C.3 General wear-and-tear at areas of the gypsum board walls noted on the Third Floor.

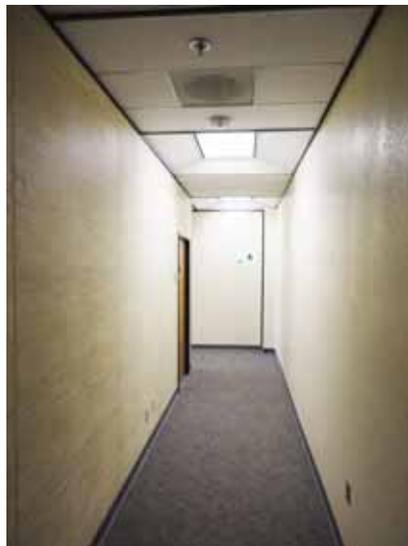
Fig. 3.0.C.4 Deteriorating and soiled wallcovering noted during the site survey visit.

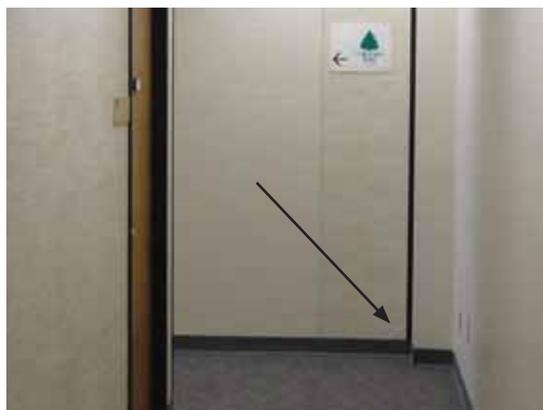
Fig. 3.0.C.5 Deteriorating and damaged wallcovering noted during the site survey visit.

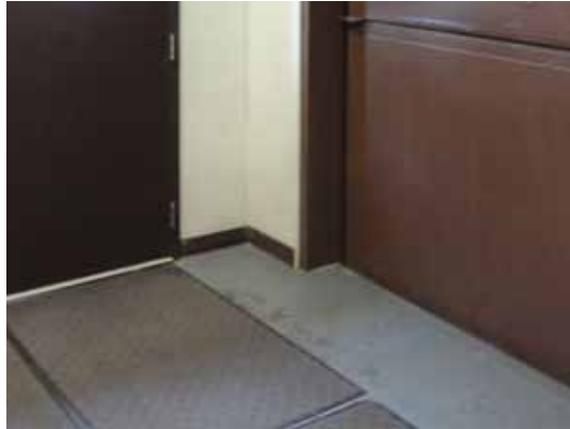
Cracking of the concrete flooring was noted at an interior exit stairway landing included in the site survey visit (see Fig. 3.0.C.12). Worn paint was observed at the concrete flooring in the employee entrance and freight elevator lobby on the east end of the north side of the First Floor (see Fig. 3.0.C.13). A portion of the rubber flooring on the stairs was observed to have been taped down and is creating a potential tripping hazard (see Fig. 3.0.C.14).

Fig. 3.0.C.13 Worn paint noted at the concrete flooring in the employee entrance and freight elevator lobby on the east end of the north side of the First Floor.

- Remove any paint wearing off of the concrete flooring throughout and repaint to match existing.
- Repair or replace any damaged and deteriorating rubber flooring on the surface of the stairs throughout the interior exit stairways.

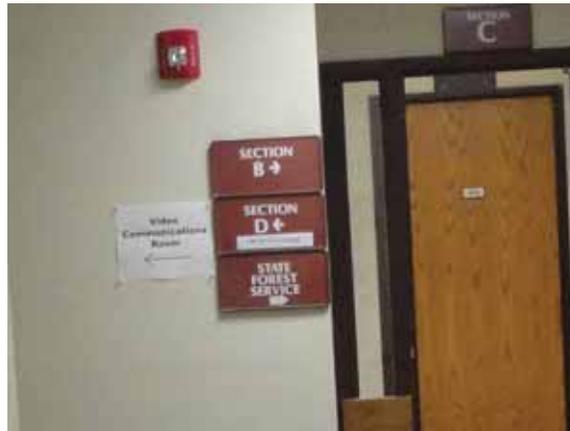
The interior signage throughout the building was noted to be deteriorating and worn overall (see Fig. 3.0.C.18). There were also a number of signs printed on paper and posted throughout the building observed during the site survey visit (see Fig. 3.0.C.19).

Fig. 3.0.C.19 Printed paper signs noted throughout the building during the site survey visit.
